# NATIONAL TRANSPORTATION SAFETY BOARD

## MATERIALS LABORATORY FACTUAL REPORT

Report No. 21-043

Place : San Juan, Puerto Rico  
Date : June 2, 2020  
Vehicle : Piper PA-23-250, N14181  
NTSB No. : ERA20LA202  
Investigator : Timothy Monville, AS-ERA

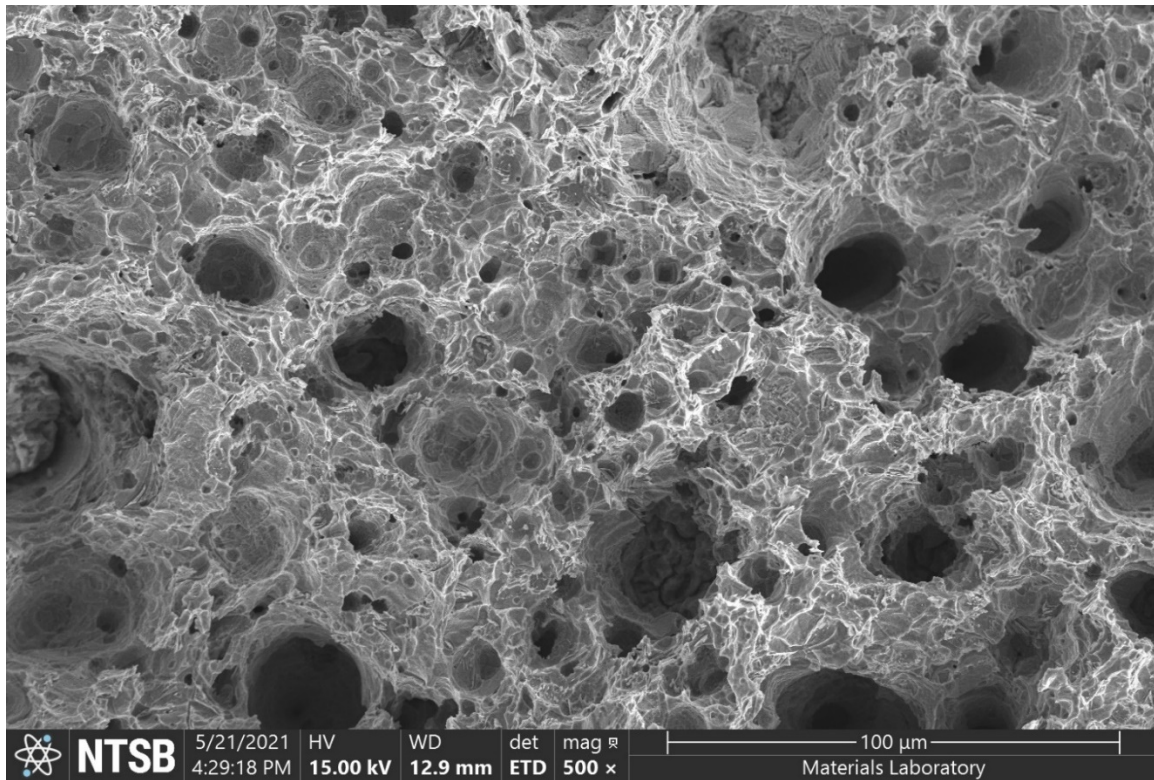
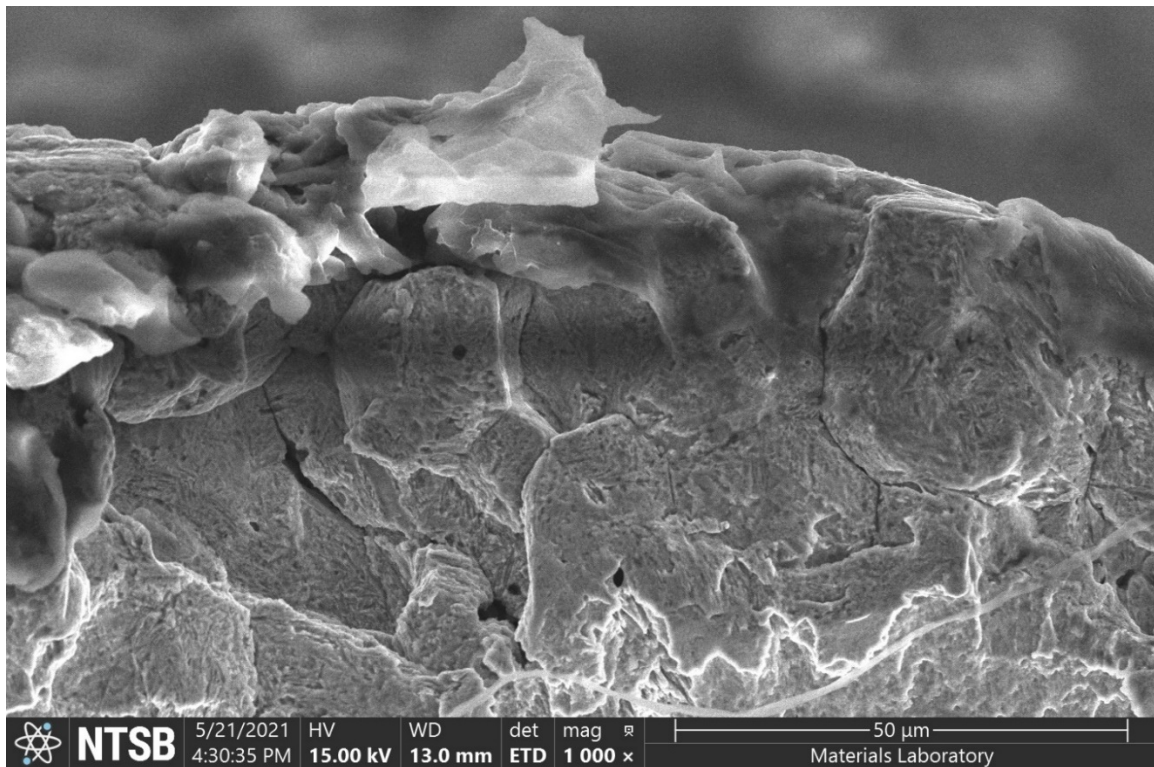
Figure 20 shows the ball side fracture surface, after cleaning. Due to the degree of post-fracture contamination, the surface had to be repeatedly cleaned. The removal of the salts and oxides left much of the fracture surface damaged. However, selected areas did exhibit discernible fracture features that could be observed using a SEM. Figure 21 shows a typical area of the interior of the fracture surface, revealing dimpled rupture. Figure 22 shows a typical outer area of the fracture surface, exhibiting intergranular fracture features. These features were consistent with those of the mating fracture surface from the lever side.

Figure 21 – SE micrograph of dimpled rupture from the neck fracture surface.

Figure 22 – SE micrograph of intergranular fracture from the neck fracture surface.

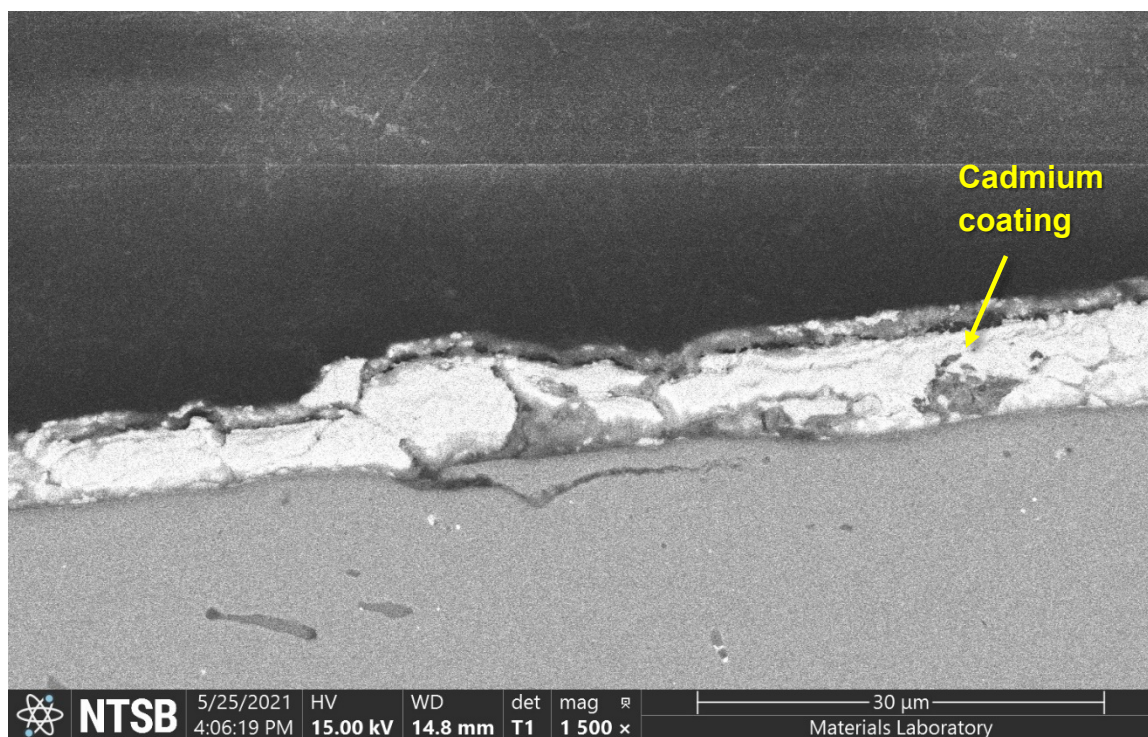
The ball remnant was cold epoxy mounted under vacuum, then ground, polished and etched using 2% Nital solution.<sup>2</sup> Figure 23 shows a typical cross section through the exterior surface, revealing the surface Cd coating layer (exhibiting brighter contrast). In this figure, there was a shallow angled crack. However, no other cracks were observed, including along or near the fracture surface.

Figure 23 – BE micrograph of a cross section of the neck surface, showing the external cadmium coating and a shallow surface crack.

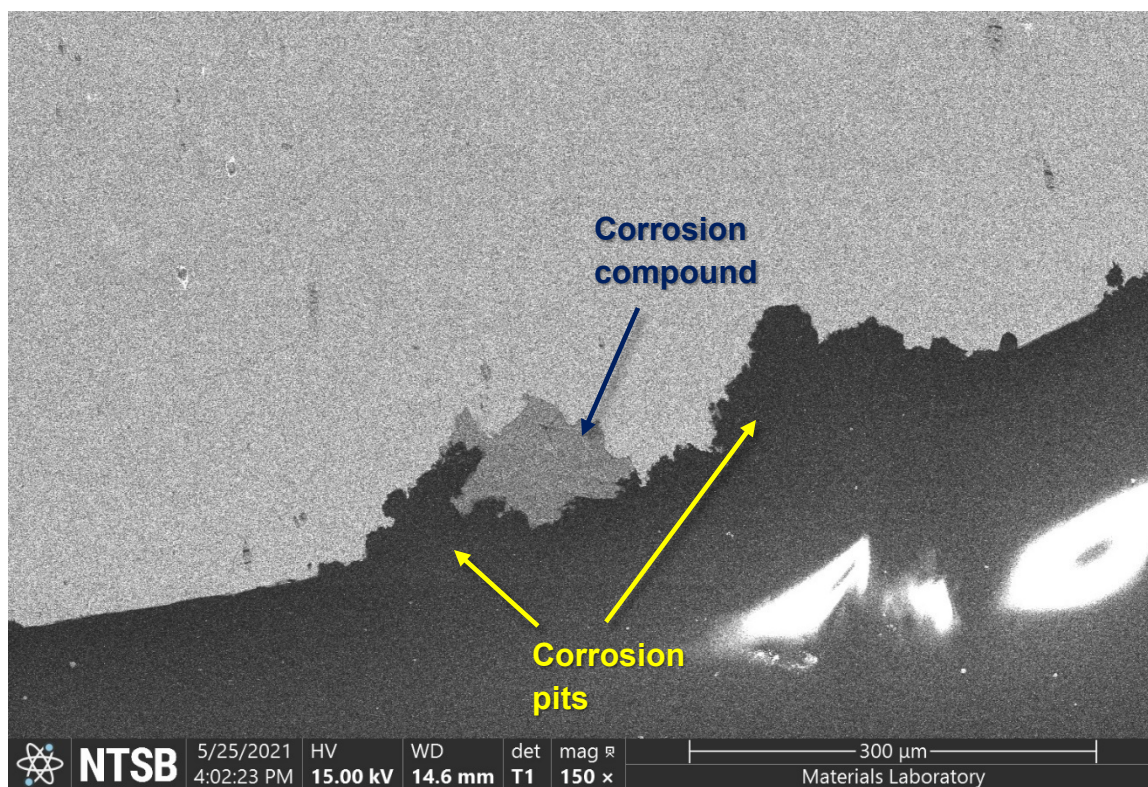
Along the surface of the spherical ball, areas of corrosion pitting were found, as typified in Figure 24. These pits did contain corrosion compounds, which contrasted dark in Figure 24. Using EDS, these corrosion compounds were consistent with iron oxides.

Figure 24 – BE micrograph of a corrosion pit on the neck surface with corrosion products.

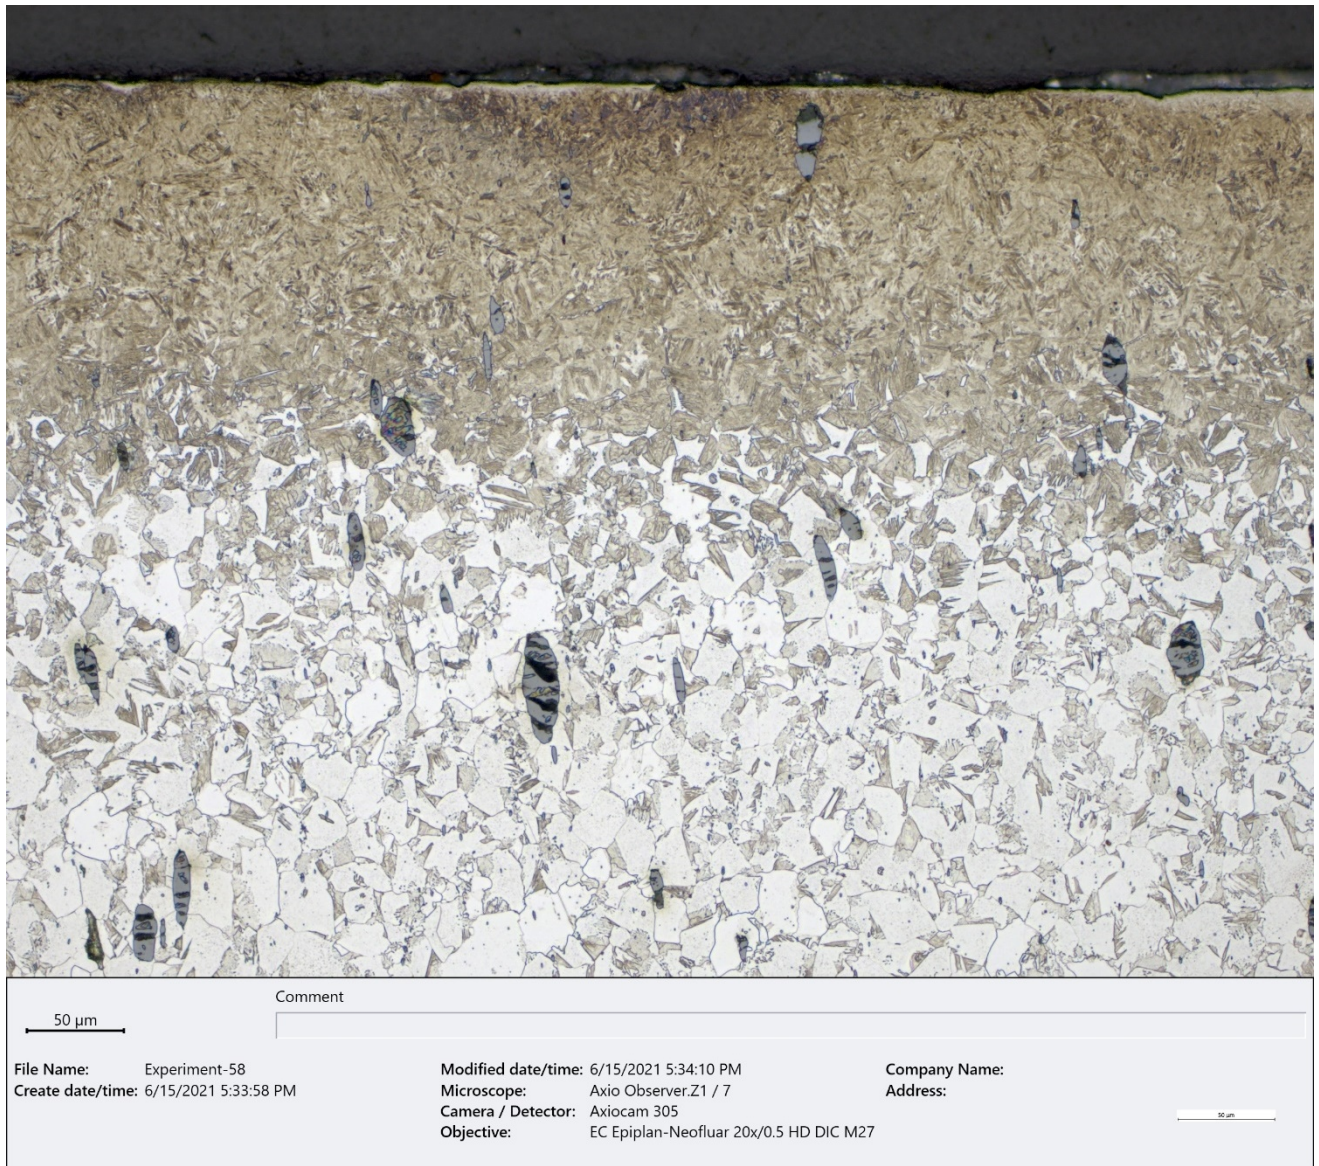
Figure 25 shows an optical cross section through the surface of the ball screw remnant after etching. The micrograph revealed a darker appearance at the surface,

contrasting with the lighter interior regions. The dark-etched regions were consistent with a case hardening treatment, such as carburizing. Examination of the drawing for the spring type ball joint assembly (P/N 31747) stated that the ball screw was to be case hardened 0.005 to 0.007 inches deep.

The cross-sectional hardness of the ball screw was examined using an automated microindentation hardness tester per ASTM E384.<sup>3</sup> The surface exhibited a hardness of 57 HRC (628 HV<sub>500</sub>), whereas the core hardness averaged 77 HRB (142 HV<sub>500</sub>).<sup>4,5</sup> The depth of the case hardening was 0.0035 inches, consistent with those seen in the intergranular region on the fracture surface and the darker case-hardened region in the optical metallograph.

Figure 25 – Bright-field (BF) optical micrograph of a cross-section through the surface of the fractured ball screw remnant. The darker areas were the carburized surface, with the core microstructure below (~200X, etched 2% Nital).

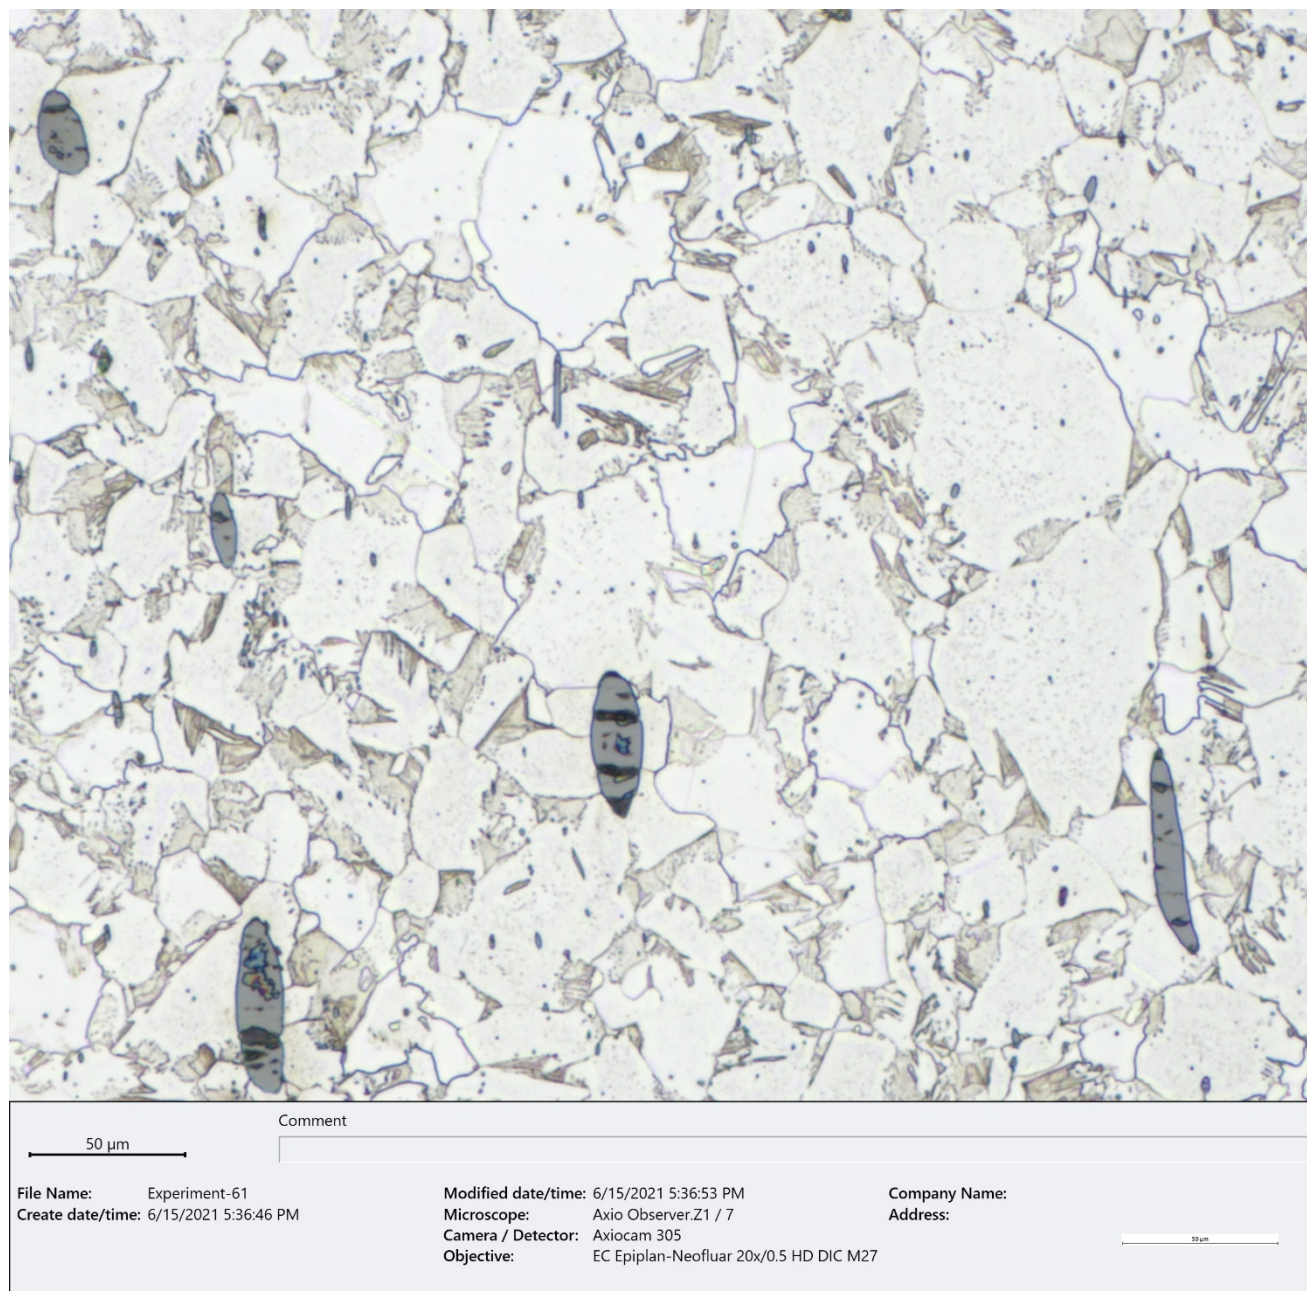
Figure 26 shows a closer view of the core microstructure of the ball screw. This microstructure exhibited ferrite grains (lighter) with smaller darker areas of pearlite and limited martensite (brown). The microstructure also exhibited ellipsoid second phase particles, consistent with manganese sulfide stringers. A closer view of these particles using SEM and EDS revealed them to be manganese sulfide (MnS) with small amounts of Pb. These characteristics were consistent with a resulfurized leaded steel, designed for easier machinability.

Figure 26 – BF optical micrograph of the core microstructure, showing the ellipsoid second phase particles (~500X, etched 2% Nital).

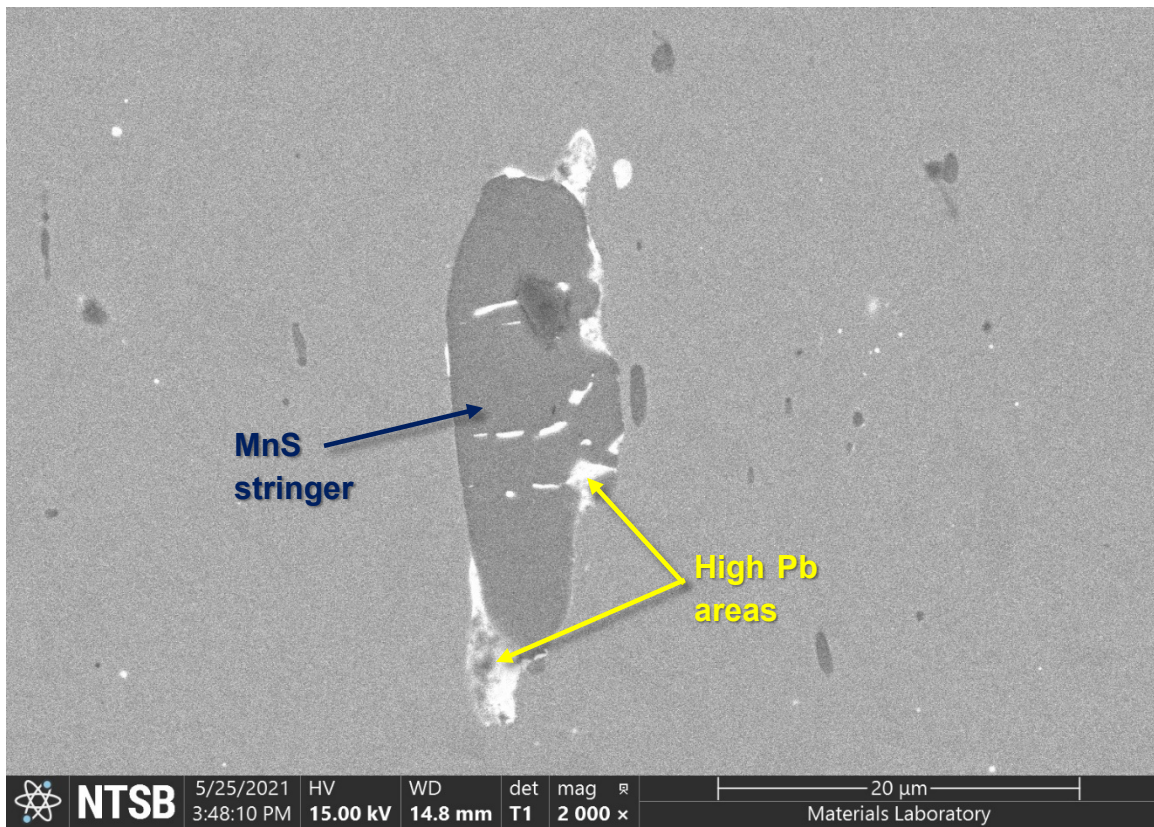
Figure 27 – BE micrograph of a second phase particle, consistent with a MnS stringer and Pb-based material.
