## **Memorandum For Record**

**Date: March 22, 2022**  
**NTSB Accident Number: ERA20LA202**

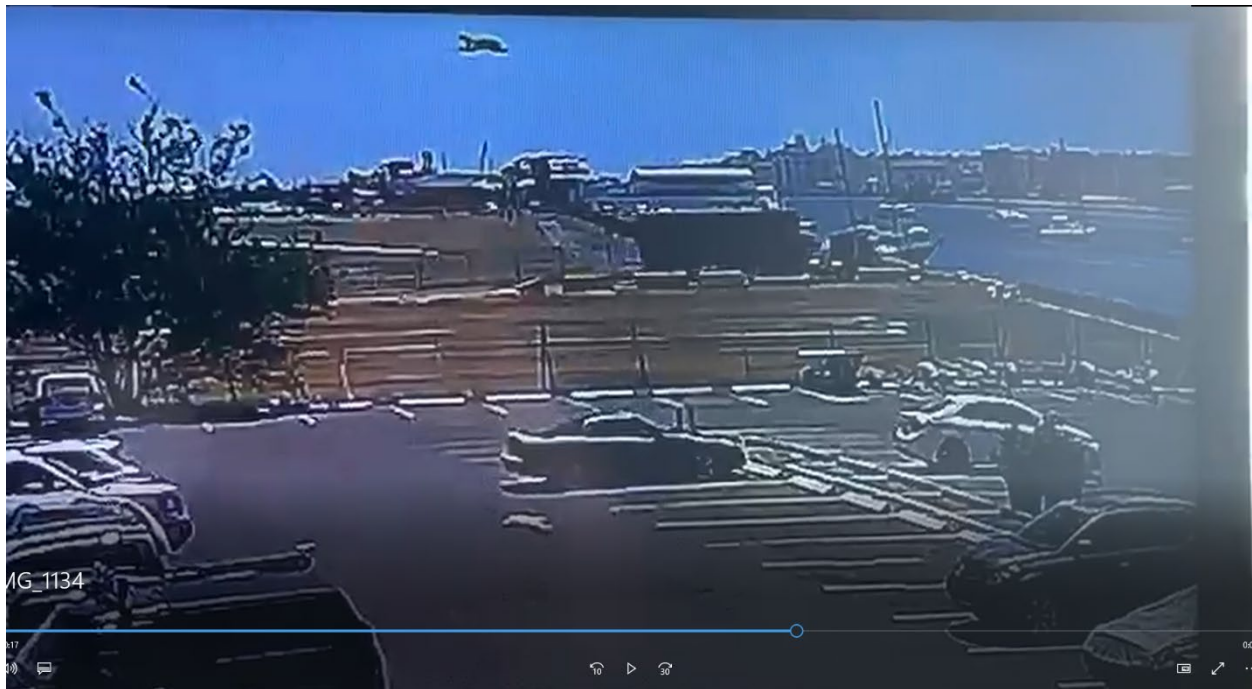
The video clip depicted the final portion of the flight and the area where the airplane impacted the water. At 0:02 seconds elapsed time, the airplane came into view of the left side of the frame and continued in a wings level slight nose-up attitude until about 0:17 seconds elapsed time (Figure 1). One of the landing gears is visibly extended at 0:17 seconds elapsed time.

Figure 1: Screenshot Capture from Security Video. Taken at 0:17 seconds elapsed time. Note the Airplane in a slight left bank and nose-up attitude.

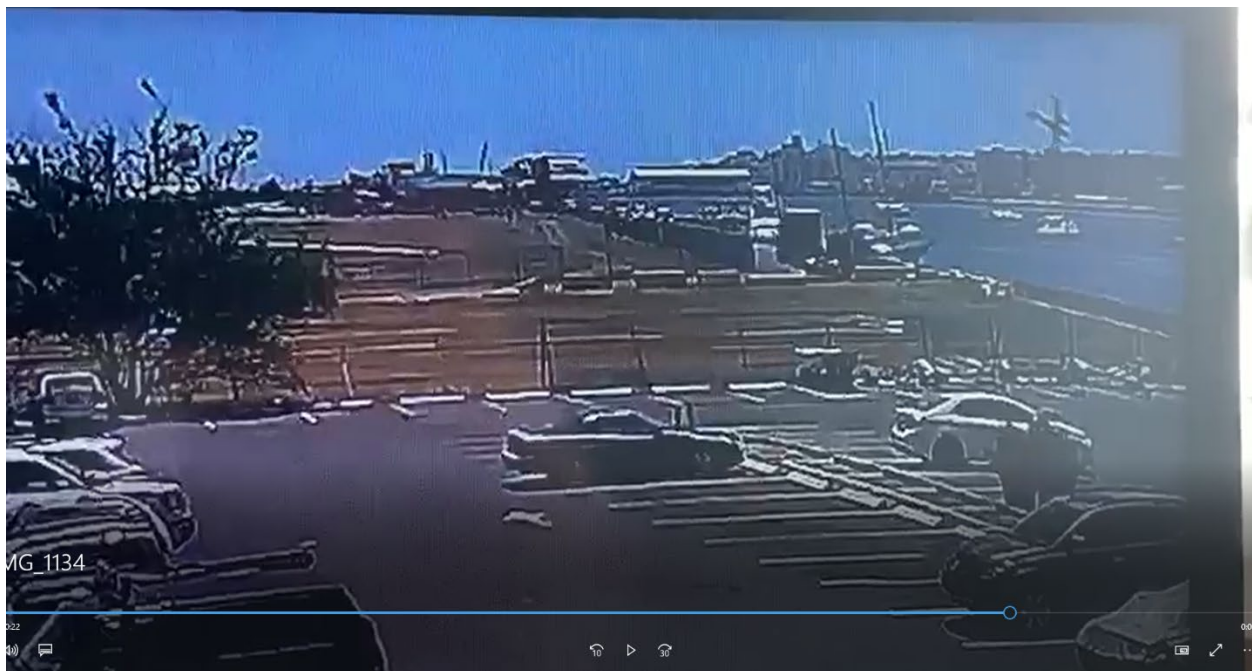
At 0:17 seconds elapsed time the airplane began a left turn briefly which was arrested in a shallow left bank and slight nose-up pitch attitude, but as the flight continued over the next 5 seconds to 0:22 elapsed time, the bank angle increased to the left to an inverted position and the airplane began a nose-low descent (Figure 2), which continued until the airplane went out of view (Figure 3). A splash in the water was noted.

Figure 2: Screenshot Capture from Security Video. Taken at 0:22 seconds elapsed time. Note the Airplane in an inverted and nose-low attitude.

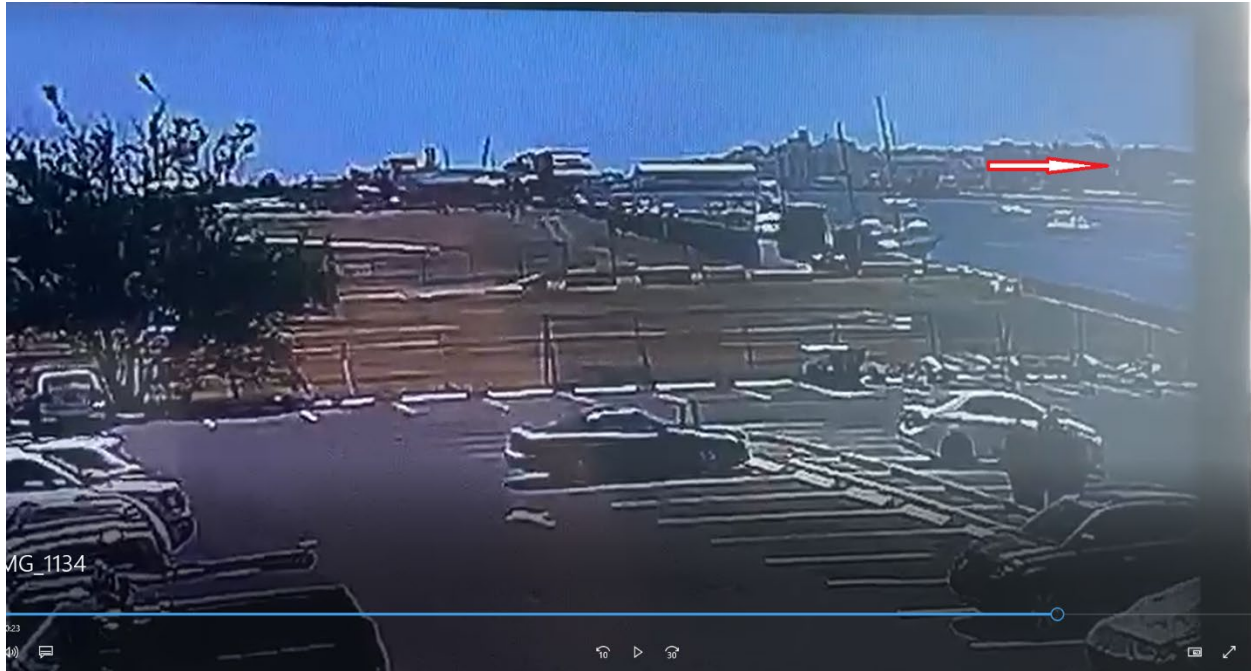
Figure 3: Annotated Video ScreenShot Capture. Arrow Points to Airplane Before Water Impact.
