## Memorandum For Record

**Date: April 11, 2022**  
**NTSB Accident Number: ERA20LA202**

The Bendix Servo Fuel Injector (Fuel Injector), Model – RSA-5AD1, Parts List 2524213-10, Serial Number (S/N) 75083, was examined with NTSB oversight at a facility that designs, manufactures, and overhauls fuel systems for general aviation customers worldwide.

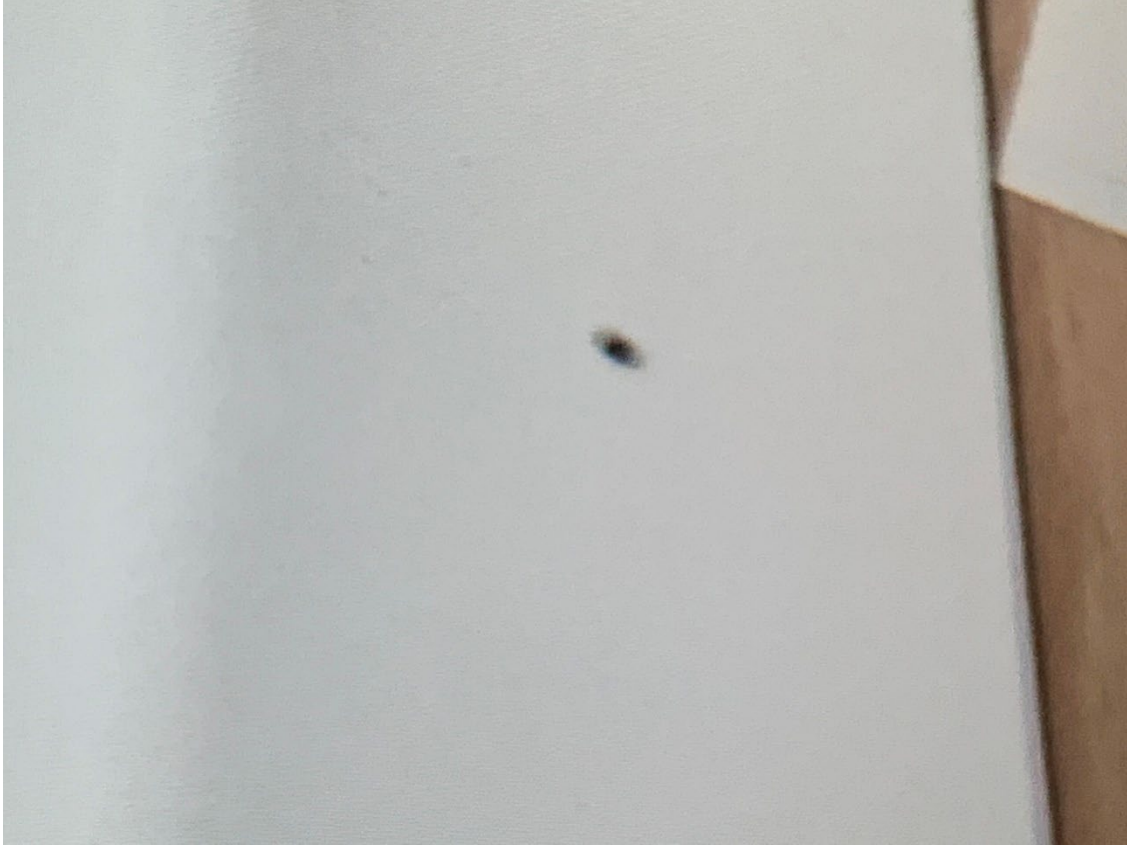
The bore path of the low pressure air to the regulator was nearly completely blocked. The high and low pressure sides of the regulator and diaphragms were contaminated throughout. The mixture control lever, and mixture control valve were removed and slight contamination was noted on the spring of the mixture control valve. No oxidation was noted to the mixture or idle valves. An oxidation pit was noted on the mixture housing area.

Figure 1: NTSB out of Focus Picture of Debris Found Between Mixture and Idle Valves. A Better Picture was not Available.
