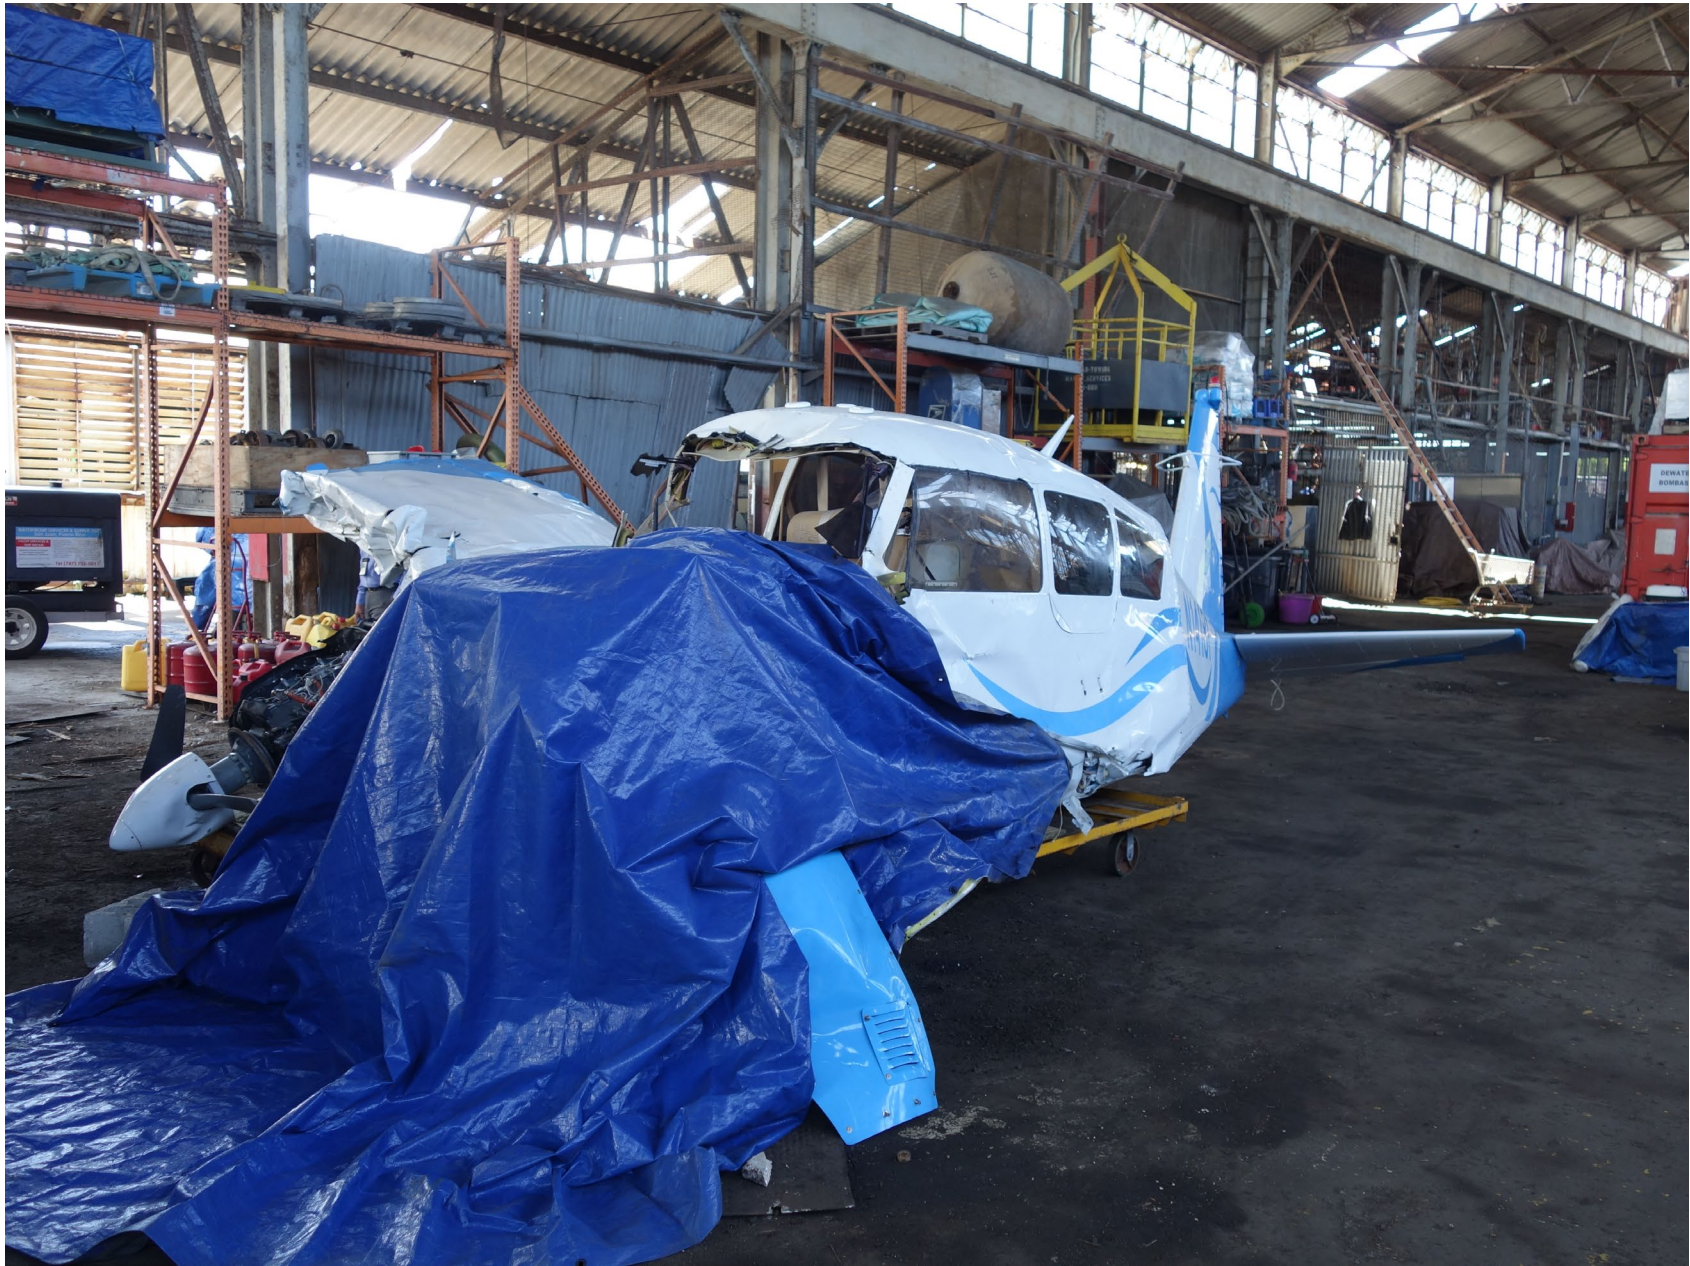
**Photo 1 – Piper Digital Photograph. Left Side View of the Airplane Following Recovery. Note the Separated Left Wing.**

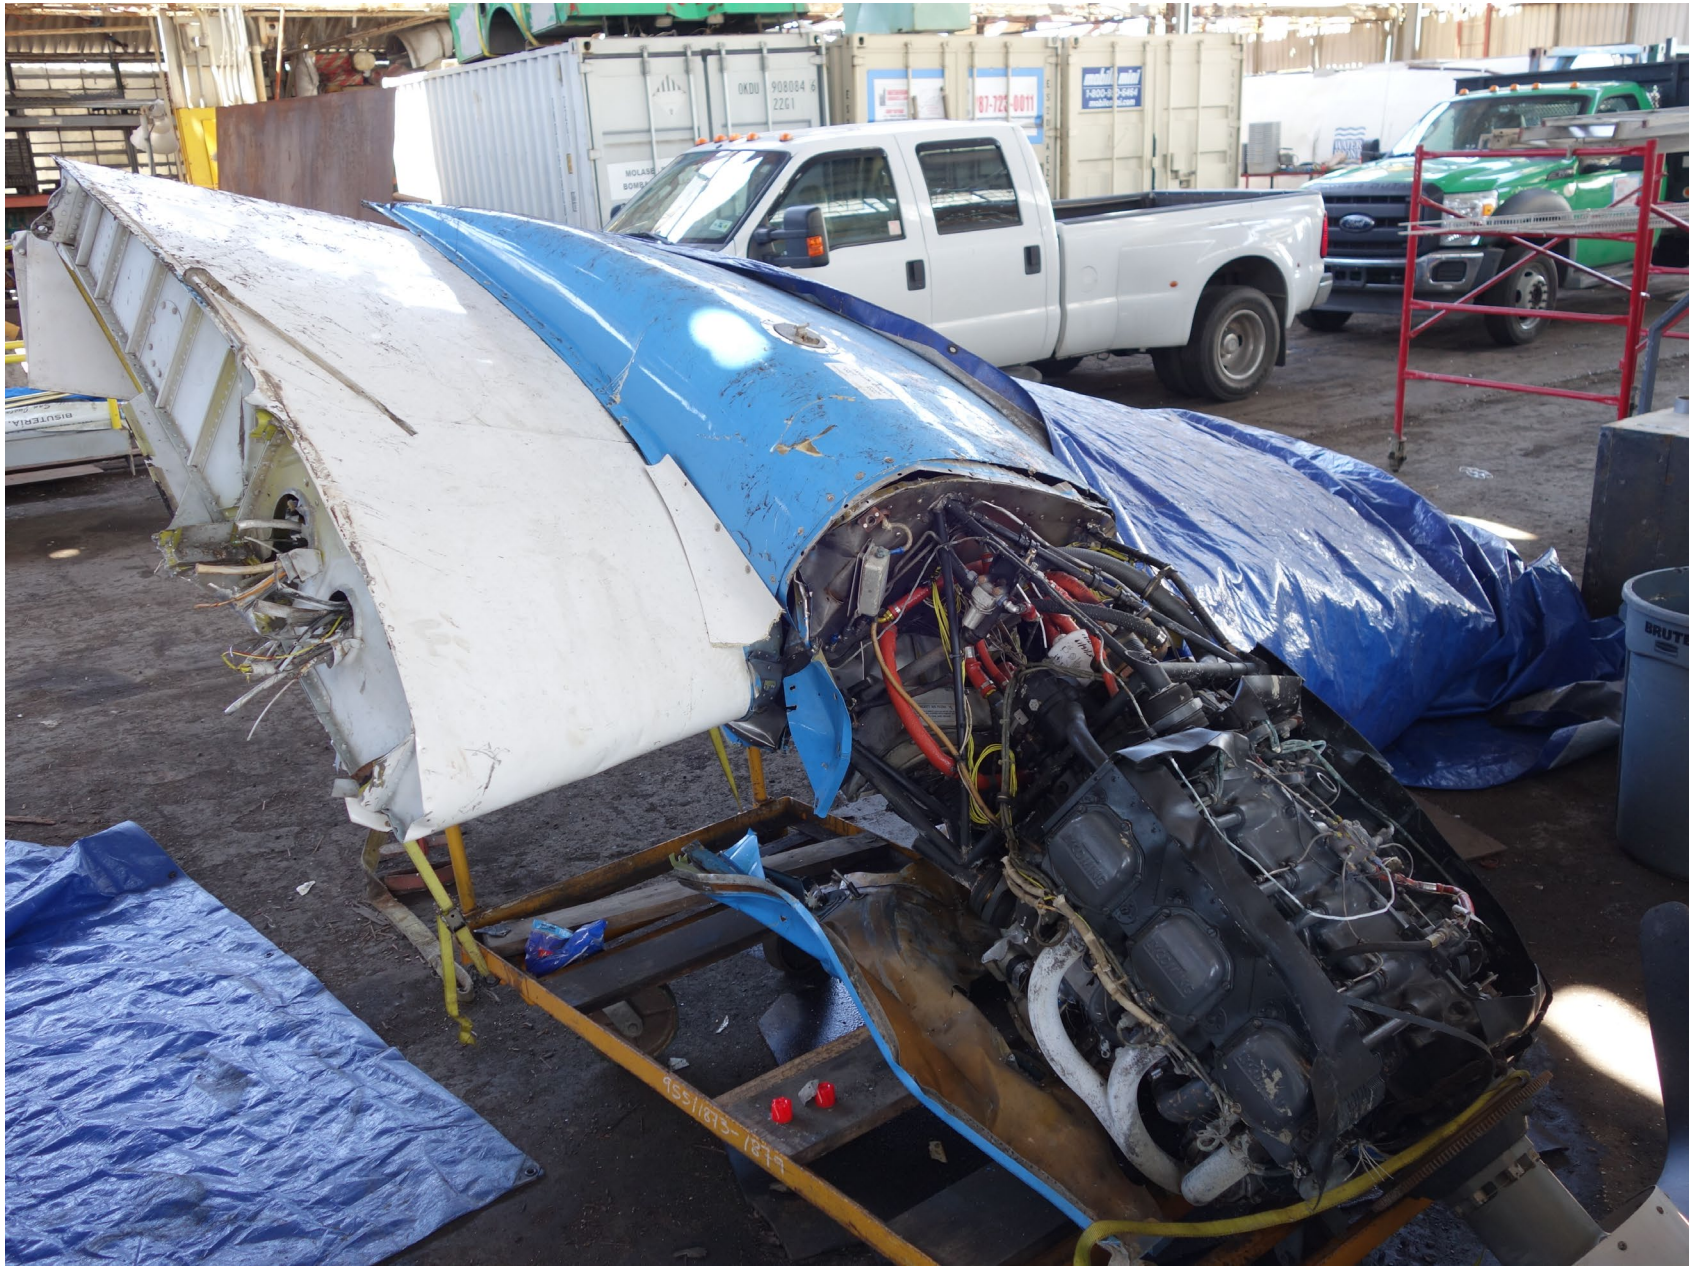
**Photo 2 - Piper Digital Photograph. View of the Separated Left Wing with Attached Engine and Propeller Assembly.**

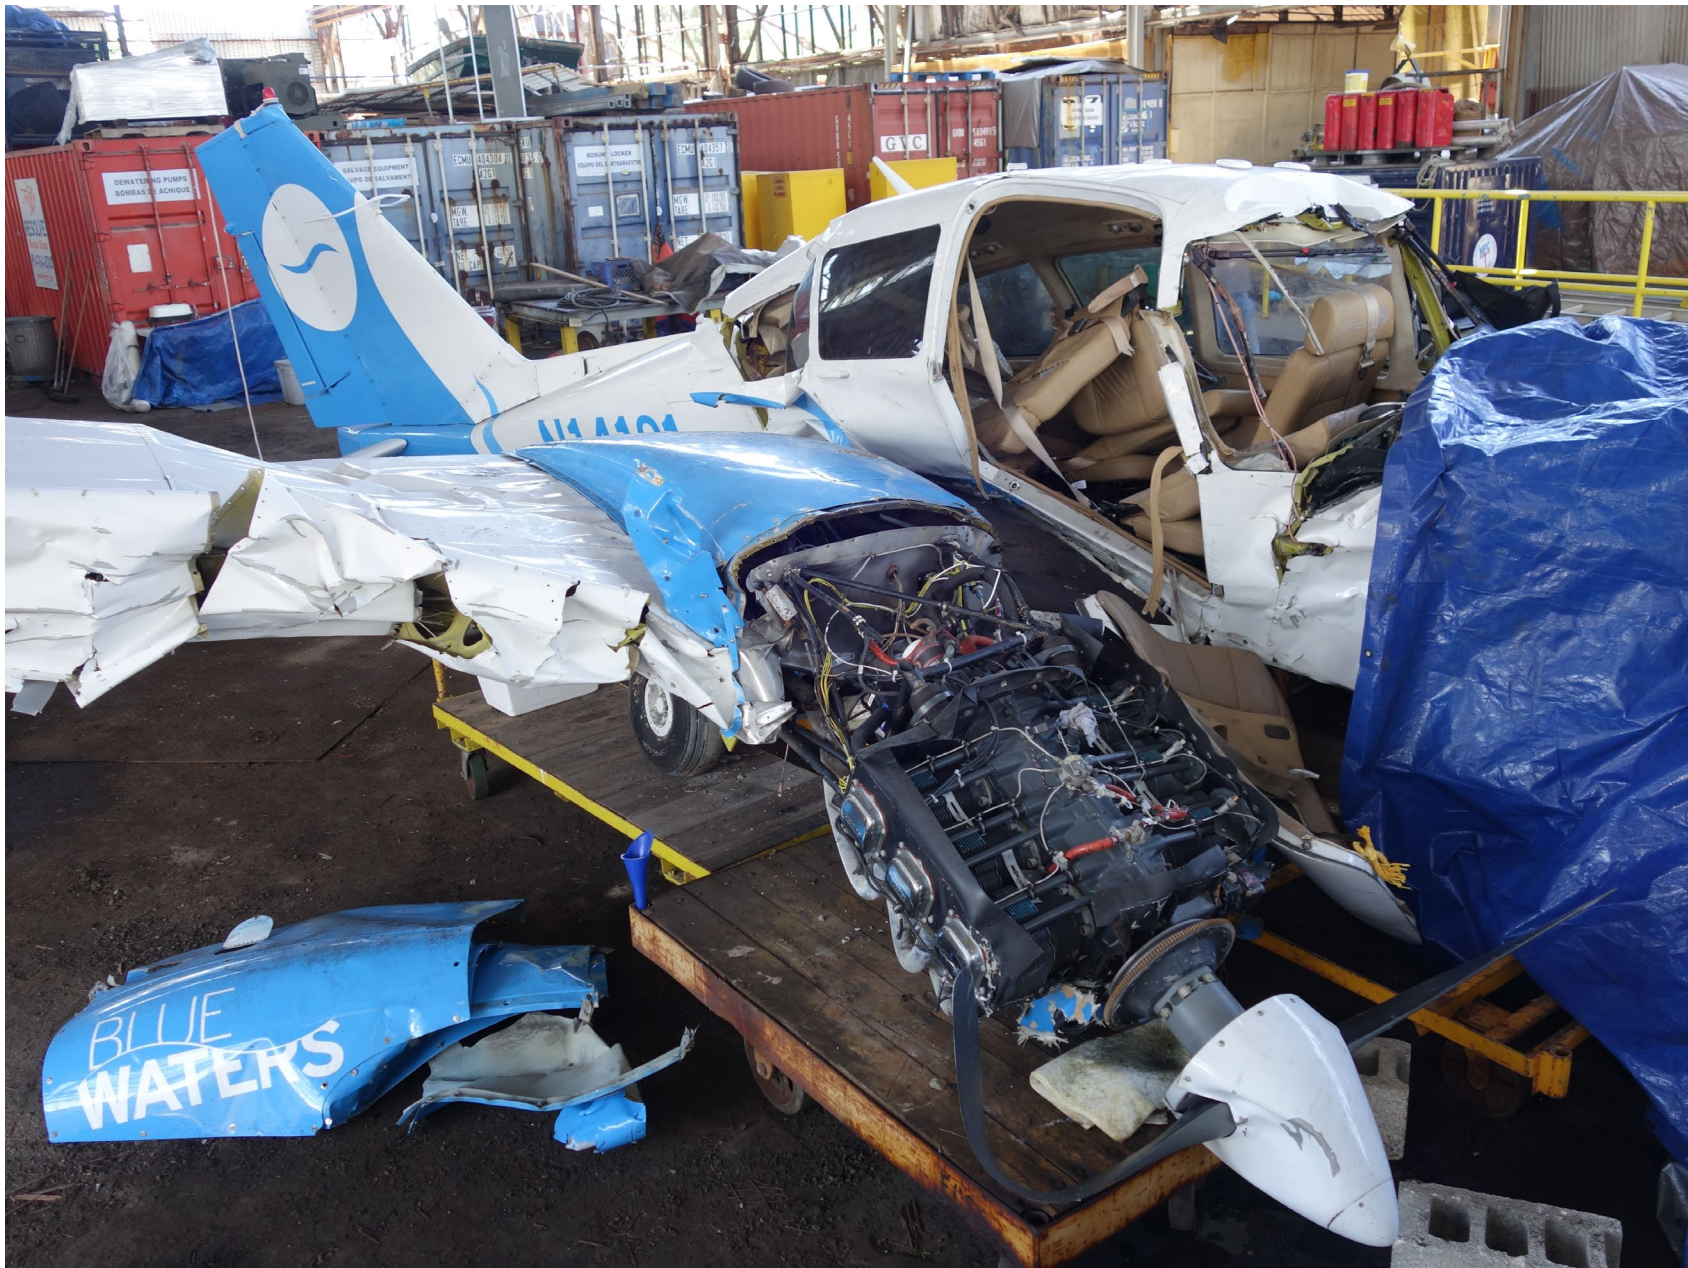
**Photo 3 - Piper Digital Photograph. Right Forward Quartering View of the Fuselage, Engine Assembly with Attached Propeller, and Portion of the Right Wing.**

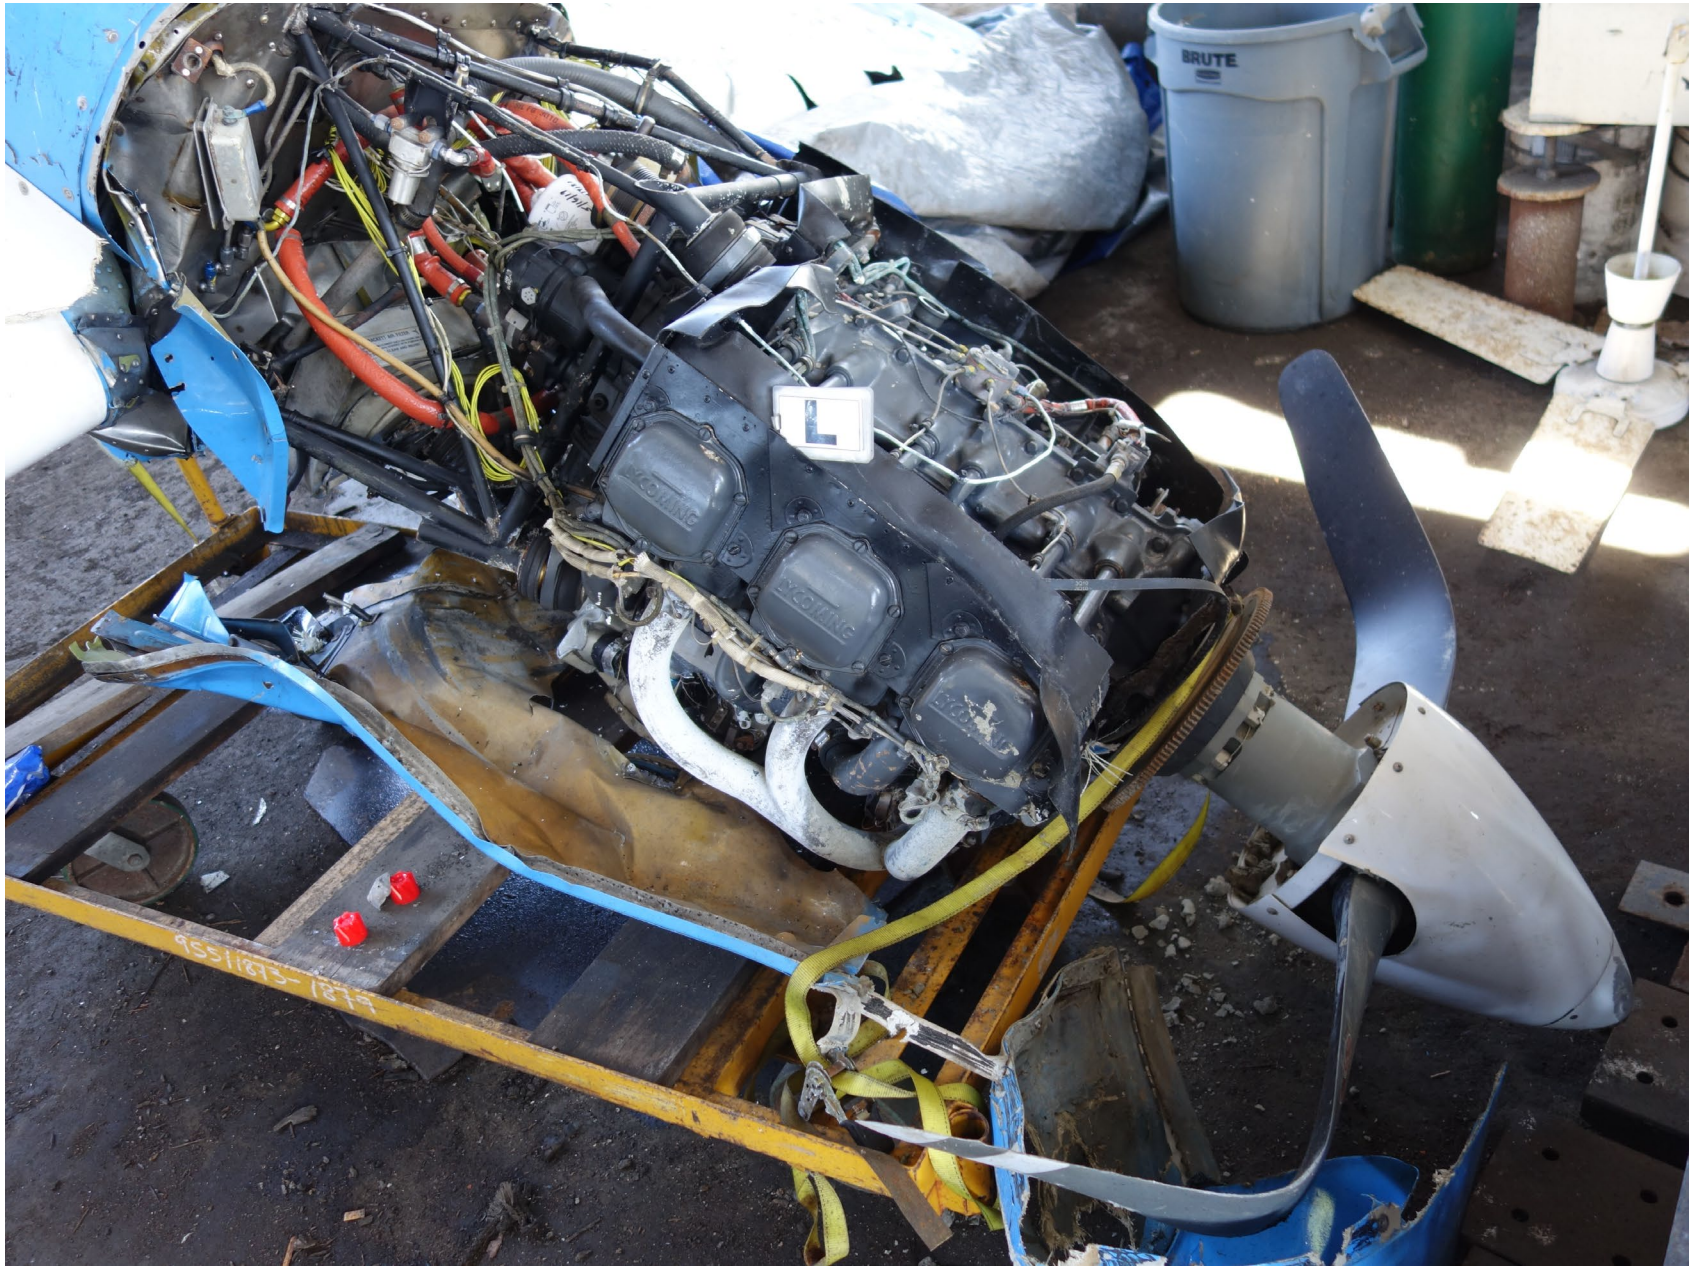
**Photo 4 - Piper Digital Photograph. View of the Right Side of the Left Engine Assembly with Attached Propeller.**

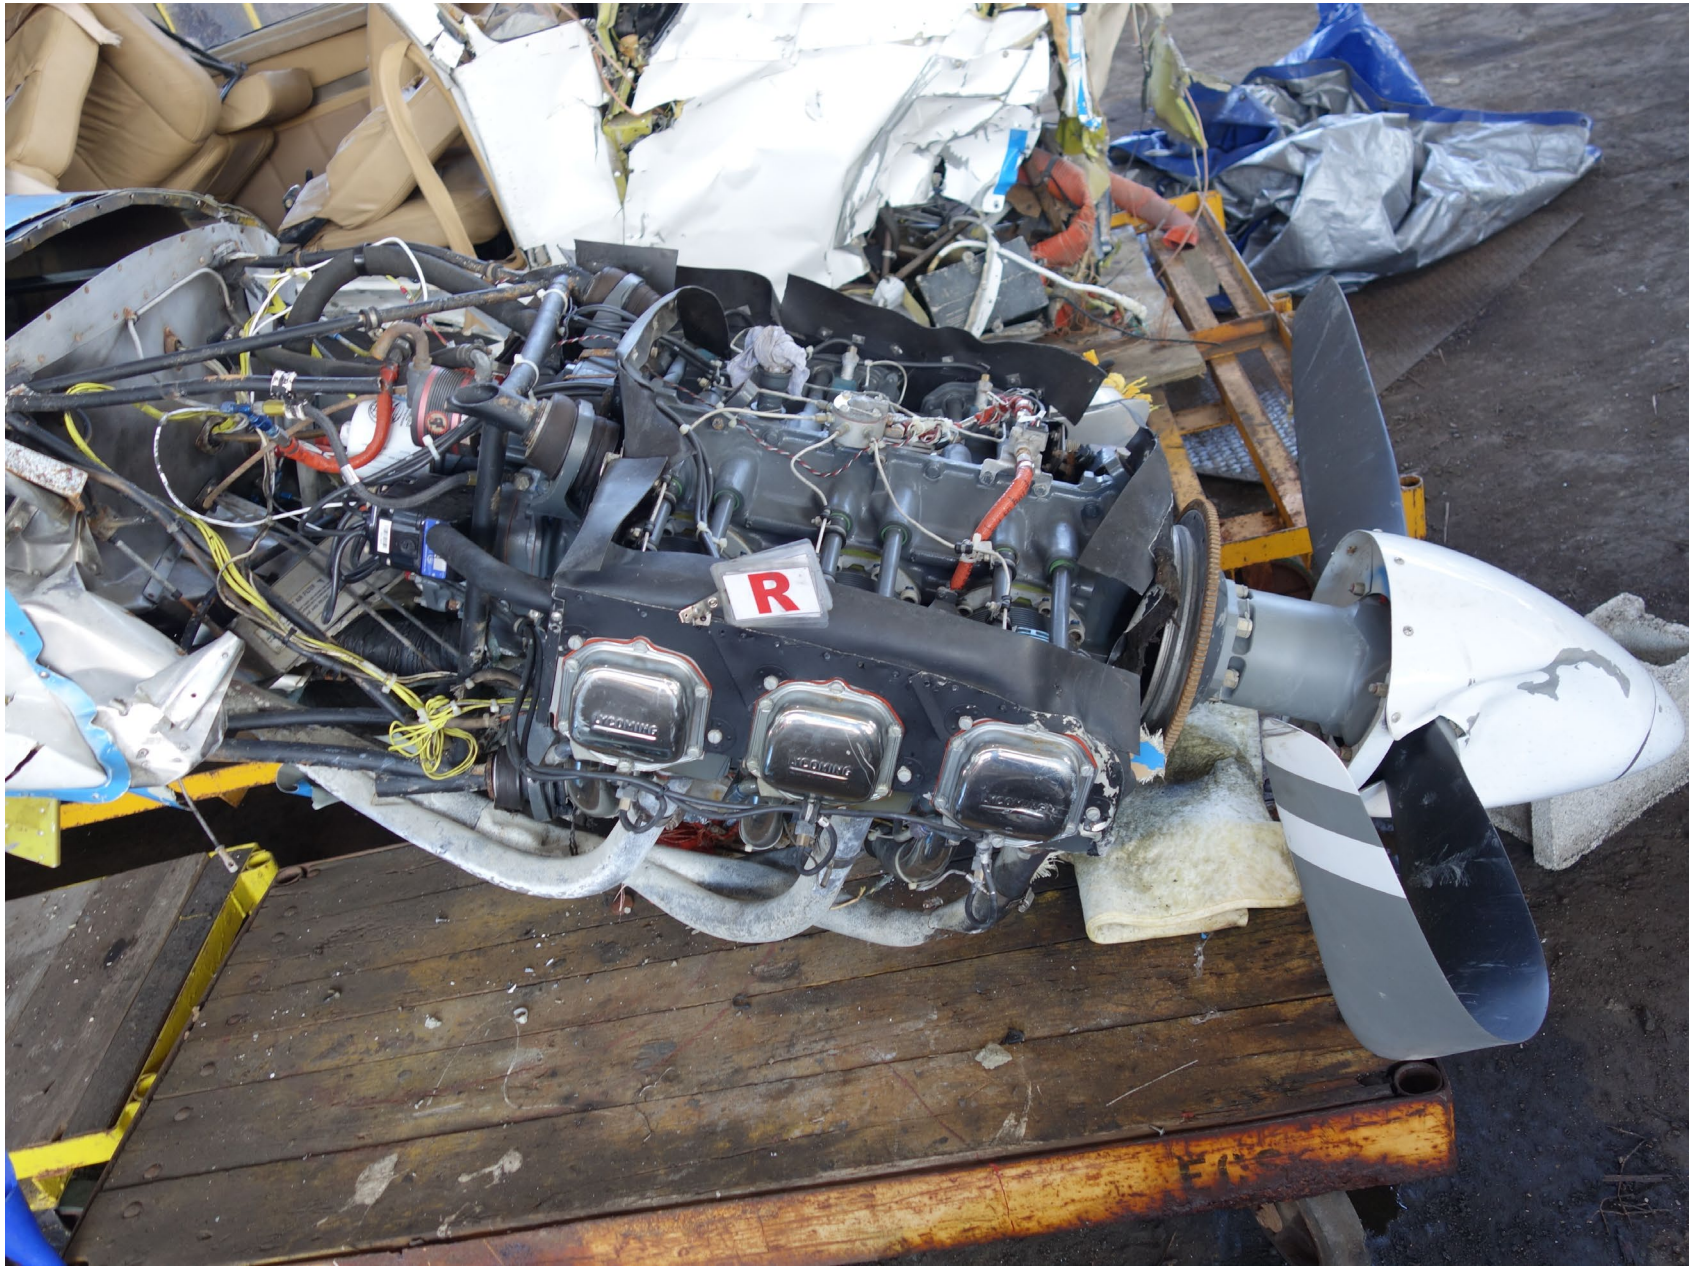
**Photo 5 - Piper Digital Photograph. View of the Right Side of the Right Engine Assembly with Attached Propeller**

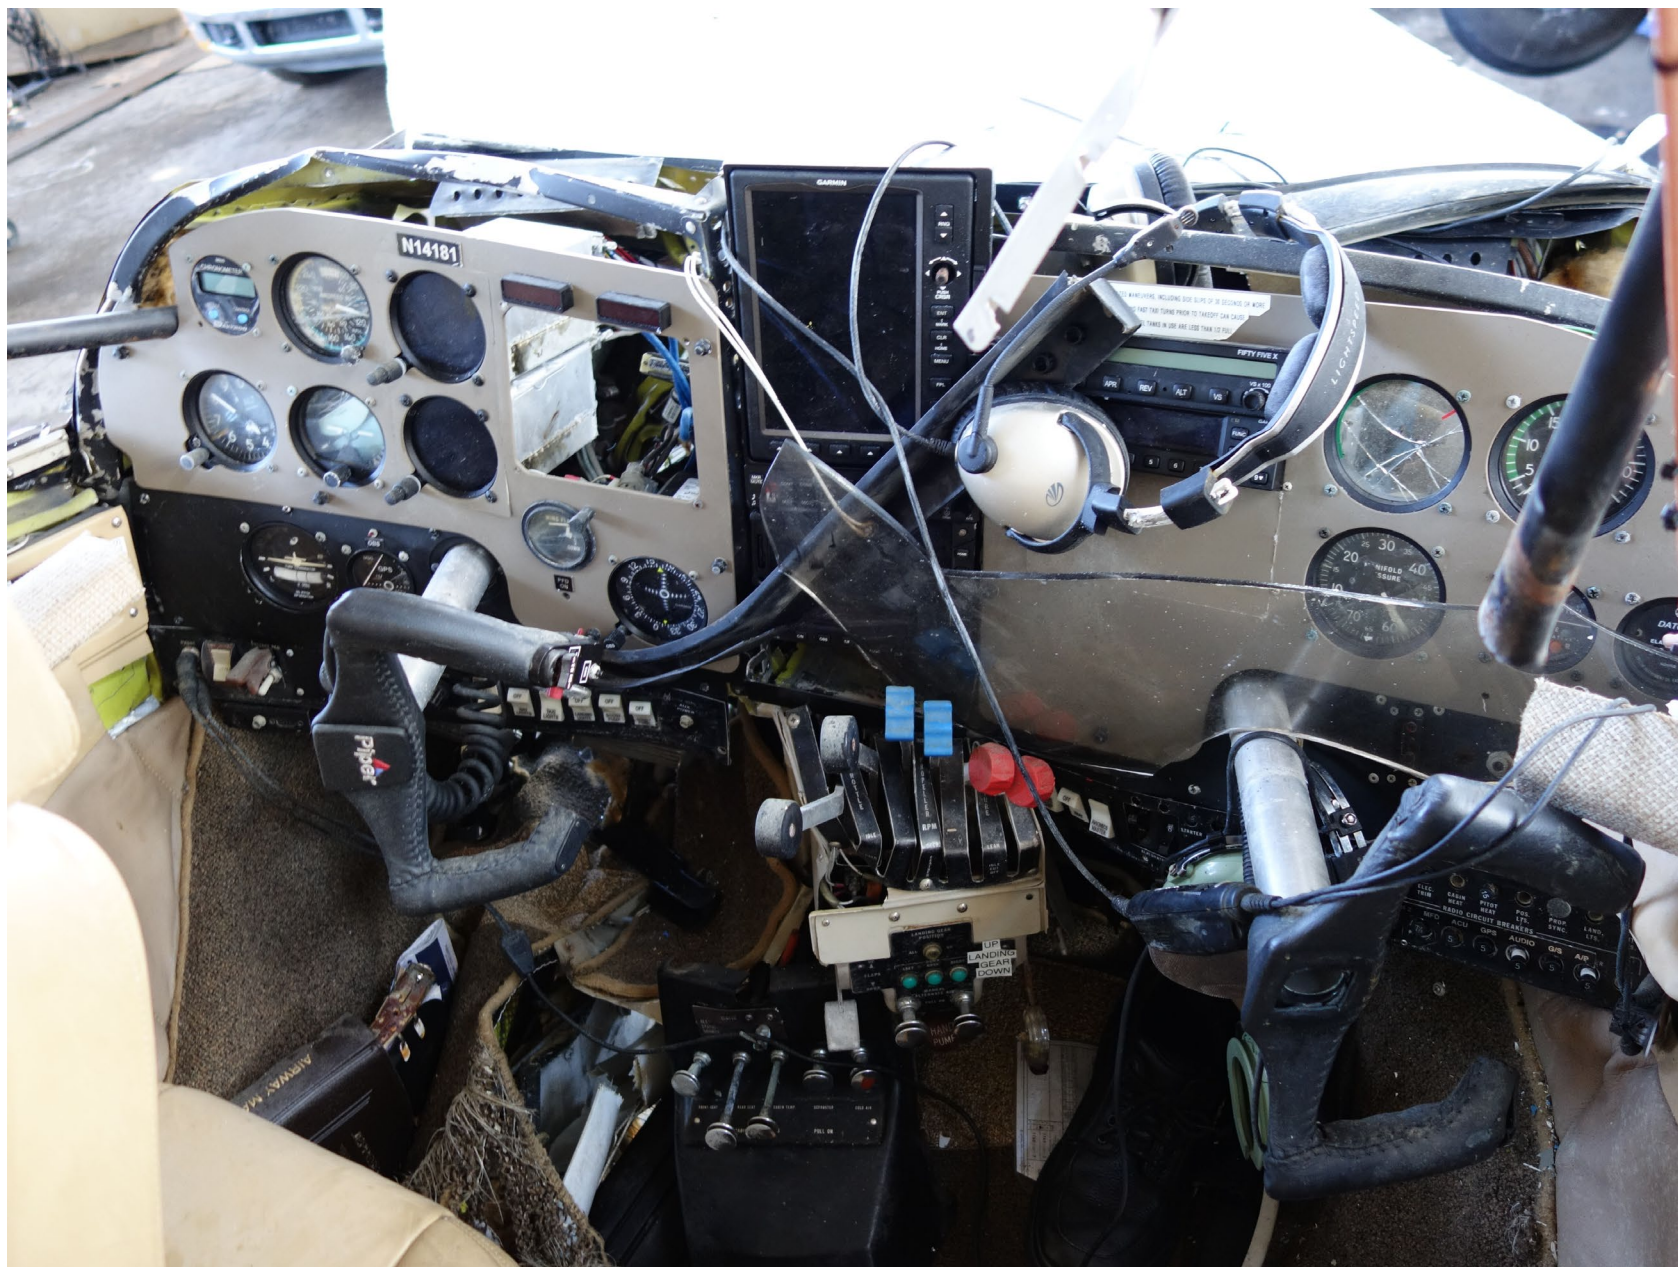
**Photo 6 - Piper Digital Photograph. View of the Instrument Panel. Note the Positions of the Throttle, Propeller, and Mixture Controls.**

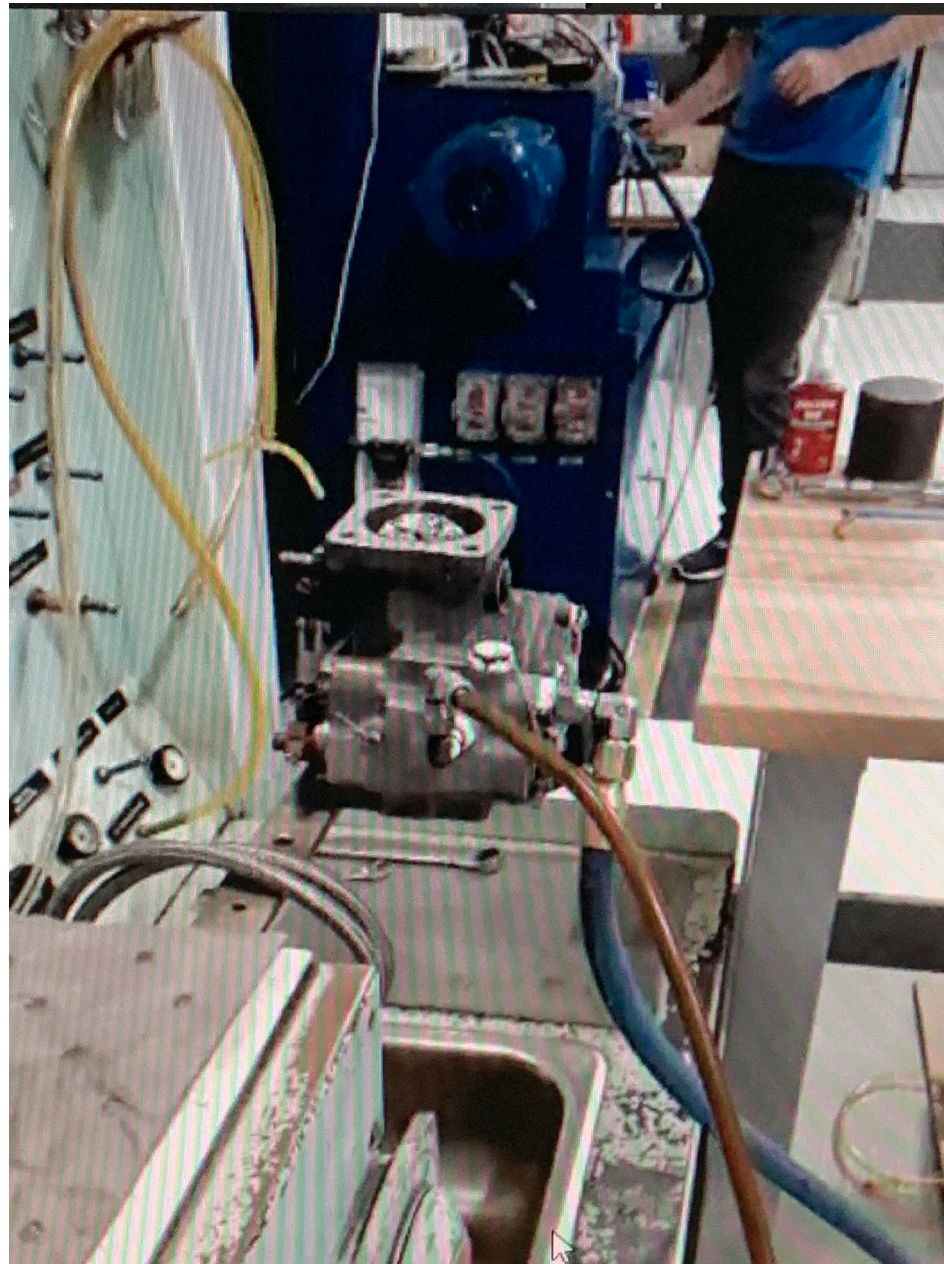
**Photo 7 – NTSB Digital Photograph. View of the Left Engine Servo Fuel Injector During Bench Testing Conducted Virtually.**

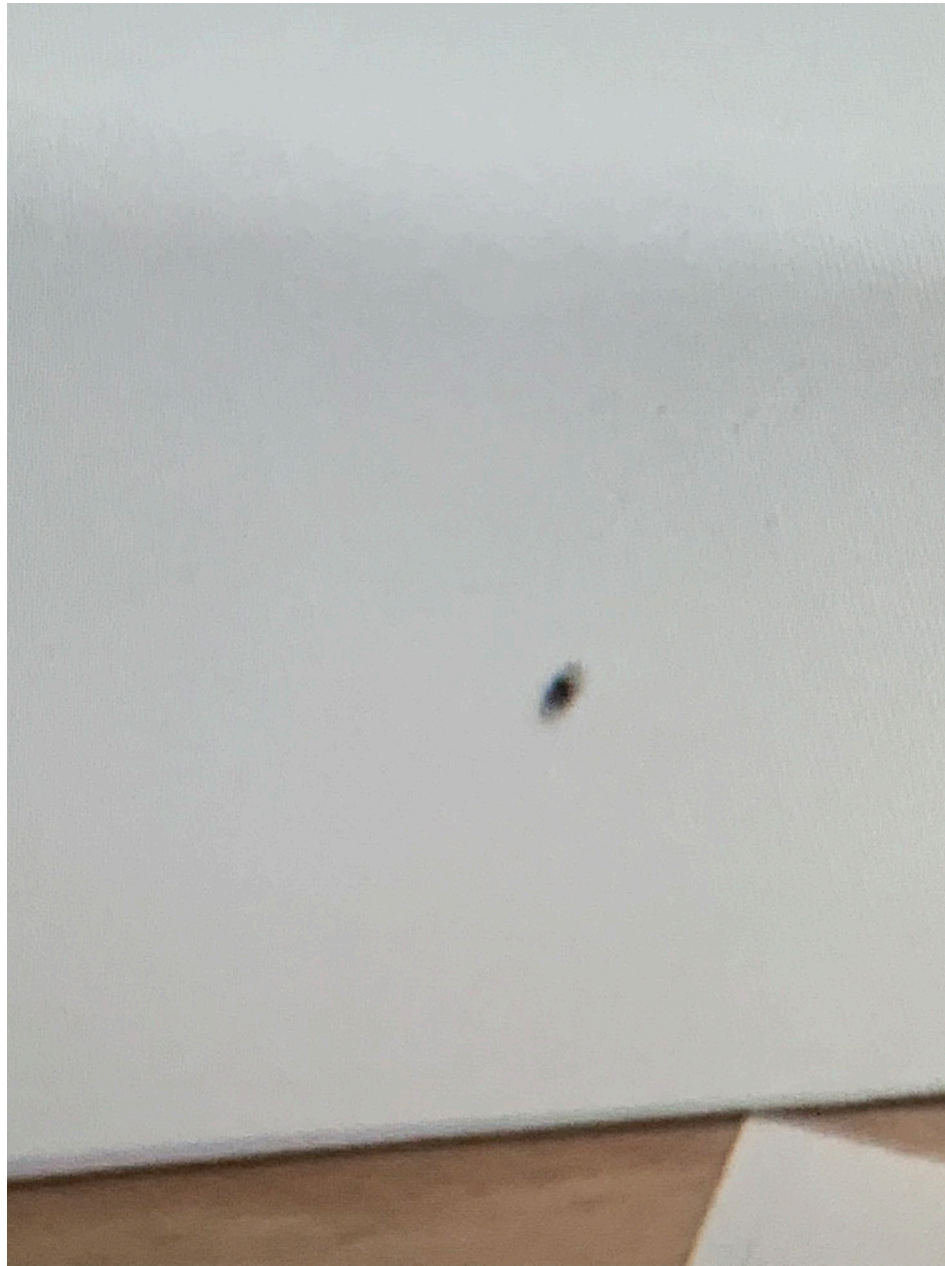
**Photo 8 - NTSB Digital Photograph. View of the Contaminant Found Between the Mixture and Idle Valves of the Left Engine Servo Fuel Injector. A better Photograph was not available.**

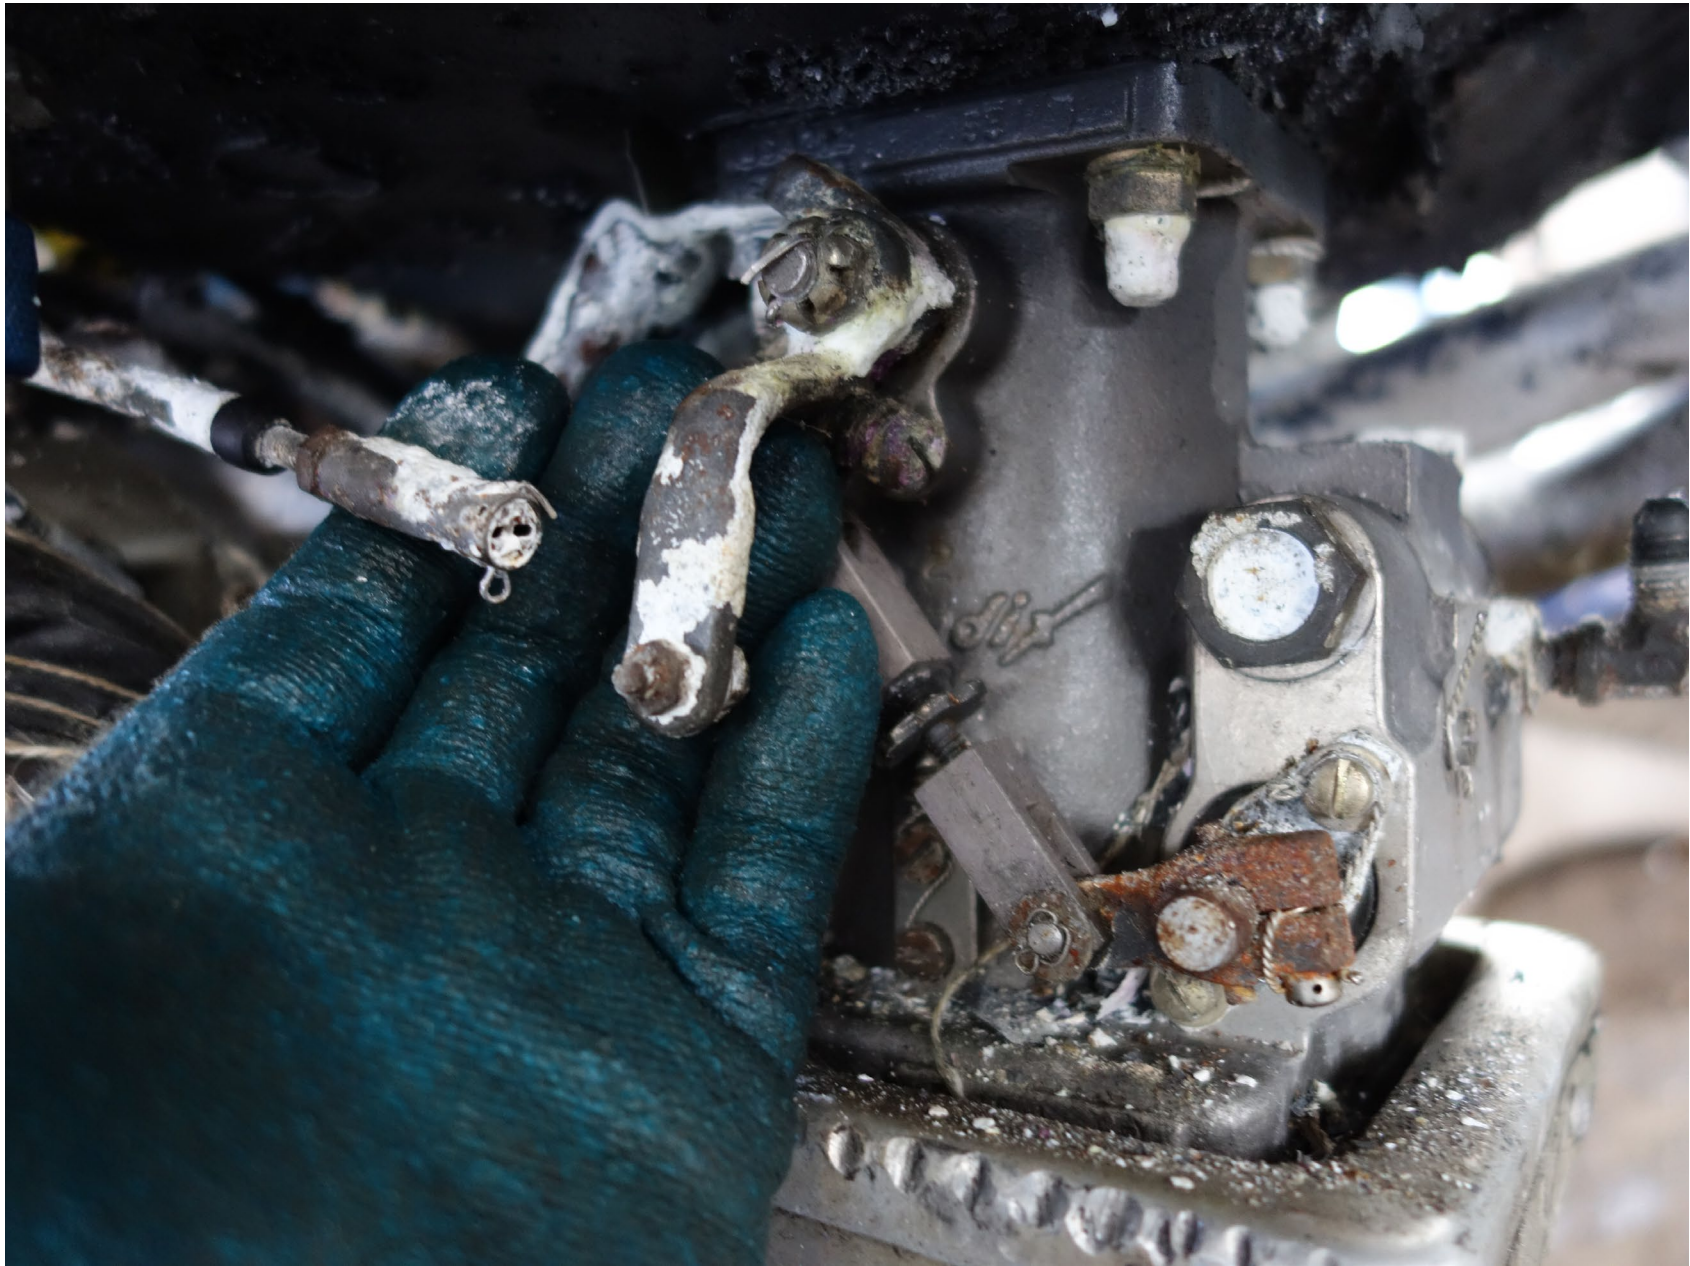
**Photo 9 - Piper Digital Photograph. View Showing the Separated Throttle Control Cable at the Left Servo Fuel Injector.**
