## **Memorandum For Record**

**Timothy W. Monville**  
**Sr. Air Safety Investigator**  
**Eastern Region**

**Date: March 22, 2022**  
**NTSB Accident Number: ERA20LA202**

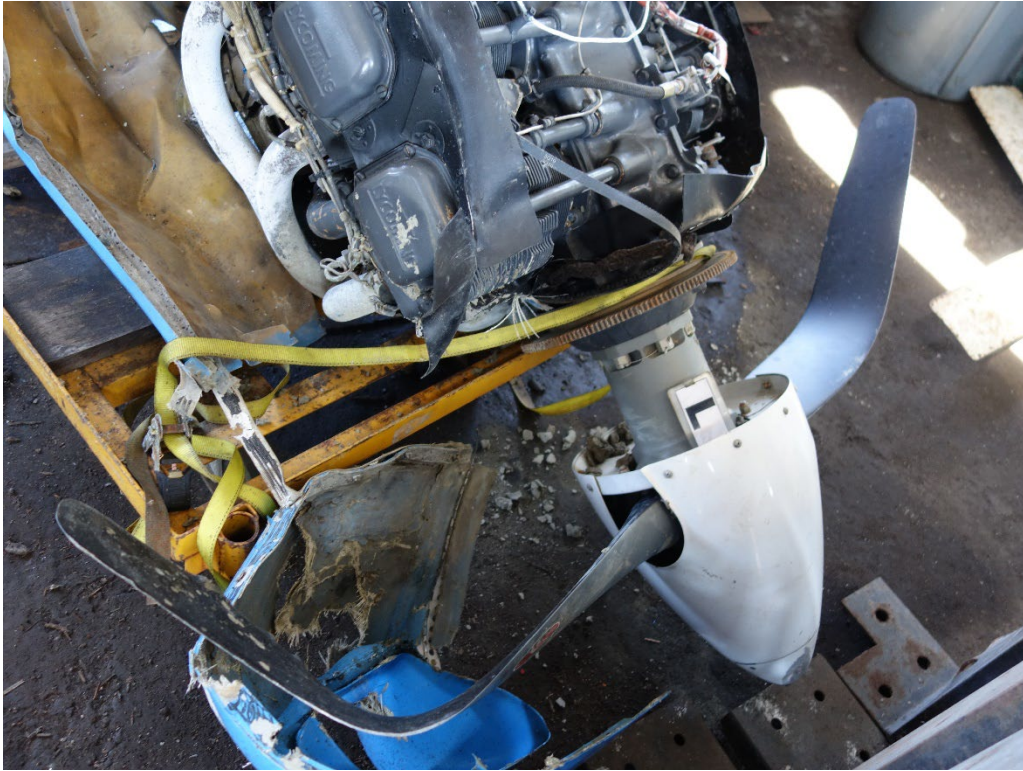
Examination of the left propeller revealed it remained attached to the crankshaft flange, both blades remained captured in the hub assembly, exhibited aft bending about mid-span, and were at or near the low pitch position (Figure 1).

Figure 1: Piper Digital Photograph. View of the Left Propeller Assembly. Note the position of both propeller blades in low pitch.
