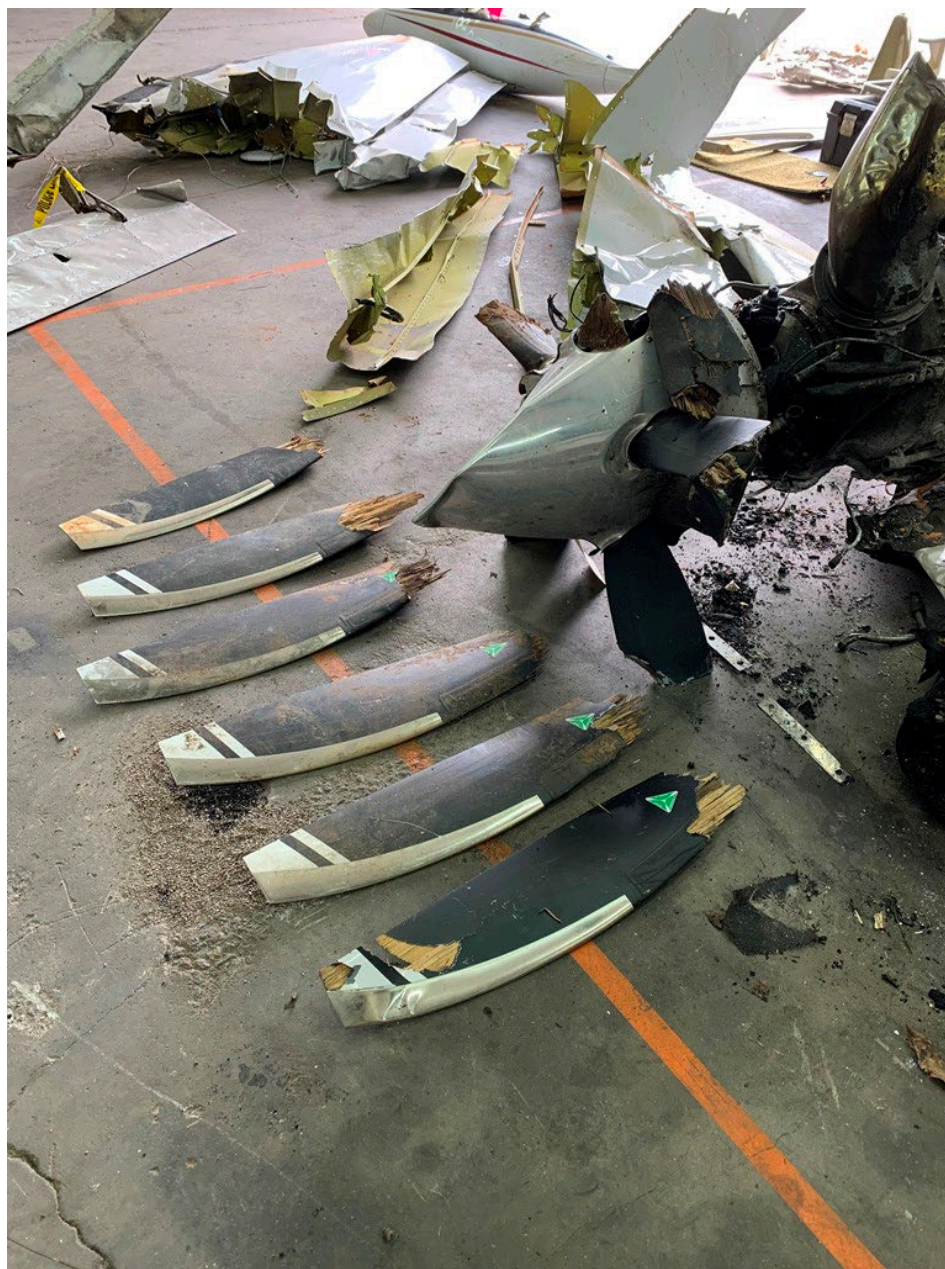
**Photo 14 – Right Engine and Six Fractured Propeller Blades (NTSB)**
