**National Transportation Safety Board**  
Office of Research and Engineering  
Washington, D.C. 20594

## Airplane Performance Study

**Location:** Eatonton, Georgia  
**Date:** June 5, 2020  
**Time:** 1920 GMT (1520 EDT)  
**Airplane:** Piper PA-31T, N135VE  
**NTSB Number:** ERA20LA206

**ERA20LA206, N135VE, Piper PA-31T Cheyenne, June 5, 2020**

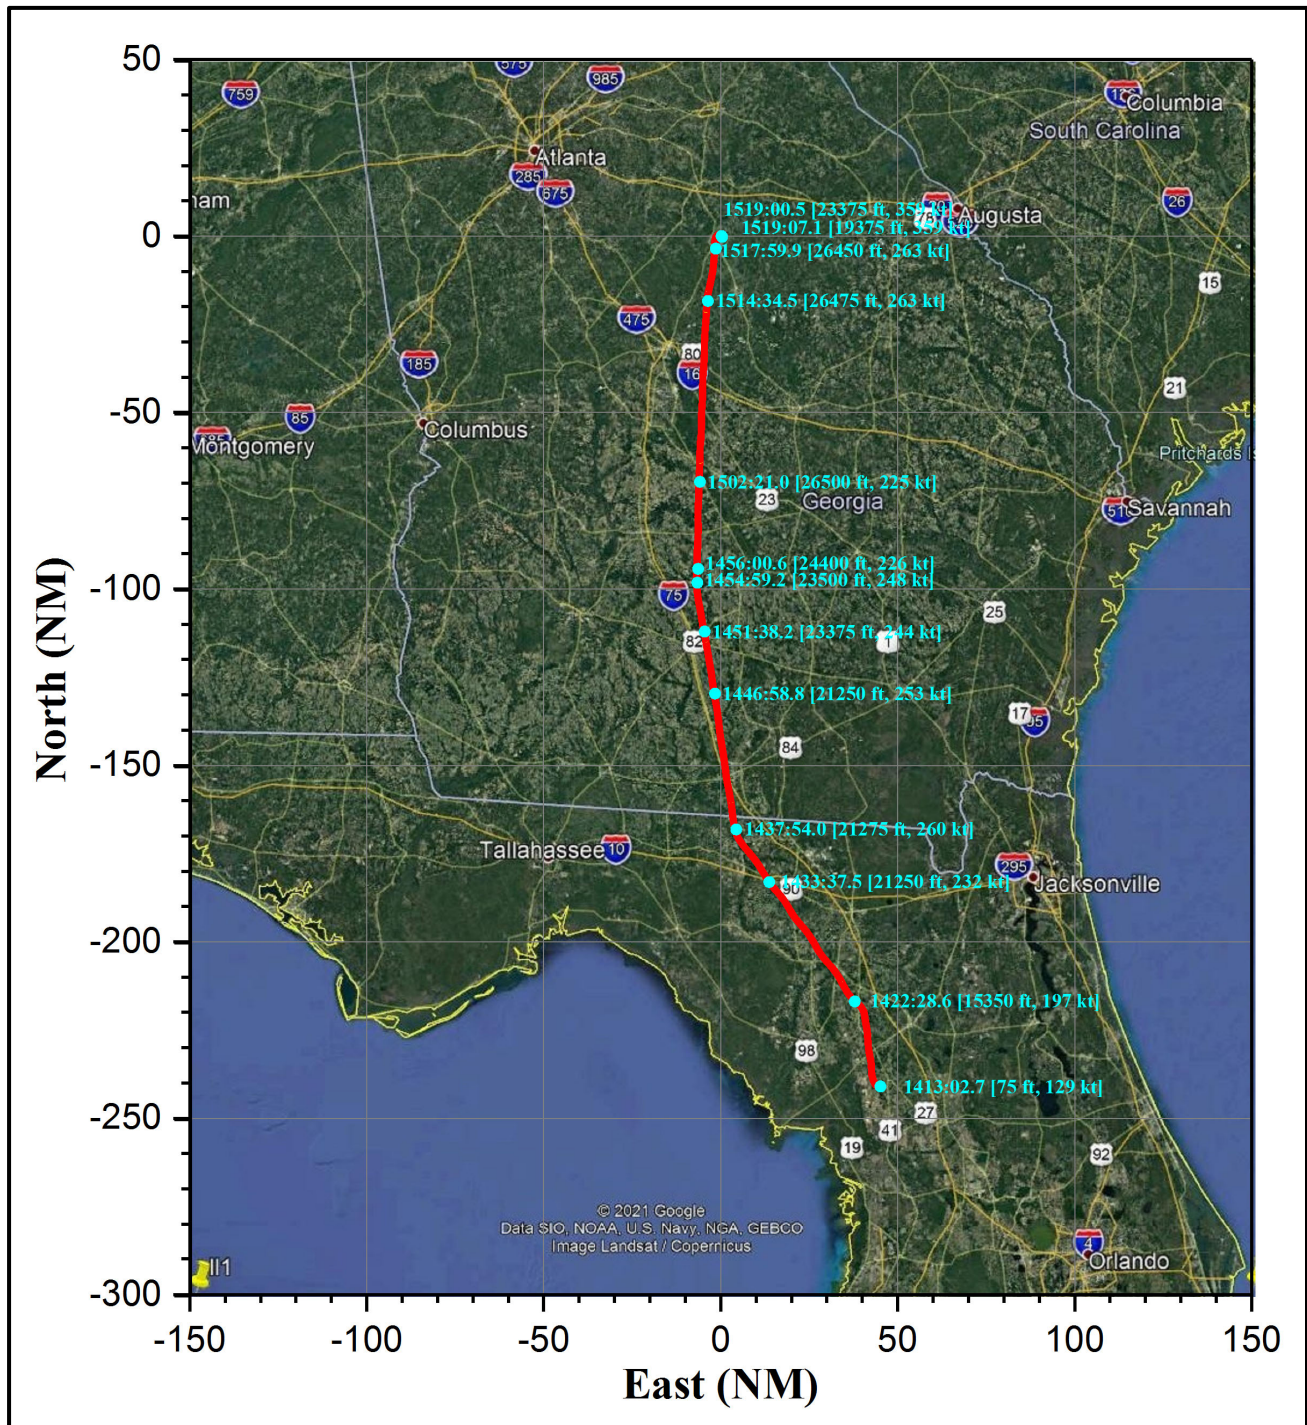
An overview of the 1 hour and 7-minute flight is shown in Figure 1. According to the air traffic control (ATC) transcript, when the airplane was about 50 miles south of Eatonton, Georgia, N135VE told ATC that they were deviating "to the right a little" to avoid weather. About 1518 EDT, as the airplane approached Eatonton, N135VE advised ATC that they wanted to proceed direct to their destination on a 353° heading, and ATC approved. This was the last communication between ATC and the airplane. About a minute later, the airplane was observed on radar entering a right turn, followed by a rapid descent. Radar contact was lost about 1520. There were no distress calls from N135VE.

**Figure 1: The Accident Flight Departed Williston Municipal Airport Around 1413 EDT  
 Select Local Times, GPS Geometric Altitudes and Ground Speeds are Shown in Cyan (●)**

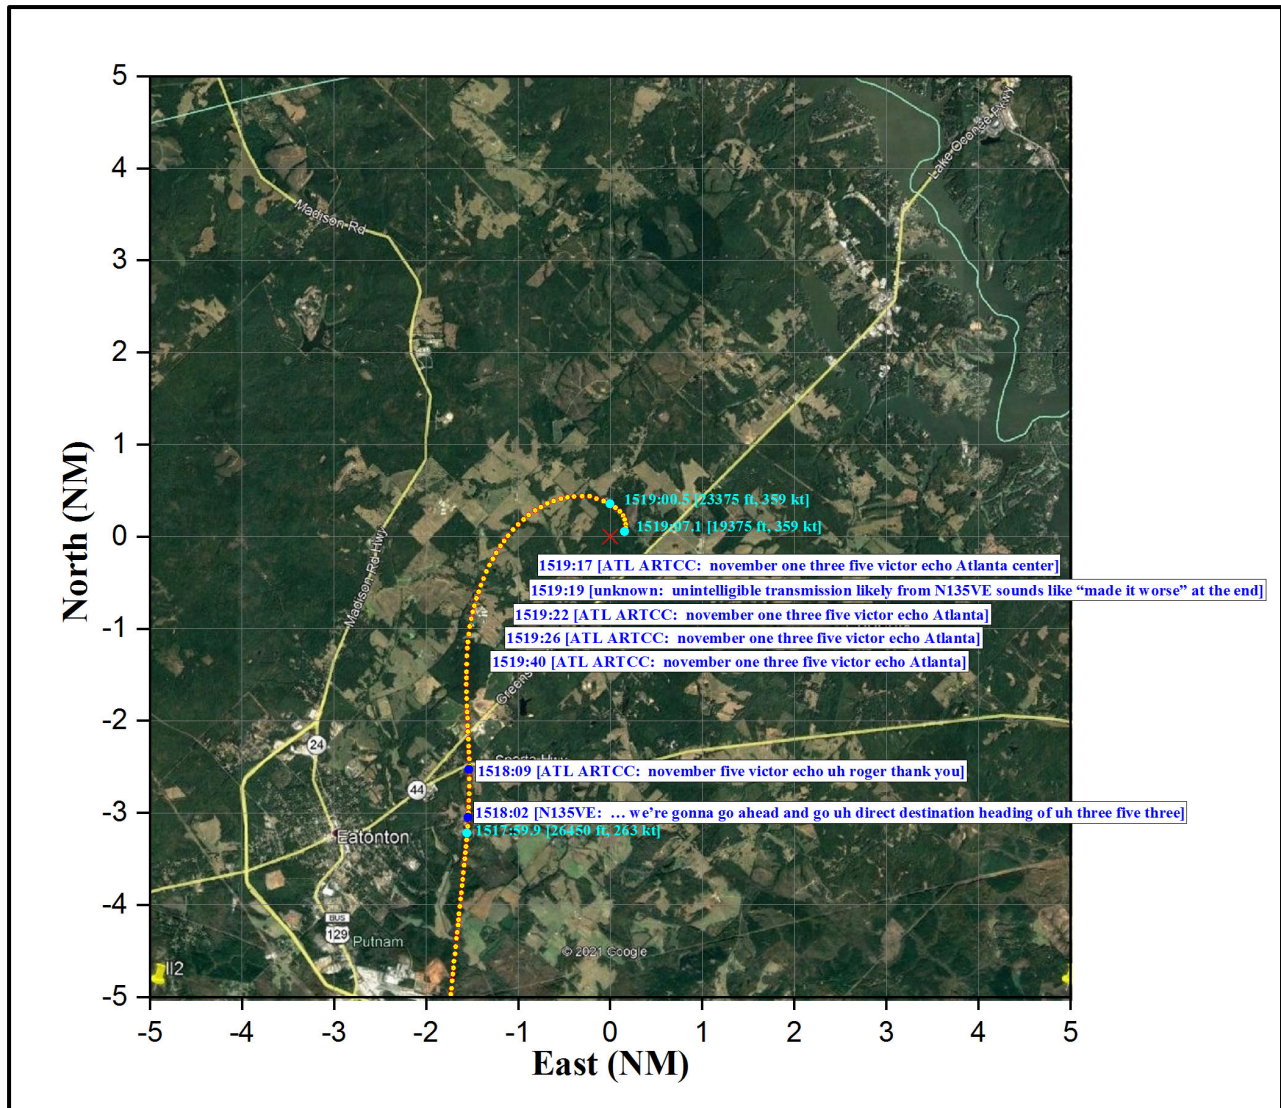
Figure 3 shows the ADS-B ground track in the vicinity of the accident site. After approximately 15 minutes of straight and level flight at 26,000 ft, the pilot or front-seat passenger<sup>2</sup> reported to ATC at 1518:02 that they were going to head direct to their destination on a heading of 350° (which was slightly left of their heading at that time). The last ADS-B return was recorded at 1519:07, and the last radio transmission, although unintelligible, was received 12 sec later at 1519:19. The recorded descent rate was about 7,000 feet per minute (fpm) at 1519:19 according to the recovered GPS data.

**Figure 3: ADS-B Ground Track (●●●) and Impact Site (X)**  
 Select Local Times, GPS Geometric Altitudes and Ground Speeds are Shown in Cyan (●),  
 ATC Communications are Shown in Blue (●)

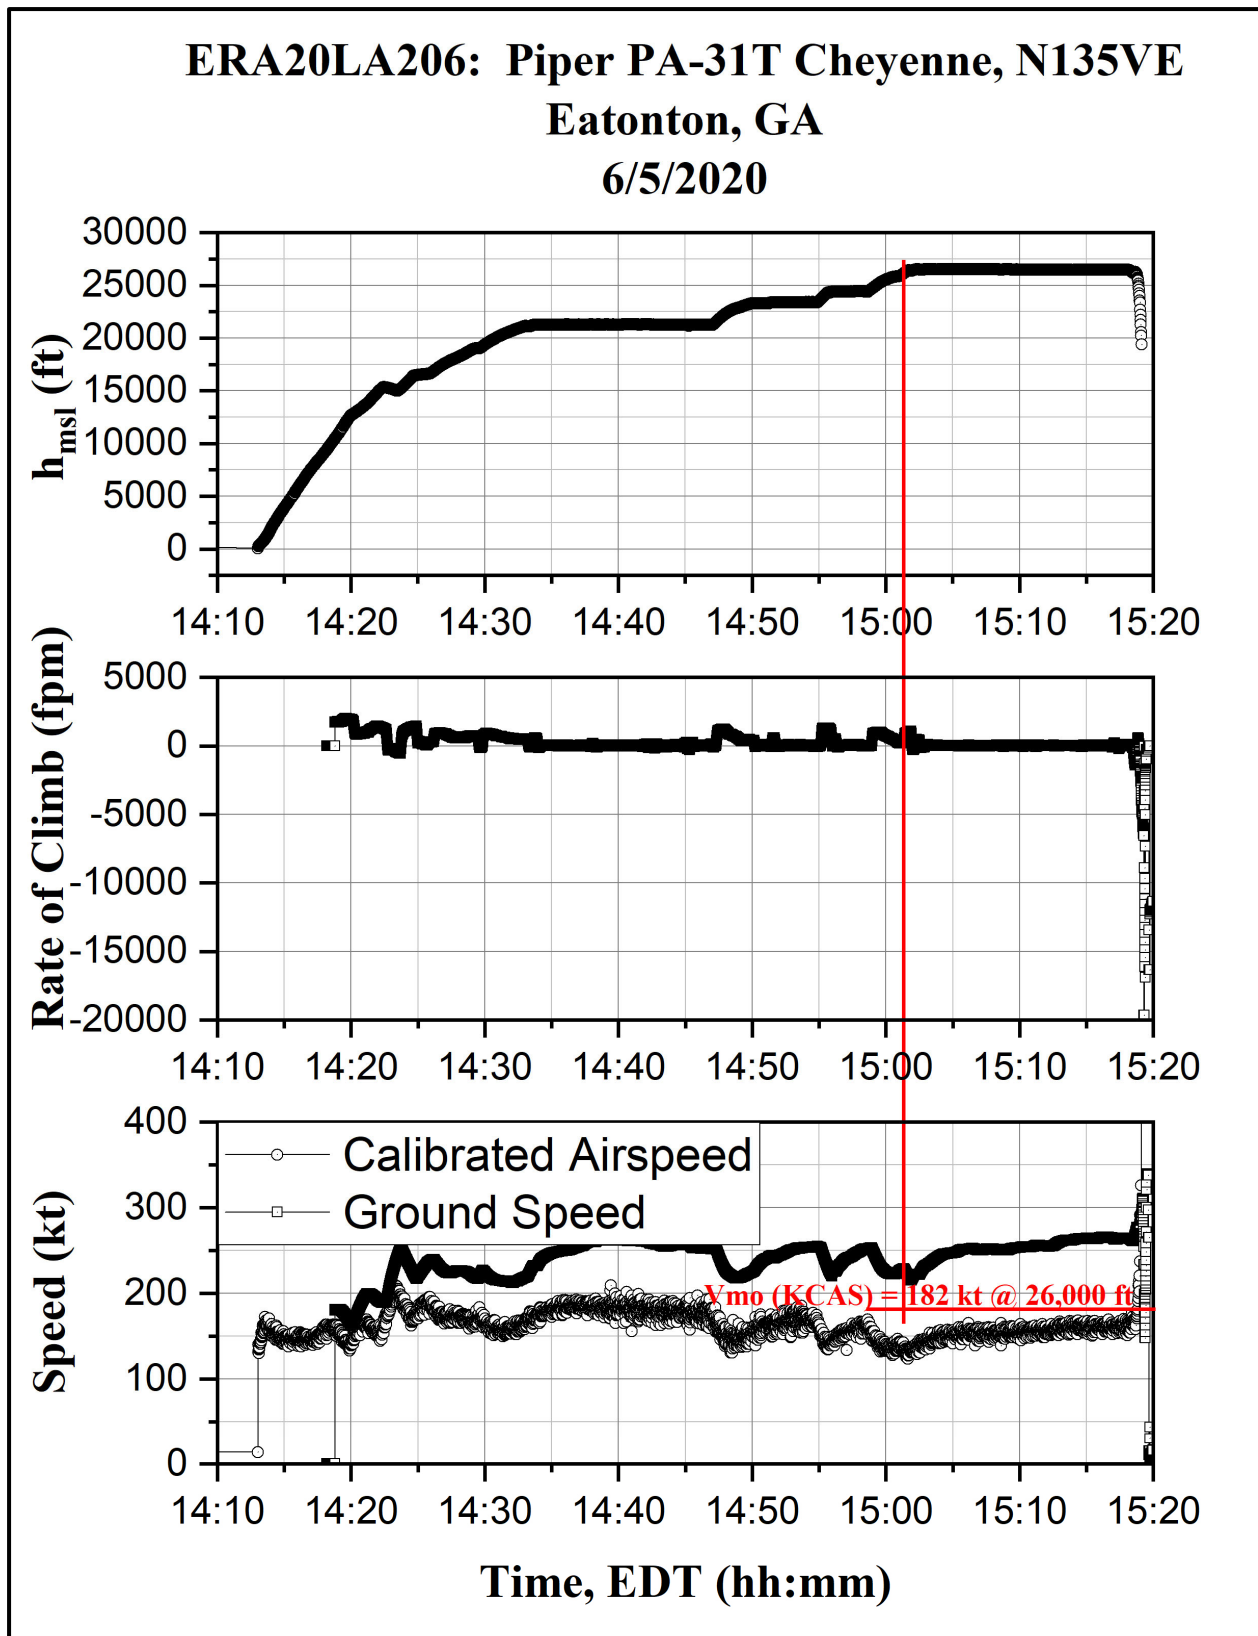
Figure 4: ADS-B Altitude and GPS Ground Speed for Entire Flight

The Pilot Operating Manual indicates that the maximum operating speed, V<sub>mo</sub>, is 246 kts up to 12,000 feet altitude and then decreases linearly to 182 kts at 26,000 ft. The airplane did not exceed the published V<sub>mo</sub> during the course of the flight. Figure 4 shows the airplane was below V<sub>mo</sub> at 26,000 feet up to the point where the airplane deviated from straight and level flight.

Figures 4, 5, and 6 show the ADS-B altitude and GPS ground speed recorded for the entire flight, the last five minutes, and the last two minutes, respectively. Figures 5 and 6 contain ATC communications and highlight that the airplane was in straight and level flight until about 30 sec after indicating they were turning direct to their destination; at about 1518:30, a pitch oscillation and a right roll that ultimately reached 115° bank angle ensued. After 1519, the large pitch and bank angles affect the calculation of airspeed, making the calculation unreliable.

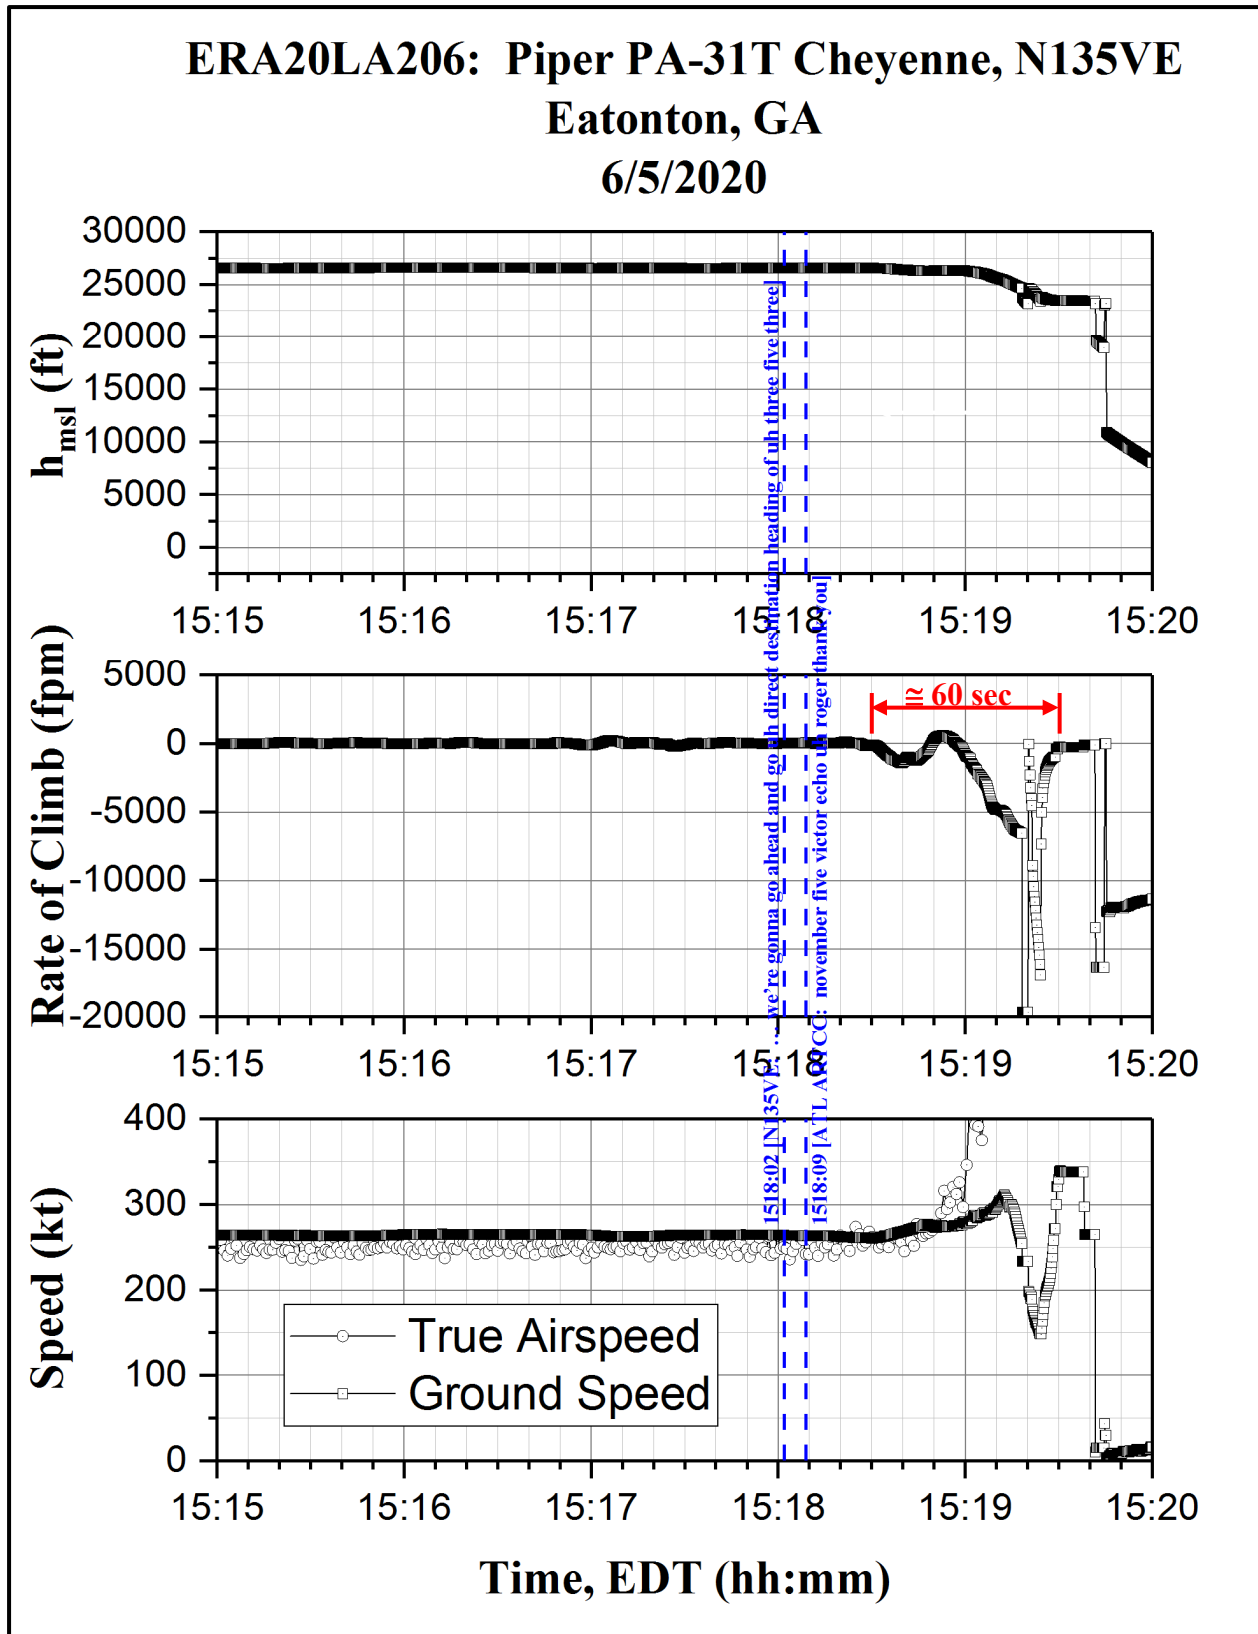
<sup>5</sup> As per FAA Advisory Circular 23-8C, Flight Test Guide for Certification of Part 23 Airplanes, the short period oscillation is the first oscillation the pilot sees after a pitch disturbance. The long period or phugoid follows and is characterized by a nearly constant angle of attack but varying pitch caused by a repeated exchange of airspeed and altitude. Flight test data obtained for the Piper Cheyenne IIIA, the successor to the PA-31T with had a 3 ft longer fuselage and a “T” tail, indicate a long period of 60-65 sec at conditions similar to the accident flight. See Figure 5.

Figure 5: ADS-B Altitude and GPS Ground Speed for Last Five Minutes

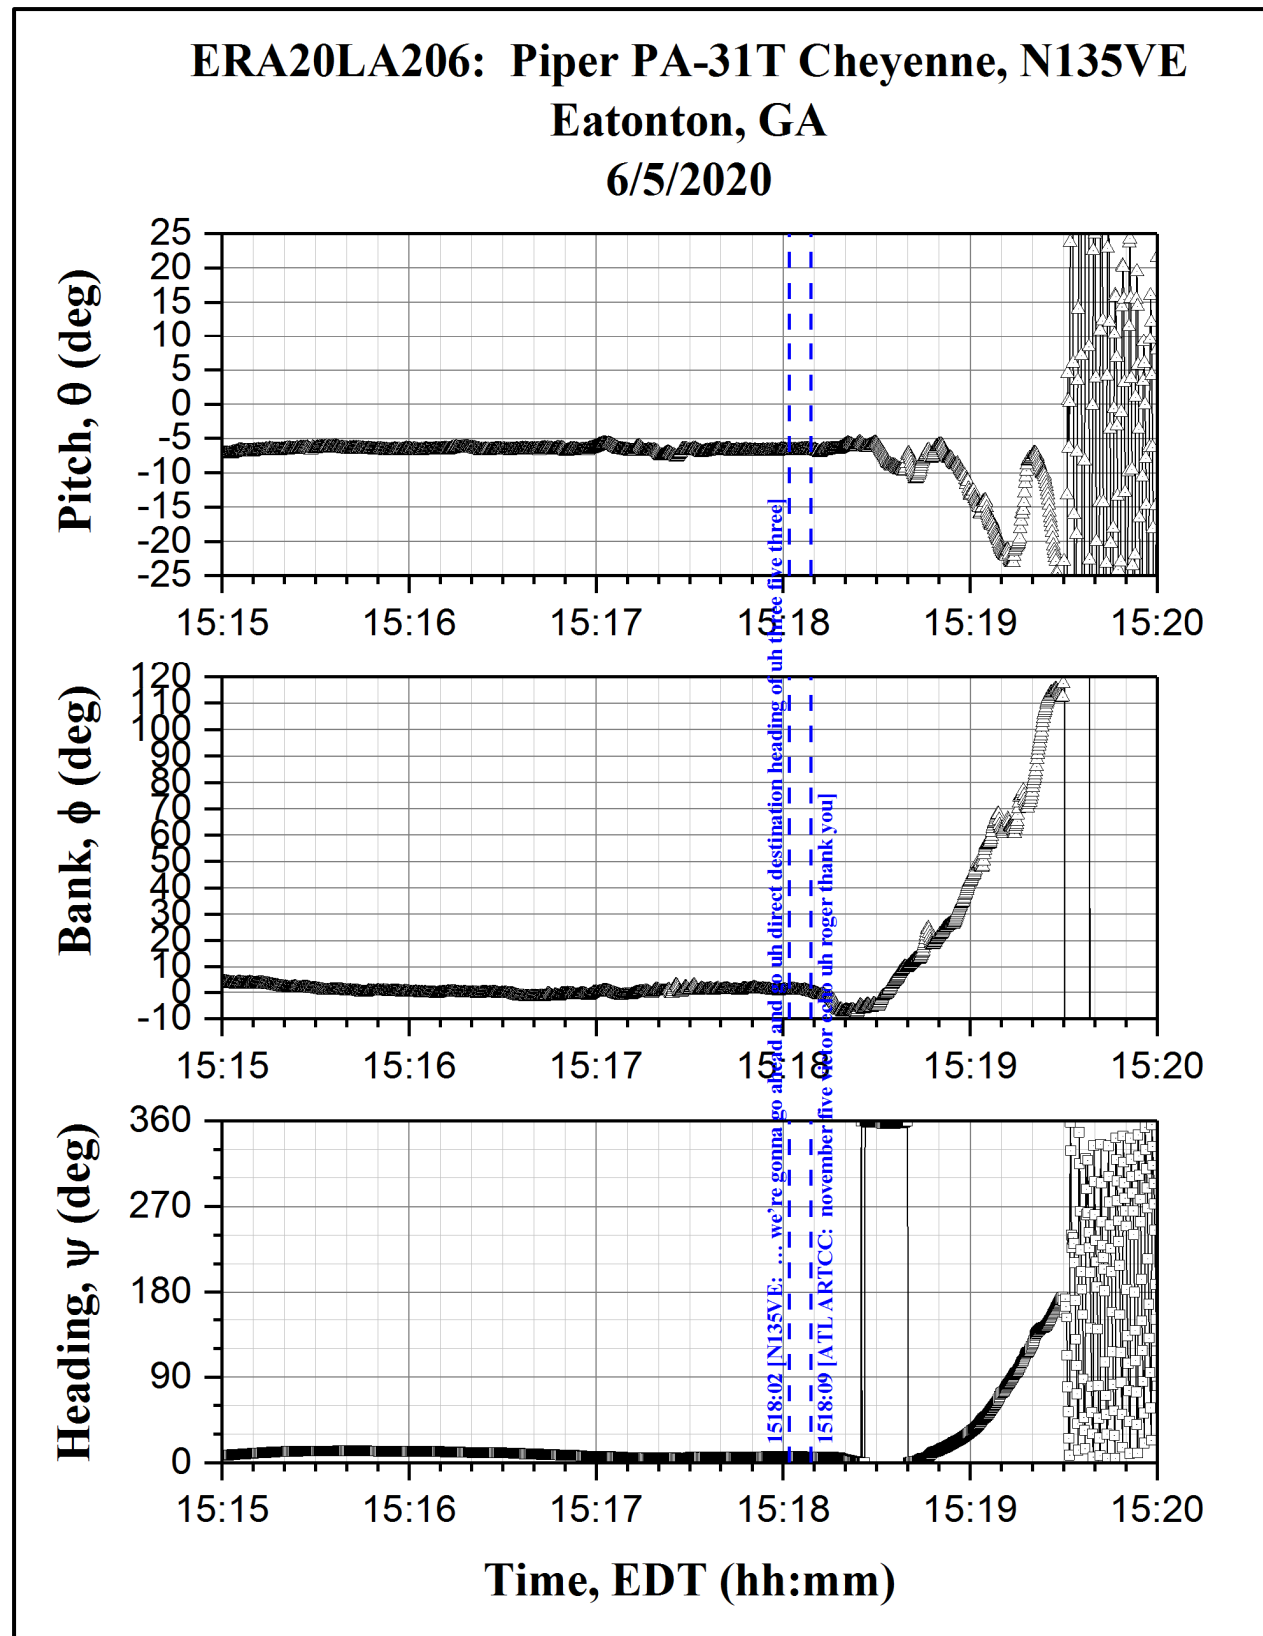
Figure 7: AHRS Pitch, Bank, and Heading for Last Five Minutes

Figures 7 and 8 include airplane attitude information recorded by the AHRS for the last two minutes. Like the altitude parameters shown in Figures 5 and 6, Figures 7 and 8 include ATC communications and highlight a pitch oscillation and a right roll about 30 sec after reporting a turn direct to their destination. In addition, Figures 7 and 8 show an approximate 10° left heading change about 10 sec after N135VE's "direct destination" radio call and before the right roll.

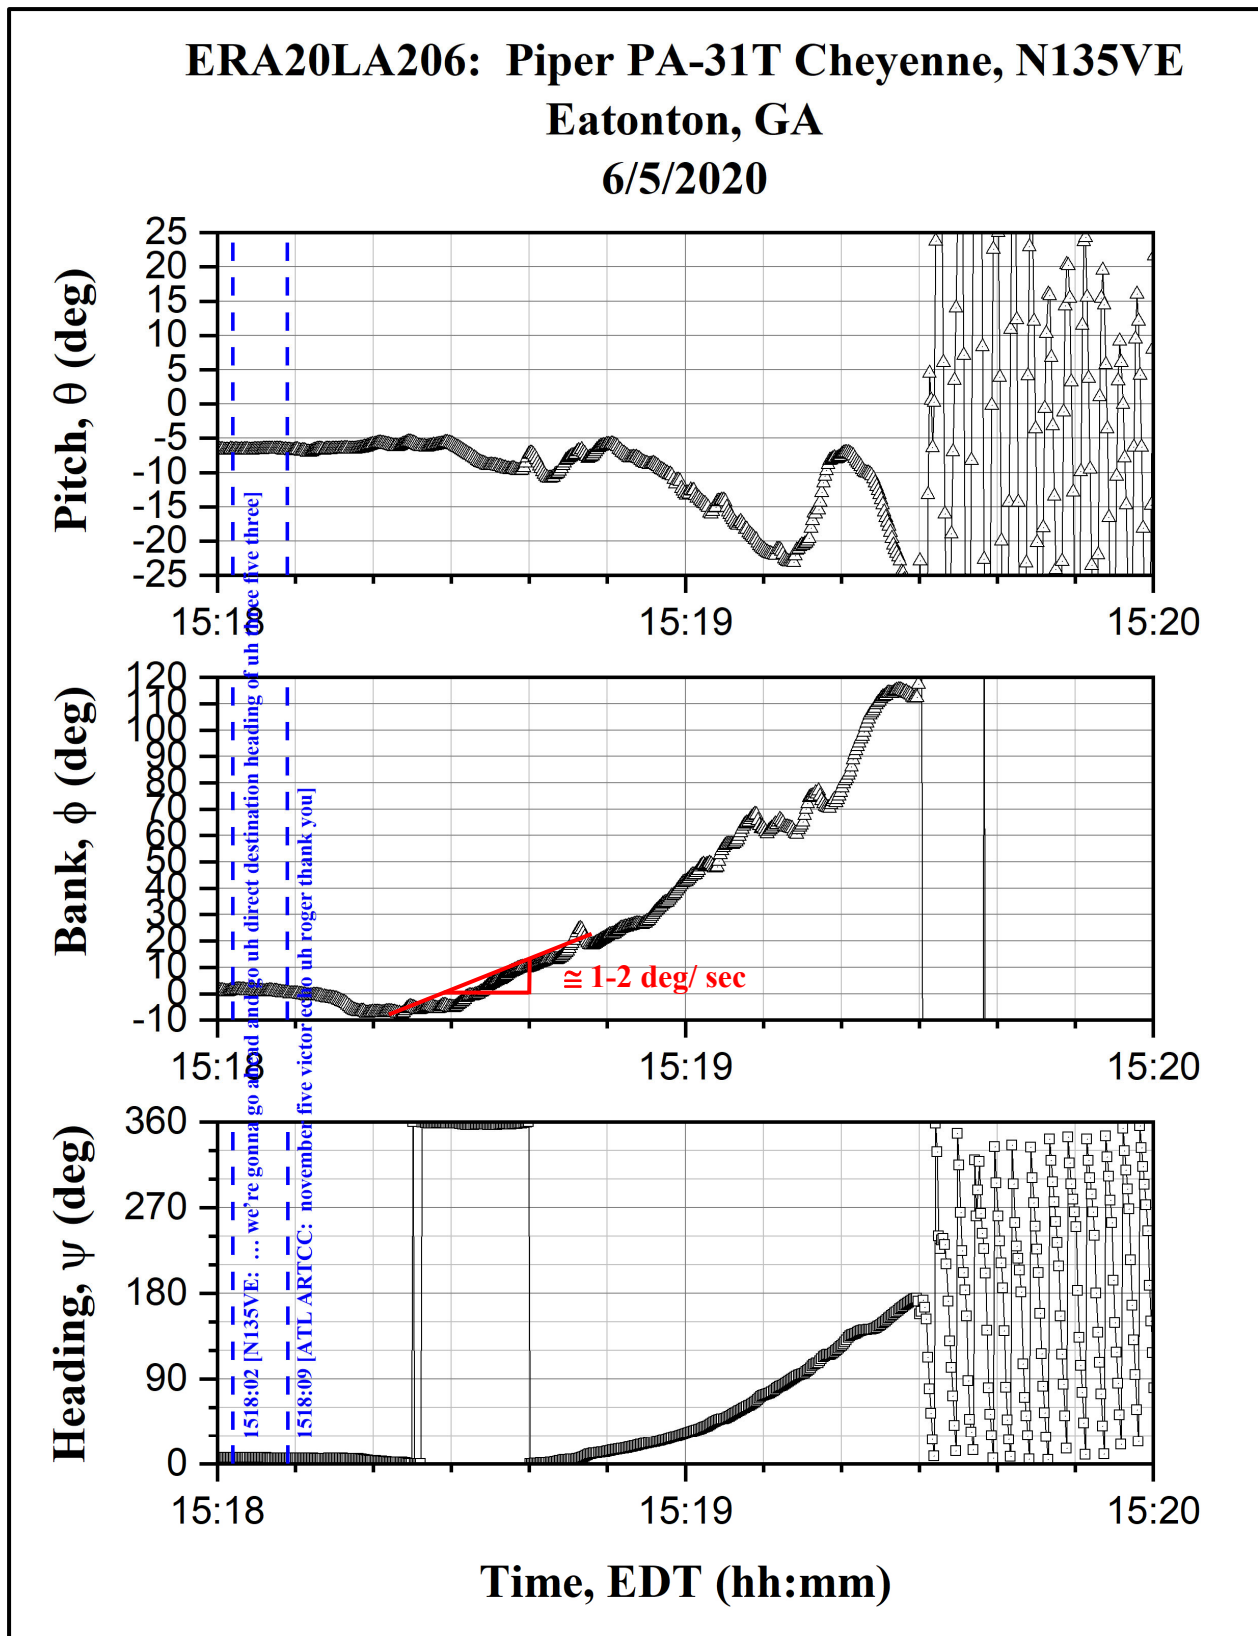
Figure 8: AHRS Pitch, Bank, and Heading for Last Two Minutes

<sup>6</sup> FAA Advisory Circular 23-8C describes the spiral mode as a slow-acting mode that may be stable but is often neutrally stable or even mildly divergent in roll. Flight test data obtained for the Piper Cheyenne IIIA indicate a spiral mode that is mildly divergent at roll rate of approximately 1-2 deg/sec at conditions similar to the accident flight. See Figure 8.

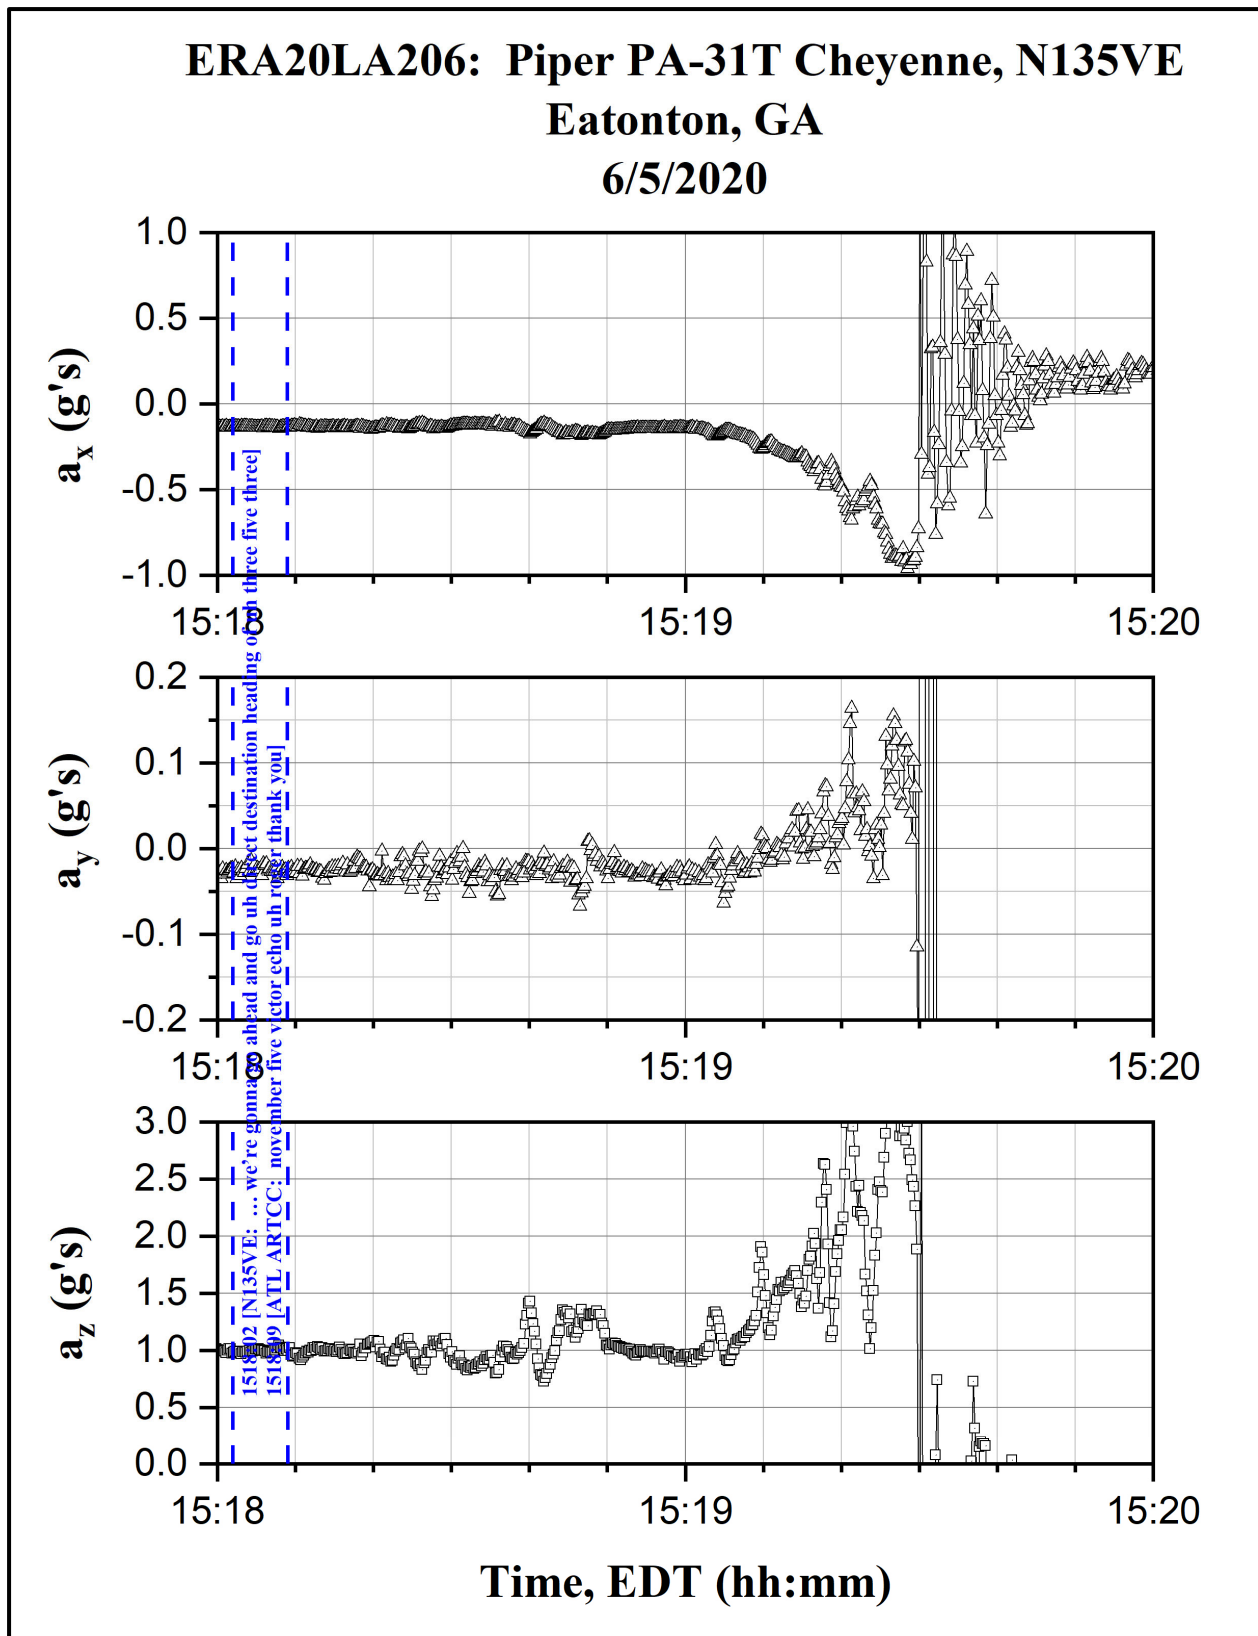
Figure 9: AHRS Accelerations for Last Two Minutes

Figure 9 contains the AHRS accelerations for the last two minutes. The accelerations highlight the change in airplane dynamics about 1518:20, especially the vertical acceleration, *a<sub>z</sub>*.

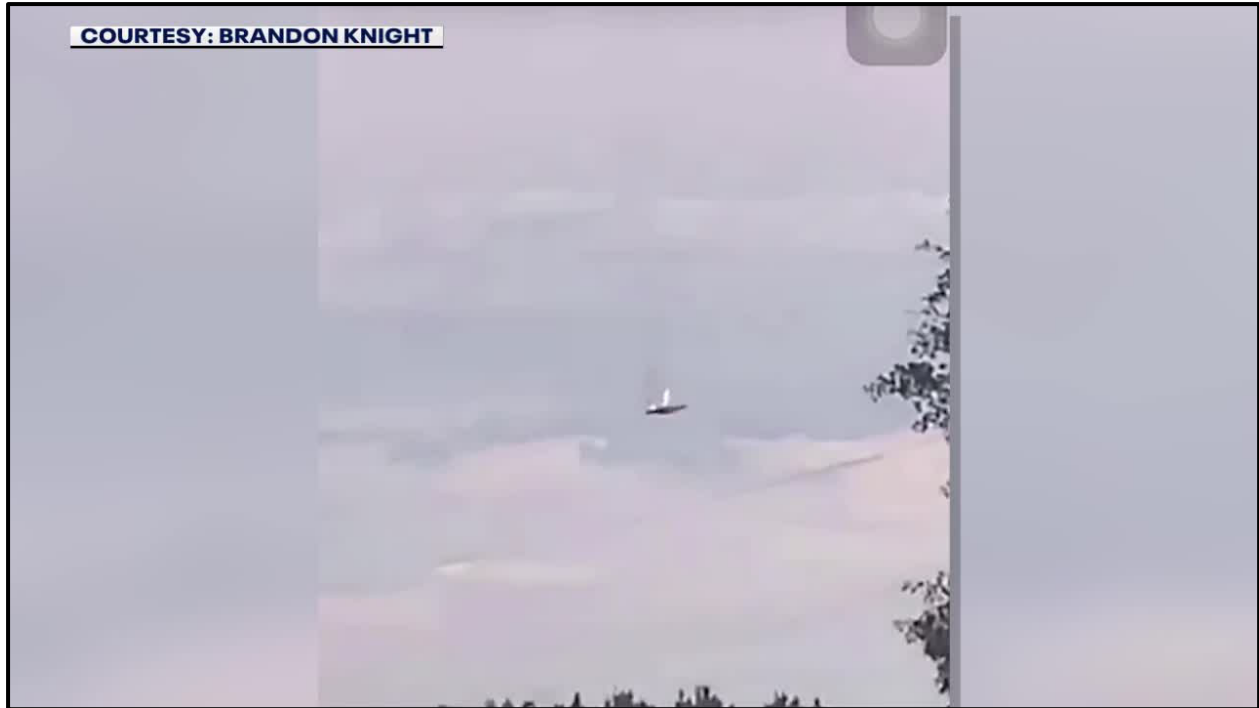
Several witnesses observed the airplane as it was descending and recorded cellphone video. A still image from one video is shown in Figure 10. A review of the video revealed the airplane was spinning and trailing smoke as it descended.

**Figure 10: Still Image from Video Showing Airplane Trailing Black Smoke as it Descended**  
(Video available at <https://www.fox5atlanta.com/news/pilot-florida-family-of-4-headed-to-funeral-in-indiana-die-in-georgia-plane-crash>, accessed June 3, 2022)
