**NATIONAL TRANSPORTATION SAFETY BOARD**  
Office of Aviation Safety

**WRECKAGE EXAMINATION SUMMARY**

**A. ACCIDENT      ERA20LA212**

Location:      Selma, Alabama  
Date:      June 10, 2020  
Time:      1631 CDT  
Operator:      Private  
Aircraft:      Piper PA-32RT-300T  
Registration:      N543GS

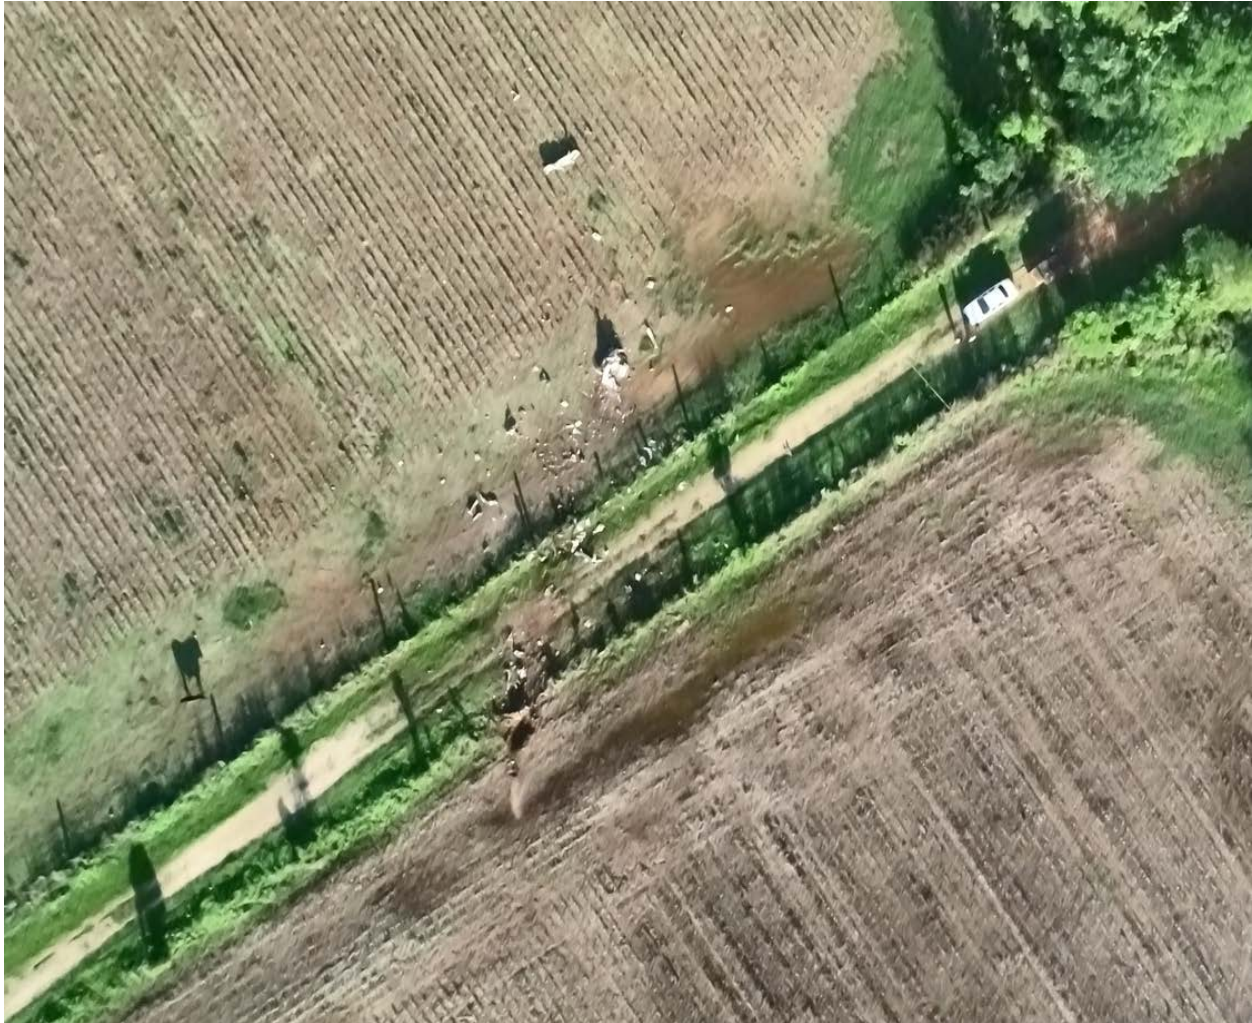
According to an FAA inspector, the airplane impacted a field and all components of the airplane were within the vicinity of the main wreckage. The initial impact crater was about 4.5 ft deep and the debris field was about 225 ft long by 120 ft wide oriented on a 125° heading.

Figure 1 – Overview of Accident Site

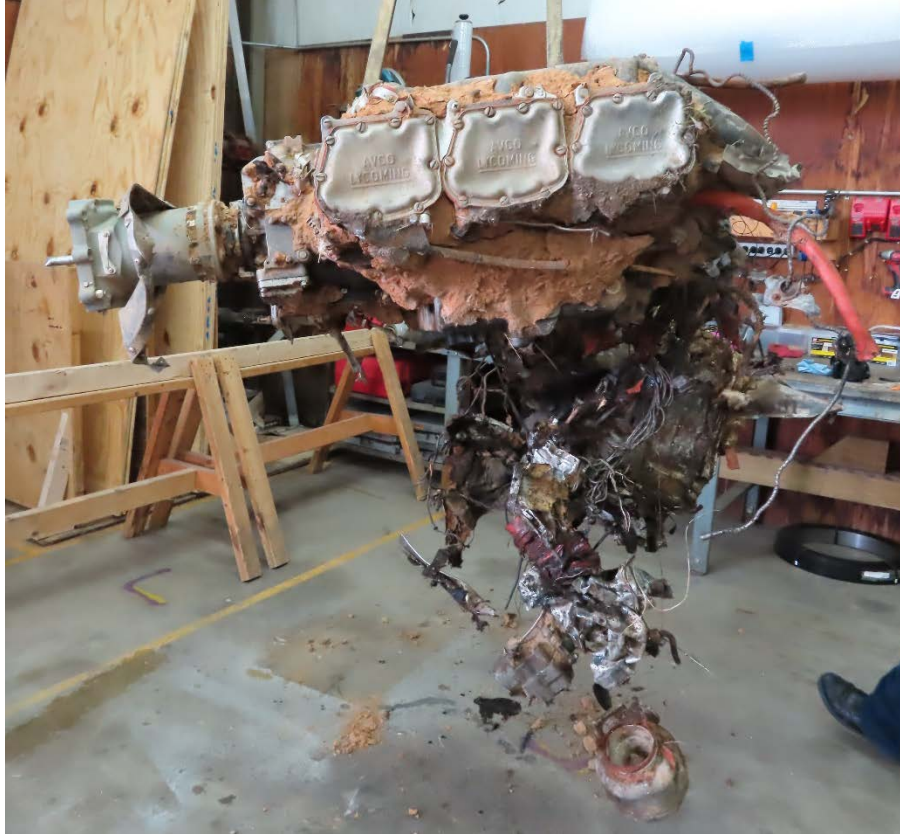
The engine was impact separated from the fragmented engine mount and located in the crater on the initial impact.

*Figure 2. View of engine after mounts removed.*

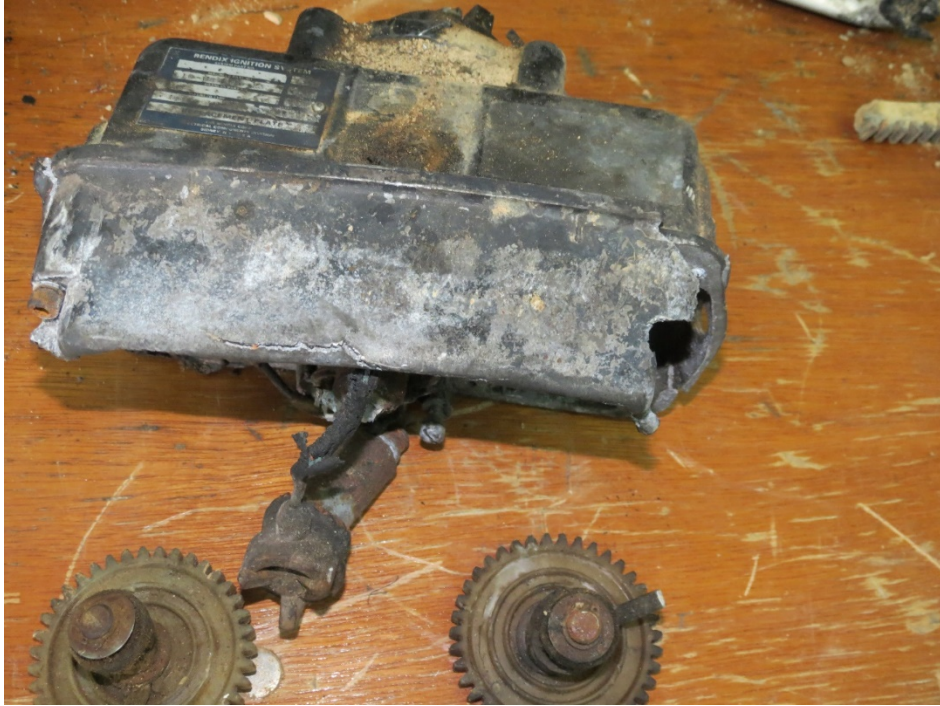
The dual magneto was thermally damaged, and it was not able to be tested.

*Figure 3. Dual magneto.*

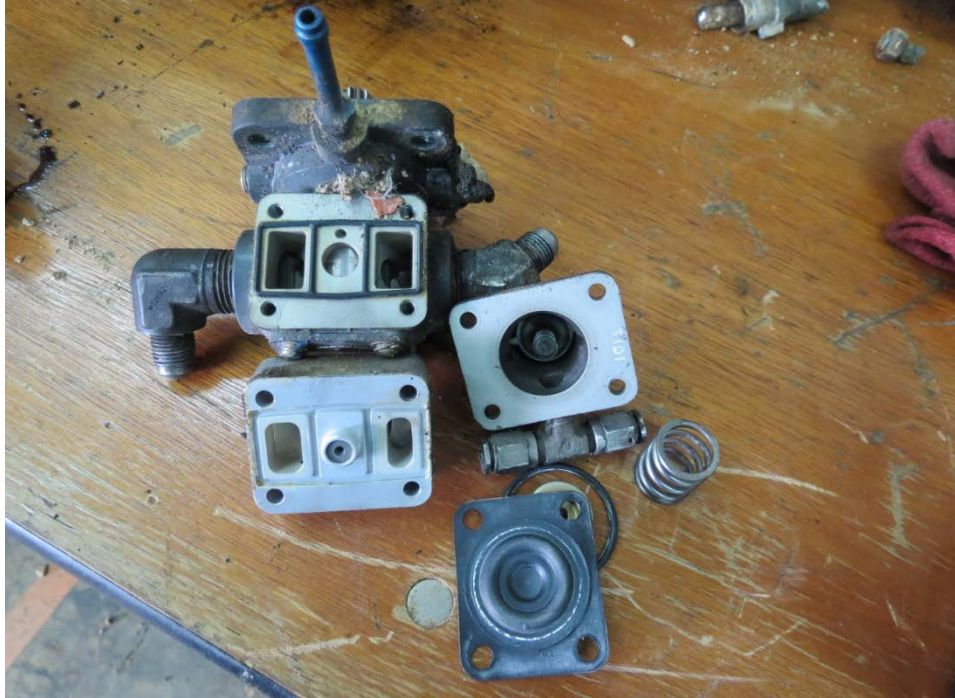
The fuel pump was examined, disassembled, and no anomalies were noted.

*Figure 4. Disassembled fuel pump.*

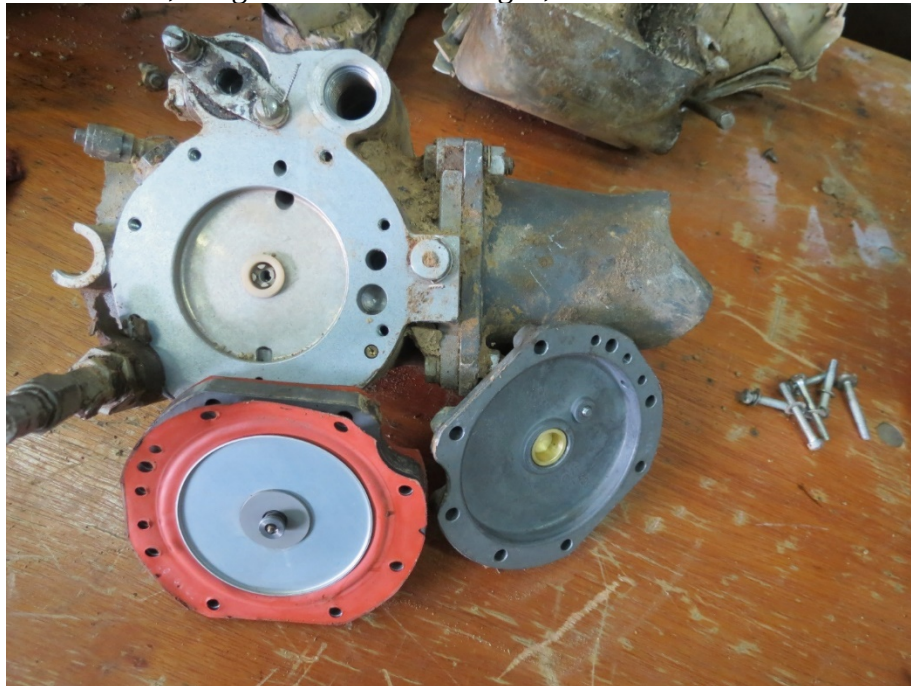
The fuel servo was impact separated and located with the main wreckage. The butterfly was separated from the assembly but remained attached through the throttle body arm. The fuel servo was disassembled, the gasket was not damaged, and no anomalies were noted.

*Figure 5. Disassembled fuel servo.*

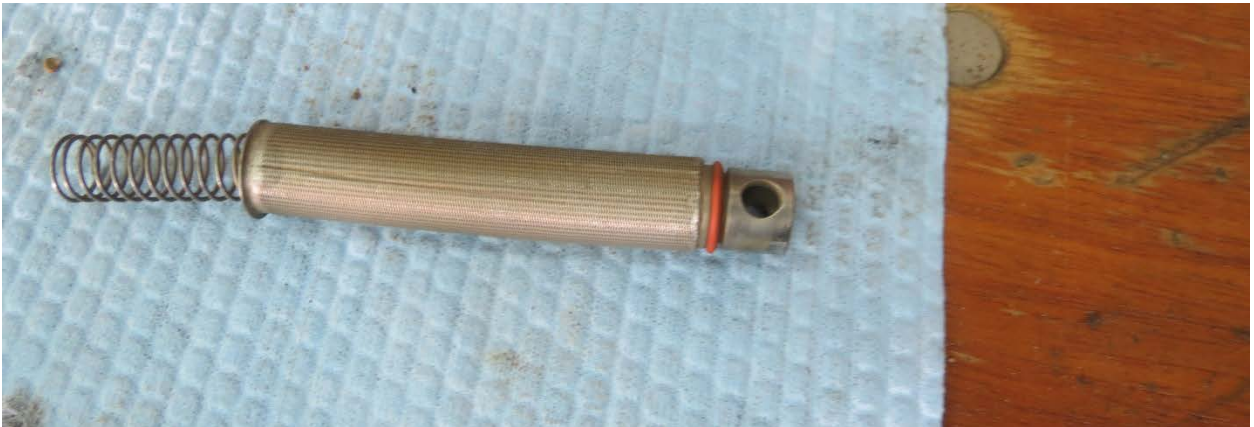
Figure 6. Fuel Screen.

The fuel screen was examined and free of debris.

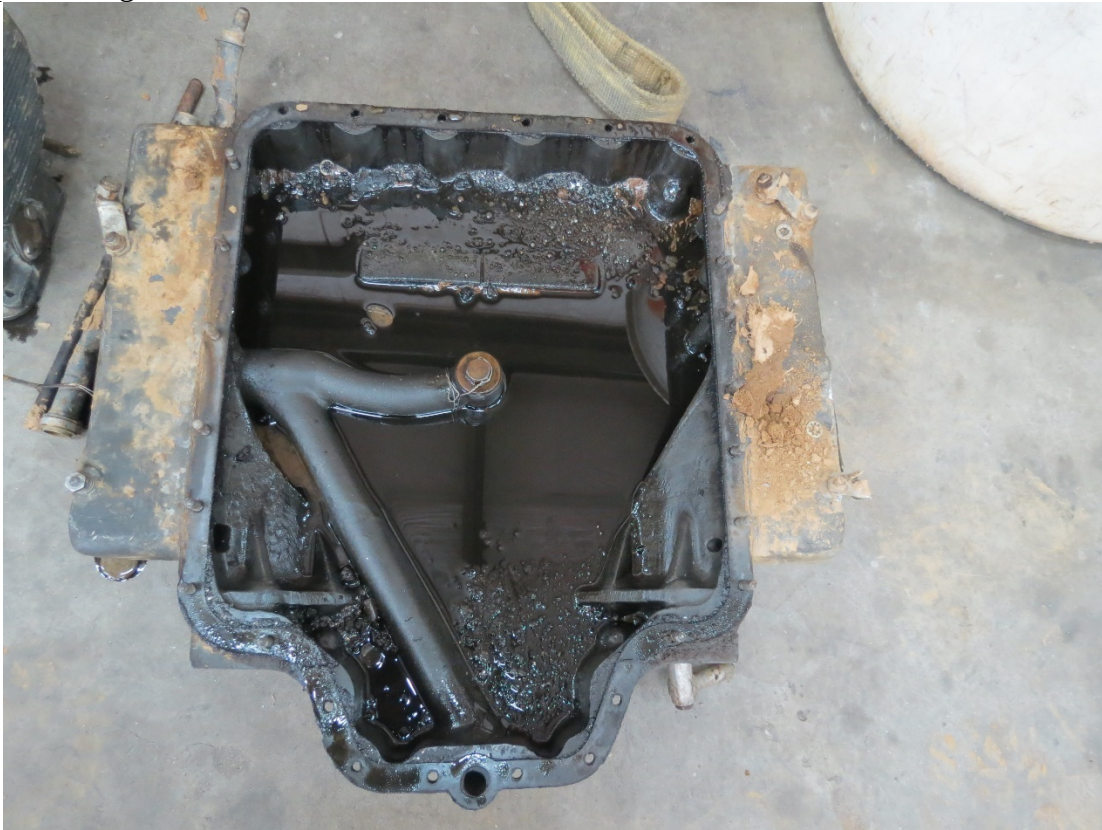
The oil sump was removed from the engine and contained oil, metallic particles, small carbon chips, and organic debris.

Figure 7. View of oil sump.

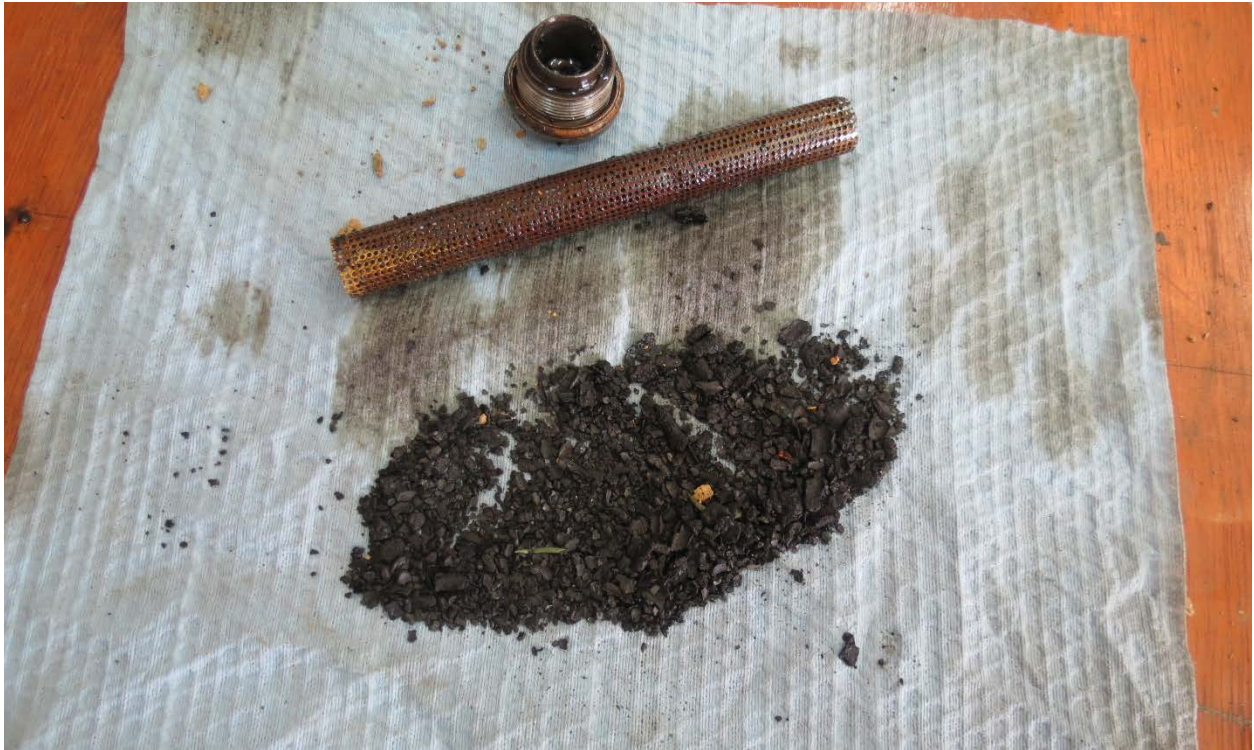
The oil screen was examined and it was obstructed by debris similar to carbon. The debris obstructed and filled about 2/3-5/8 of the oil screen. The debris was retained for further examination.

Figure 8. View of oil suction screen.

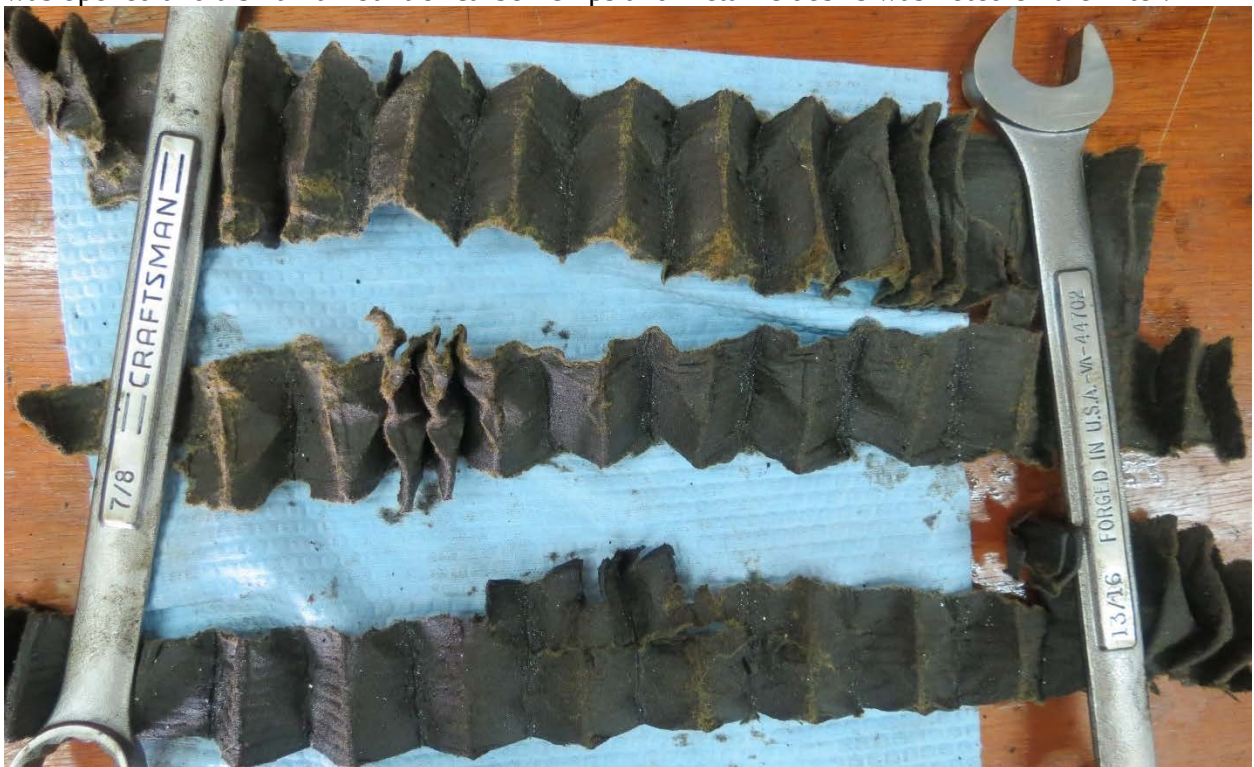
The oil filter was removed from the engine. It had a date of March 27, 2020, written on it. It was opened and a small amount of carbon chips and metallic debris was noted on the filter.

Figure 9. View of disassembled oil filter.

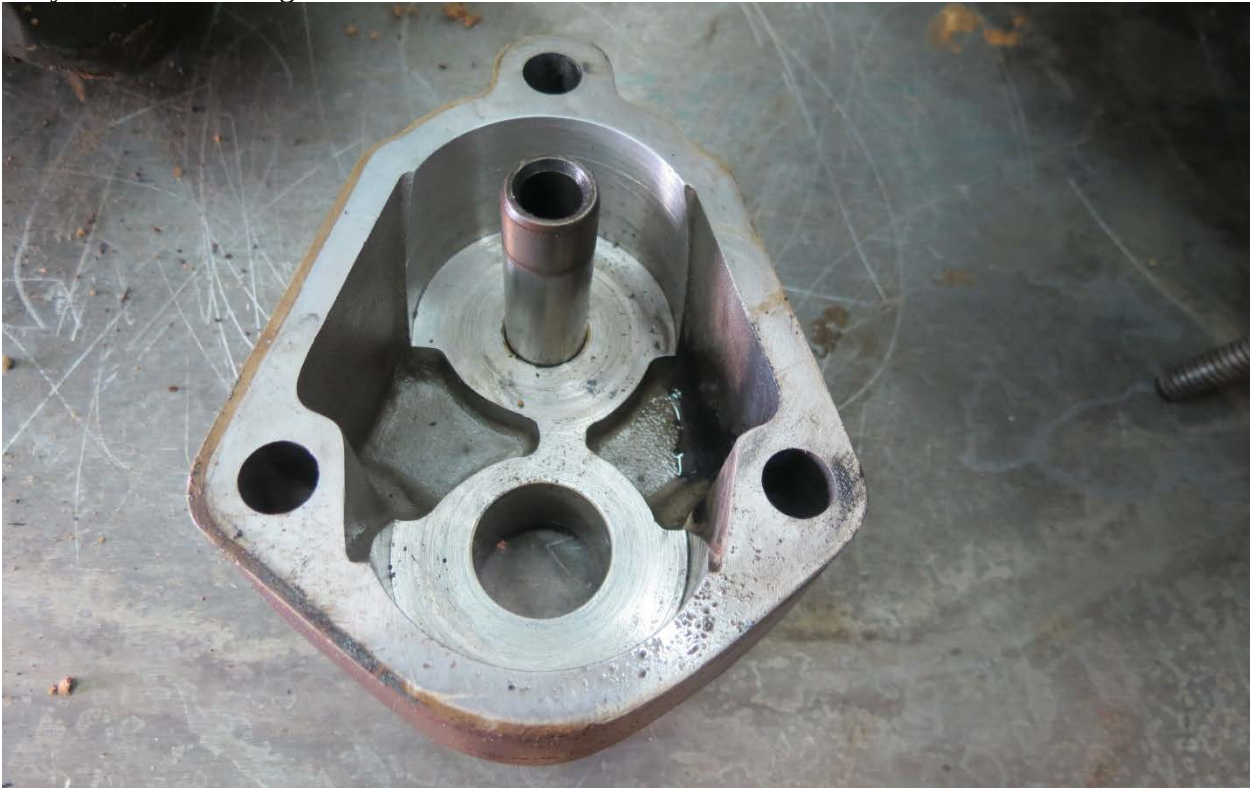
The oil pump was removed from the accessory section of the engine and examined. The pump body exhibited scoring.

*Figure 10. View of disassembled oil pump.*

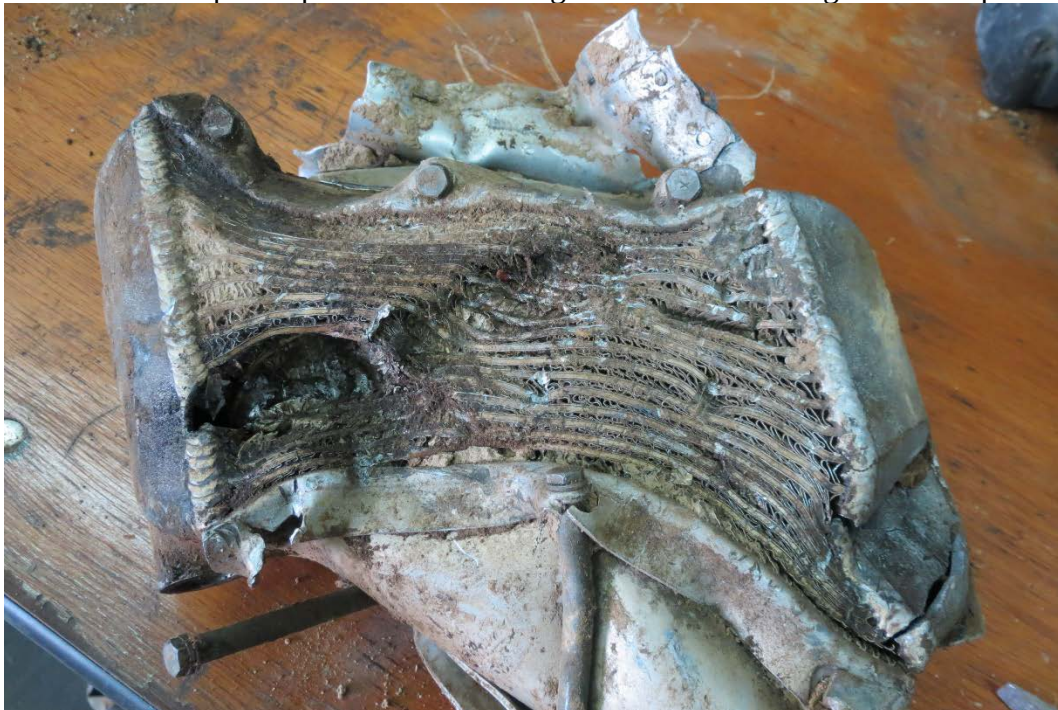
The oil cooler was impact separated from the engine and located along the debris path.

*Figure 11. View of oil cooler as found.*

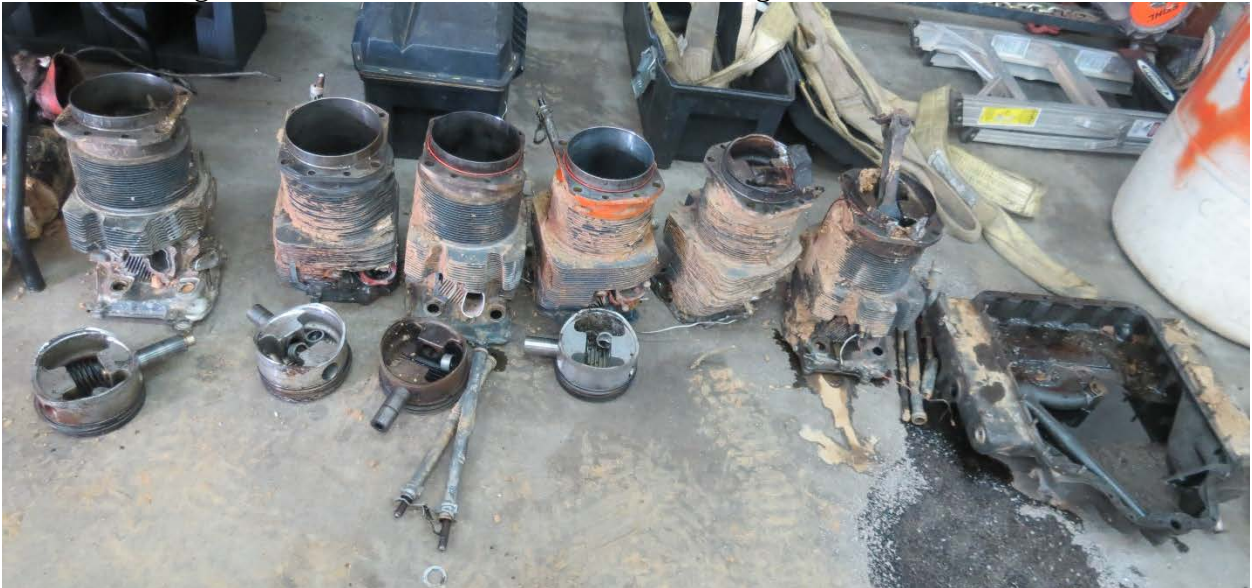
Cylinder Nos. 1-4 were removed from the engine with minor difficulty. The No. 5 cylinder skirt was damaged and was difficult to remove from the engine.

*Figure 13. View of cylinders after removed from the engine.*

Cylinder No. 1 was impact damaged. The rocker box cover was removed and no anomalies were noted with the rocker arms or valves. Corrosion was noted on the interior of the cylinder. The valves were seated with no anomalies noted.

Cylinder No. 3 was impact damaged. The rocker box cover was removed and no anomalies were noted with the rocker arms or valves. The interior of the cylinder exhibited normal wear. The valves were seated and no anomalies were noted.

Cylinder No. 5 was impact damaged. The rocker box cover was removed and no anomalies were noted with the rocker arms or valves. The piston could not be removed from the cylinder. The connecting rod remained attached to the piston.

Cylinder No. 2 was impact damaged. The rocker box cover was removed and no anomalies were noted with the rocker arms or valves. The interior of the cylinder exhibited normal wear. The valves were seated and no anomalies were noted.

Cylinder No. 4 was impact damaged. The rocker box cover was removed and no anomalies were noted with the rocker arms or valves. The interior of the cylinder exhibited normal wear and oil was present. The valves were seated and no anomalies were noted.

Cylinder No. 6 was impact damaged and exhibited thermal damage. The rocker box cover was removed and no anomalies were noted with the rocker arms or valves. The piston could not be removed from the cylinder. The connecting rod remained attached to the piston.

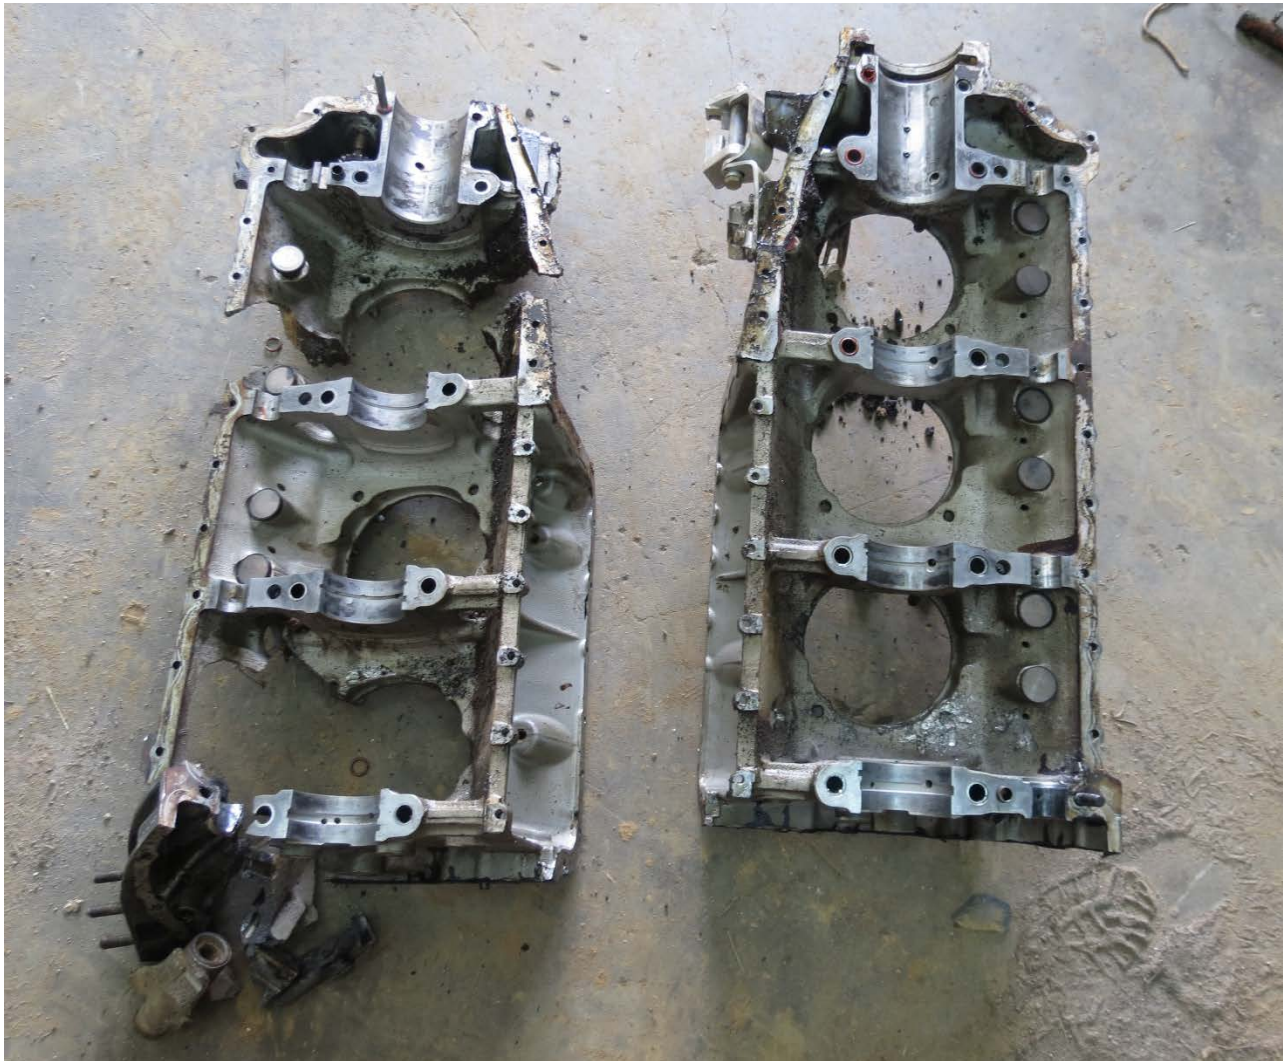
The crankcase was examined and a hole was located in the top of the case in the vicinity of the No. 6 cylinder. The forward section of the 2-4-6 section side of the crankcase was impact damaged. The 1-3-5 side exhibited impact damage on the interior. No other anomalies were noted.

*Figure 14. View of crankcase halves.*

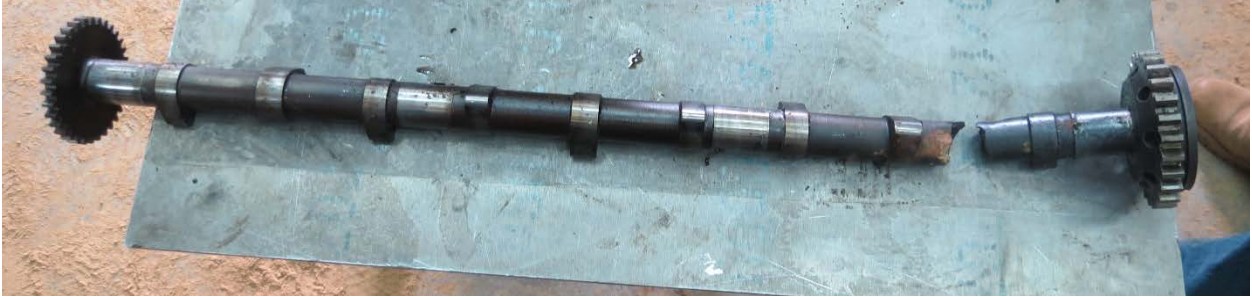
The camshaft was fractured into two sections above the No. 6 crankshaft journal. The section of the camshaft near the aft portion of the engine exhibited thermal discoloration. The camshaft lobes exhibited normal wear. The No. 6 lifters were impact separated and one lifter was not located. No anomalies were noted with the camshaft gears and all gear teeth remained intact. No anomalies were noted with the camshaft.

*Figure 15. View of camshaft after removed from engine.*

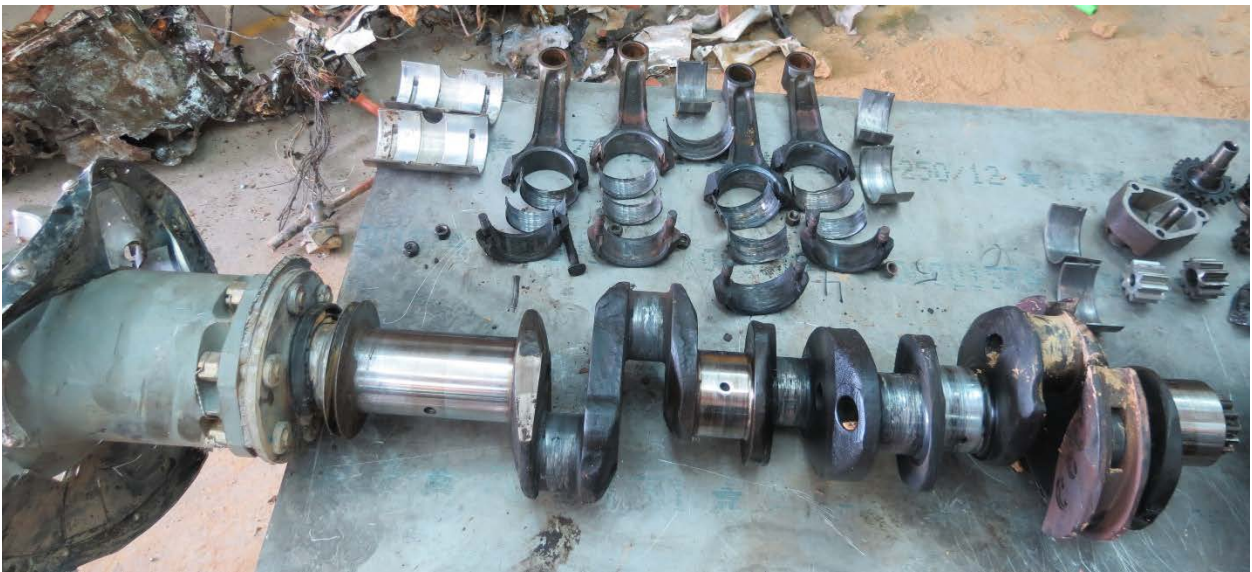
The crankshaft was removed from the crankcase and examined. It remained in one piece but exhibited thermal discoloration on the aft section of the crankshaft.

*Figure 16. View of crankshaft, crankshaft bearings, and connecting rods.*

The No. 1 crankshaft journal did not exhibit any anomalies. The No. 1 crankshaft journal bearings were examined and did not exhibit any anomalies.

The No. 2 crankshaft journal exhibited a small amount of thermal discoloration. The No. 2 journal bearings exhibited fretting.

The No. 3 crankshaft journal exhibited rotational scoring and thermal discoloration. The No. 3 crankshaft journal bearing exhibited smearing and rotational scoring.

The No. 4 crankshaft journal exhibited a small amount of thermal discoloration. The No. 4 crankshaft journal bearing exhibited fretting.

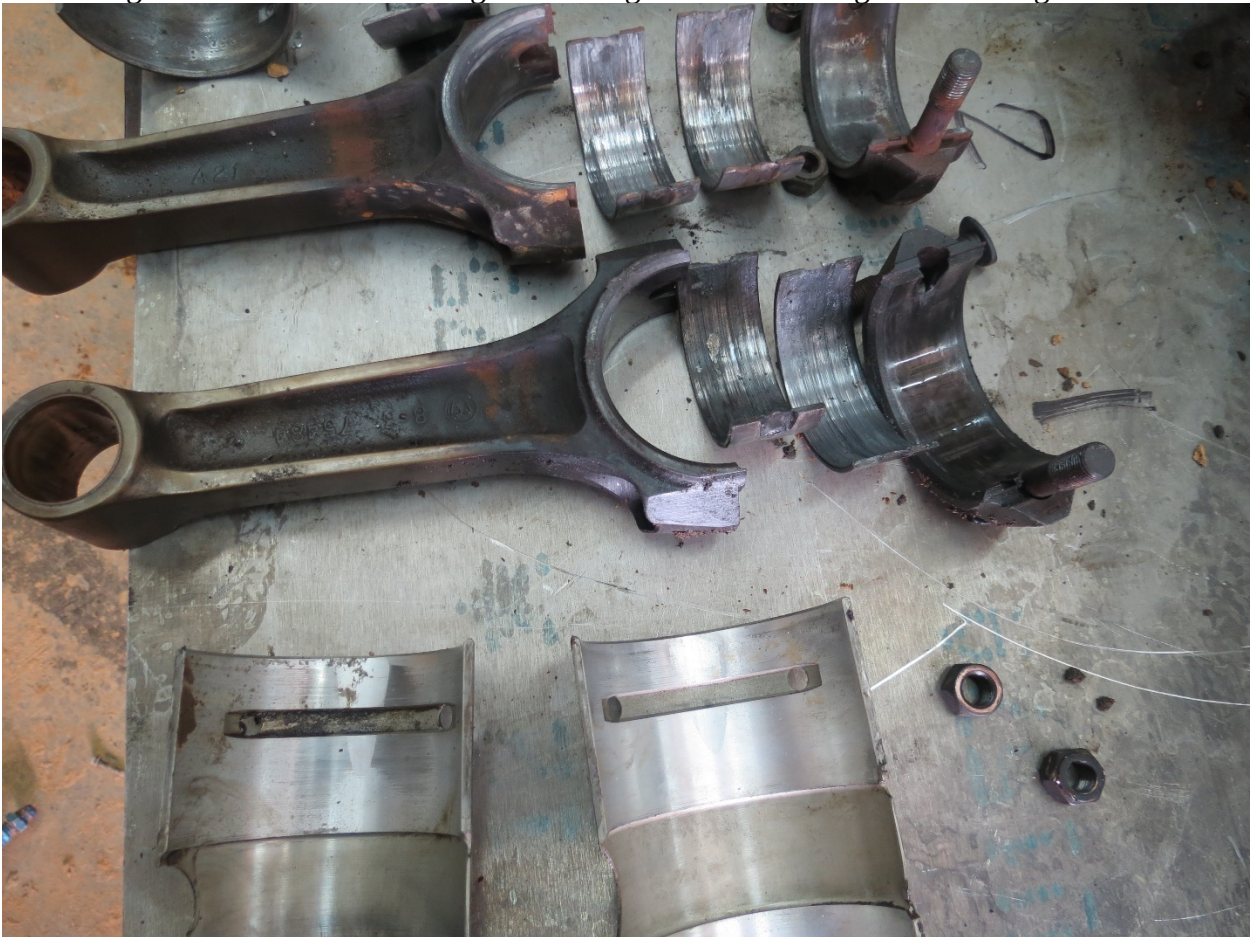
The No. 1 connecting rod exhibited thermal discoloration on the crankshaft side of the connecting rod. The No. 1 connecting rod bearing exhibited scoring and smearing.

The No. 2 connecting rod exhibited thermal discoloration on the crankshaft side of the connecting rod. The No. 2 connecting rod bearing exhibited scoring and smearing.

*Figure 17. View of Nos. 1 and 2 connecting rods and bearings.*

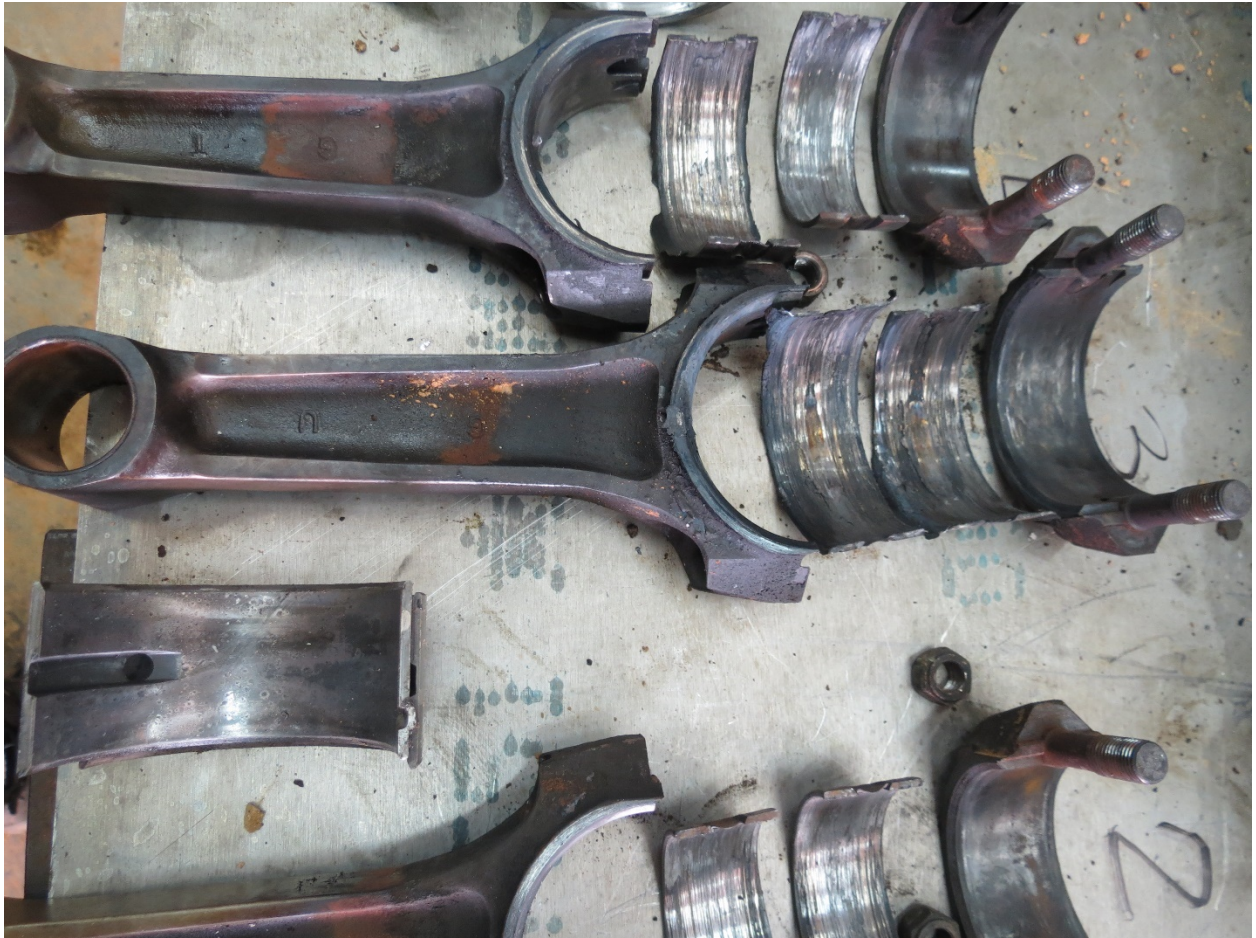
The No. 3 connecting rod exhibited thermal discoloration on about half of the connecting rod on the side of the crankshaft. The No. 3 connecting rod bearing exhibited thermal damage and smearing.

The No. 4 connecting rod exhibited thermal discoloration on about half of the connecting rod on the side of the crankshaft. The No. 4 connecting rod bearing exhibited thermal damage and smearing.

*Figure 18. Nos. 3 and 4 connecting rods and bearings.*

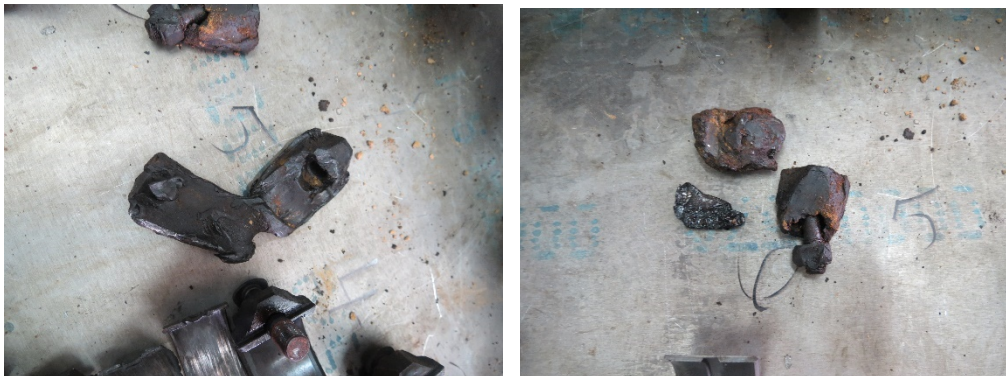
The No. 5 connecting rod was detached from the crankshaft journal. In addition, the journal exhibited extensive thermal discoloration and rotational scoring.

The No. 6 connecting rod was detached from the crankshaft journal and small pieces of the No. 6 connecting rod and bearing were located. The rest of the connecting rod was not located. The No. 6 rod journal exhibited severe thermal discoloration.

*Figure 19. Nos 5 and 6 section of connecting rod.*

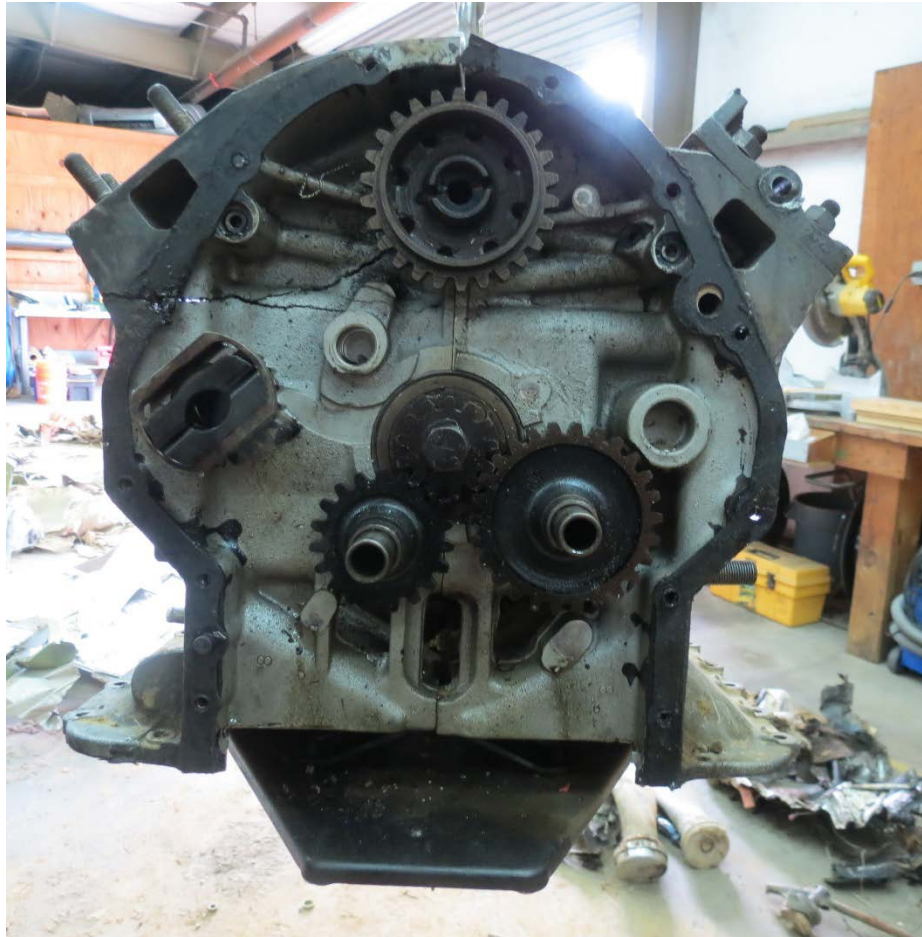
The accessory section of the engine was examined and no anomalies were noted. All gear teeth remained intact and no anomalies were noted.

*Figure 20. View of Accessory Section Gears.*

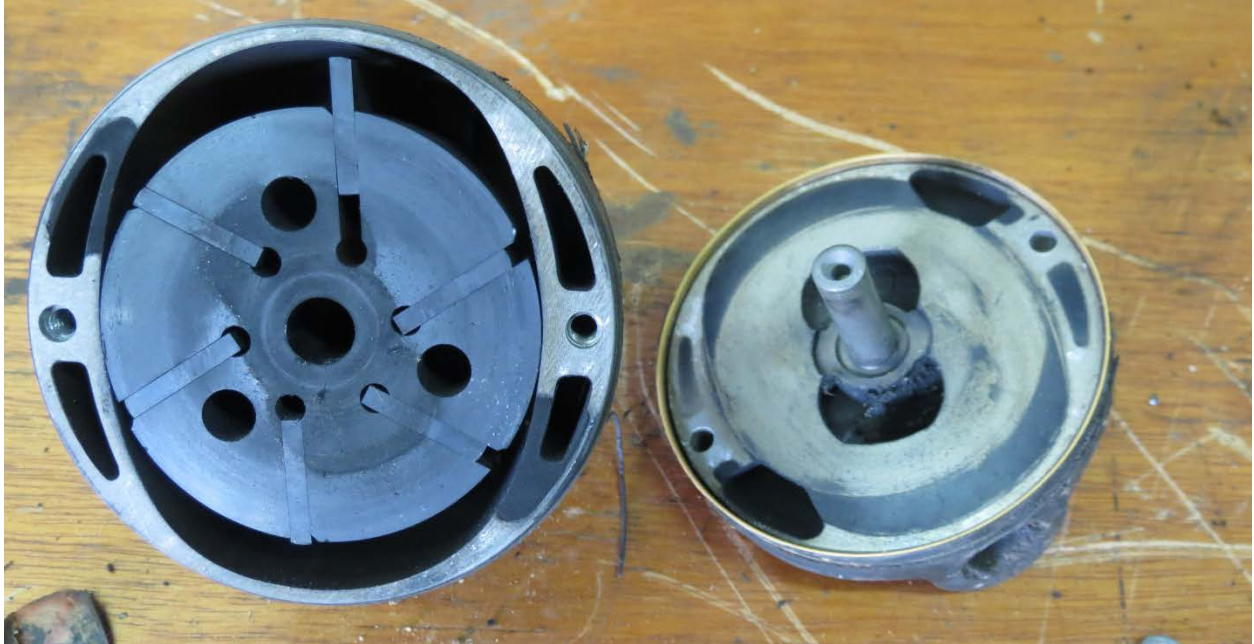
The vacuum pump was examined and disassembled. The rotor and vanes remained intact.

Figure 23. View of interior of vacuum pump.

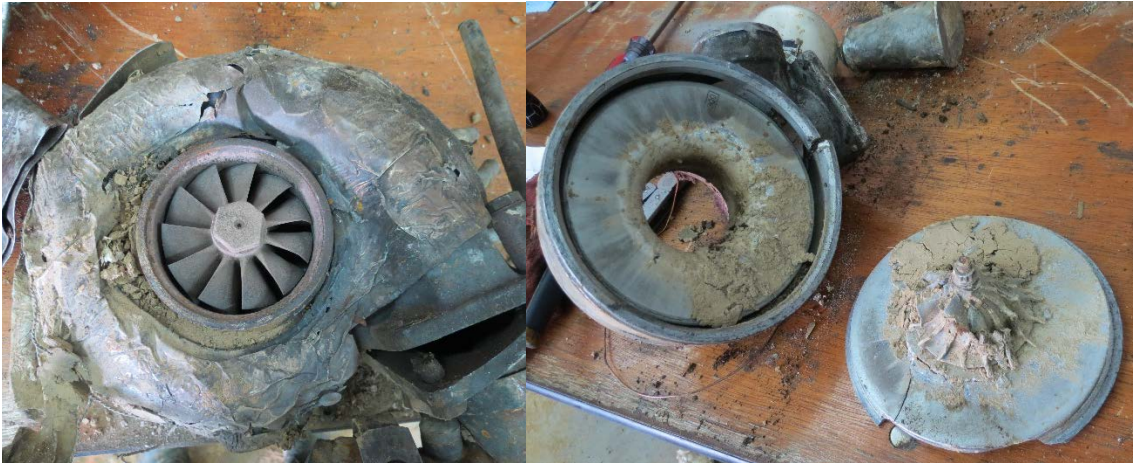
The turbocharger was impact damaged and broken in half. The compression wheel was impact damaged. The manifold pressure relief valve was impact separated and partially crushed.

Figure 24. View of disassembled turbo and impeller.

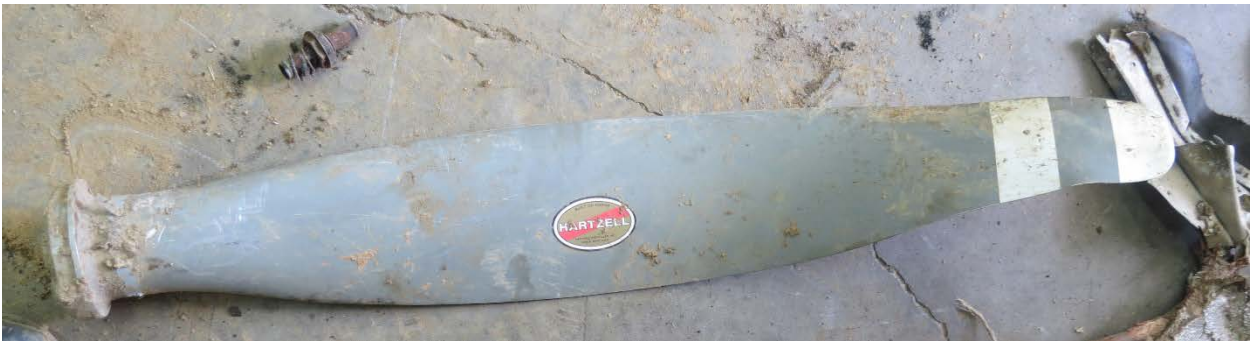
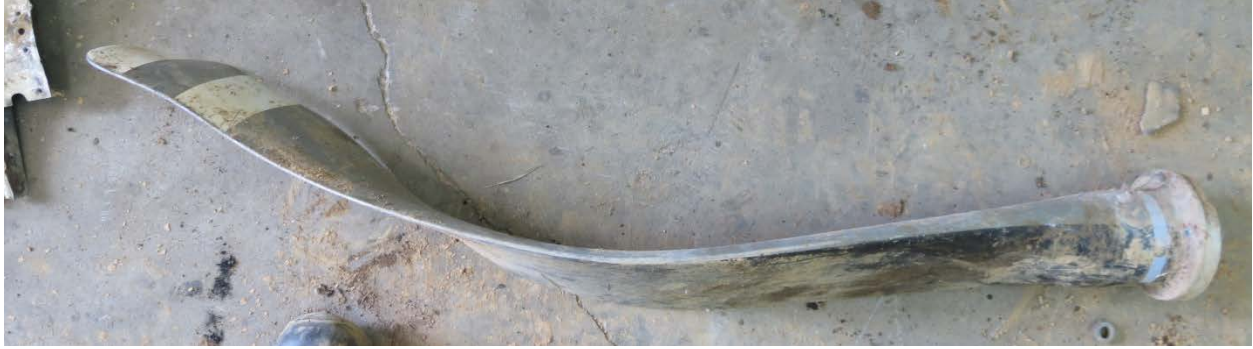
Blade A was examined and exhibited a small amount of bending. There were no chordwise scratch markings on the blade.

*Figure 26. View of side of Blade A. Note bending.*

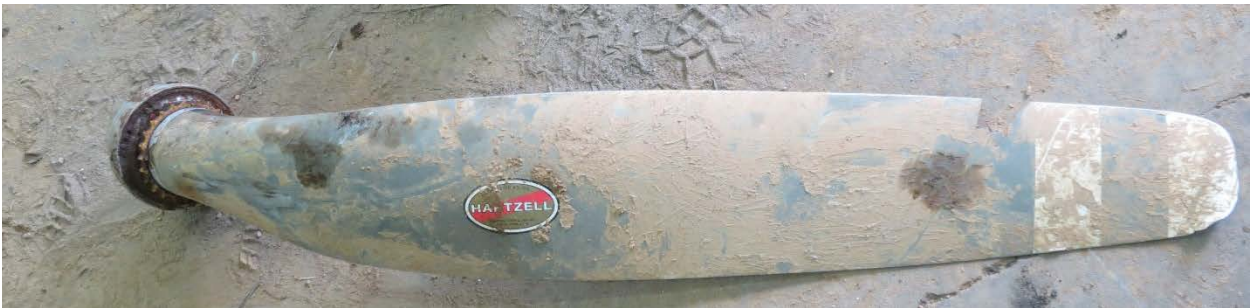
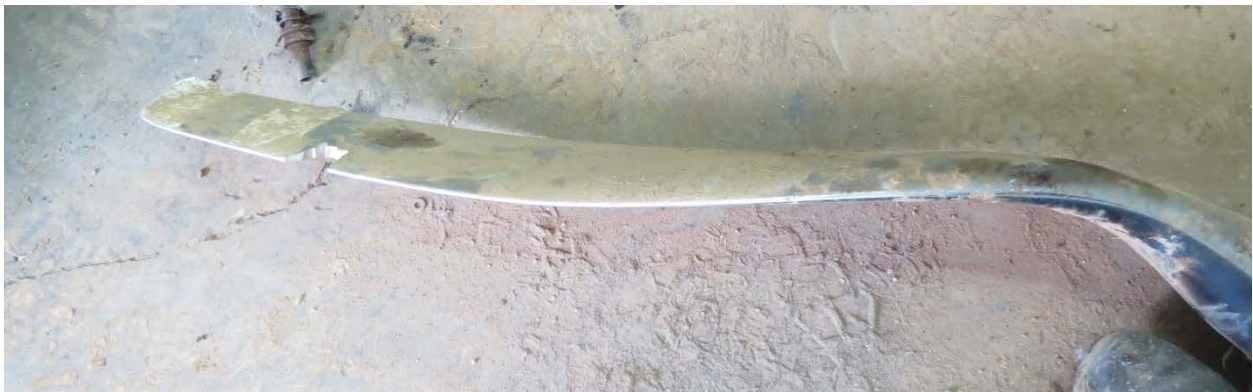
Blade B was examined and was bent aft about 30°. A gouge was cut into the blade by personnel during the recovery. The tip exhibited a slight bend. The blade back did not exhibit any chordwise scratches.
