# NATIONAL TRANSPORTATION SAFETY BOARD

## MATERIALS LABORATORY FACTUAL REPORT

Report No. 21-024

Place : Selma, AL  
Date : June 10, 2020  
Vehicle : Piper PA-32RT-300T, N543GS  
NTSB No. : ERA20LA212  
Investigator : Heidi Kemner (AS-ERA)

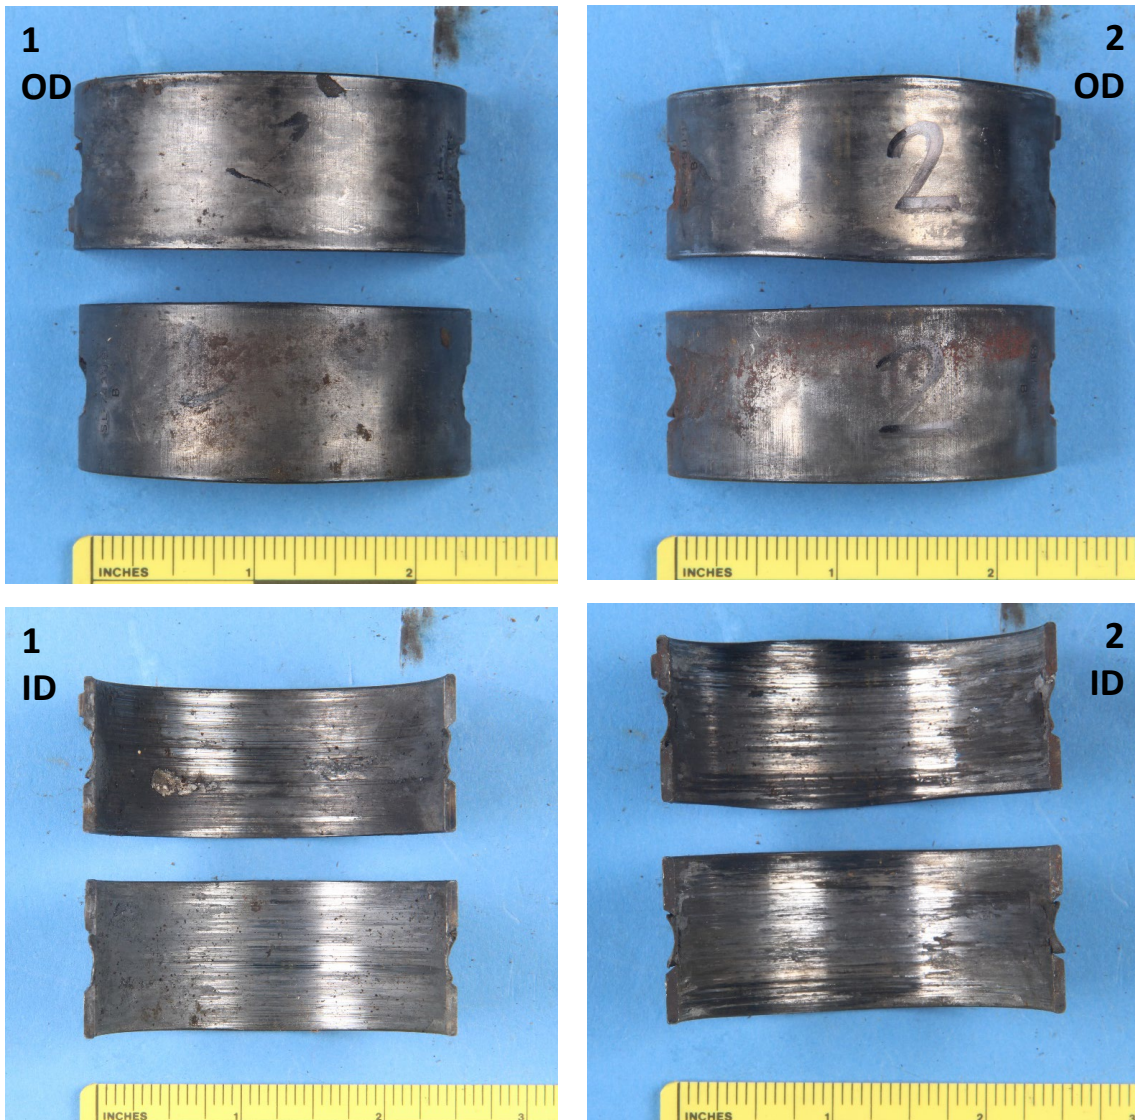
Four connecting rod journal bearings were submitted for examination, as shown in Figures 1 and 2. The outer diameter (OD) of each bearing half was labeled with the mating crankshaft journal location of 1, 2, 3, or 4, but whether each bearing was in the cap or rod position was not indicated.

There was extensive damage to all the submitted bearings. Circumferential score marks and heavy wear were visible on the inner diameter (ID) of the bearing halves. Galling and displaced material were observed on most of the IDs, with the worst galling damage on the ID of bearing #3, details of which are shown in digital microscope images in Figure 3. Discoloration due to overheating was also present on the journal IDs. No evidence of remaining Babbitt material was observed on the ID surfaces.

The journal bearings and connecting rod pieces had damage consistent with high temperatures, likely due to oil starvation.

Figure 1: Overall photos showing bearings #1 (left) and #2 (right). The top photos show the outer diameter and the bottom photos show the inner diameter of the bearing halves.

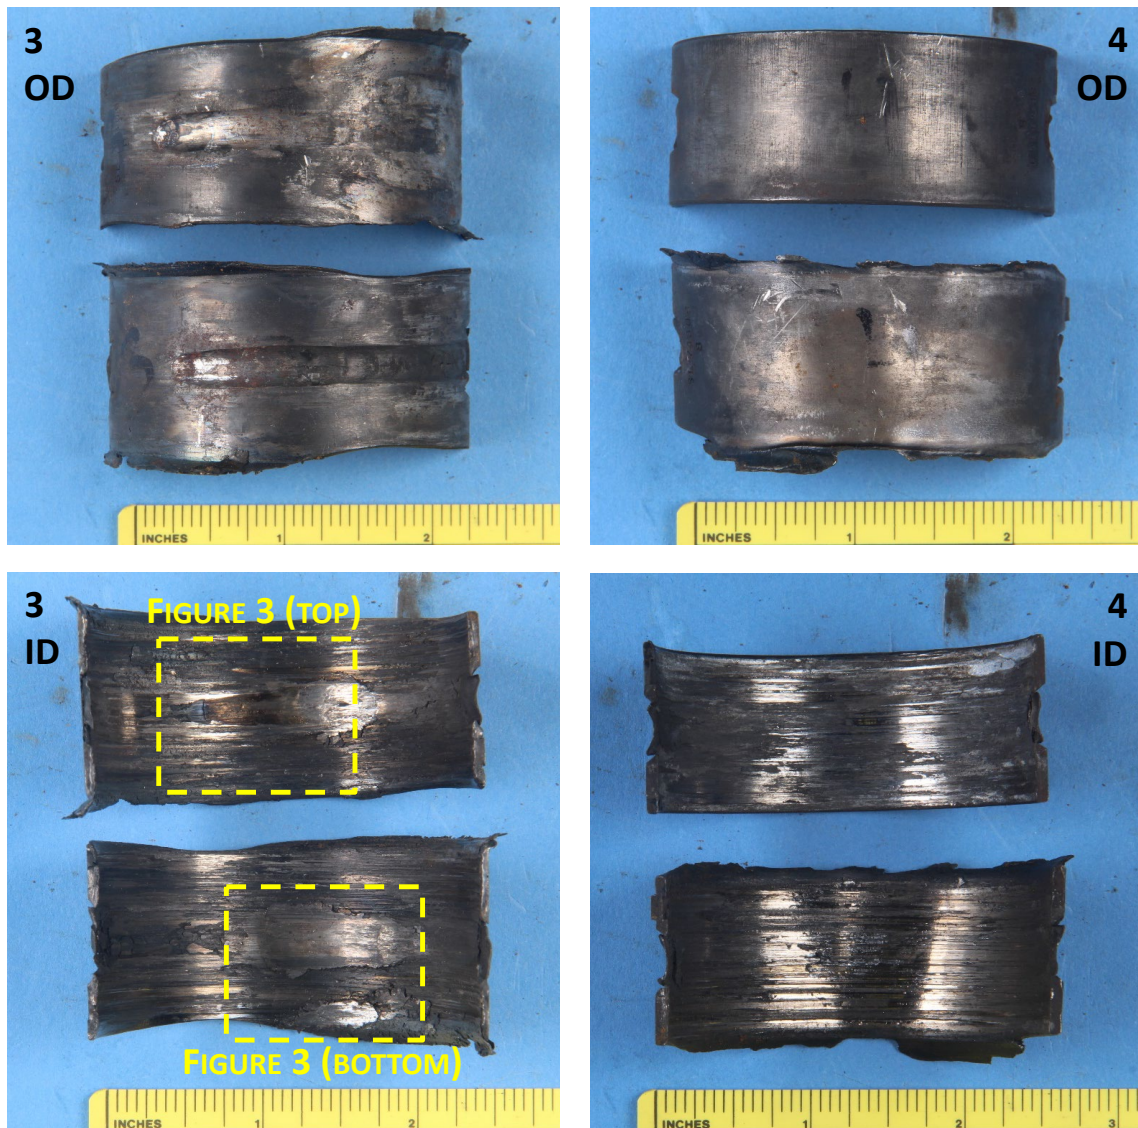
The bearing halves had material pushed out of the ID onto the sides, resulting in thinning of the bearing walls and widening of the bearing widths. The deformed shape and displaced material were worst on bearings #3 and #4. Scuff marks and rub damage were observed on the bearing ODs. Bearing #3 also had a channel gouged into the OD, as seen in the top left image of Figure 2.

Figure 2: Overall photos showing bearings #3 (left) and #4 (right). The top photos show the outer diameter and the bottom photos show the inner diameter of the bearing halves.

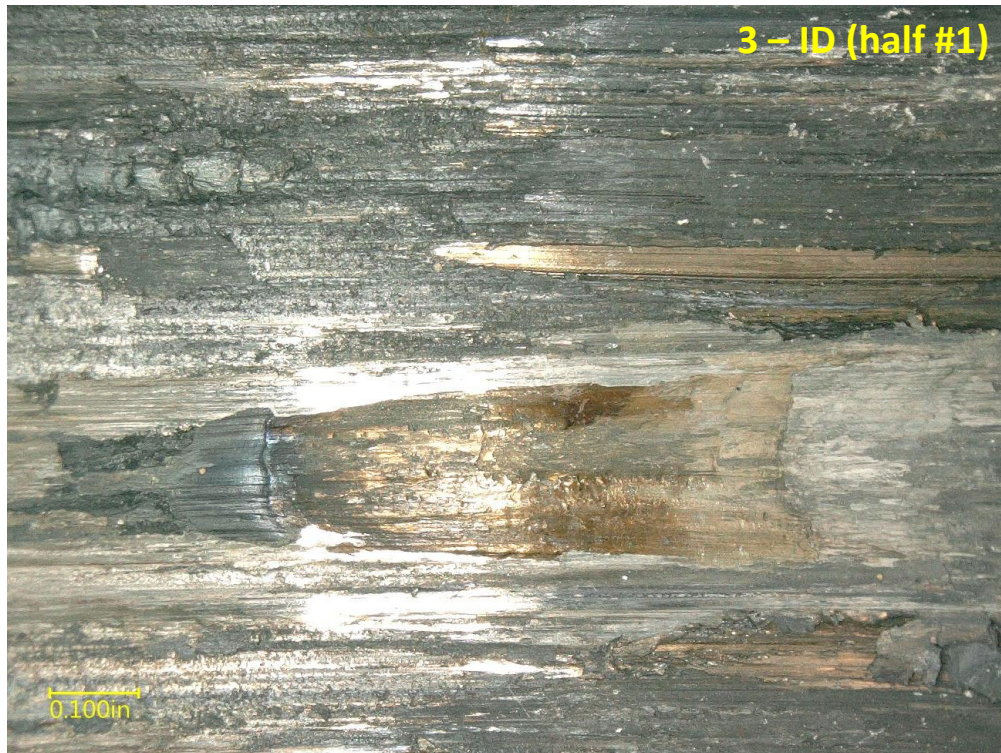
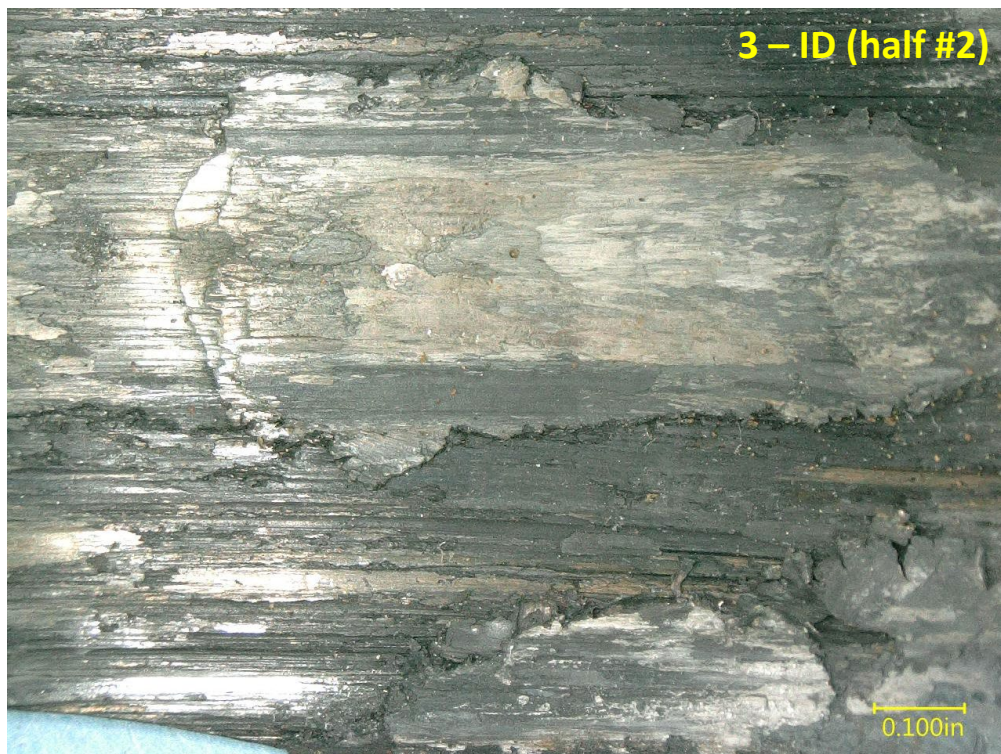
Figure 3: Digital microscope images of the inner diameter surface on the two halves of bearing #3 in the areas indicated in Figure 2.

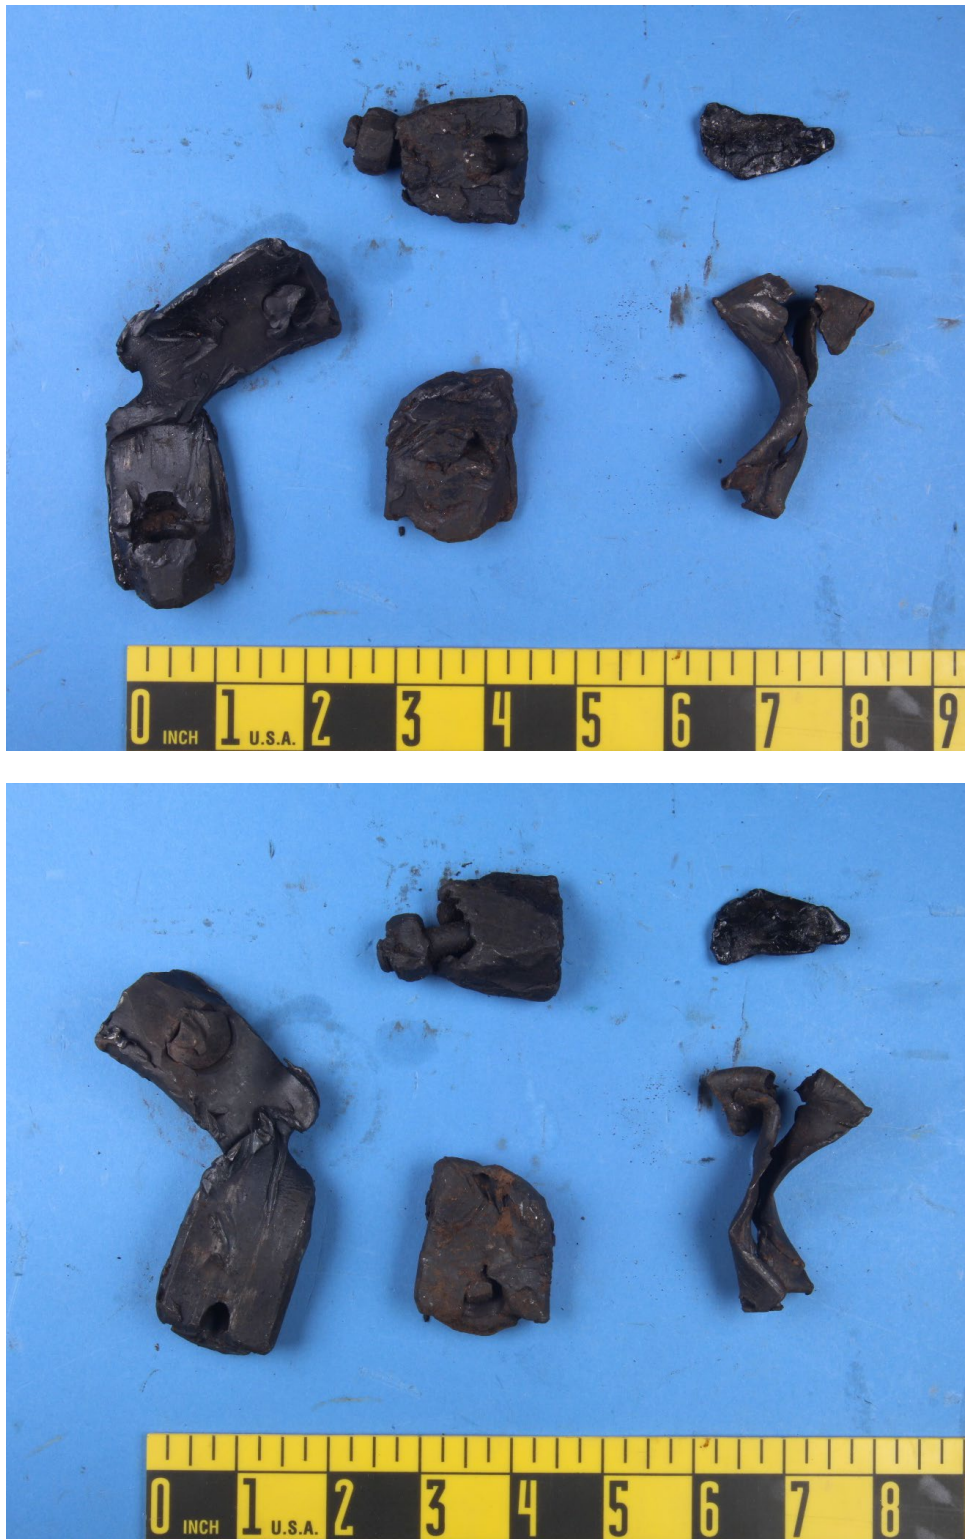
Several pieces of connecting rod were submitted and are shown in Figure 4. The pieces were extremely deformed and had heavy smearing damage.

Figure 4: Overall photos showing the two sides of the connecting rod pieces.

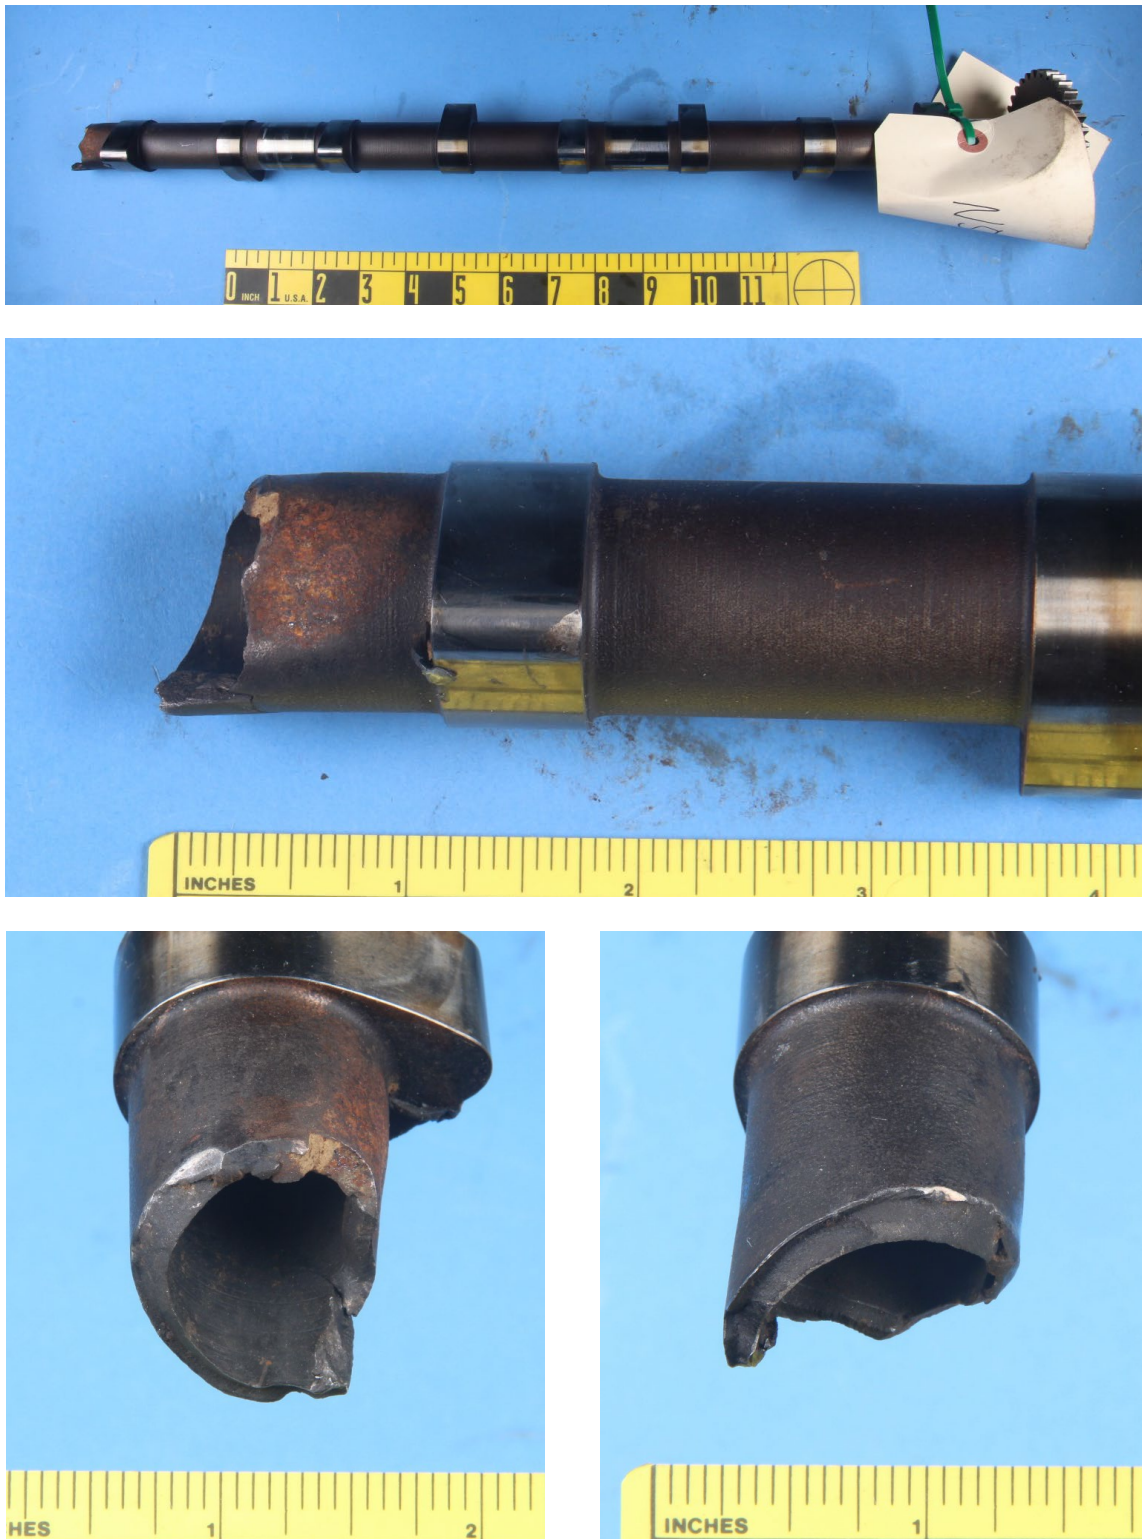
The camshaft was submitted separated adjacent to one cheek. Only 1 half of the fractured camshaft was submitted. The fracture surface spiraled circumferentially around the shaft diameter and had shear lips present around half of the circumference. The separation of the camshaft was consistent with torsional overstress.

Figure 5: Overall and close-up photos showing the separated camshaft. The bottom two photos show the fracture surface adjacent to one cheek.

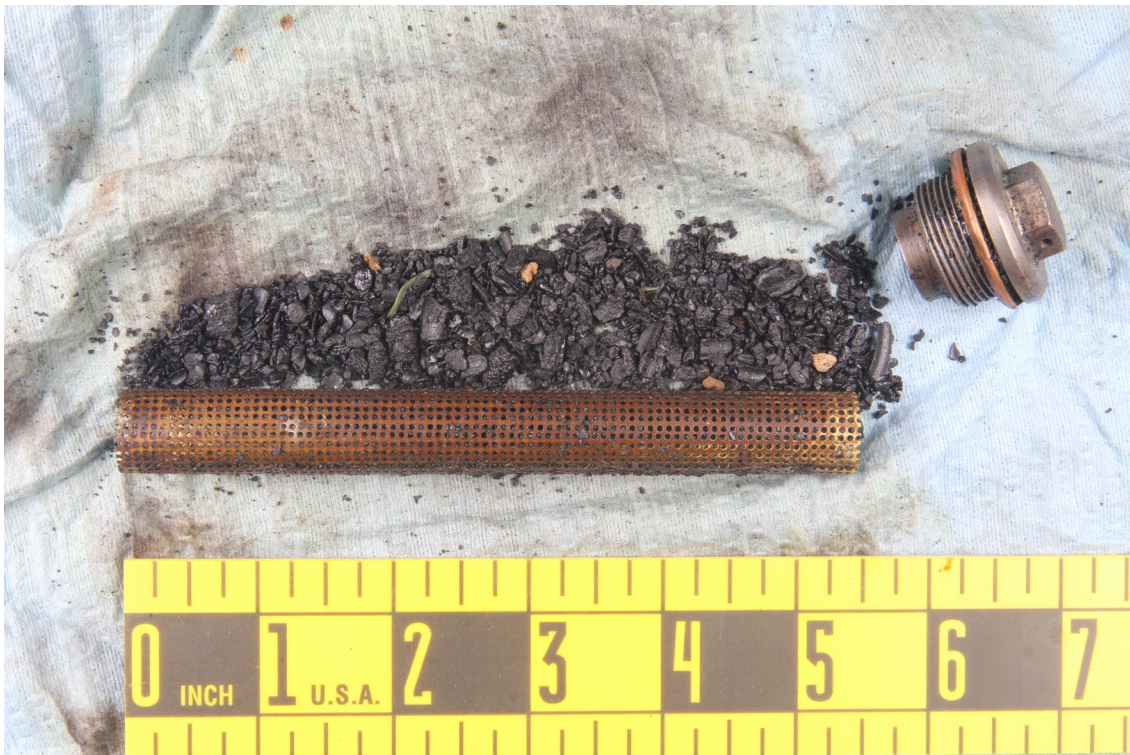
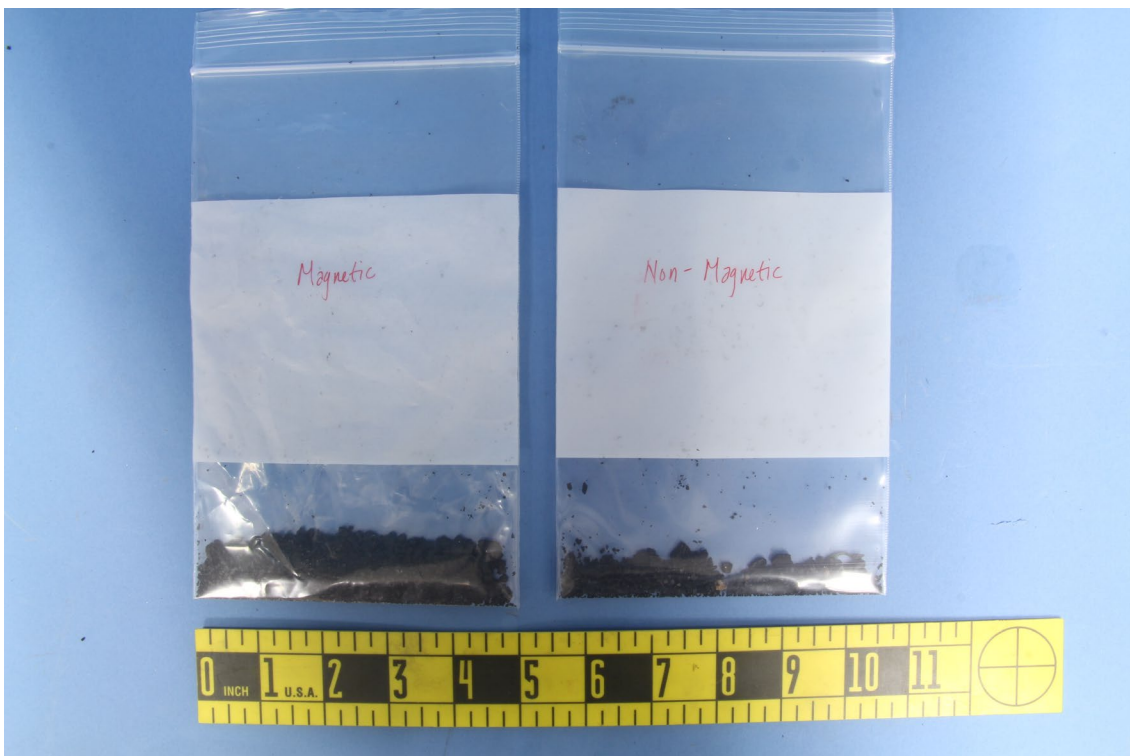
The oil suction screen and debris found within it were also submitted, as shown in the top photo of Figure 6. The debris was sorted using a magnet and is shown grouped in the bottom photo. The magnetic debris weighed 9.8 grams, while the non-magnetic debris weighed 3.1 grams. Thus, approximately 75% of the debris was metallic and most of it likely resulted from damage to the hardware during the accident. The remaining 25% of the debris was not metallic.

Figure 6: Overall photos of the oil suction screen debris (top) as-received and (bottom) after sorting using a magnet.
