**From:** [REDACTED]  
**To:** [REDACTED]  
**Cc:** [REDACTED]  
**Subject:** ERA20LA216-Fuel line  
**Date:** Tuesday, September 22, 2020 3:27:56 PM  
**Attachments:** [IMG\\_3085.jpg](#)  
[IMG\\_3089.jpg](#)

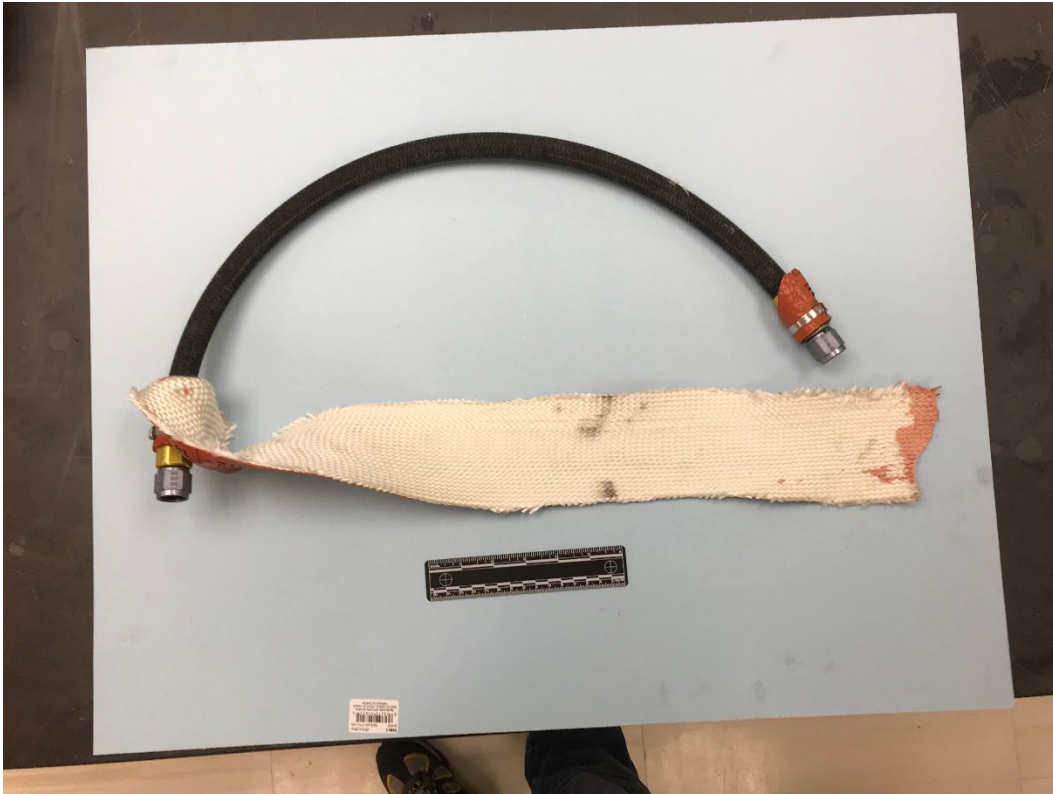
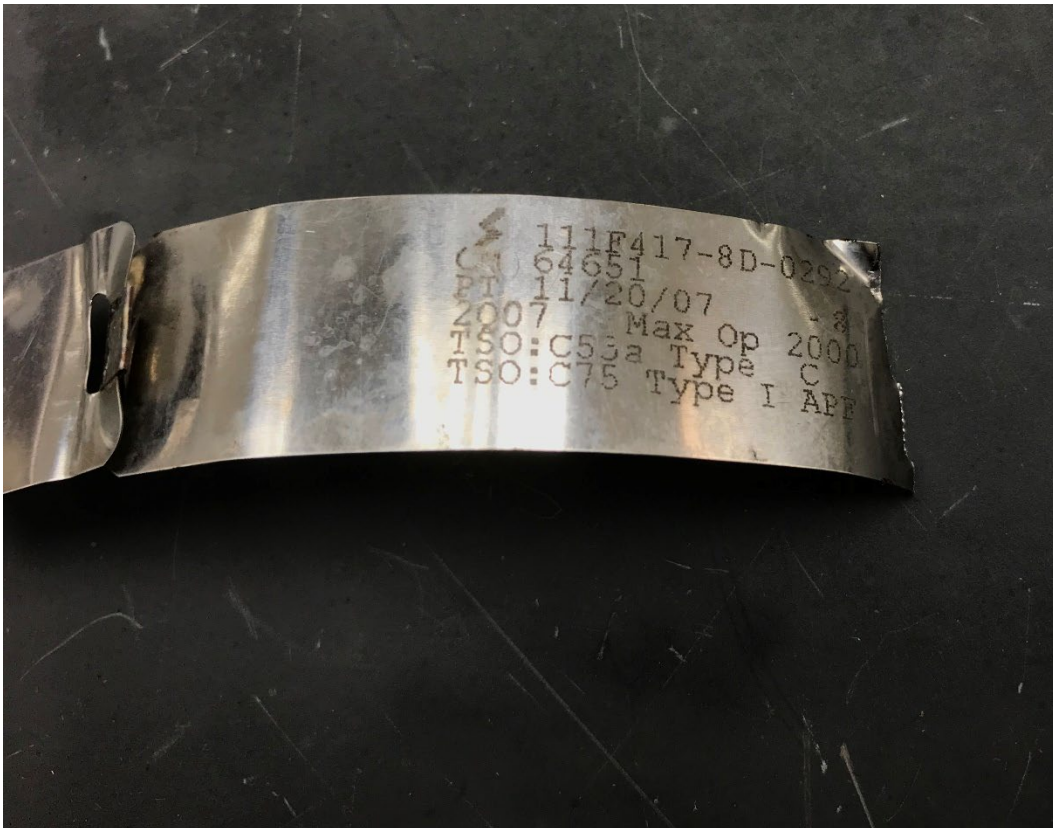
The fuel line from the accident aircraft was submitted to the Materials Laboratory. The fuel line was a Parker Stratoflex 111F417-8d-0292 hose (1/2 in. inner diameter, synthetic rubber hose with fiberglass and steel wire braiding reinforcement with silicone fiberglass fire sleeving.) The full length of the hose was examined using a borescope. No blockages were observed and the interior of the hose appeared undamaged and intact. The fire sleeving was removed to visualize the exterior of the hose. No evidence of kinks, creases or material creep were observed on the exterior.
