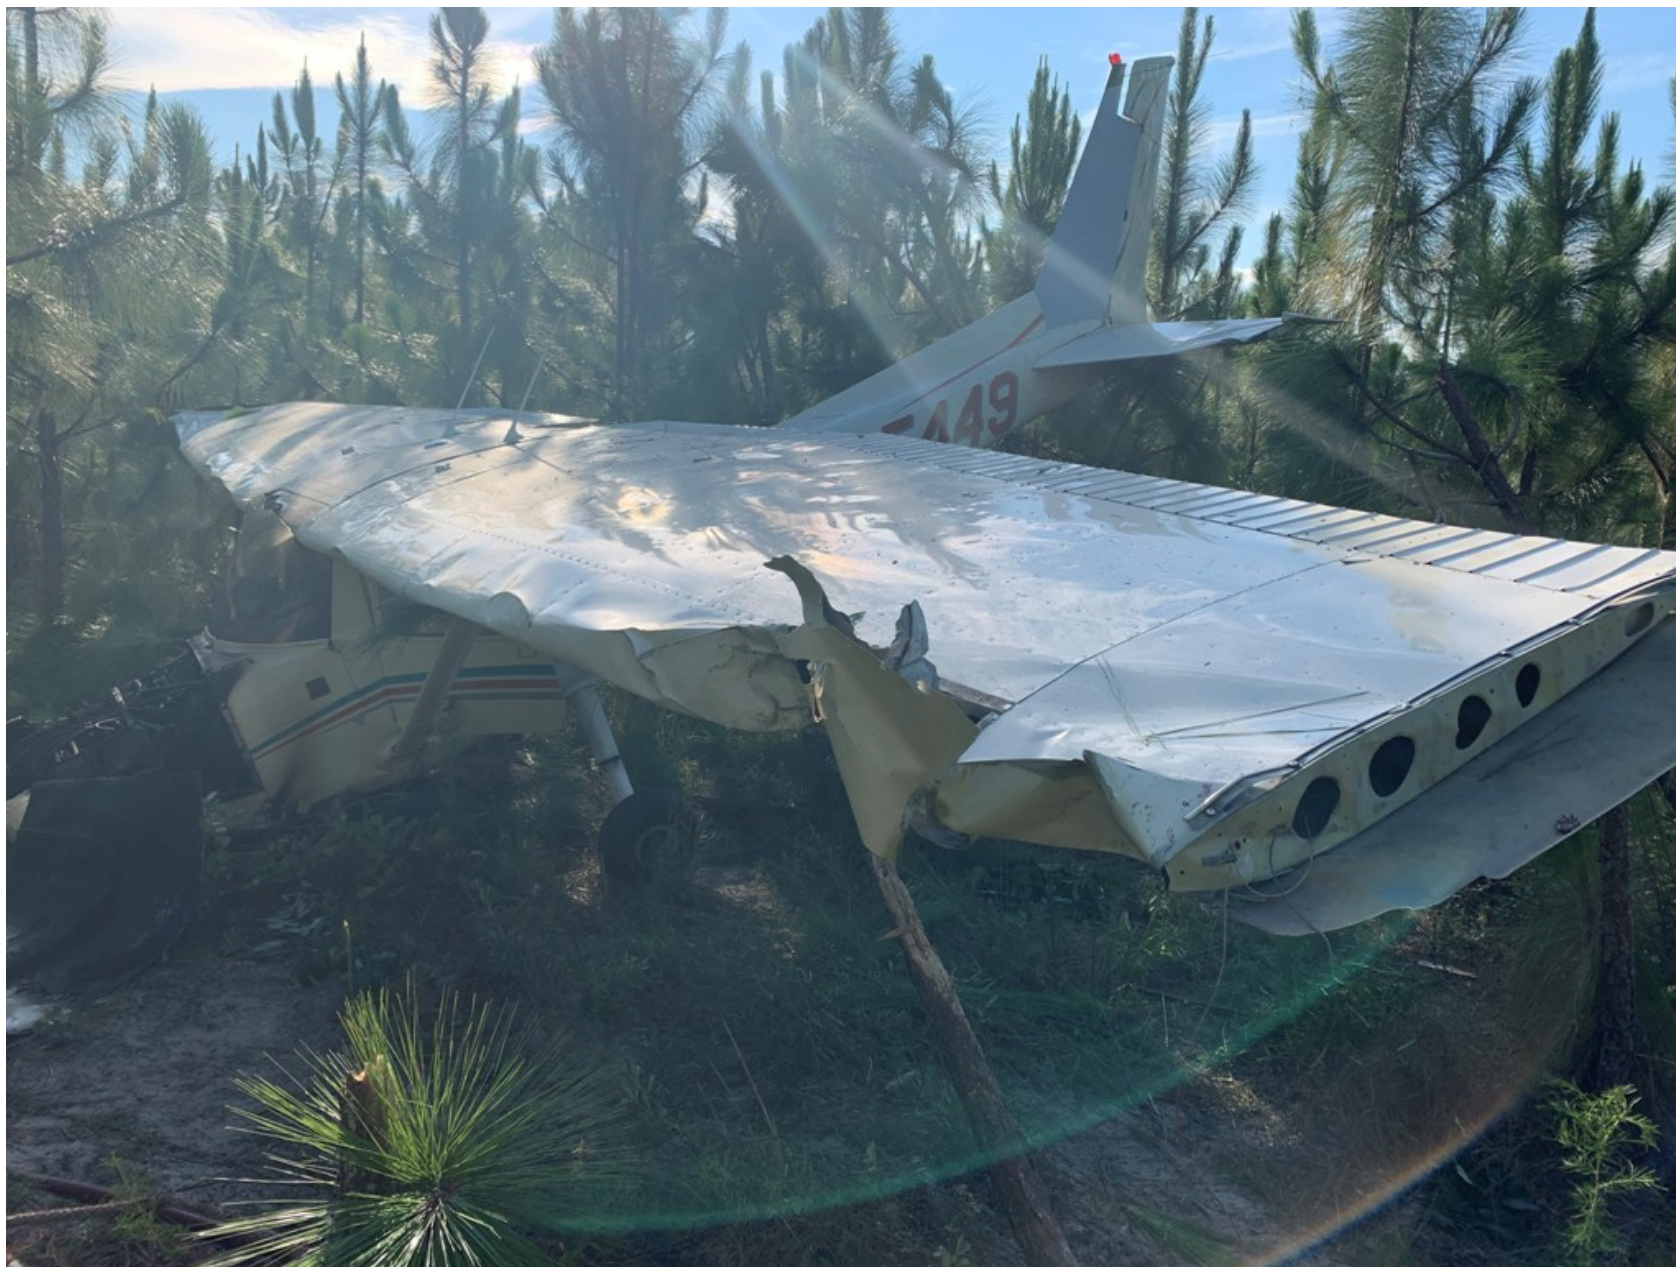
**Photo 1 – Digital Photograph From Adam McCook. Left Side View of the Airplane at the Accident Site. Note the Extensive Damage to the Leading Edge of the Left Wing.**

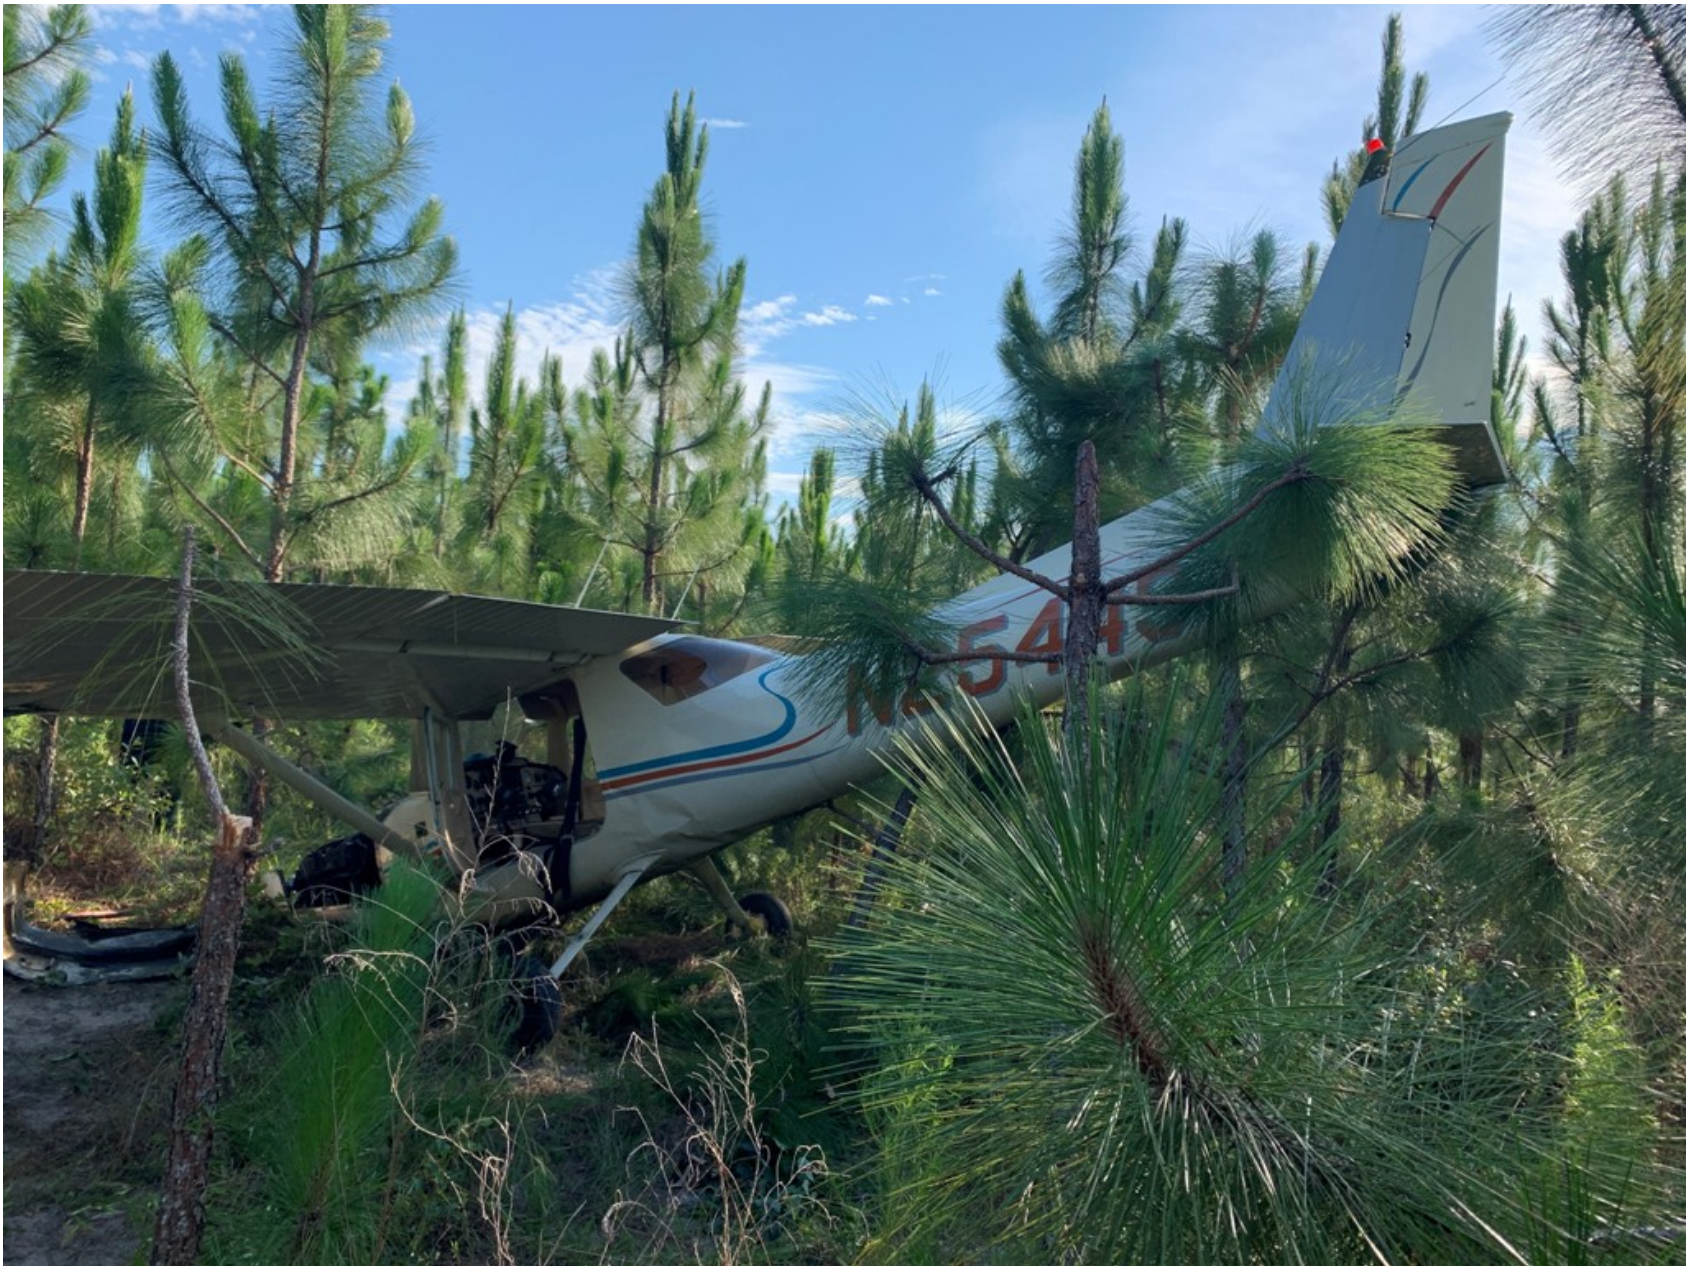
**Photo 2 - Digital Photograph From Adam McCook. Left Side View of the Airplane at The Accident Site. Note the Compression Wrinkle in the Fuselage Near the Left Main Landing Gear Attach Point.**

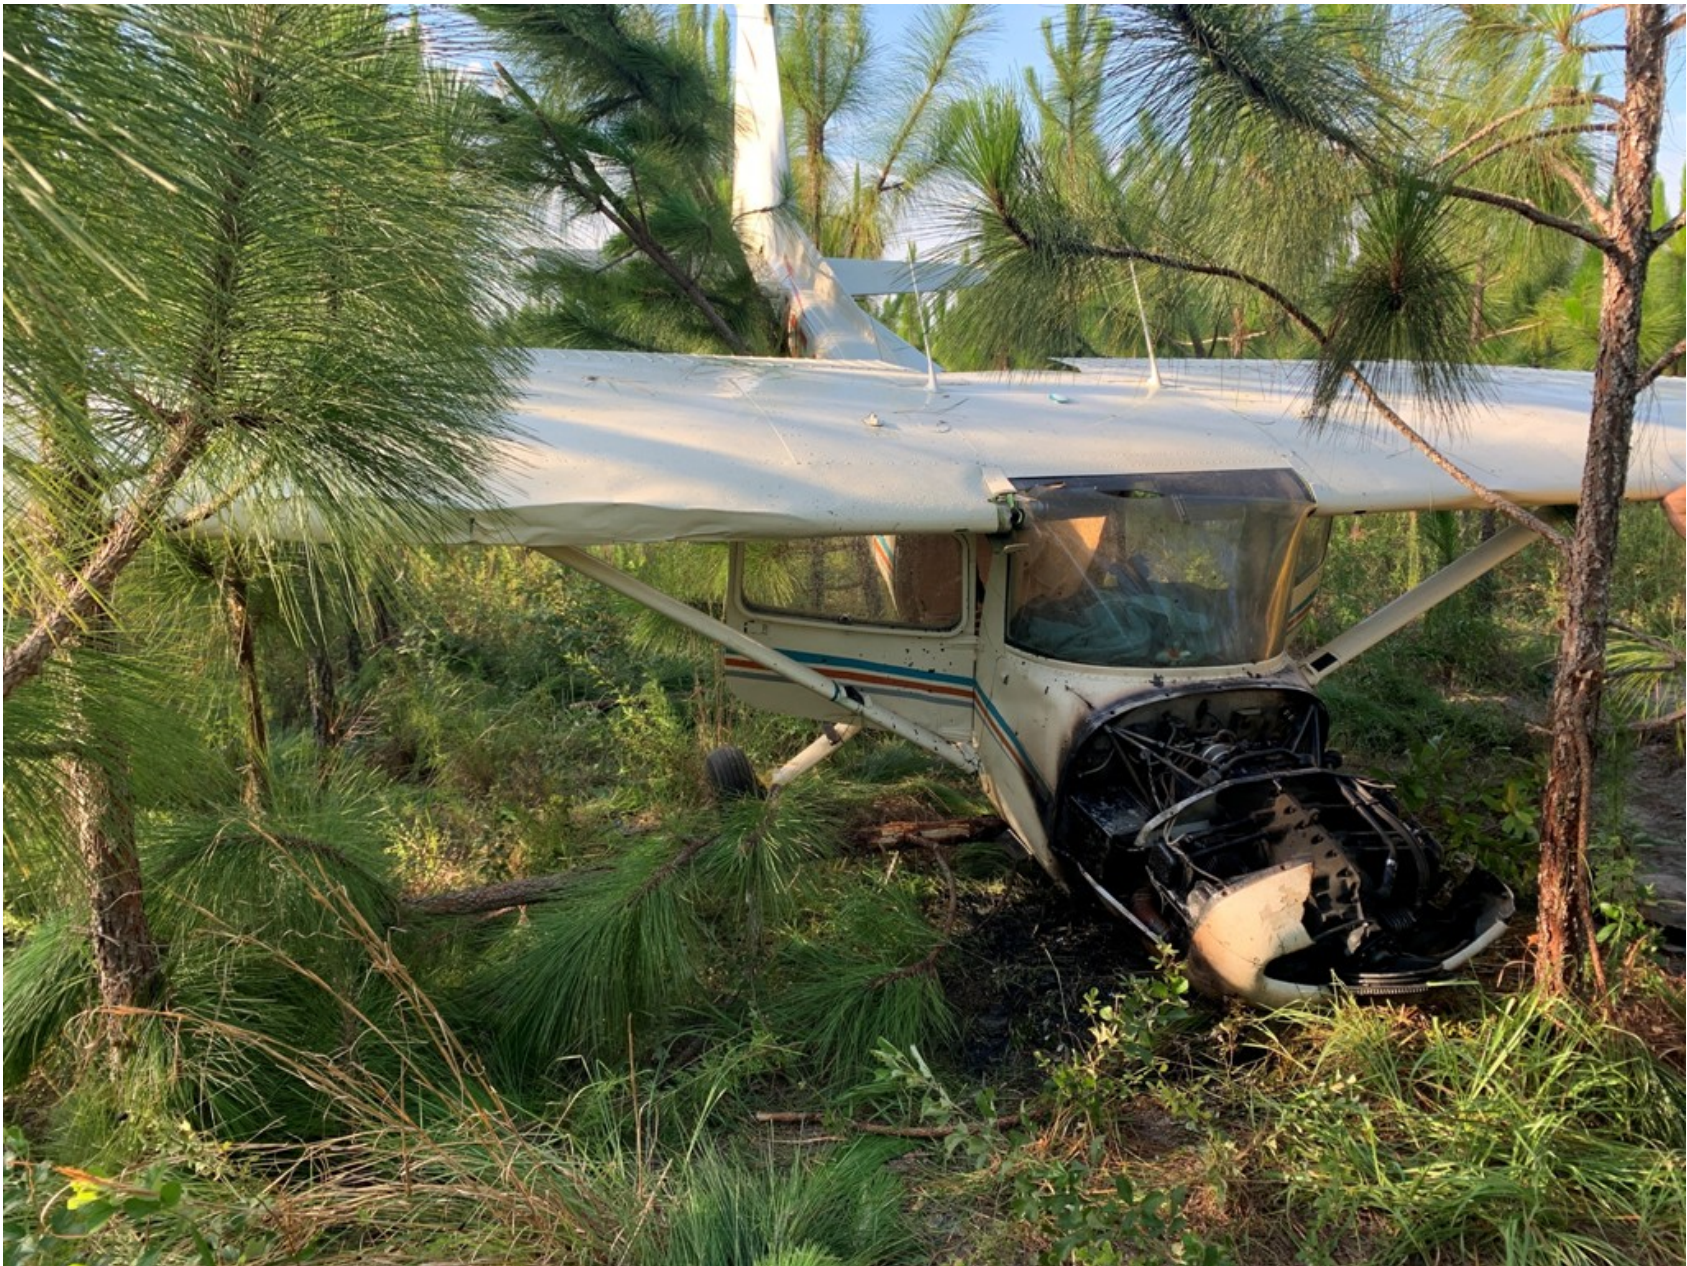
**Photo 3 - Digital Photograph From Adam McCook. Forward View of the Airplane at The Accident Site. Note the Fire Damage in the Engine Compartment.**

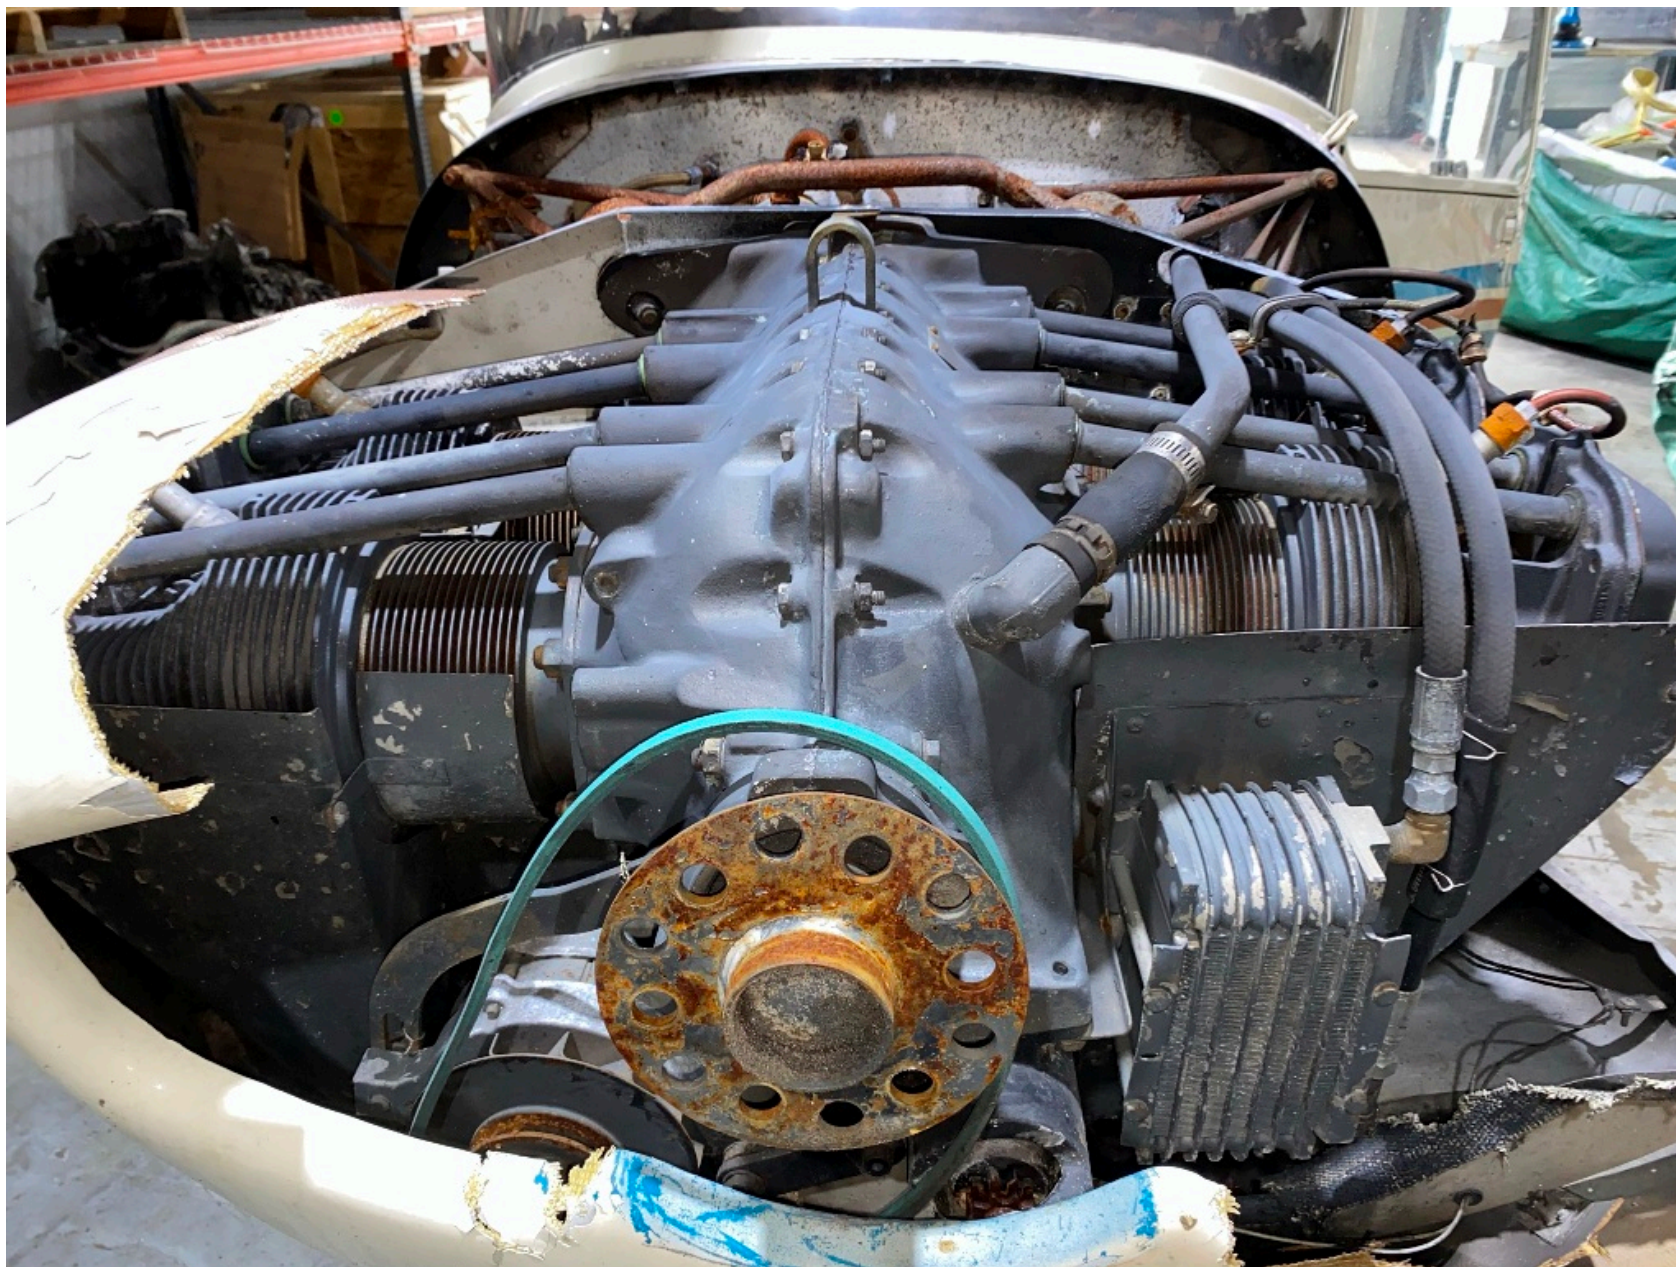
**Photo 4 – Digital Photograph From Florida Air Recovery. Frontal View of the Engine Assembly Without Propeller Before Engine Postaccident Examination.**

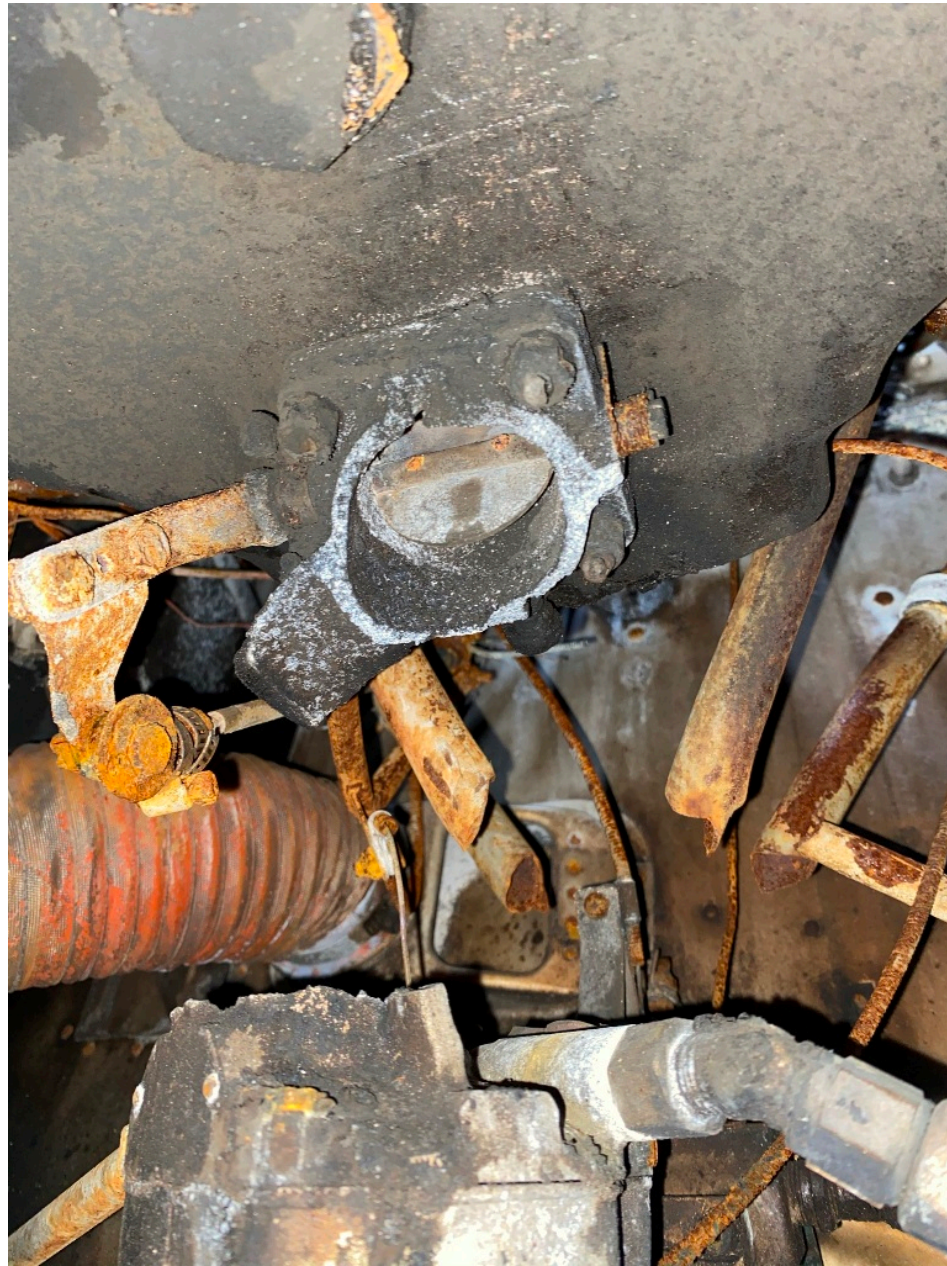
**Photo 5 - Digital Photograph From Florida Air Recovery. View Showing the Fractured Throttle Body of the Carburetor. Note the Heat Damage in the Surrounding Area.**

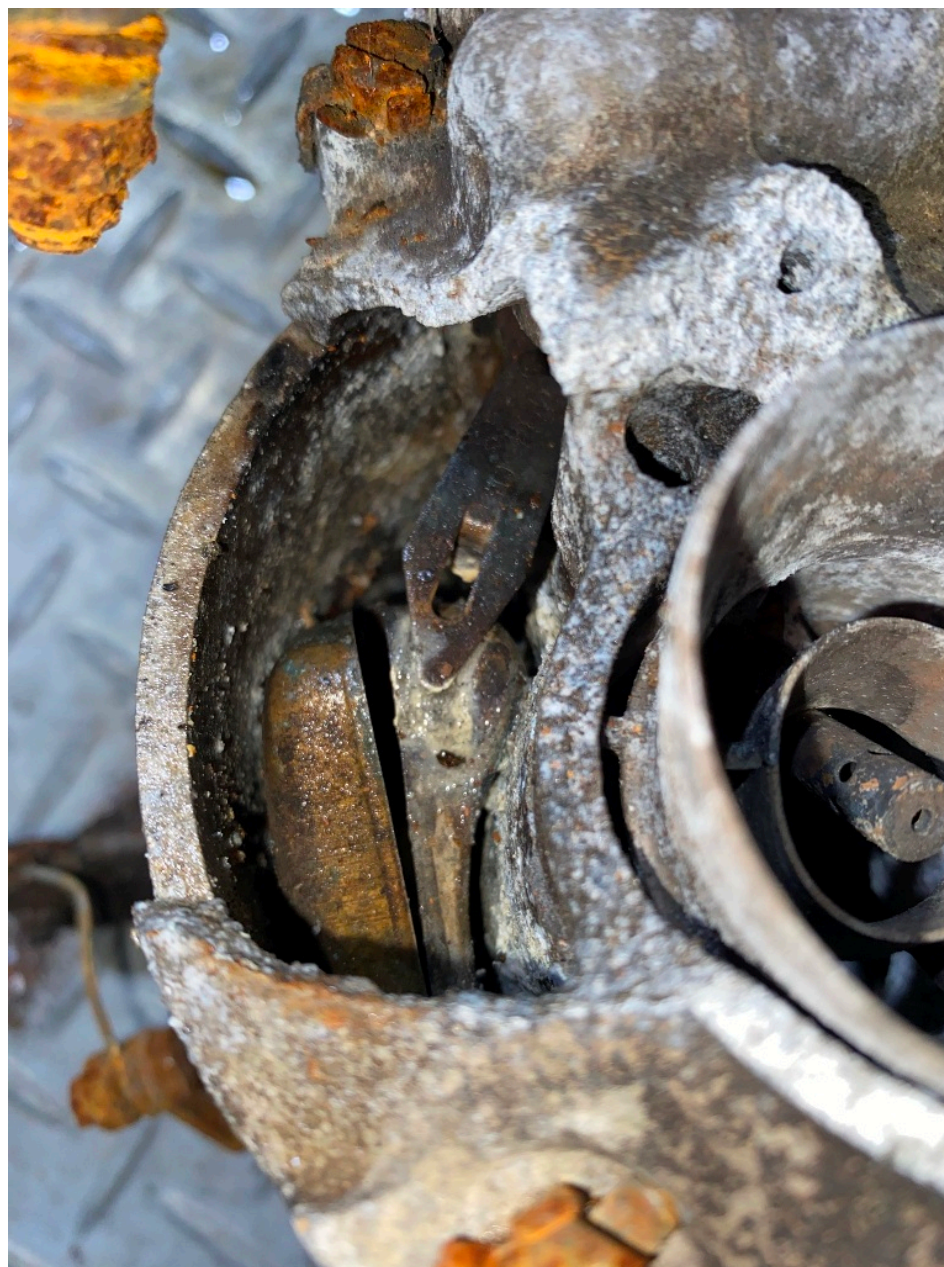
**Photo 6 - Digital Photograph From Florida Air Recovery. View Showing the Carburetor Bowl and the Split Halves of the Brass Float.**

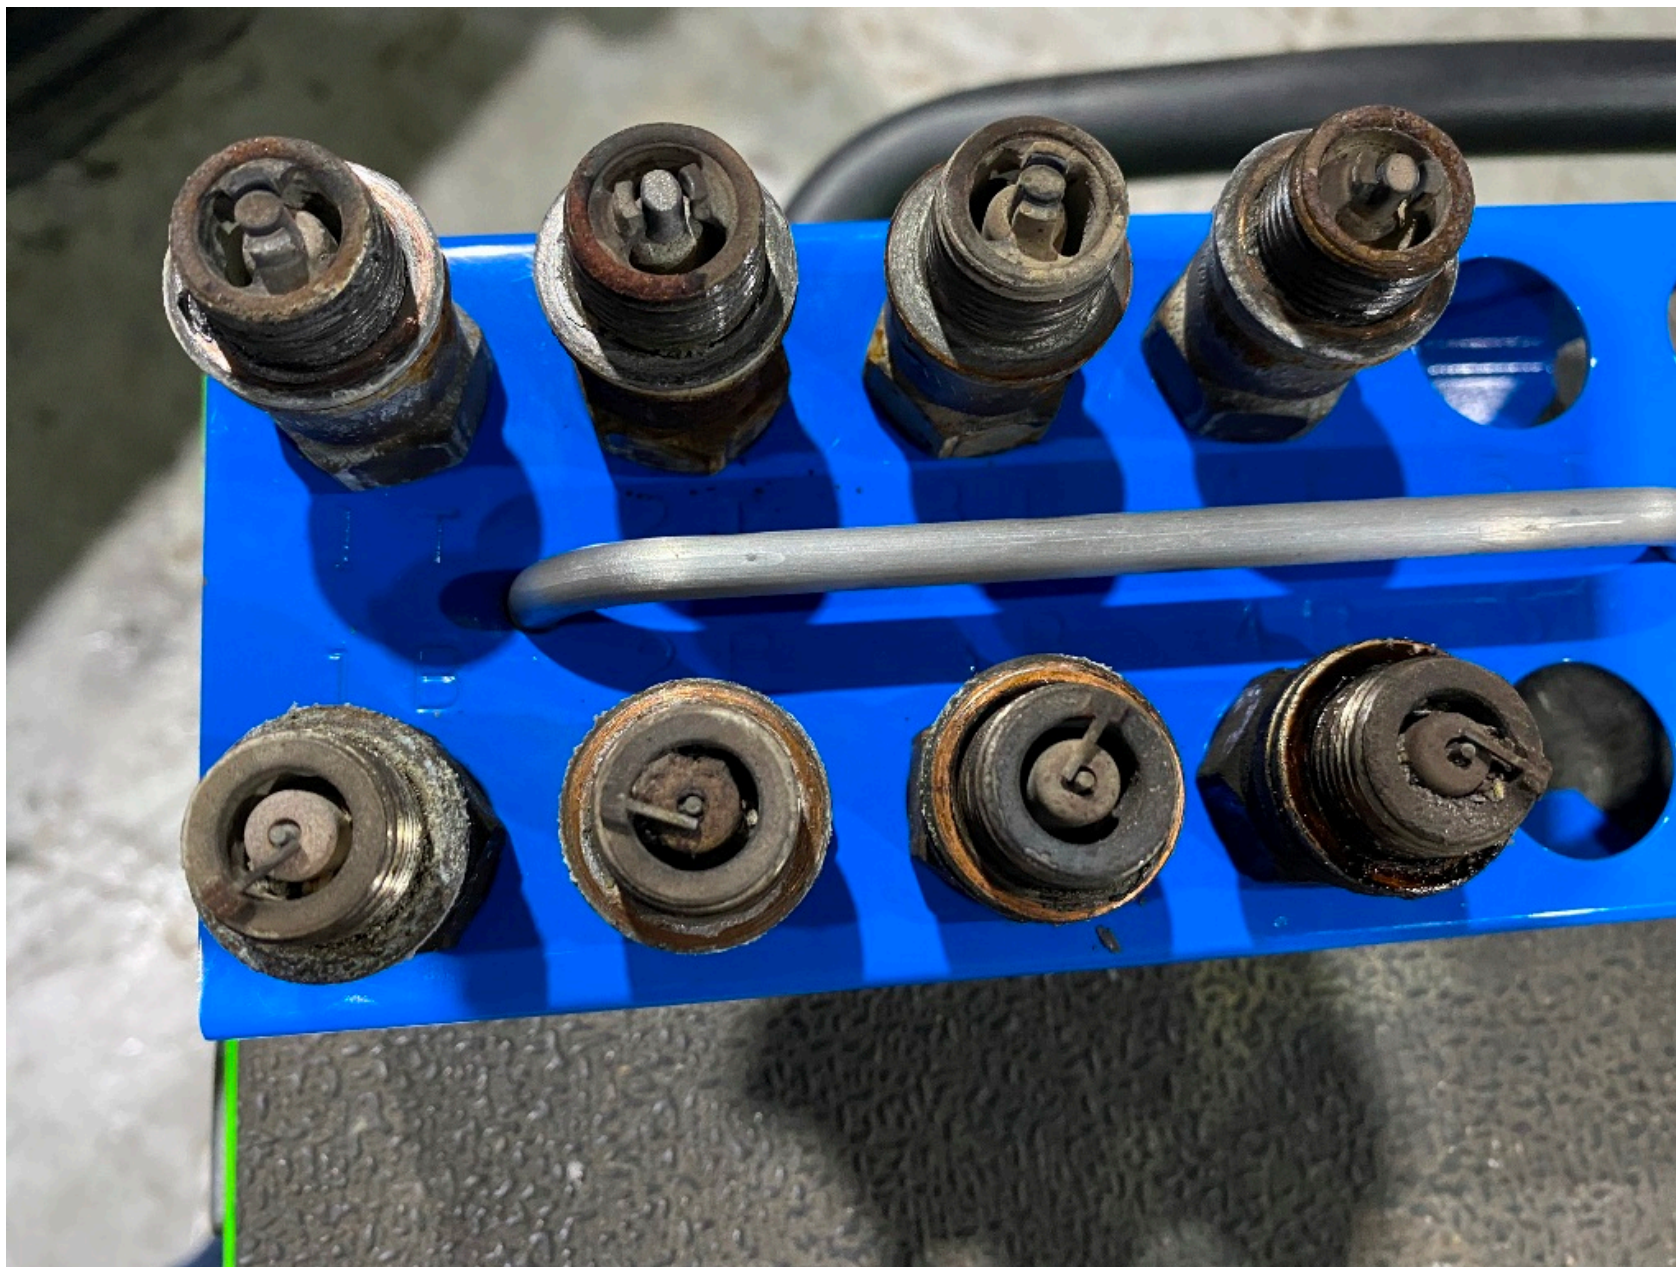
**Photo 7 - Digital Photograph From Florida Air Recovery. View Showing the Condition of the Spark Plugs.**

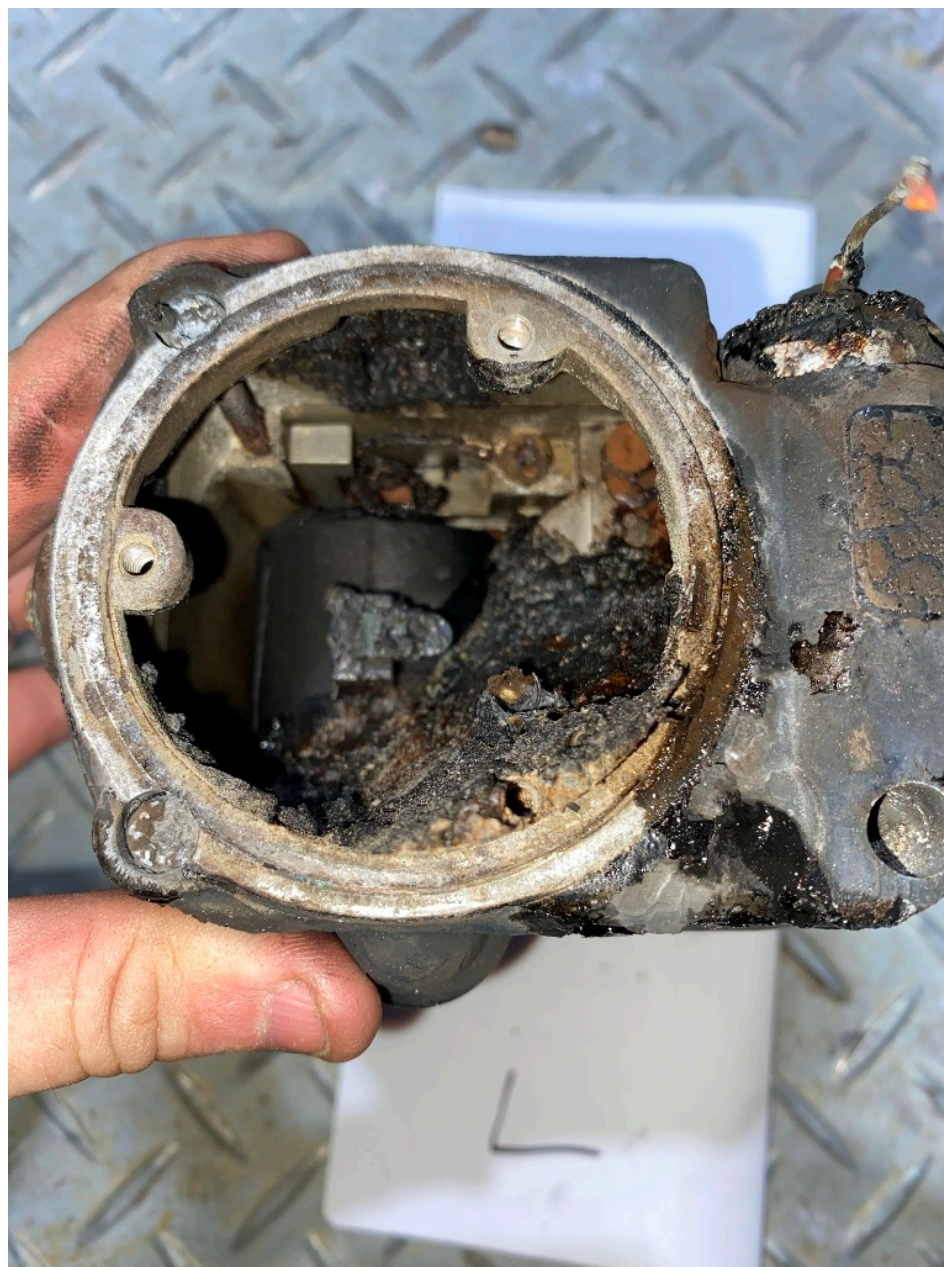
**Photo 8 - Digital Photograph From Florida Air Recovery. View Showing the Internal Condition of the Left Magneto. Note the Extensive Postimpact Heat Damage.**

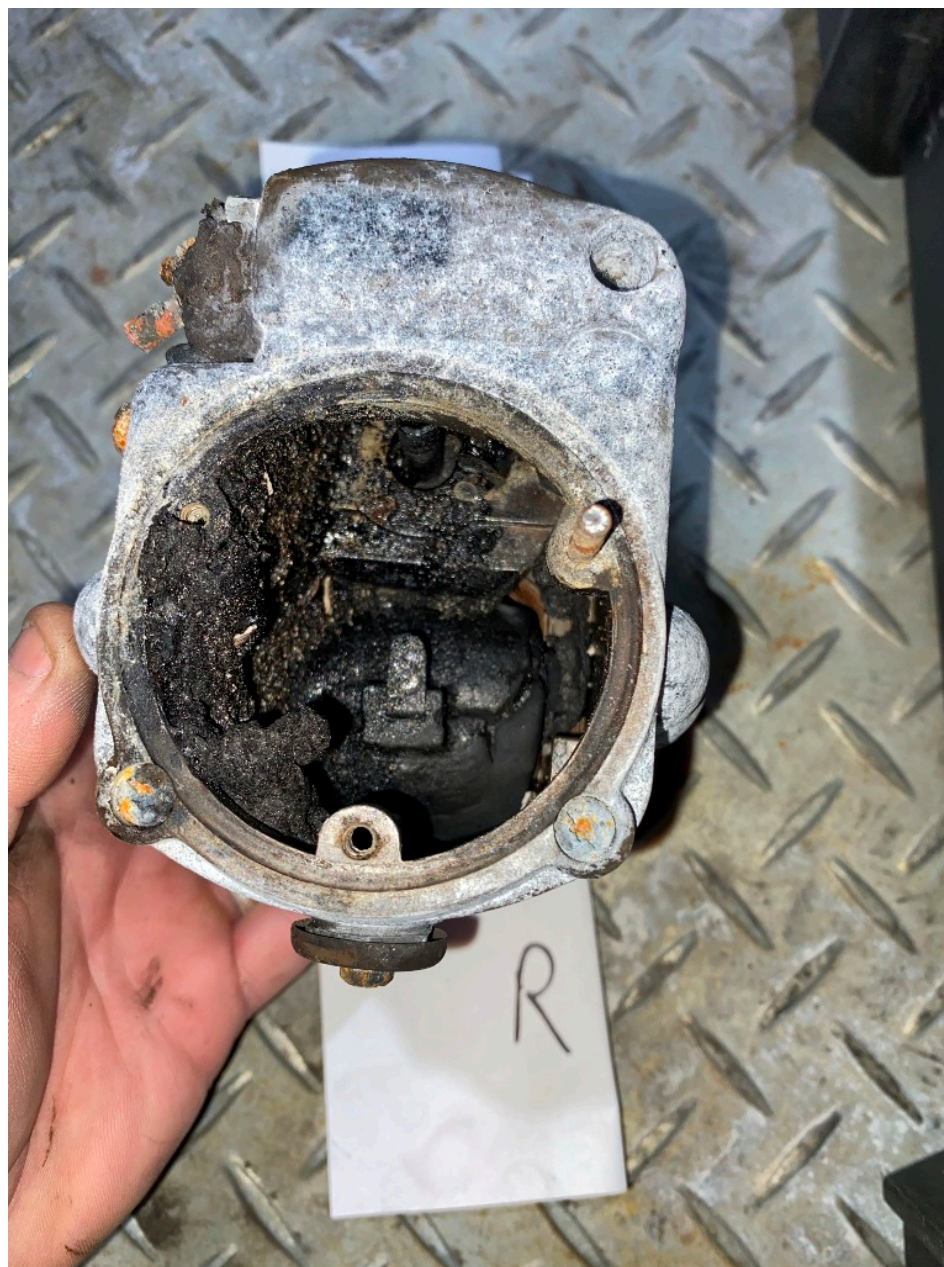
**Photo 9 - Digital Photograph From Florida Air Recovery. View Showing the Internal Condition of the Right Magneto. Note the Extensive Postimpact Heat Damage.**
