**NATIONAL TRANSPORTATION SAFETY BOARD**  
Office of Aviation Safety

**AIRWORTHINESS GROUP CHAIRMAN'S FACTUAL REPORT**

**ERA20LA237**

Operator: Private  
Location: Titusville, Florida  
Date: July 3, 2020  
Time: 1157 Eastern Daylight Time (EDT)  
Aircraft: Piper PA-46-600TP (M600), SN 4698109  
Registration: N89MA

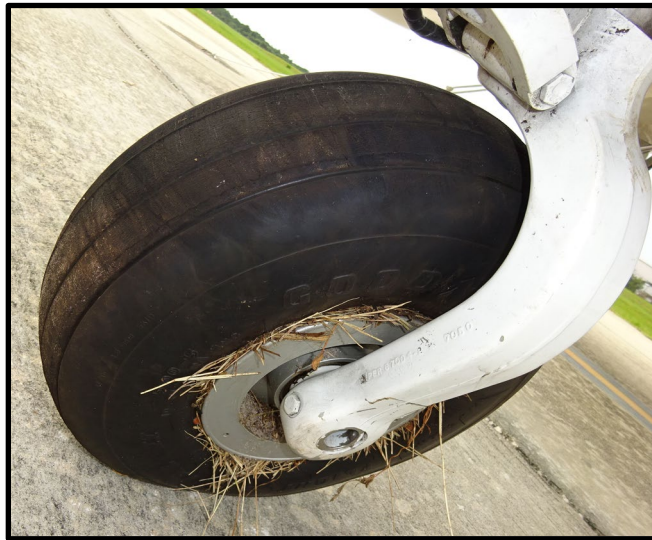
The NLG tire was aligned with the longitudinal axis of the airplane after it came to rest in the grass. The NLG strut and lower fork were deformed to the right such that the wheel was offset about 25° from vertical. There was dirt and grass embedded between the left tire bead and wheel, Figure 8. The NLG tire had crosswise scuffing of the tread that extended part way up the left sidewall. The steering horn was separated from the strut and all 3 bolts were fractured. The head of one fractured bolt was retained by safety wire and the other two heads were not recovered. The threaded shanks of the fractured bolts remained installed in the strut. The NLG tire pressure was measured at 91 psi. There was mechanical damage noted to the right turn mechanical stops on the trunnion and strut. There was mechanical damage noted to the aft face of the left side of the steering arm that serves as the left turn mechanical stop. There were wear marks in the paint on the forward faces of the steering arm where they interfaced with the steering horn pads and rollers. The left and right rudder pedal pushrod forward rod ends had several threads exposed forward of the jam nut.

*Figure 8-NLG tire with embedded dirt and grass and crosswise scuffing.*

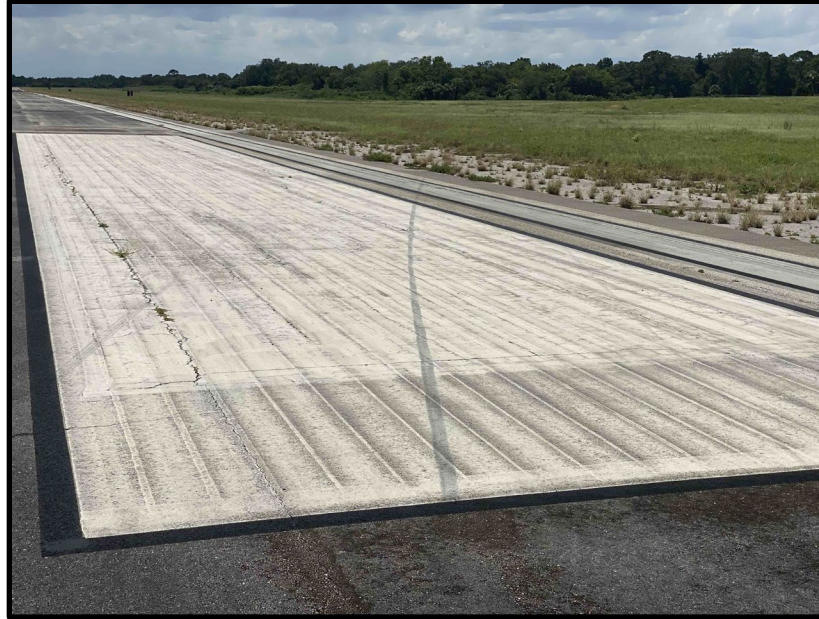
There were distinct rubber transfer marks in the white paint of the Runway 27 right aiming point marking where the airplane departed the runway, Figure 9. The LMLG and RMLG rubber transfer marks showed four parallel lines with spaces between consistent with the tire tread patterns and the tires rolling with brakes applied. The LMLG rubber transfer marks were darker in appearance than the RMLG consistent with heavier braking action on the left wheel. The NLG rubber transfer mark was a darker and wider line with no tread pattern consistent with a skidding tire.

*Figure 9-Rubber transfer marks on white Runway 27 right aiming point marking.*

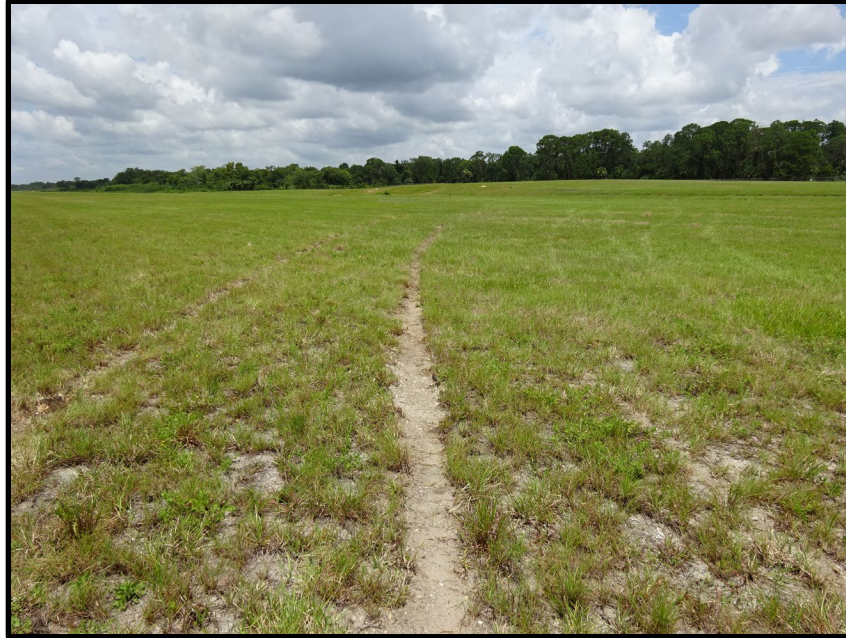
The rubber transfer marks were more difficult to discern on the asphalt but were able to be traced back to the touchdown point on the runway. The rubber transfer marks indicated the airplane MLG touched down about 620 feet from the Runway 27 threshold and the airplane was about 4 feet left of the centerline. The NLG tire markings were traced back to the land and hold short operation lines (used when operating on runway 09) painted on runway 27 about 770 feet from the threshold. The NLG markings were heavier and darker than the MLG markings with no tread pattern visible consistent with a skidding tire from the moment of touchdown. There was a short dark skid mark prior to the hold lines in line with the continuous NLG tire markings. The markings became darker along the length and arced to the right from their inception. The airplane tire markings departed the right side of the paved area centered about 1,140 feet from the threshold. The ground scars in the grass from the runway departure point to the airplane resting point showed disturbed grass where the RMLG traveled, trenching where the LMLG traveled and heavy trenching where the NLG traveled, Figure 10. The disturbed areas in the grass were continuous from the edge of the runway to the location where the airplane came to rest.

*Figure 10-Ground scars in grass on the right side of Runway 27 from landing gear.*

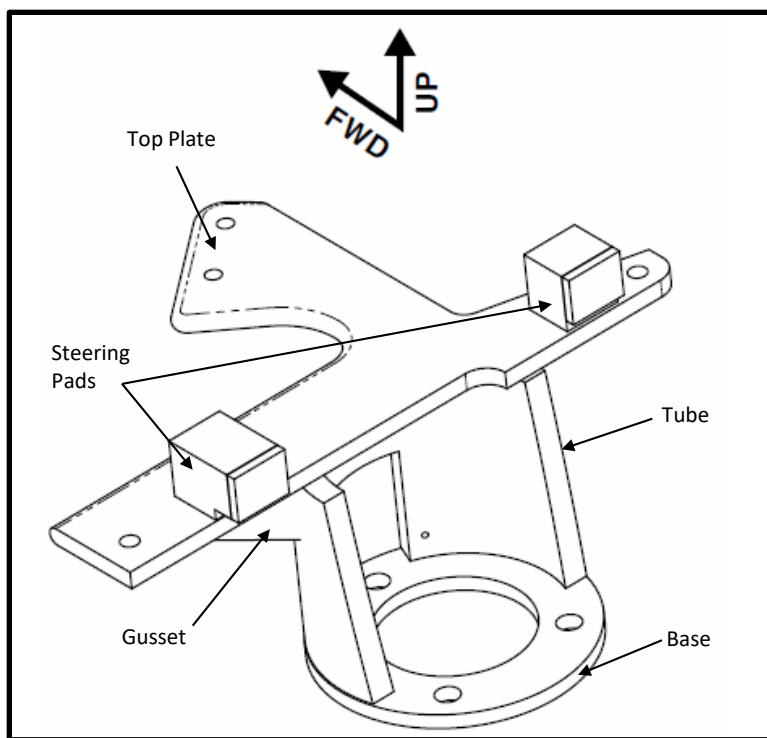
Figure 11-Drawing of Steering Horn Assembly.

The accident airplane had a part number (PN) 85154-012 steering horn assembly installed at manufacture. The 85154-012 steering horn assembly consists of a steel base (PN 85154-004), tube (PN 85154-003), gusset (PN 85154-006), top plate (PN 85154-013), and two steering pads (PN 85154-010 and -011) welded together in accordance with drawing 85154, Figure 11. The steering horn is attached to the NLG strut with 3 bolts through the base. A PN 83638-005 rub block is attached to the forward leg of the top plate, a PN 83638-002 roller (large) is attached to the left leg of the top plate, and a PN 83638-006 roller (small) is attached to the right leg of the top plate through the holes shown in accordance with revision C of the Nose Landing Gear Assy drawing 46N32A001. The two steering pads and two steering rollers interface with the steering arm to provide nose wheel steering with the NLG in the down position. The 85154-012 steering horn assembly was the same as used on the M500 airplane and was installed on M600 airplanes with serial number (SN) 4698001 to SN 4698135. Piper discovered alignment issues with certain steering horn assemblies installed on airplanes with SN 4698102 and above where the location of the steering pads and rollers was not consistent due to variances in the tolerance stack up. The alignment could be adjusted by machining the faces of the steering pads to achieve the necessary dimensional relationship between the pads and rollers. The accident airplane steering horn was reworked at the factory prior to delivery to align the pad faces with the rollers.

The accident steering horn assembly was PN 85154-012 that was manufactured in August 2019 and had the airplane SN 4698109 marked on it. The base (PN 85154-004) was visibly deformed down near the intersection with the tube and measured 0.0230-inch out of flatness. The forward hole measured 0.030-inch out of round maximum, the aft right hole measured 0.007-inch out of

round maximum, and the aft left hole measured 0.004-inch out of round maximum. The top plate (PN 85154-013) was visibly deformed and twisted and measured 0.0198-inch out of flatness. The maximum distance between the top plate and base measured 0.004-inch out of tolerance. The left (large) roller bolt was deformed forward such that the roller face was 8° forward of vertical. The left (large) roller and right (small) roller were measured within tolerance for all dimensions. The left steering pad (PN 85154-010) face measured 0.055-inch aft of the left (large) roller tangent line at its maximum due to the deformed roller bolt. The lateral location of the left steering pad could not be measured accurately due to the deformation of the top plate. The right steering pad face measured 0.004-inch aft of the right (small) roller tangent line. The right steering pad (PN 85154-011) measured 0.05-inch closer laterally to the center of the base than its maximum tolerance. The right roller hole location on the top plate measured 0.028-inch forward of its maximum tolerance. The left roller hole location on the top plate was measured to be 0.092-inch forward of its maximum tolerance. All other dimensions were within the drawing tolerances.

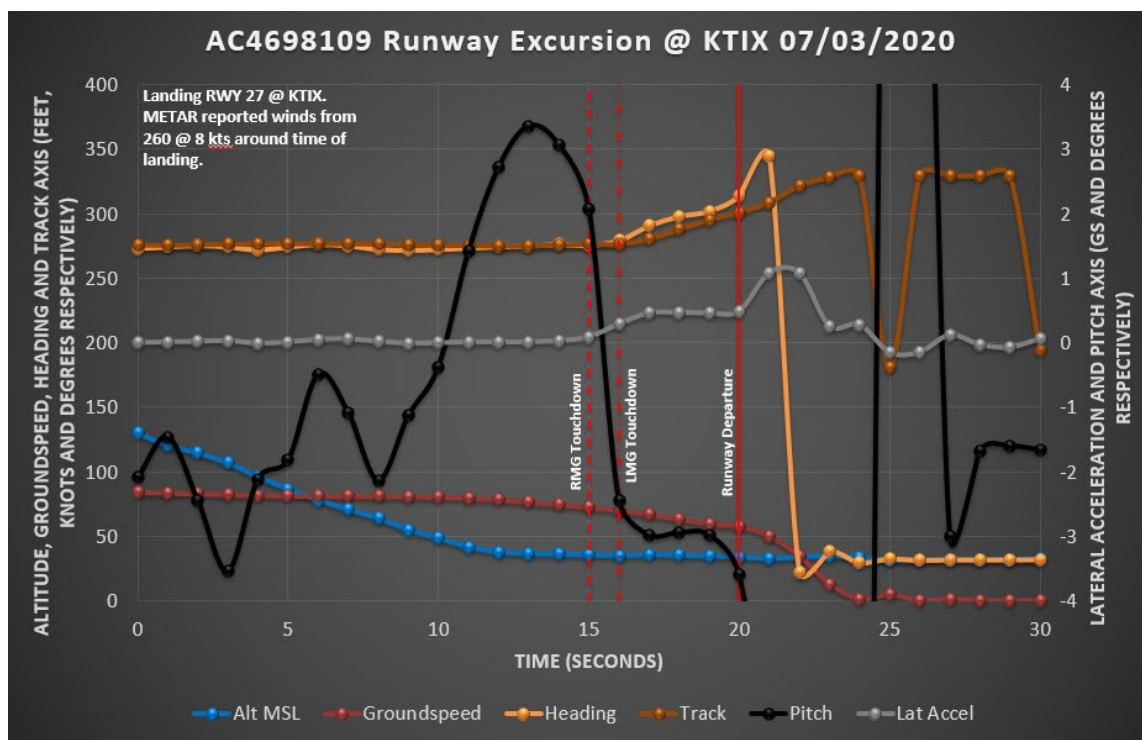
Figure 12-Plot of data from accident landing.

Piper plotted the altitude, groundspeed, heading, track, pitch and lateral acceleration data for the accident landing from the SD card at the request of the NTSB, Figure 12. The RMLG and LMLG touchdown points were established with the wheel speed information contained in the internal CMC data. The runway departure timing was estimated based on the airplane position information. The NLG touchdown can be estimated based on the pitch parameter. Shortly after MLG touchdown the heading and track begin to diverge indicating the airplane is in a skid which is confirmed with the increase in lateral acceleration. The touchdown speed was about 73 kts. The airplane departed the runway about 5 seconds after the RMLG touchdown at a ground speed about 58 kts. The pitch parameter was recorded for the entire time but exceeds the plotted limits in the graph after the airplane departs the runway and goes into an unusual attitude before coming to rest.

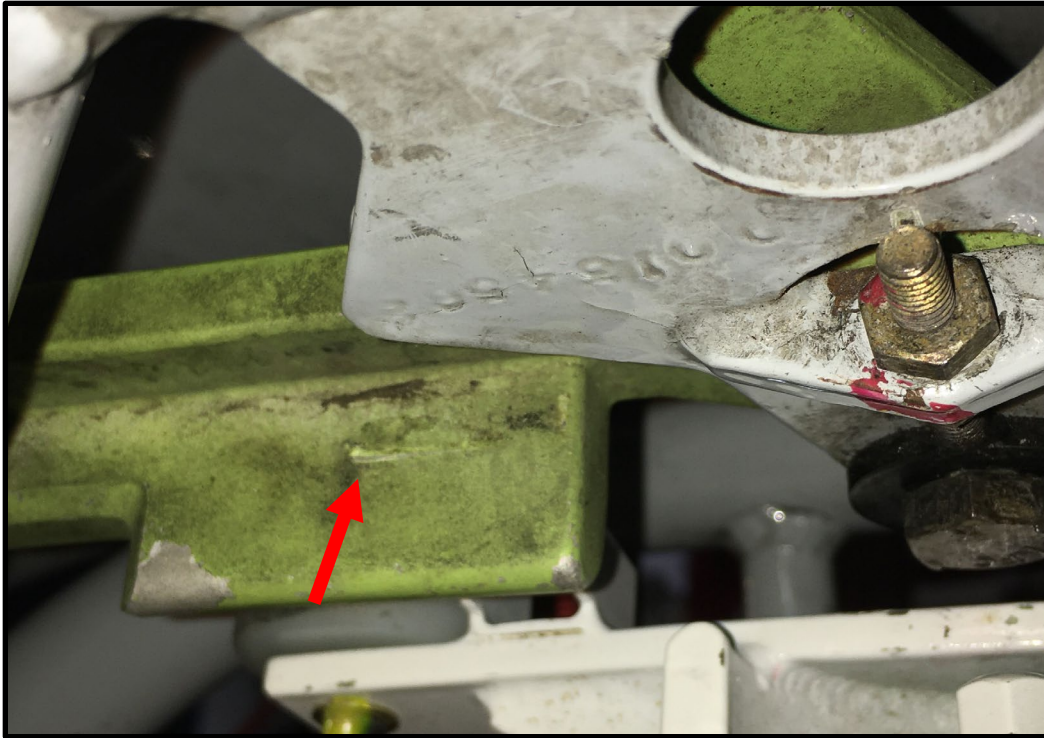
The NLG strut was rotated left until the steering arm left flange aft face was in contact with the steering arm mount plate on the engine mount. The simulated left turning force was increased to about 194 pounds producing a moment about 8,560 in-lb when the aft left bolt attaching the steering horn to the strut fractured. There was a slight separation between the aft left portion of the steering horn base and the strut, but the NLG was still steerable from the steering arm through the steering horn. The force was reapplied to about 144 lb producing a moment about 6,354 in-lb when the aft right bolt fractured. There was a larger separation between the aft portion of the steering horn base and the strut, and the steering horn base was visibly deformed. The NLG was still somewhat steerable from the steering arm through the steering horn, but the inputs required to achieve rotation of the NLG strut increased substantially. The force was reapplied to about 35 pounds producing a moment about 1,544 in-lb when the forward bolt fractured, and the steering horn was completely separated from the strut. Examination of the steering arm left flange aft face after the test showed a witness mark where the steering arm contacted the engine mount, Figure 13.

*Figure 13-Witness mark on left aft face of steering arm after test.*
