# NATIONAL TRANSPORTATION SAFETY BOARD

## MATERIALS LABORATORY FACTUAL REPORT

Report No. 21-012

Place : Titusville, Florida  
Date : 07/03/2020  
Vehicle : Piper PA-46-600TP (N89MA)  
NTSB No. : ERA20LA237  
Investigator : Lynn Spencer

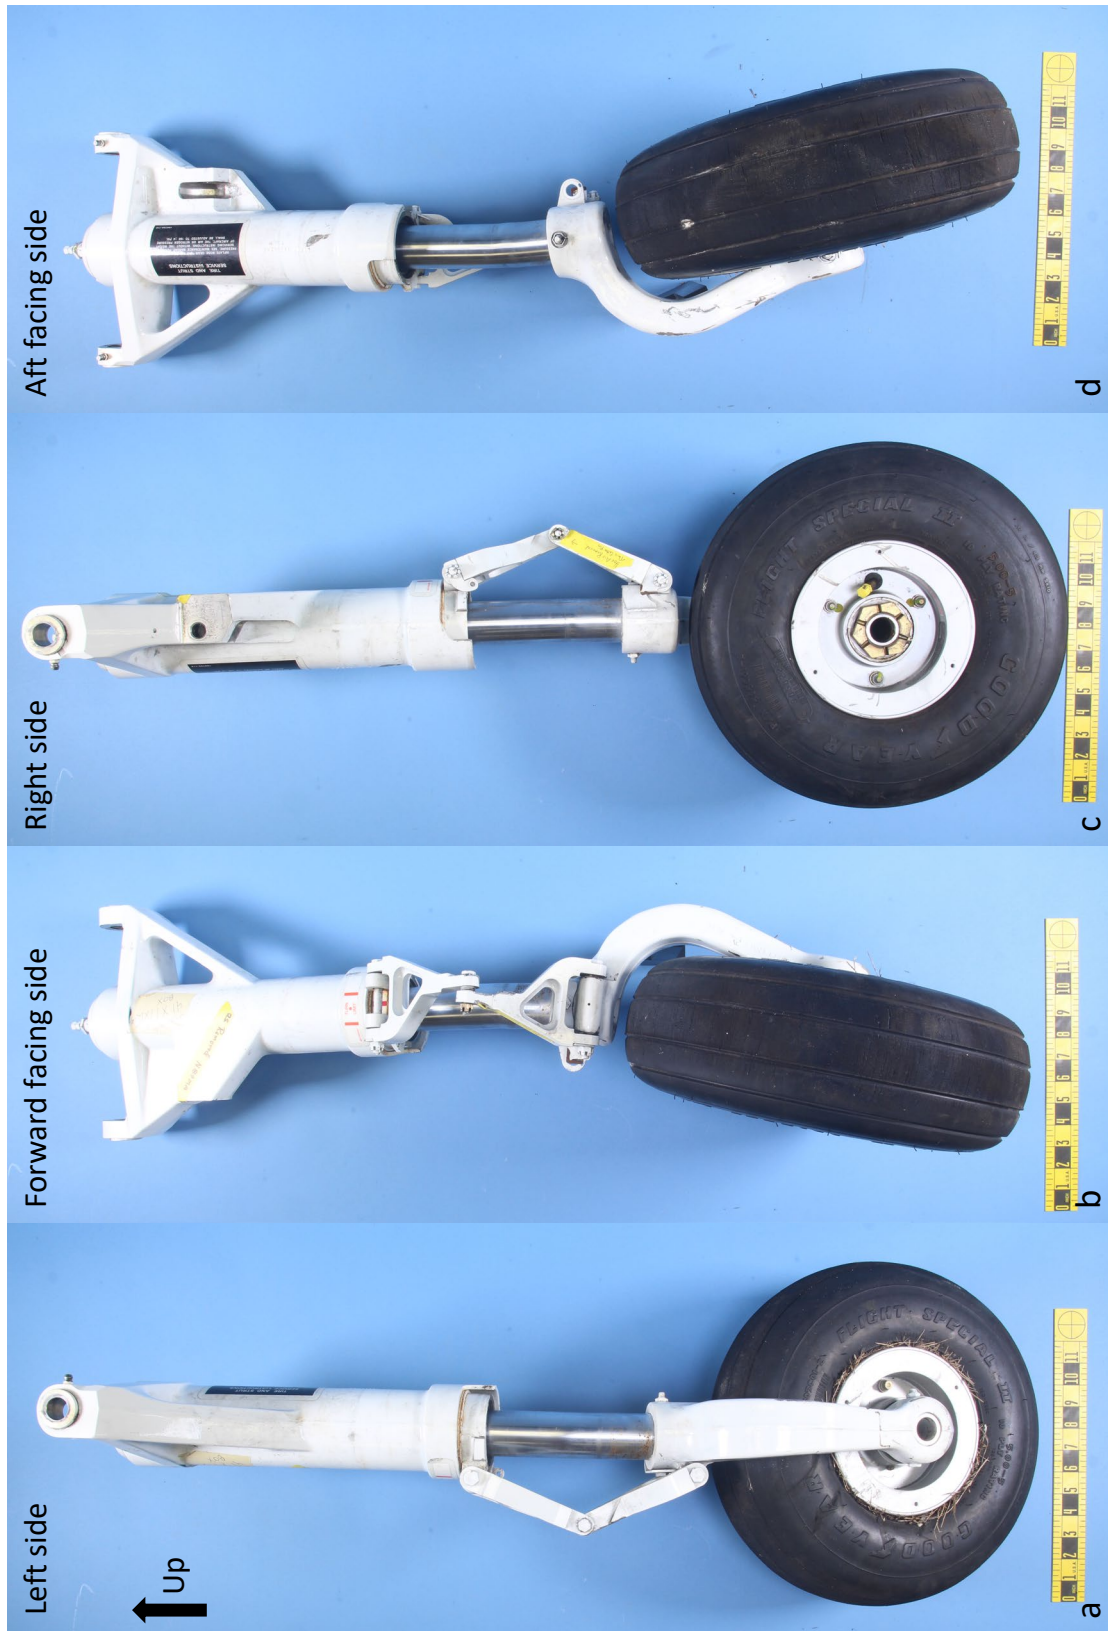
Portions of the as-received nose landing gear assembly are shown in Figure 1. Close views of the right and left turn stops for the as-received nose landing gear assembly are shown in Figure 2. In Figure 3, the right and left turn stops have been cleaned with isopropyl alcohol. As revealed in the figure, the paint is not present on the right-turn trunnion stop and strut stop and the surface texture on the trunnion stop is embossed on the surface of the strut stop. The figure also reveals partial paint loss on the left-turn strut stop.

Figure 1 Forward, aft, and side views of a portion of the as-received nose gear assembly.

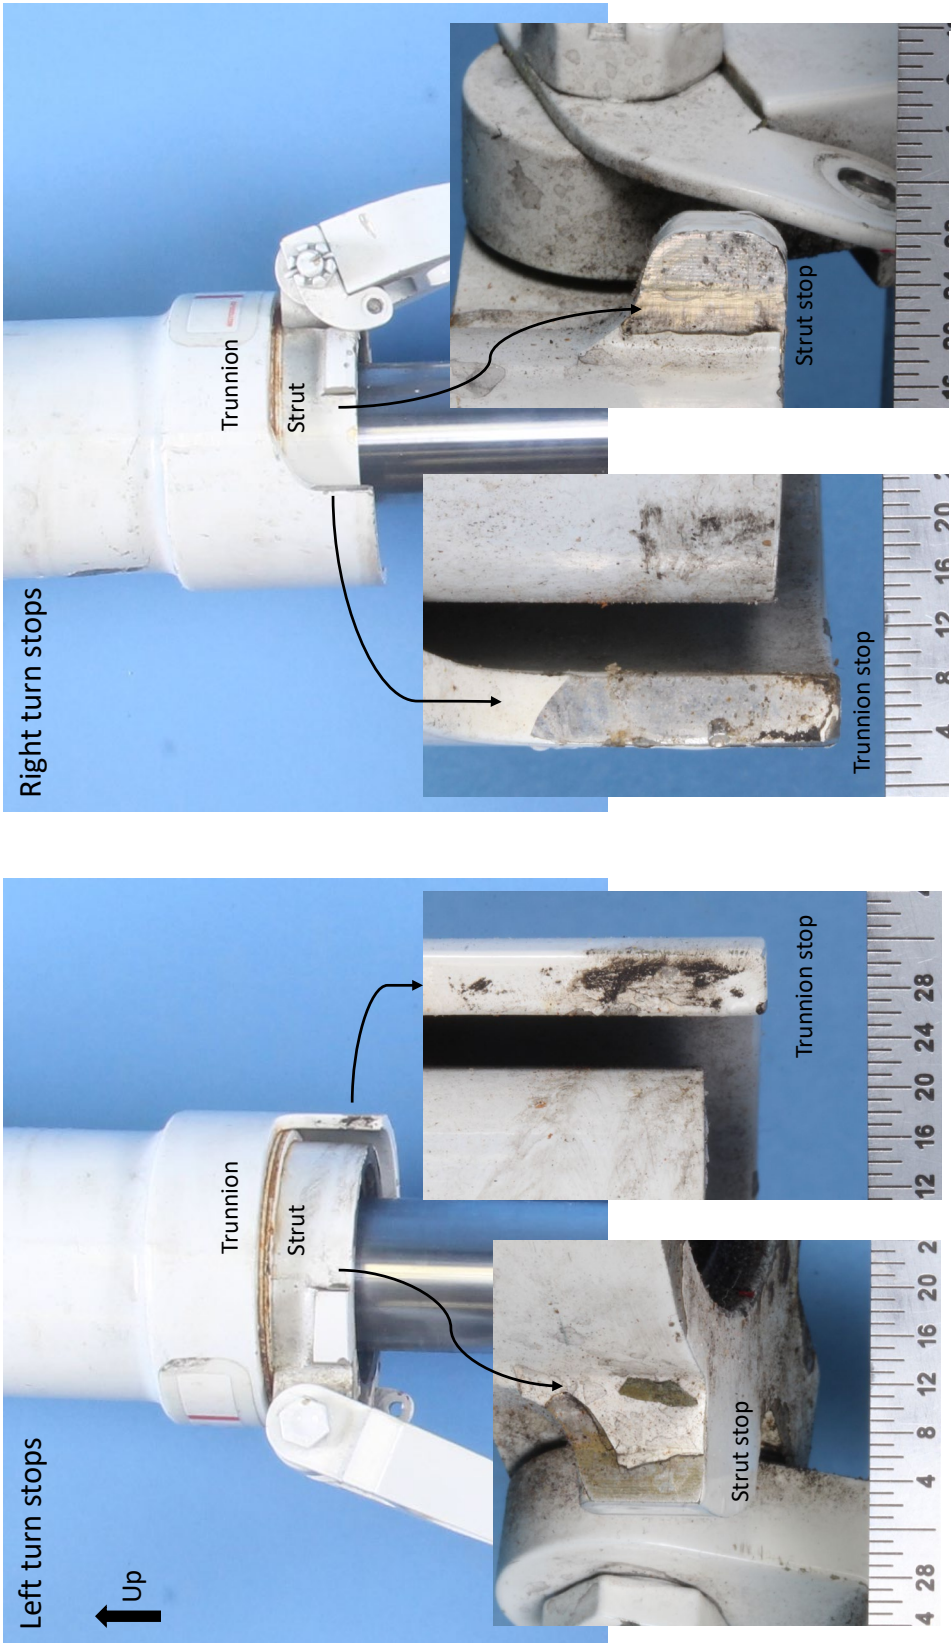
Figure 2 Views of the left and right turn stops on the trunnion and strut. As-received, before cleaning.

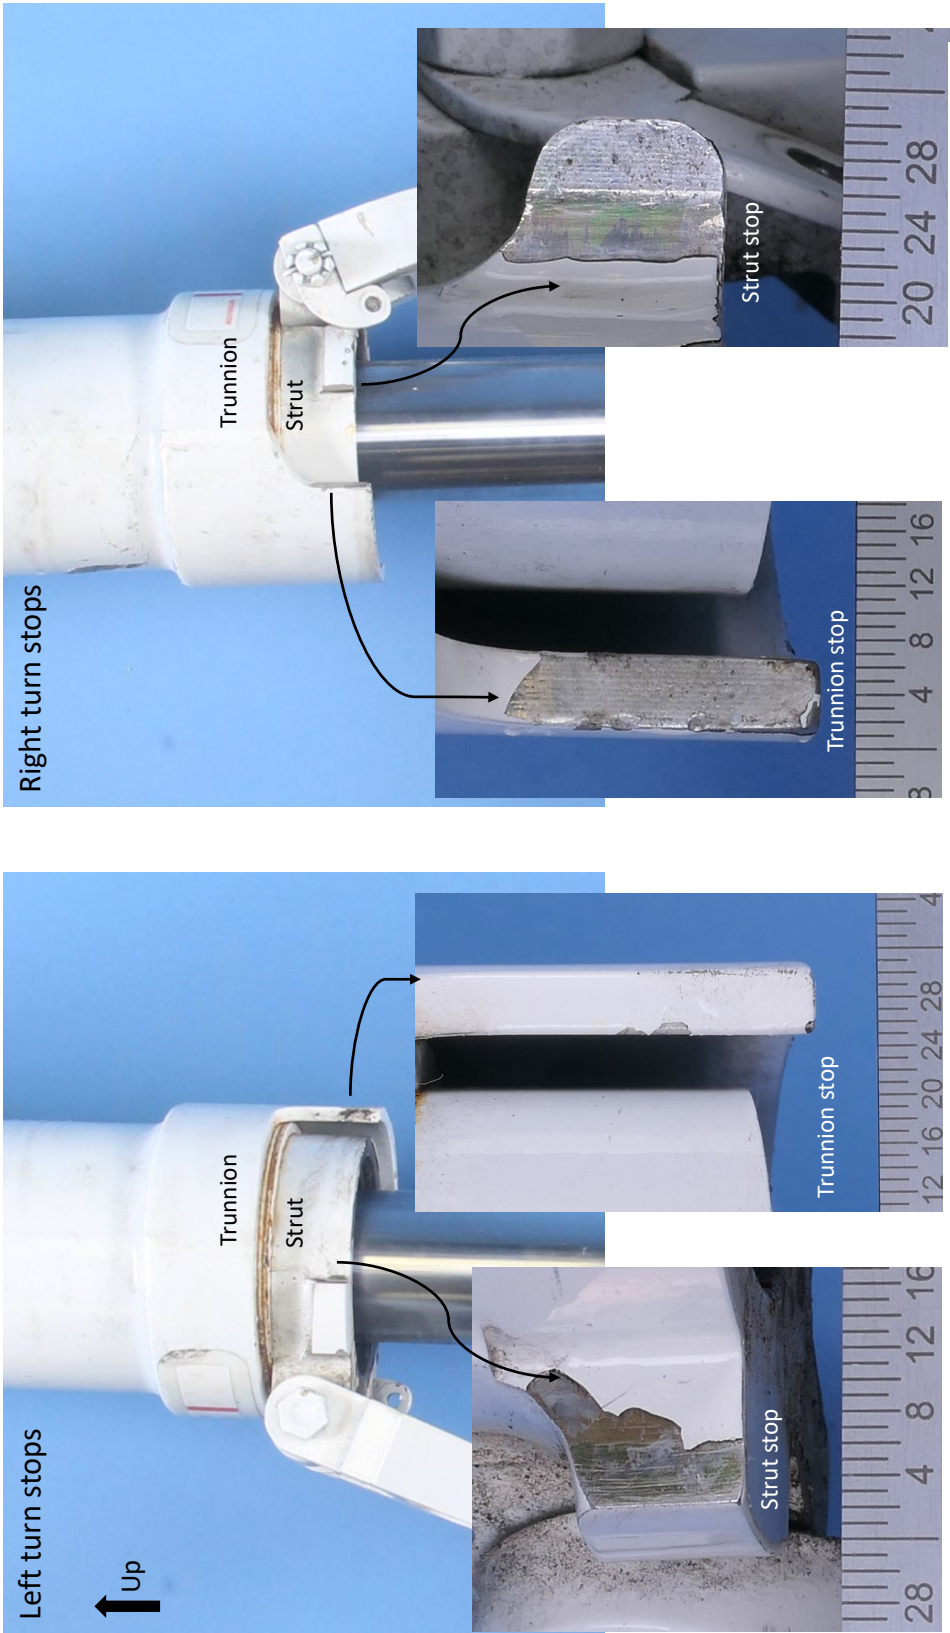
Figure 3 Views of the left and right turn stops on the trunnion and strut. The stop contact faces were cleaned with isopropyl alcohol.

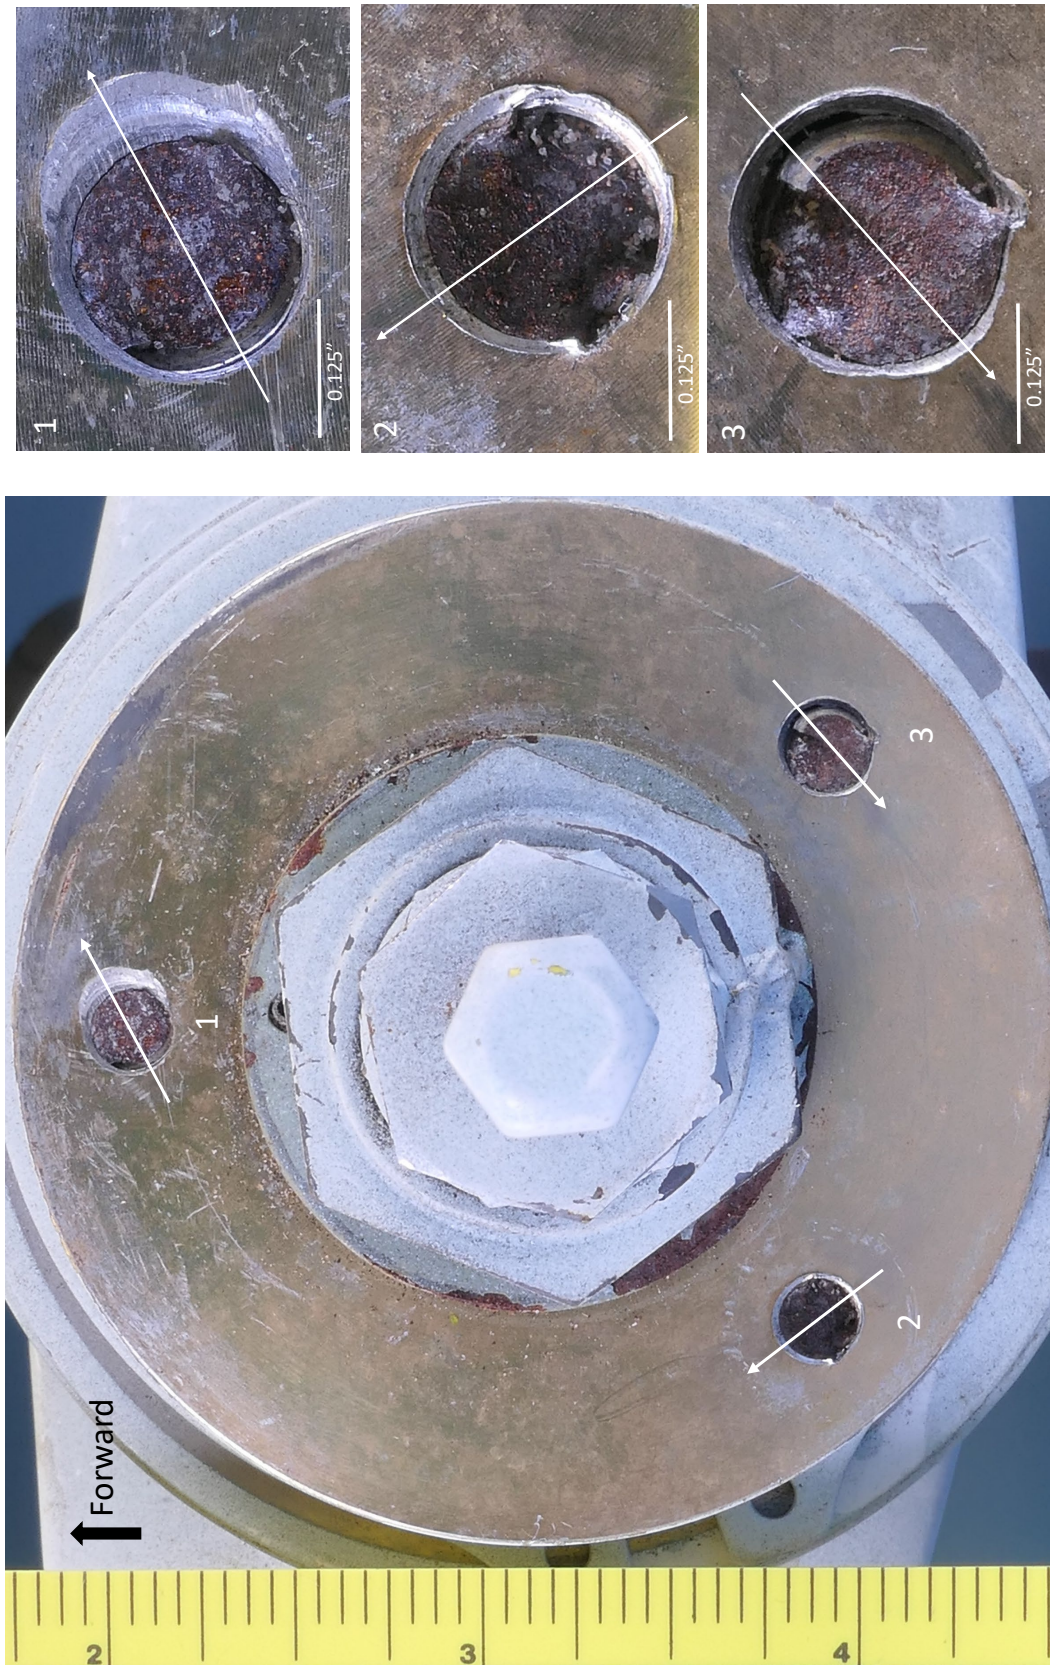
The upper surface of the nose landing gear assembly strut is shown in Figure 4. Fractured remnants of the three bolts used to secure the steering horn assembly to the top of the strut are present as indicated in the figure. The bolt positions have been numbered for documentation purposes. Closer images of the fractured bolt remnants are superposed in Figure 4. Based on fractographic evaluation, the white arrows indicate the direction of shear loading required to fracture the bolts. Fractography indicated that Bolt 2 fractured predominately in tension with minor shear loading. Based on deformation signatures on the bolt remnants and on damage to the top of the strut housing, Bolts 3 and 1 experienced progressively greater levels of shear/bending loading, respectively.

Figure 4 The top of the strut showing the remnants of three fractured steering horn mounting bolts with closer views of the fracture faces of the bolts at the right.

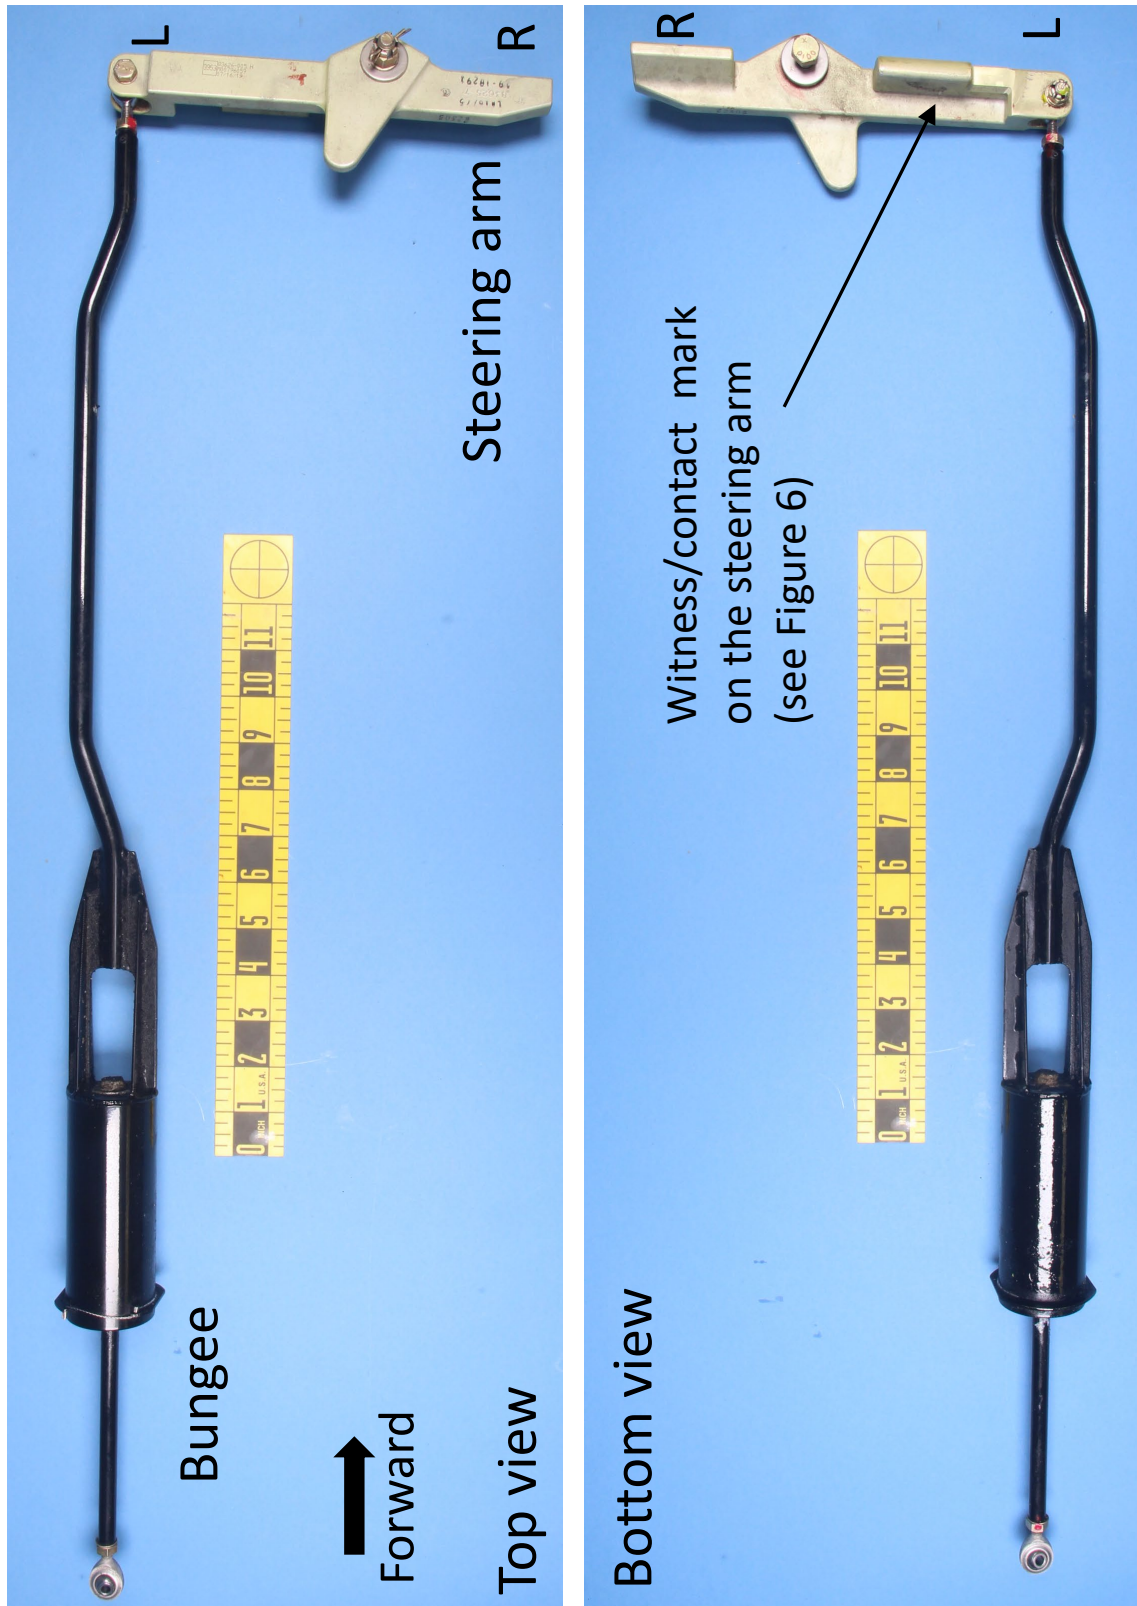
The steering arm and bungee subassembly is shown in Figure 5. The aft or backside of the left steering arm contact pad exhibited a witness or contact mark as indicated in the figure. Closer views of the contact mark on the backside of left pad are shown in Figure 6. According to the IIC, examination of the accident airplane revealed that this contact mark is consistent with contact with the engine mount plate.

Figure 5 Views of the top and bottom of the bungee and steering arm subassembly.

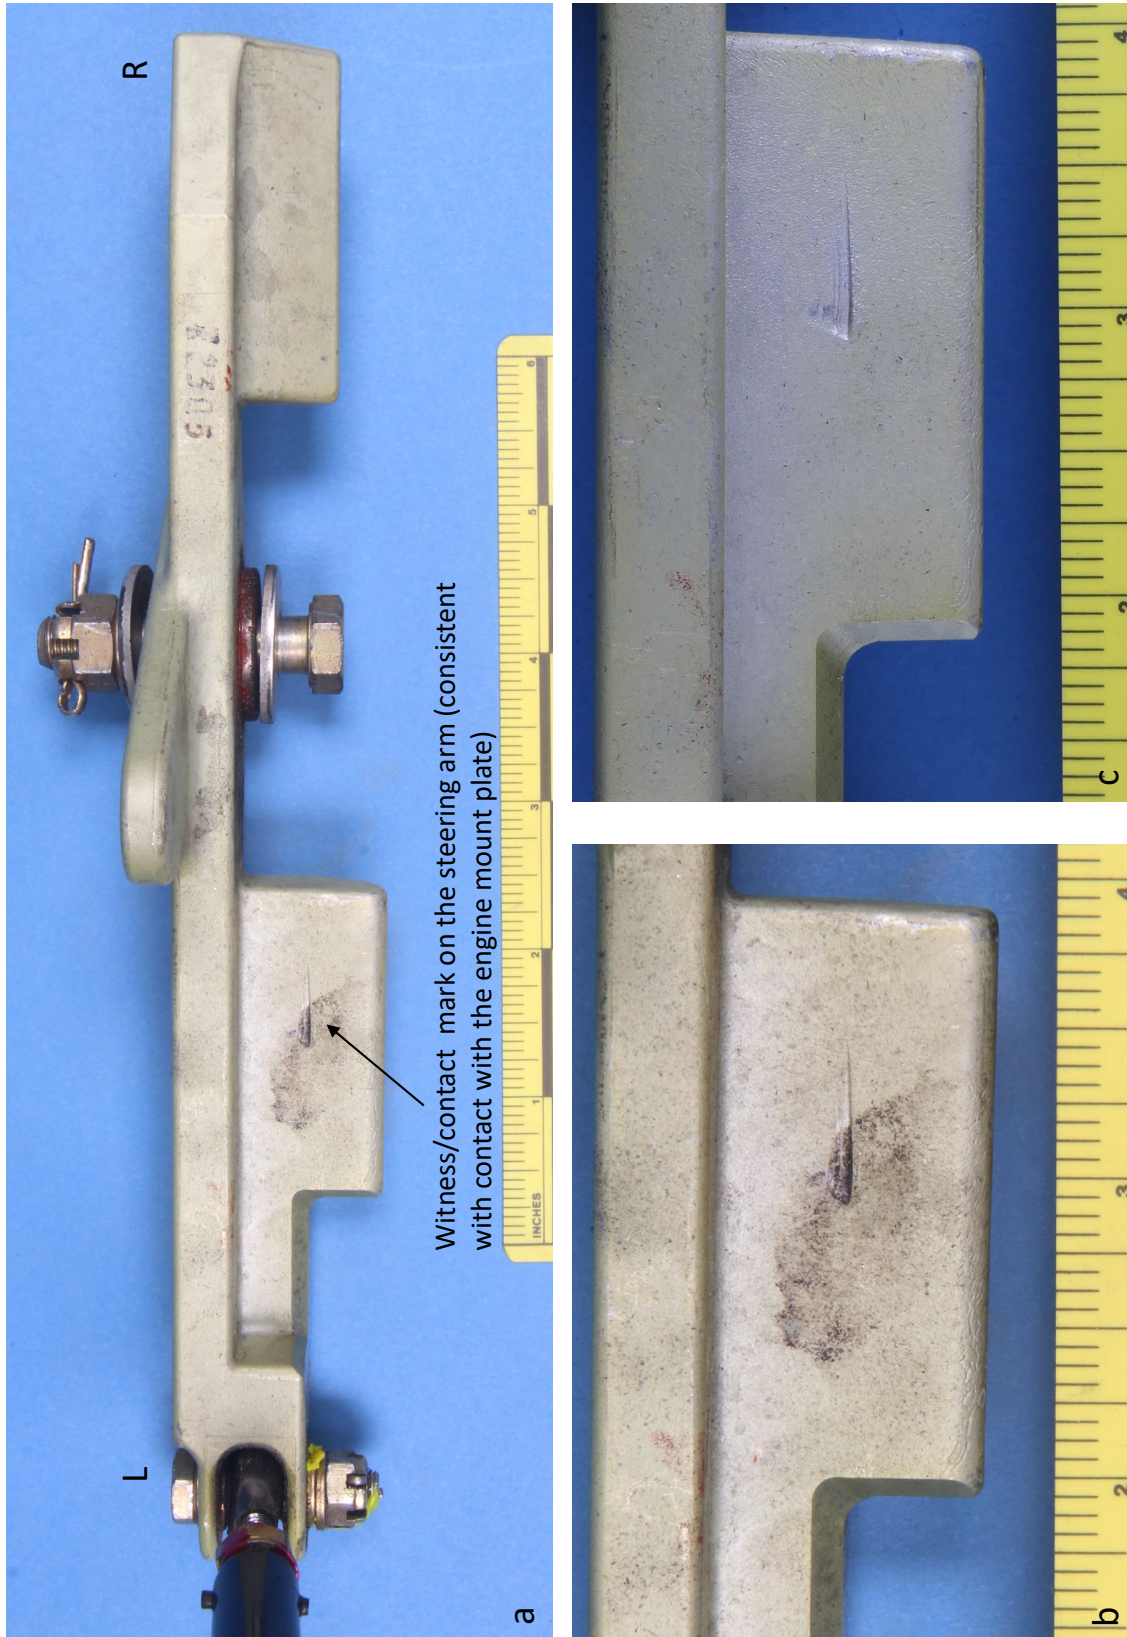
Figure 6 View of the steering arm showing a contact mark on the left side. Views b and c show closer images before and after cleaning with isopropyl alcohol.

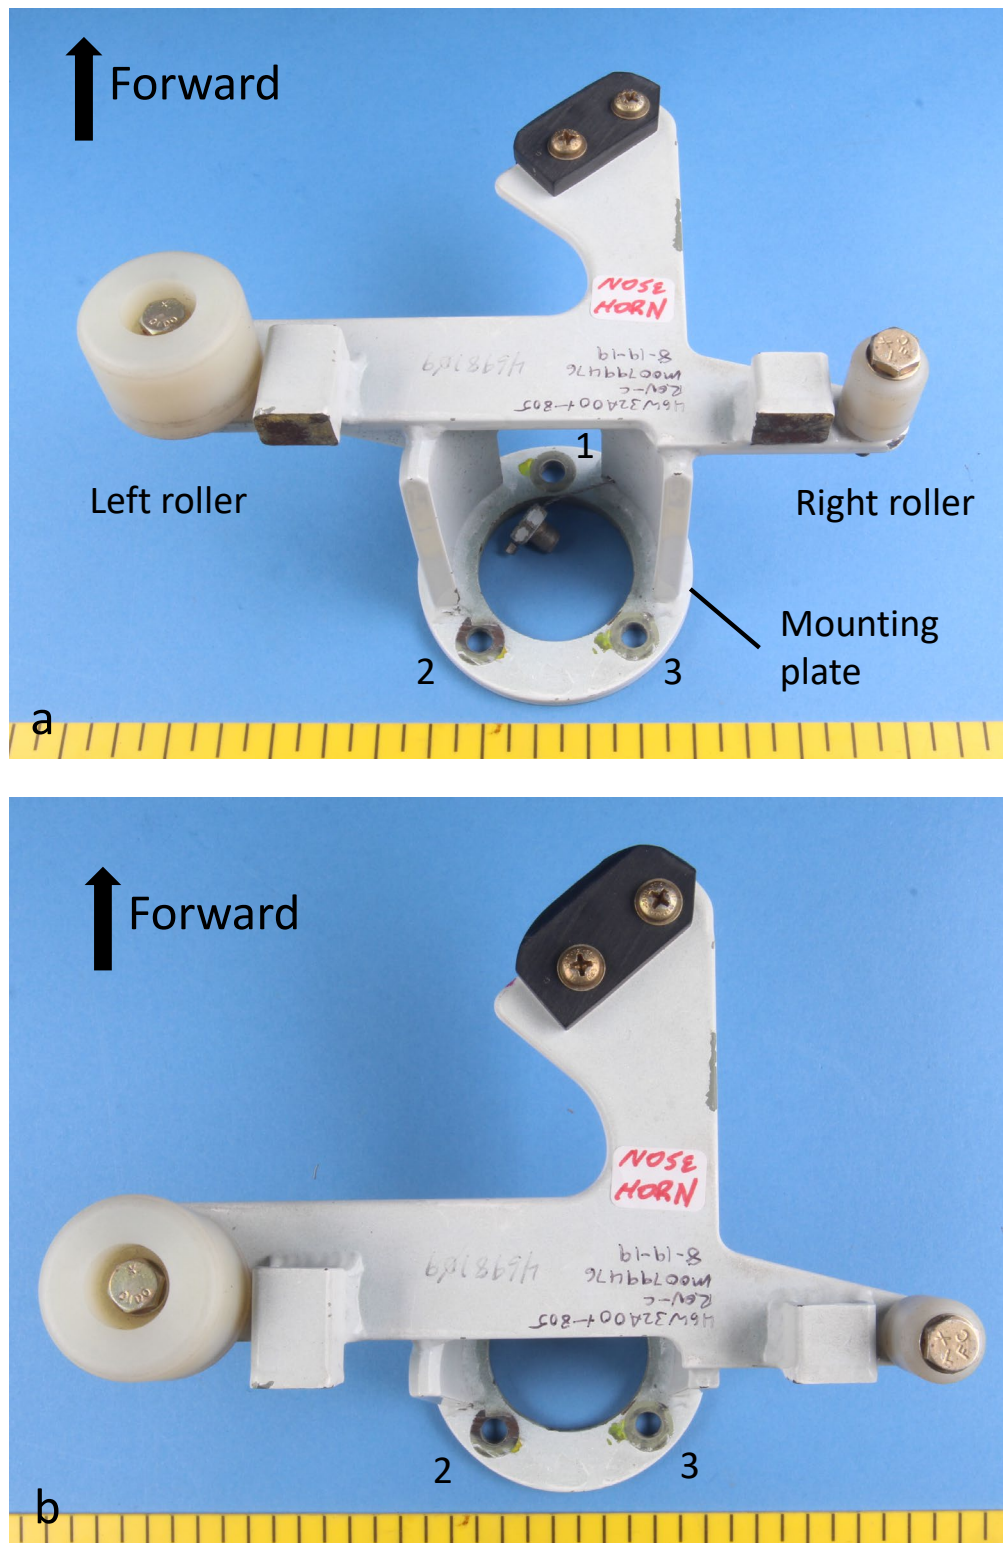
Figures 7 through 15 document the steering horn subassembly. Figures 7, 8, and 9 document the general appearance of the steering horn. In the figures, the mounting bolt holes are numbered consistent with the numbering scheme on the strut top in Figure 4. In bolt position 1, a fractured portion of the bolt consisting of the head and grip are safety-wired to the steering horn. This bolt remnant and its fracture surface is documented in Figures 16 through 20. Profile views of the steering horn in Figures 10 and 11 reveal that the bolt/axle for the left roller is bent about 7° forward and that the mounting plate has out-of-plane deformation. Such mechanical deformation resulted in strain and cracks in the paint film over the weld deposits adjacent to bolt holes 2 and 3 as documented in Figures 12 through 14. Lastly, Figure 15 documents the manufacturer's markings on the steering horn.

Figure 7 Images of the steering horn. View a is an oblique top view. View b is a top view.

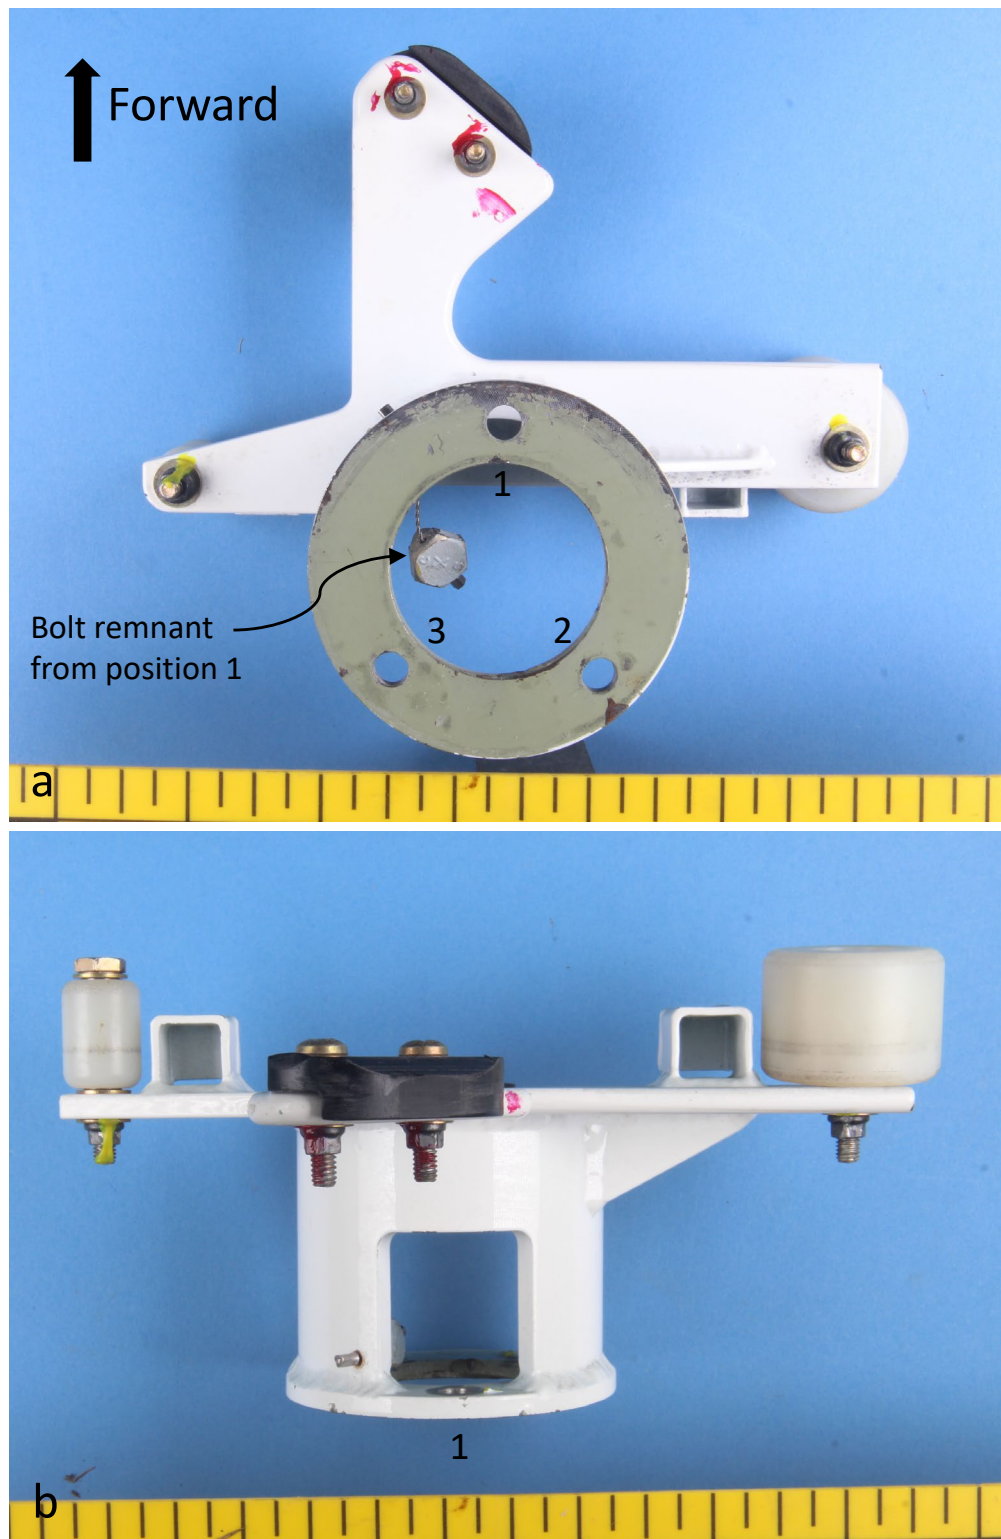
Figure 8 Images of the steering horn. View a is a bottom view. View b is looking aft.

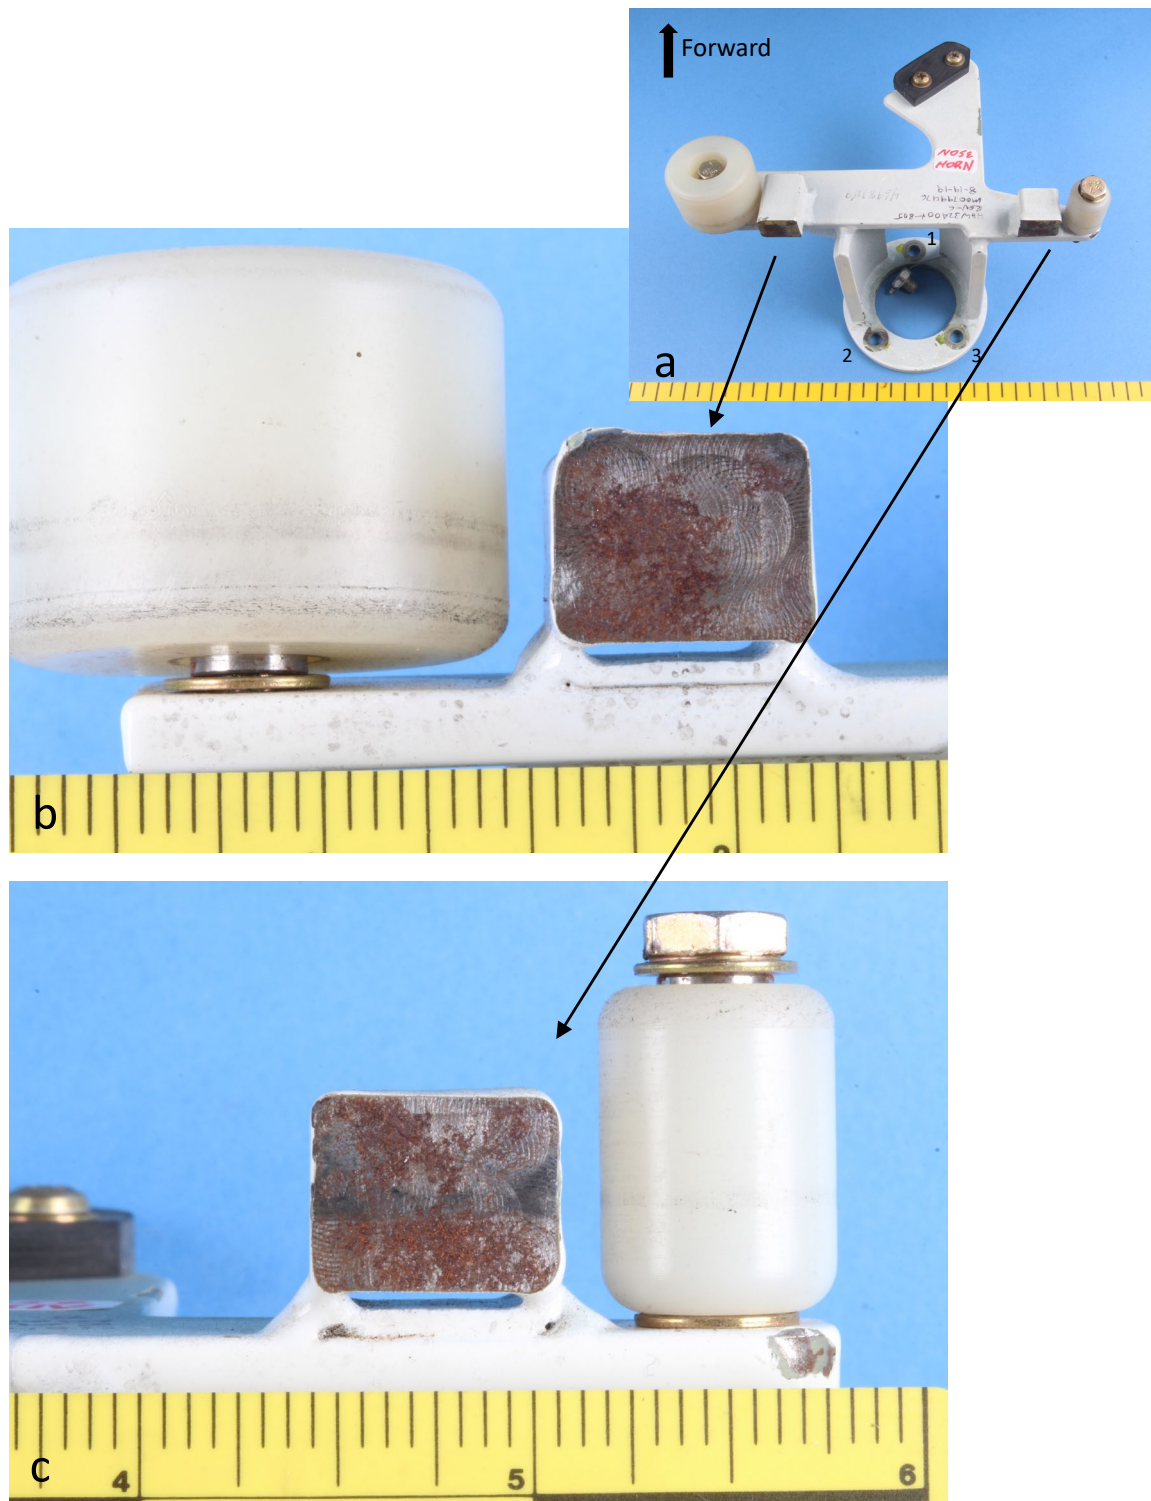
Figure 9 Images of the steering horn. Details of the rollers and pads.

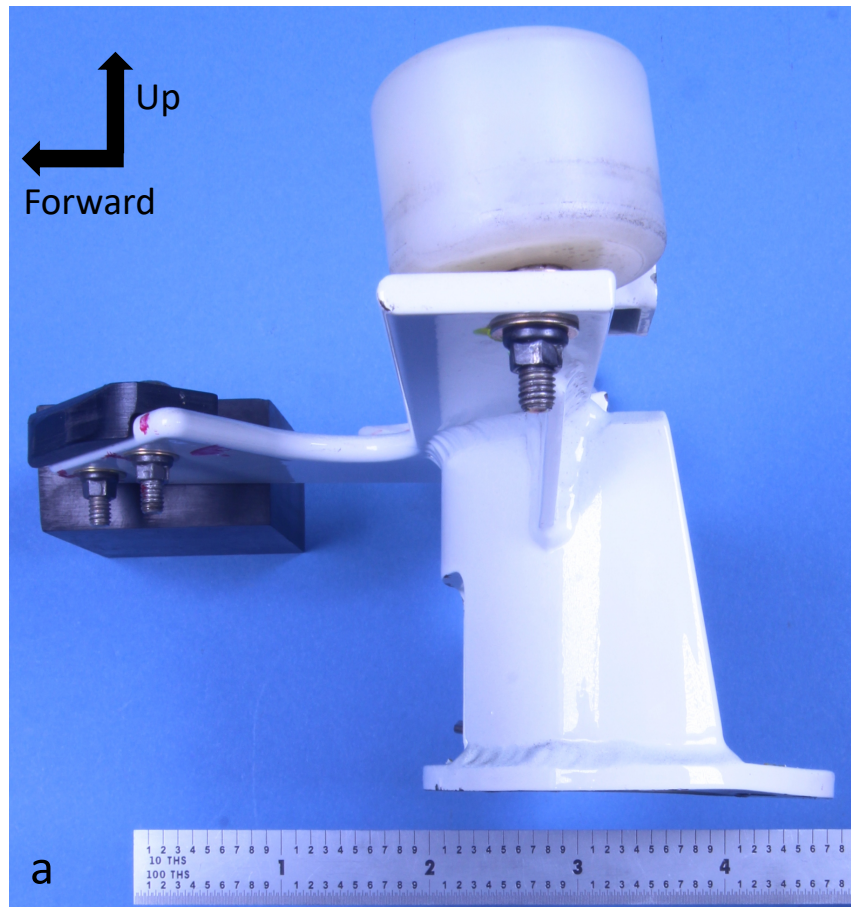
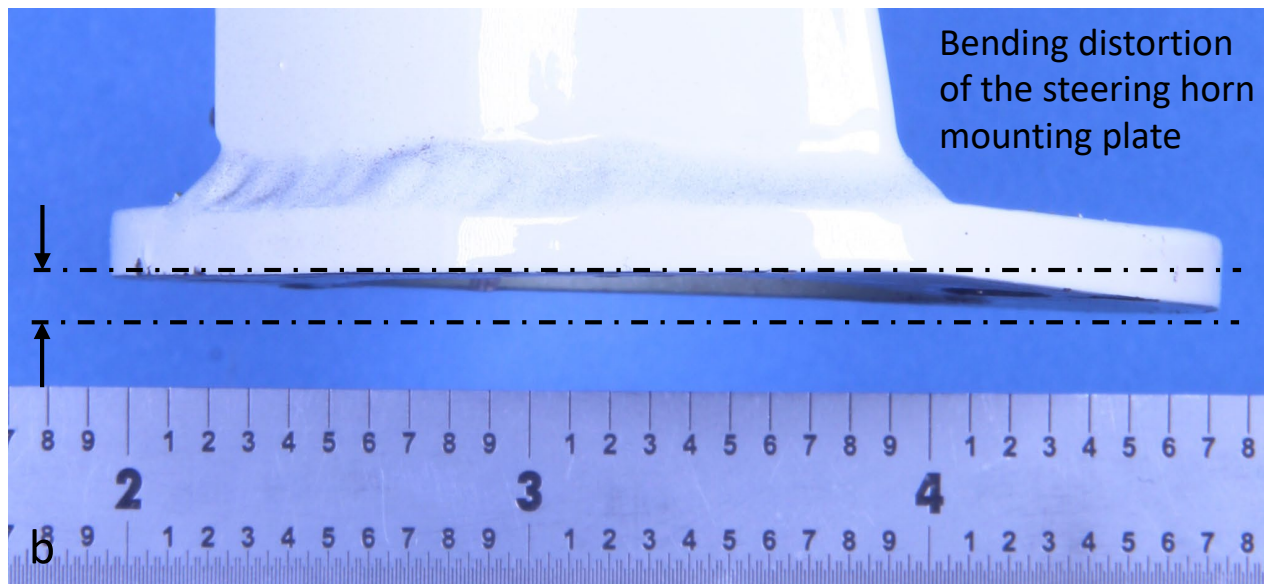
Figure 10 Profile views of the steering horn. View b shows out of plane deformation in the mounting plate.

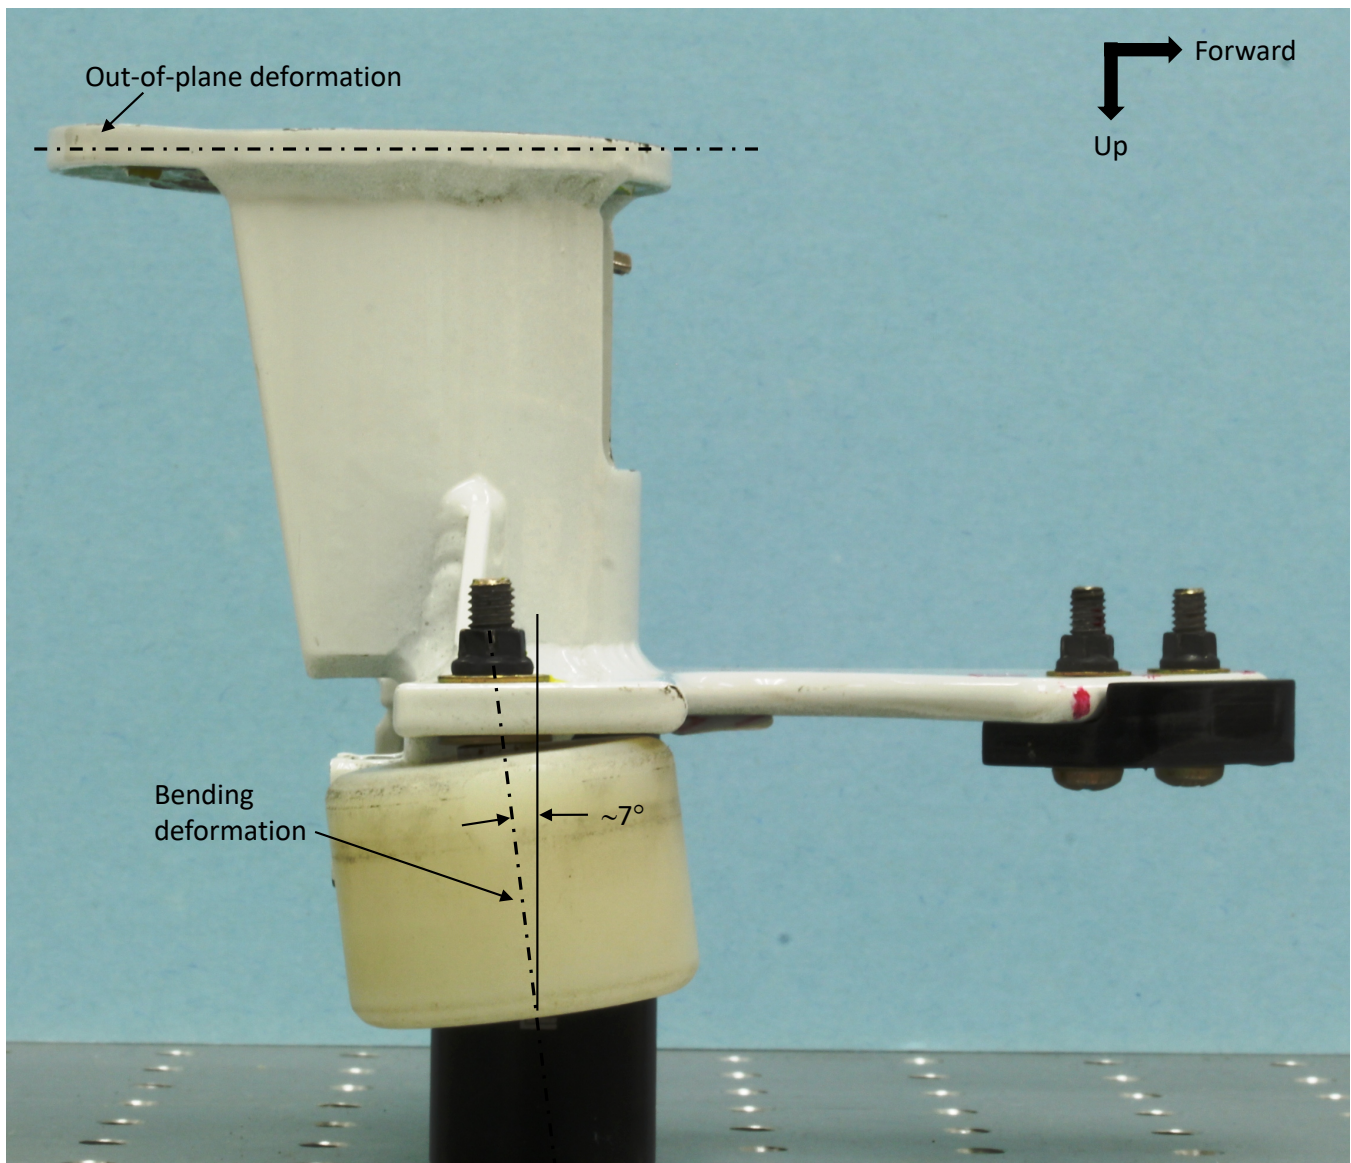
Figure 11 Profile views of the steering horn revealing out of plane deformation in the mounting plate and forward bending deformation of the left side roller axle.

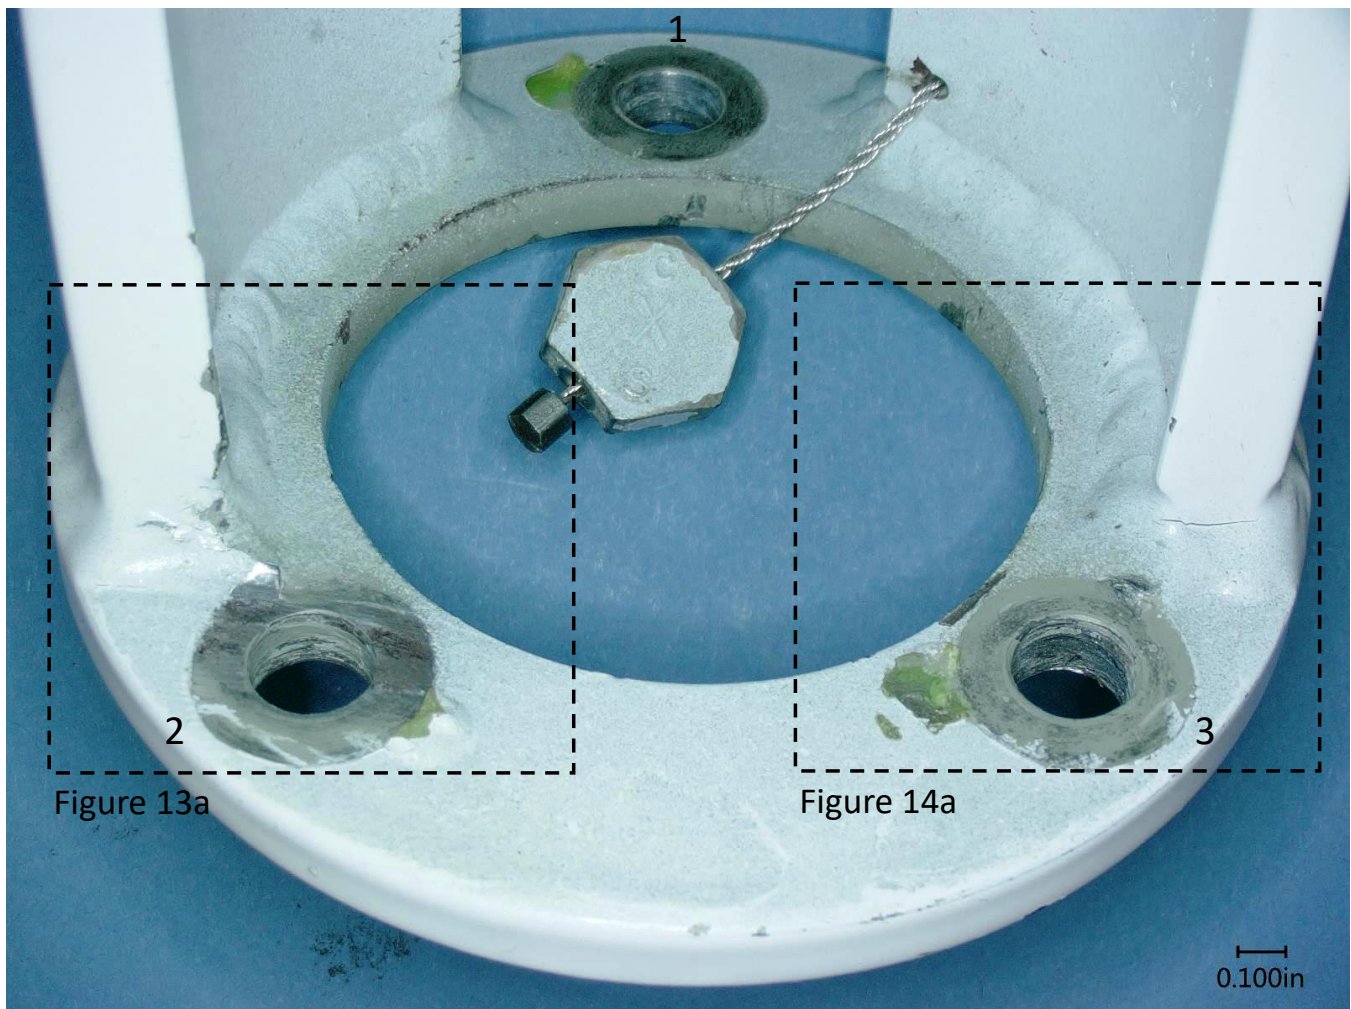
Figure 12 Views of the weld deposit between the upright and the base plate.

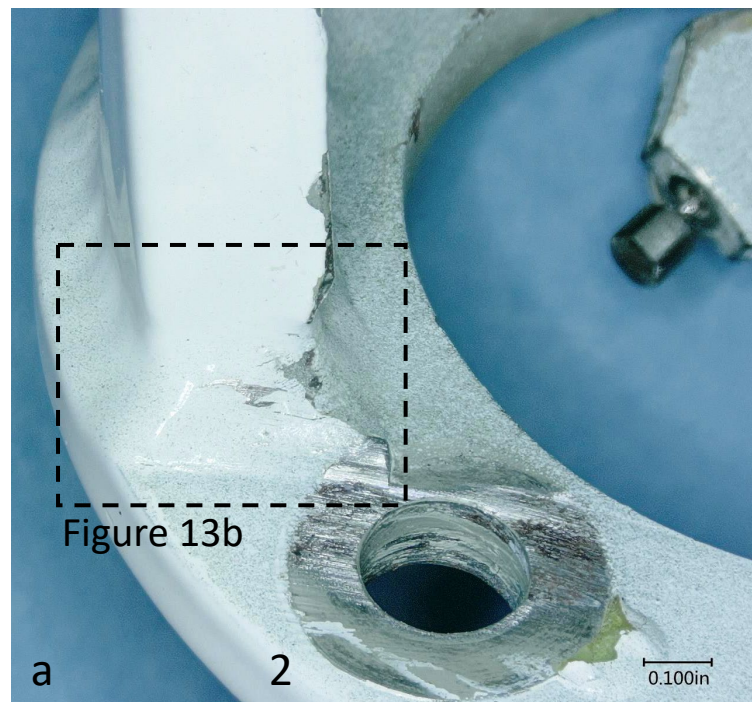
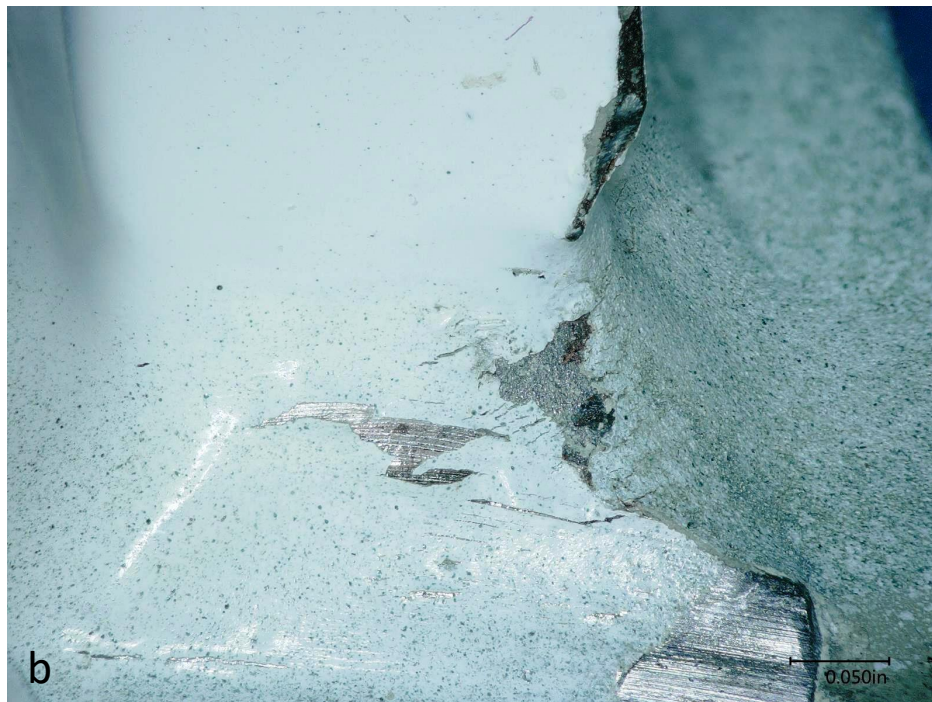
Figure 13 Views of the weld deposit between the upright and the base plate closest to bolt hole 2. Cracks in the paint film and disbonded paint are observed.
