# NATIONAL TRANSPORTATION SAFETY BOARD

## MATERIALS LABORATORY FACTUAL REPORT

Report No. 21-012

Place : Titusville, Florida  
Date : 07/03/2020  
Vehicle : Piper PA-46-600TP (N89MA)  
NTSB No. : ERA20LA237  
Investigator : Lynn Spencer

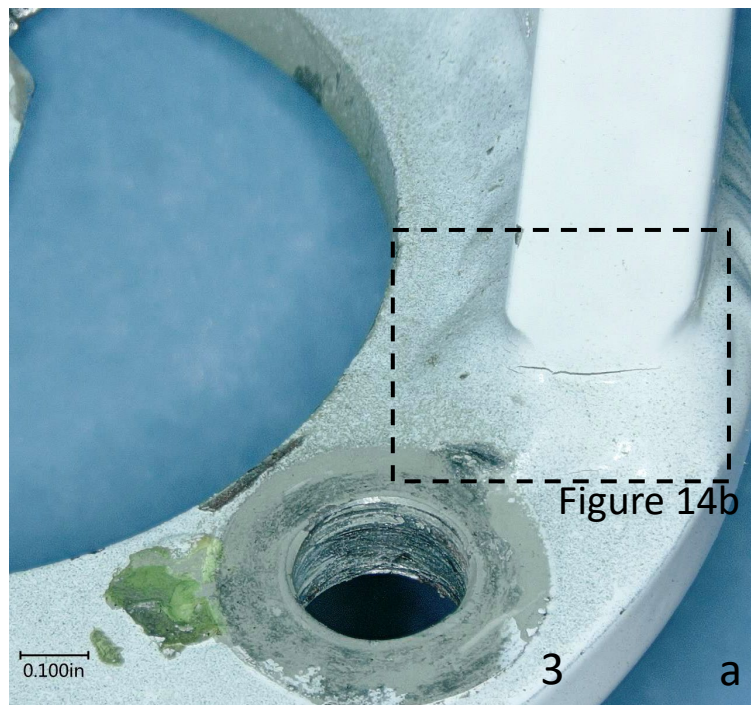
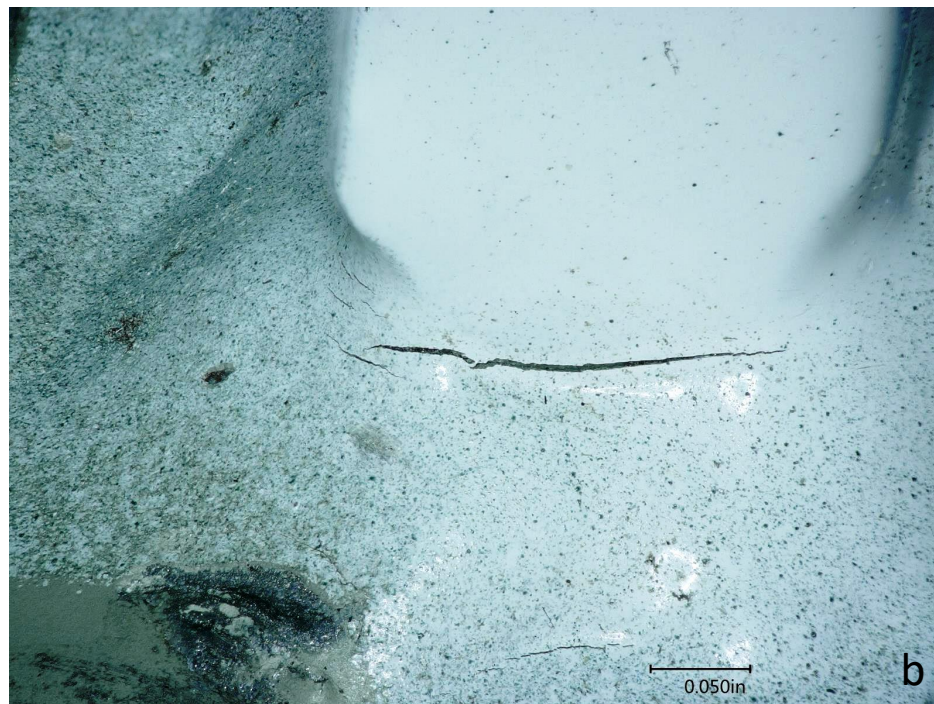
Figures 7 through 15 document the steering horn subassembly. Figures 7, 8, and 9 document the general appearance of the steering horn. In the figures, the mounting bolt holes are numbered consistent with the numbering scheme on the strut top in Figure 4. In bolt position 1, a fractured portion of the bolt consisting of the head and grip are safety-wired to the steering horn. This bolt remnant and its fracture surface is documented in Figures 16 through 20. Profile views of the steering horn in Figures 10 and 11 reveal that the bolt/axle for the left roller is bent about 7° forward and that the mounting plate has out-of-plane deformation. Such mechanical deformation resulted in strain and cracks in the paint film over the weld deposits adjacent to bolt holes 2 and 3 as documented in Figures 12 through 14. Lastly, Figure 15 documents the manufacturer's markings on the steering horn.

Figure 14 Views of the weld deposit between the upright and the base plate closest to bolt hole 3. Cracks in the paint film and disbonded paint are observed.

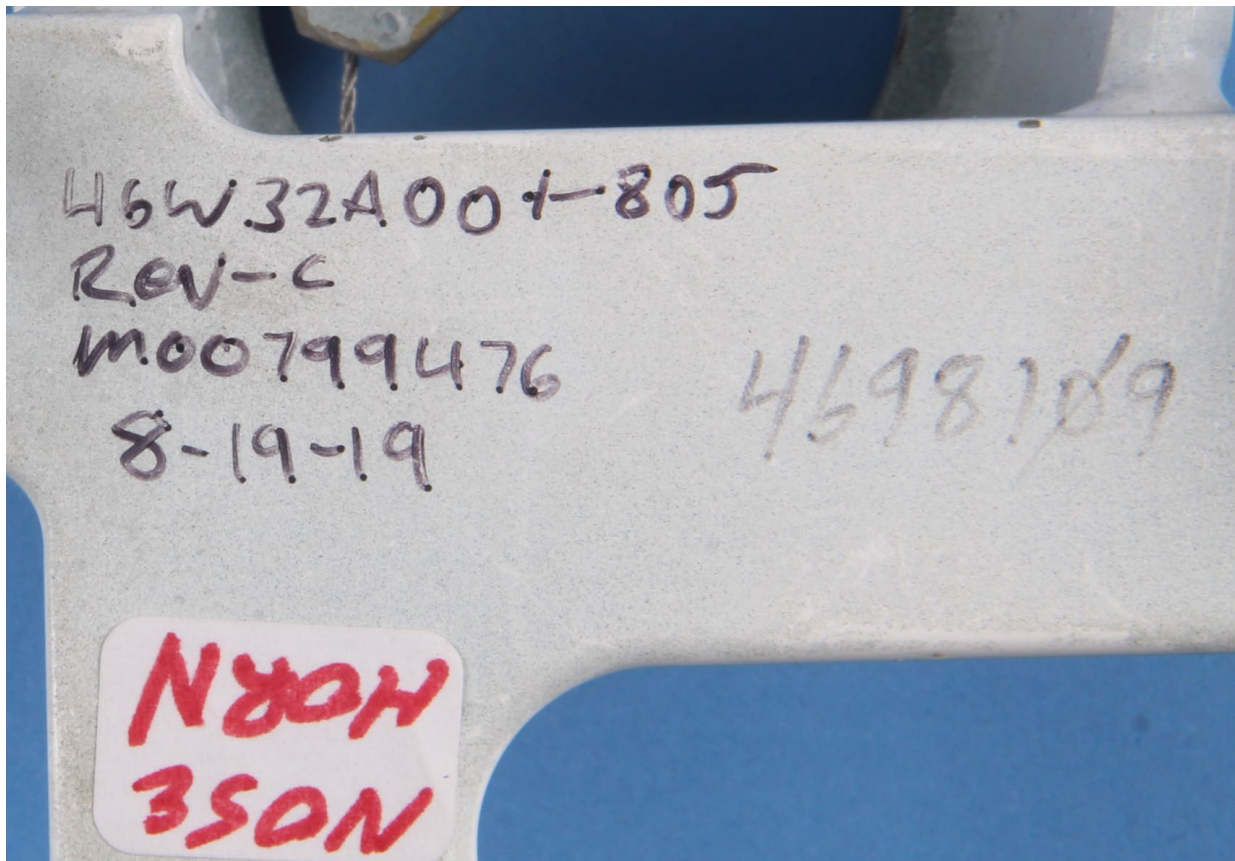
Figure 15 Image showing manufacturer identification markings.

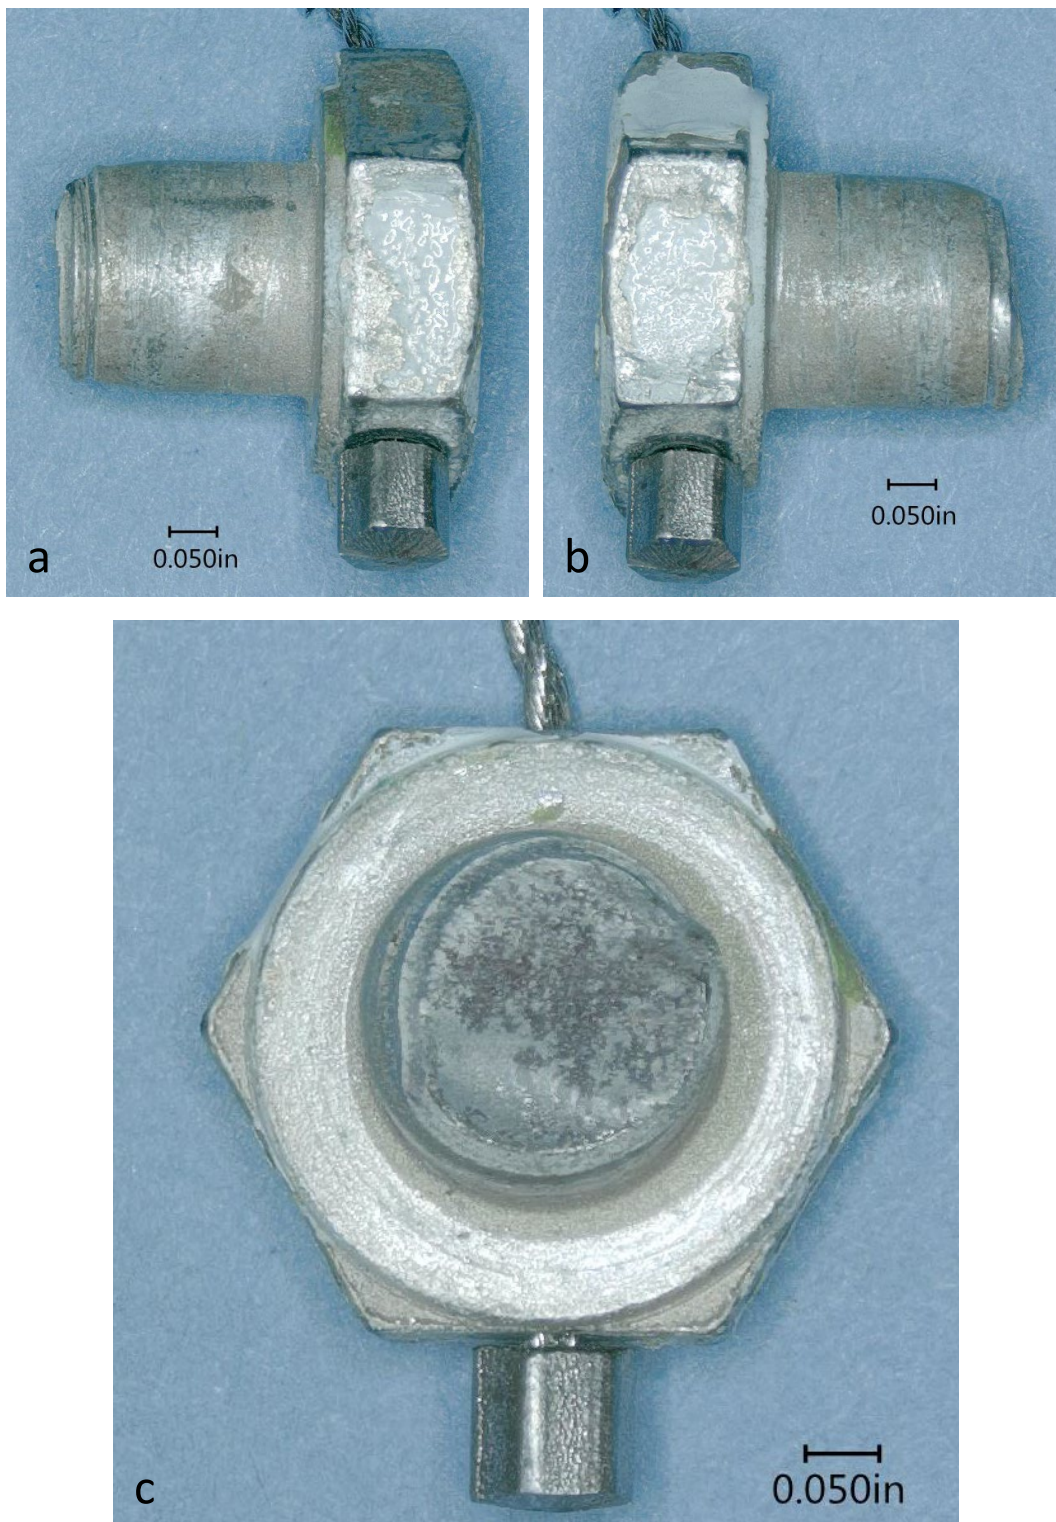
The fractured bolt piece from the Bolt 1 position of the steering horn is documented in Figures 16 through 20. The bolt piece fractured at the first thread adjacent to the grip as revealed in Figure 16. A metallurgical cross section prepared through the head of Bolt 1 revealed a microstructure of tempered martensite (see Figure 18). Microhardness measurements made at the core of the head cross section yielded a hardness of 319 HV500 to 328 HV500 (about 32 HRC to 33 HRC as converted via ASTM E140).

Figure 16 Digital microscope images of the Bolt 1 head and grip.

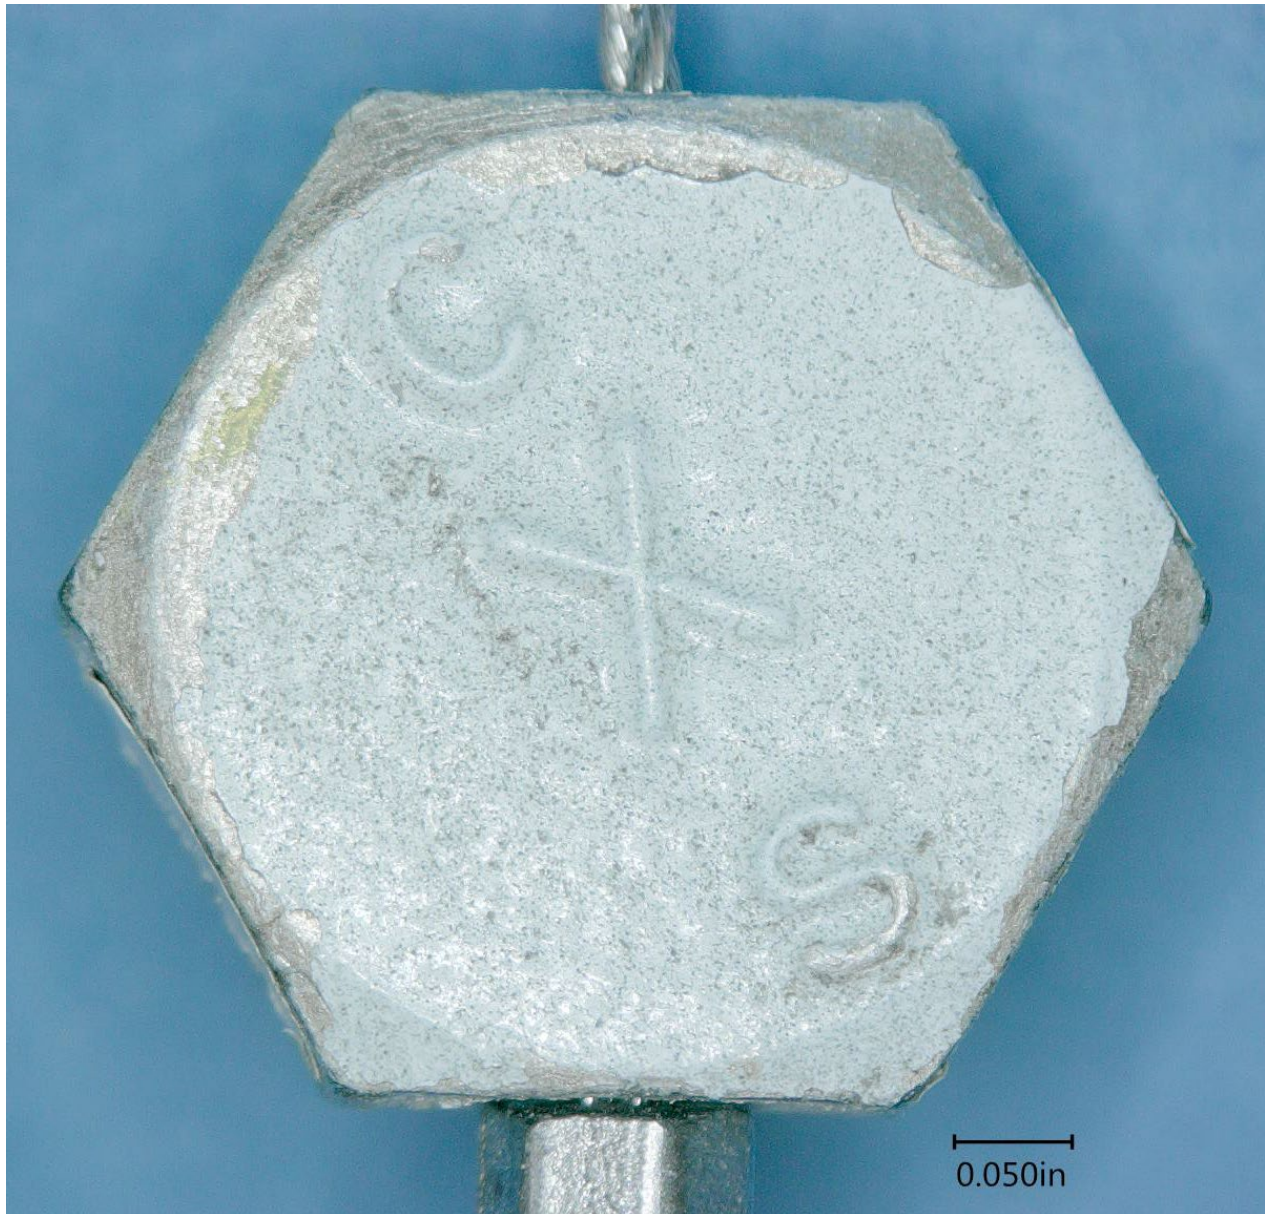
Figure 17 The top side of the Bolt 1 head revealing manufacturing markings.

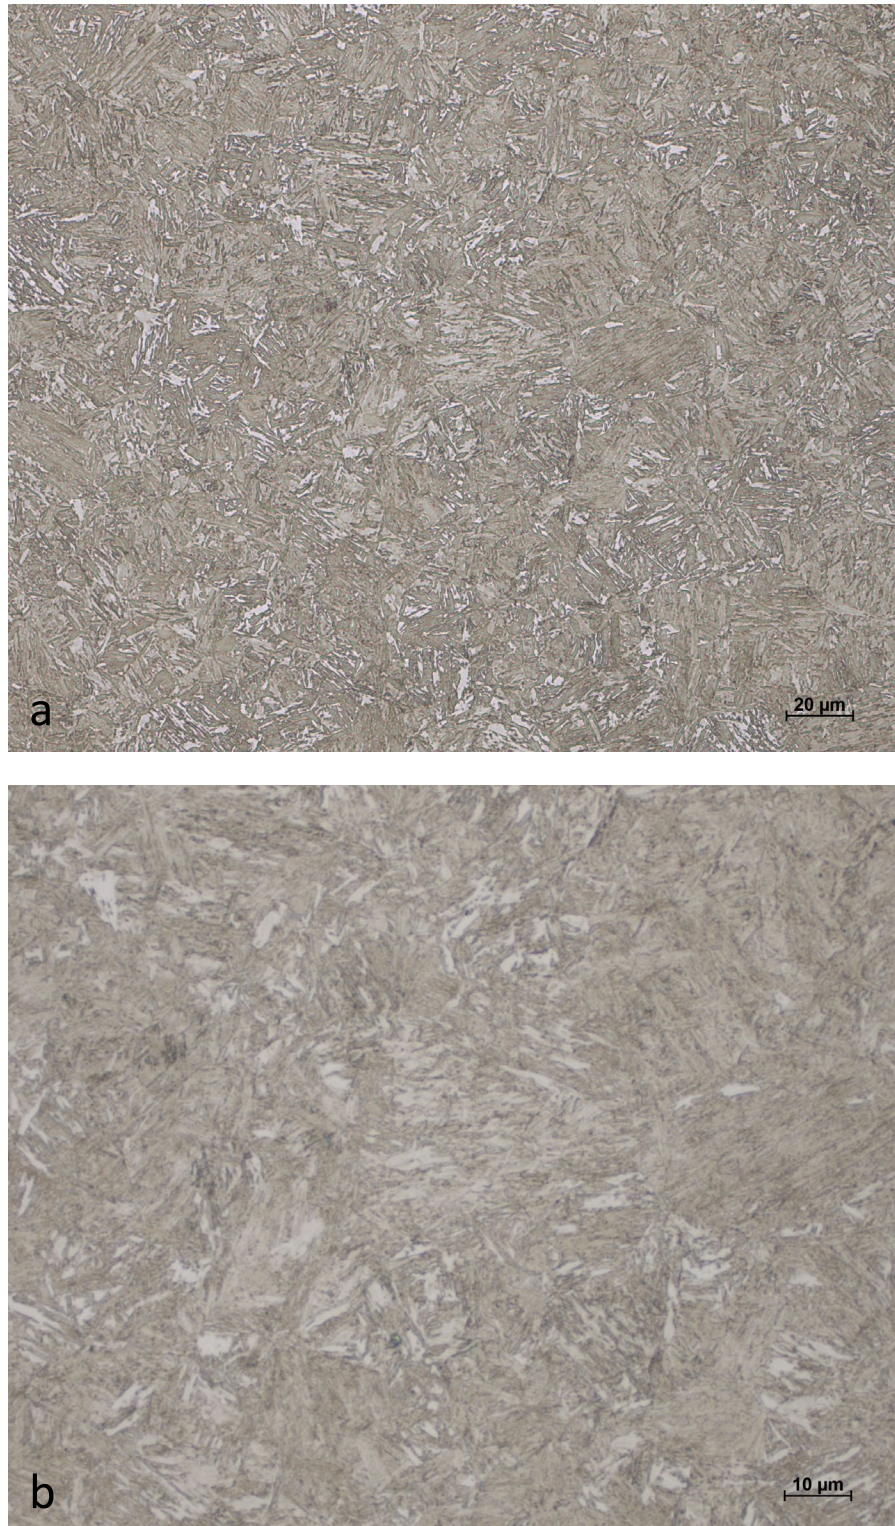
Figure 18 Brightfield optical photomicrographs of the microstructure from a cross section of the Bolt 1 head revealing tempered martensite. View a is at 500X and view b is at 1000X (original magnification). (2% nital etch)

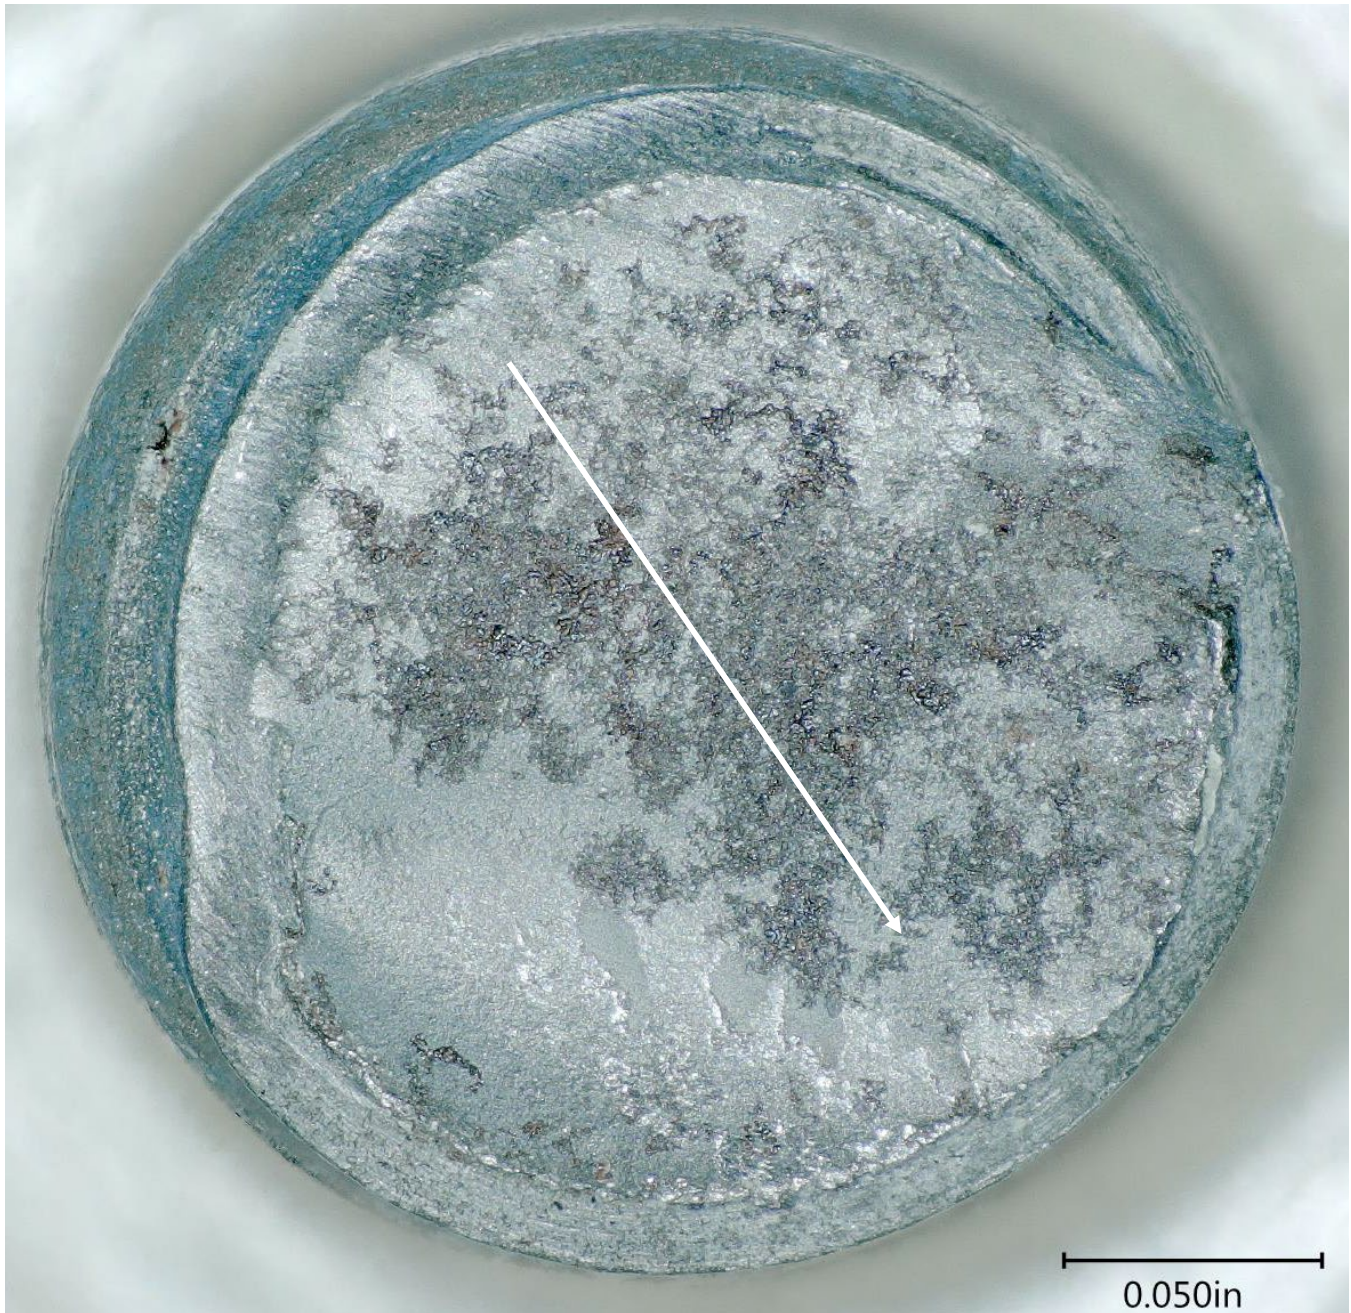
A close view of the as-received Bolt 1 fracture surface is shown in Figure 19. After cleaning in Evaporust, the fracture surface of Bolt 1 was examined using a scanning electron microscope (SEM) and the surface coating on the bolt shank was determined using standardless semiquantitative energy dispersive spectroscopy (EDS) as cadmium. The bolt in the Bolt 1 is specified to be AN4H-5A. Table 1 compares the specification requirements of the bolt with the characteristics measured on the Bolt 1 remnant.

Figure 19 Digital microscope images of the Bolt 1 fracture surface. A white arrow depicts the approximate direction of fracture.

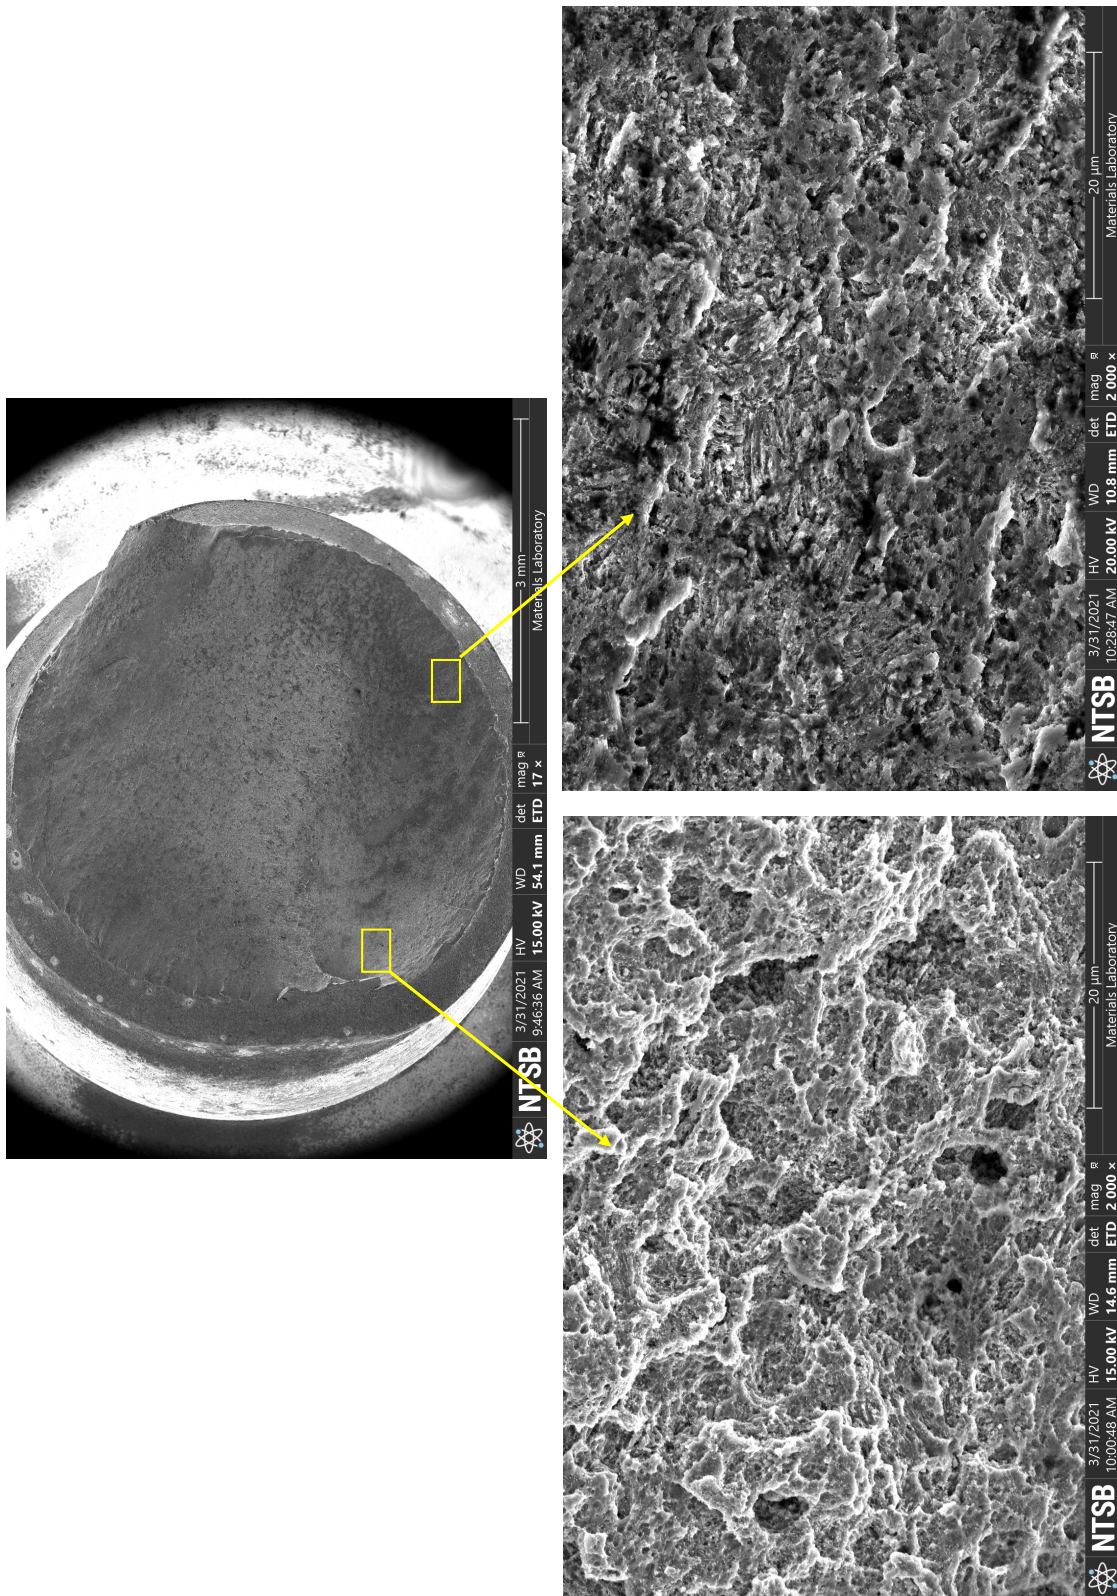
The Bolt 1 fracture surface exhibited macroscope and microscopic features consistent with ductile overstress fracture by microvoid coalescence (see Figure 20) due to in-plane shear and bending (e.g., Mode I and Mode II loading). By matching fracture features on the bolt head remnant and the Bolt 1 remnant in the strut, the approximate position of the bolt was determined as documented in Figures 21 through 23.

Figure 20 Secondary electron SEM images of the Bolt 1 fracture surface, showing microvoid coalescence fracture features.

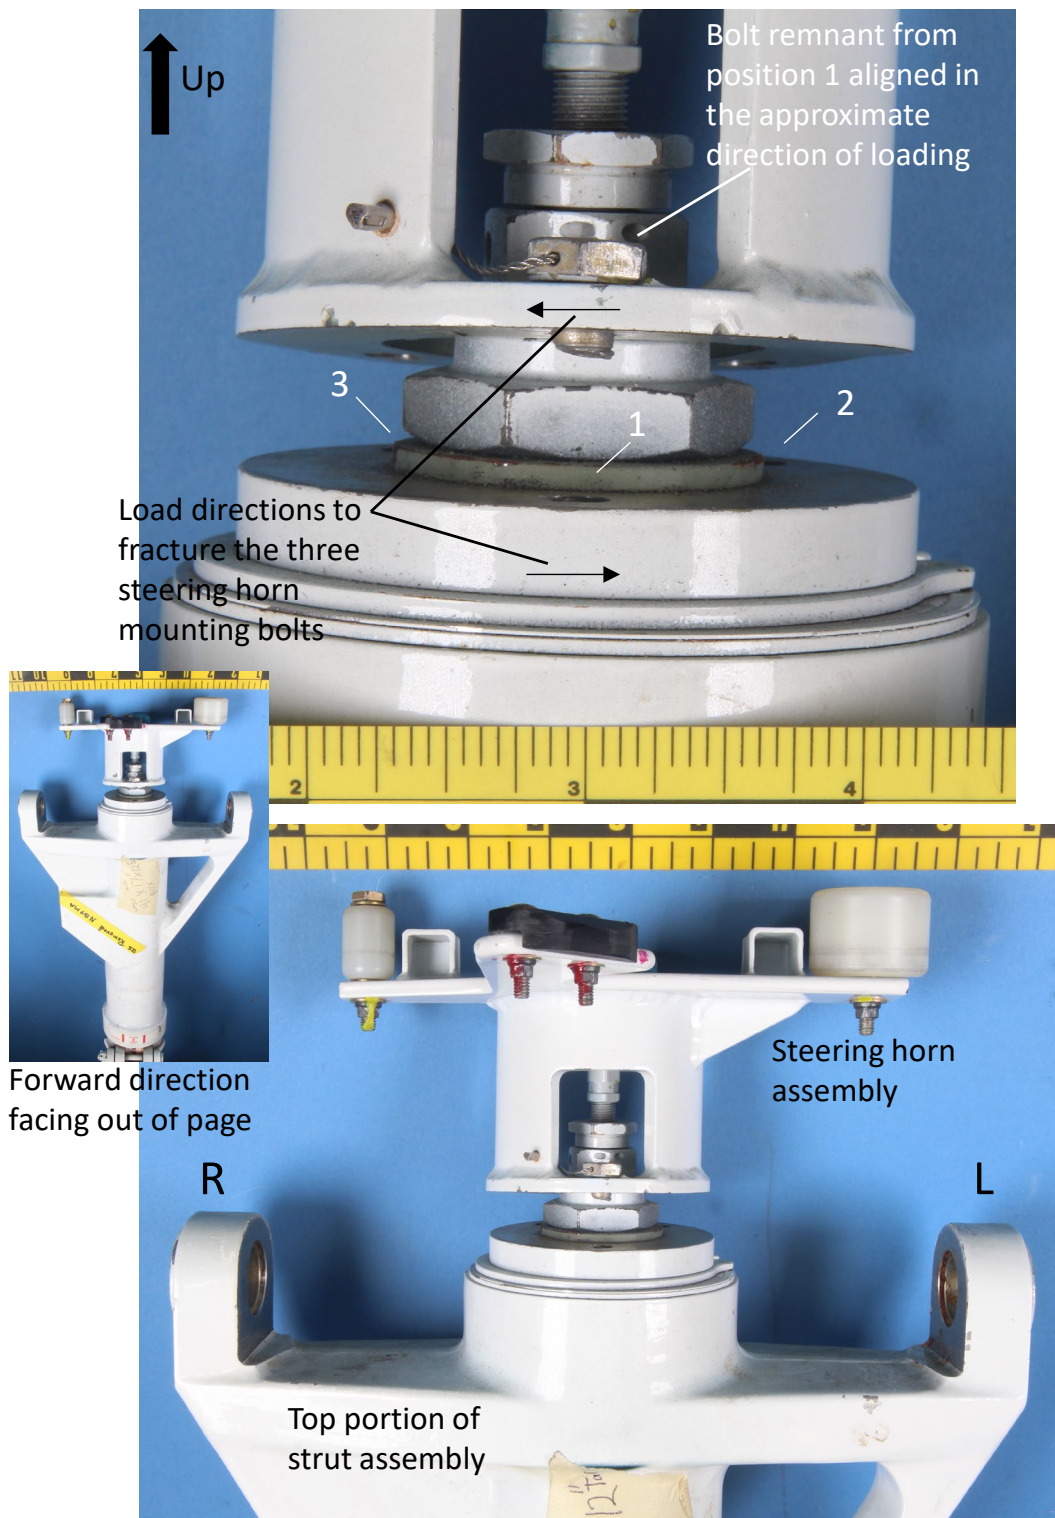
Figure 21 Views of the steering horn placed in close proximity to the top of the strut on the nose gear assembly.

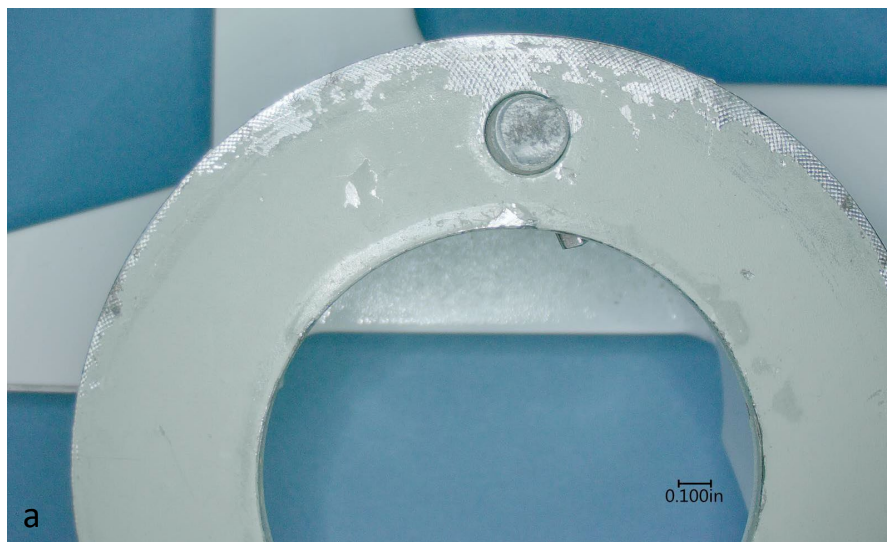
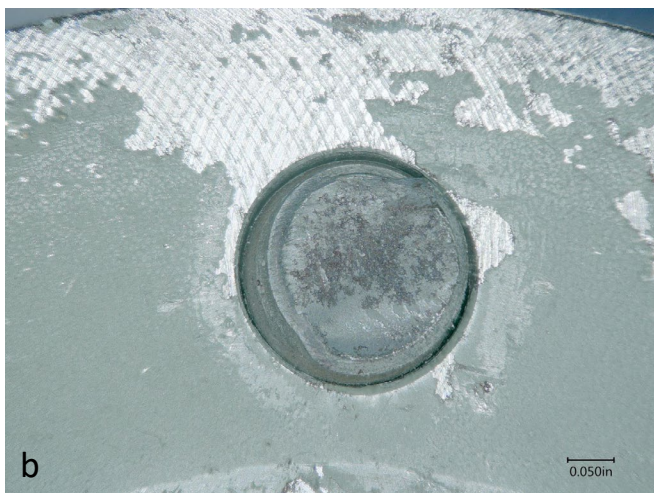
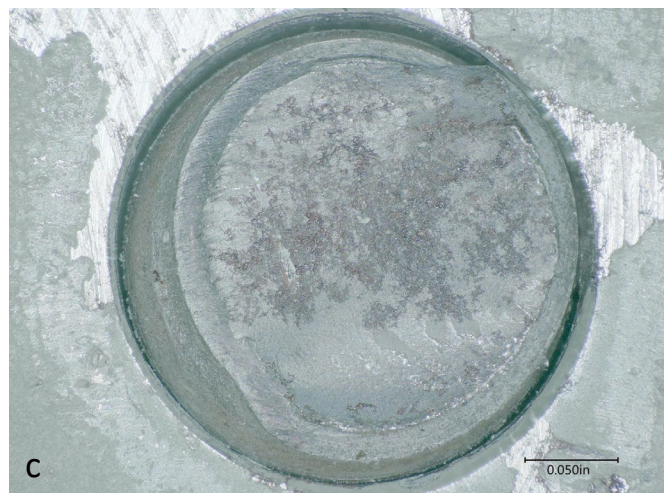
Figure 22 Bottom view of the steering horn with the Bolt 1 remnant in place, oriented in its approximate position at the time of fracture.

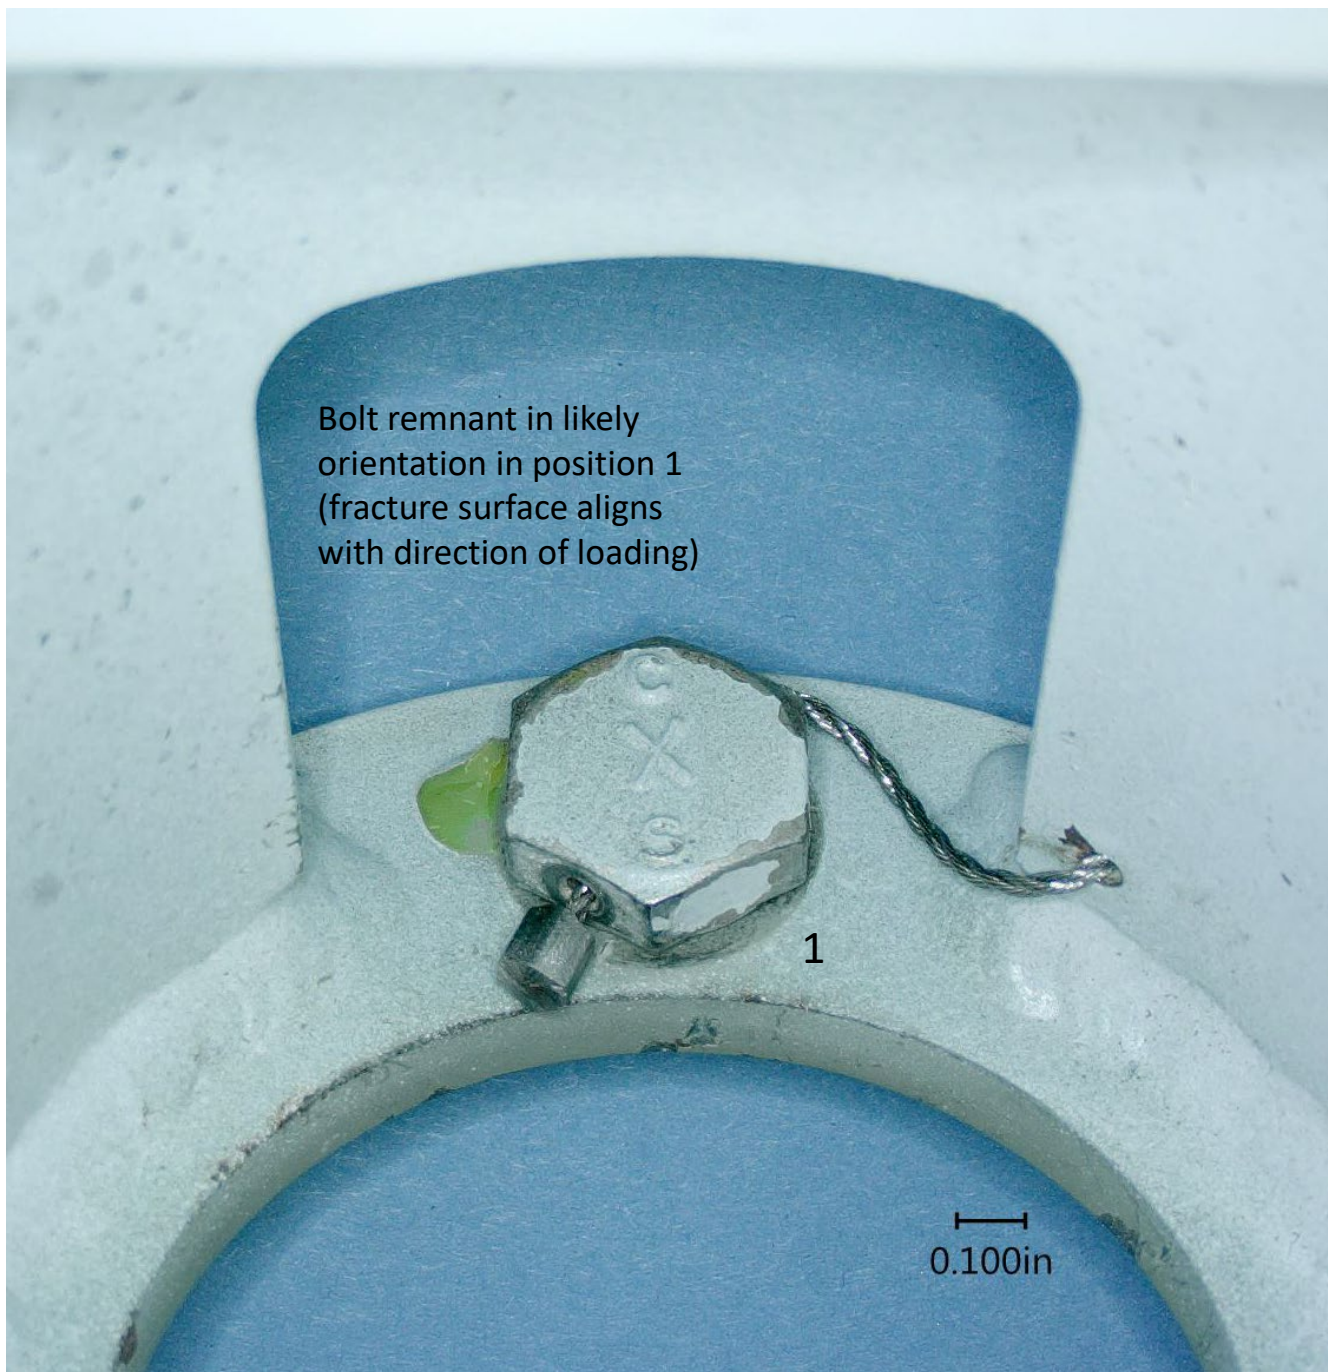
Figure 23 Oblique top view of the steering horn with the Bolt 1 remnant in place, oriented in its approximate position at the time of fracture.

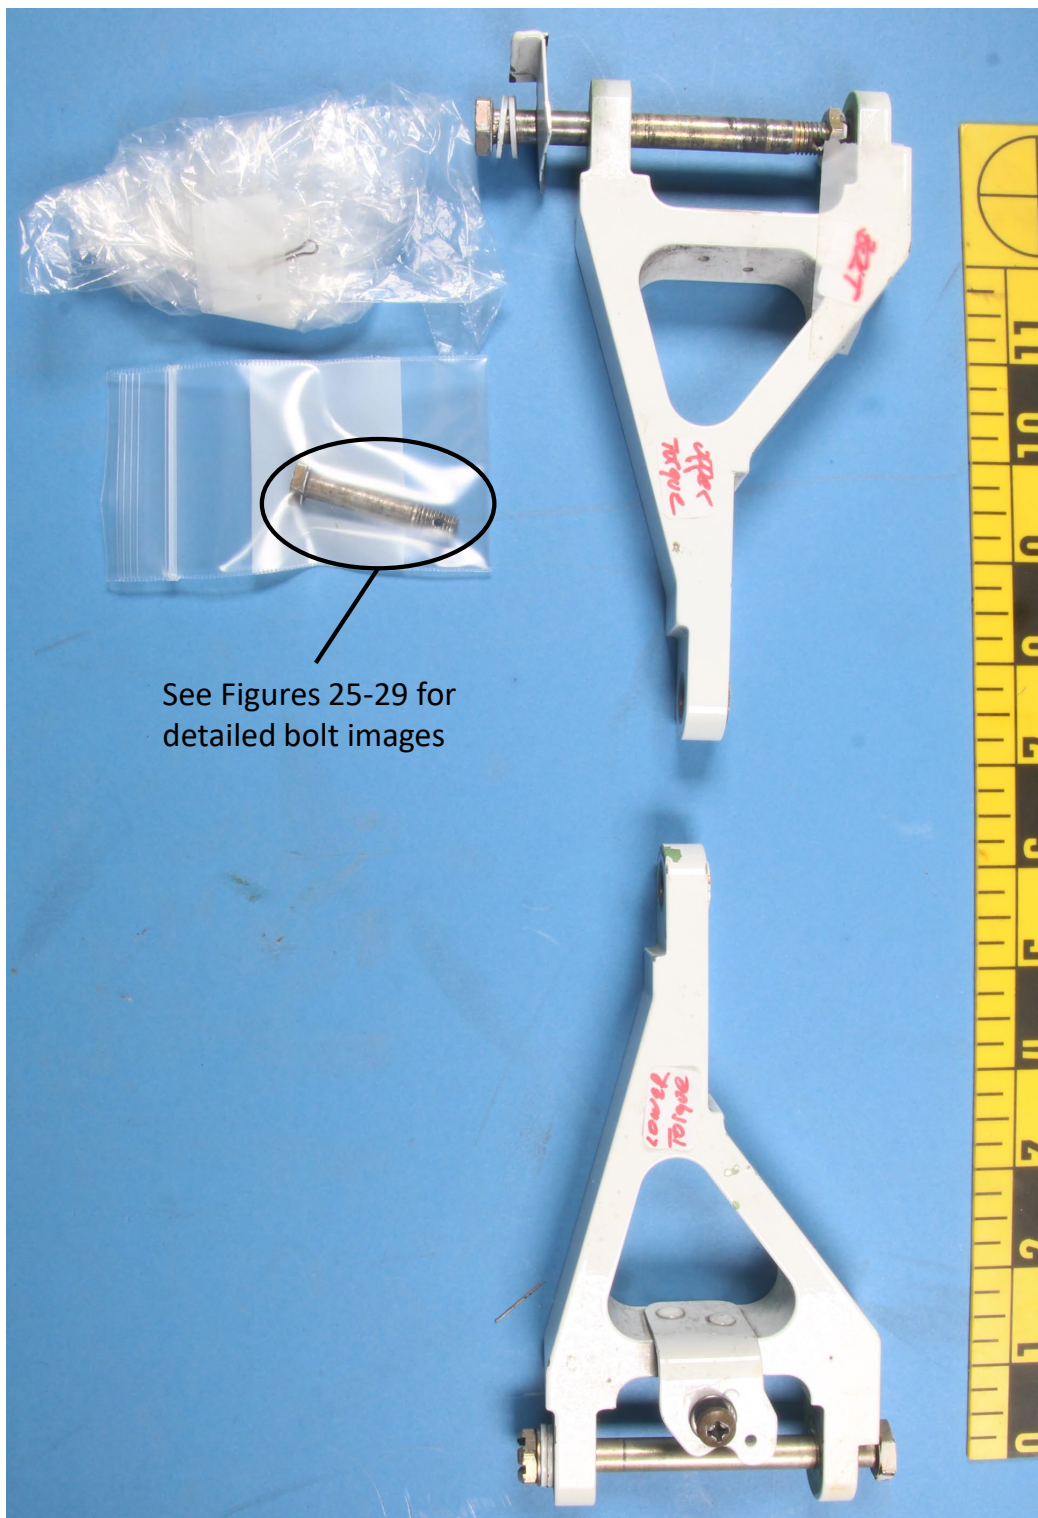
The as-received left main landing gear upper and lower torque arm pieces along with a cotter pin and a bolt are shown in Figure 24. The submitted bolt was the pivot between the upper and lower torque arms. It was found at the accident site with the nut and cotter pin missing. The pivot bolt is documented further in Figure 25, with six positions shown associated with the hexagonal flats of the head. The views are numbered 1 through 6 for identification purposes. Close views of the threads are shown in Figure 26, with the same clock positions as indicated in Figure 25. Thread deformation between the cotter pin hole and the tip of the bolt is documented in Figure 27. A remnant of a stripped nut thread was observed with the bolt thread immediately adjacent to the grip. An image of the top of the bolt head in the as-received condition is shown in Figure 29. For evidence preservation purposes, the paint coating was not removed.

Figure 24 The as-received left main landing gear upper and lower torque arm pieces along with a cotter pin and a bolt.

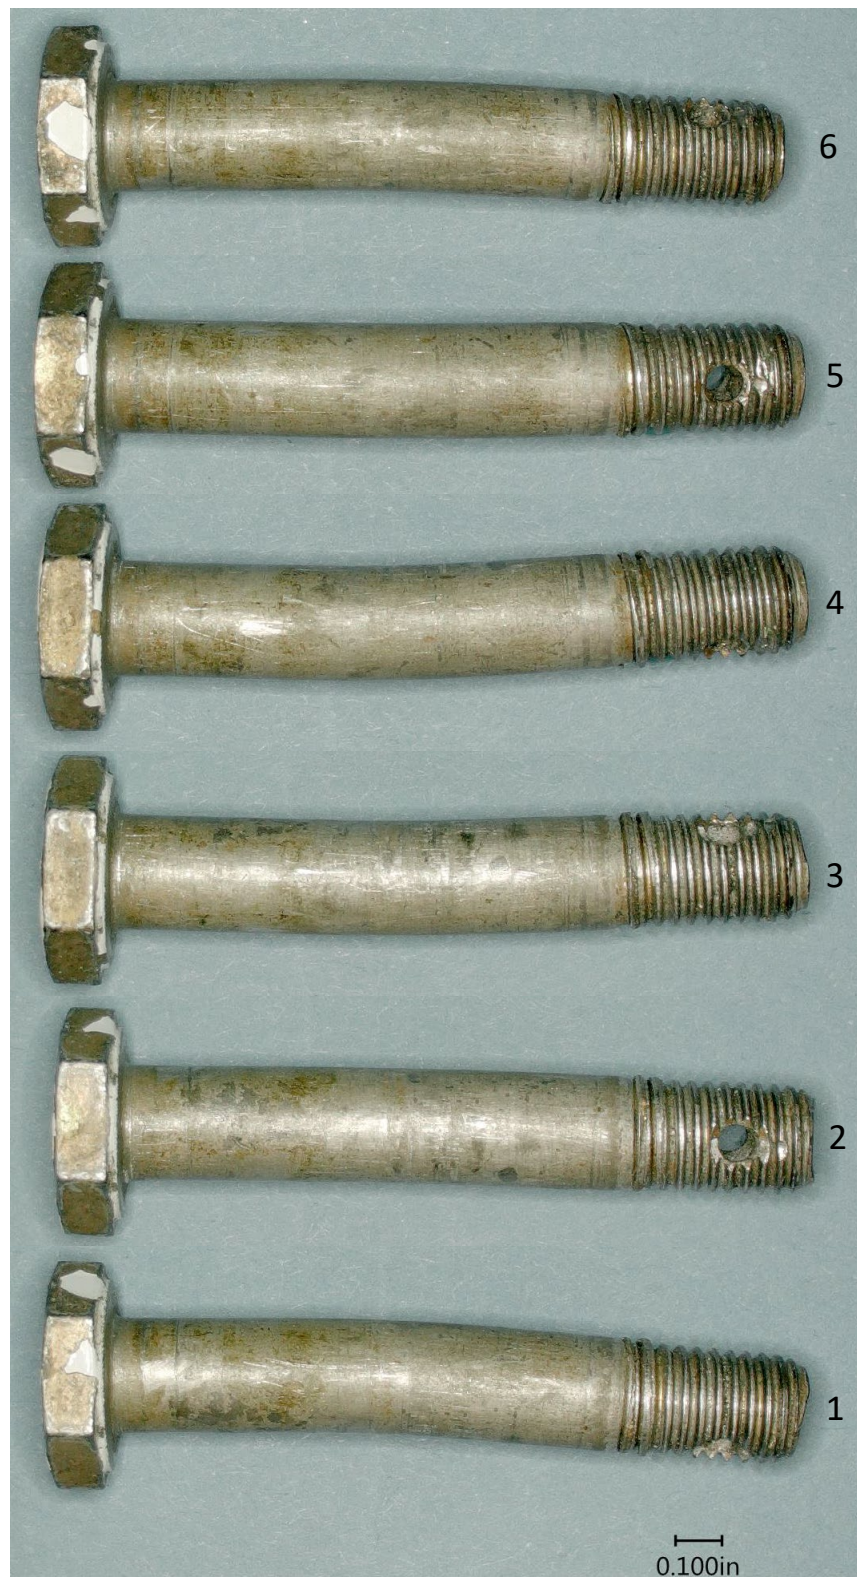
Figure 25 Digital microscope images of the pivot bolt between the left main landing gear upper and lower torque arm pieces.

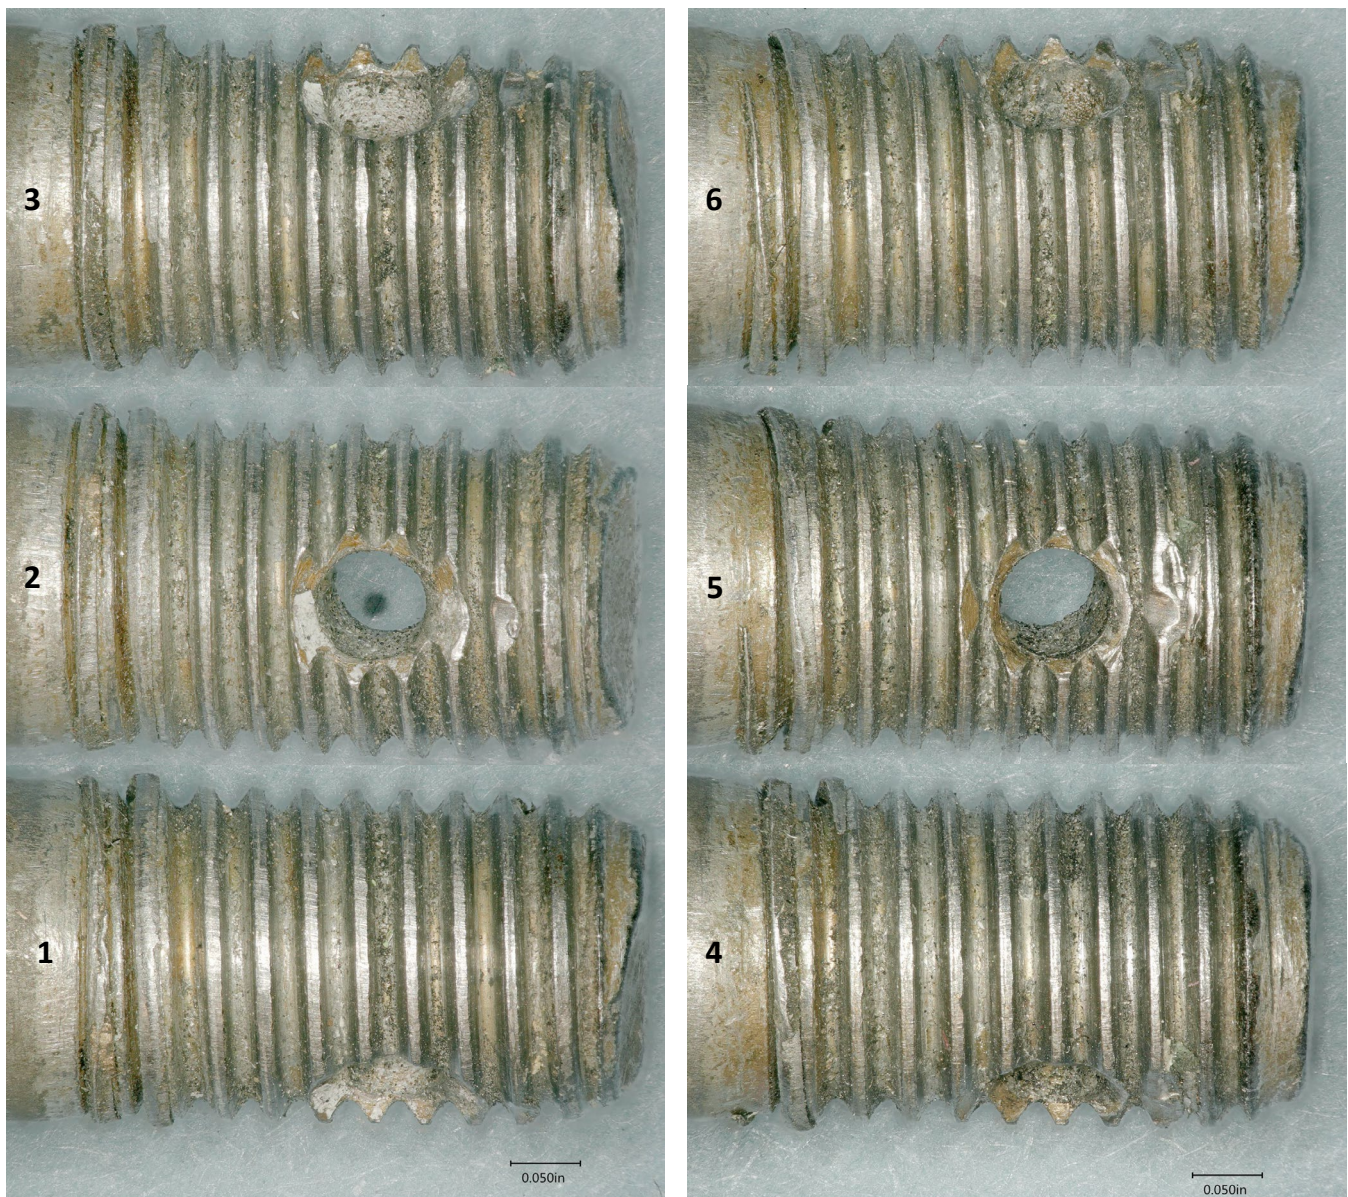
Figure 26 Digital microscope images of the threads in Figure 24.

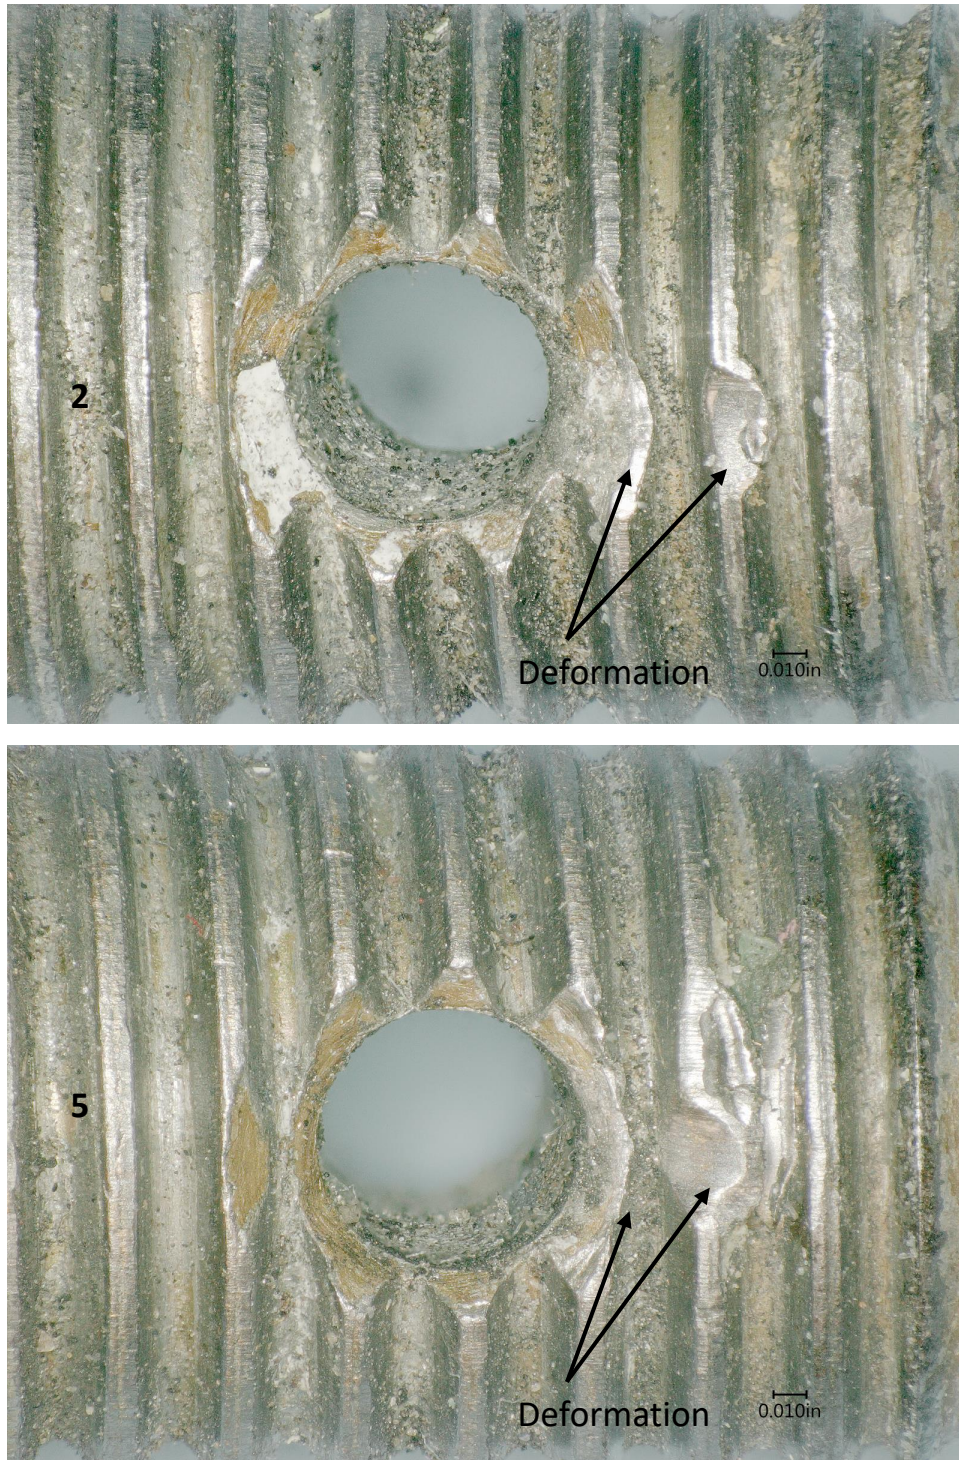
Figure 27 Digital microscope images showing close views of deformation to the threads (see Figures 25 and 26 for orientation).
