# NATIONAL TRANSPORTATION SAFETY BOARD

## MATERIALS LABORATORY FACTUAL REPORT

Report No. 21-012

Place : Titusville, Florida  
Date : 07/03/2020  
Vehicle : Piper PA-46-600TP (N89MA)  
NTSB No. : ERA20LA237  
Investigator : Lynn Spencer

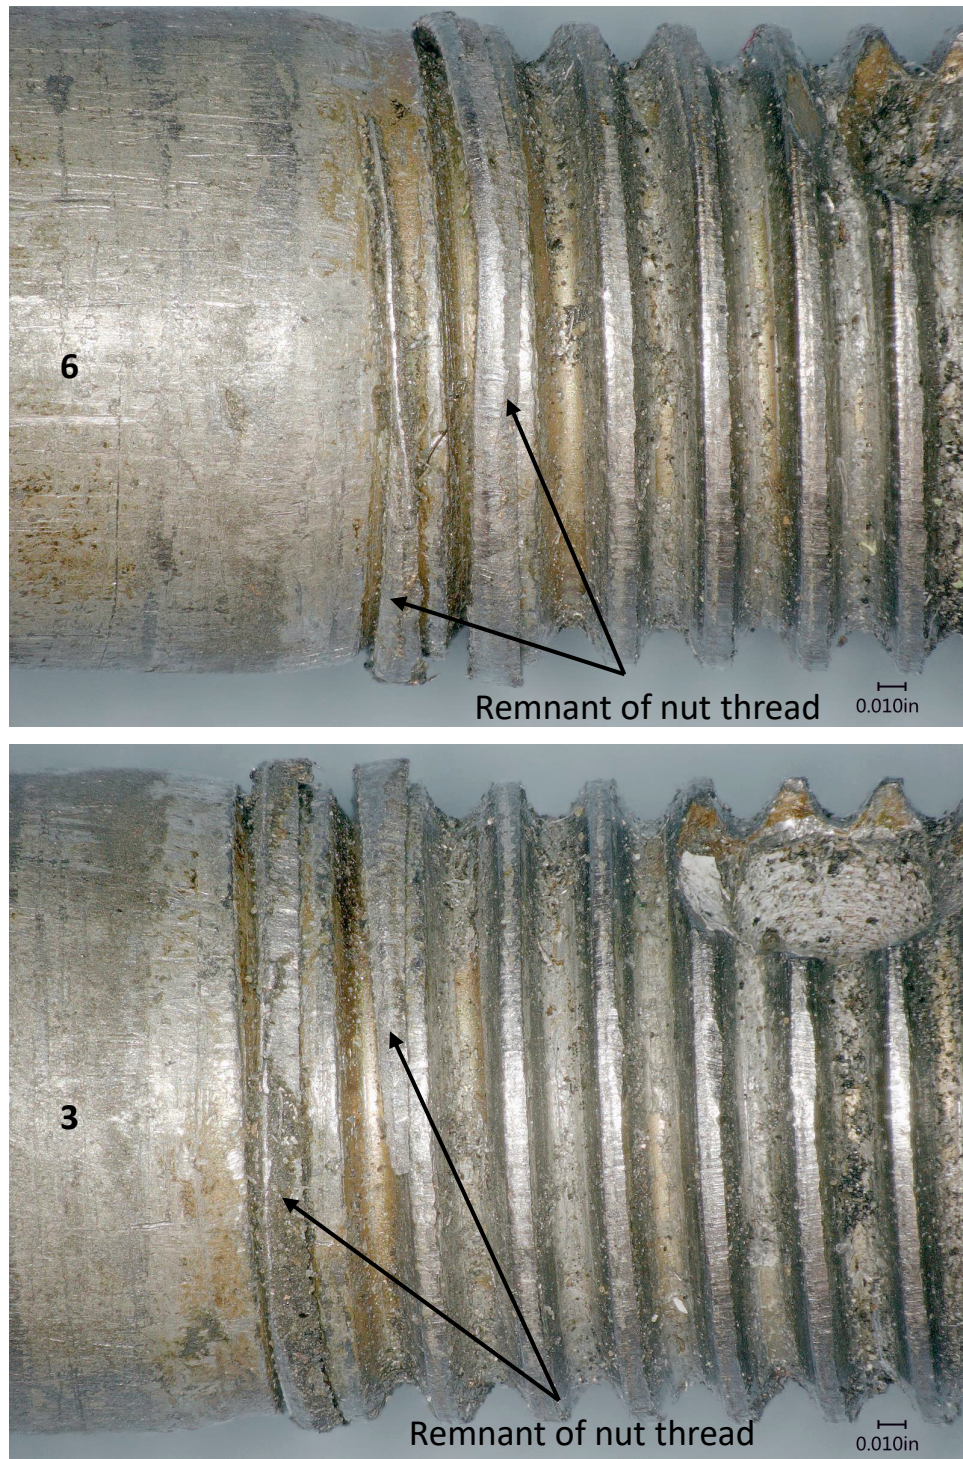
The as-received left main landing gear upper and lower torque arm pieces along with a cotter pin and a bolt are shown in Figure 24. The submitted bolt was the pivot between the upper and lower torque arms. It was found at the accident site with the nut and cotter pin missing. The pivot bolt is documented further in Figure 25, with six positions shown associated with the hexagonal flats of the head. The views are numbered 1 through 6 for identification purposes. Close views of the threads are shown in Figure 26, with the same clock positions as indicated in Figure 25. Thread deformation between the cotter pin hole and the tip of the bolt is documented in Figure 27. A remnant of a stripped nut thread was observed with the bolt thread immediately adjacent to the grip. An image of the top of the bolt head in the as-received condition is shown in Figure 29. For evidence preservation purposes, the paint coating was not removed.

Figure 28 Digital microscope images showing remnants of nut threads within the bolt threads. See Figures 24 and 25 for orientation.

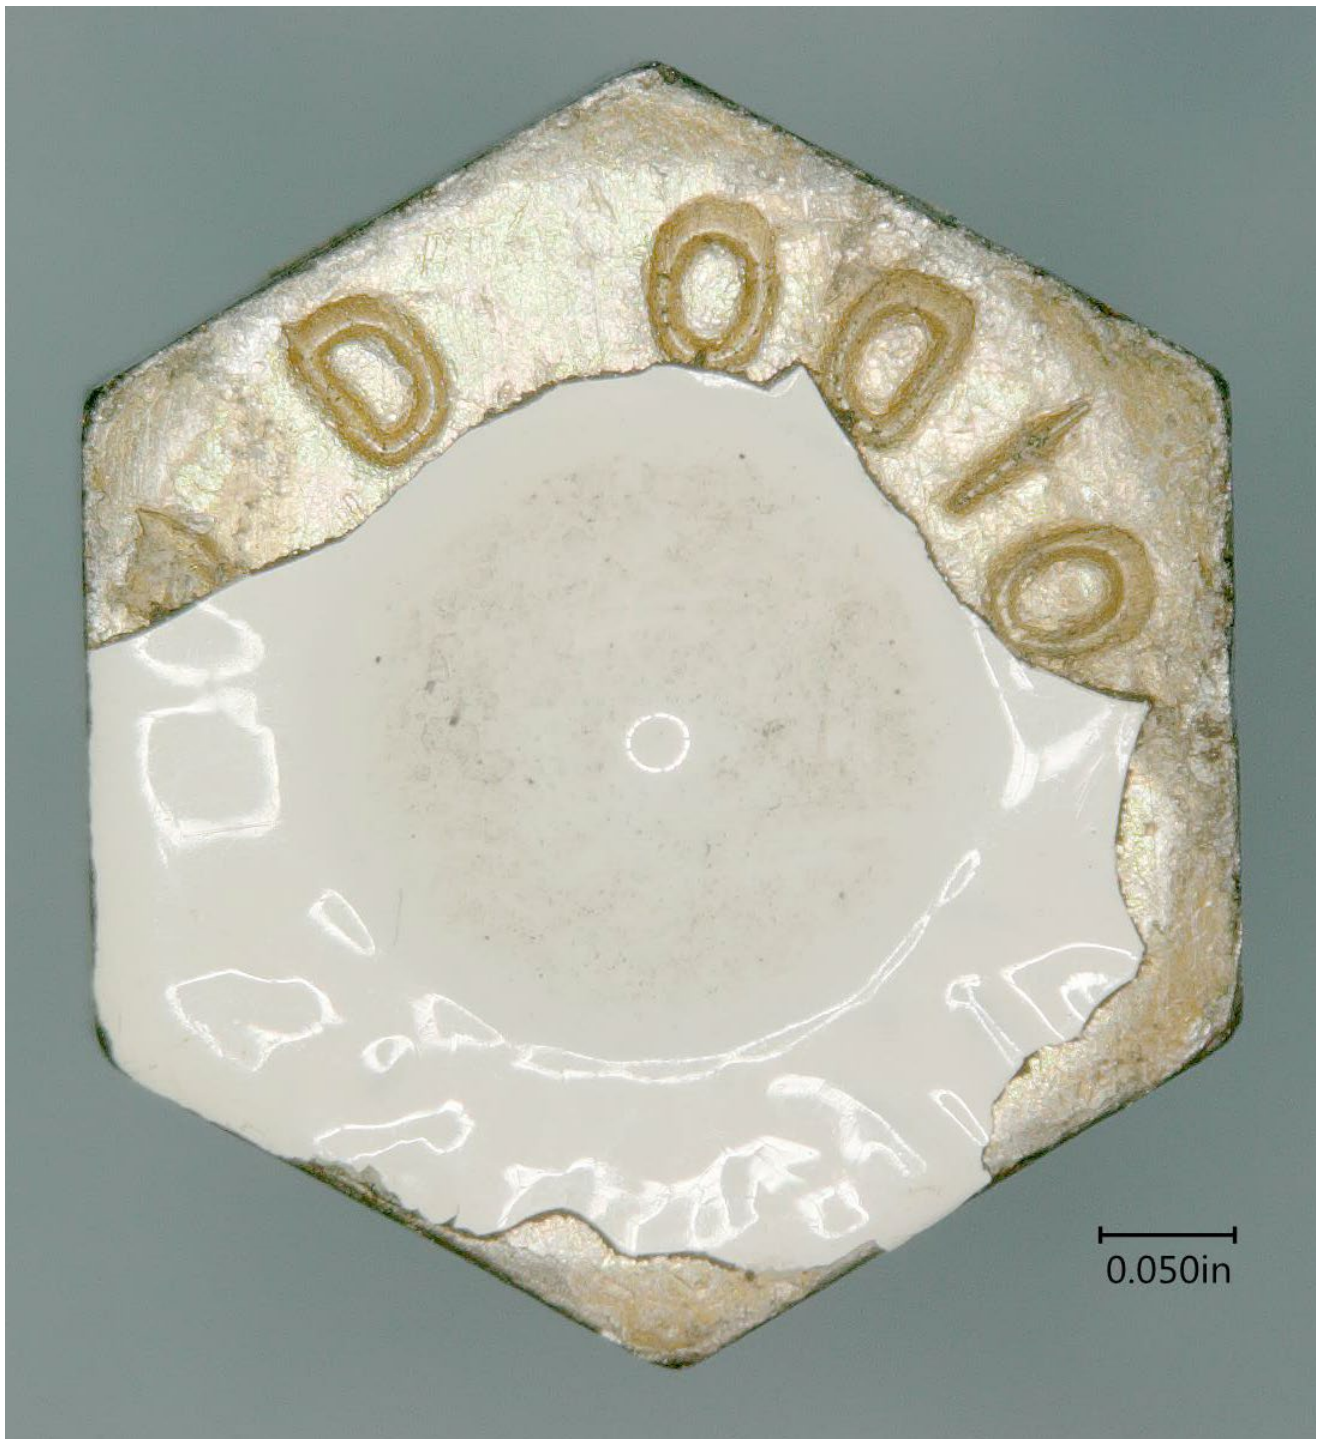
Figure 29 Top view of the pivot bolt in Figure 24.
