## RECORD OF CONVERSATION

**Date: September 2, 2020**  
**Person Contacted: Ronald D. Redmon**  
**NTSB Accident Number: ERA20LA245**

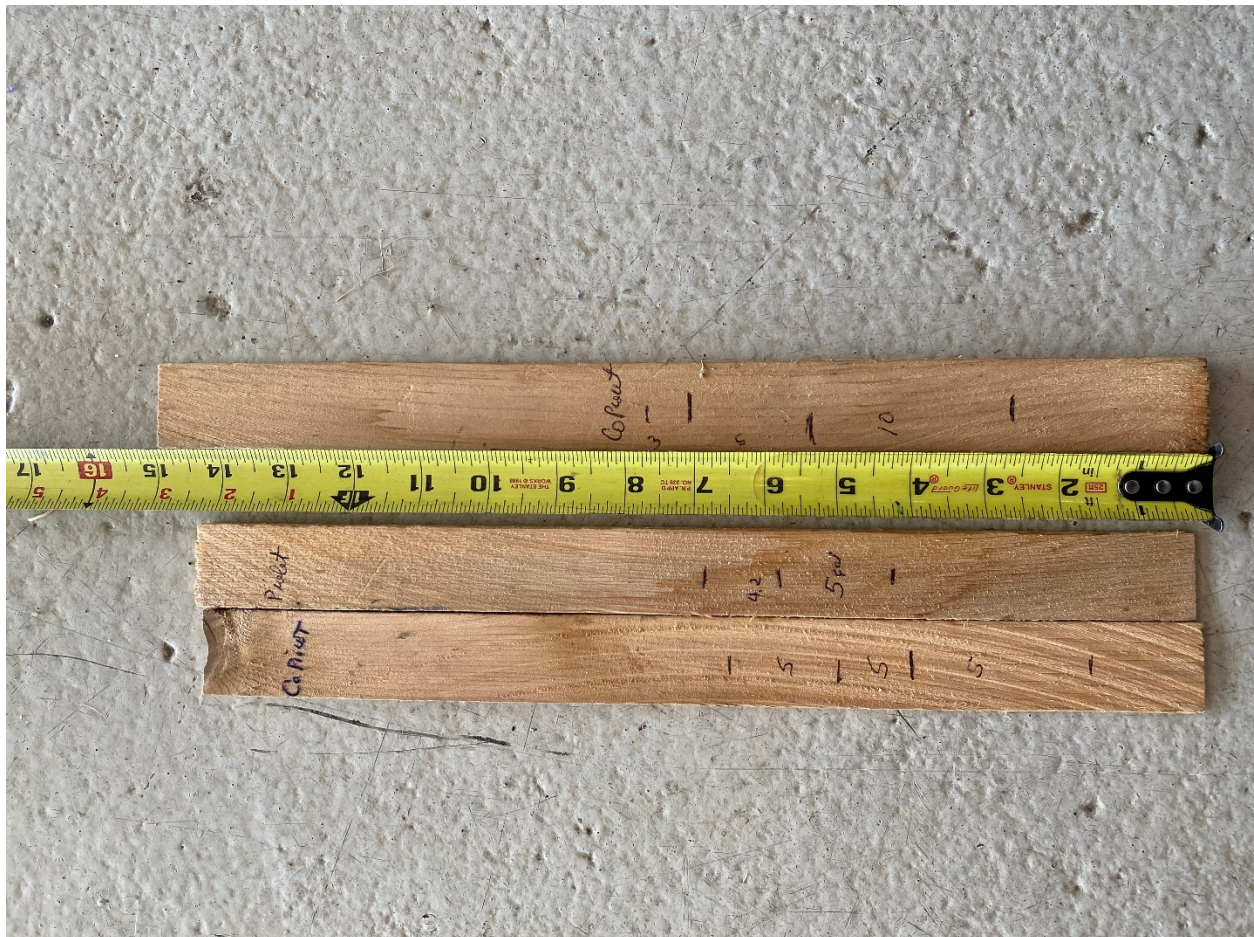
On the same day at 1031 EDT, Mr. Redmon was e-mailed 2 pictures of the three wooden fuel dipsticks found in the airplane and asked to clarify which dipstick he used. He was also asked in an e-mail on March 10, 2021, to clarify what photograph and dipstick he used. He replied by e-mail on March 11, 2021 at 0507 EST by attaching a single photograph captioned, "Photo Taken by Chris F 8 25 2020 Same as Acc Site Pic by FAA[1848].jpg" with verbiage, "Good morning Timothy, Attached is the photo I was referring to. I believe the dipstick on the bottom of this photo was the one I used. The only one I found in the pocket in the back of the pilots seat during my pre-flight. Ron Redmon."

Figure 1: Photograph provided by Pilot March 11, 2021 and labeled, "Photo Taken by Chris F 8 25 2020 Same as Acc Site Pic by FAA[1848].jpg"

The digest was e-mailed to him for review on September 2, 2020. He replied on September 9, 2020, at 1925 EDT with, "Tim, I reviewed the conversation and don't have any further comments or concerns other than the fuel dipstick I "believed" I used was the one on the bottom of the other photo labeled "FAA[1848].jpg." Ron Redmon" The corrected digest was e-mailed to him on March 11, 2021.
