**Cessna 177-A**

**N30309**

**NTSB Accident # ERA20LA245**

**FAA Inspector Statement**

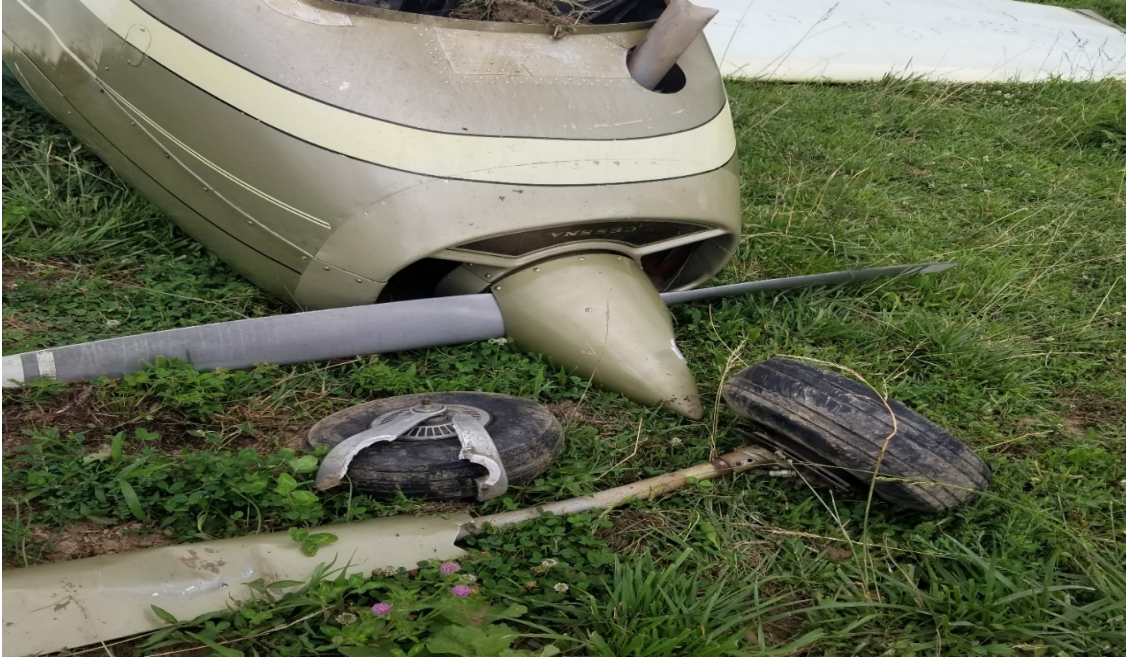
**Propeller:**

The propeller indicated no “S” bending or apparent damage consistent with impact with terrain during rotation, except to the spinner due to impact.

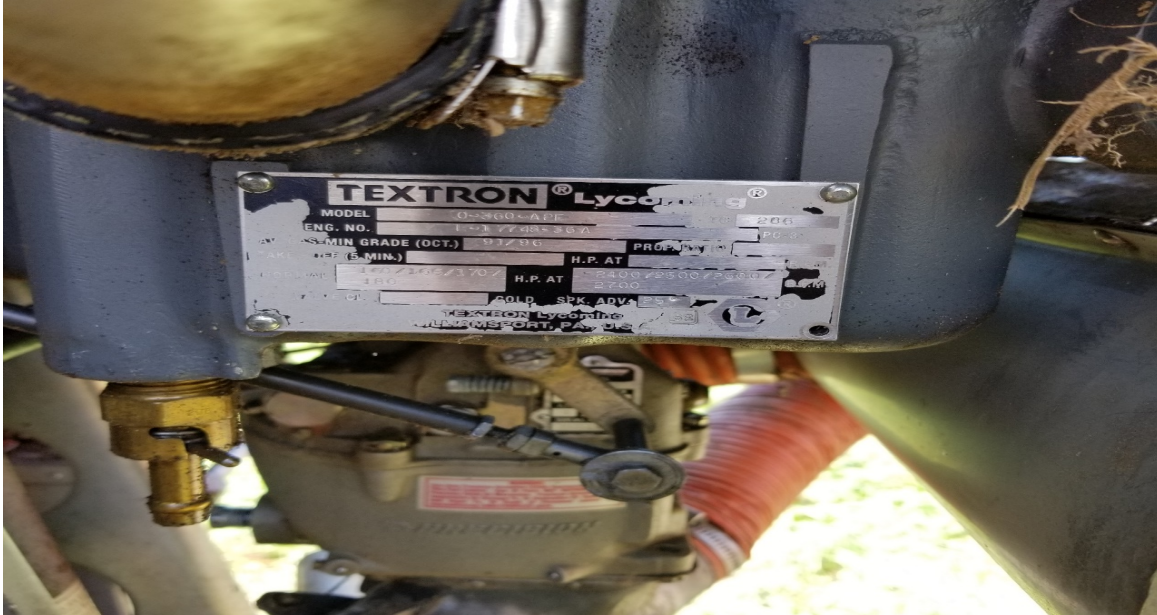
### Engine:

The engine was intact and connected to the mounts. The cowling was still in place, and exhibited minor damage.

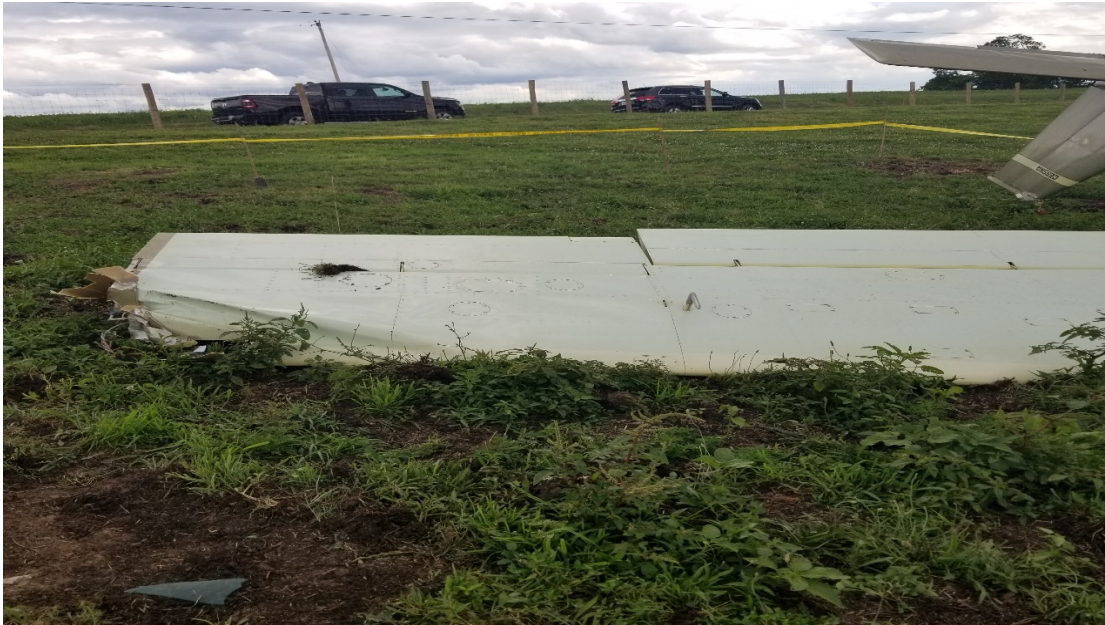
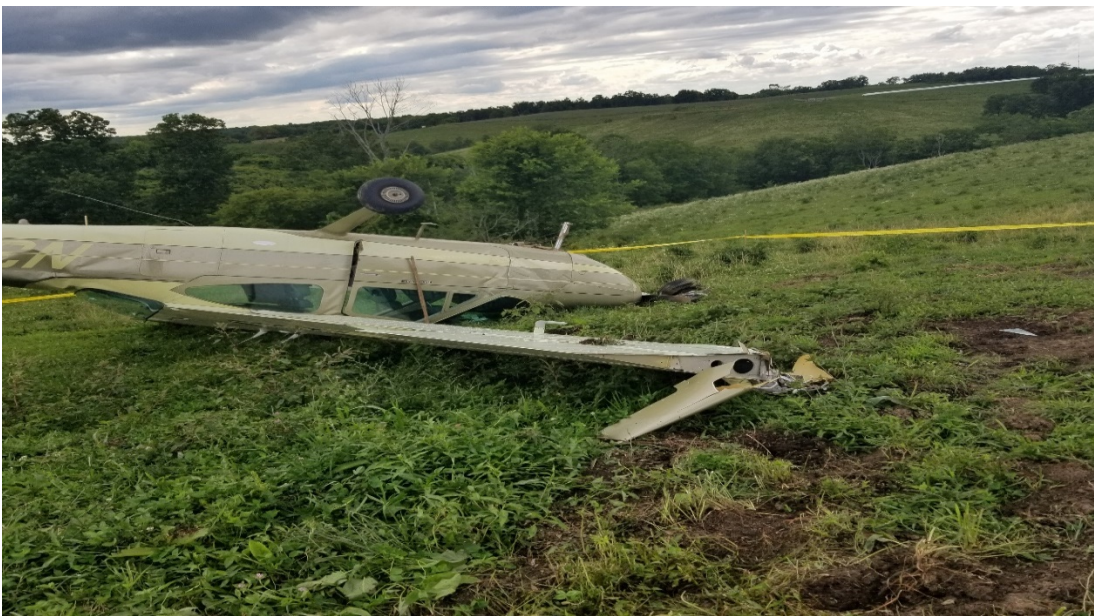
### **Left Wing:**

The Left wing leading edge and outboard section received substantial damaged during impact indicative to a “flip over event.” Due to the wing being inverted, fuel tank level could not be determined. However, no visual evidence of fuel was observed leaking from the wing, fuel cap or vent system. No “browning” or “wilting” of the grass around the wing or engine area was observed.

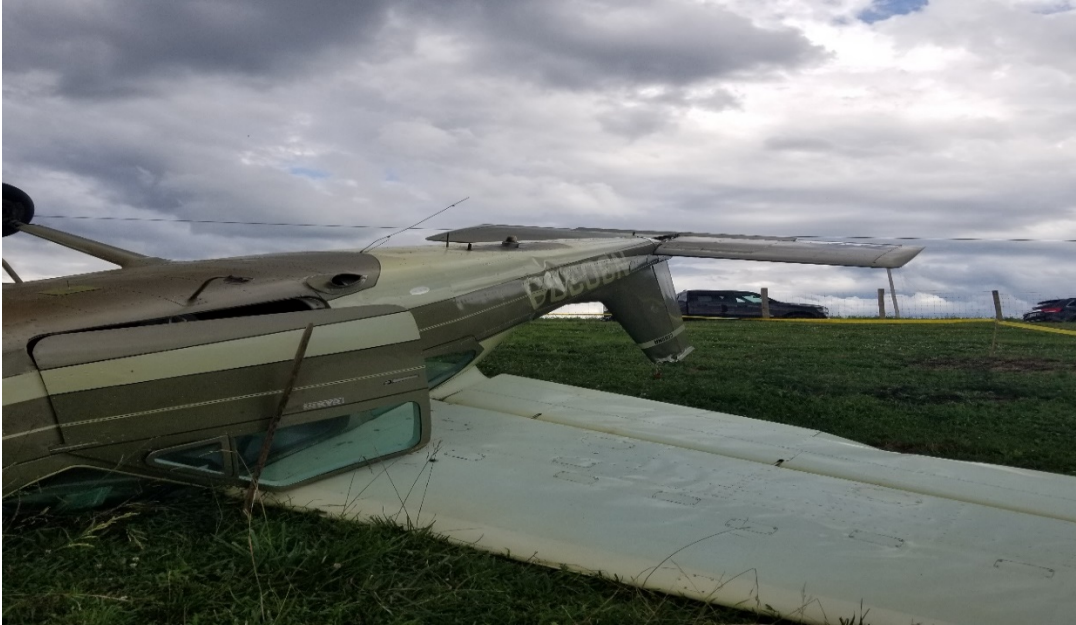
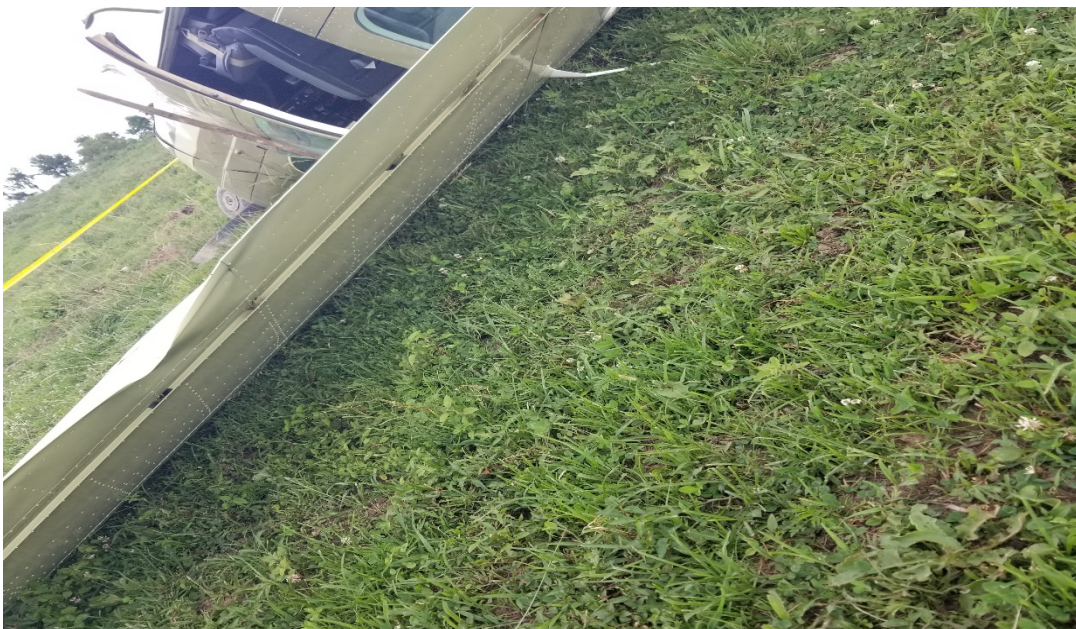
### **Right Wing:**

The Right wing leading edge and outboard section received substantial damaged during impact indicative to a “flip over event.” Due to the wing, being inverted fuel tank level could not be determined. However, no visual evidence of fuel was observed leaking from the wing, fuel cap or vent system. No “browning” or “wilting” of the grass around the wing or engine area was observed.

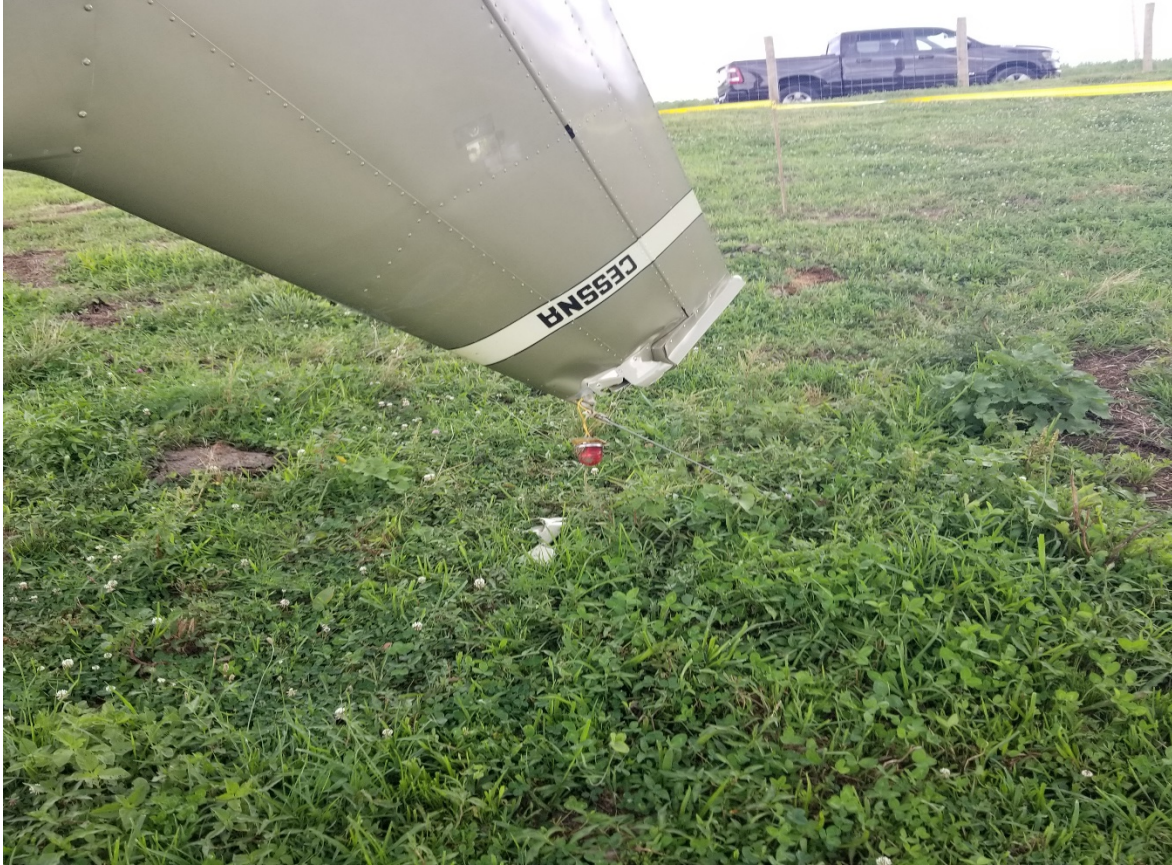
### **Tail Section: (Vertical Fin)**

The Vertical Fin received moderate damage during impact indicative to “flip over event”

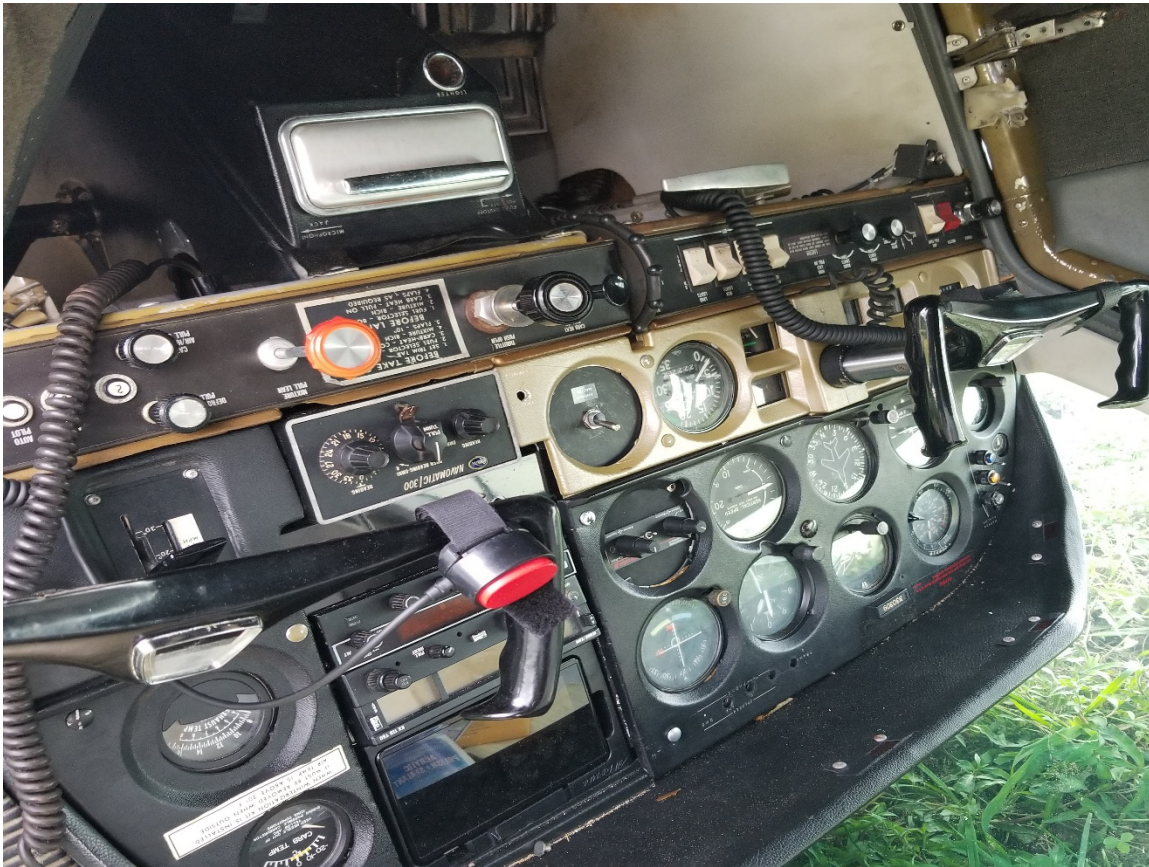
## Cockpit:

The cockpit instrument panel was intact; and did not exhibit distortion or damage due to impact. Continuity of the flight controls was established. Mixture control, carburetor heat and throttle continuity was established.

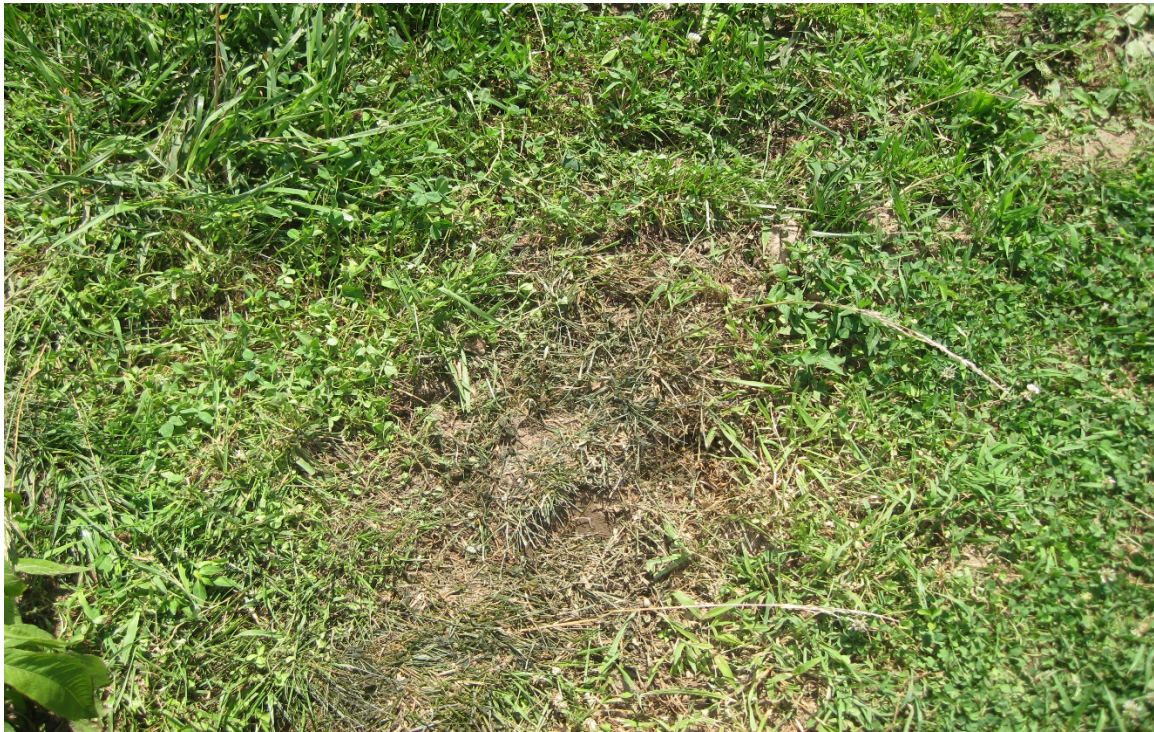
During removal of the wings by AMF Aviation, LLC during the recovery process, it was noted that a very little amount of fuel came out when the B-nuts were loosened on both wings at the fuel tanks. Both wings were removed and up righted, the fuel tanks were observed to comply with Airworthiness Directive (AD) 79-10-14 R1 with vented fuel caps. (See AD Compliance Record Attached) The fuel caps were removed and no fuel was visible in either fuel tank. There was no evidence of fuel leakage in the grass under or around the wings. No “browning” or “wilting” of the grass around the wing areas was observed.

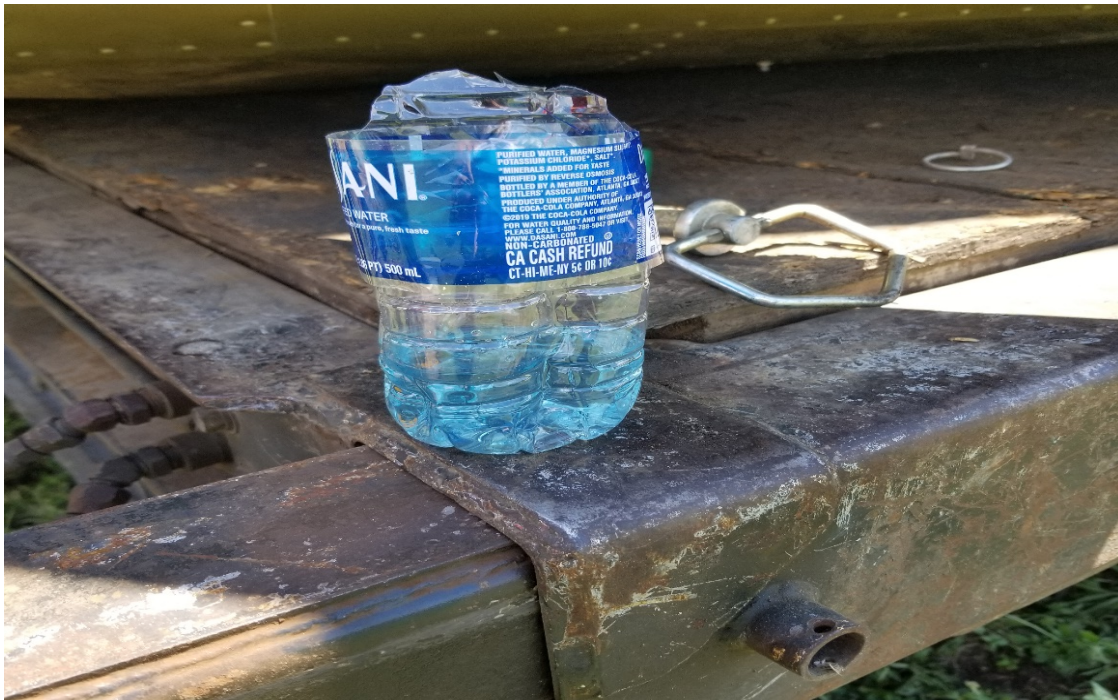
After up righting the aircraft visual observation of the engine indicated no visible damage to the engine due to impact. Rotation of the propeller indicated reasonable compression on each cylinder and the magneto impulse coupling was heard to “snap”. Approximately 2 ounces of fuel consistent with the smell and color of AVGAS was drained from the carburetor float bowl and approximately 4 ounces of fuel drained from the fuel sump on the firewall. No water or contamination noted. *(See AMF Aviation Statement Attached)*
