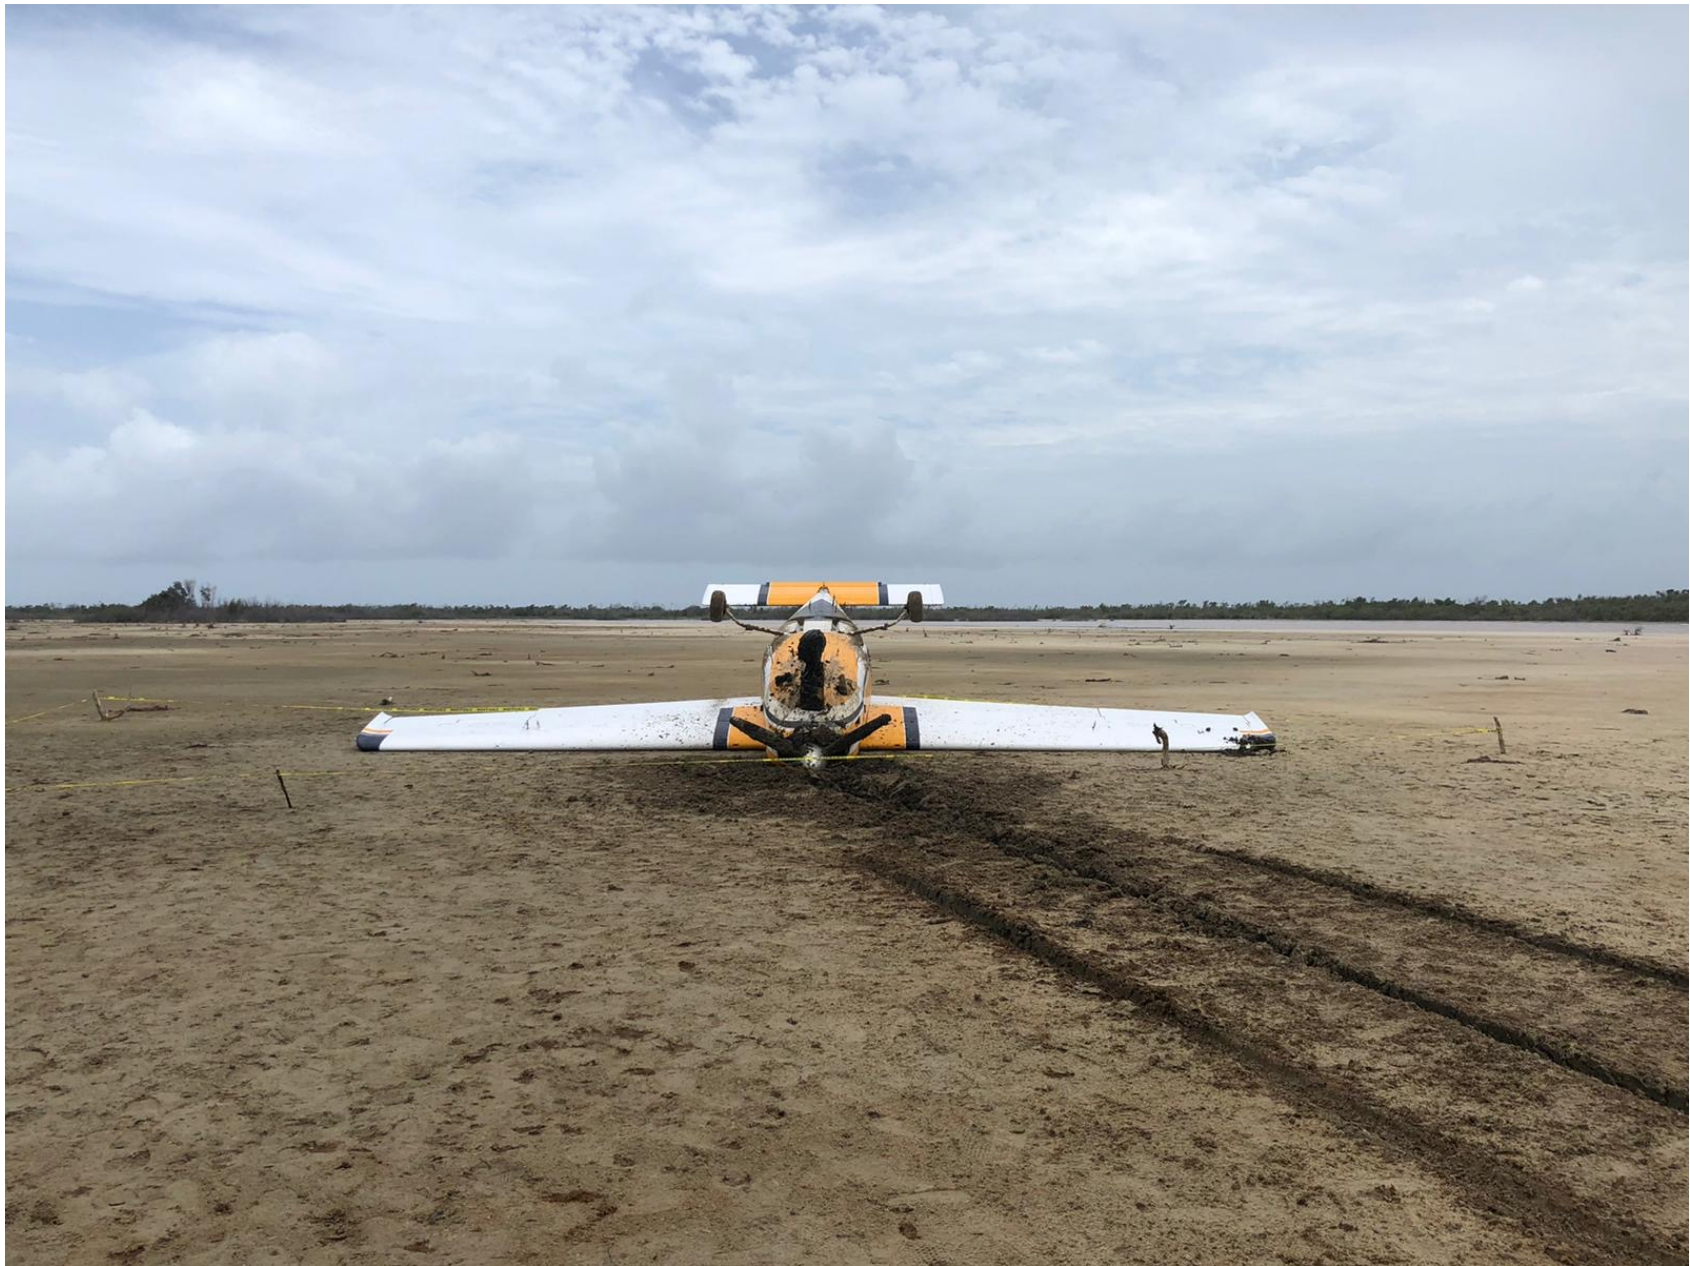
**Photo 1 – FAA Digital Photograph. Frontal View of the Inverted Airplane At the Accident Site.**

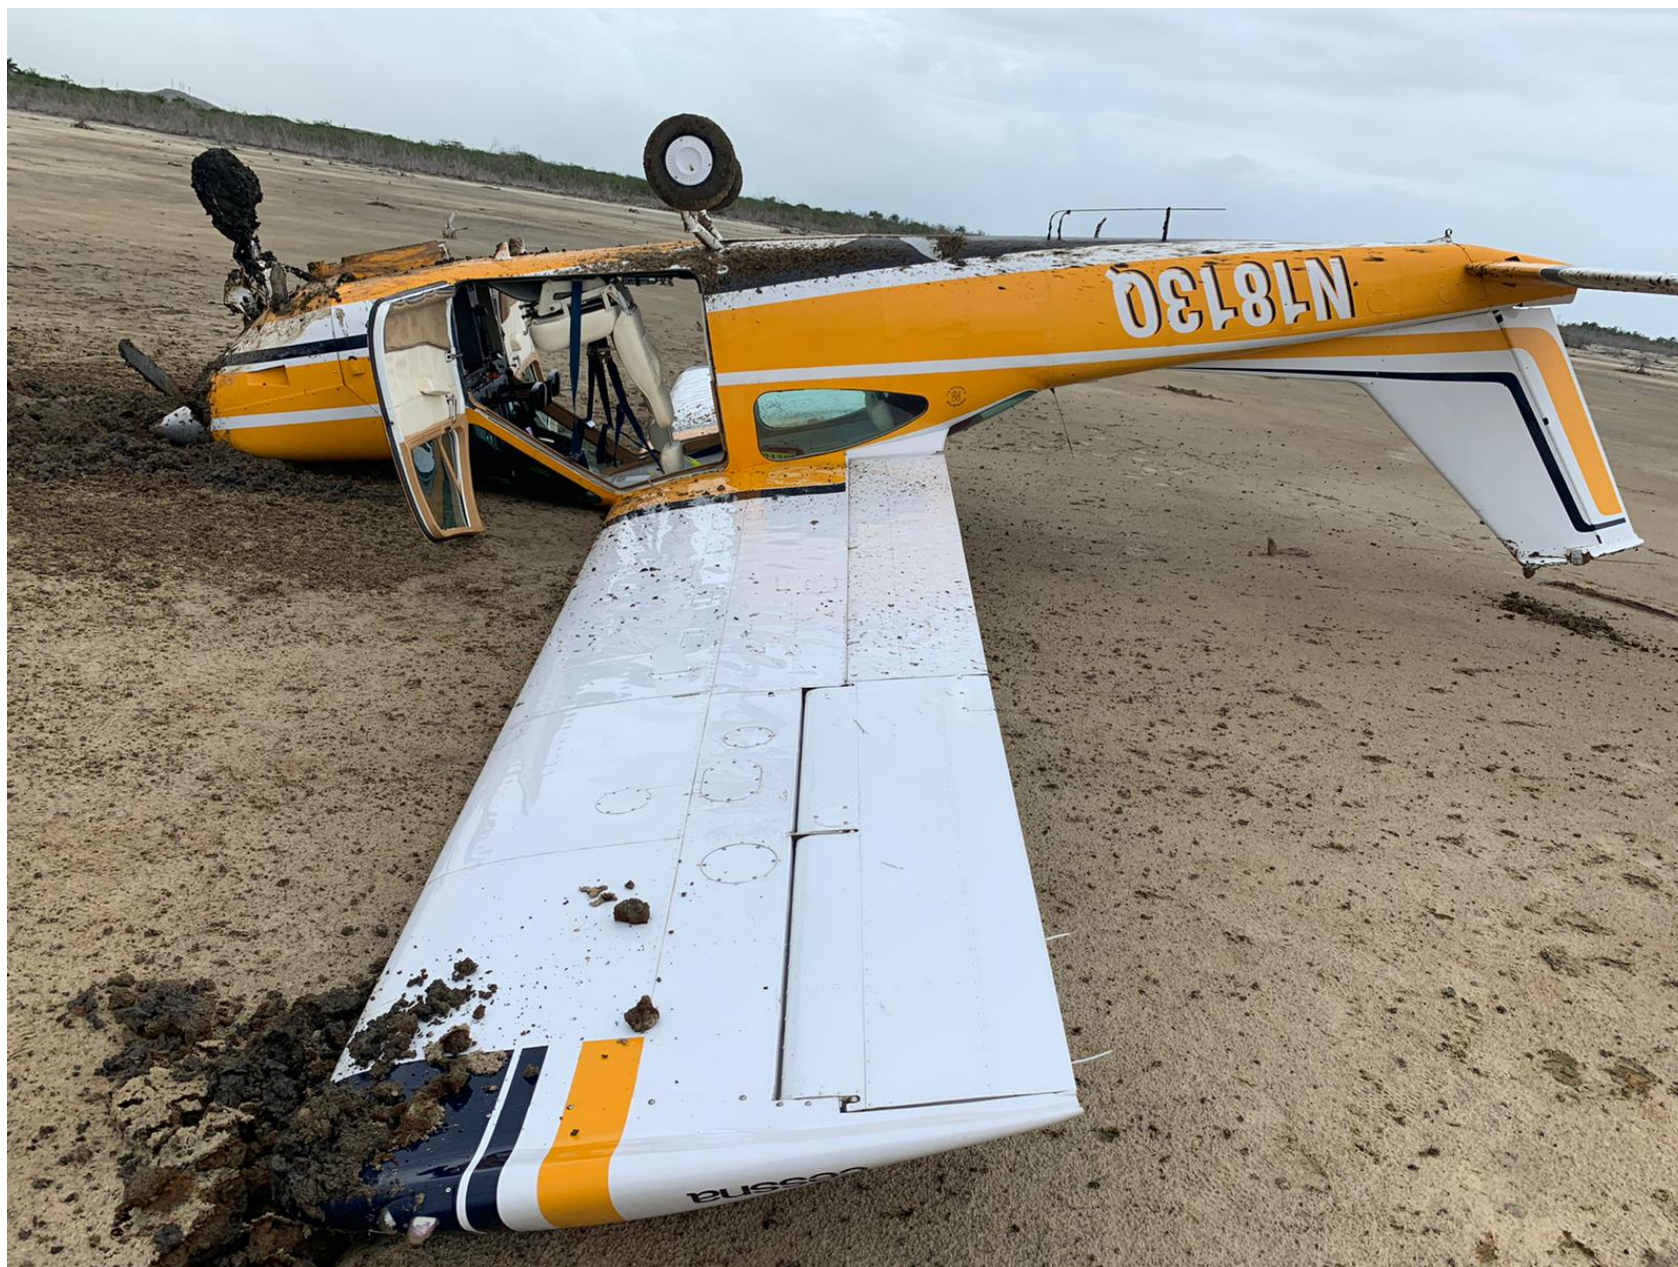
**Photo 2 - FAA Digital Photograph. Right Side View of the Inverted Airplane At The Accident Site.**

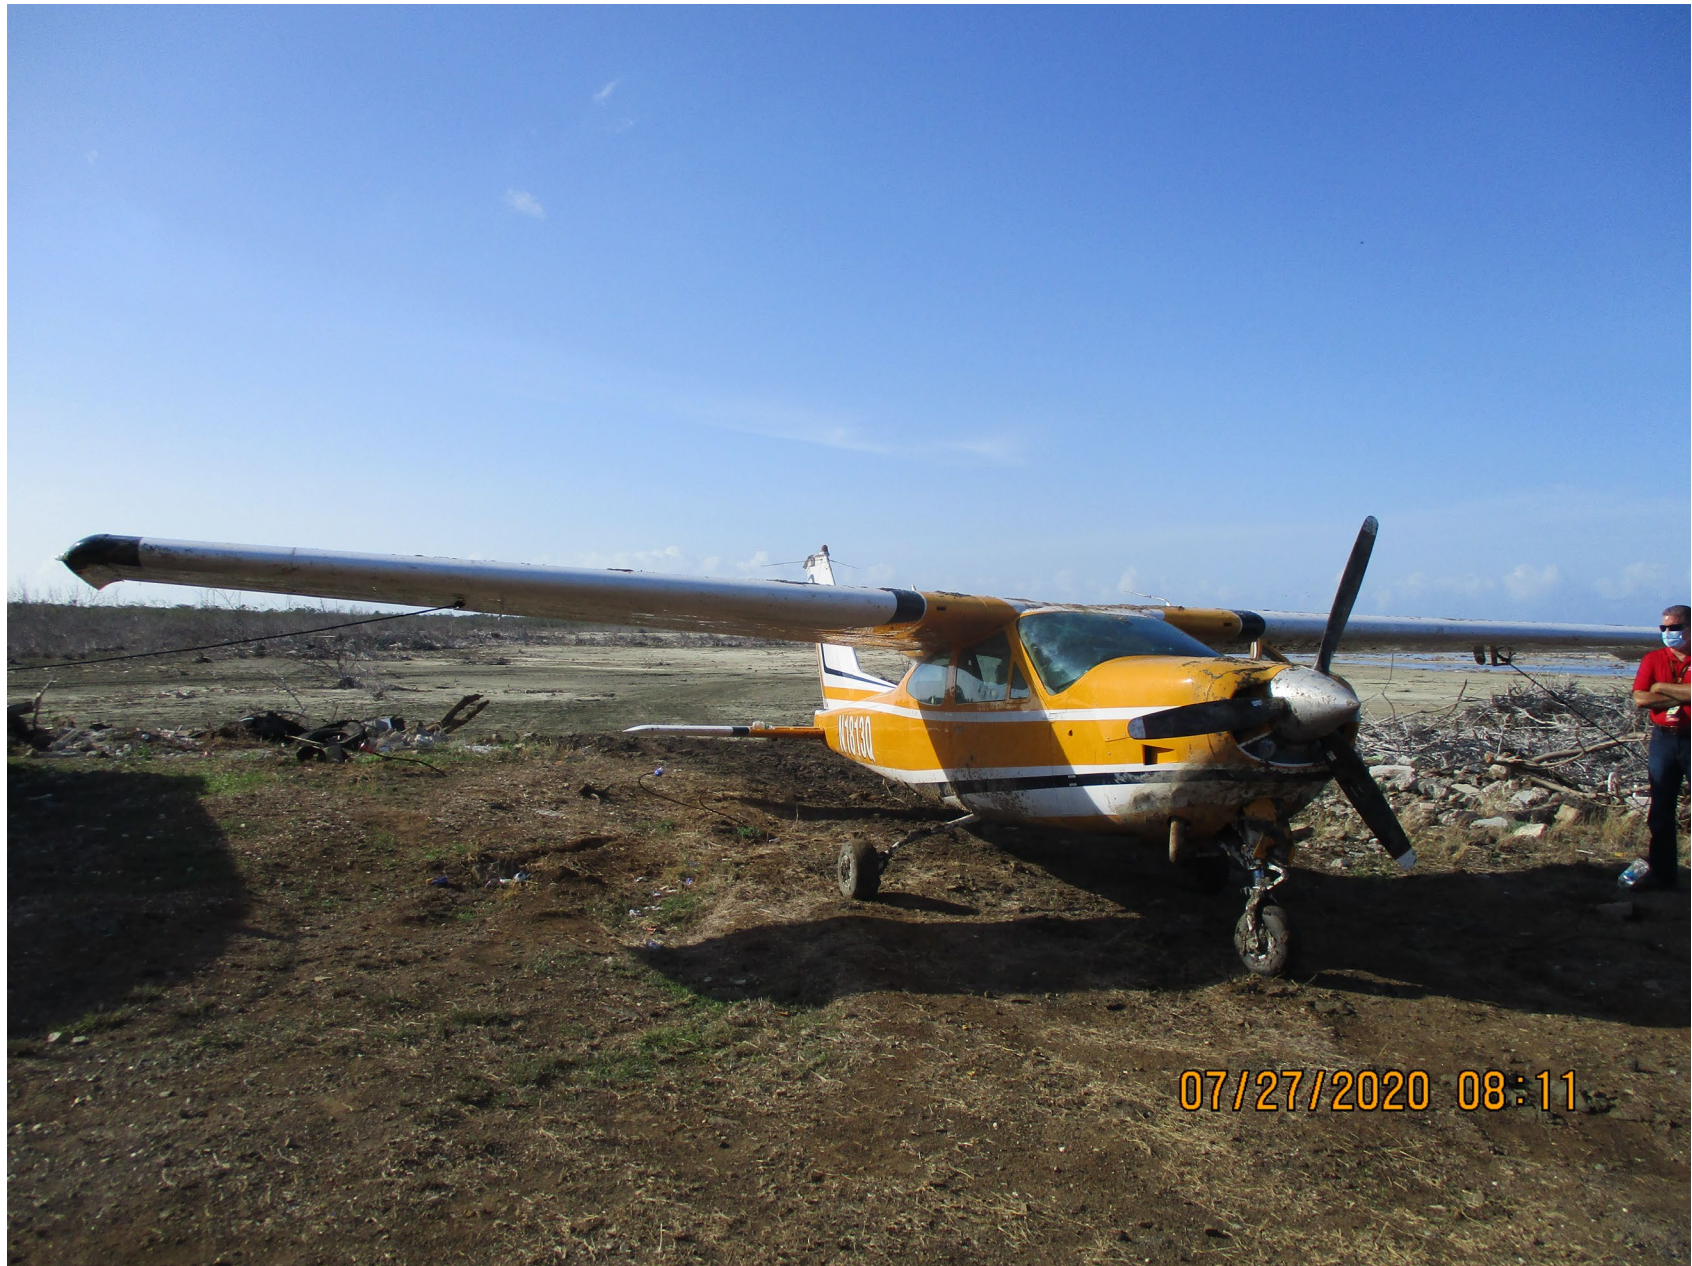
**Photo 3 – FAA Digital Photograph. Right Forward Quartering View of the Airplane Following It Being Uprighted.**

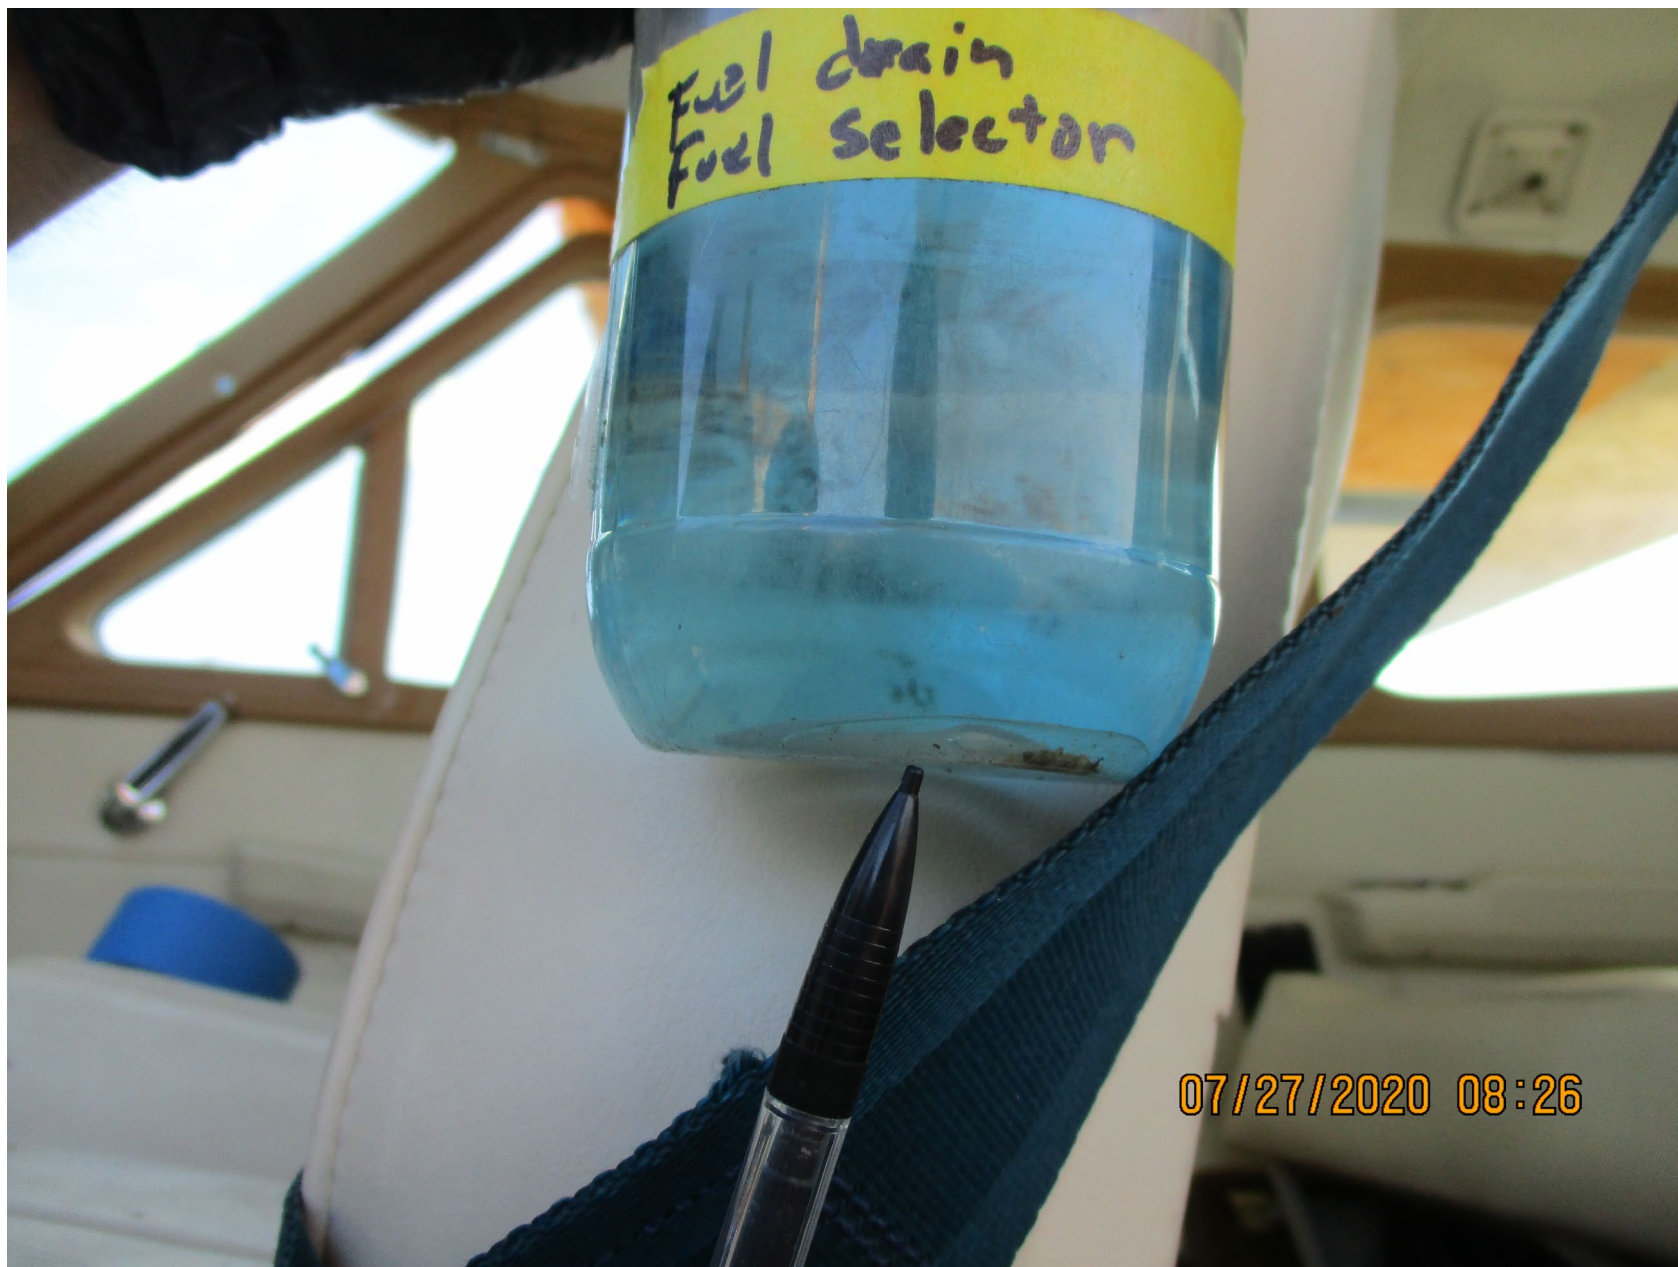
**Photo 4 - FAA Digital Photograph. View of the Fuel Sample Drained From Fuel Reservoir Tank Assembly. Note the Pen Pointing to Water in Sample.**

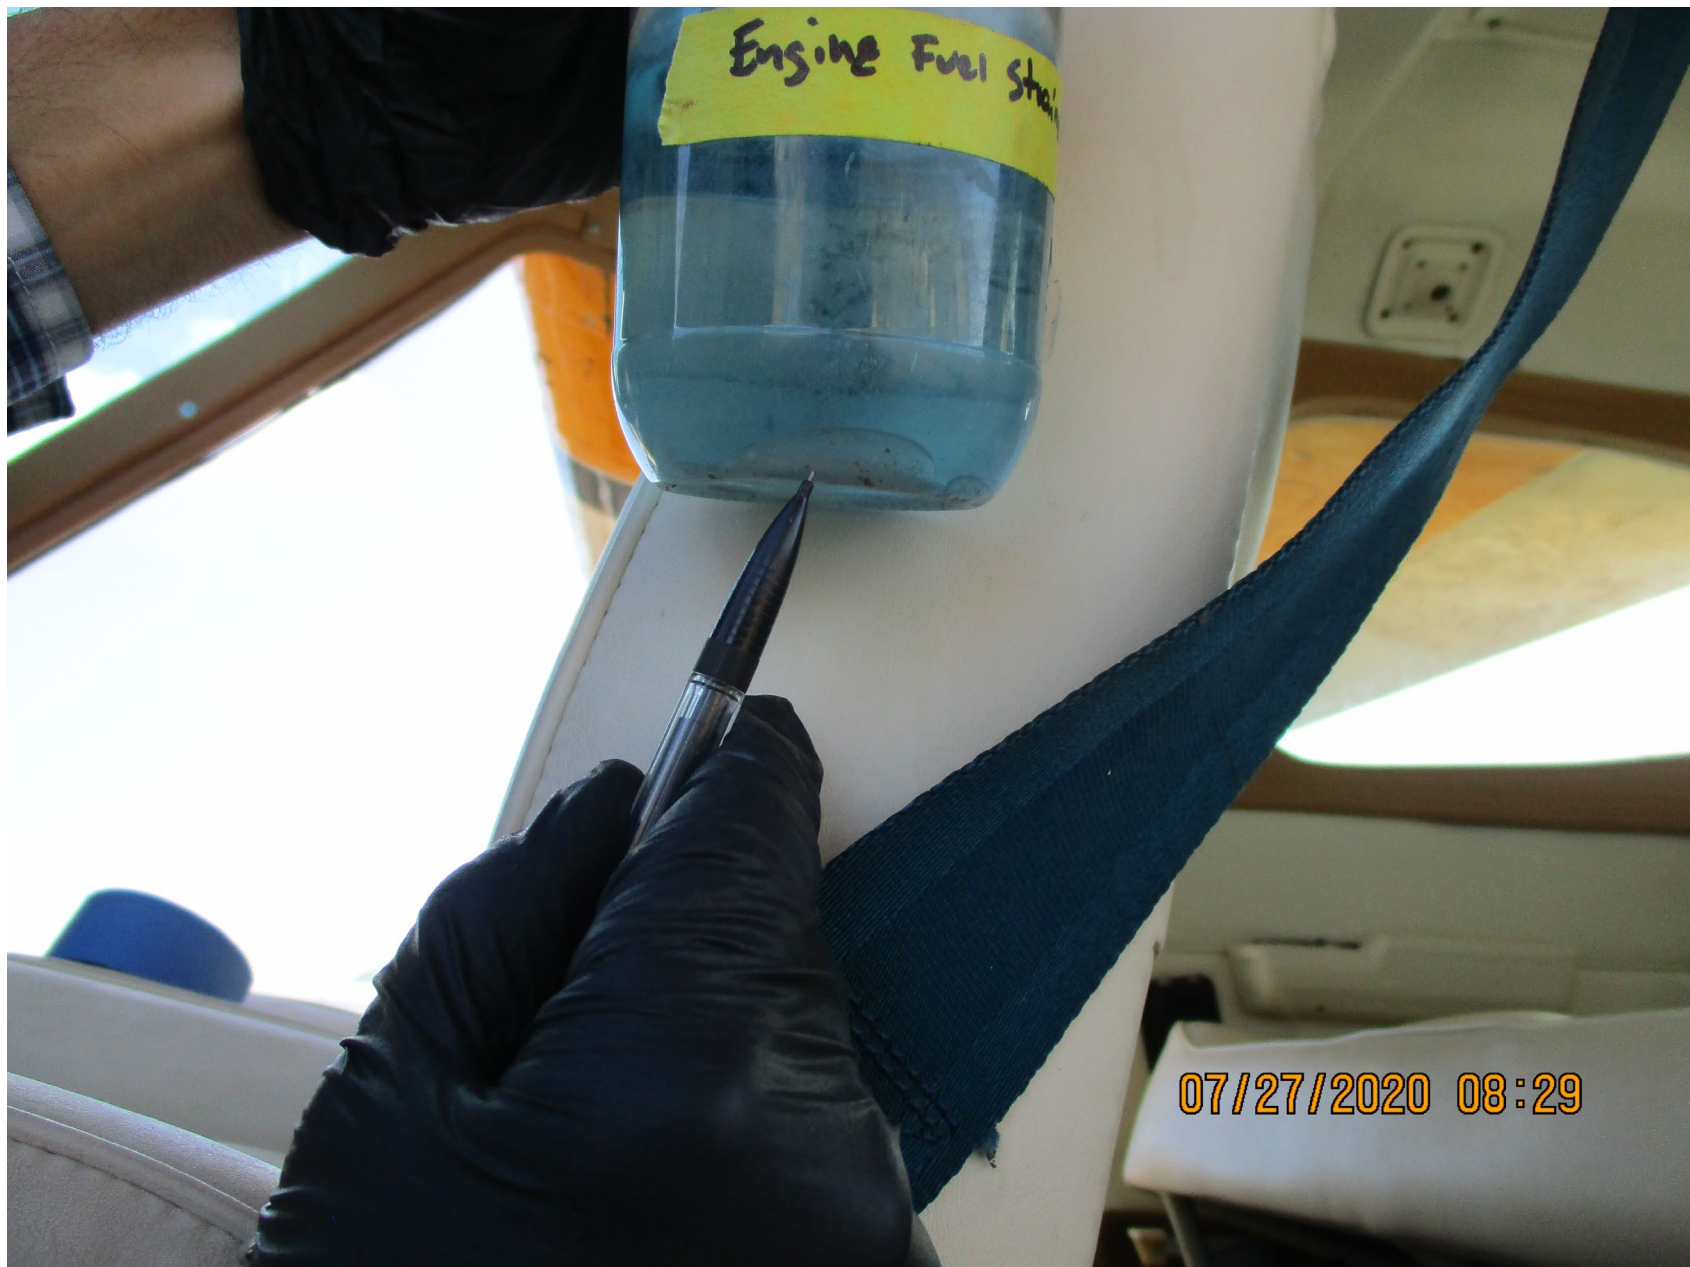
**Photo 5 - FAA Digital Photograph. View of the Fuel Sample Drained From Fuel Strainer. Note the Pen Pointing to Water in Sample.**

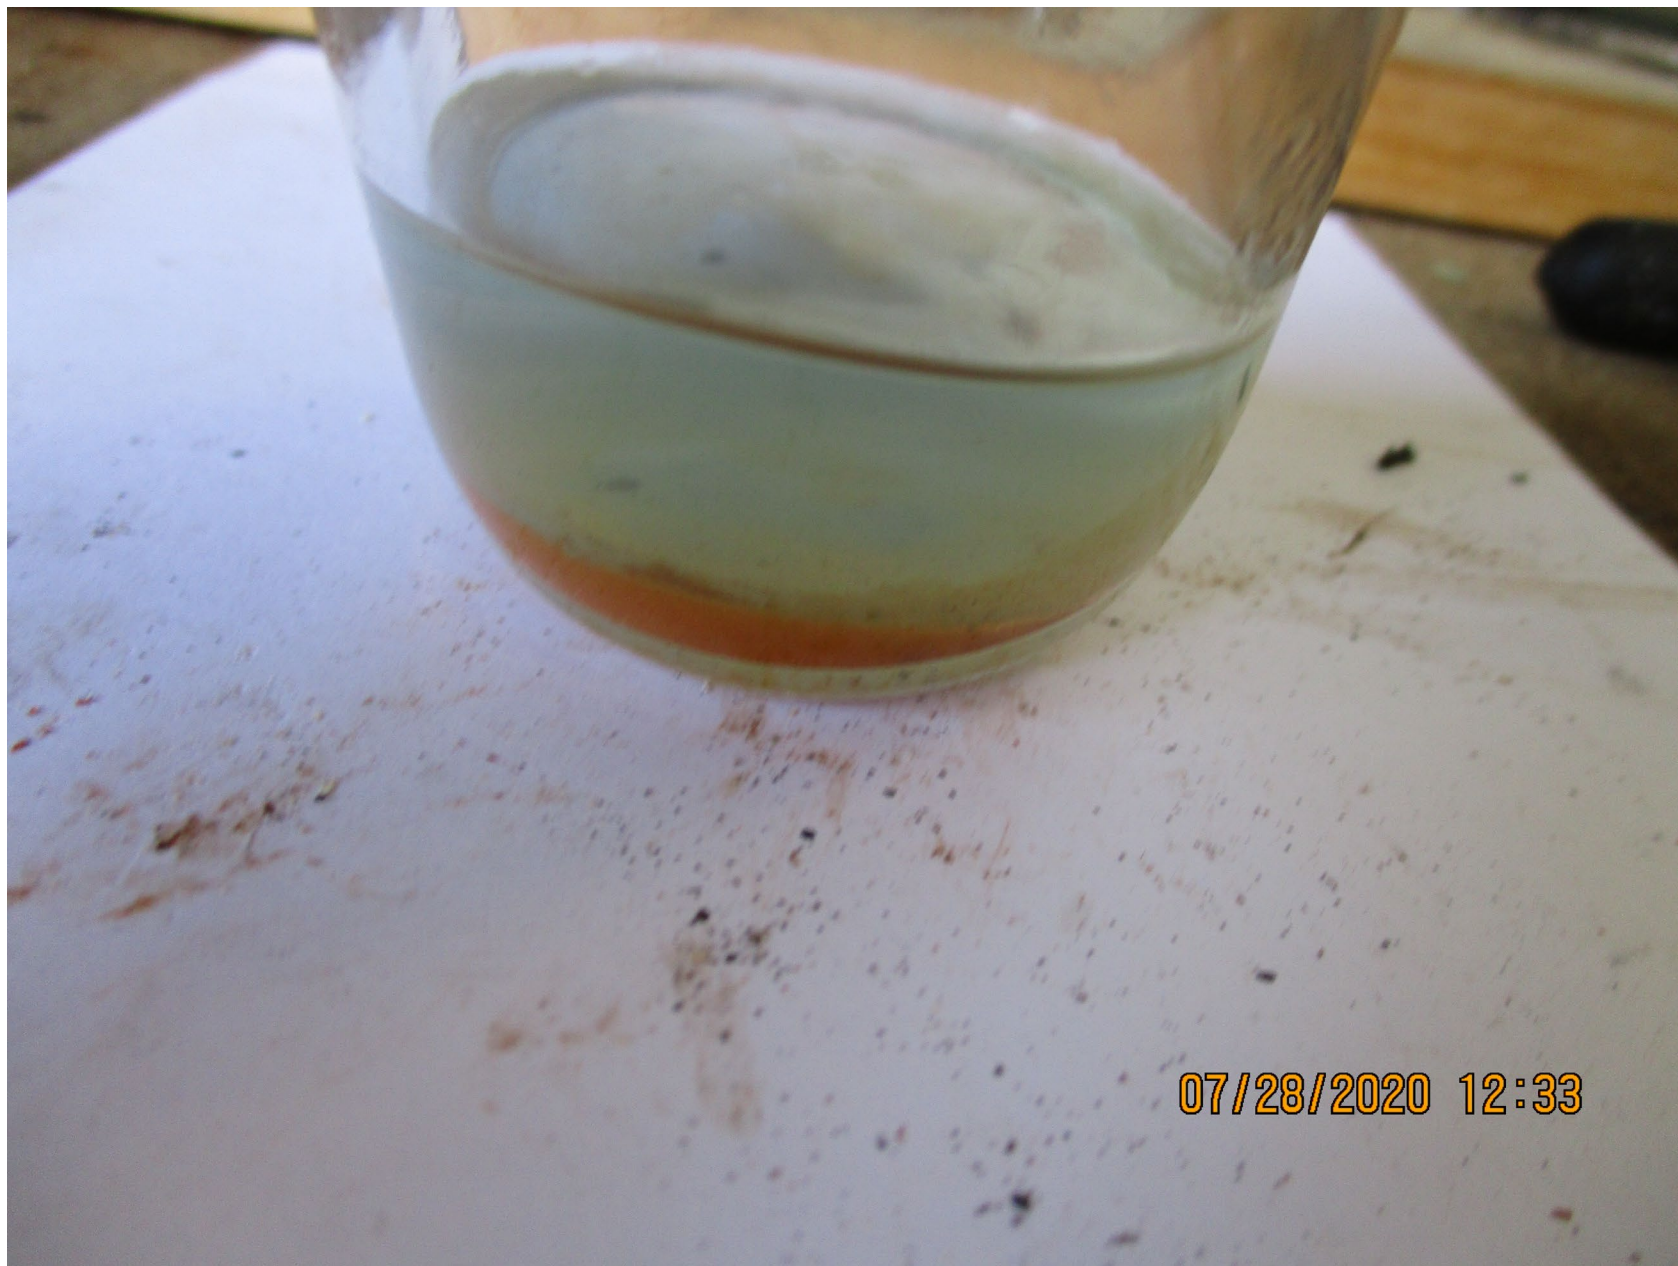
**Photo 6 - FAA Digital Photograph. View of the Fuel Sample Drained From Servo Fuel Injector Inlet. Note the rust Colored Water Contamination in the Bottom of the Sample.**

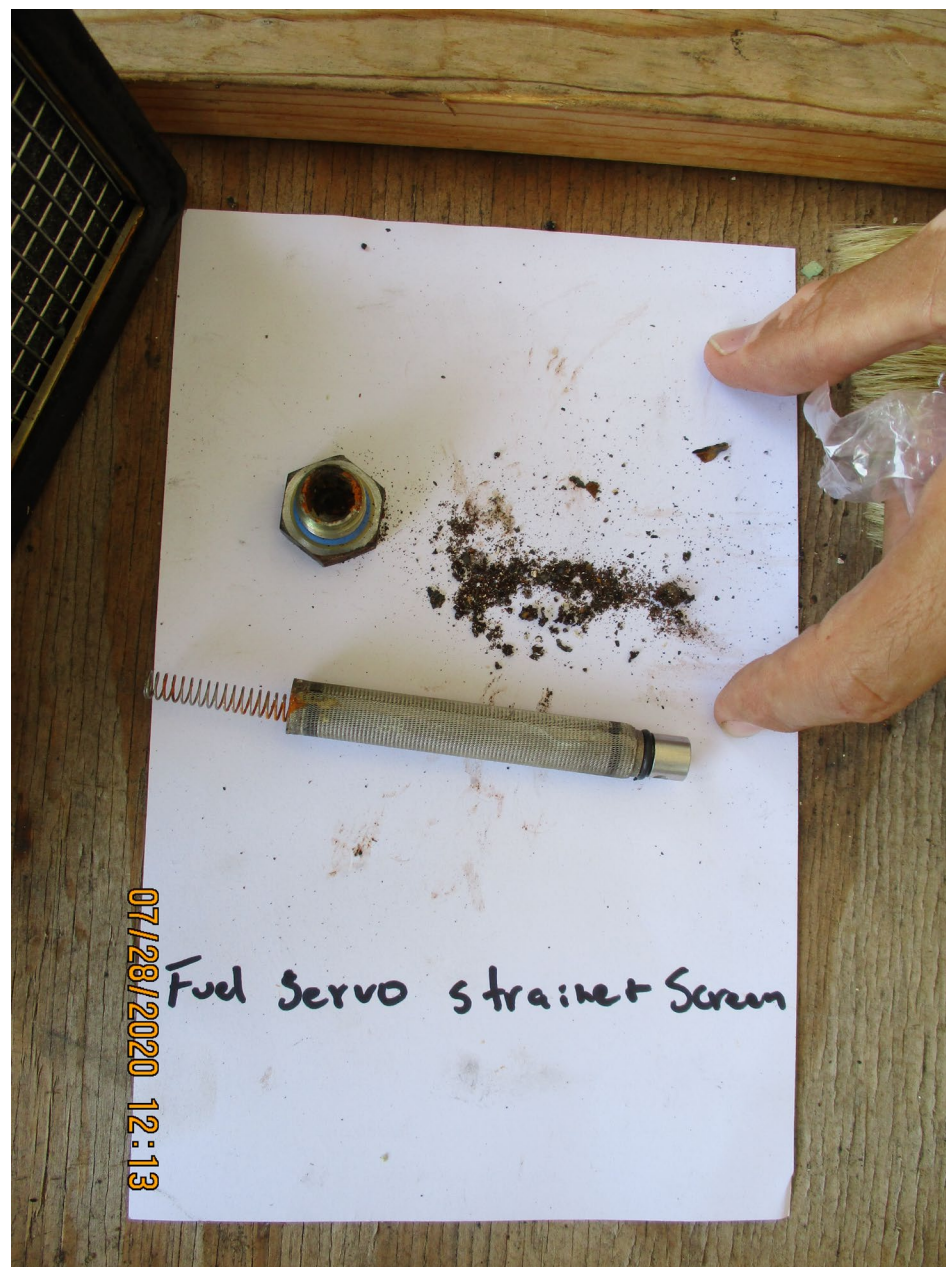
**Photo 7 - FAA Digital Photograph. View of the Ferrous Contaminant Collected From Inside The Servo Fuel Injector Inlet Screen.**

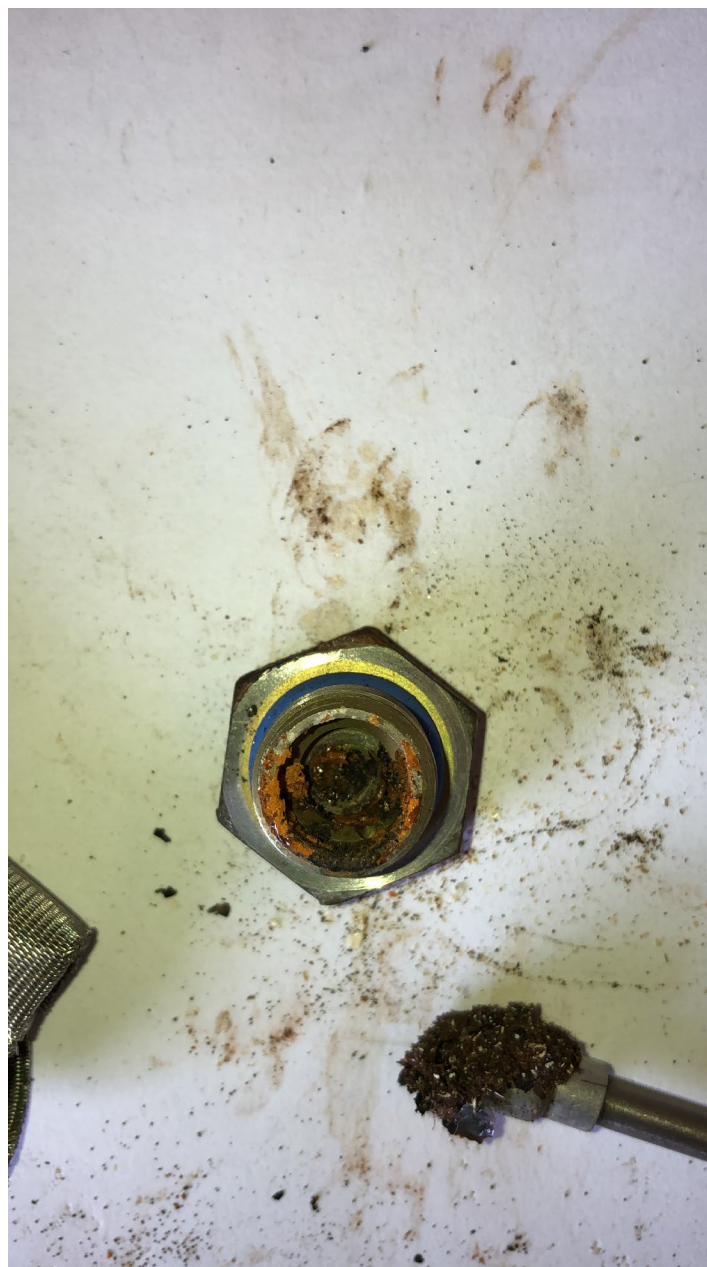
**Photo 8 - FAA Digital Photograph. View of the Ferrous Contaminant Recovered From the Inlet Screen of the Servo Fuel Injector. Note the Corrosion of the Plug.**

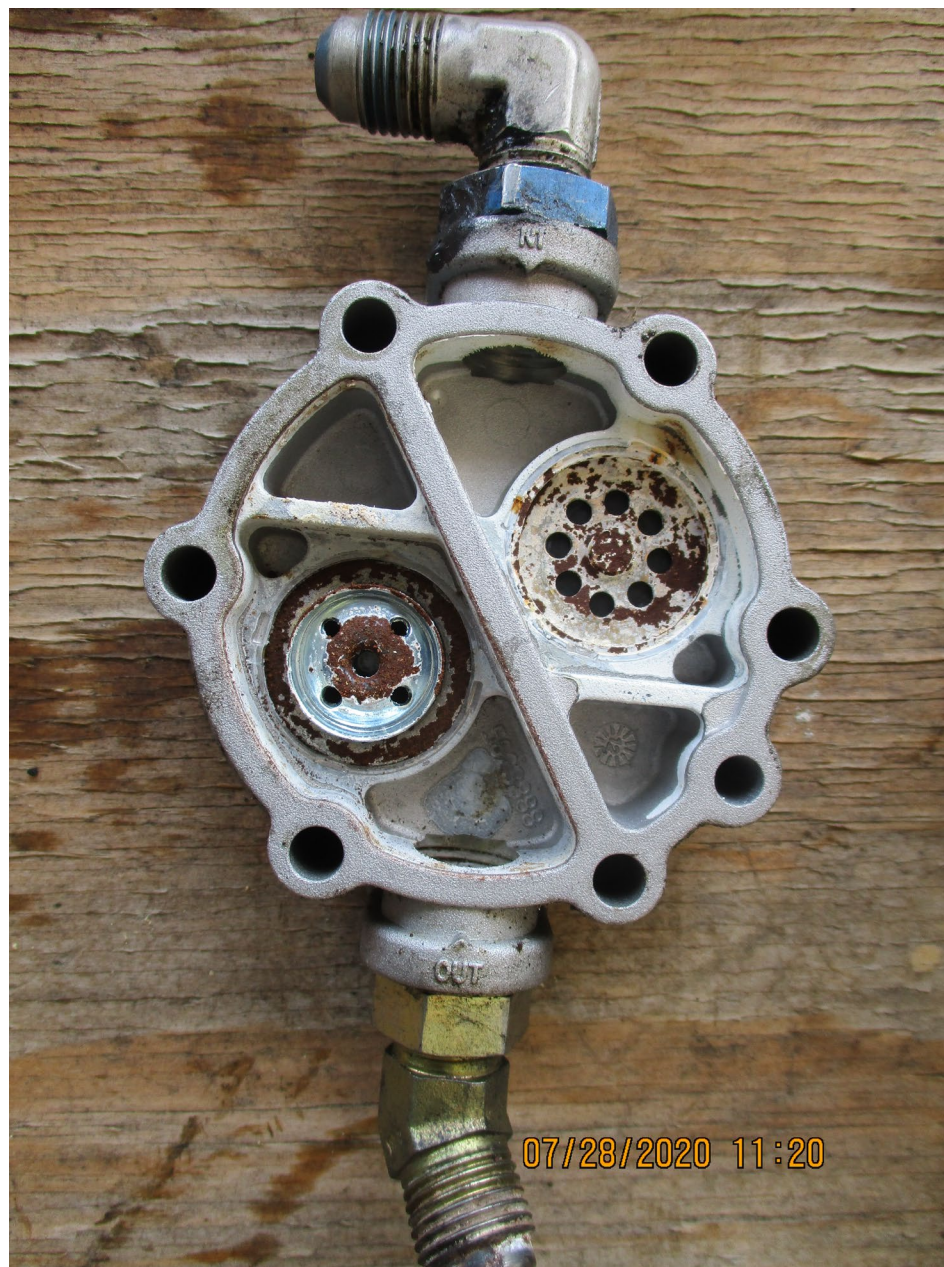
**Photo 9 - FAA Digital Photograph. View of the Disassembled Engine-Driven Fuel Pump. Note the Corrosion of the Internal Valves.**

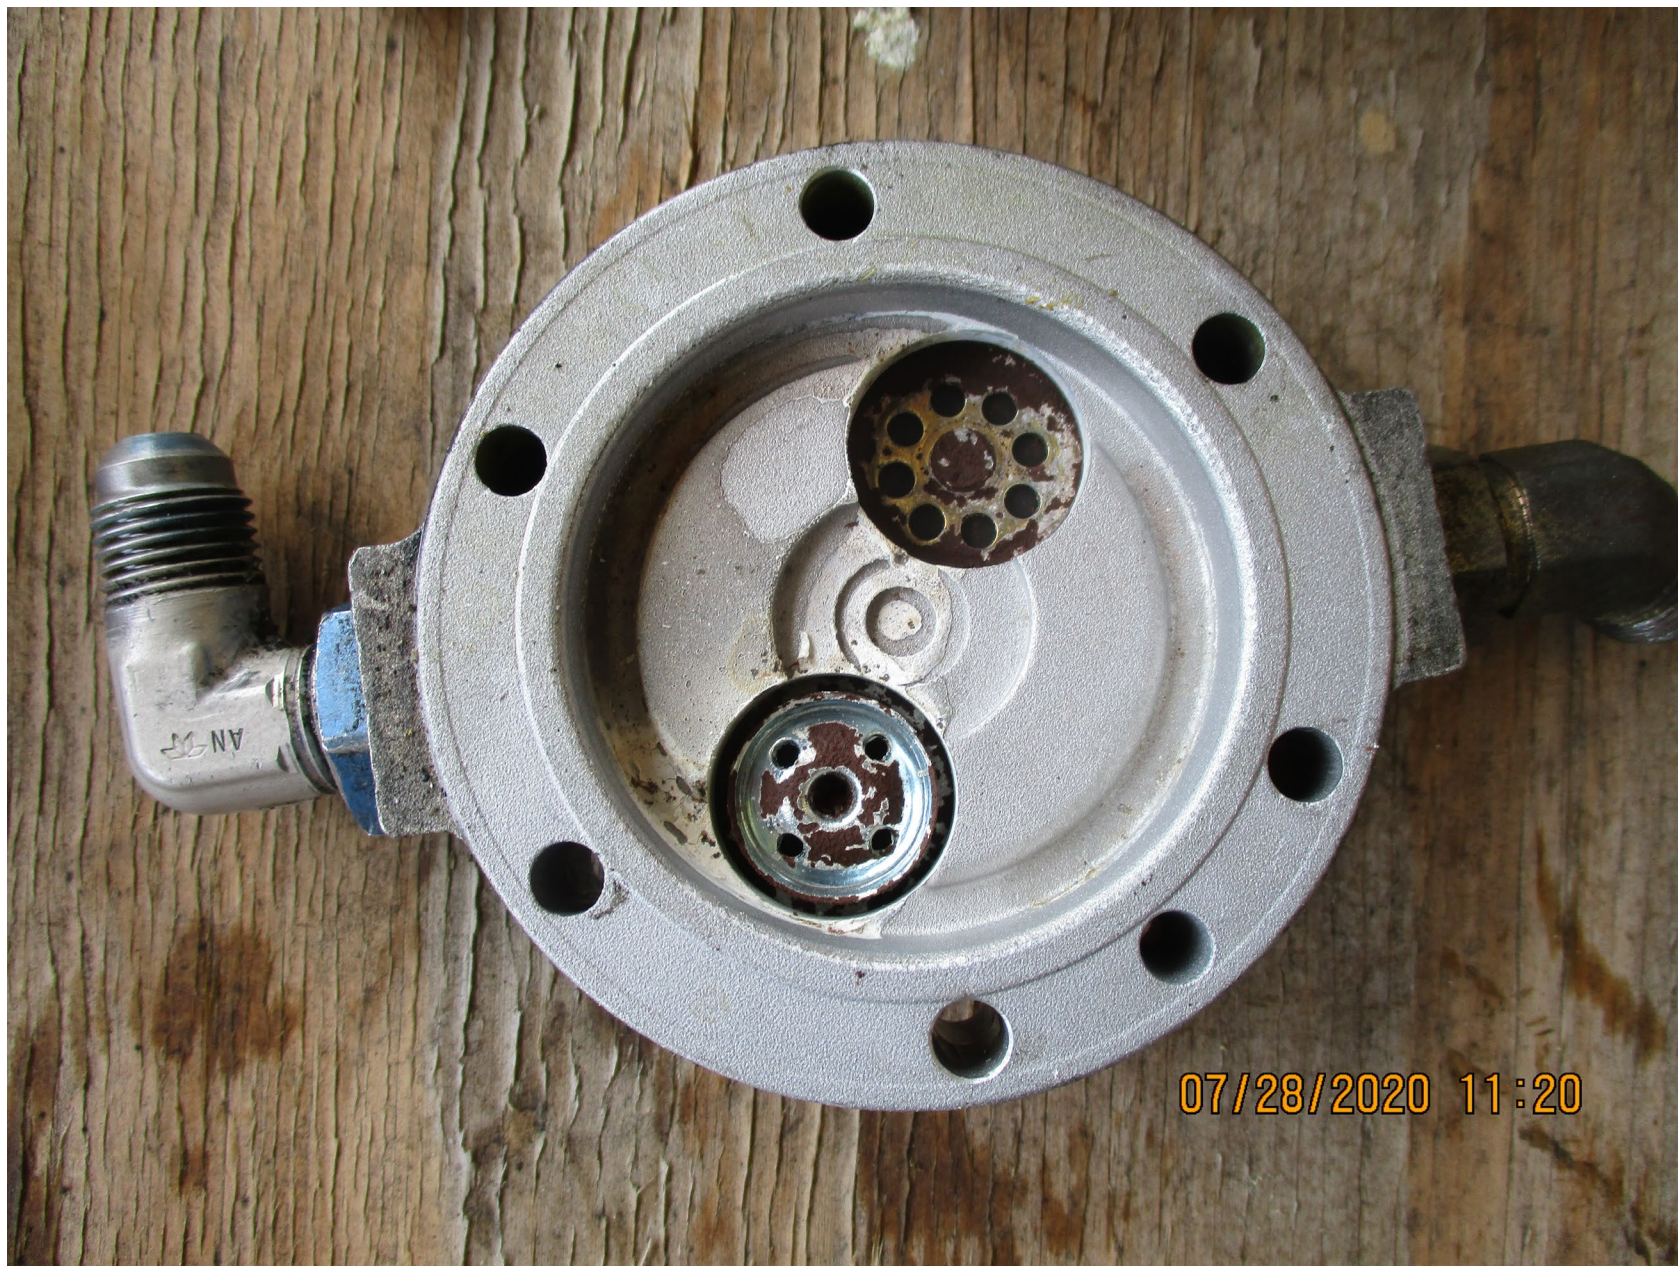
**Photo 10 - FAA Digital Photograph. View of the Disassembled Engine-Driven Fuel Pump. Note the Corrosion of the Internal Valves.**

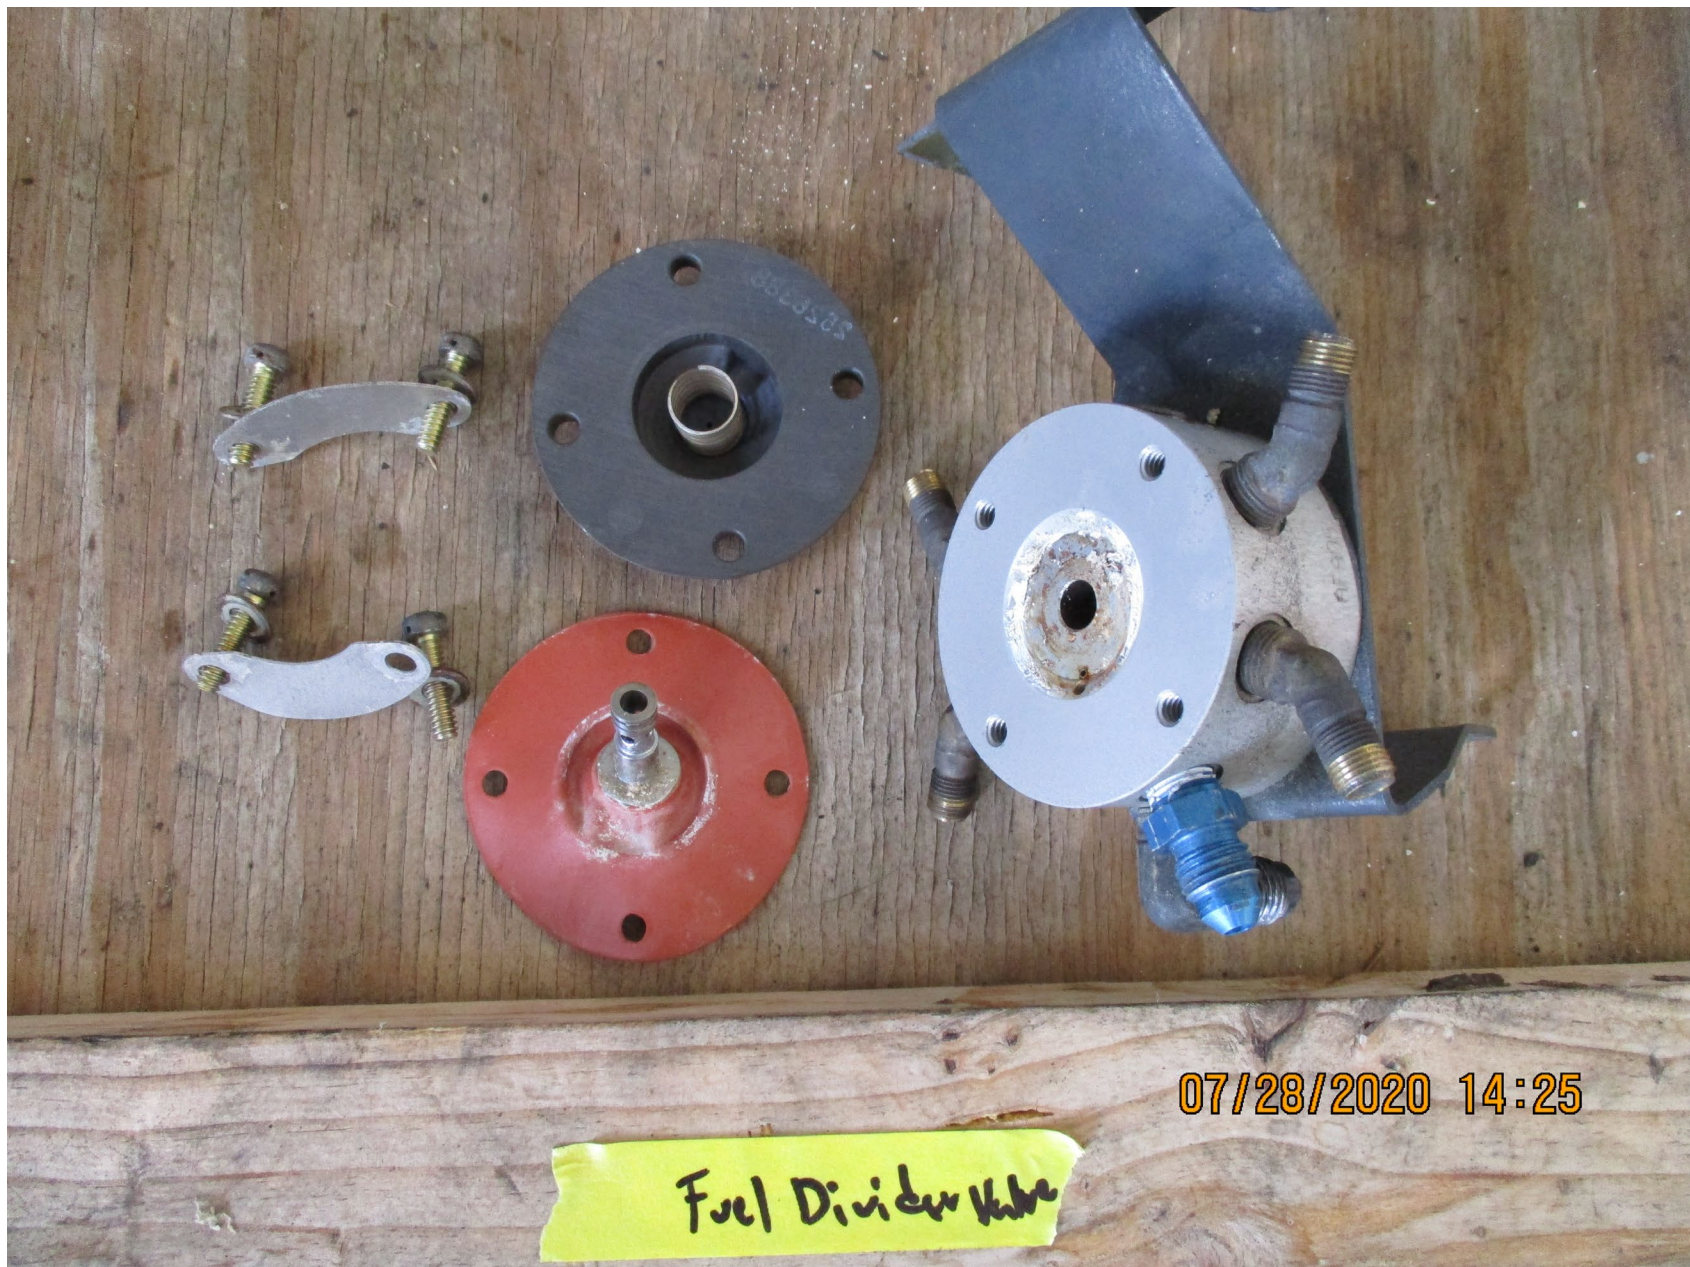
**Photo 11 - FAA Digital Photograph. View of the Disassembled Flow Divider or Manifold Valve. Note the Corrosion of the housing and spool.**

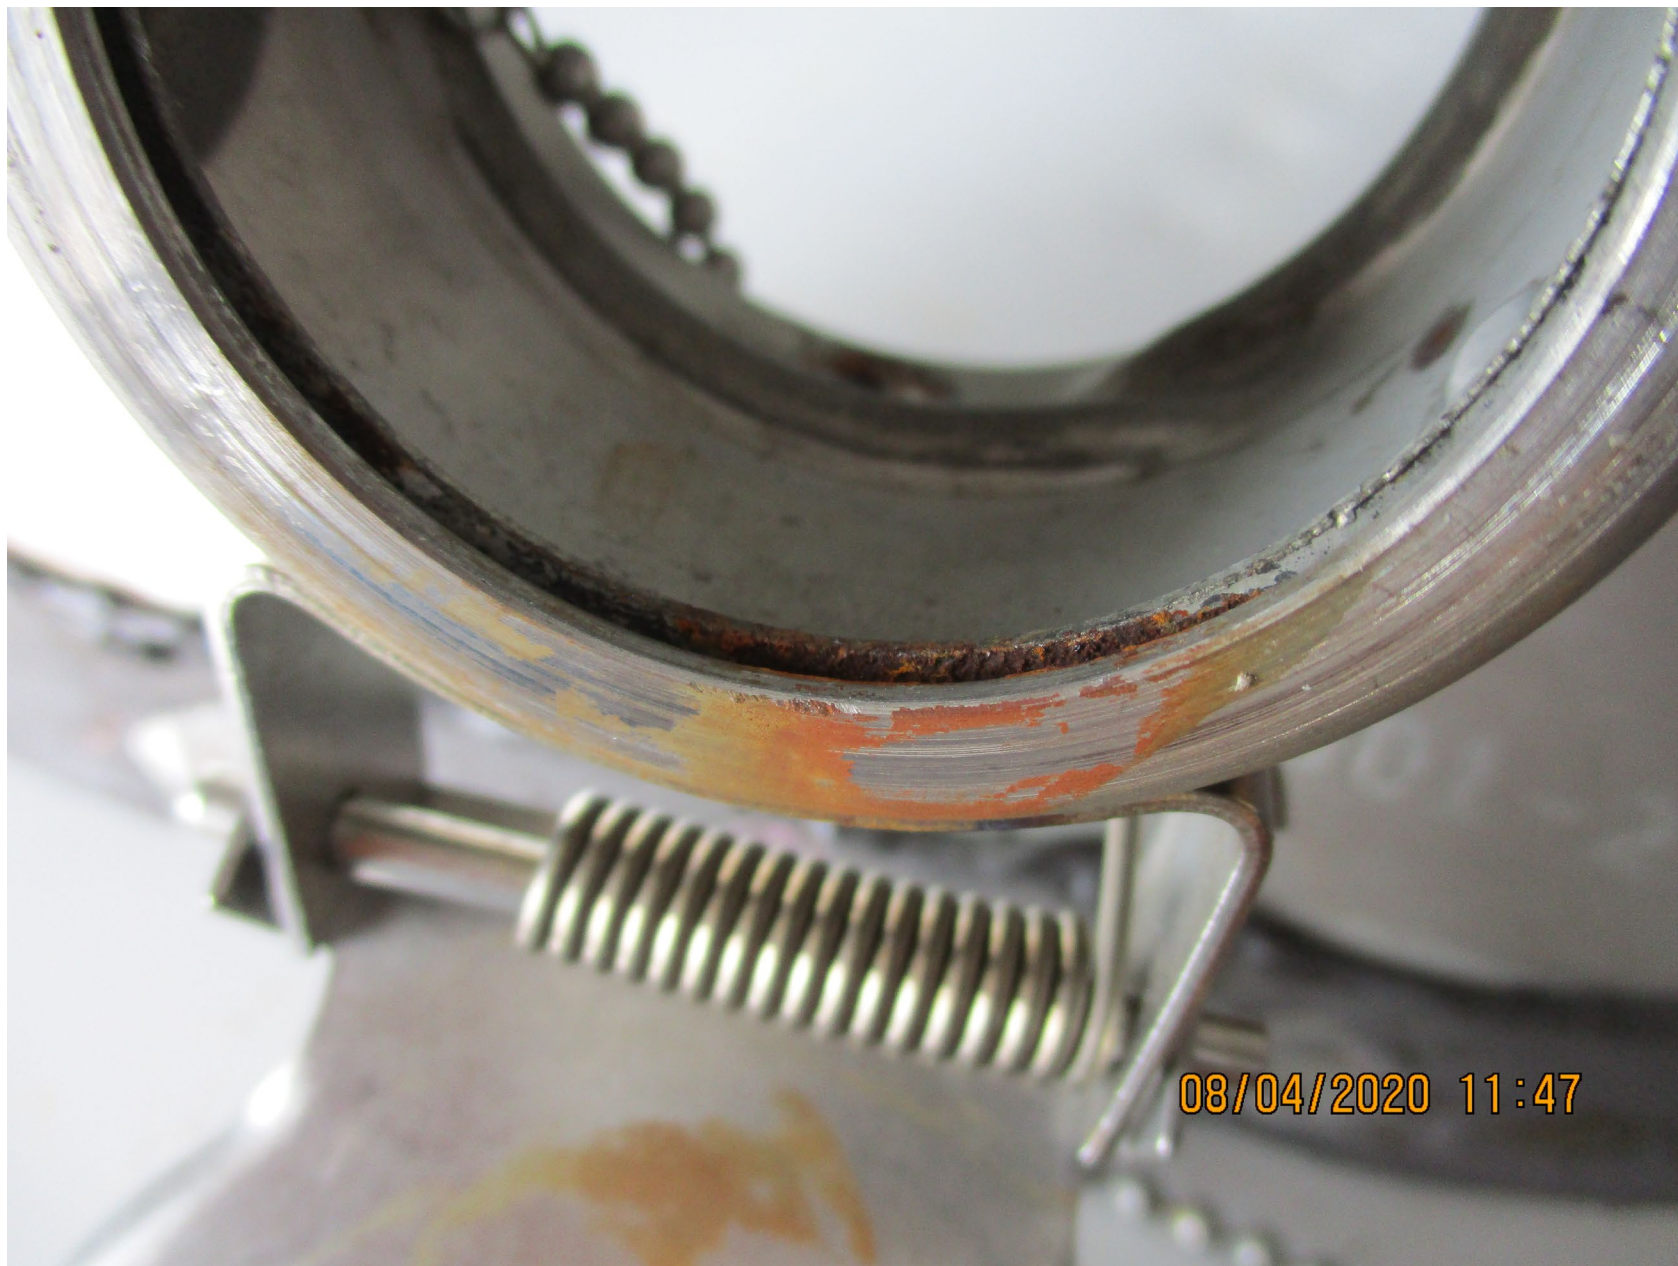
**Photo 12 - FAA Digital Photograph. View of the Right Fuel Cap Assembly. Note the Corrosion.**
