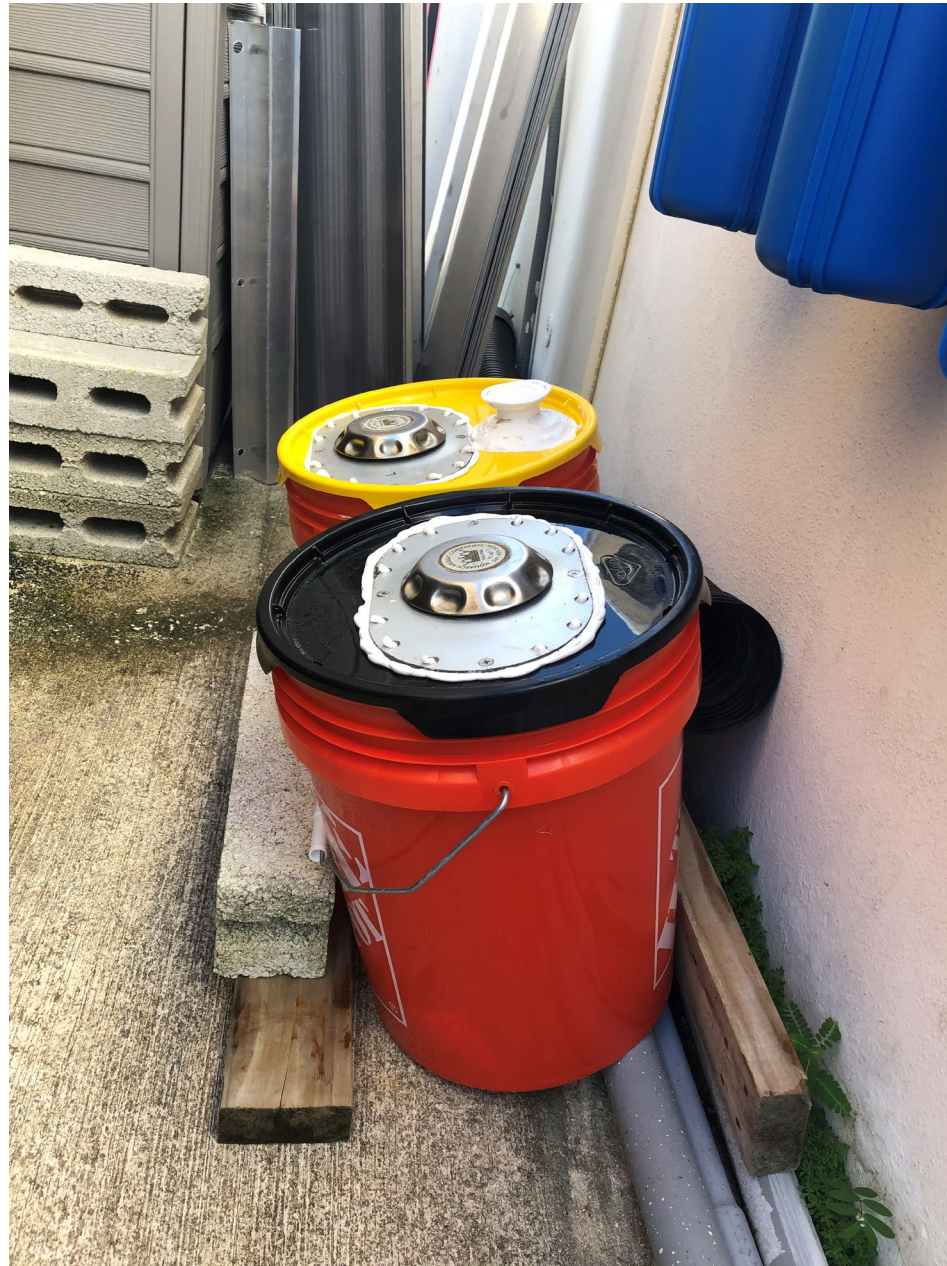
**Photo 13 - FAA Digital Photograph. View of the Testing of the Fuel Caps.**
