## HELICOPTER ENGINES

# N-55GJ ENGINE EECU DUMP ANALYSIS

October 2020

# N-55GJ - EECU P/N 70BMF01000 S/N846 dump analysis

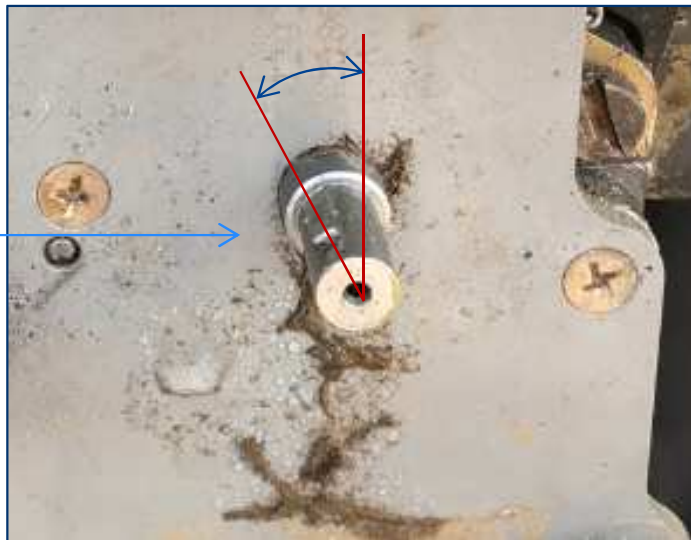
- > XPc failure flag was regularly met at impact in other accident cases, and indicated the moment of the impact of the aircraft with water.
  - ◆ It is coherent with the high torque met at this instant.
- > No failure flag before impact. All recordings were post impact.
- > The high value of XPc meant a significant power demand at the moment of the crash.
- > N1=98,49% at impact : it showed that the engine was delivering power at the moment of impact.
- > Instantaneous variation of N2 was highly negative at impact, which could have been due to main rotor contact with water.
- > Loss of both NTL signal and/or high N2 gradient led to the EECU total failure, therefore EBCAU activated, which is granted by the final position of the EBCAU shaft key.
- > The powershaft transmission rupture and the blade shedding led to a quick decrease of raw torque.

Rotation of EBCAU shaft.

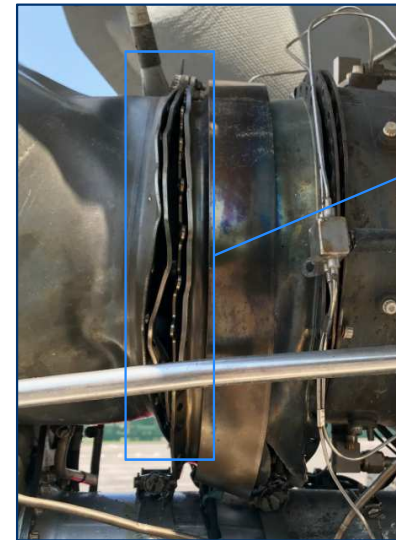
Blade Shedding
