## **NATIONAL TRANSPORTATION SAFETY BOARD**

Office of Aviation Safety  
Eastern Region

**Photo Array**

**ERA20LA273**

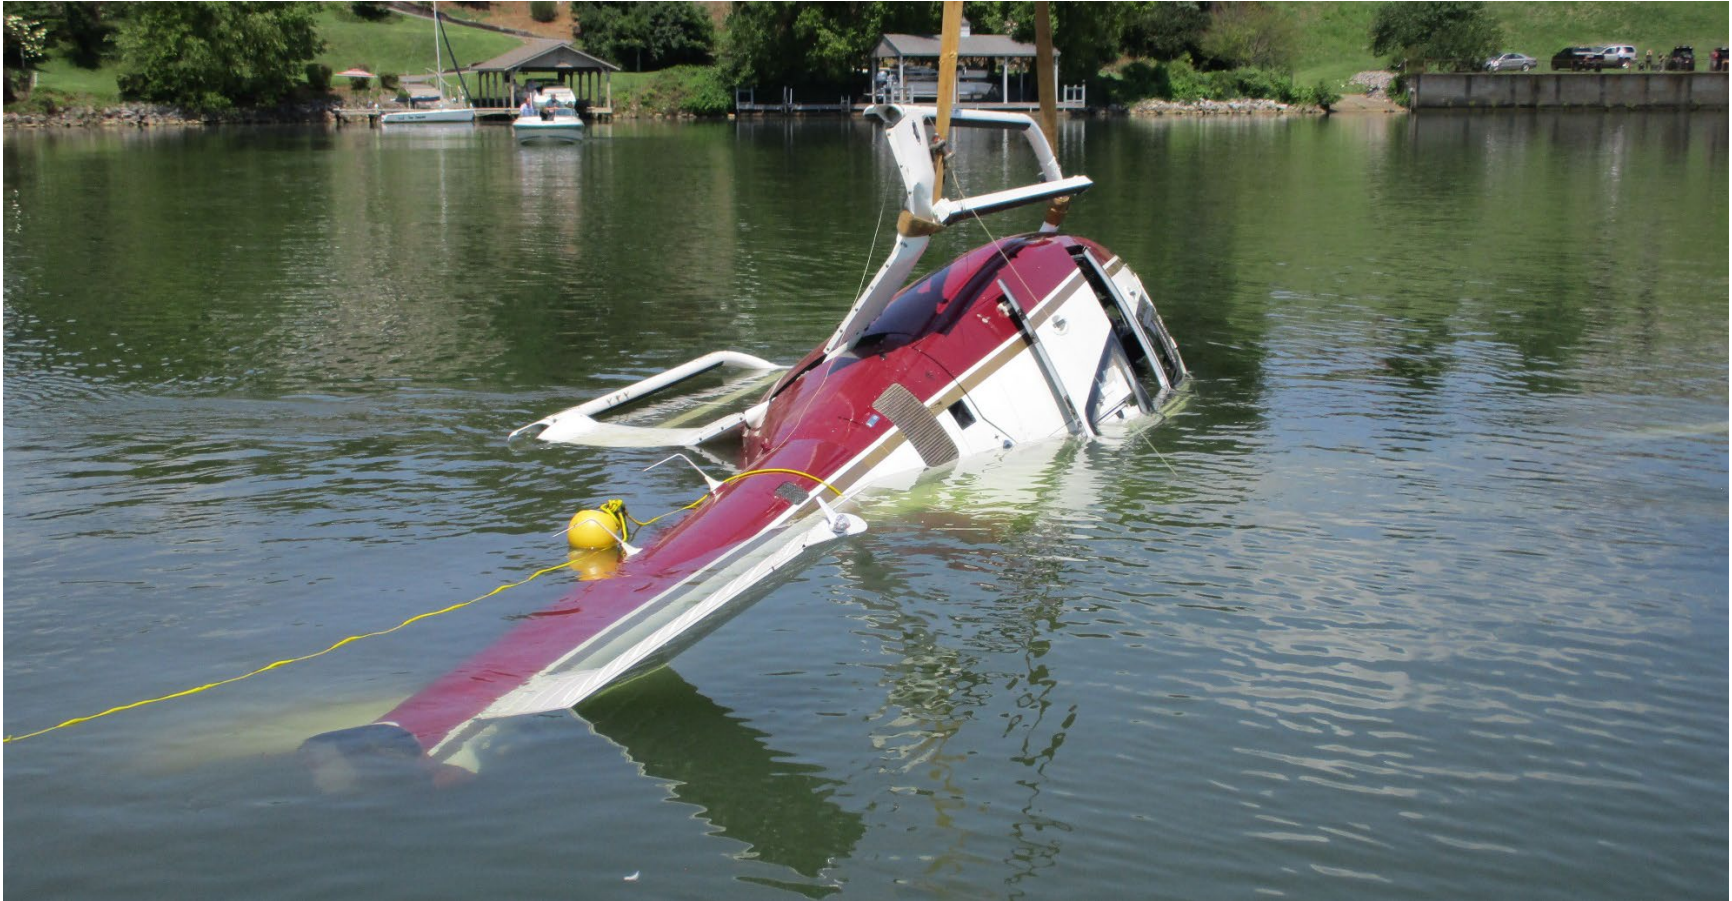
**Photo 1 – View of Helicopter upon Recovery (Photo Courtesy of FAA)**

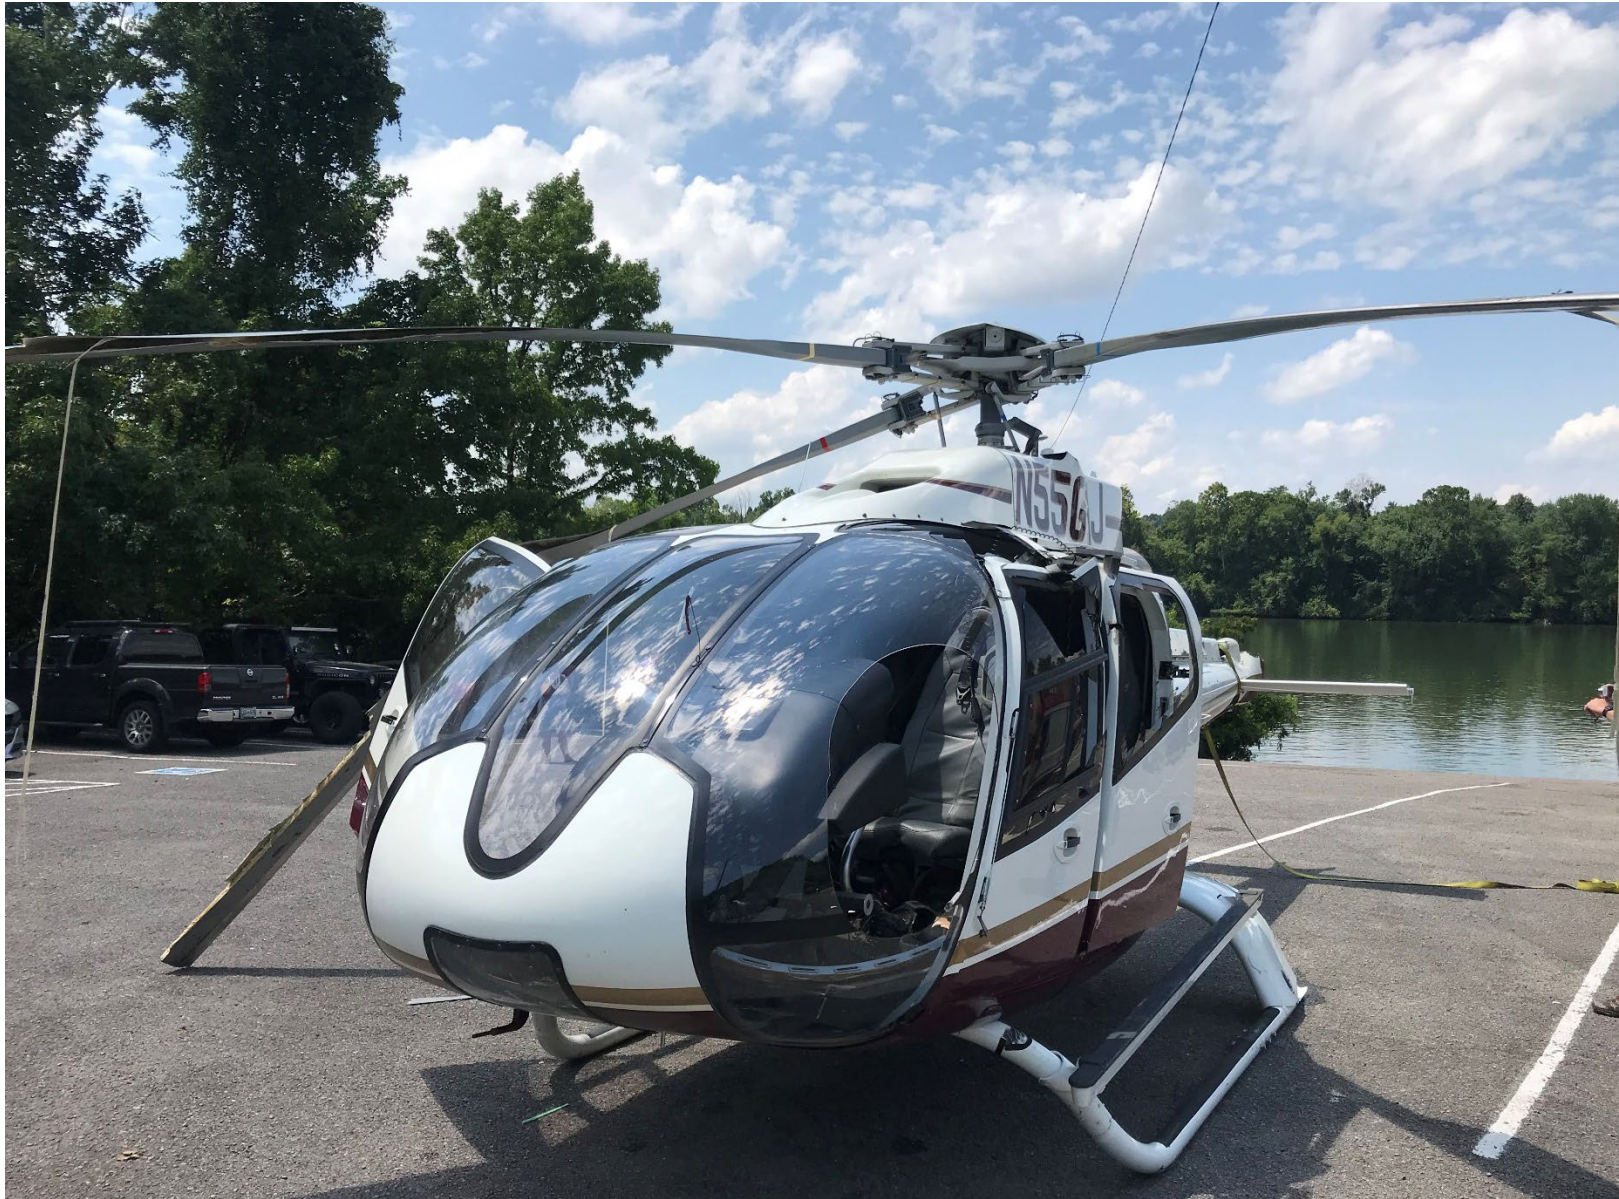
**Photo 2 – View of Helicopter from Front (Photo Courtesy of Airbus Helicopter)**

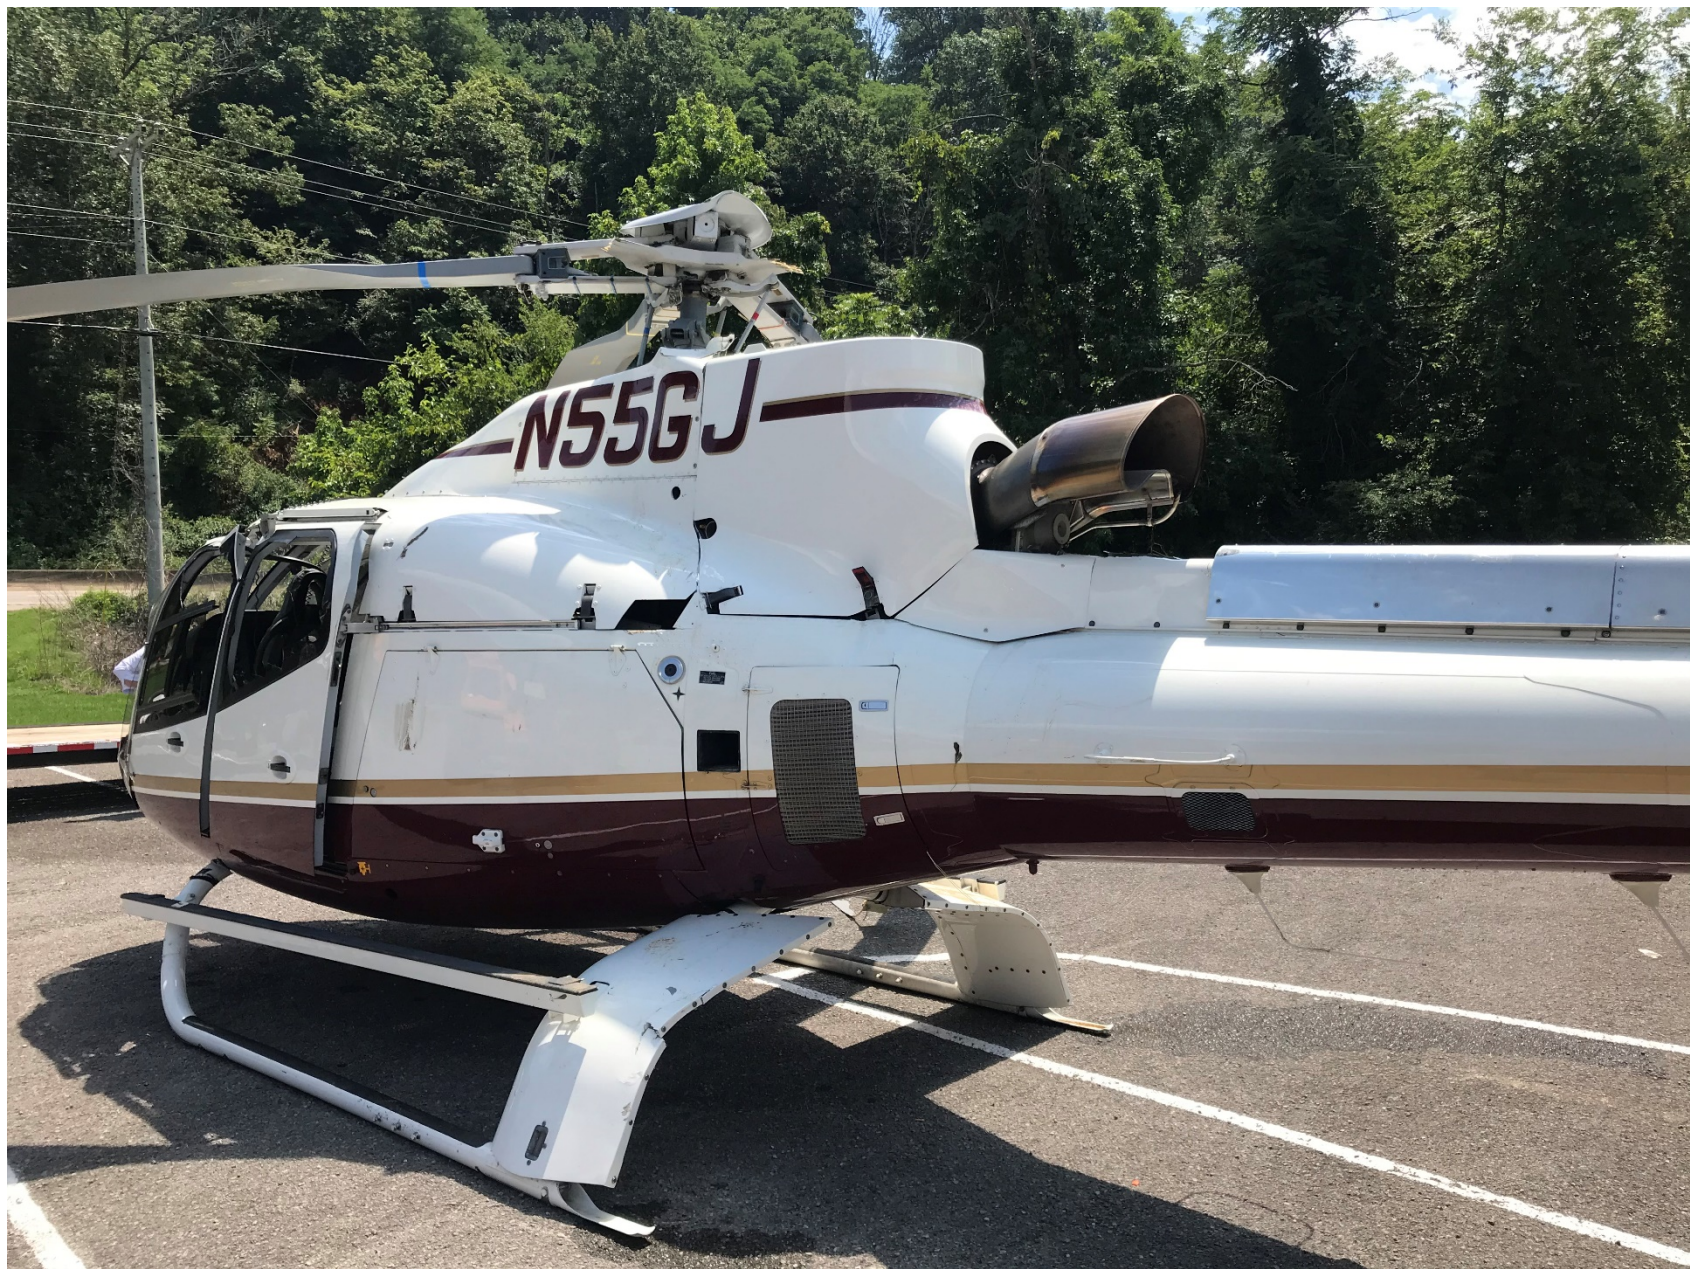
**Photo 3 – View of Helicopter from Left (Photo Courtesy of Airbus Helicopter)**

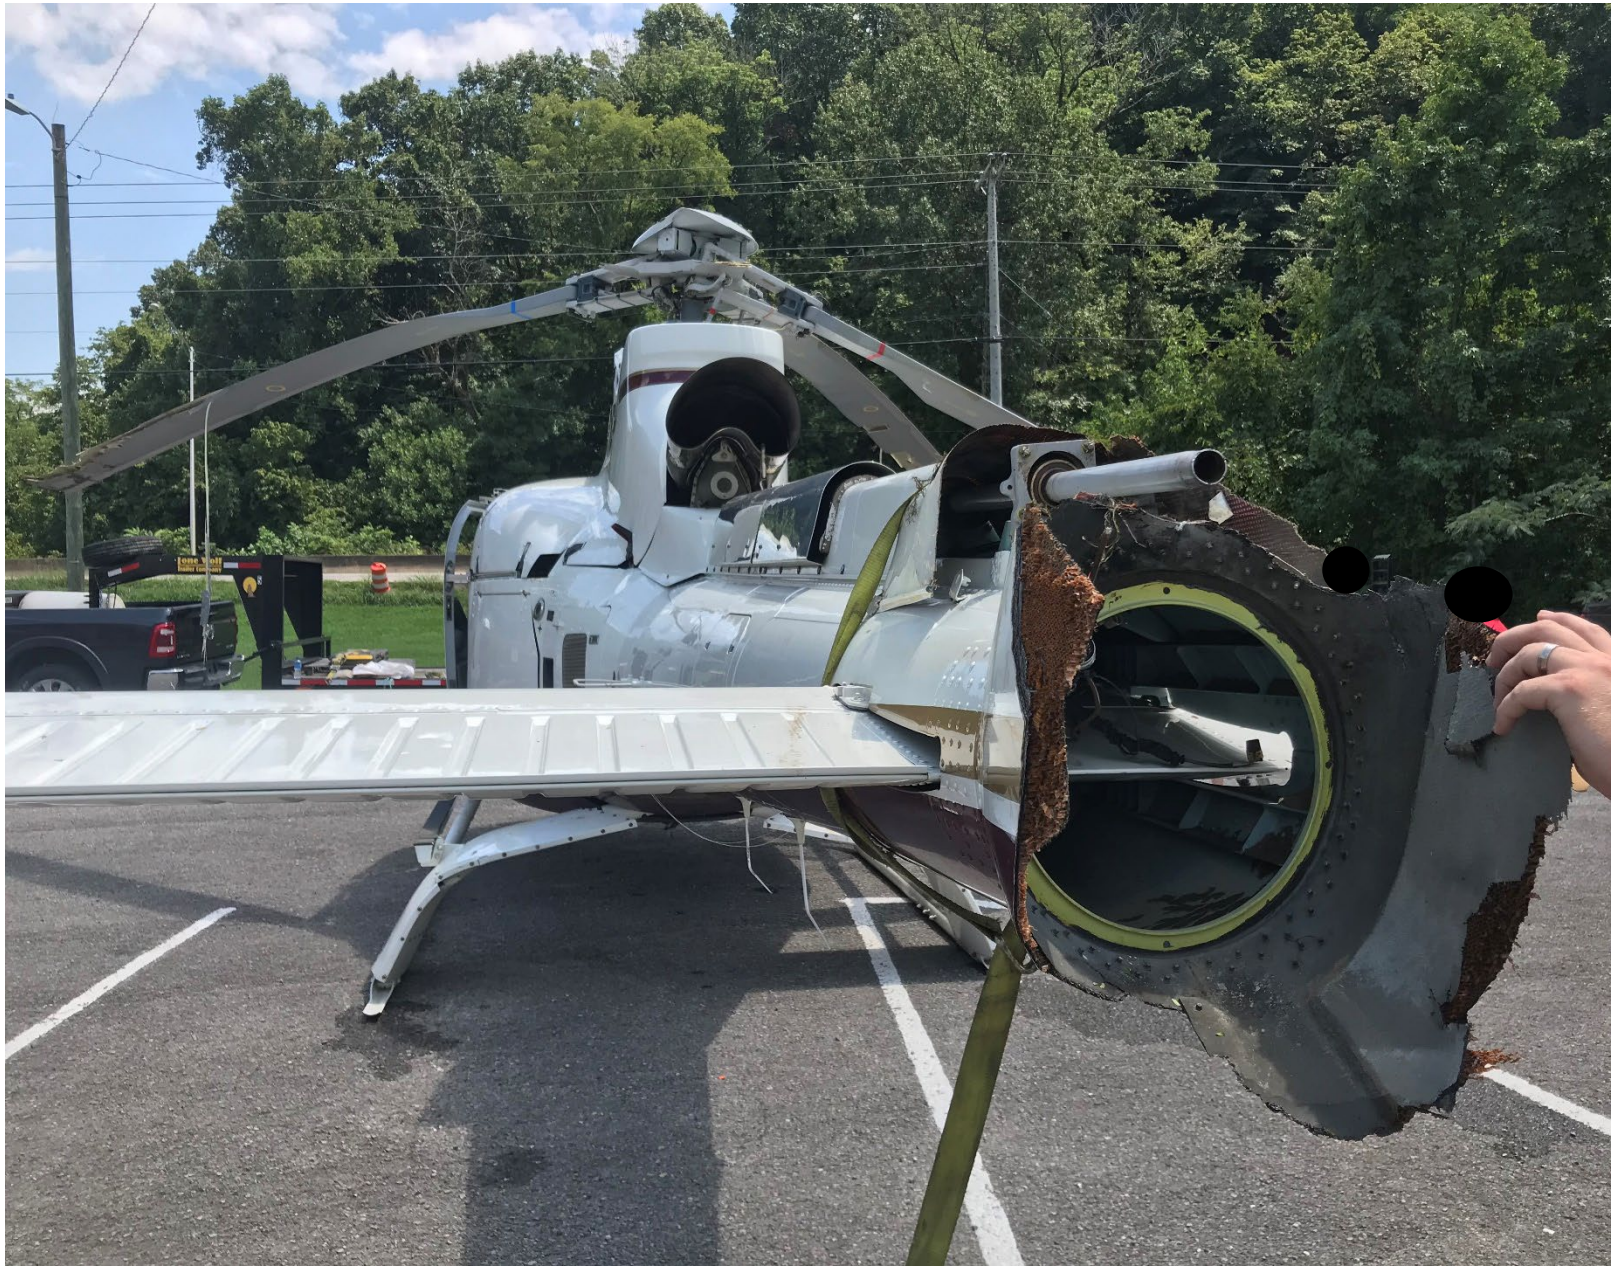
**Photo 4 – View of Helicopter from Rear (Photo Courtesy of Airbus Helicopter)**

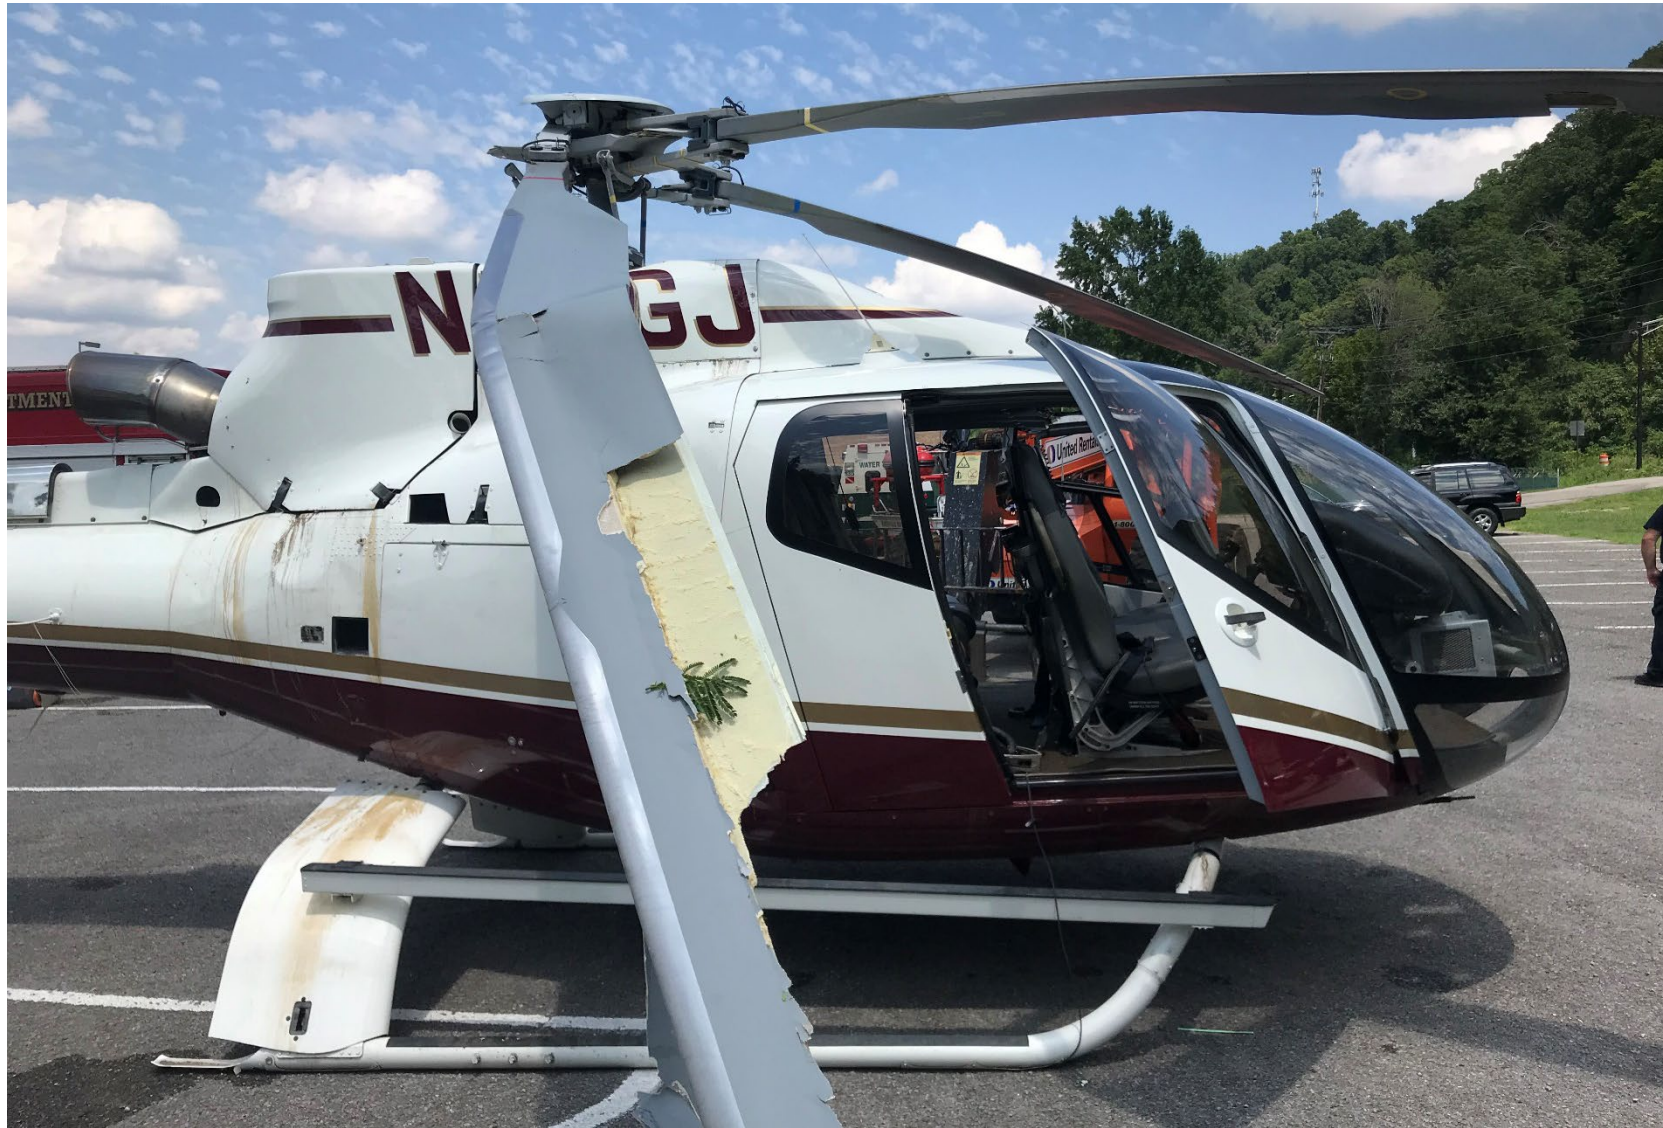
**Photo 5 – View of Helicopter from Right (Photo Courtesy of Airbus Helicopter)**

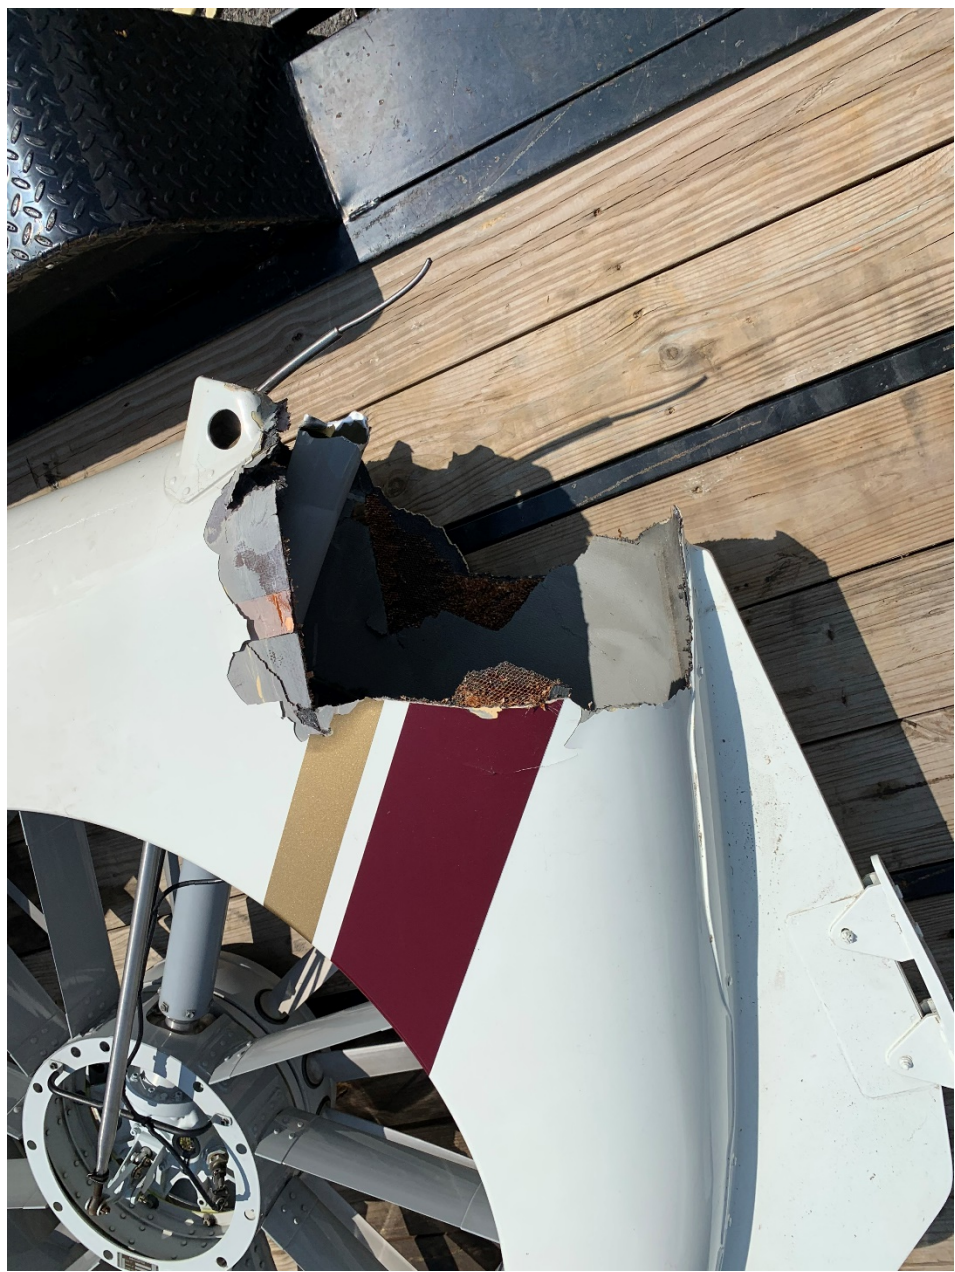
**Photo 6 – View of Fenestron Fracture (Photo Courtesy of Airbus Helicopter)**

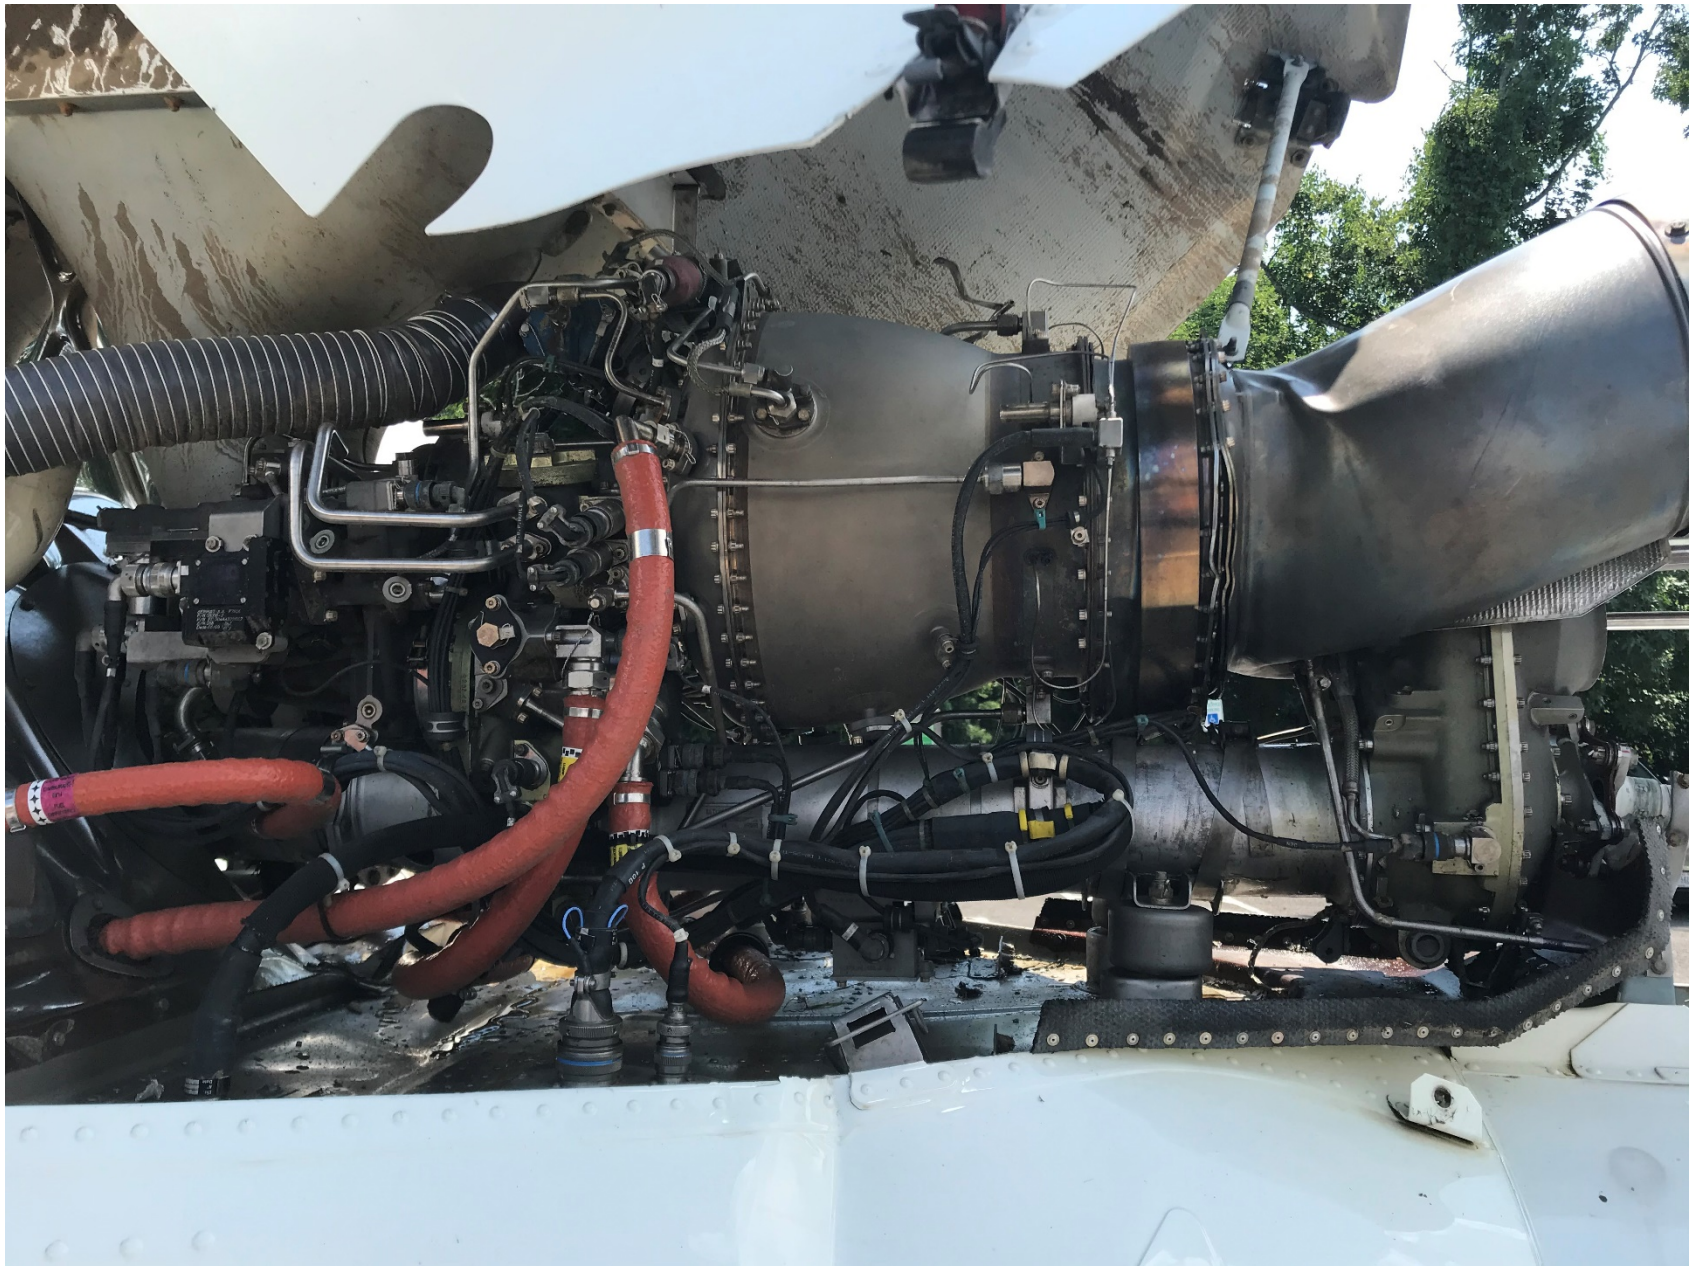
**Photo 7 – View of Engine (Photo Courtesy of Safran Helicopter Engines)**
