## **Airframe and Engine Examination**

NTSB ACCIDENT NUMBER: ERA20LA273

August 5, 2020

AIRCRAFT REGISTRATION: N55GJ  
OPERATOR: CFA Holdings, Inc.  
ACCIDENT LOCATION: Knoxville, TN

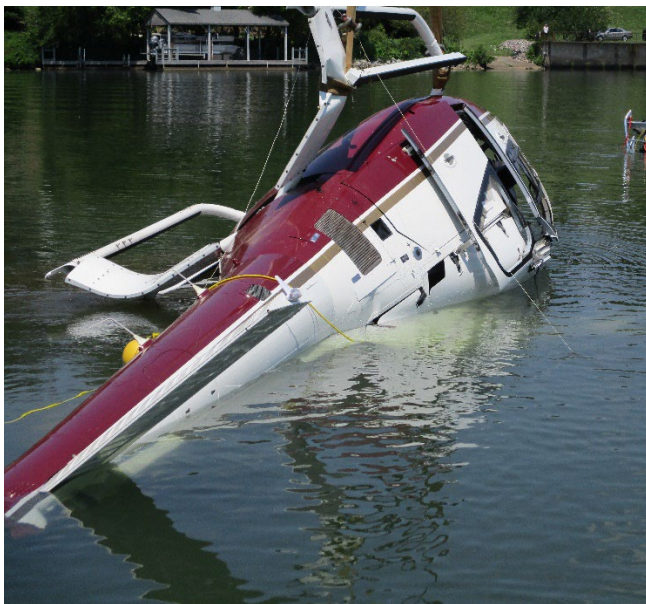
*Photo 1: Helicopter upon initial recovery*

The helicopter was recovered from underwater and transferred to a parking lot next to the river. It was mostly intact. The left side windshield exhibited a large hole was broken out/door and window broken out; Damage to the helicopter was consistent with a low-energy impact. All rotor blades exhibited after body damage consistent with impact with water. The lift struts were fractured midspan. The tailboom was still attached, and the fenestron fractured just aft of the ring frame.

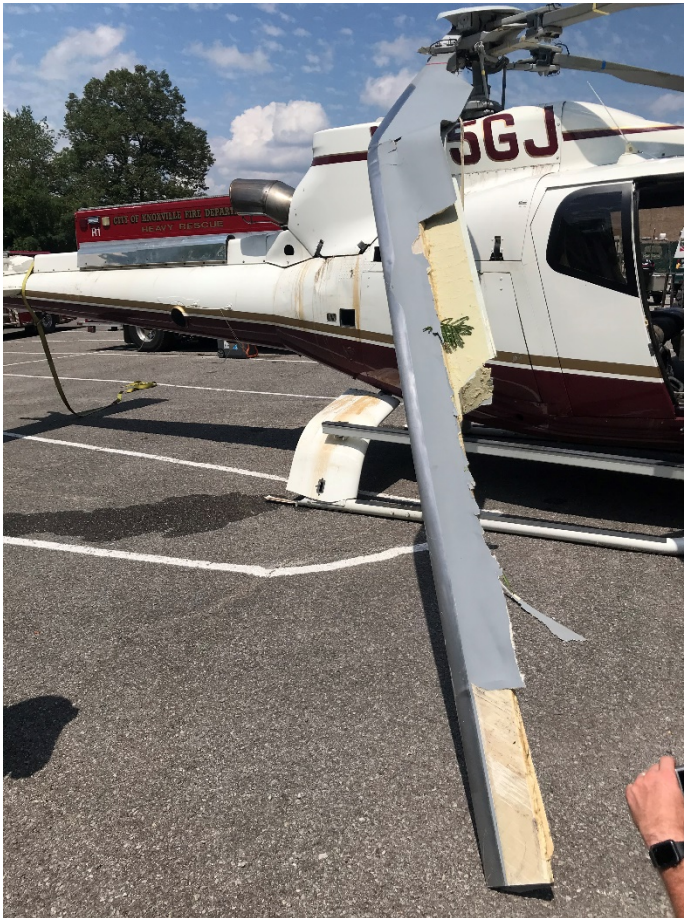
All three rotor blades exhibited trailing edge impact fracture damage consistent with impact with water. Two of the three Starflex star arms were broken with diagonal brakeage across the arm web. Two of the four suspension bars were fractured and separated near mid-span with a buckling break.

*Photo 3: Main rotor blade damage*

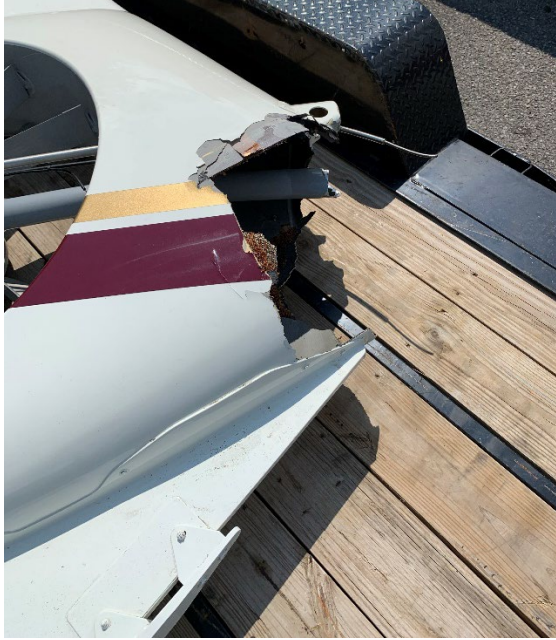
The tail boom was still attached; however, the Fenestron was separated, with the fracture just after of the ring frame. Some of the damage in the area of where it fractured appeared to have been from one of more of the main rotor blade tips. Otherwise, the appearance of the fracture at the Fenestron appeared to be from blunt impact and not that of fatigue. A few of the Fenestron blades were slightly bent consistent with aerodynamic contact with the water. The Fenestron gear box hub was not attached and not recovered.

*Photo 4: Fenestron Fracture Area*

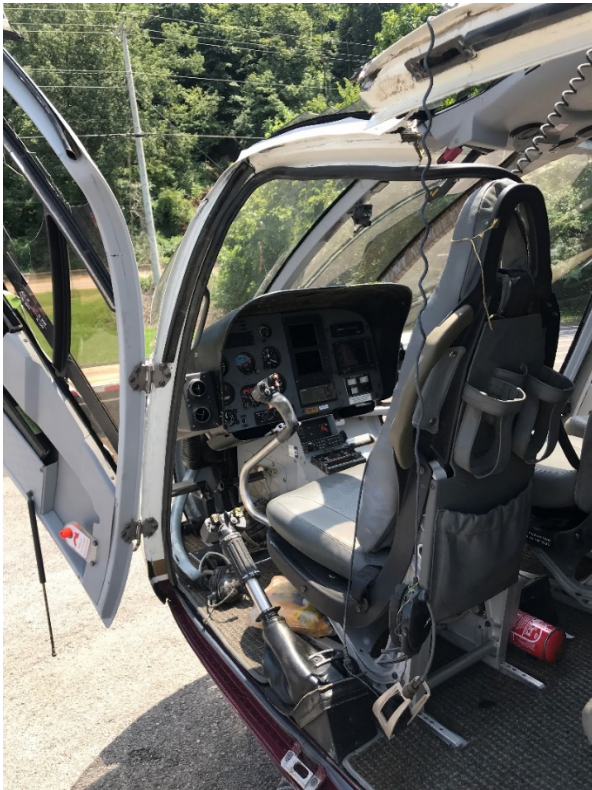
*Photo 5: Cockpit Area*

All the instruments in the cockpit were not reliable for reasonable information having been in the water. There was no cockpit image recorder.

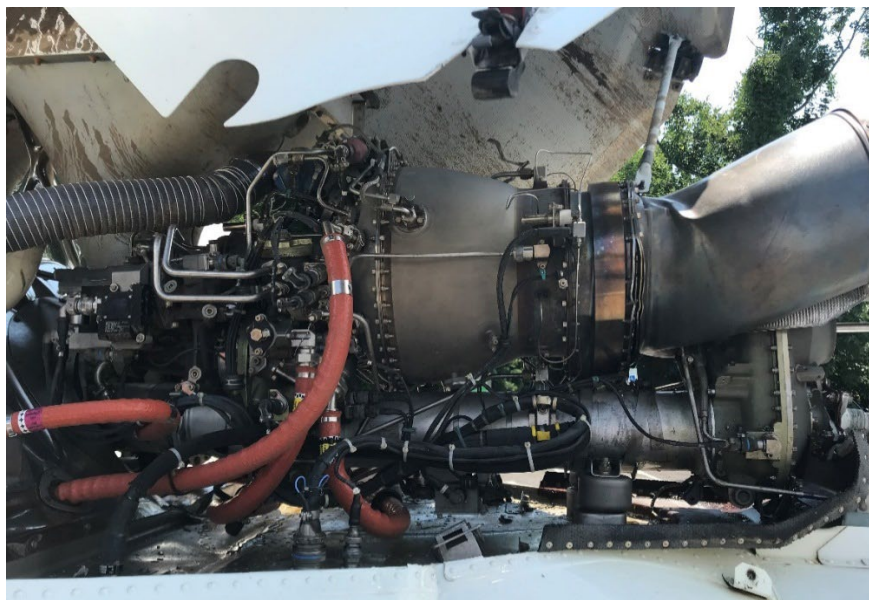
Photo 8: Engine

The engine remained attached in the engine bay and the front and rear engine supports were still intact.

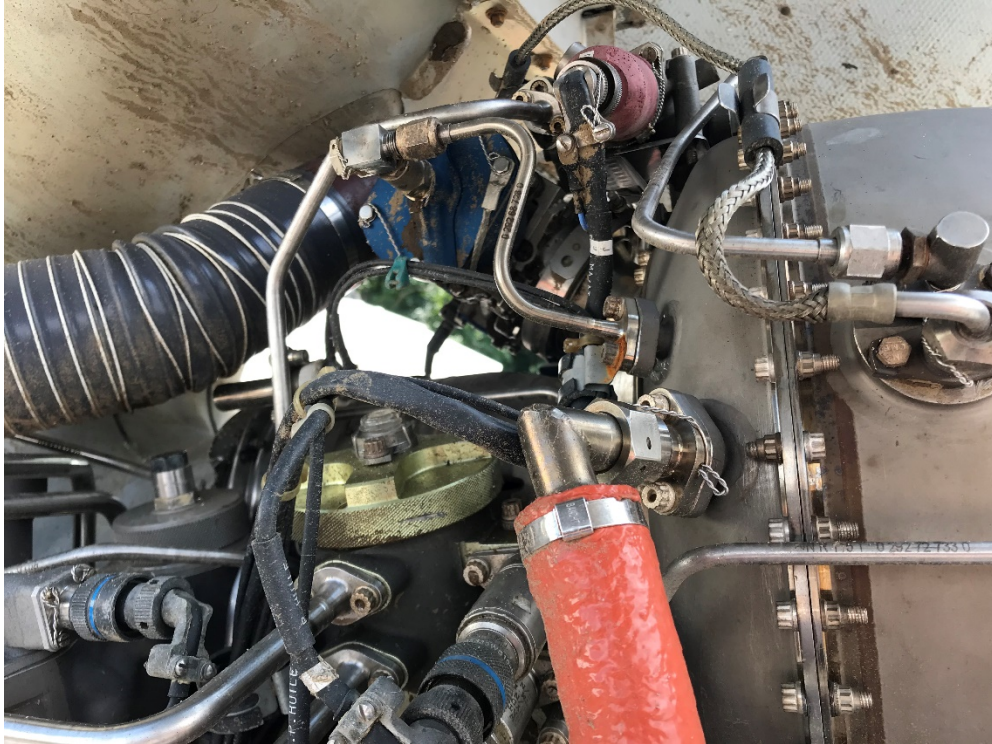
*Photo 9: Oil Filter*

Neither the oil or fuel filter bypass indicators were activated. The fuel filter was removed and examined. It was clean except for a few very small particles of foreign material. It was straw color to clear with an odor consistent with Jet-A fuel. There was a small amount of water in the bowl.

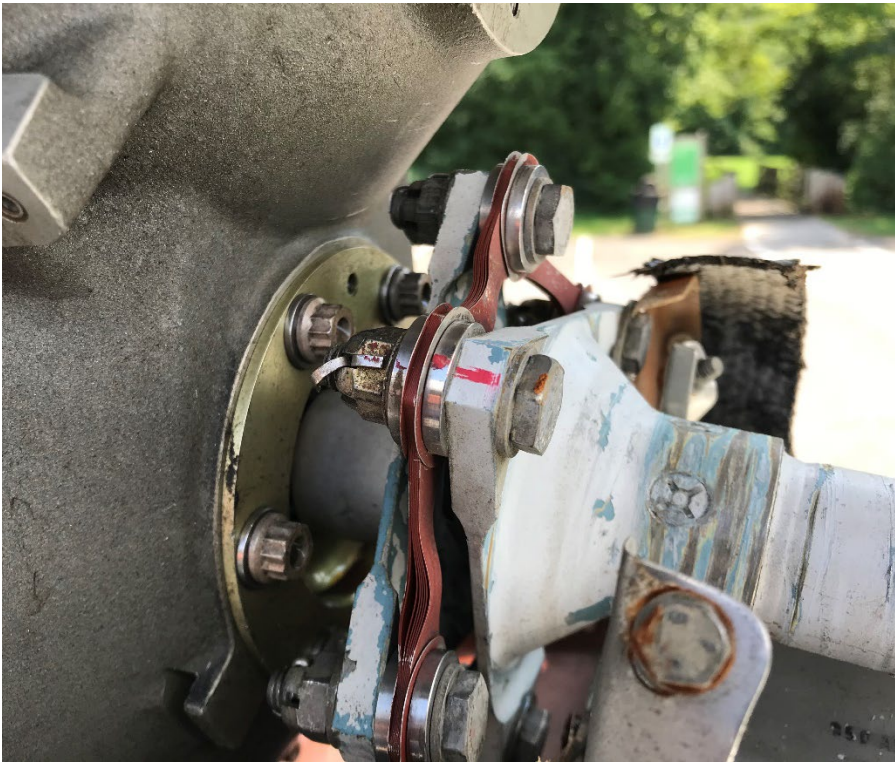
*Photo 12: Tail Rotor Drive Coupling*

The axial compressor exhibited FOD damage and the gas generator could be rotated by hand. The free turbine blades had shed consistent with overspeed protection. The flector group between the transmission shaft and helicopter transmission input was broken.

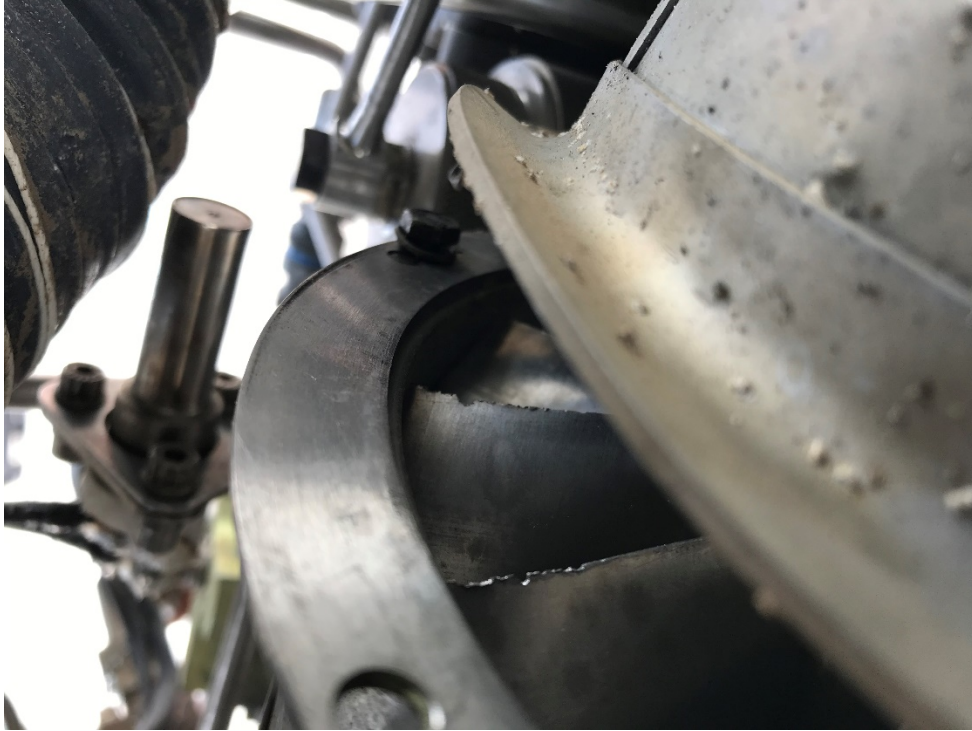
*Photo 13: Axial compressor FOD damage*
