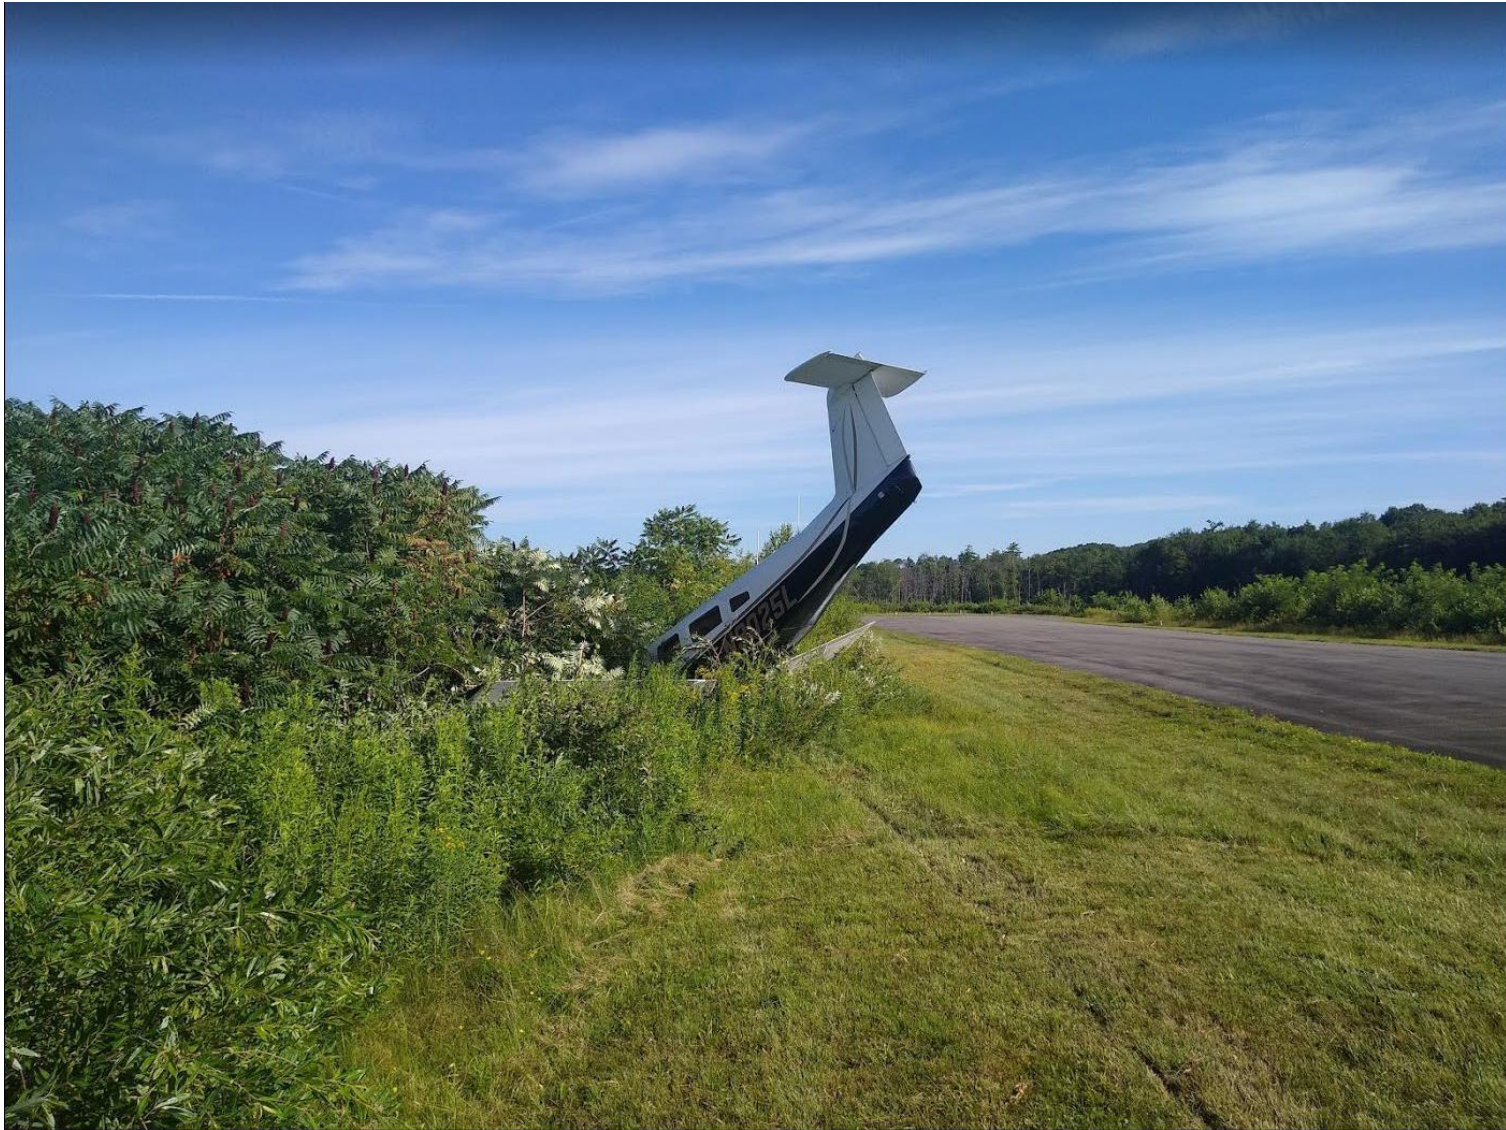
**Photo 1 – Main Wreckage Courtesy of Cherry Ridge Airport**

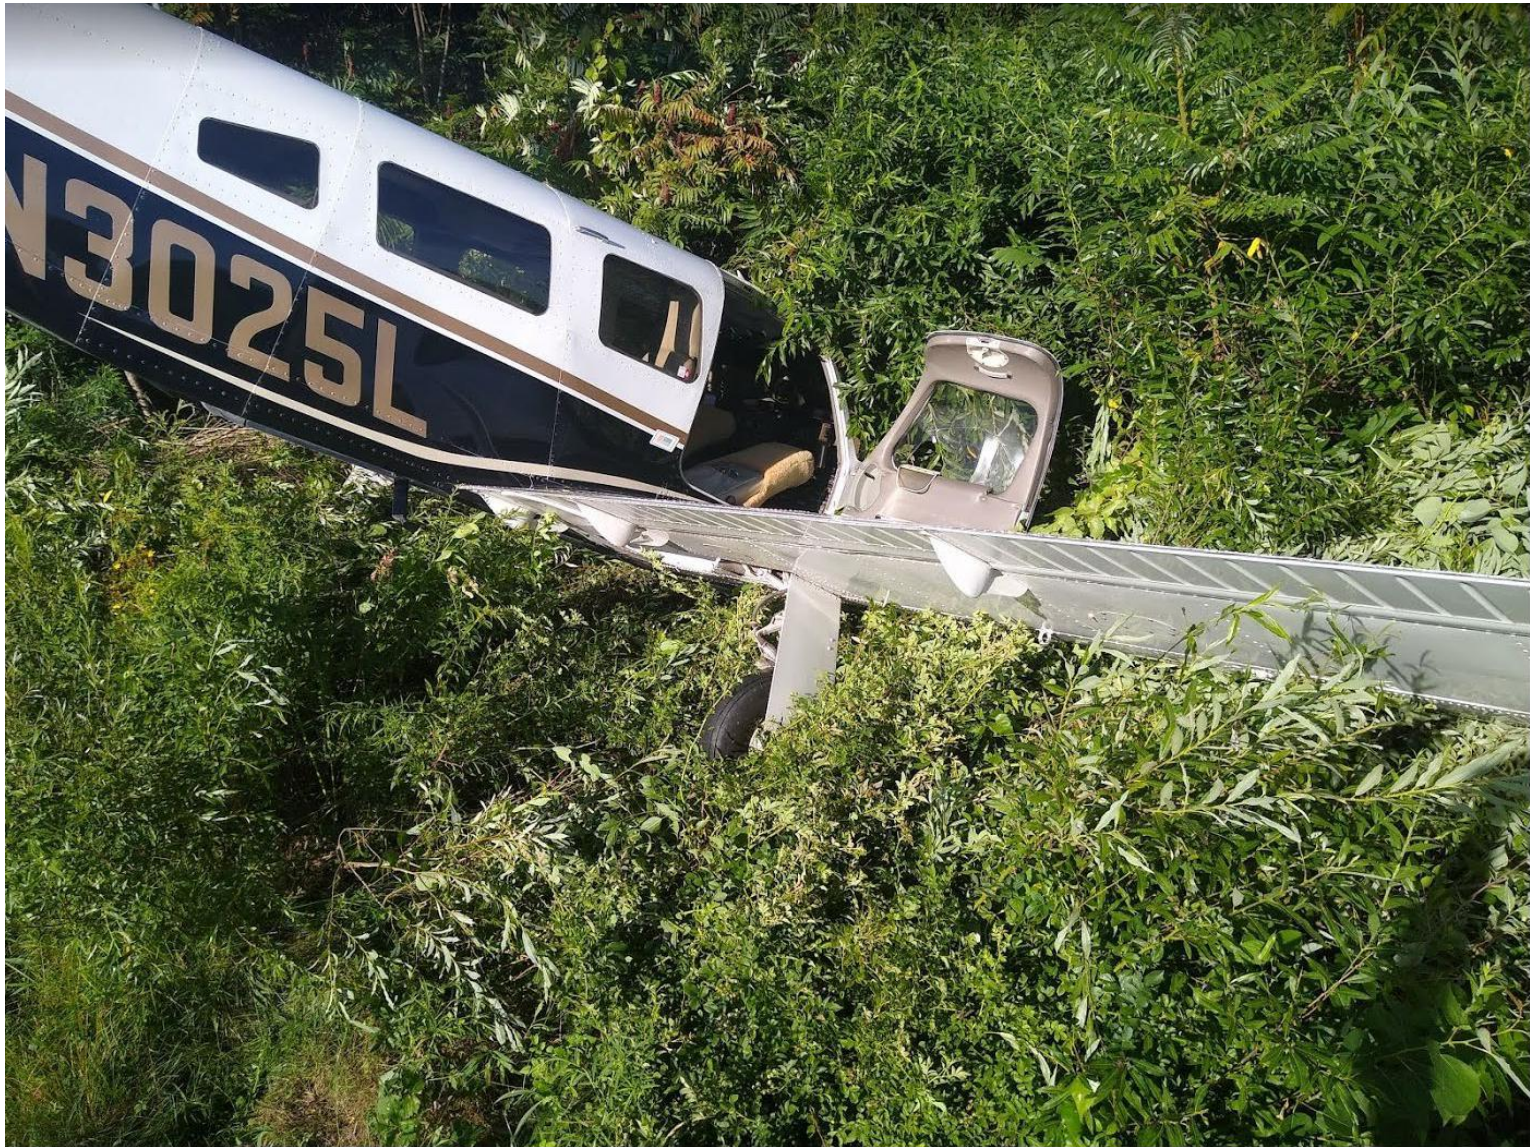
**Photo 2 – Close Up of Main Wreckage – Courtesy of Cherry Ridge Airport**

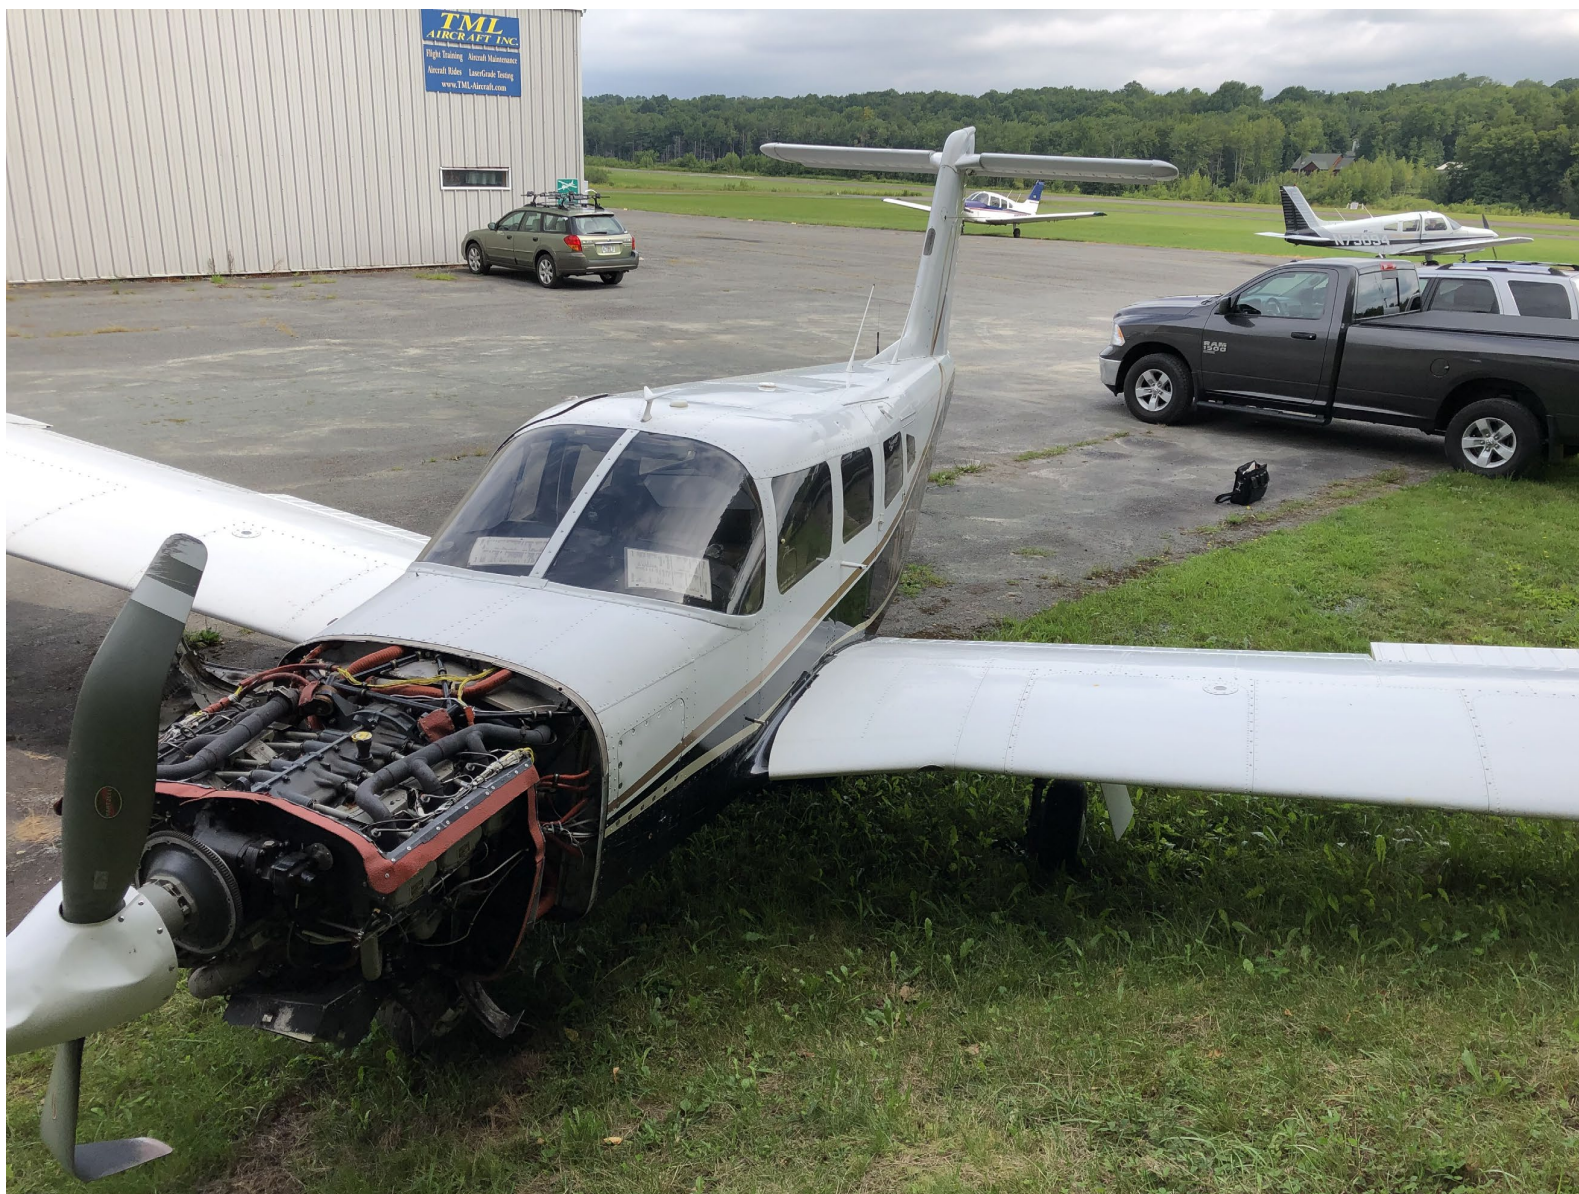
**Photo 3 – After Recovery – Courtesy of McLarens Adjusters**

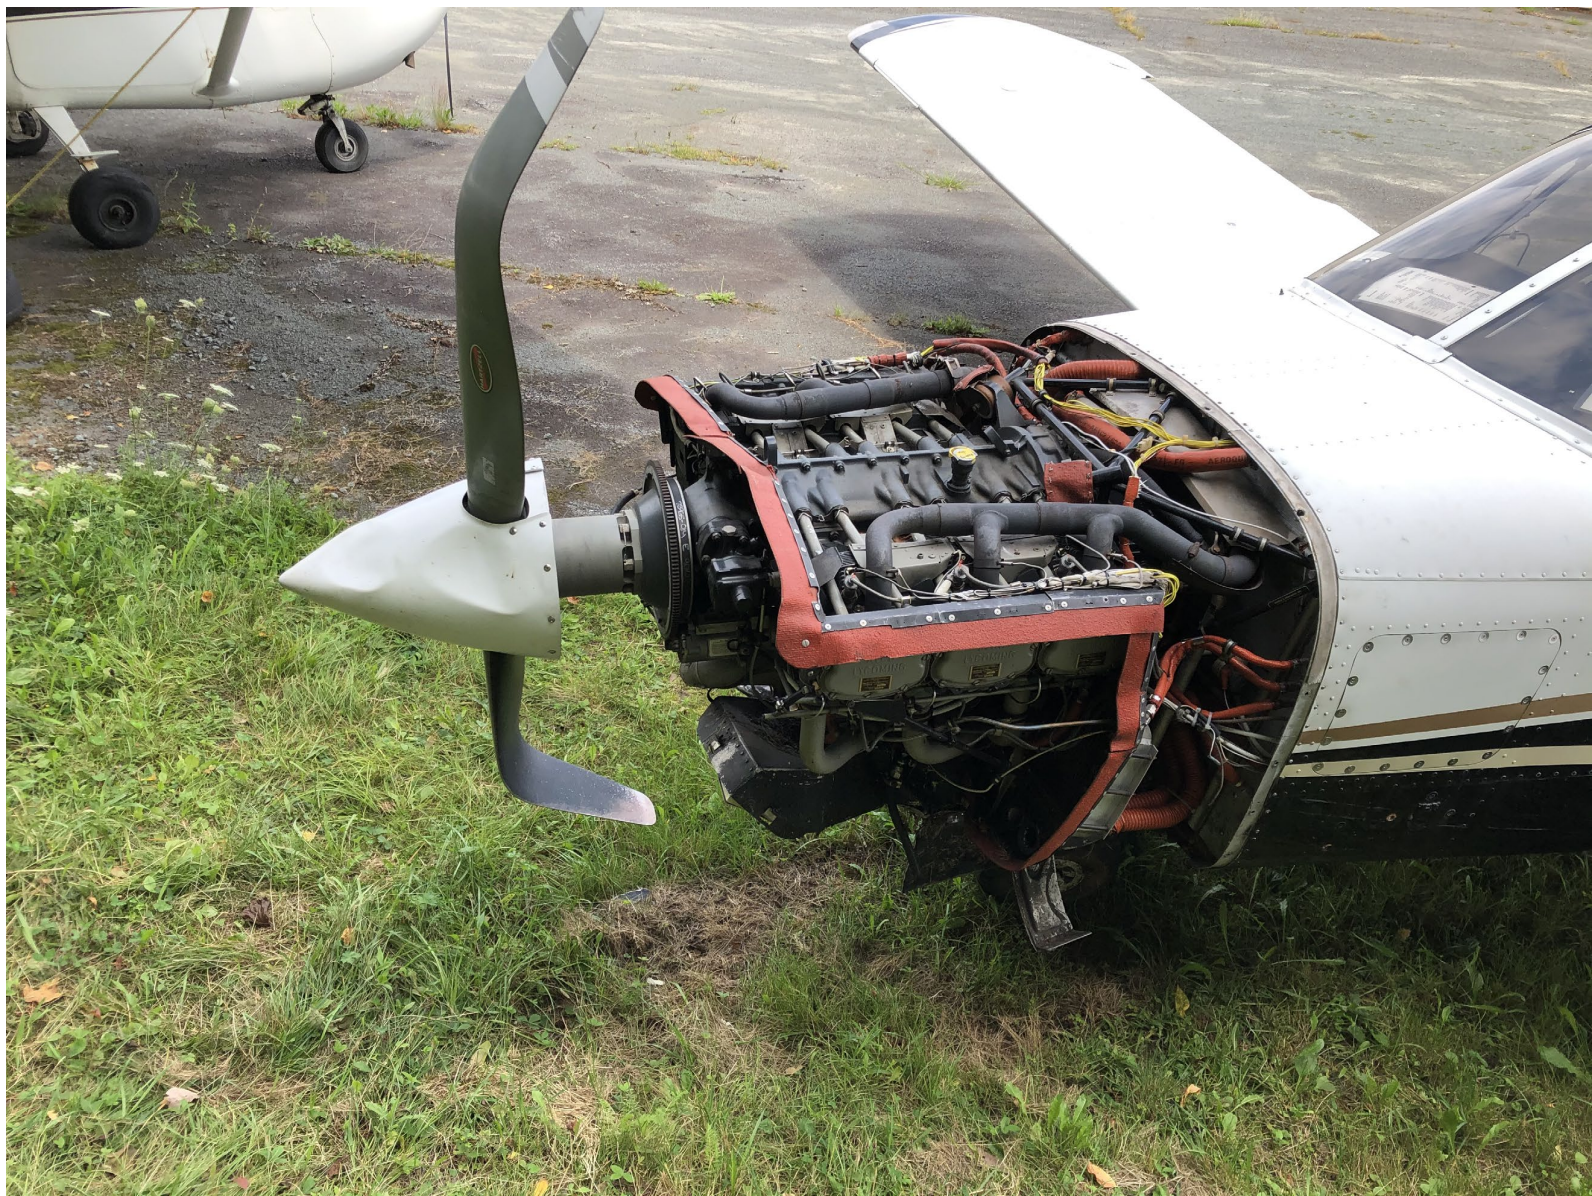
**Photo 4 – Top View of Propeller and Engine - Courtesy of McLarens Adjusters**

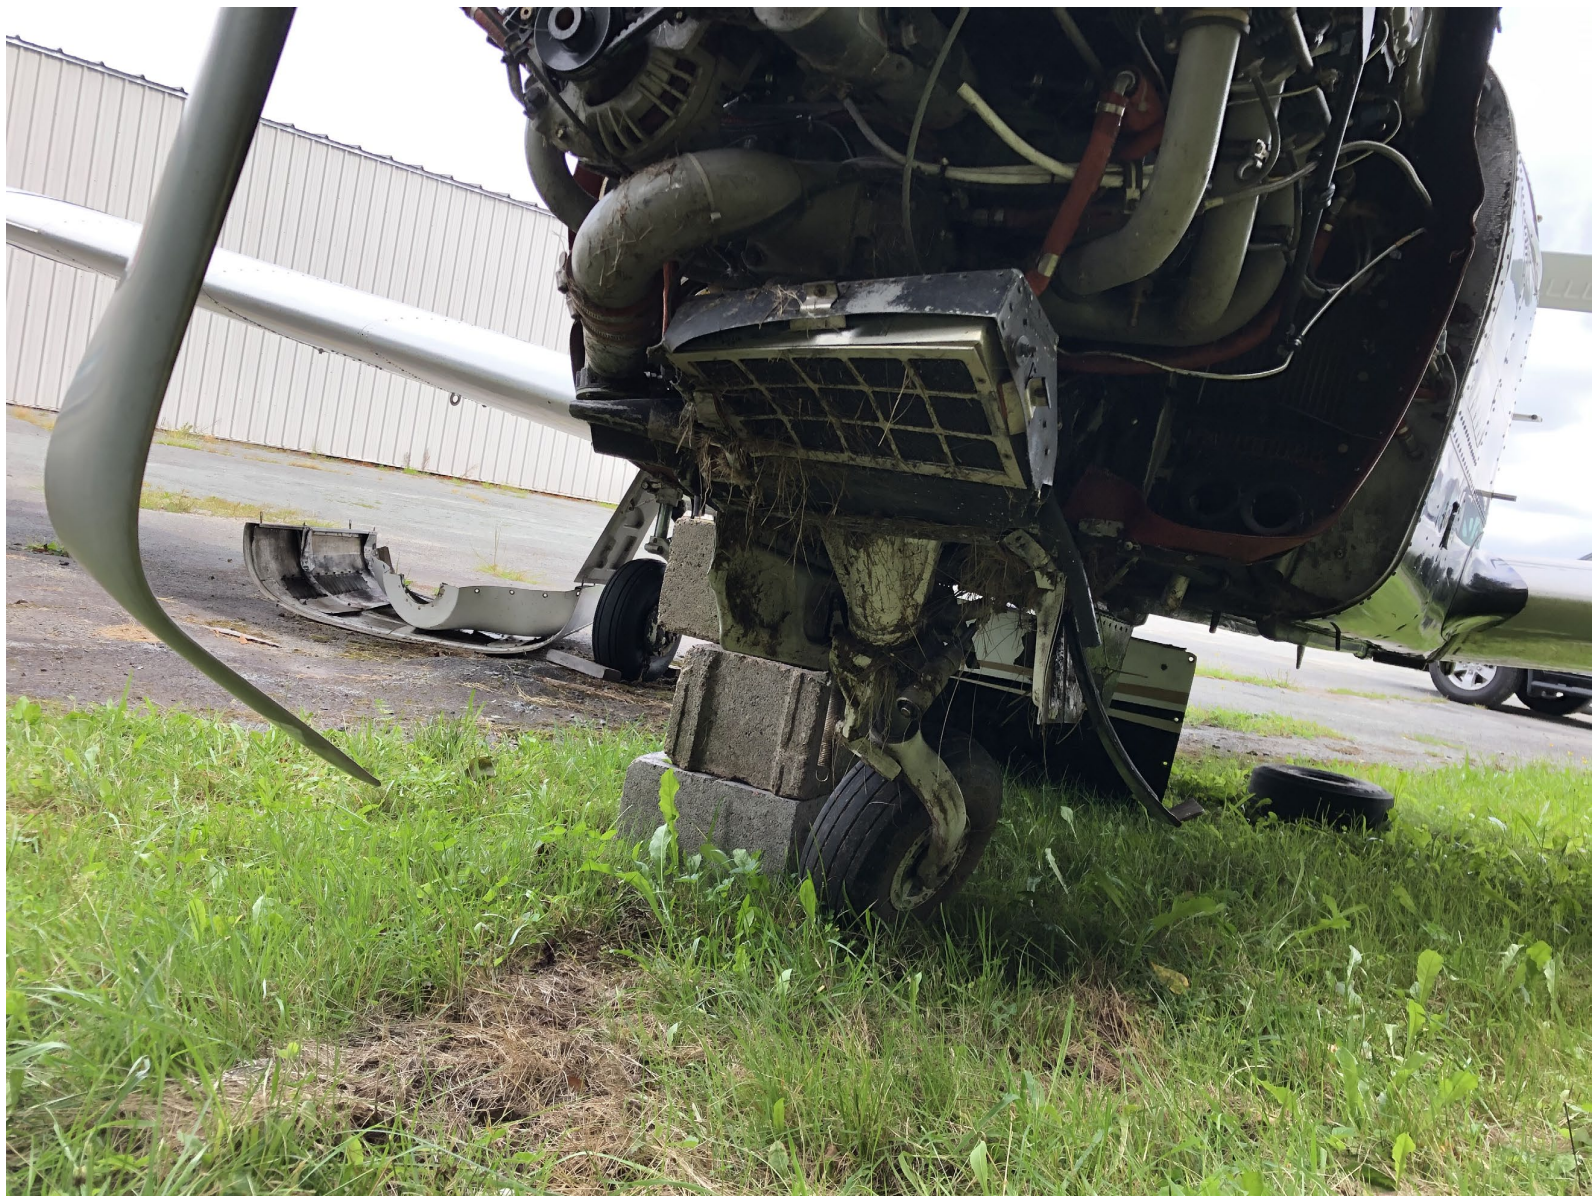
**Photo 5 – Front View – Courtesy of McLarens Adjusters**

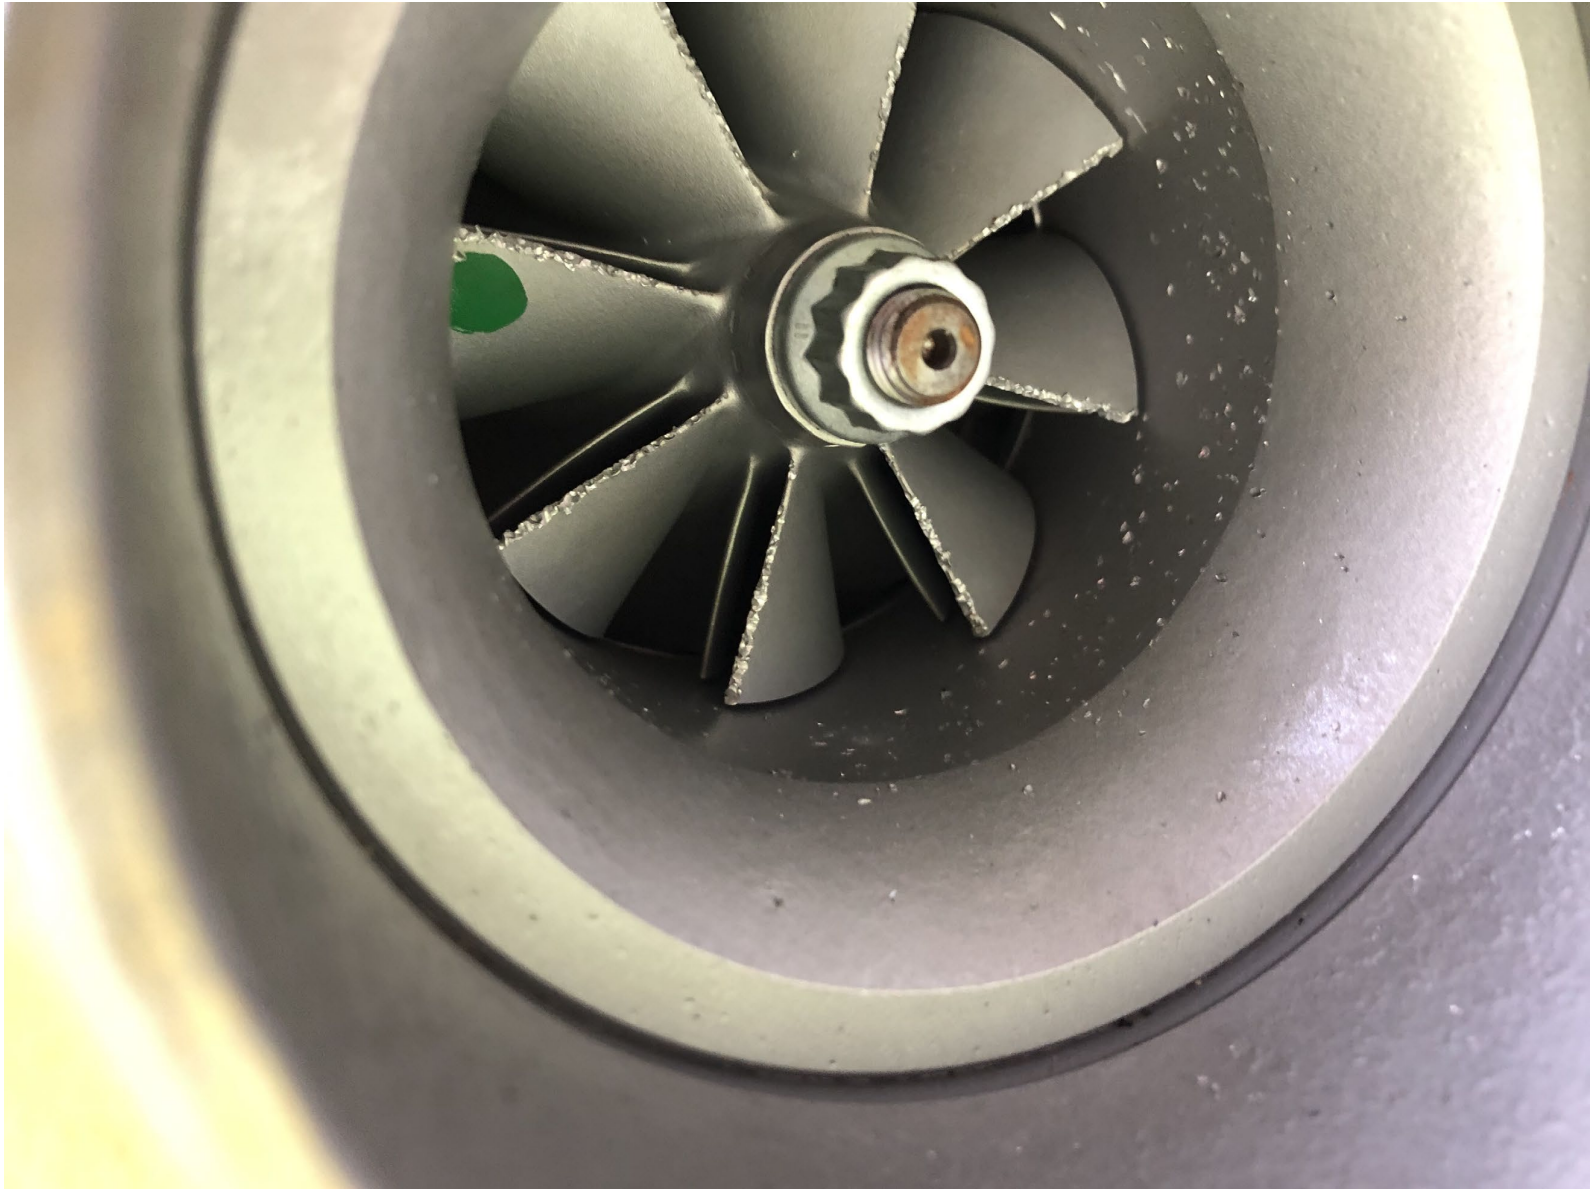
**Photo 6 – Turbocharger Inlet – Courtesy of McLarens Adjusters**

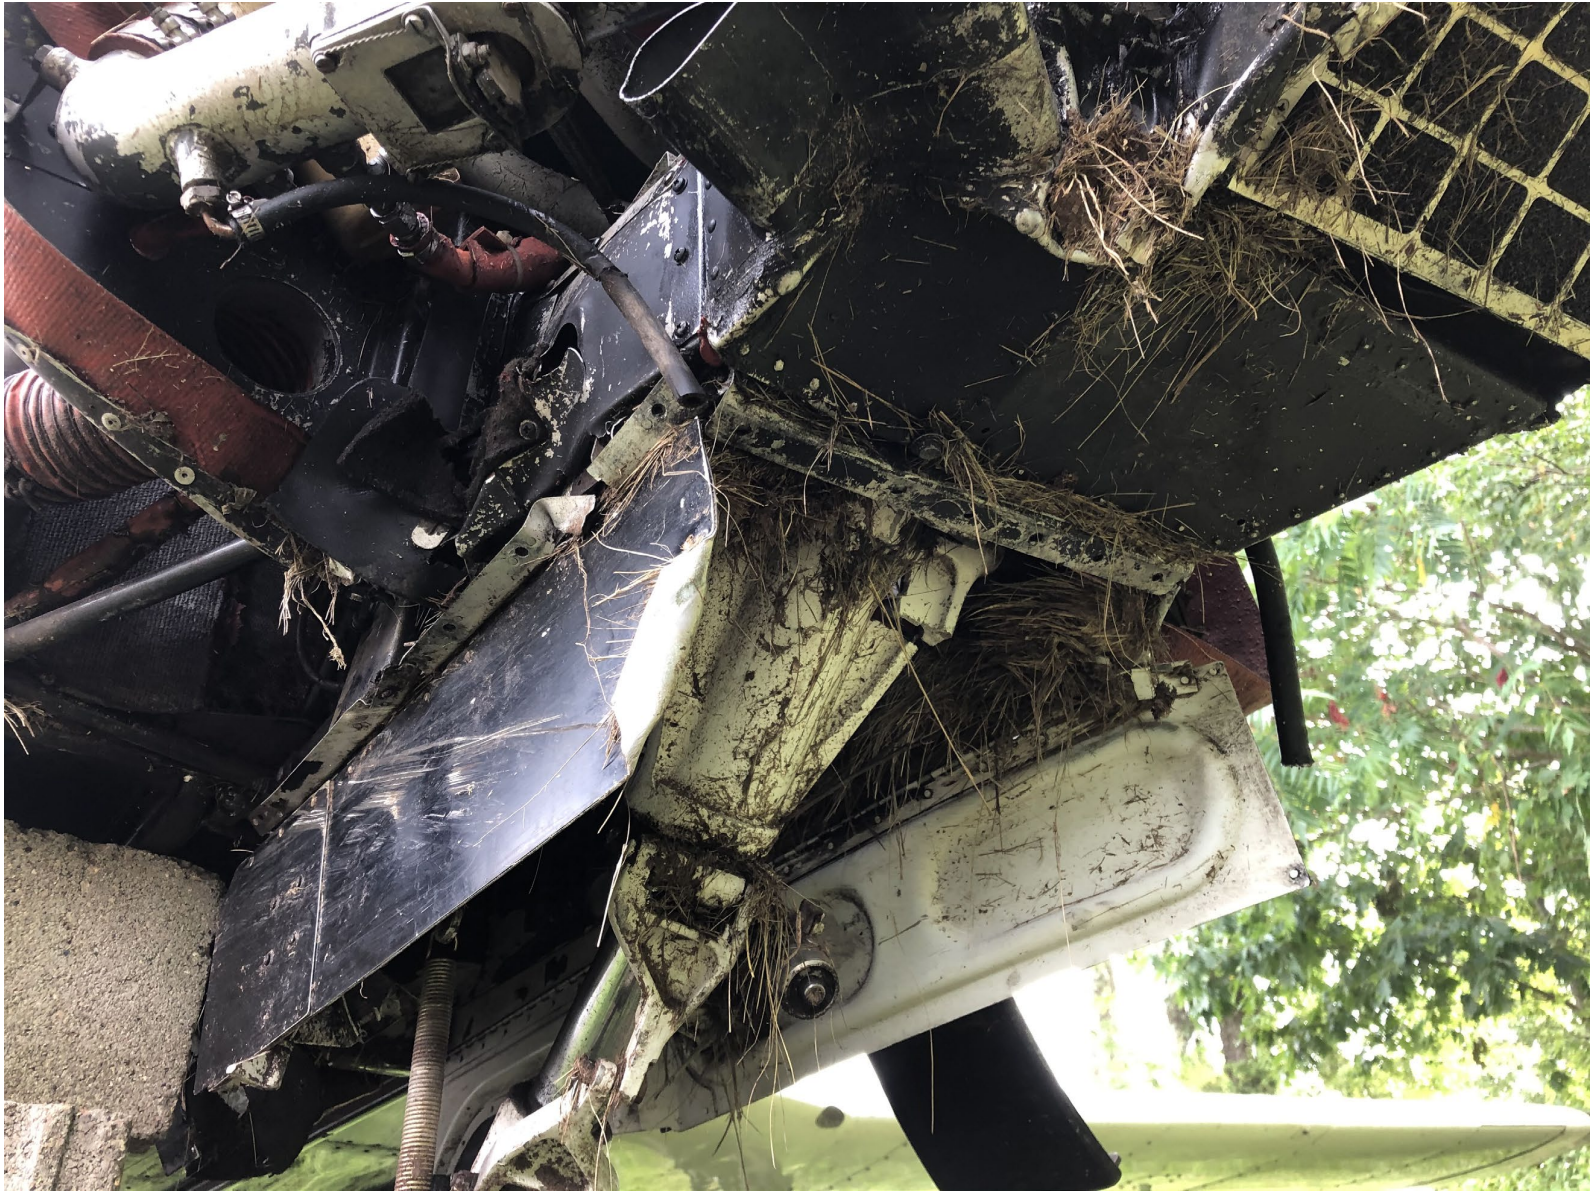
**Photo 7 – Displaced and Twisted Tunnel and Wheel Well Area – Courtesy of McLarens Adjusters**

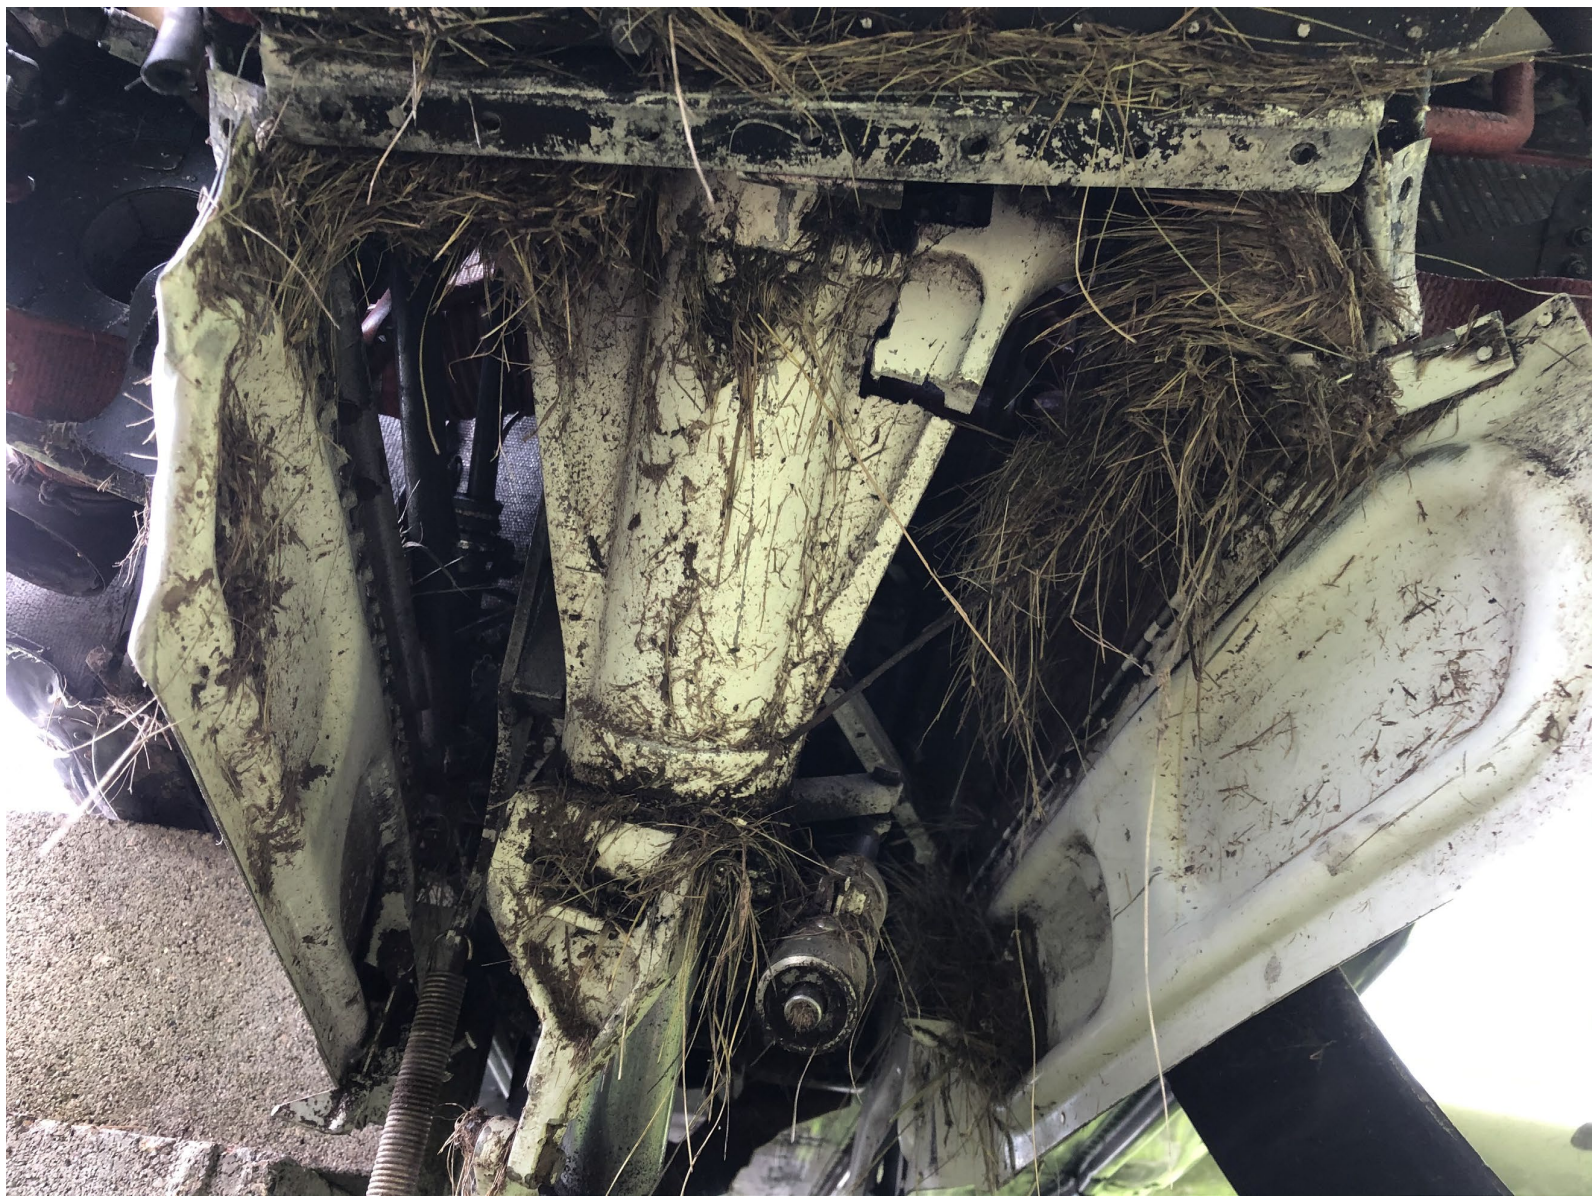
**Photo 8 – Front of Nose Landing Gear Displaying Crack and Separation from Left Trunnion – Courtesy of McLarens Adjusters**

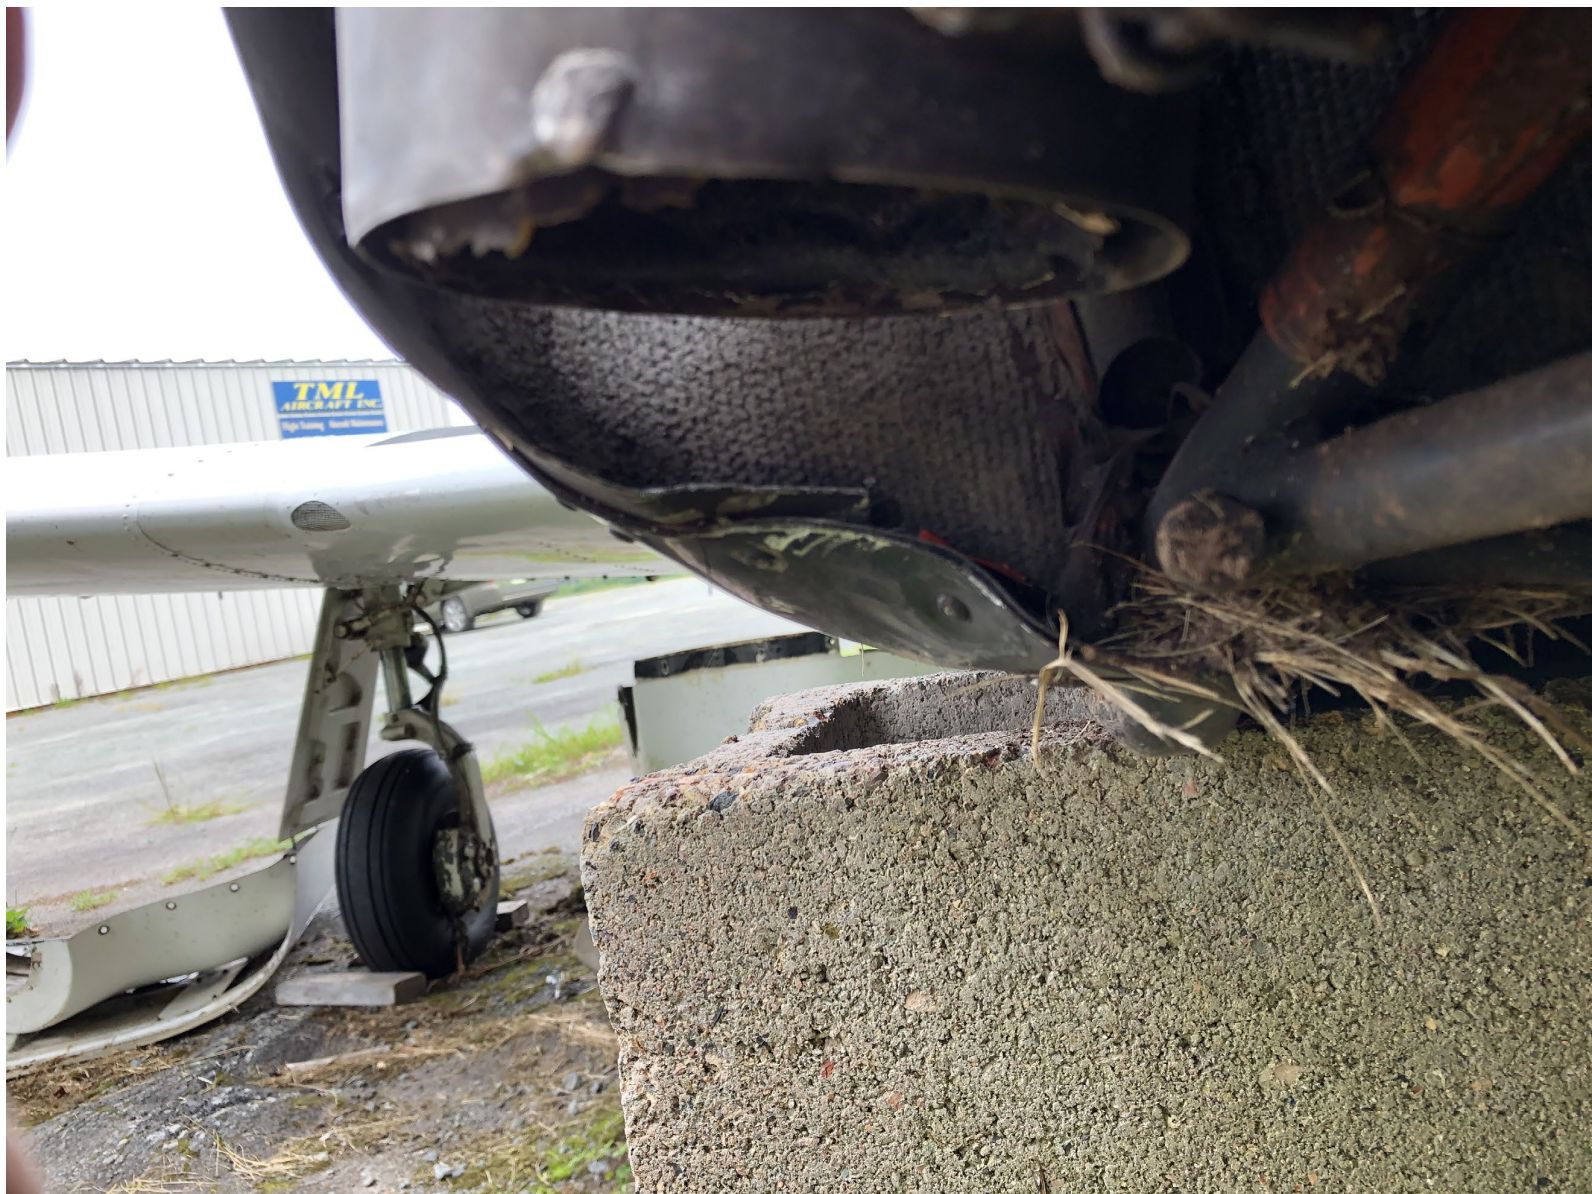
**Photo 9 – Right Side of Front Lower Fuselage Displaying Damage at Fuselage Firewall Structure – Courtesy of McLarens Adjusting**

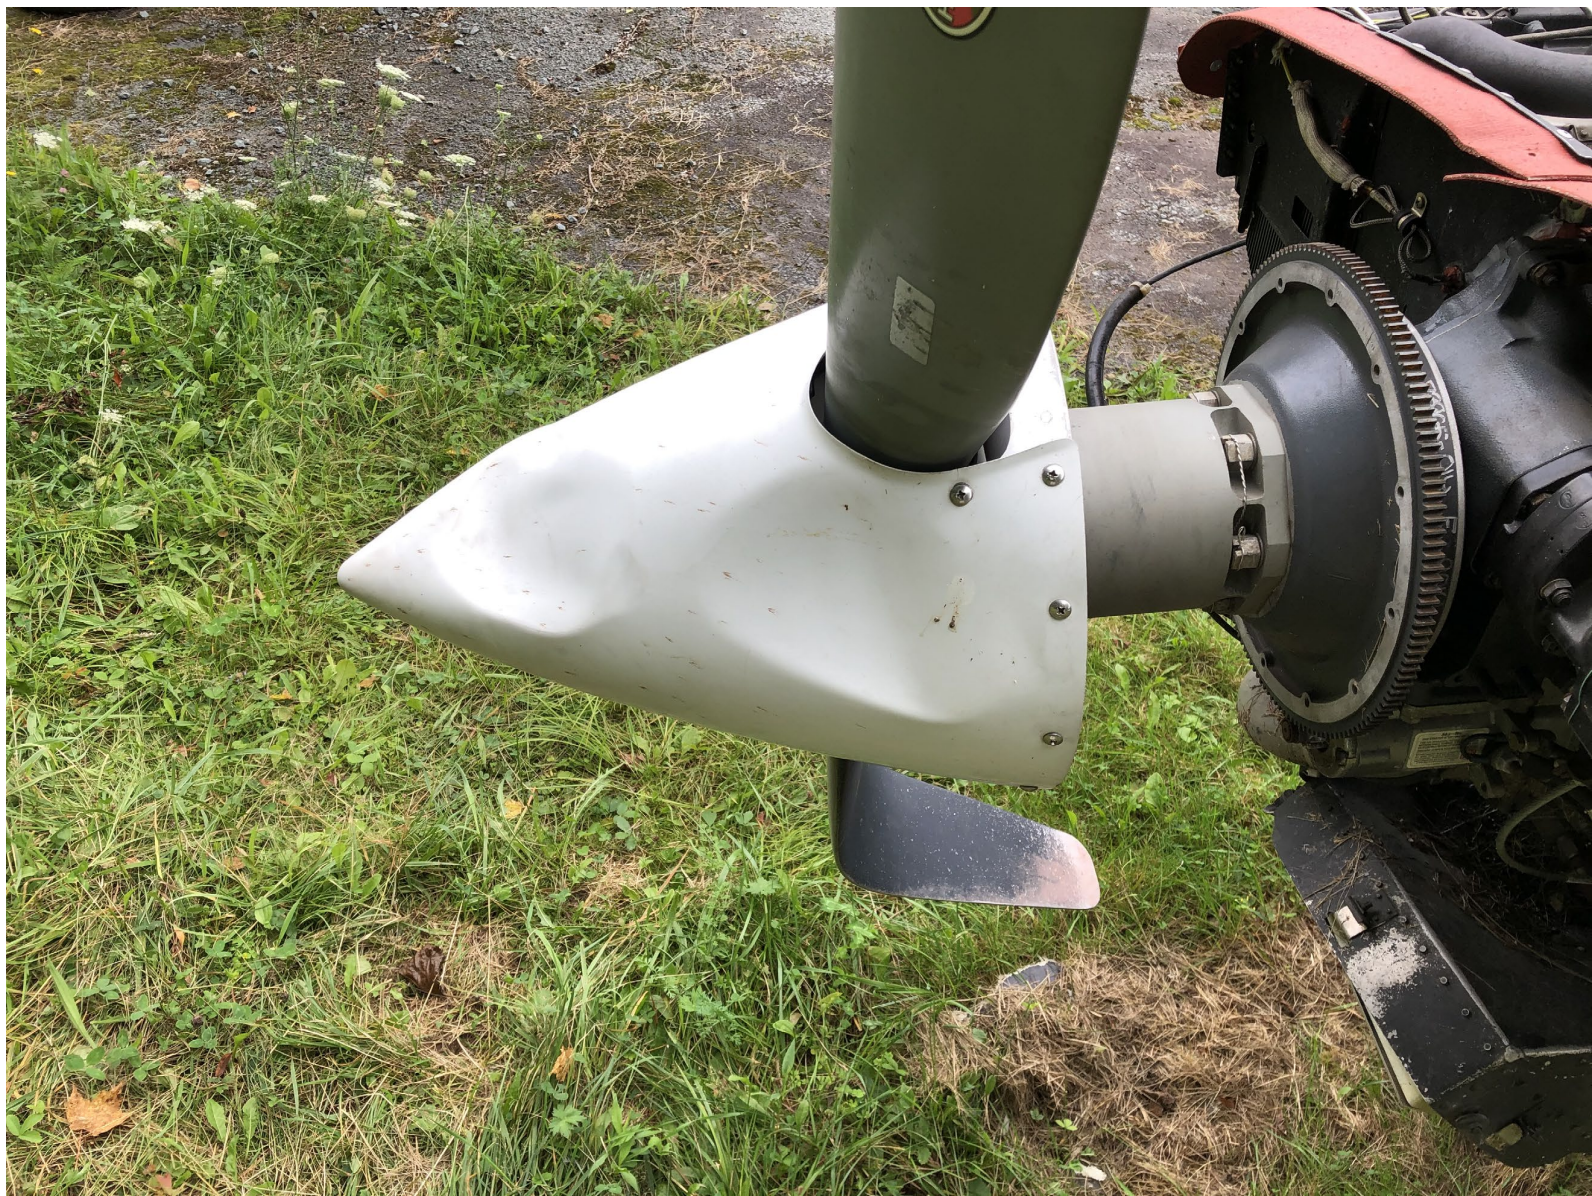
**Photo 10 – Close Up of Spinner – Courtesy of McLarens Adjusting**

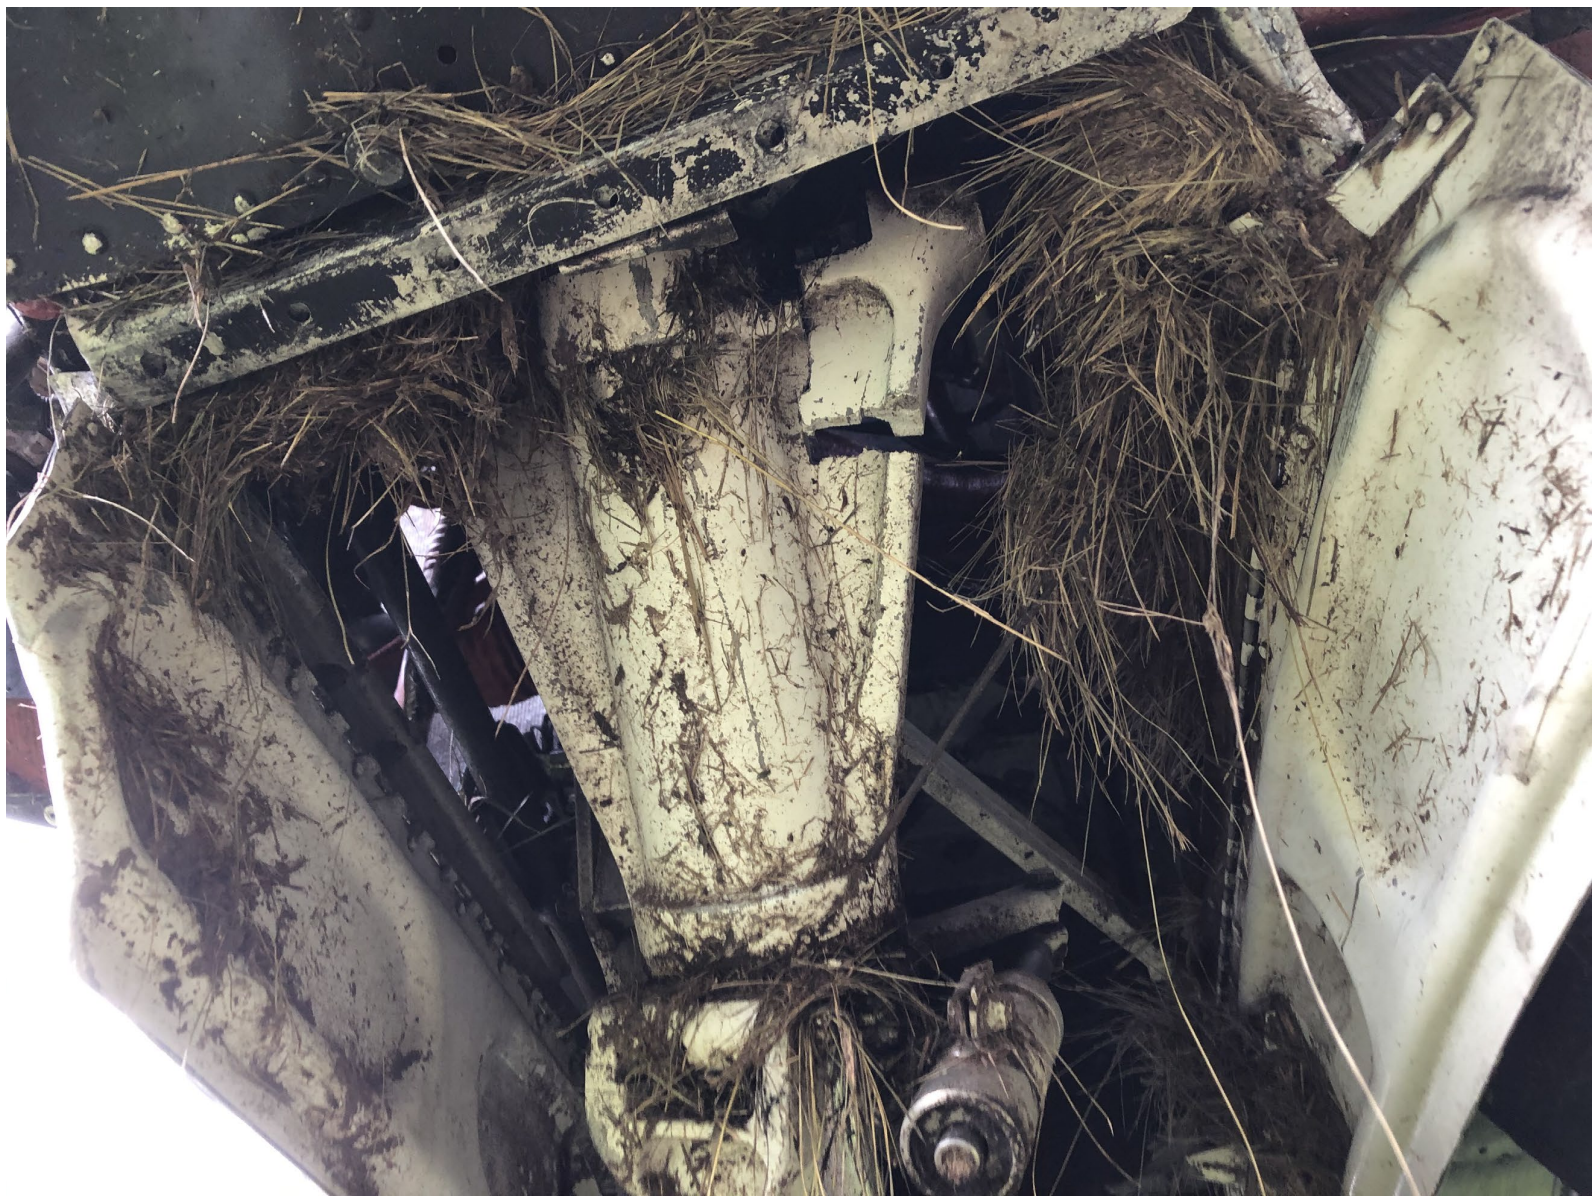
**Photo 11 – Close Up of Displaced Nose Landing Gear – Courtesy of McLarens Adjusting**

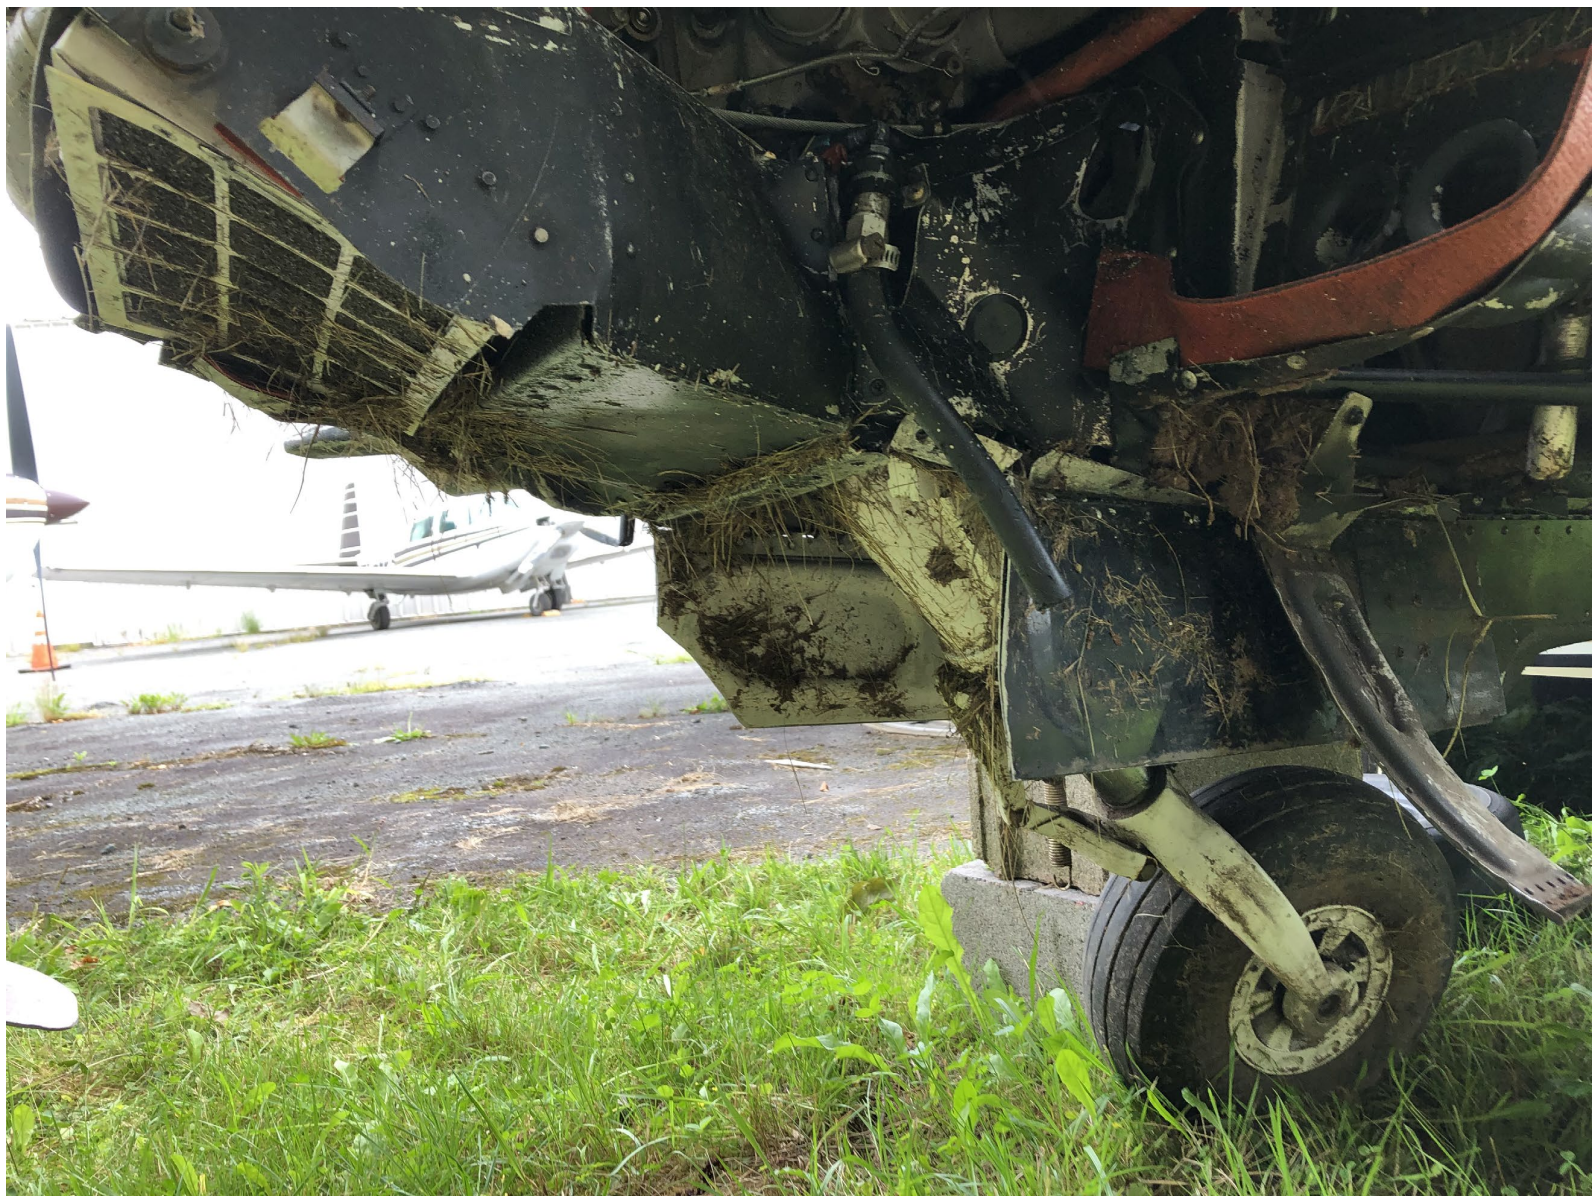
**Photo 12 – Left Side of Wheel Well and Tunnel – Courtesy of McLarens Adjusting**
