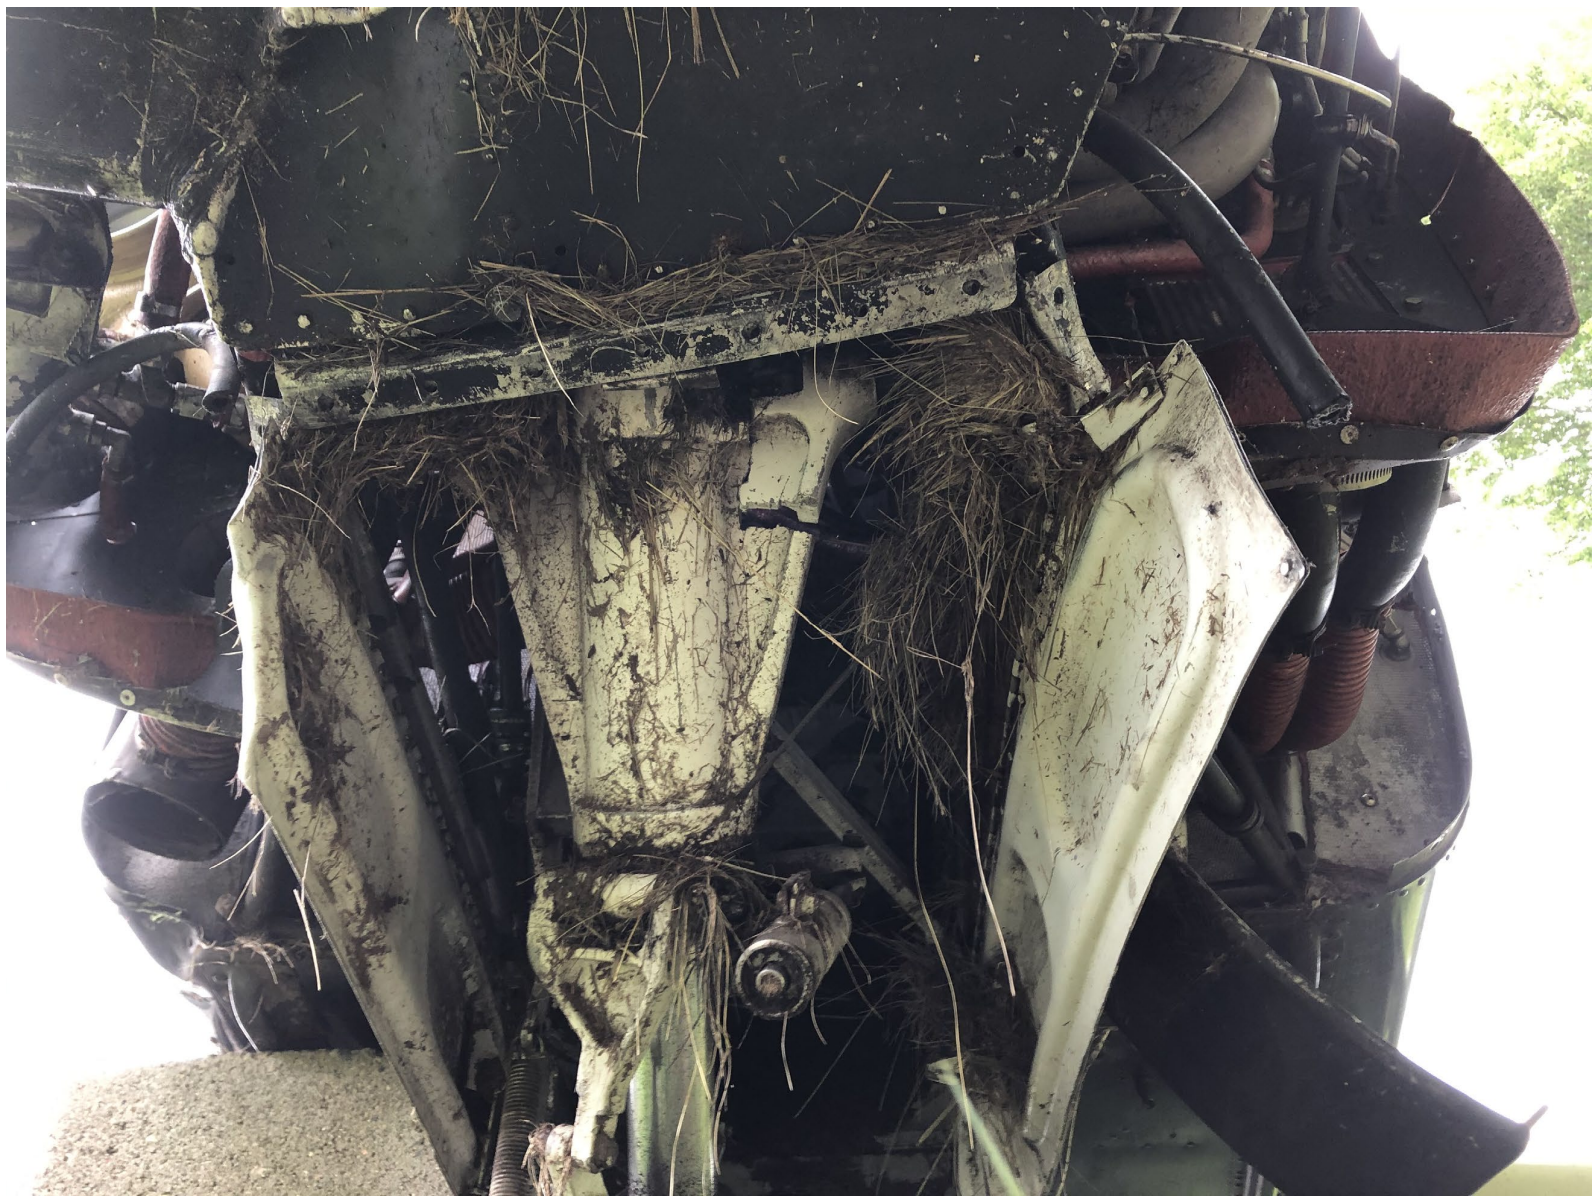
**Photo 13 – Bottom View of Engine Showing Displacement to Right of Mounting Location – Courtesy of McLarens Adjusters**

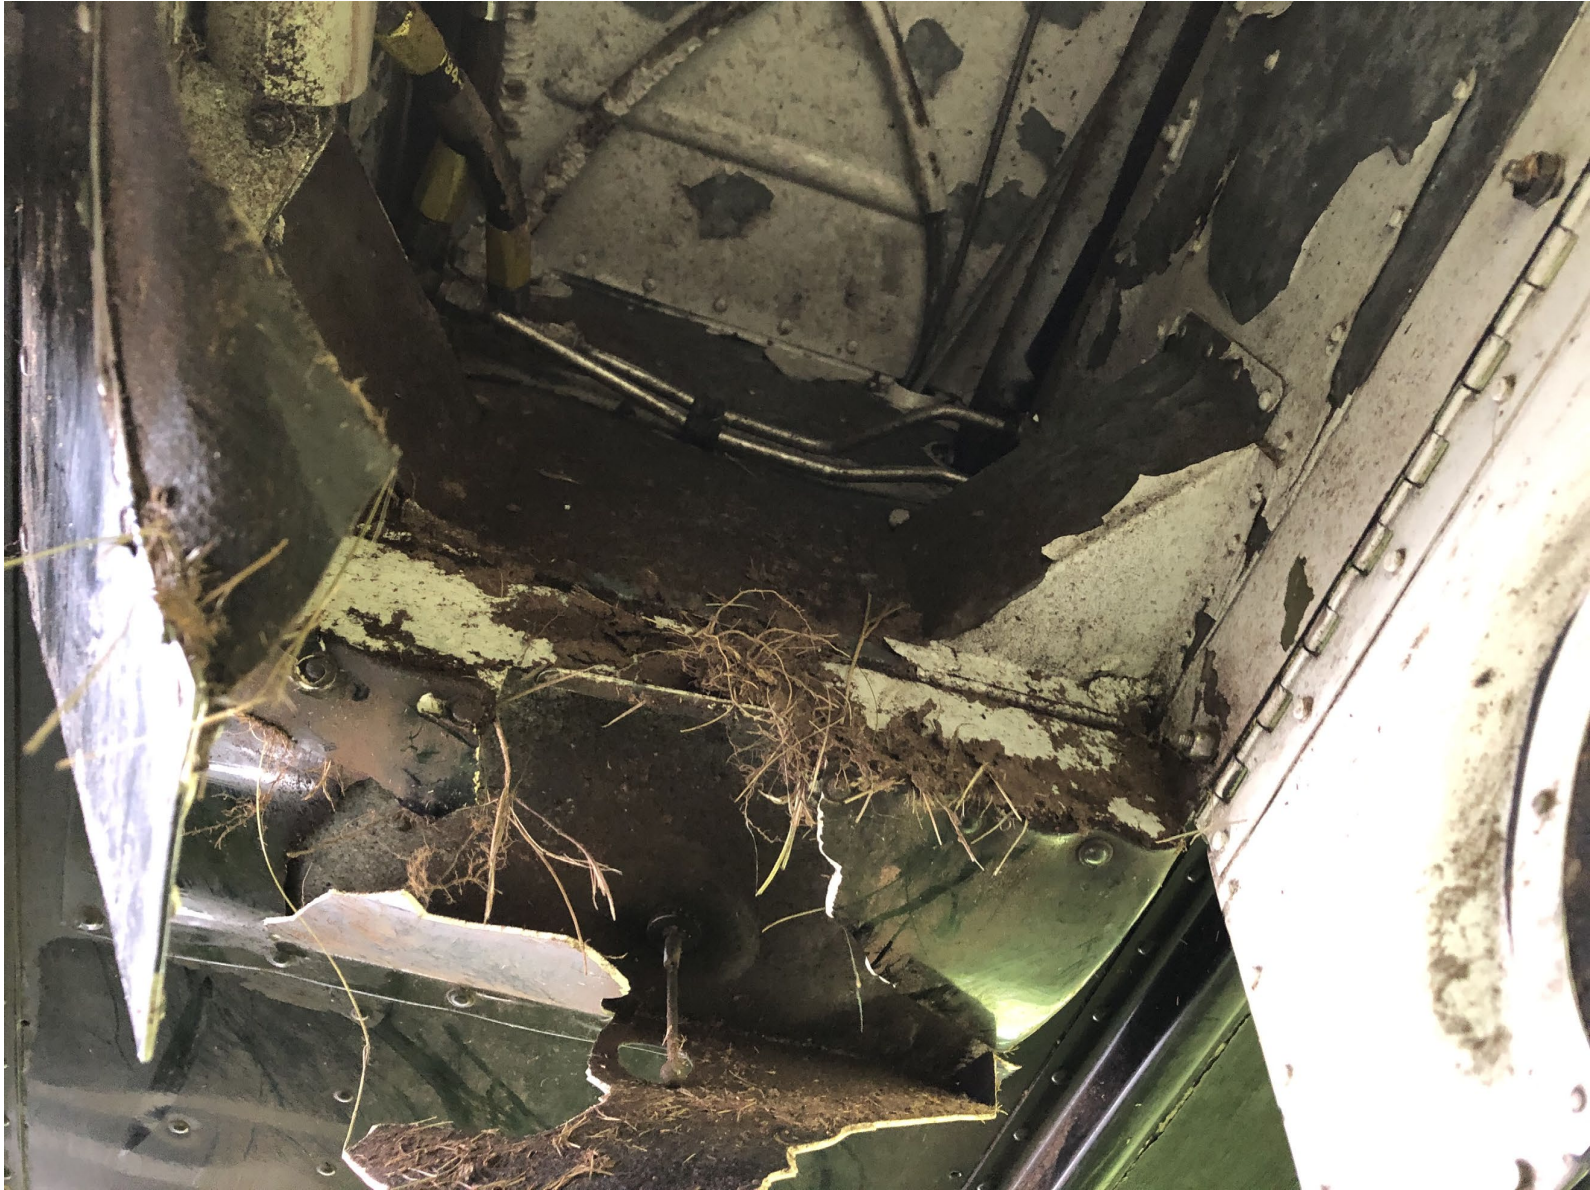
**Photo 14 – Damage to Aft Wheel Well, Sheet Metal and Bulkhead – Courtesy of McLarens Adjusters**
