# NATIONAL TRANSPORTATION SAFETY BOARD

## MATERIALS LABORATORY FACTUAL REPORT

Report No. 21-013

Place : St. Agatha, Maine  
Date : August 5, 2020  
Vehicle : Piper PA-28-180, N7213W  
NTSB No. : ERA20LA277  
Investigator : Adam Gerhardt, AS-ERA

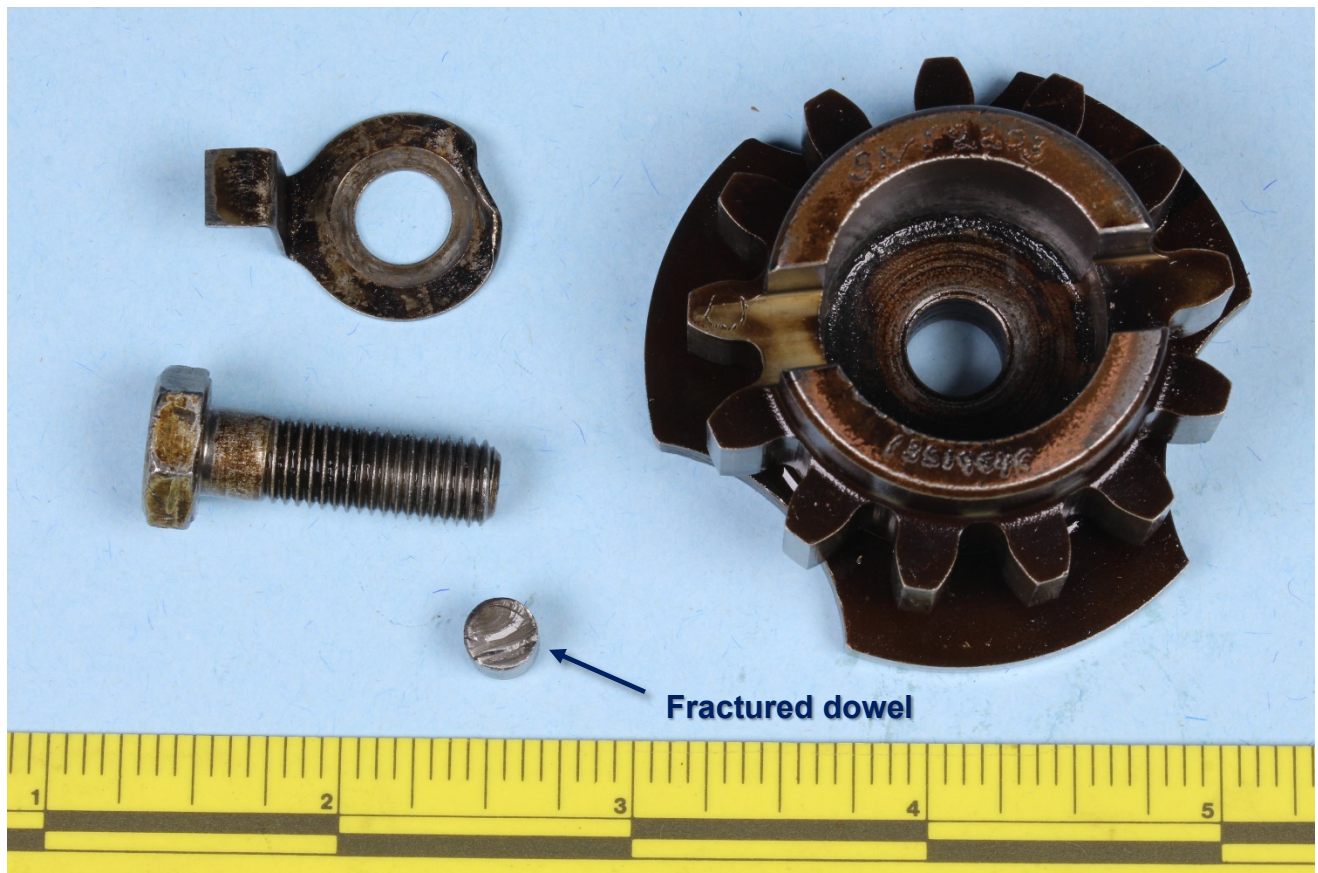
Figure 1 shows the parts from the Lycoming O-360 engine, as received.<sup>1</sup> These parts, from the aft position of the crankshaft, included a crankshaft drive gear, attachment bolt, lock plate, and a fractured dowel remnant.

Figure 1 – View of the crankshaft drive gear, bolt, lockplate, and fractured pin, as received.

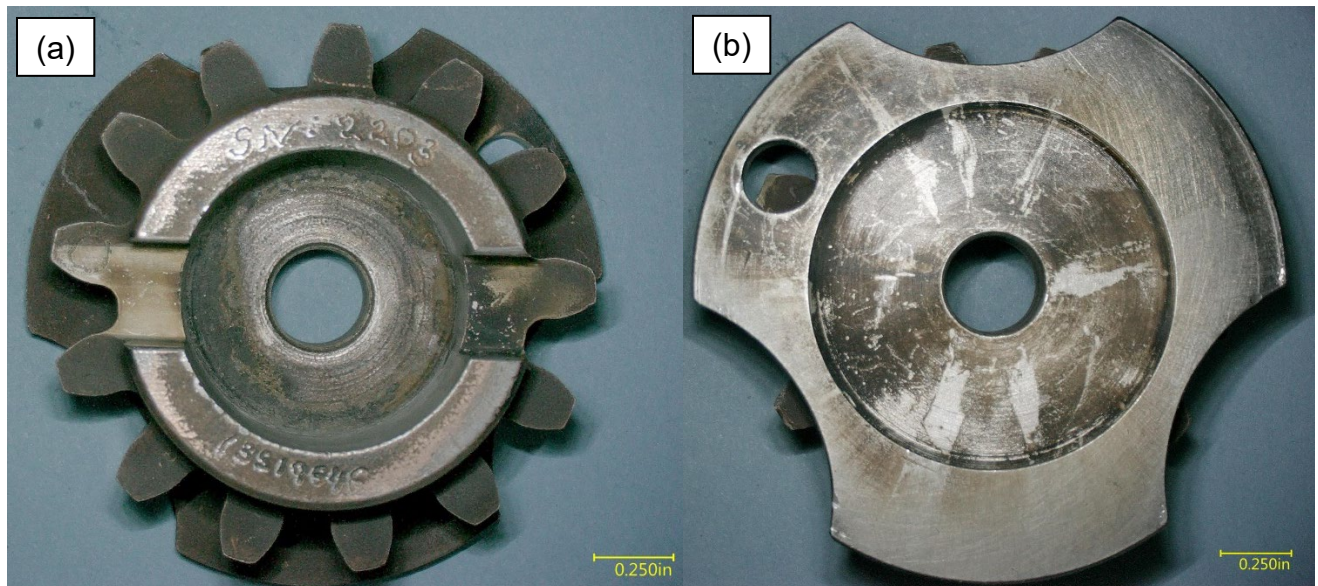
Figure 2 shows the drive gear from the aft and forward faces, as received. The drive gear had affixed to the aft face of the crankshaft via the lock plate and the attachment bolt. The aft face of the drive gear, shown in Figure 2a, exhibited the following vibroetched

markings: "SN: 2203 13519548". The aft face did not exhibit any indications of plastic deformation or impact damage, although it did exhibit some darker areas consistent with carbonaceous deposits.

The forward face, shown in Figure 2b, exhibited some rotational scratch marks on the outer areas. As such, it exhibited a shinier, lighter color than the recessed central regions. This area though, did exhibit some radial witness marks. In the upper left of Figure 2b was the dowel hole. There were some circular wear marks surrounding the hole, with some rounding on the forward edge.

Figure 2 – The drive gear viewed from the (a) aft side and (b) the forward side, as received.

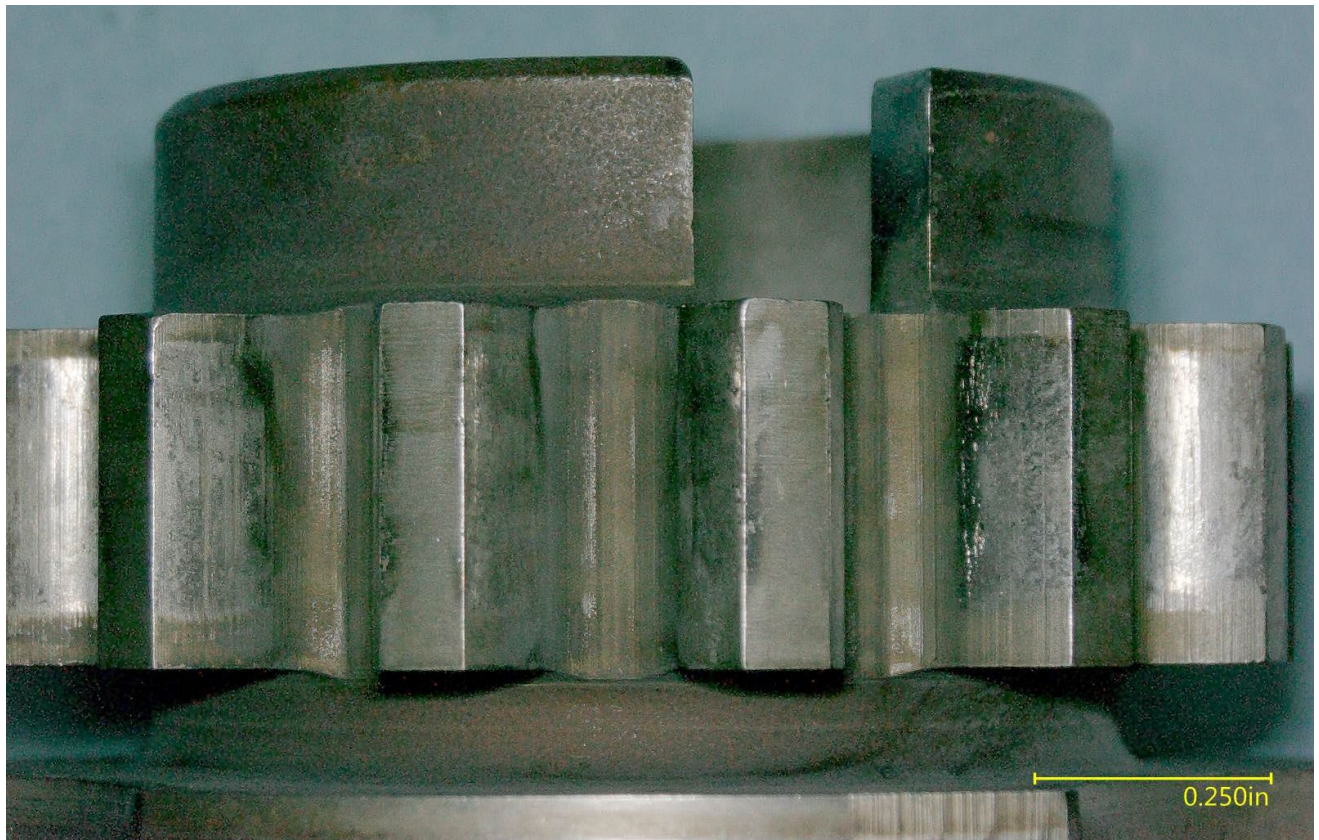
Figure 3 shows a typical view of some of the gear teeth. This figure demonstrates the contact areas on the faces of many of the drive gear teeth. The faces of the gear teeth exhibited some longitudinal wear marks and rectangular reflective regions, consistent with contact with the teeth of the mating gear. None of this wear was severe enough to manifest as gouging, deformation, or material loss on the gear, and was consistent with typical contact between gear teeth.

Figure 3 – Closer view of the drive gear teeth surfaces, as received.

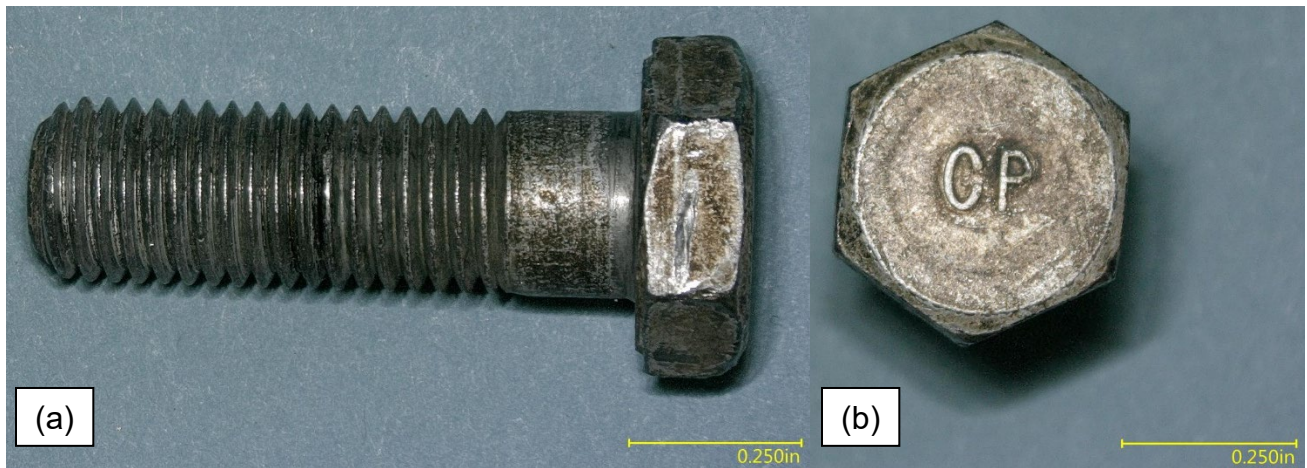
Figure 4 shows the attachment bolt from the side and the head. The head exhibited the markings "CP". The threaded areas of the bolt exhibited a consistent color and luster along all of the threads, and there was no indications of missing material, plastic deformation, or wear. The unthreaded portion of the shaft underneath the head side exhibited an area of chatter marks, consistent with fretting wear. No other damage was noted on the bolt.

Figure 4 – The attachment bolt, viewed from (a) the side with the threads and (b) the head.

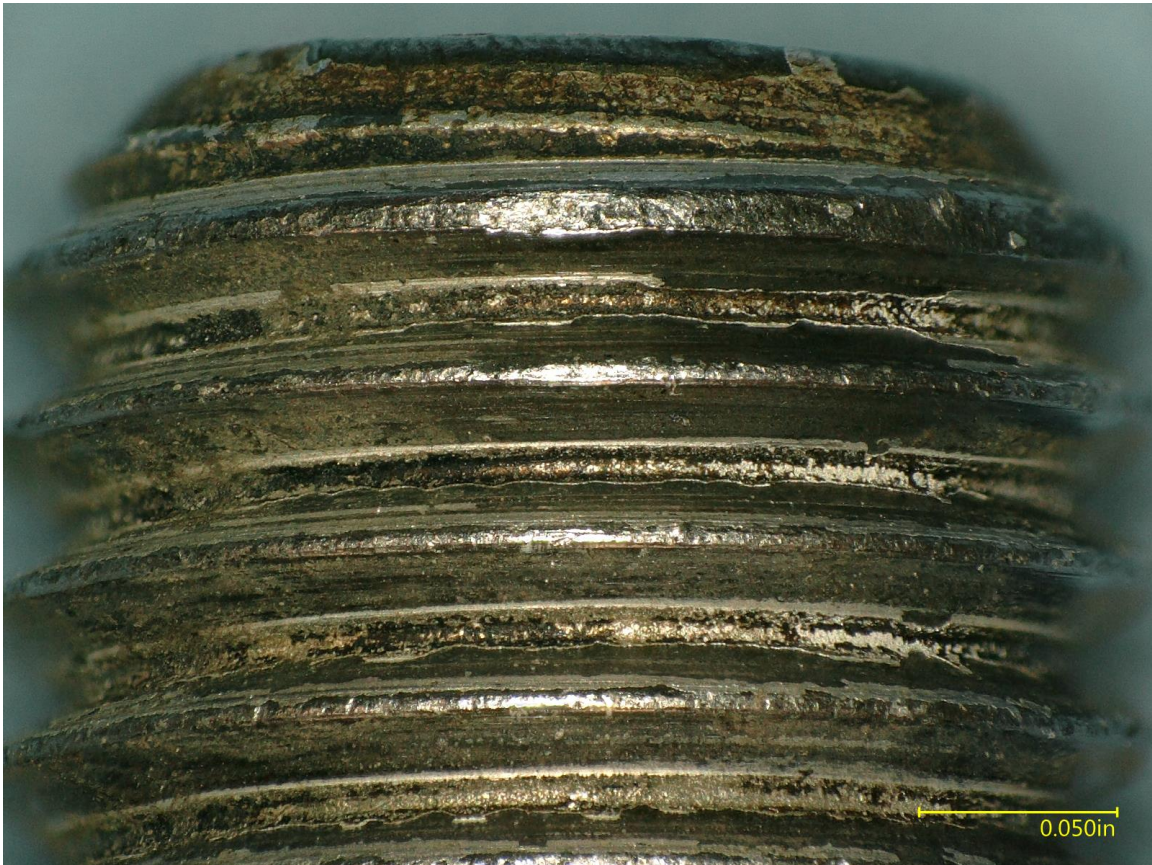
Figure 5 shows a closer view of the threads from the bolt. The threads exhibited some rounding of the crests and wear on the threads of the lands. There were no indications of any purple, blue, red, or green substances that would be consistent with an applied thread-locking fluid.

Figure 5 – Closer view of the threads of the attachment bolt.

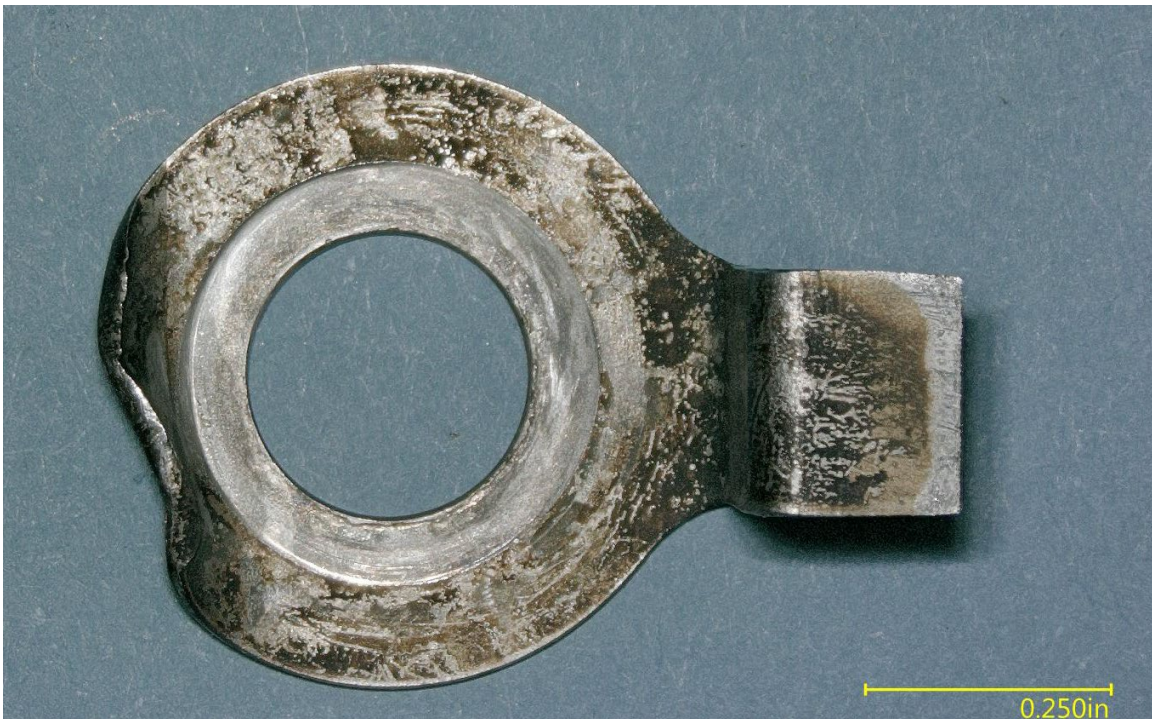
Figure 6 shows the lock plate from the aft face, as received. The face edge opposite the U-shaped tab had been deformed aft ward. While most of the surfaces exhibited a light brown color consistent with oil exposure, the central portions of this face exhibited a ring of rotational wear, which exhibited circular witness marks and a lighter, more reflective luster. Further, the outer edges of the tab exhibited some lateral wear, exemplified by the witness marks and lighter color.

Figure 6 – The lock plate, viewed from the aft side, as received.

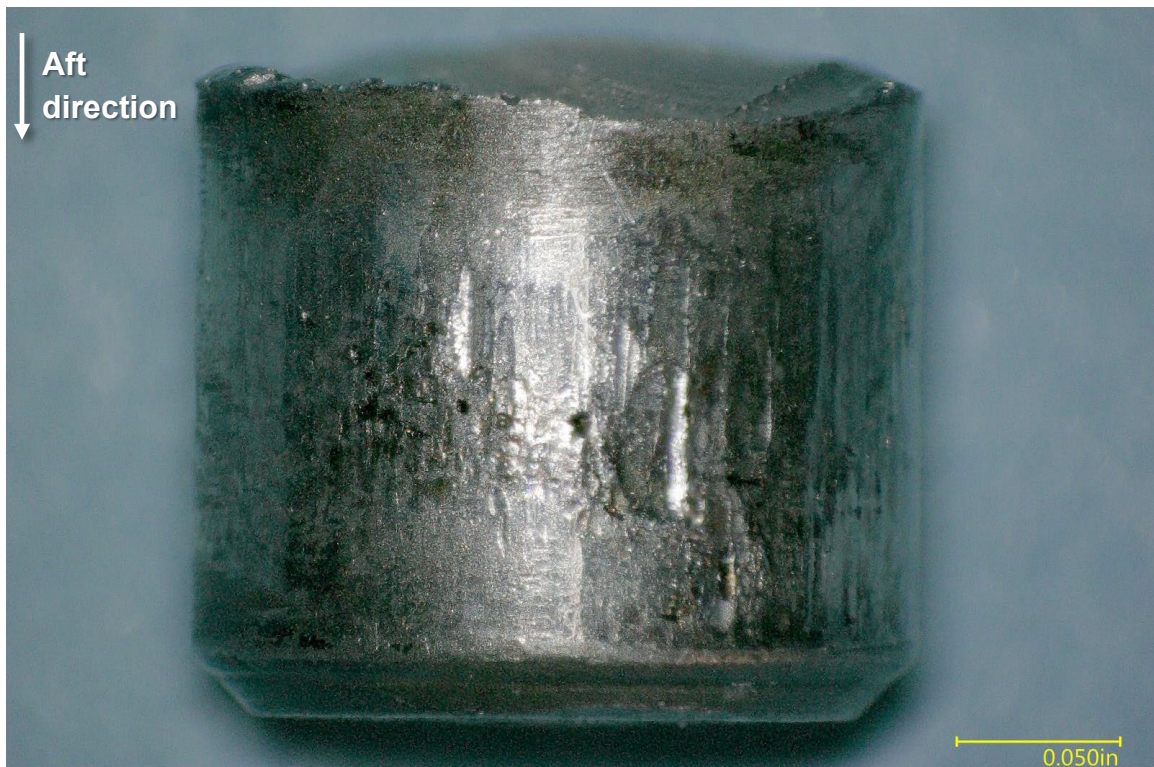
Figure 7 shows the fractured crankshaft dowel remnant, viewed from the side. As shown in the figure, the dowel exhibited longitudinal gouging and chatter marks, with areas of missing material, consistent with spalling. The forward area exhibited a fracture surface, which was oriented generally perpendicular to the longitudinal direction of the part.

Figure 7 – View of the fractured crankshaft dowel from the side.

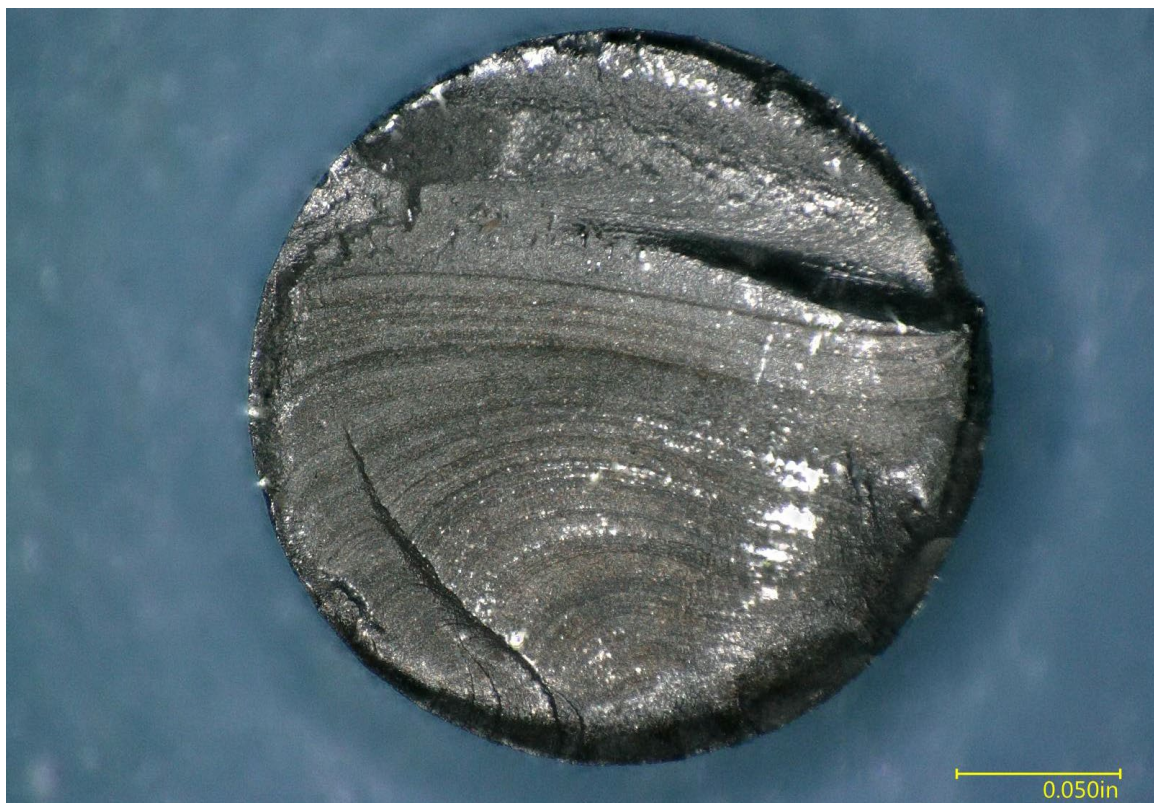
The fracture surface of the dowel remnant is shown in Figure 8 and annotated to illustrate the different areas of interest in Figure 9. The fracture surface exhibited banded crack arrest marks, consistent with crack propagation, and ratchet marks, consistent with multiple crack initiation sites. These features were determined to be consistent with fatigue crack propagation, as detailed below. As demonstrated in Figure 9, the fracture surface

Figure 8 – View of the fracture surface of the dowel remnant.

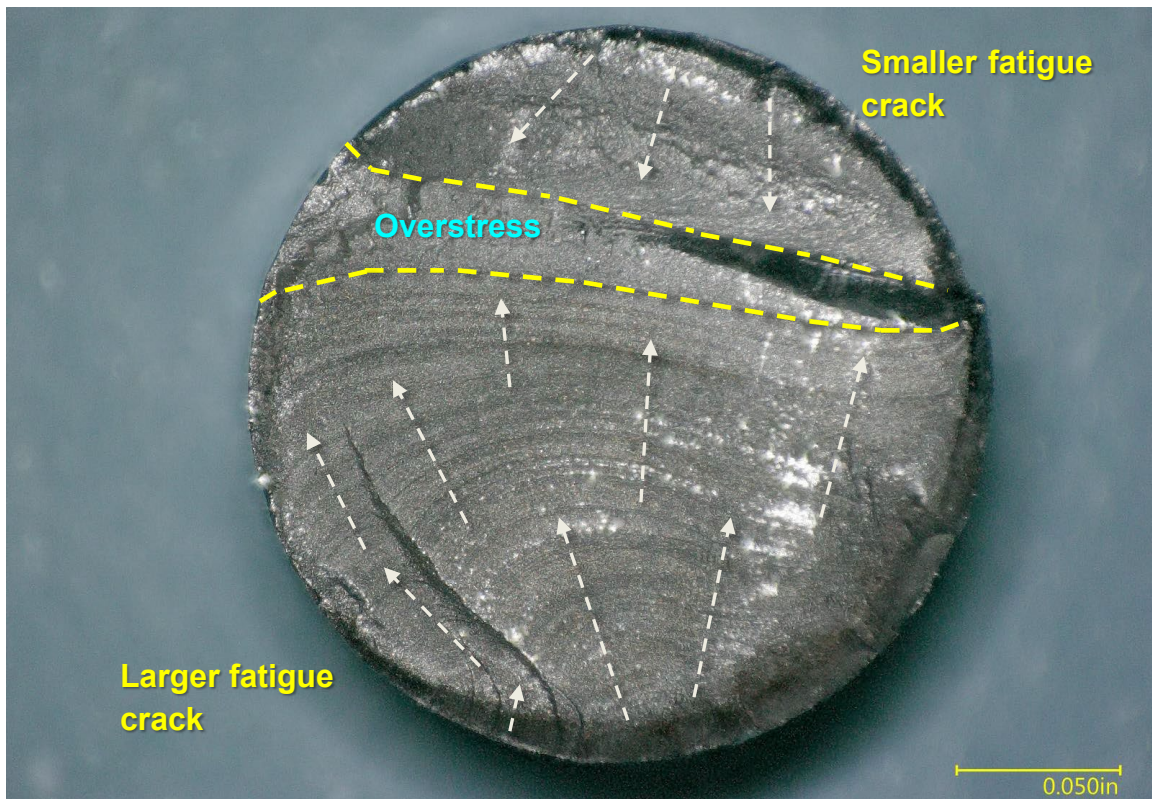
exhibited two opposite-facing fatigue cracks, whose features were consistent with having initiated at the dowel surface and propagating inward. A thin middle region exhibited different features, later determined to be consistent with subsequent overstress fracture.

The observed features from the fractured dowel remnant were consistent with reverse bending fatigue. This bending led to crack initiation along worn regions of the dowel exterior at multiple locations. These smaller cracks eventually coalesced and propagated inward, eventually from opposite sides. Once the fatigue cracks had propagated far enough inward, the remaining cross section of the dowel succumbed to overstress fracture.

Figure 9 – Annotated view of Figure 8, showing different fracture areas.

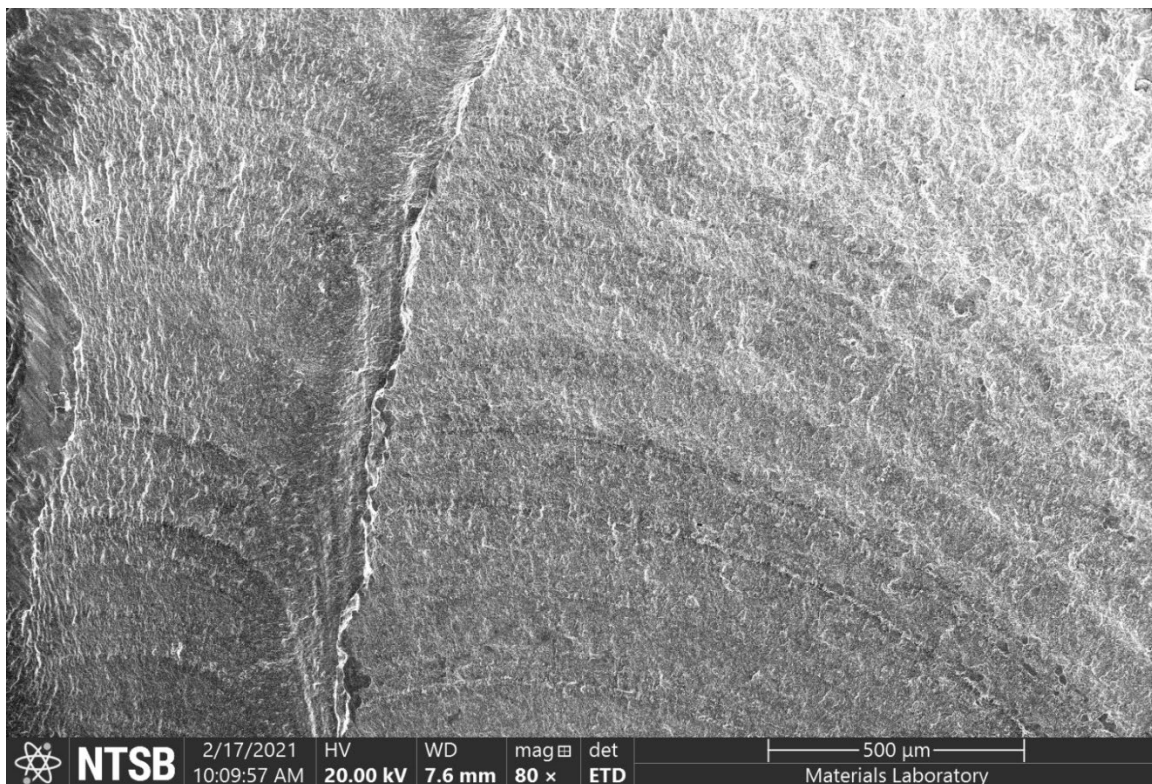
The dowel remnant fracture surface was cleaned using acetone and examined using a scanning electron microscope (SEM). As shown in Figure 10 through Figure 12, the progressive regions of the fracture surface exhibited fatigue striations, consistent with fatigue crack propagation. On the larger crack, there was a large ratchet mark separating two areas of convex-shaped arrest marks (Figure 10). These features were consistent with two areas of crack propagation that advanced side-by-side. The fatigue striations increased in size towards the end of the crack (compare Figure 12 with Figure 11). Outside of the larger fatigue crack, dimpled rupture was observed (Figure 13). These features were consistent with subsequent overstress of the remnant cross section material.

Figure 10 – Secondary electron (SE) micrograph of bow-shaped fatigue striations on two cracks separated by a ratchet mark.

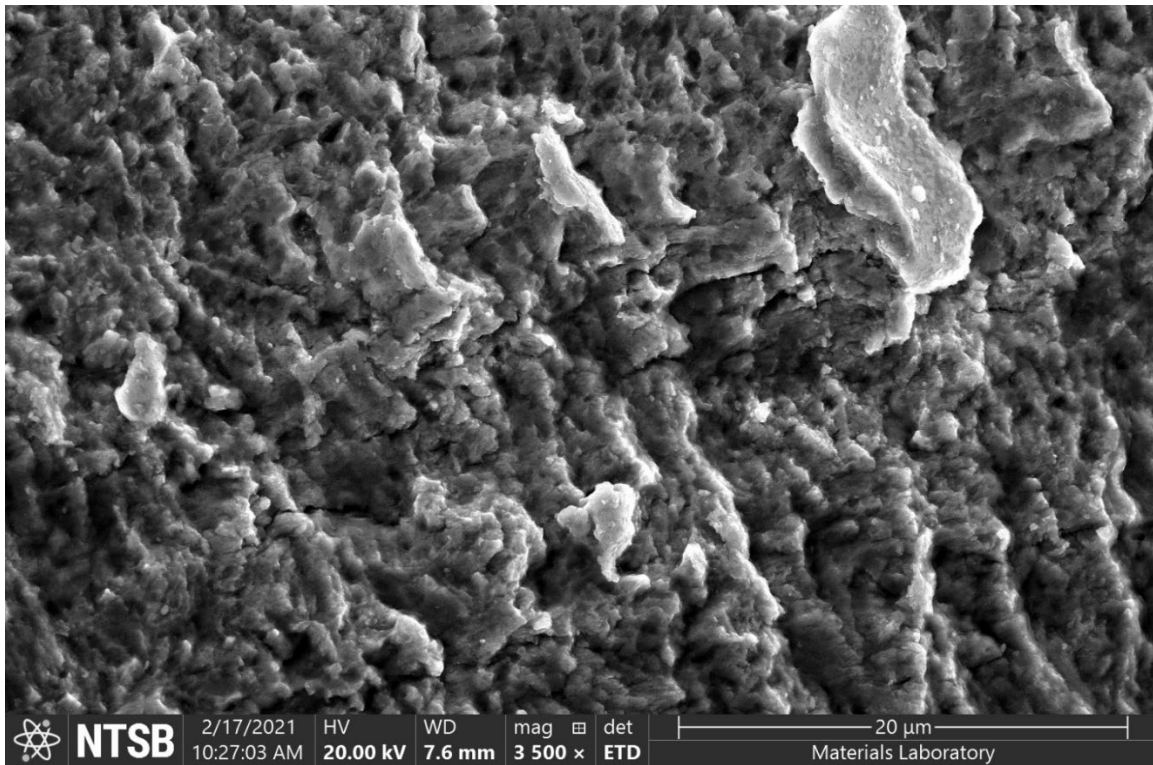
Figure 11 – SE micrograph of a closer view of the fatigue striations in Figure 10.

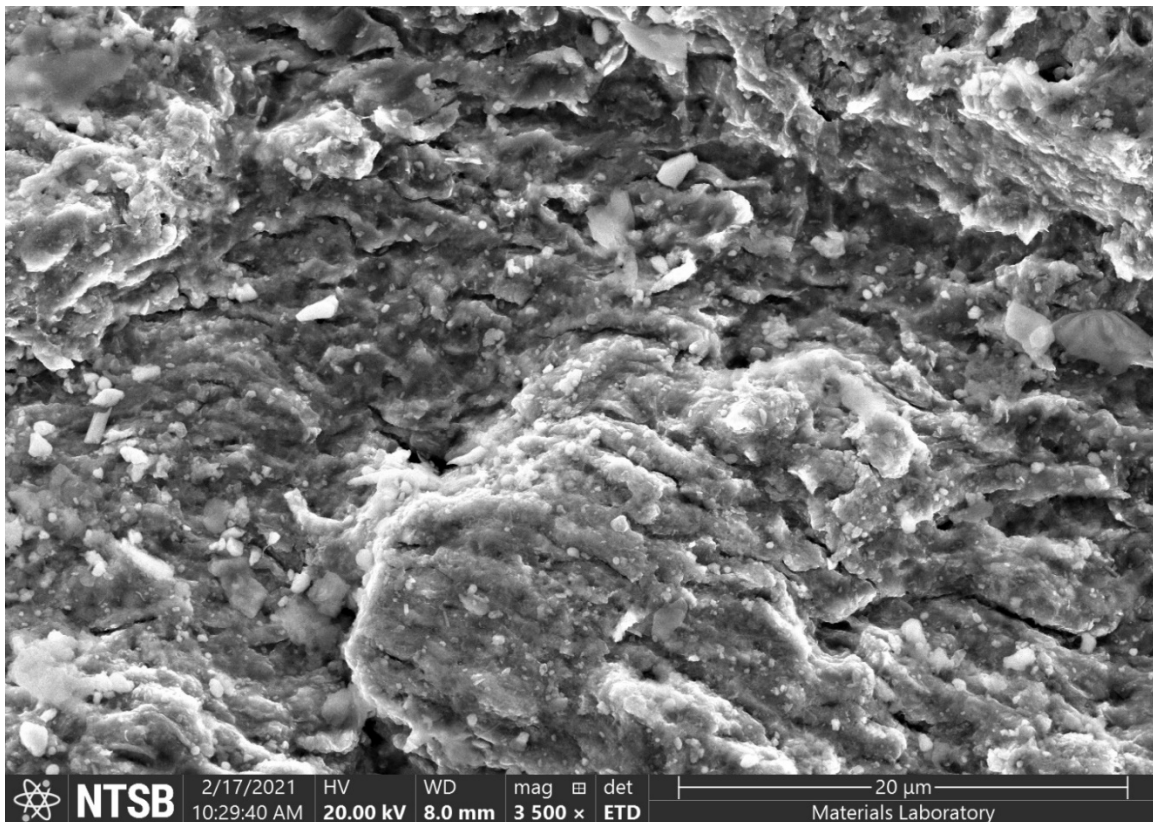
Figure 12 – SE micrograph of fatigue striations at the end of the large crack front.

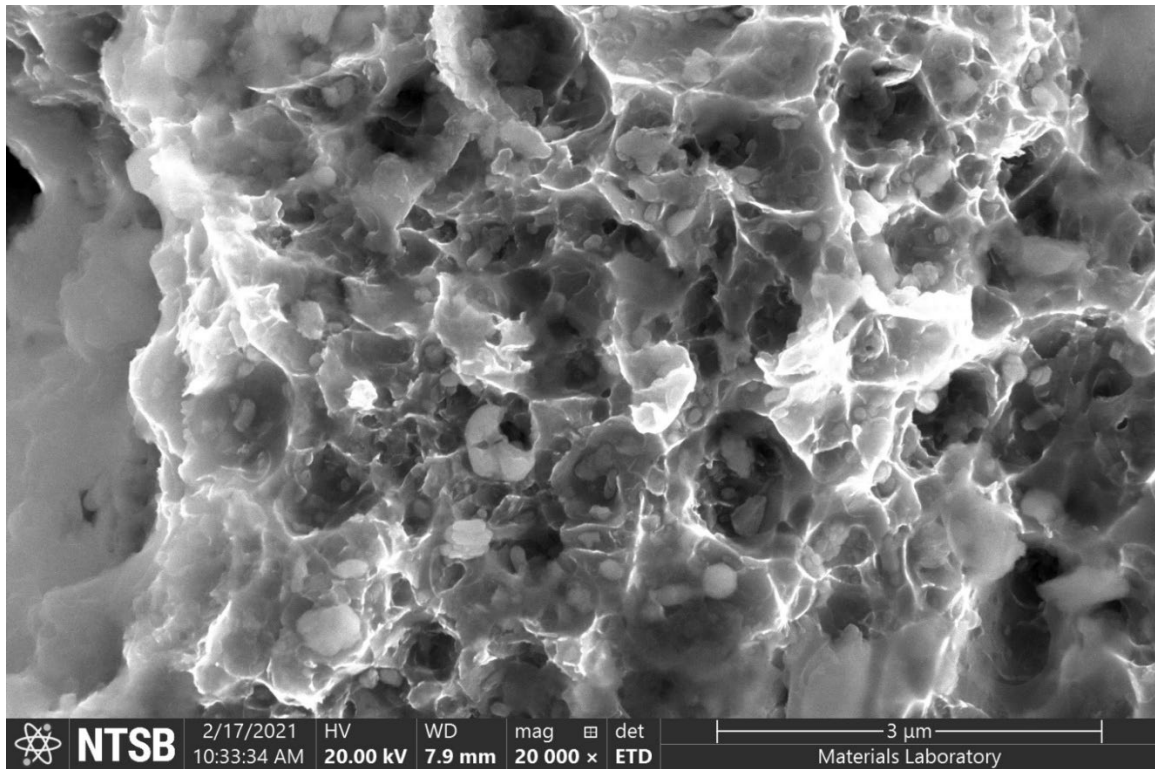
Figure 13 – SE micrograph of dimpled rupture in the overstress area of the dowel.

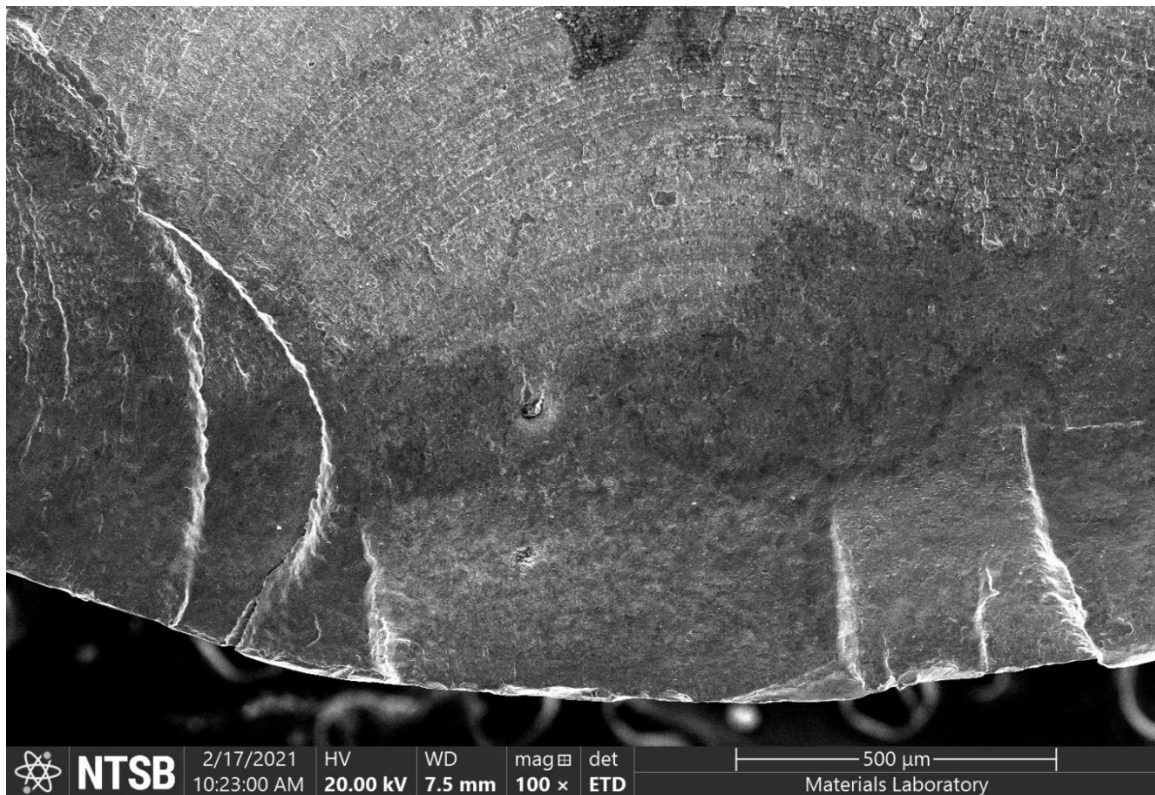
The two areas of fatigue crack initiation along the dowel surface of the larger crack themselves exhibited smaller ratchet marks consistent with additional crack initiation sites (see Figure 14 and Figure 15). The primary fatigue crack initiation site is highlighted in Figure 16. This area exhibited radial marks emanating from the site along the surface. The site itself exhibited a rounded facet morphology, consistent with mechanical damage from impact. Figure 17 exhibits another crack initiation site near the one in Figure 16, which had been less damaged. This crack initiation site did not exhibit any mechanical or material fracture features.

Figure 14 – SE micrograph of the primary fatigue crack initiation sites.

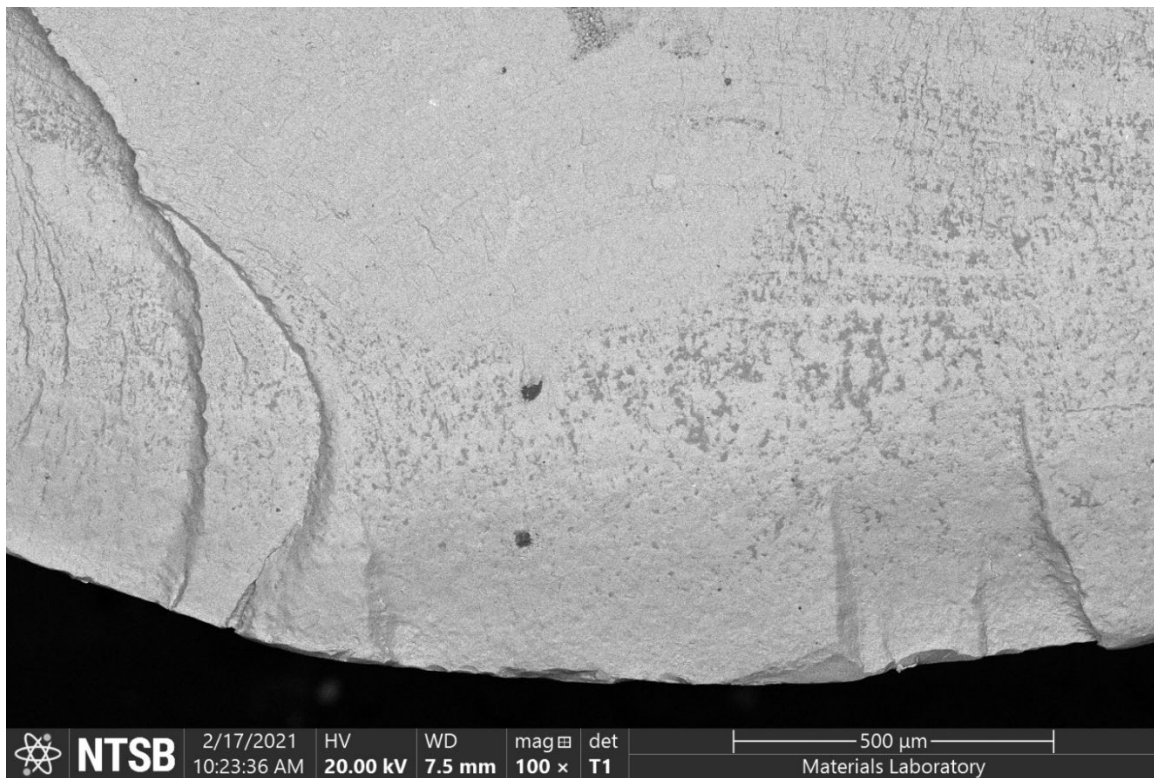
Figure 15 – Backscattered electron (BE) micrograph of the initiation sites in Figure 14.

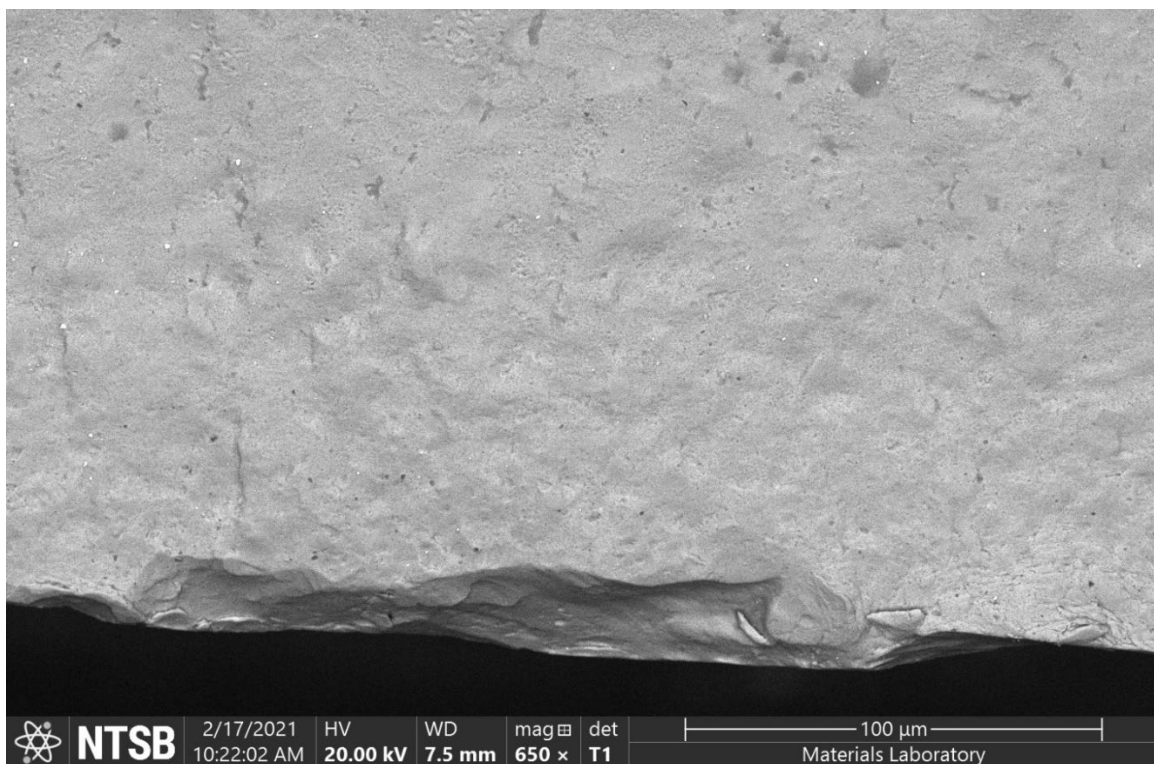
Figure 16 – BE micrograph of the main fatigue crack initiation site, showing mechanical damage.

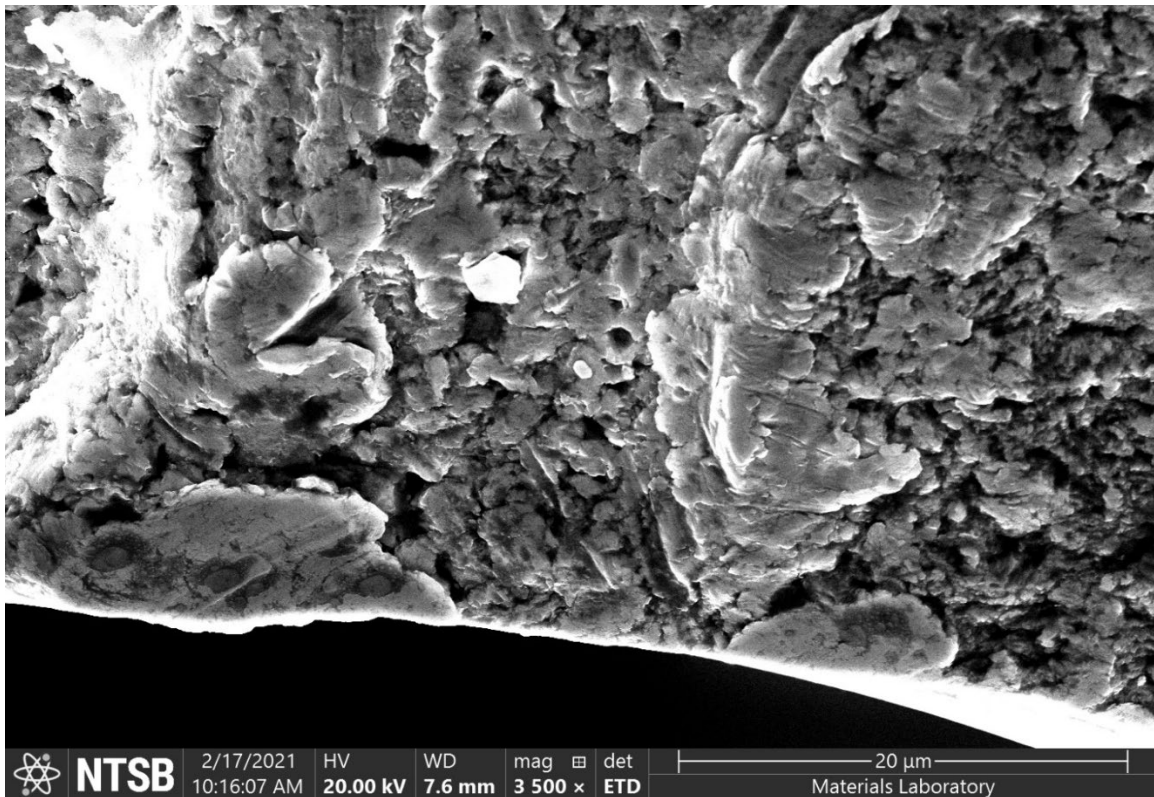
Figure 17 – SE micrograph of another crack initiation site away from Figure 16.

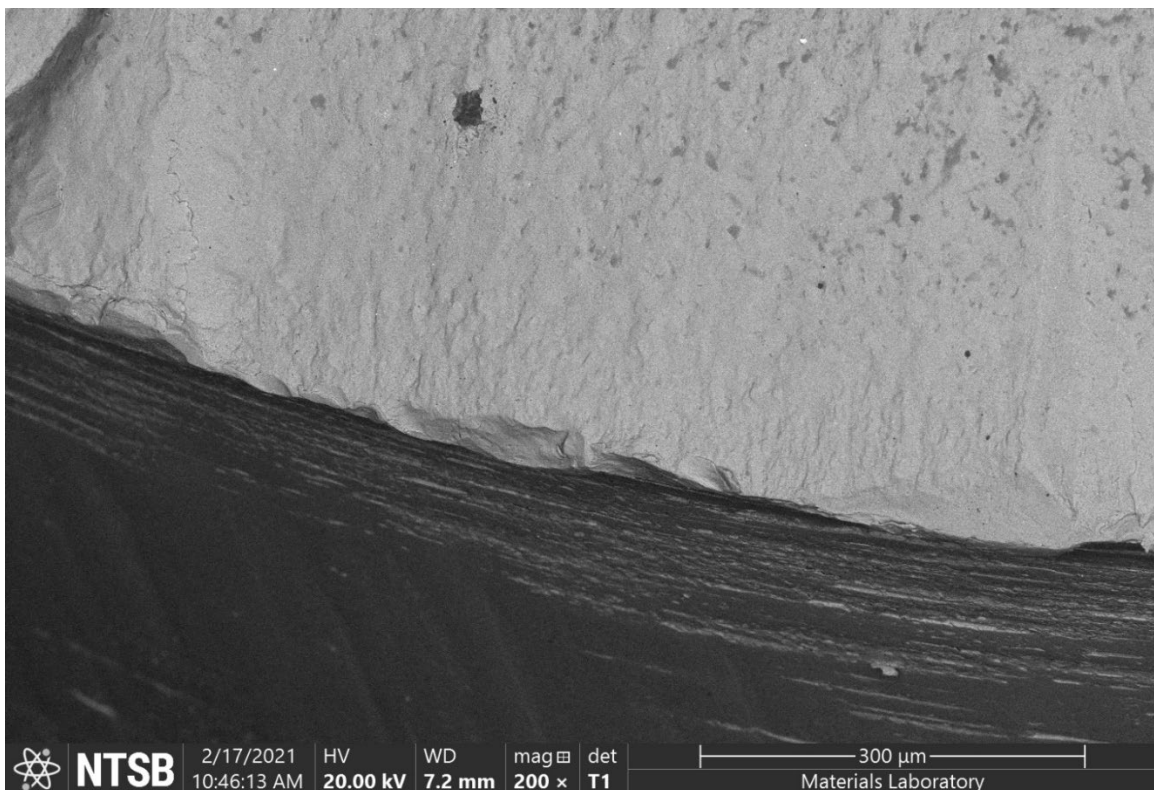
The large crack primary crack initiation sites from Figure 16 are shown at an angle in Figure 18. This figure shows the impact damage to the crack initiation site. In addition, the site was located along an area of circumferential wear. The worn area exhibited a recessed morphology, with streaks of varying depths. Figure 19 shows a less damaged fatigue crack initiation site viewed from an angle. This location shows radial marks and crack arrest marks emanating from the worn surface.

Figure 18 – BE micrograph of the initiation site in Figure 16, shown at an angle.

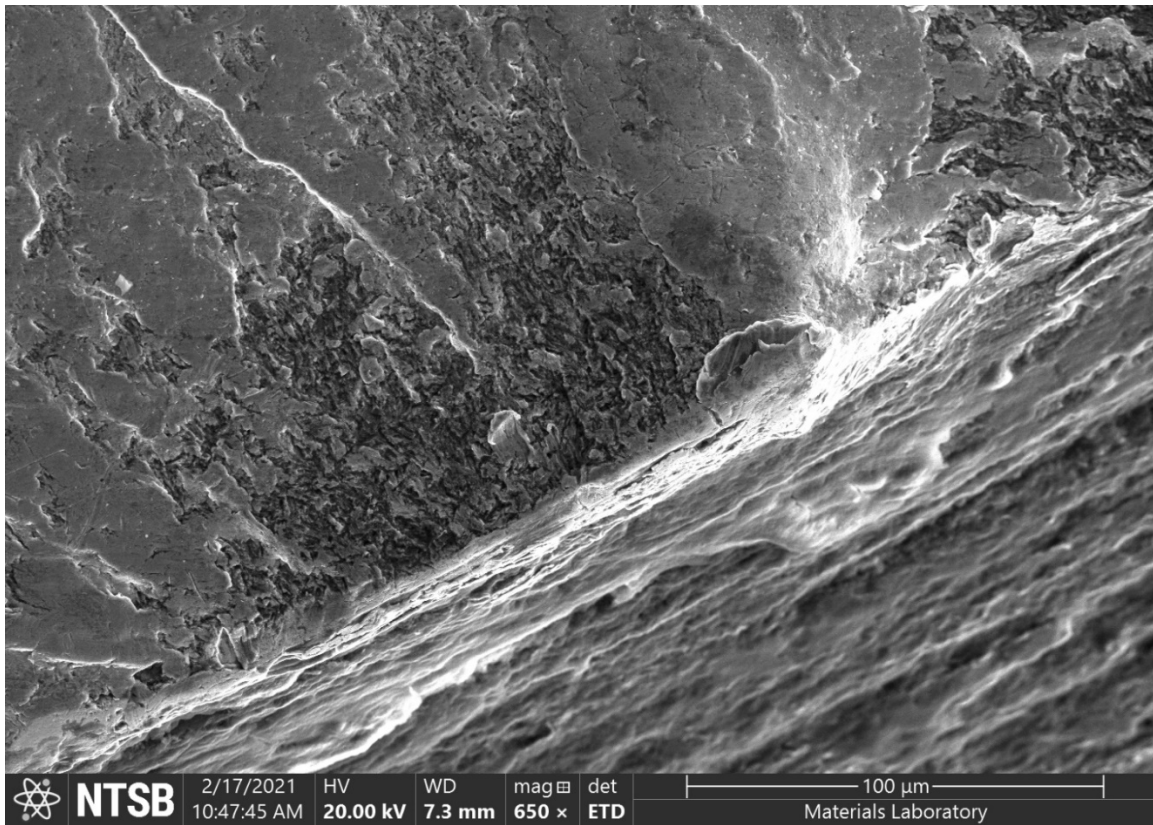
Figure 19 – SE micrograph of an angled view of an undamaged initiation site.

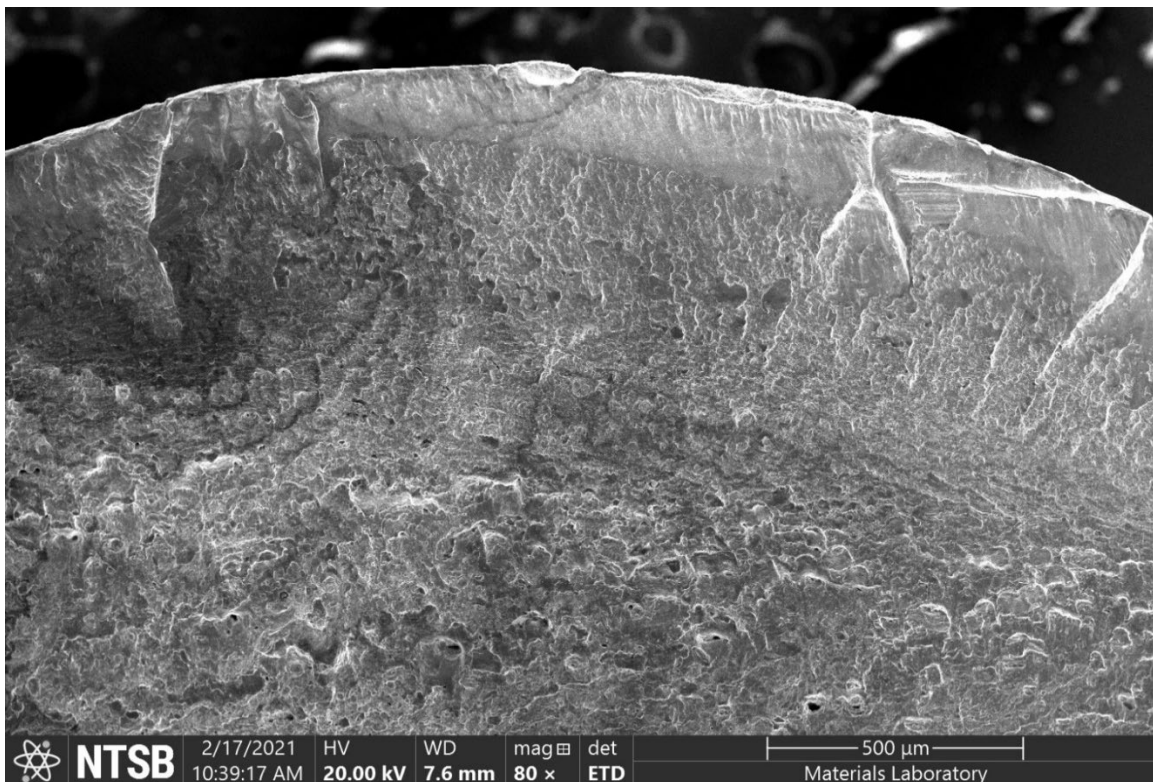
As shown in Figure 8 and Figure 9, the dowel fracture surface exhibited a second, smaller progressive crack, facing opposite the larger fatigue crack. Part of this smaller crack face is shown in Figure 20. This area exhibited fatigue striations, consistent with fatigue crack propagation with ratchet marks, consistent with multiple fatigue crack initiation sites. One of those crack initiation sites is shown in Figure 21. This site, as well as many of the other, exhibited smearing, consistent with post-fracture or post-cracking impact damage.

Figure 20 – SE micrograph of the smaller opposite-facing fatigue crack.

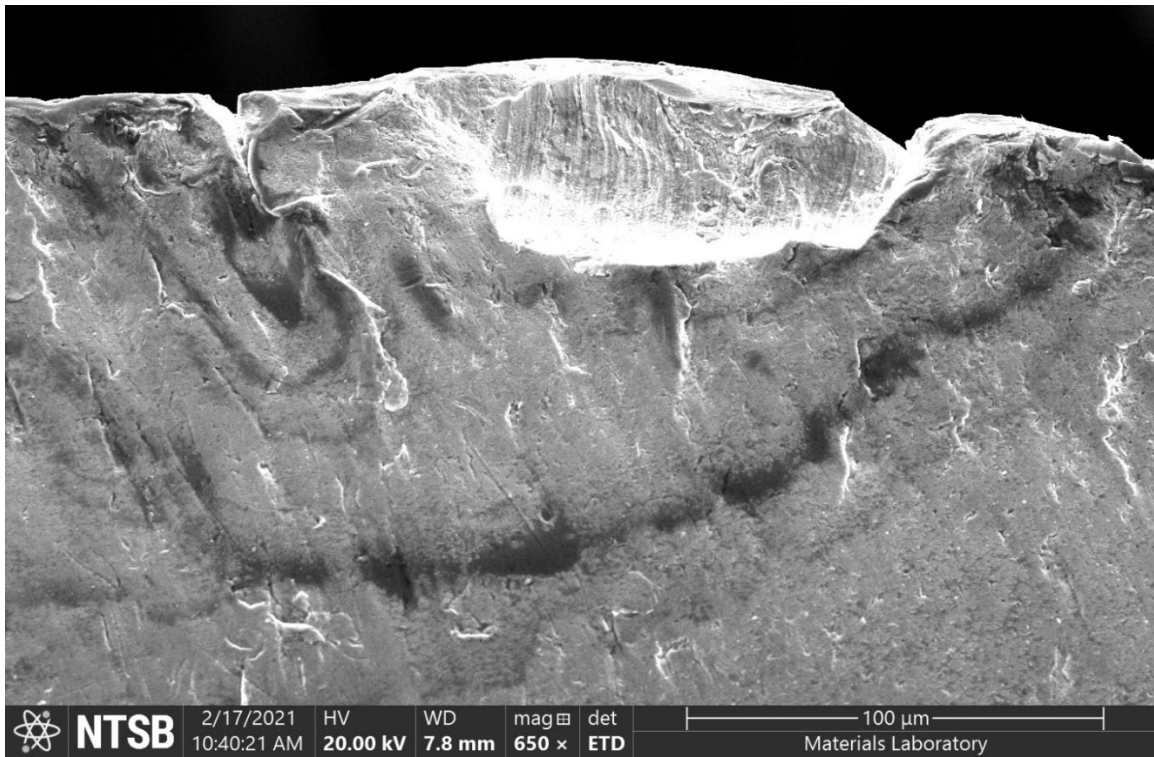
Figure 21 – SE micrograph of one of the fatigue crack initiation sites of the smaller fatigue crack.
