## **MEMORANDUM for RECORD**

**Date: August 18, 2020**  
**Person Contacted: Karrie Bowden, FAA Operations Inspector, South Carolina**  
**FSDO**  
**NTSB Accident Number: ERA20LA286, Clover, SC**

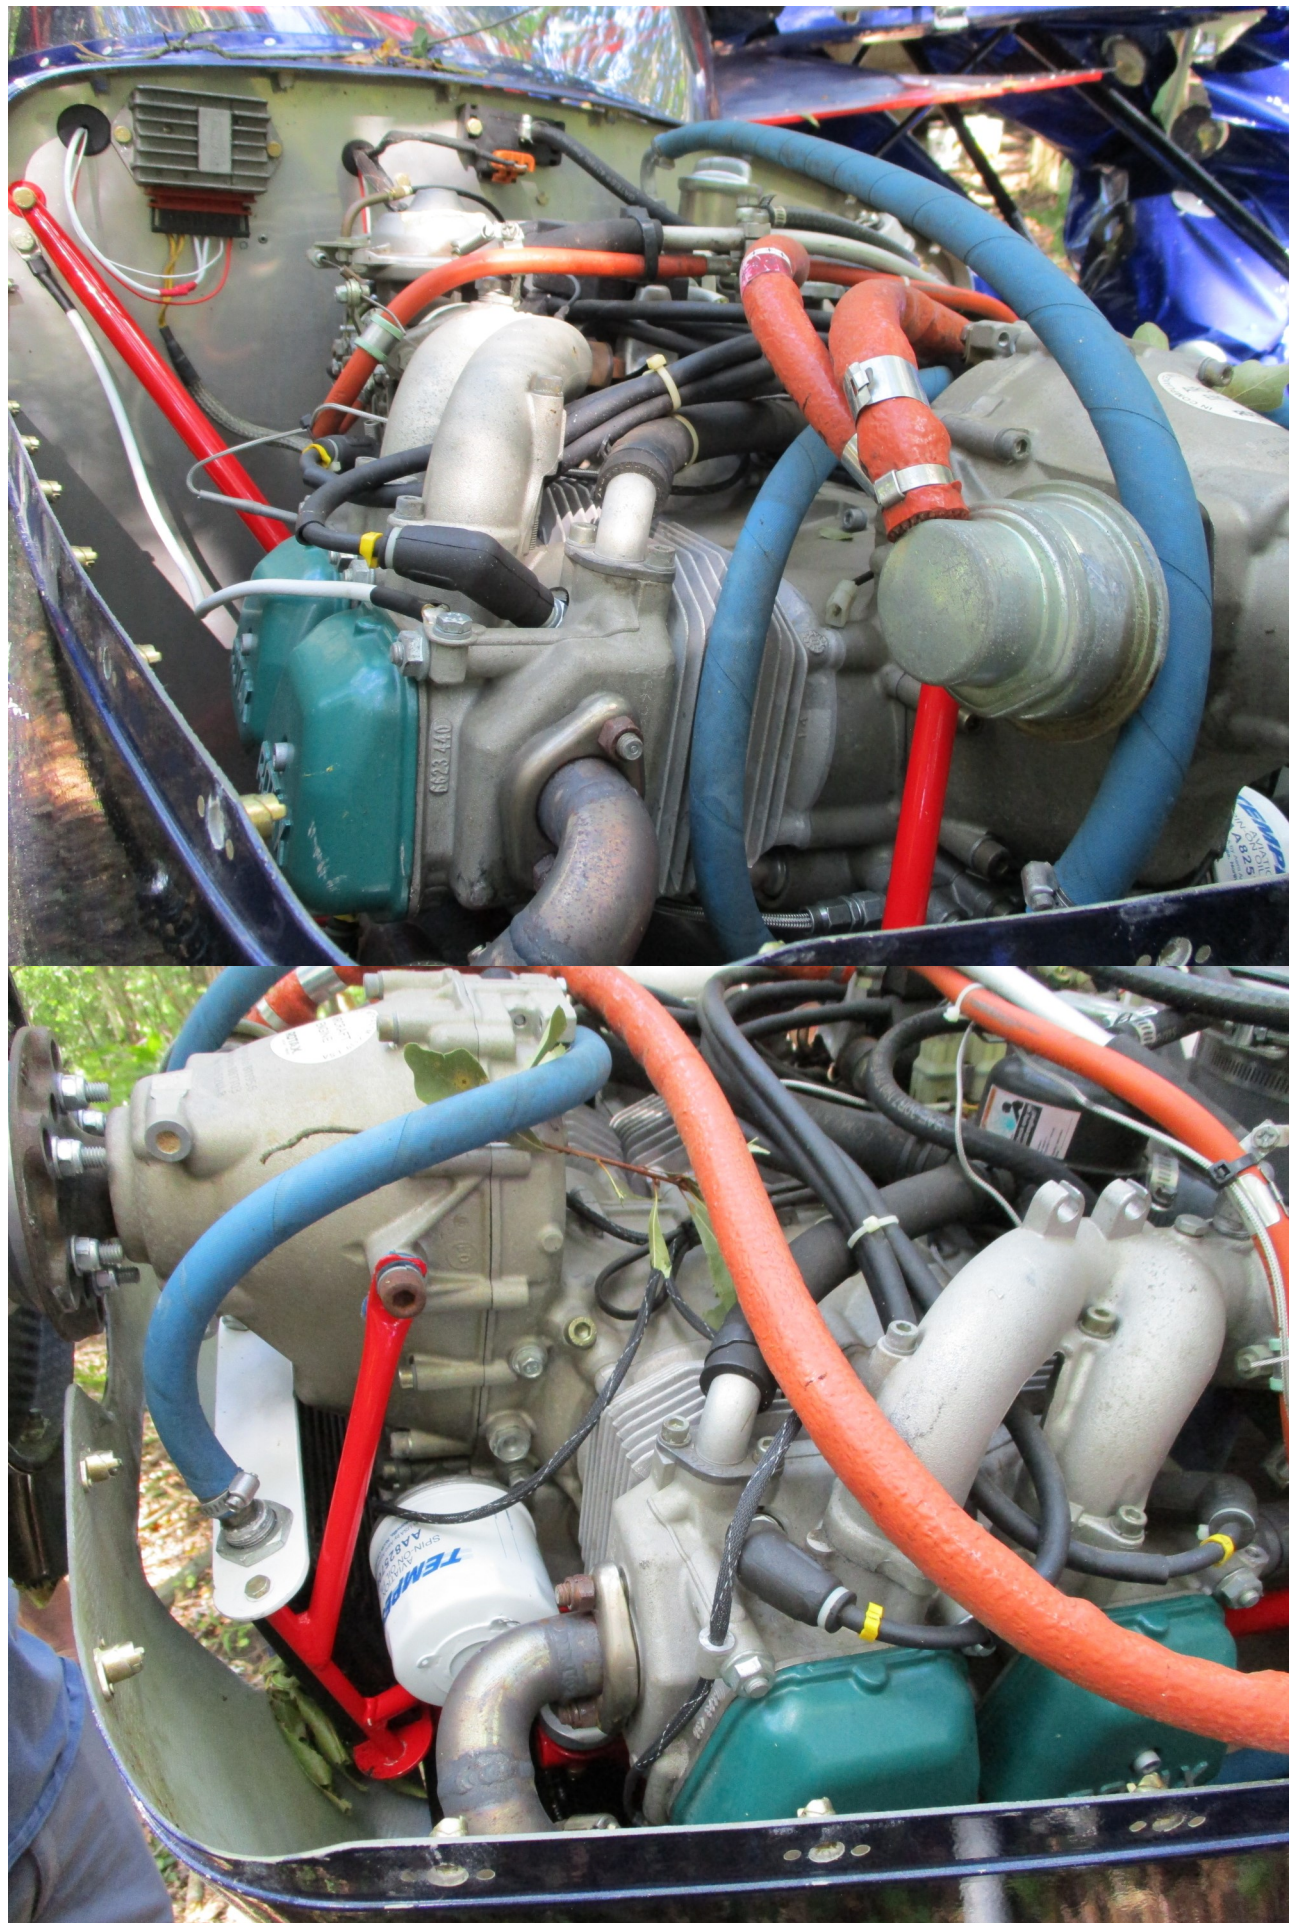
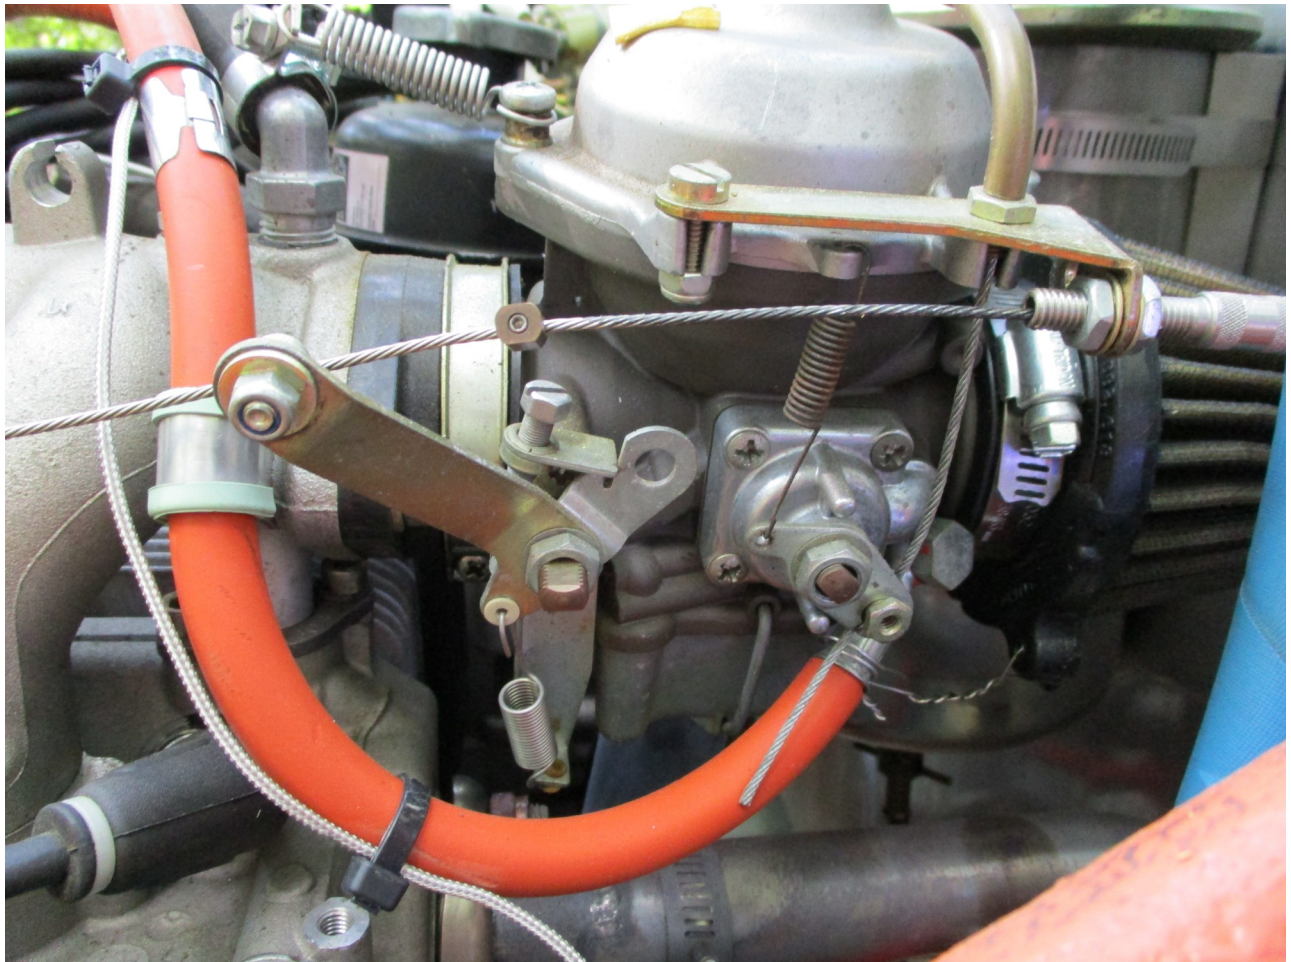
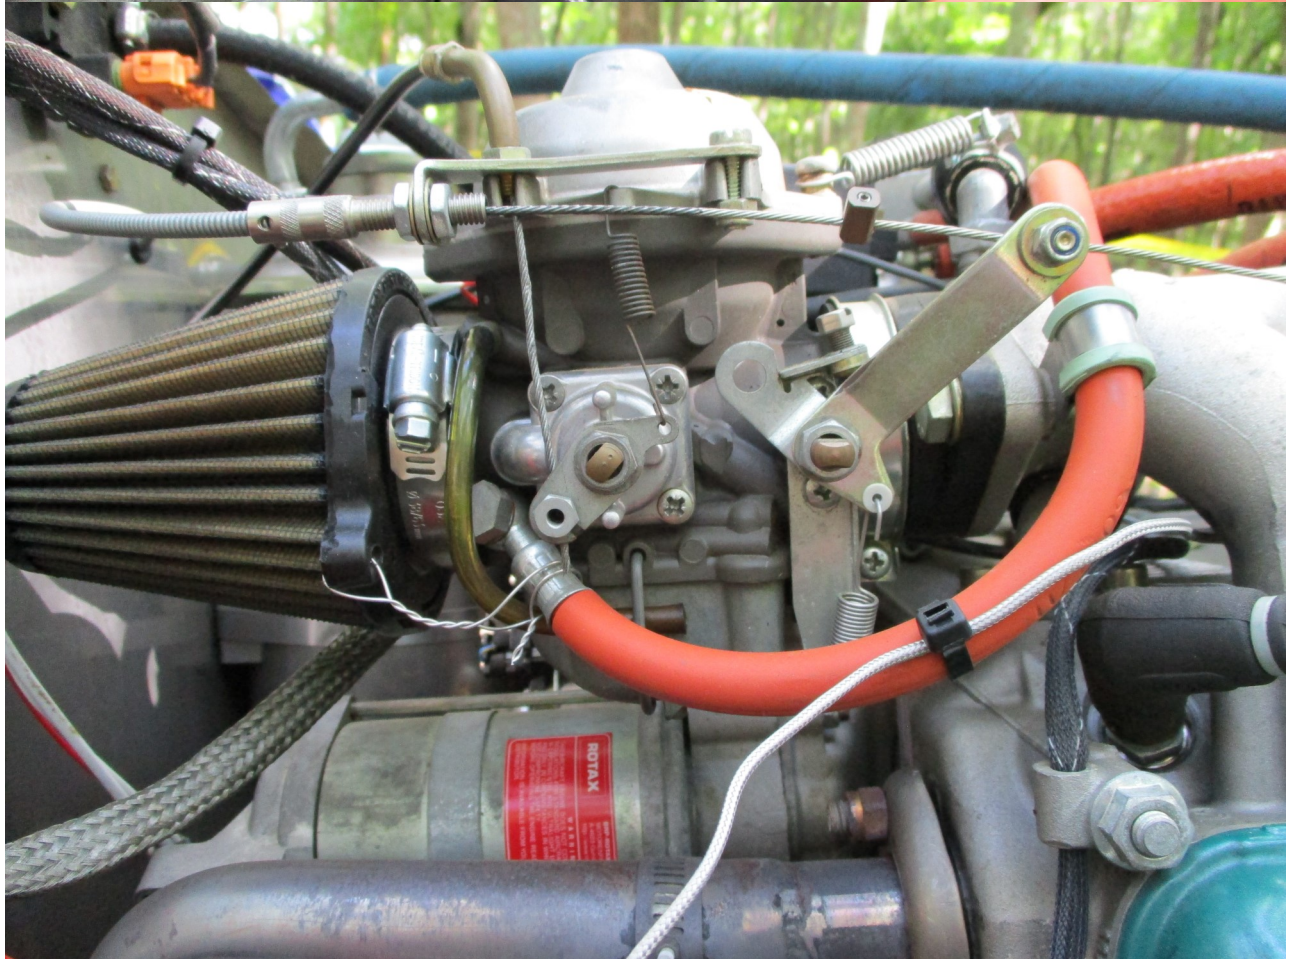
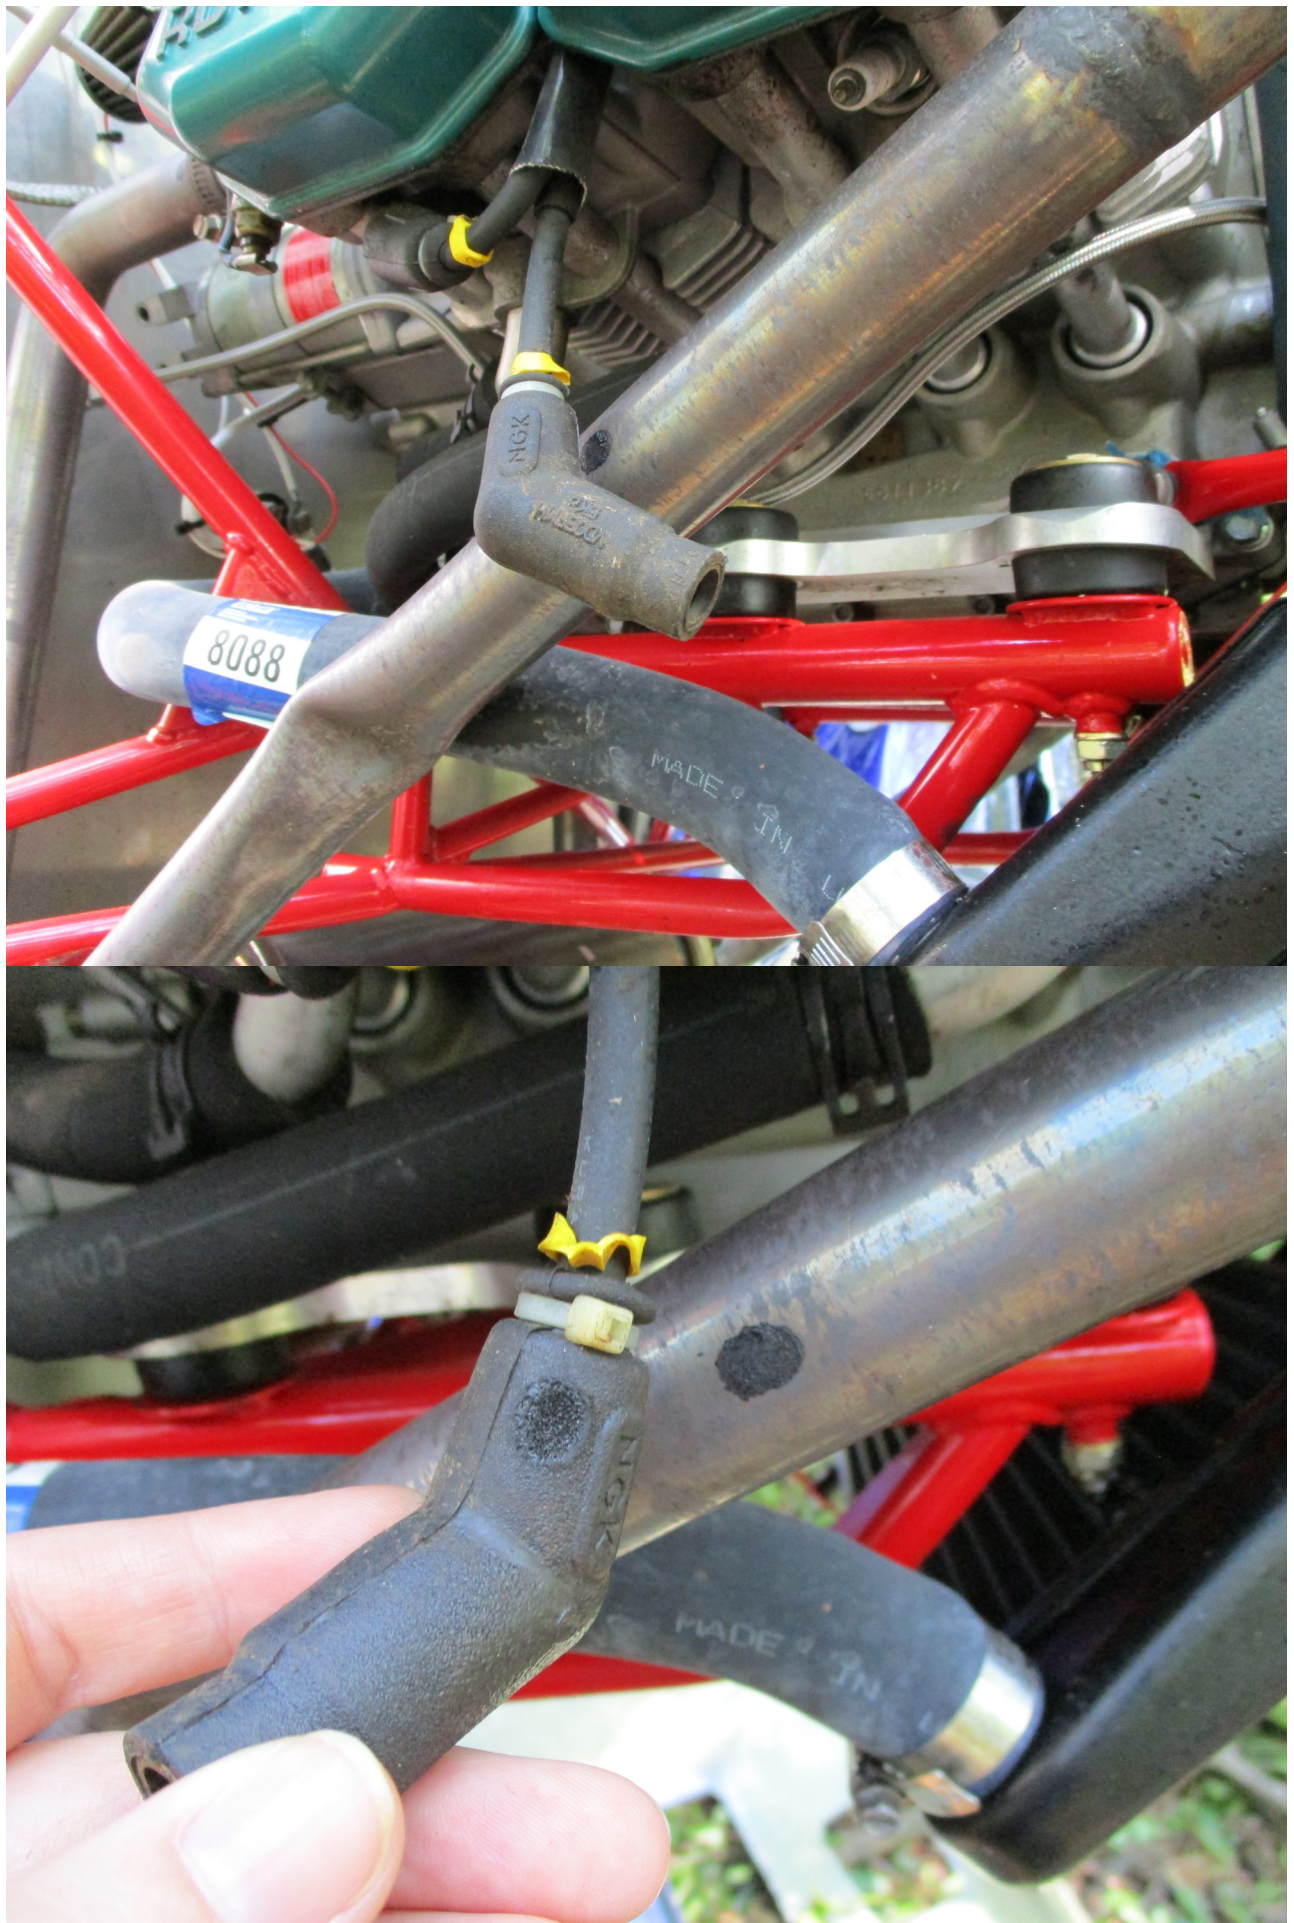
- The pilot was attempting a takeoff from a short (1.000 ft long) private grass strip.
- Pilot reported that he was not getting full power after liftoff.
- The airplane became airborne and could not clear trees located past the end of the runway.
- The airplane contacted the trees and the pilot lost control.
- Airplane came to rest within the wooded area.
- Substantial damage to the left and right wings, fuselage, and empennage. Landing gear remained attached.
- Found adequate fuel on board for the flight. The propeller was splintered from contact with trees. Engine continuity established. Linkage to engine controls established.
- Further examination of the engine revealed that the right, forward cylinder spark plug lead was separated from the plug. No evidence of impact damage in this area.
