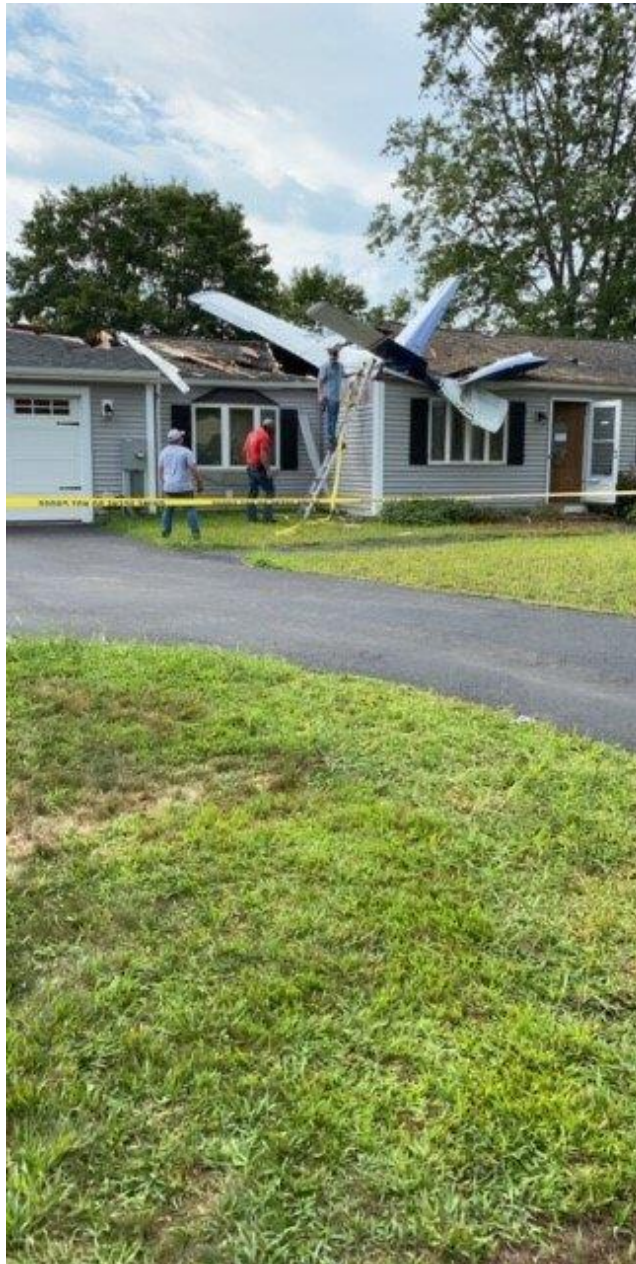
**Photo 1 – Digital Photograph From Insurance Adjuster. View of the Airplane on the Roof Before Recovery.**

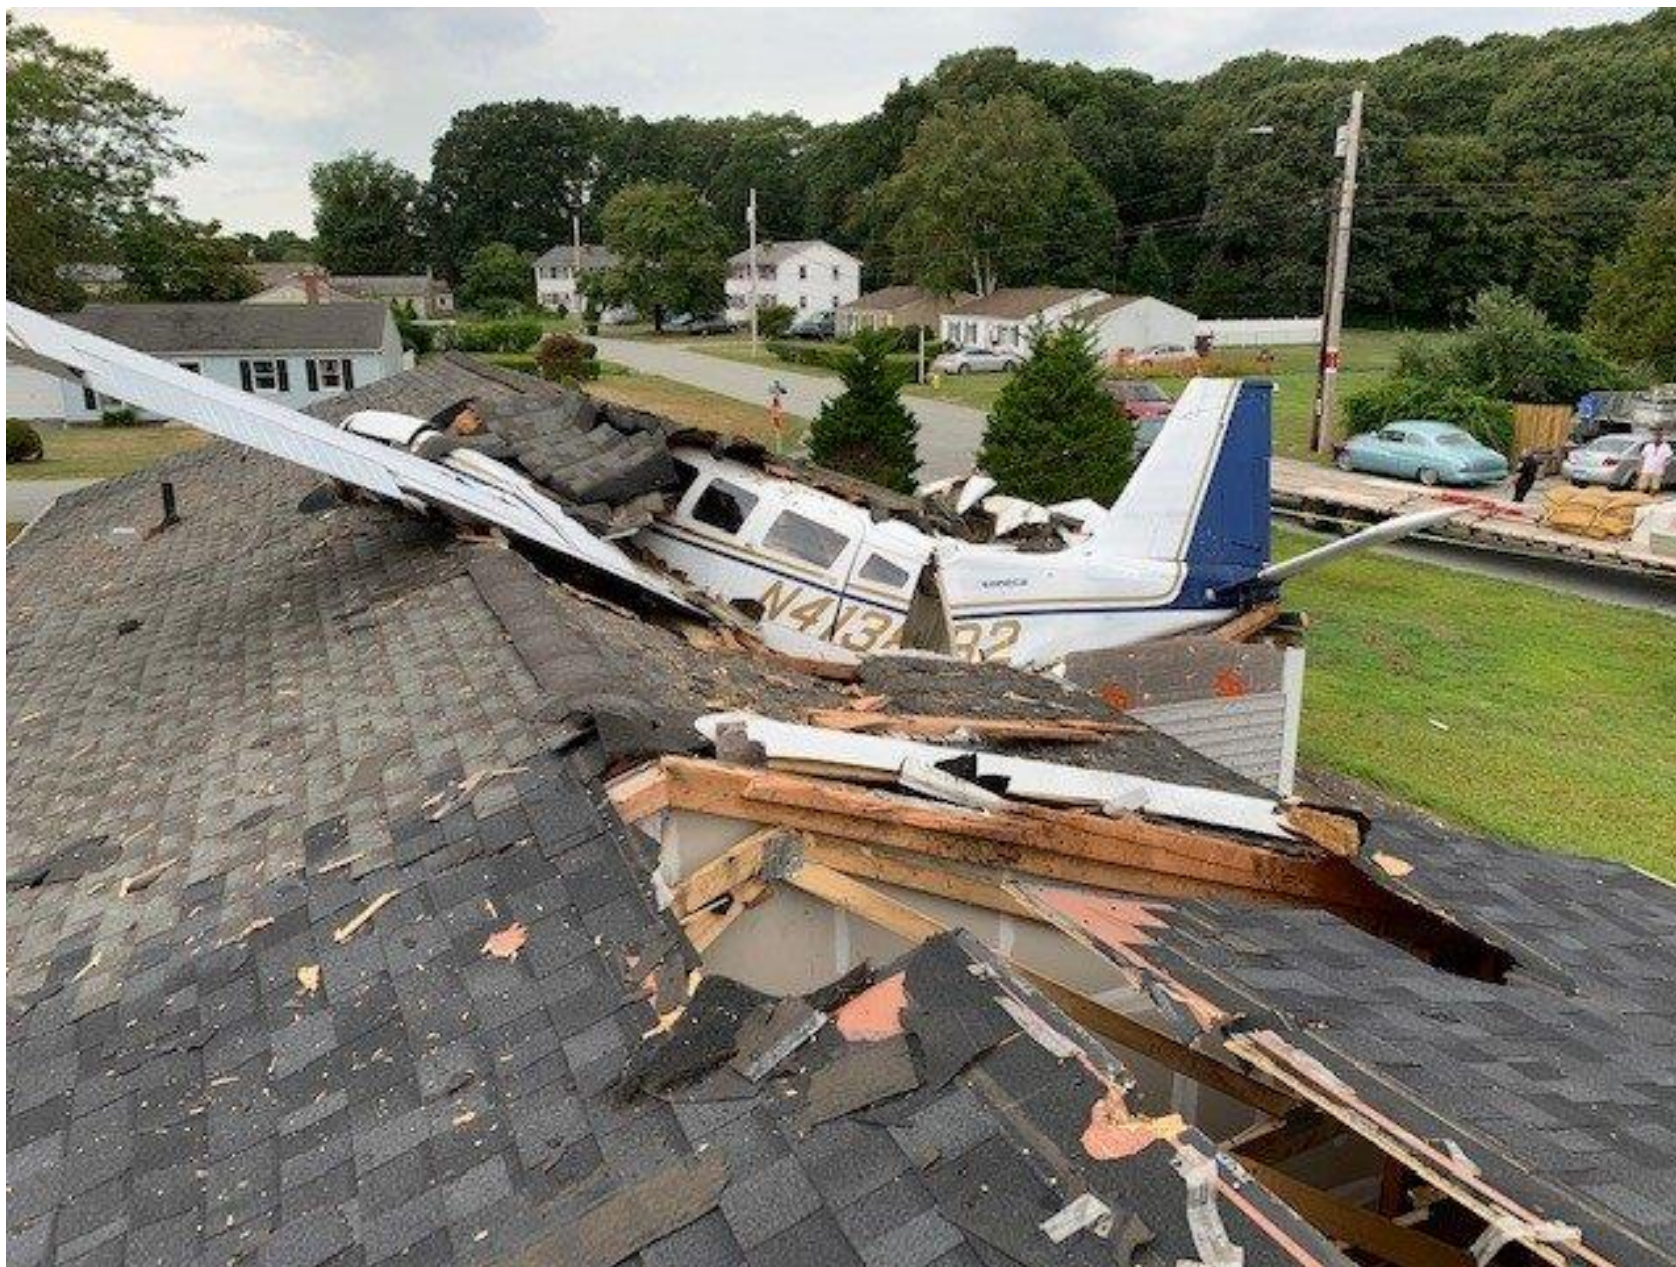
**Photo 2 - Digital Photograph From Insurance Adjuster. View of the Airplane on the Roof Before Recovery.**

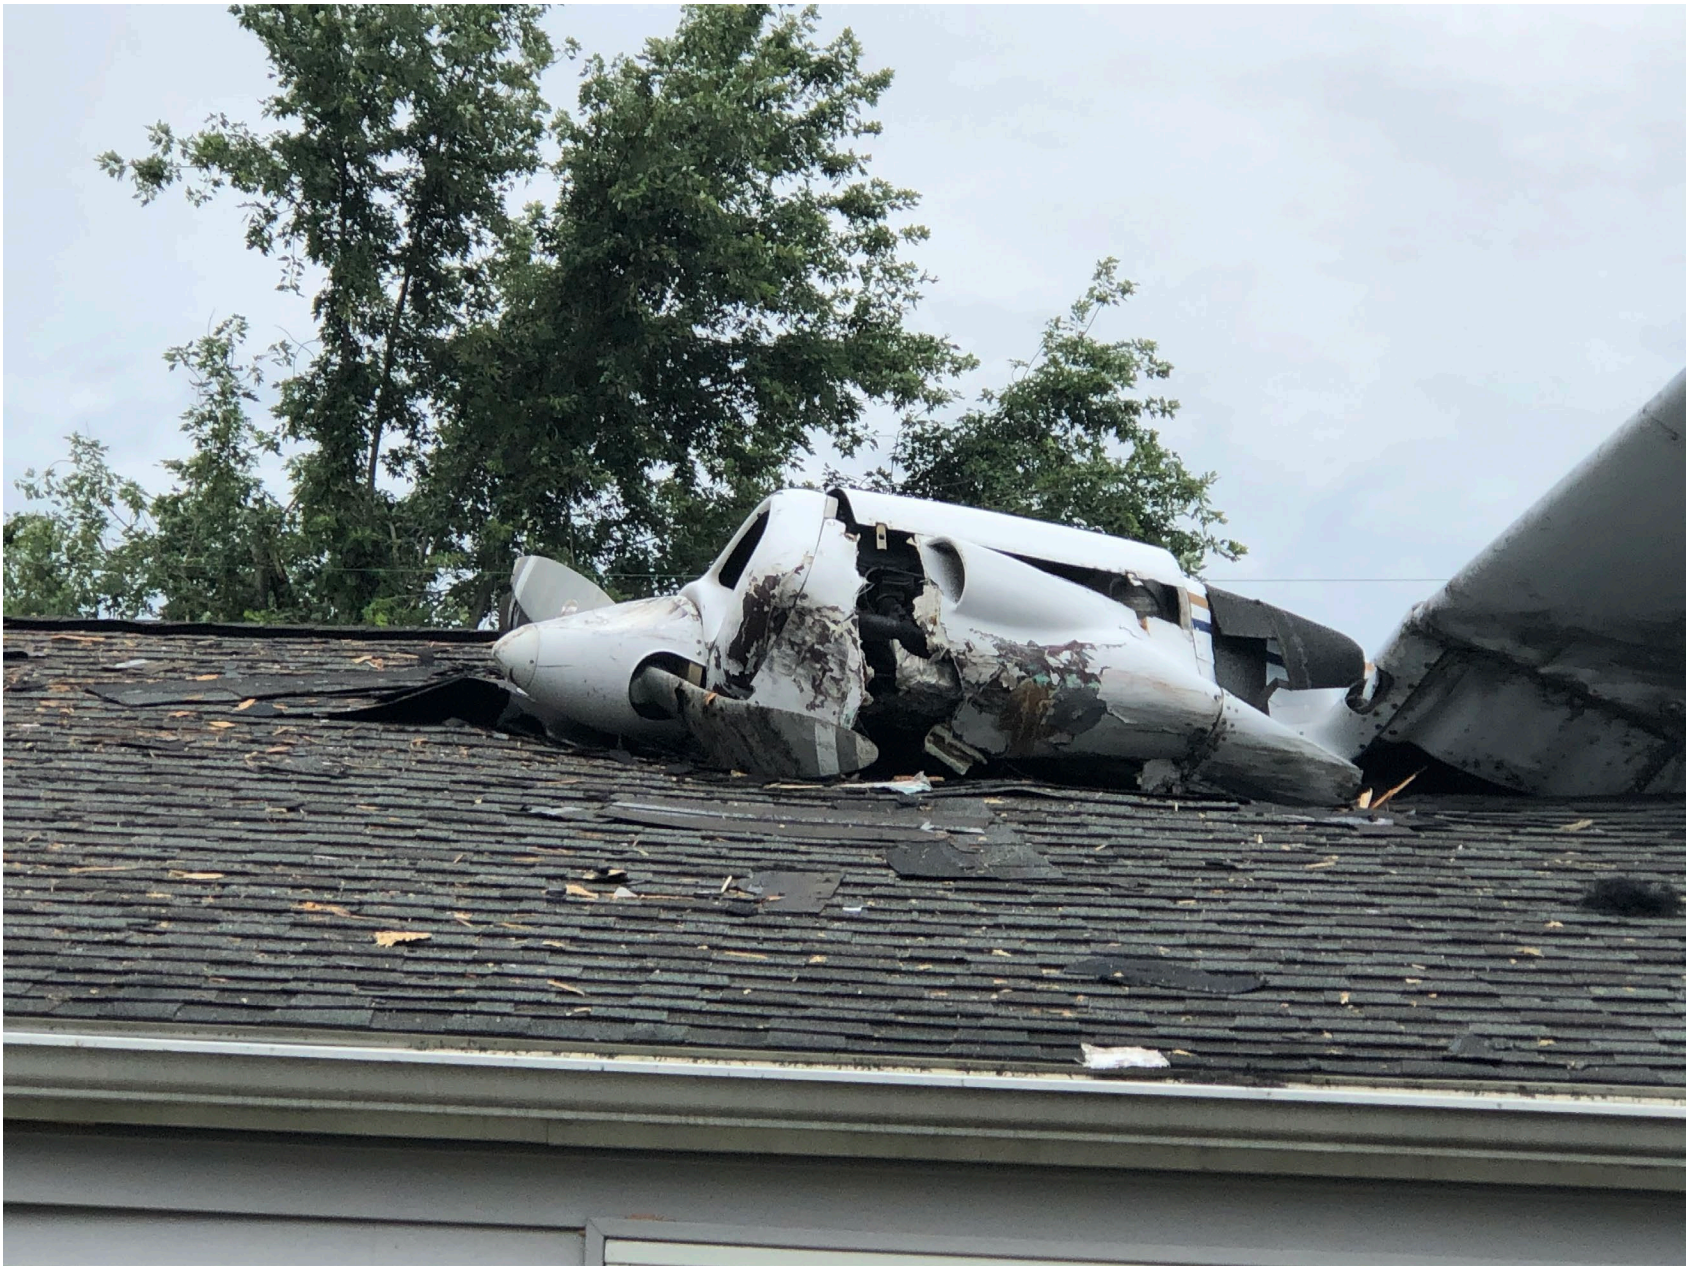
**Photo 3 – Digital Photograph From Federal Aviation Administration. View of a Portion of the Left Wing, Left Engine Assembly and Left Propeller.**

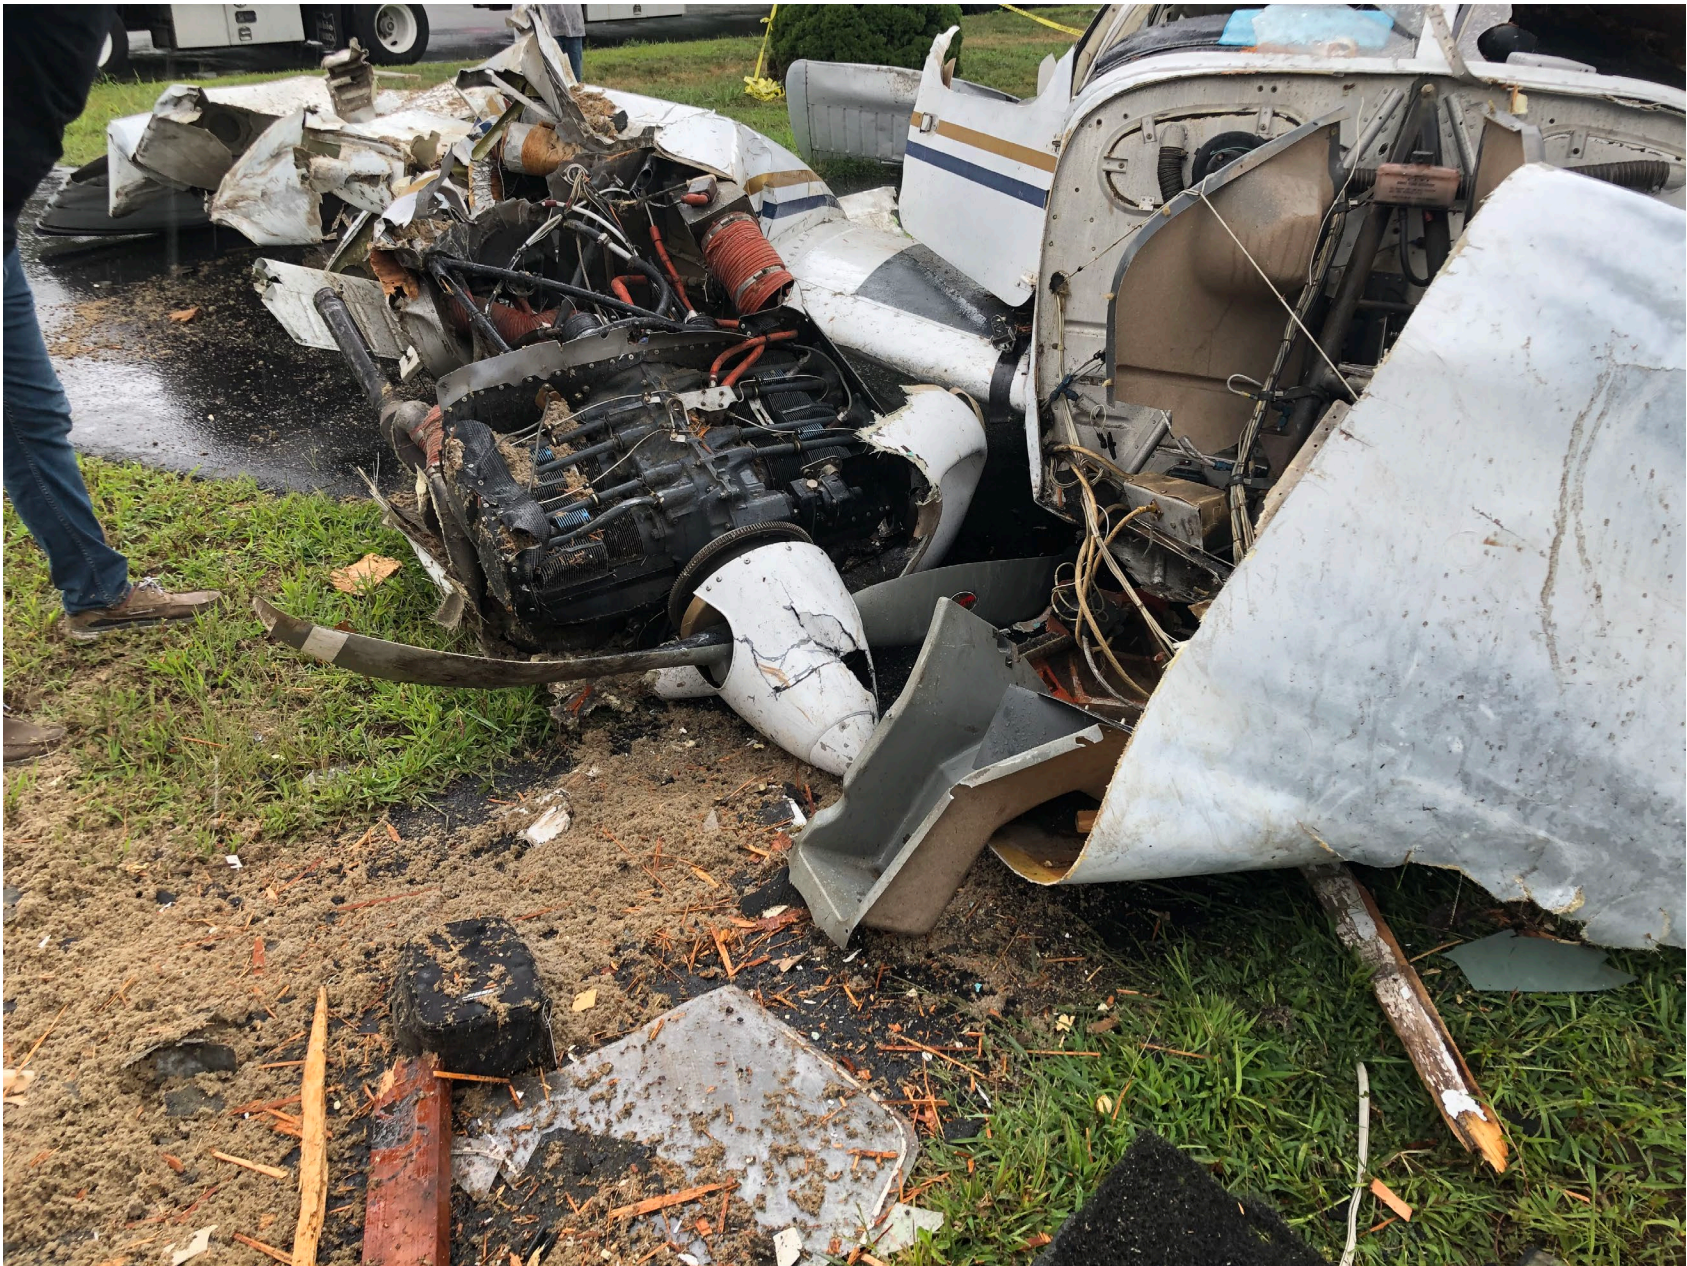
**Photo 4 - Digital Photograph From Federal Aviation Administration. Frontal View of the Airplane, Right Wing, Right Engine Assembly and Right Propeller After Recovery From Roof.**

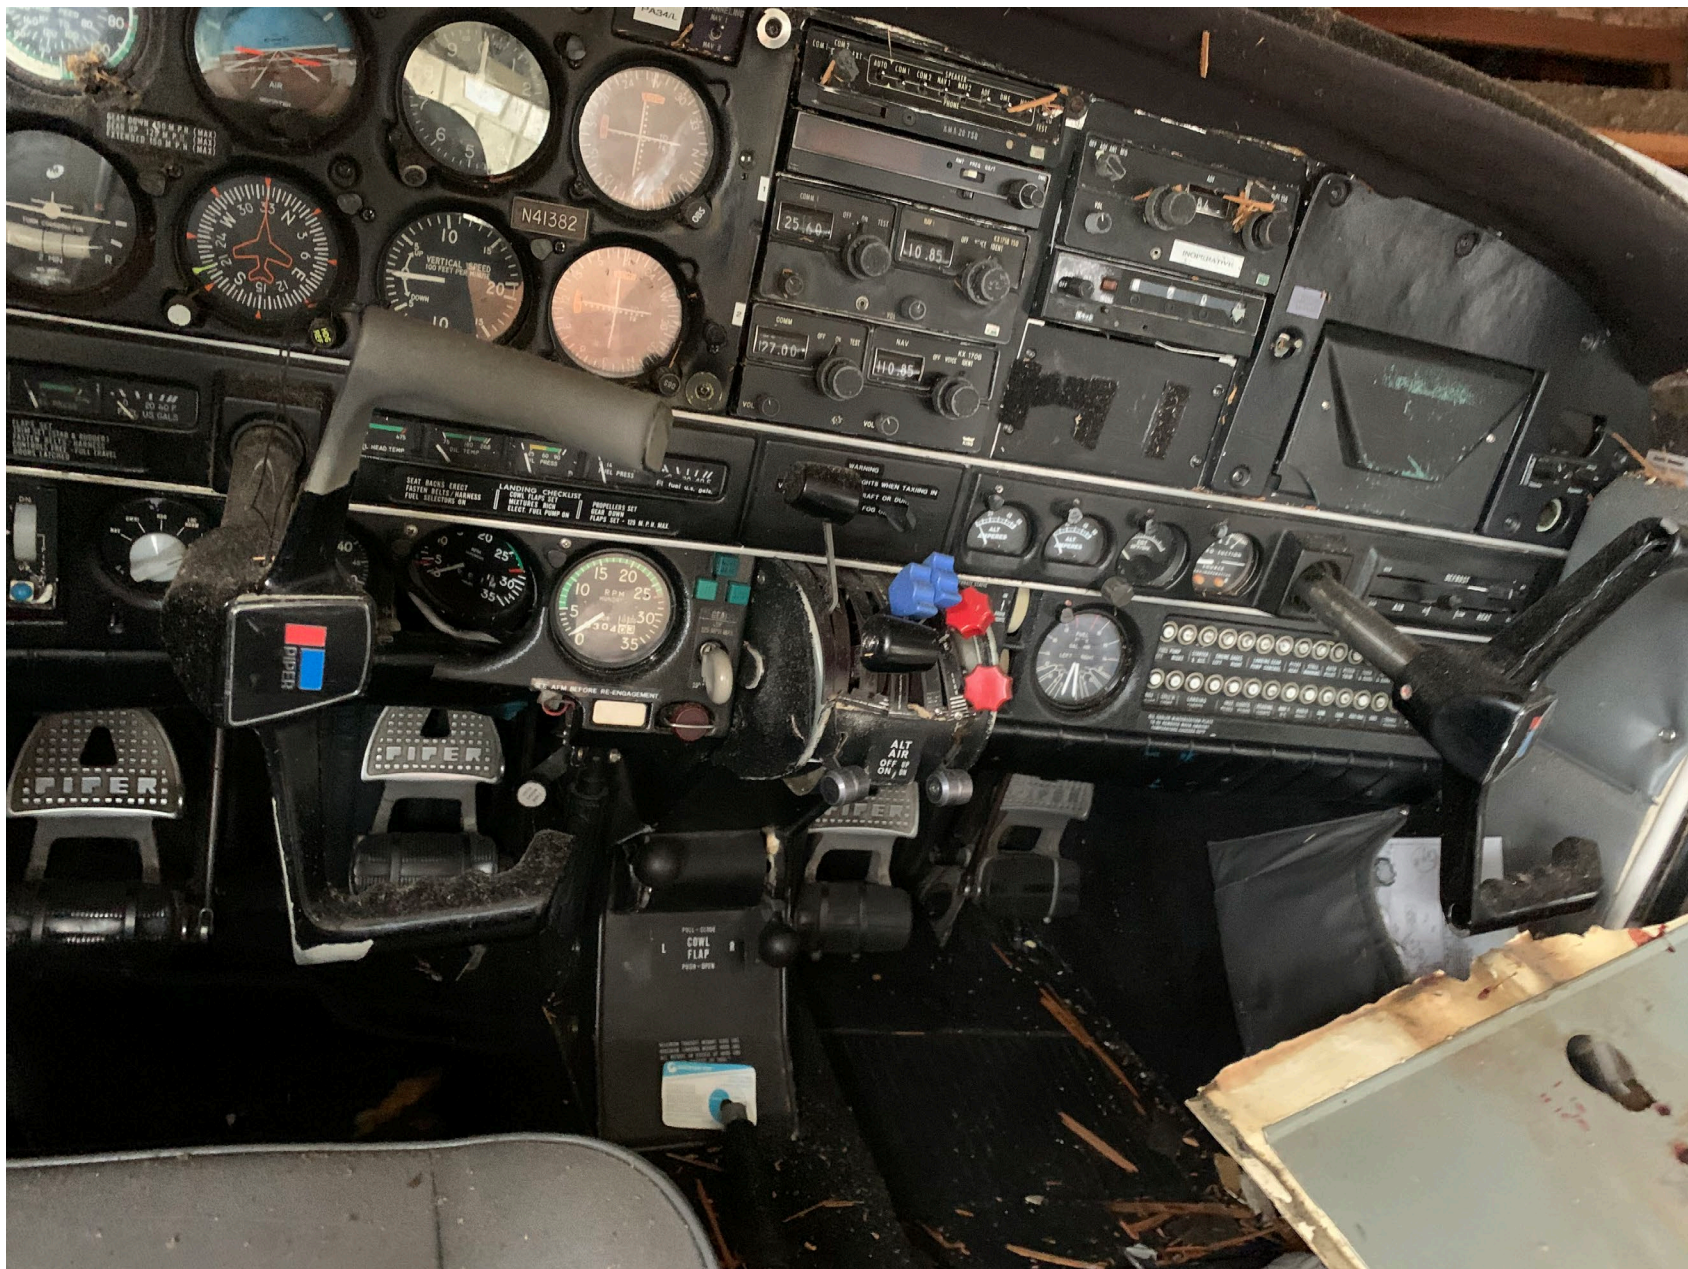
**Photo 5 - Digital Photograph From Federal Aviation Administration. View of the Lower Portion of the Instrument Panel, and Throttle Quadrant While the Airplane was Suspended by the Roof.**
