**Subject:** Re: N3962V

## **MEMORANDUM FOR RECORD**

**Date: August 31, 2020**  
**Subject: Information from Mr. John Nicholas Kohnen (Pilot of N3962V)**  
**NTSB Case Number: ERA20LA288**

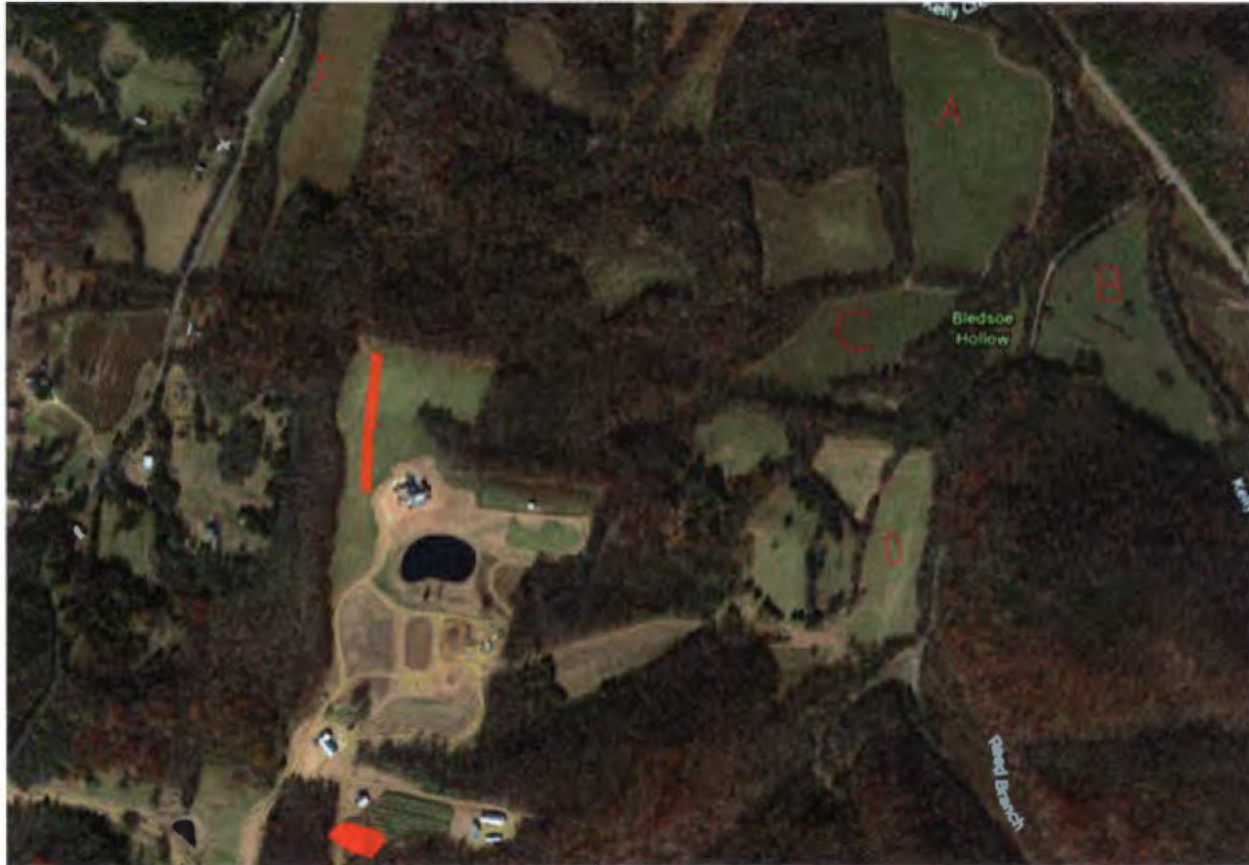
Takeoff and crash site are noted. Will follow with pilot statement.
