**Photo 1 – Main Wreckage – Courtesy of FAA**

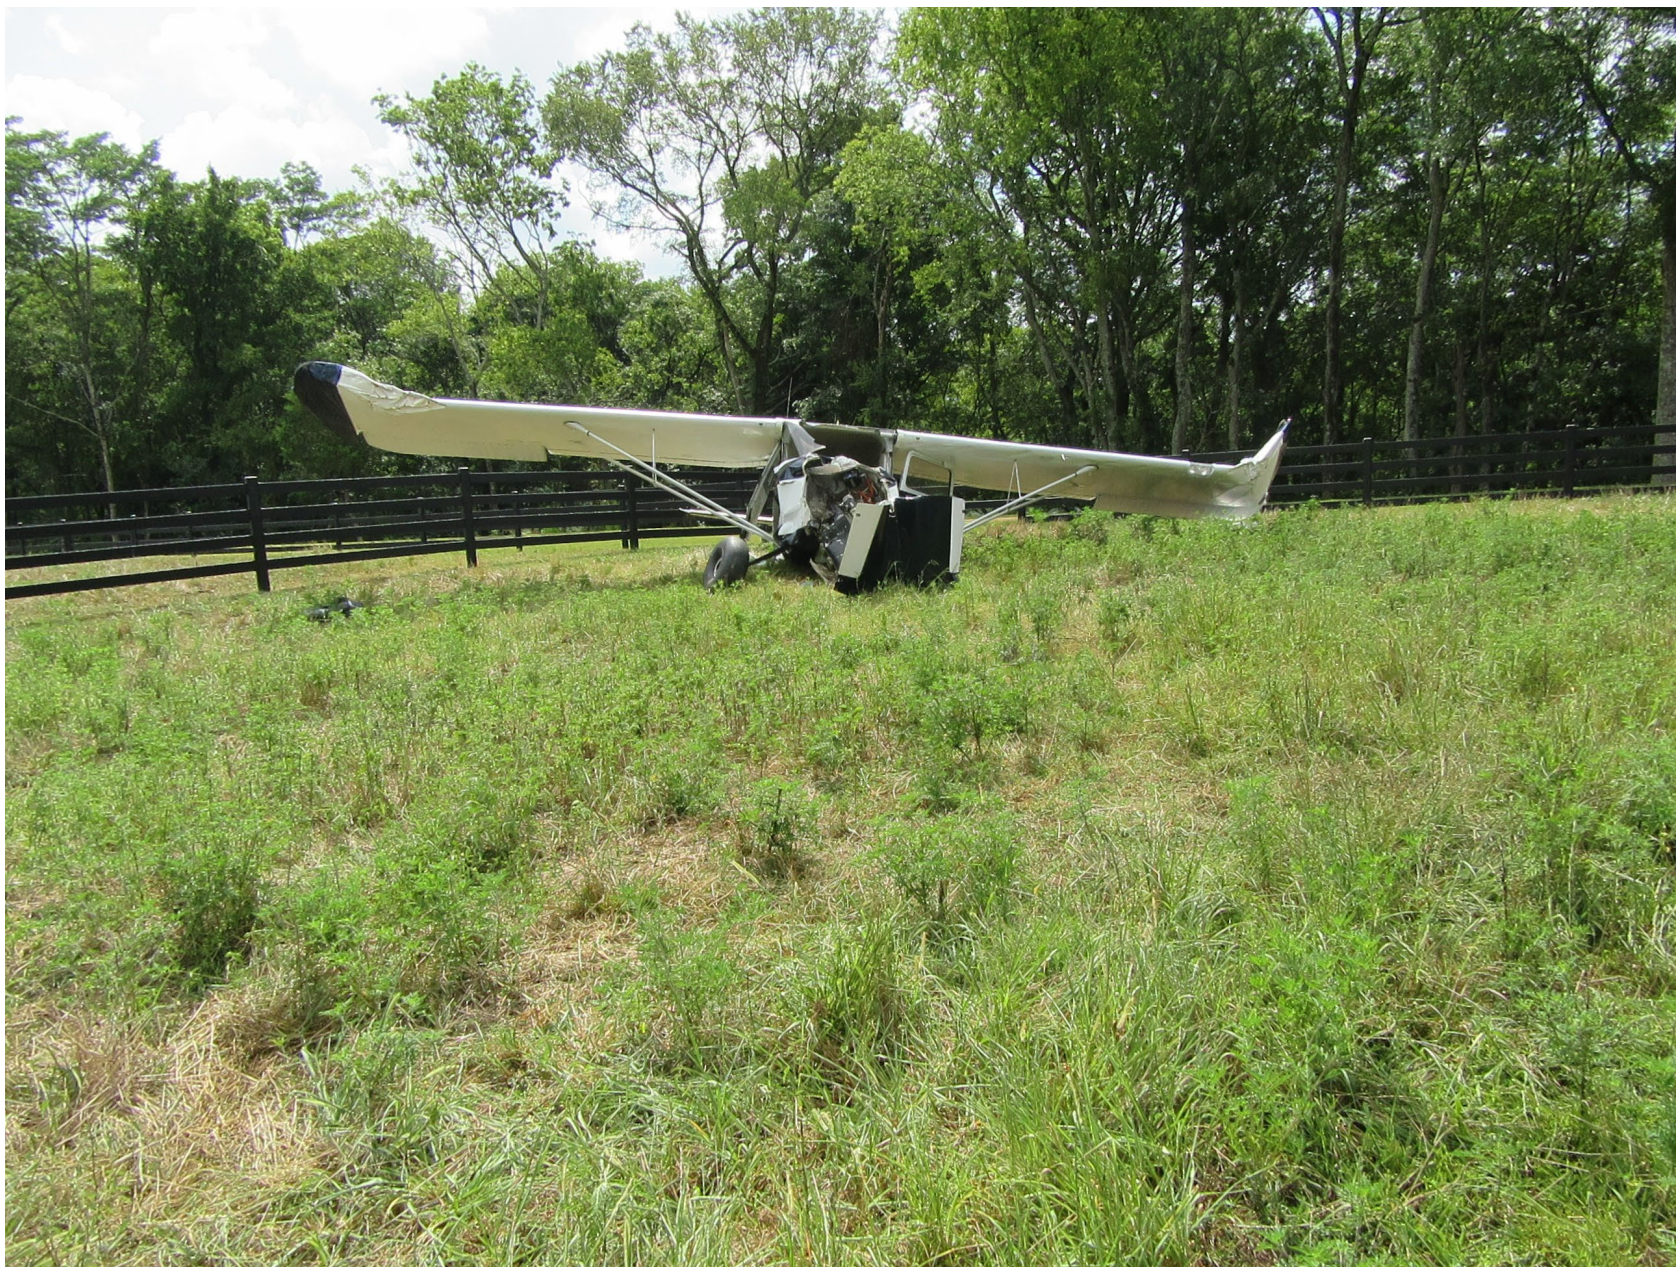
**Photo 2 – Front View of Main Wreckage – Courtesy of FAA**

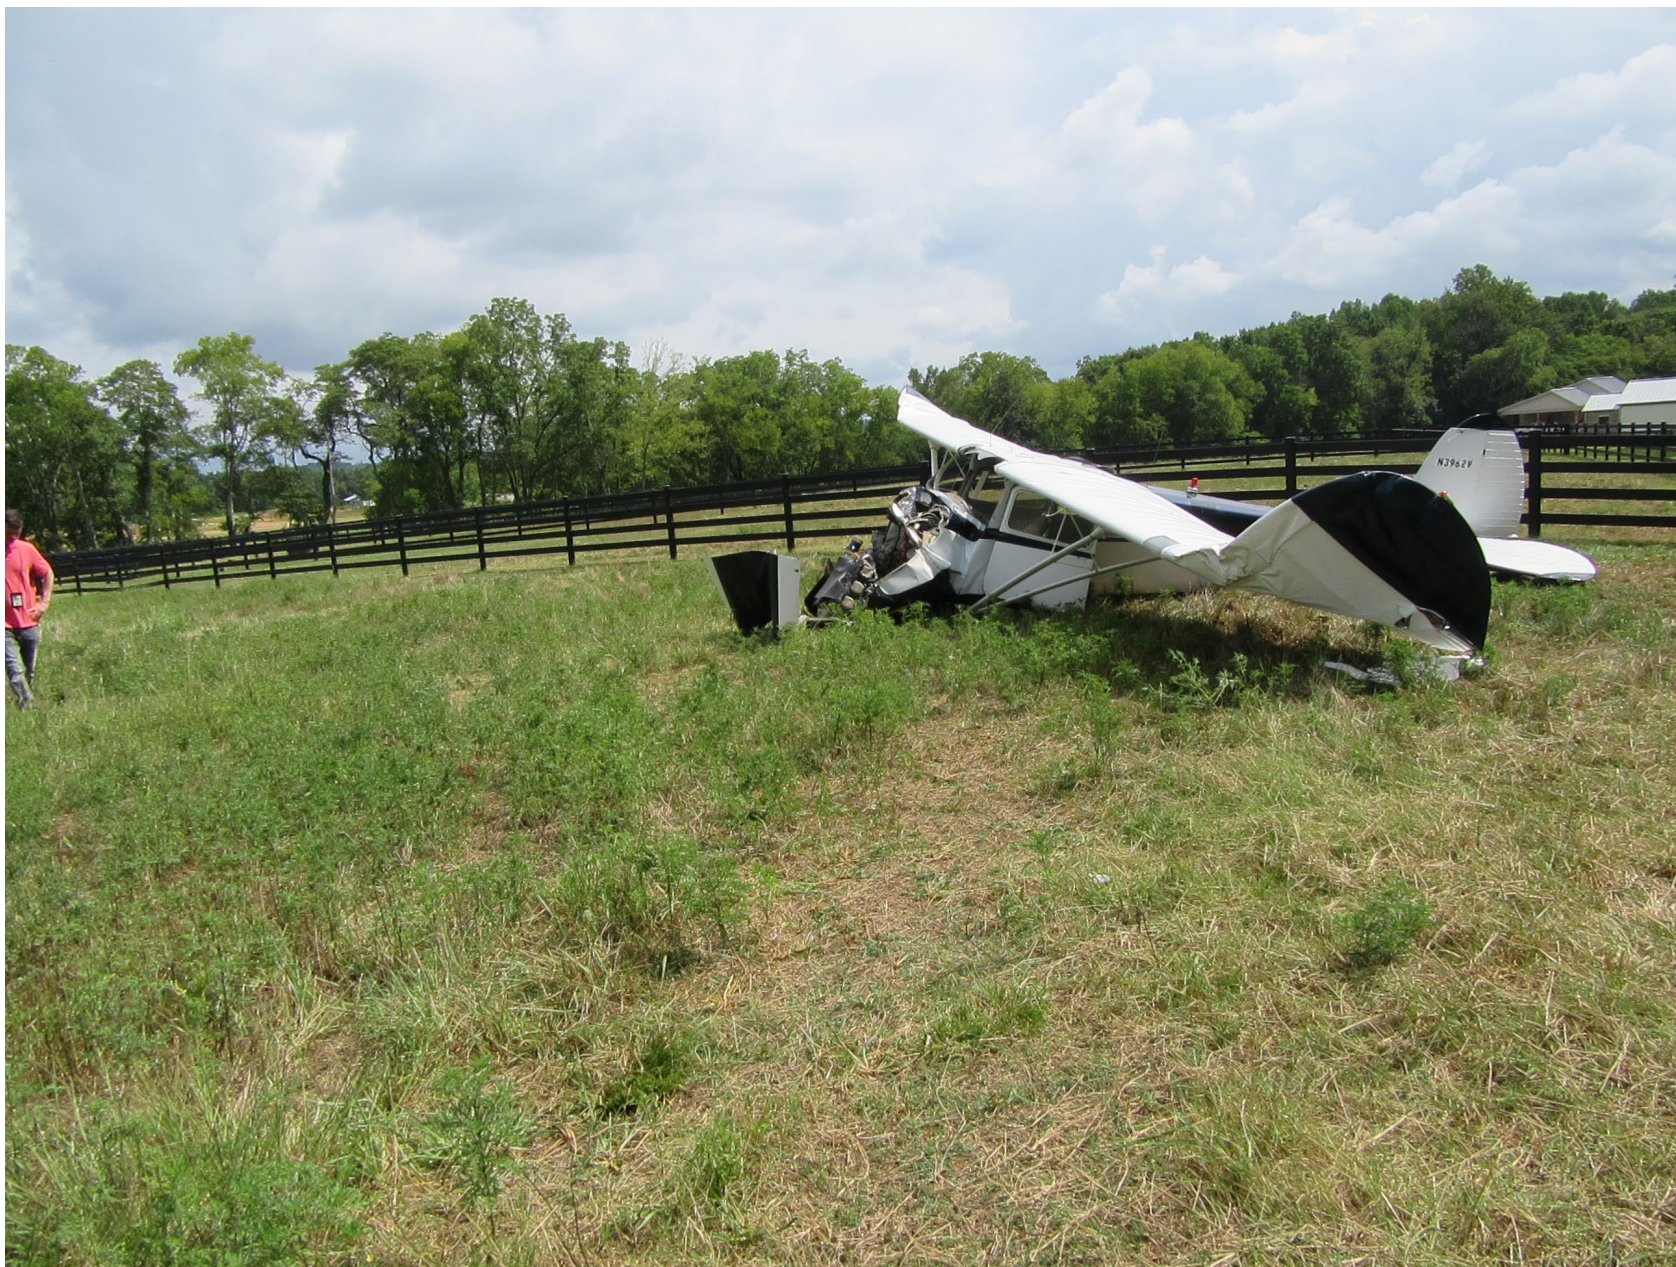
**Photo 3 – Left Side View of Main Wreckage – Courtesy of FAA**

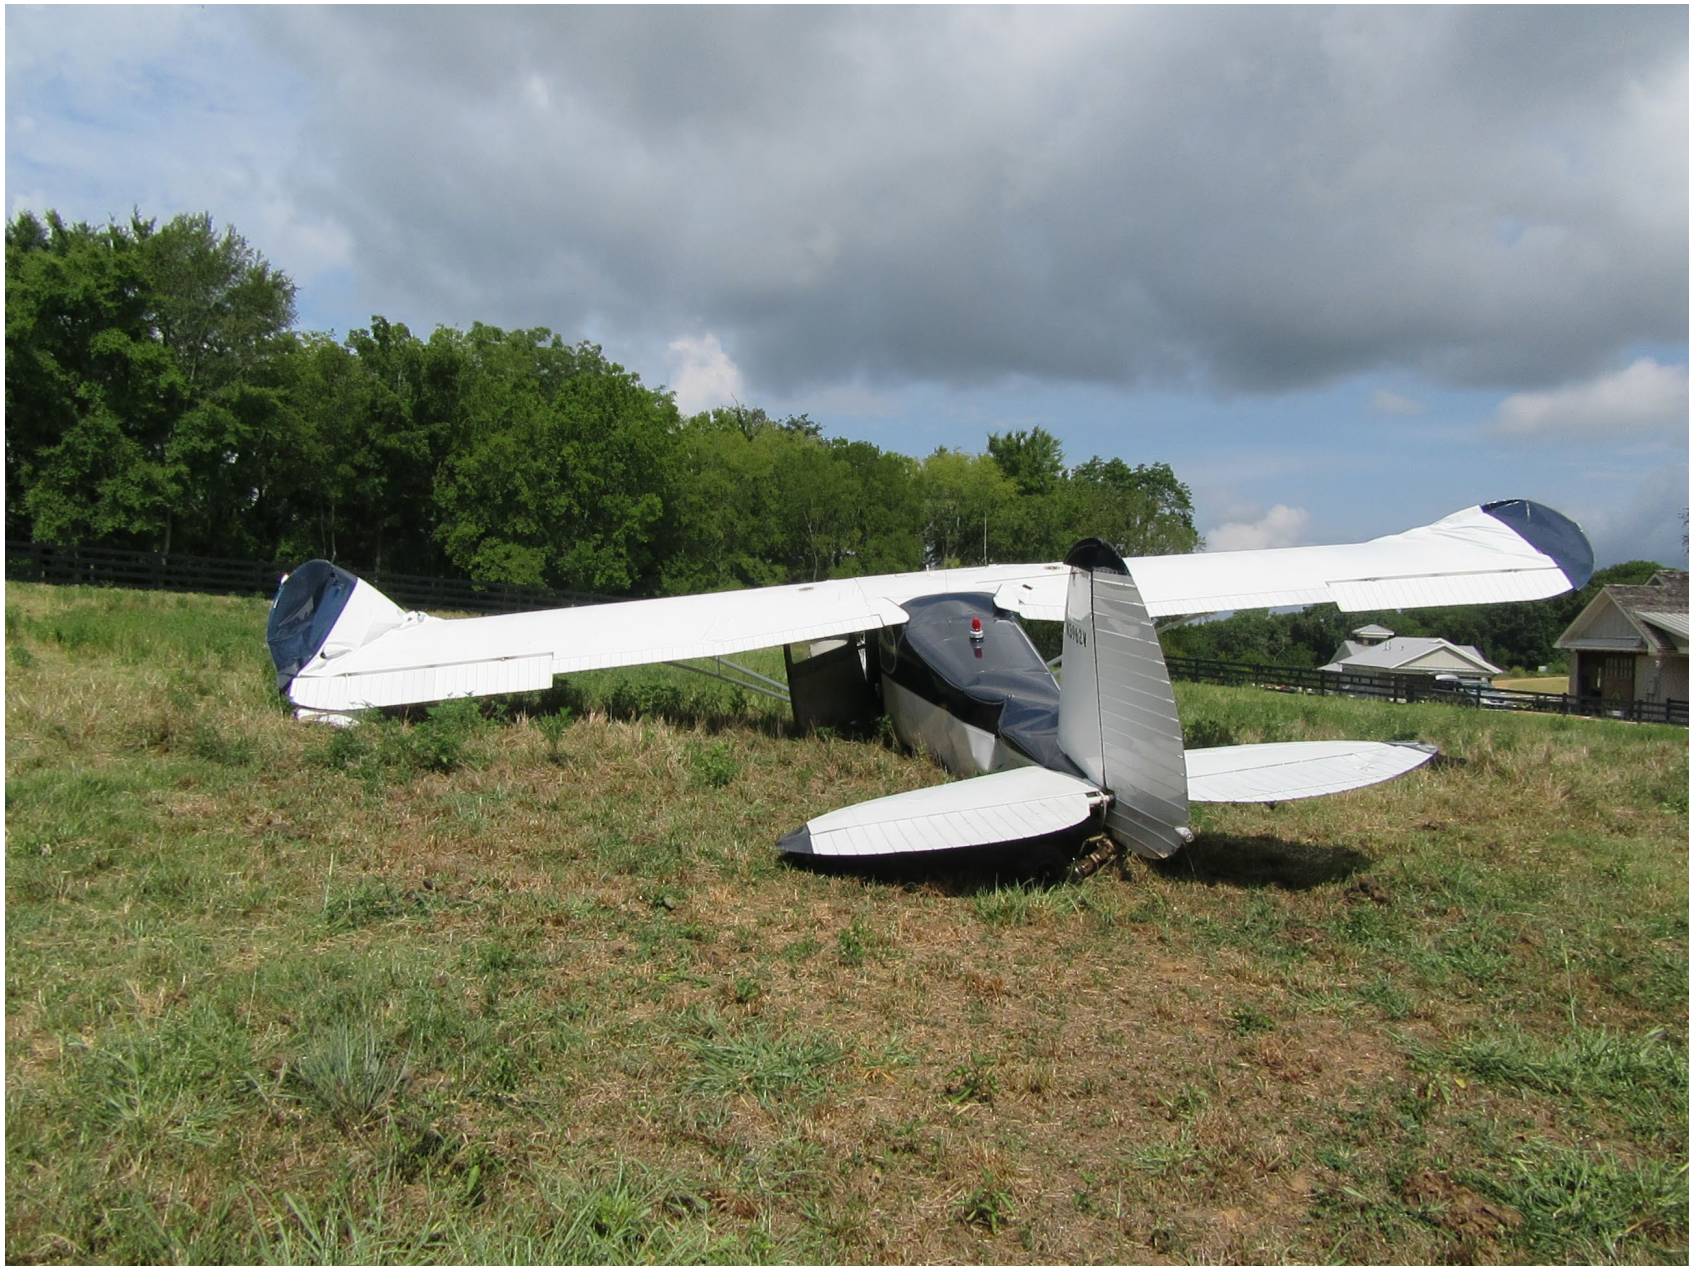
**Photo 4 – Rear View of Main Wreckage – Courtesy of FAA**

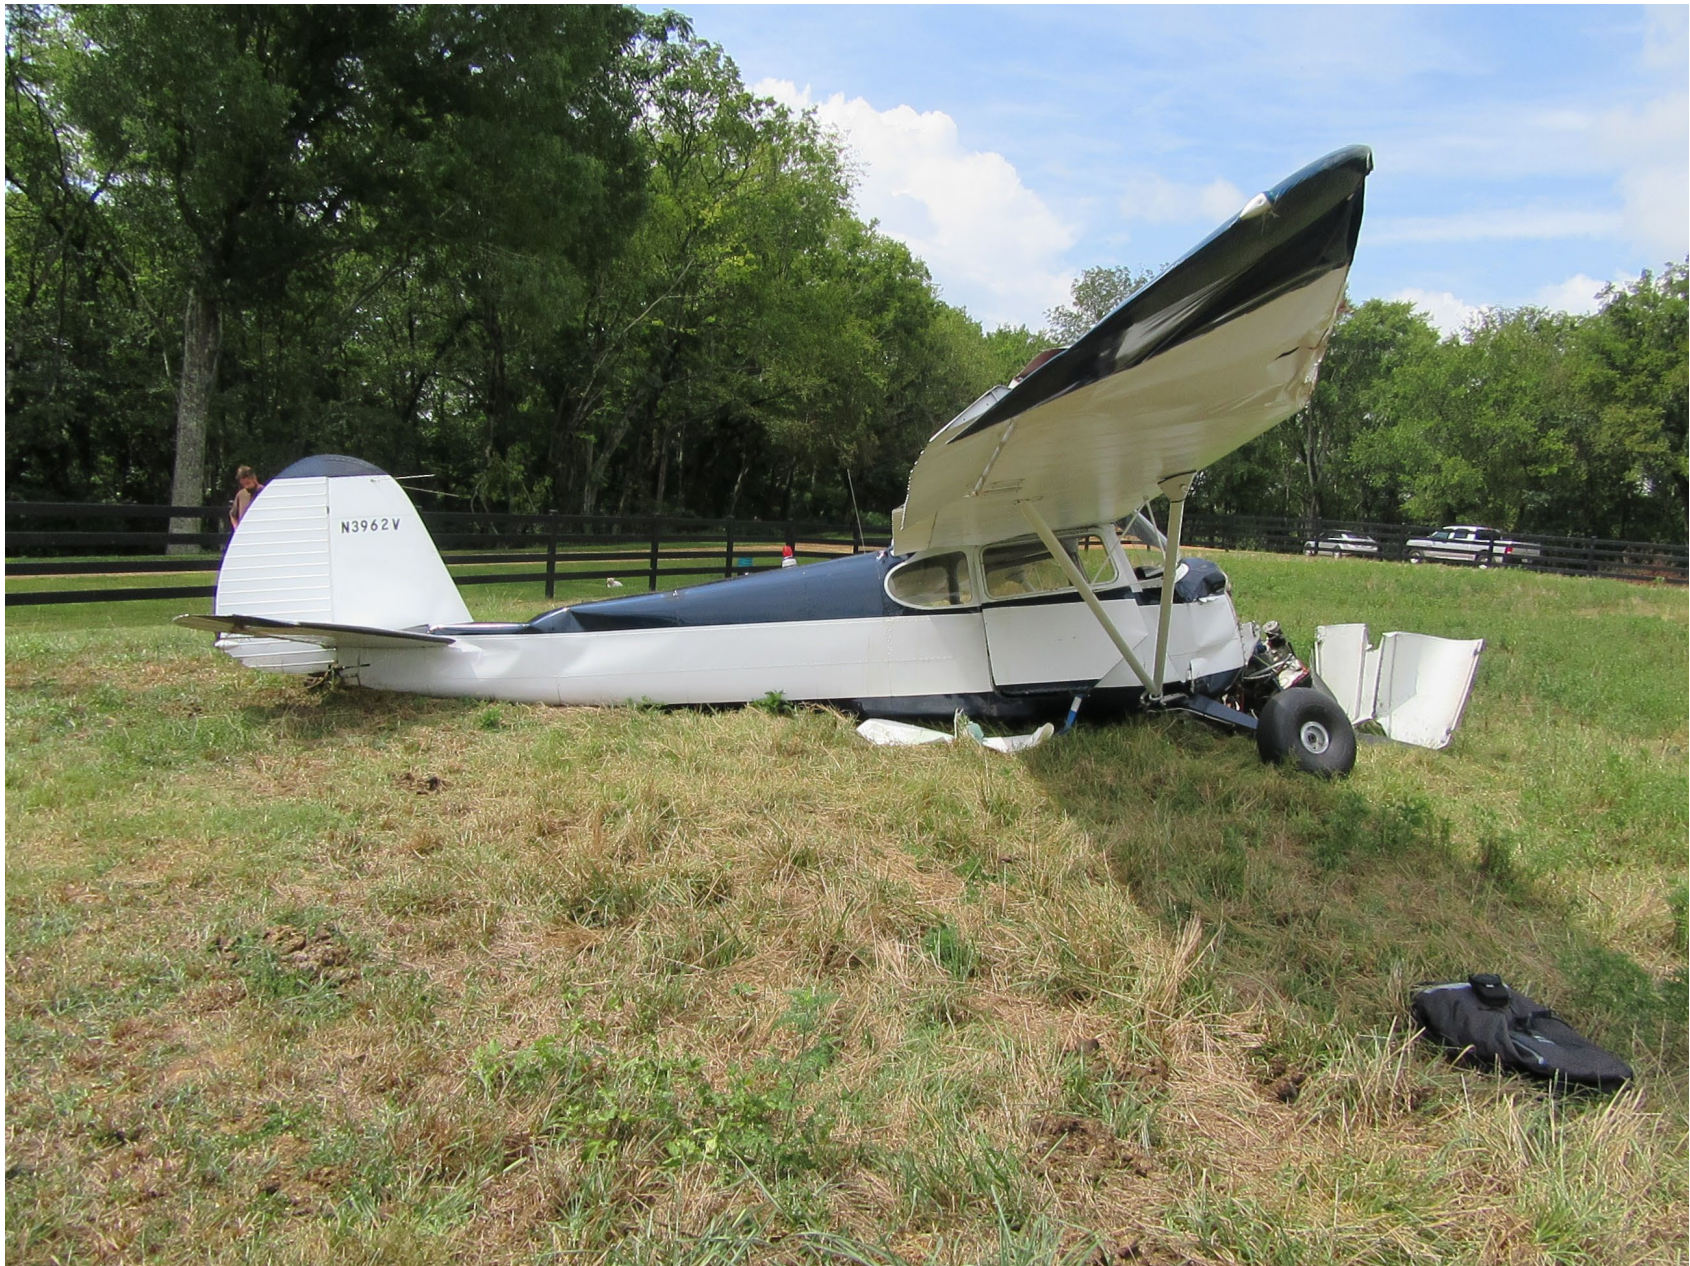
**Photo 5 – Right Side View of Main Wreckage – Courtesy of FAA**

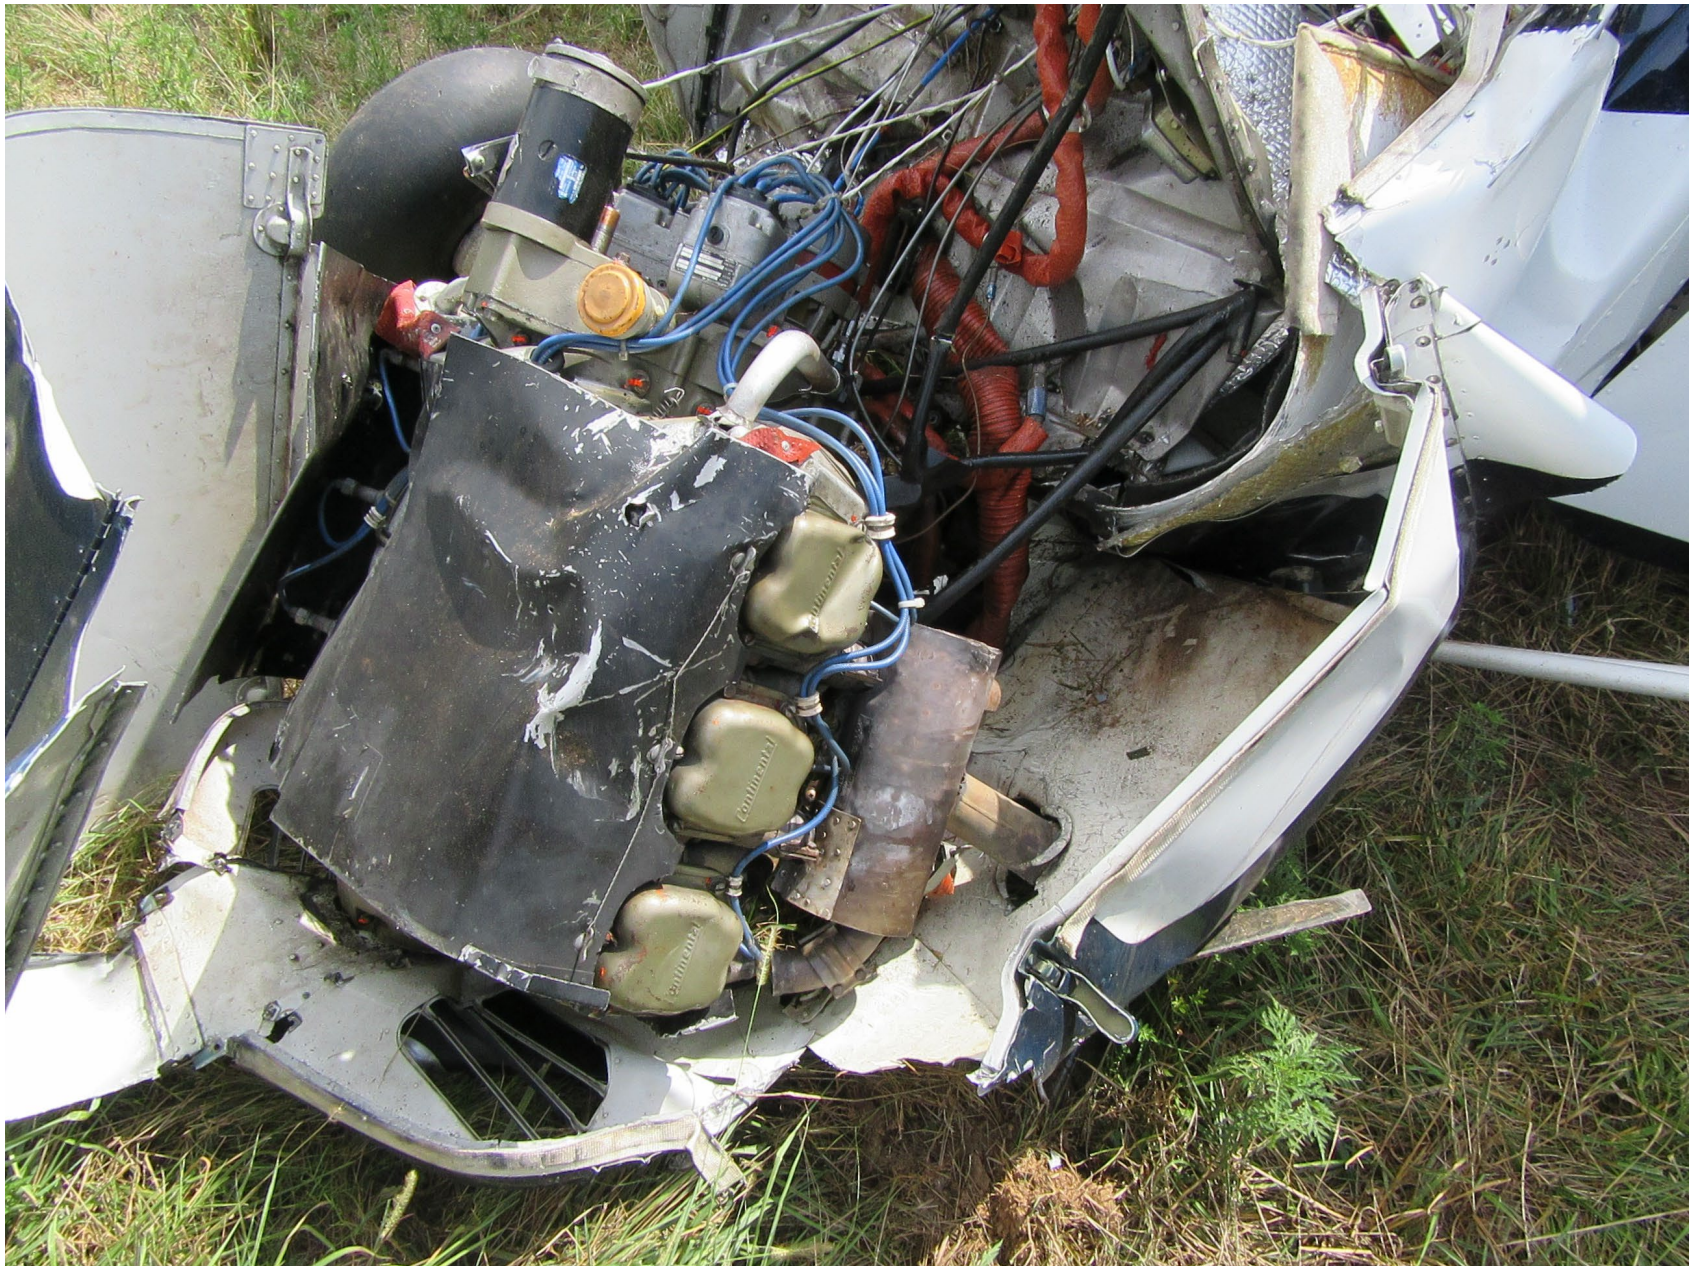
**Photo 6 – Engine – Courtesy of FAA**

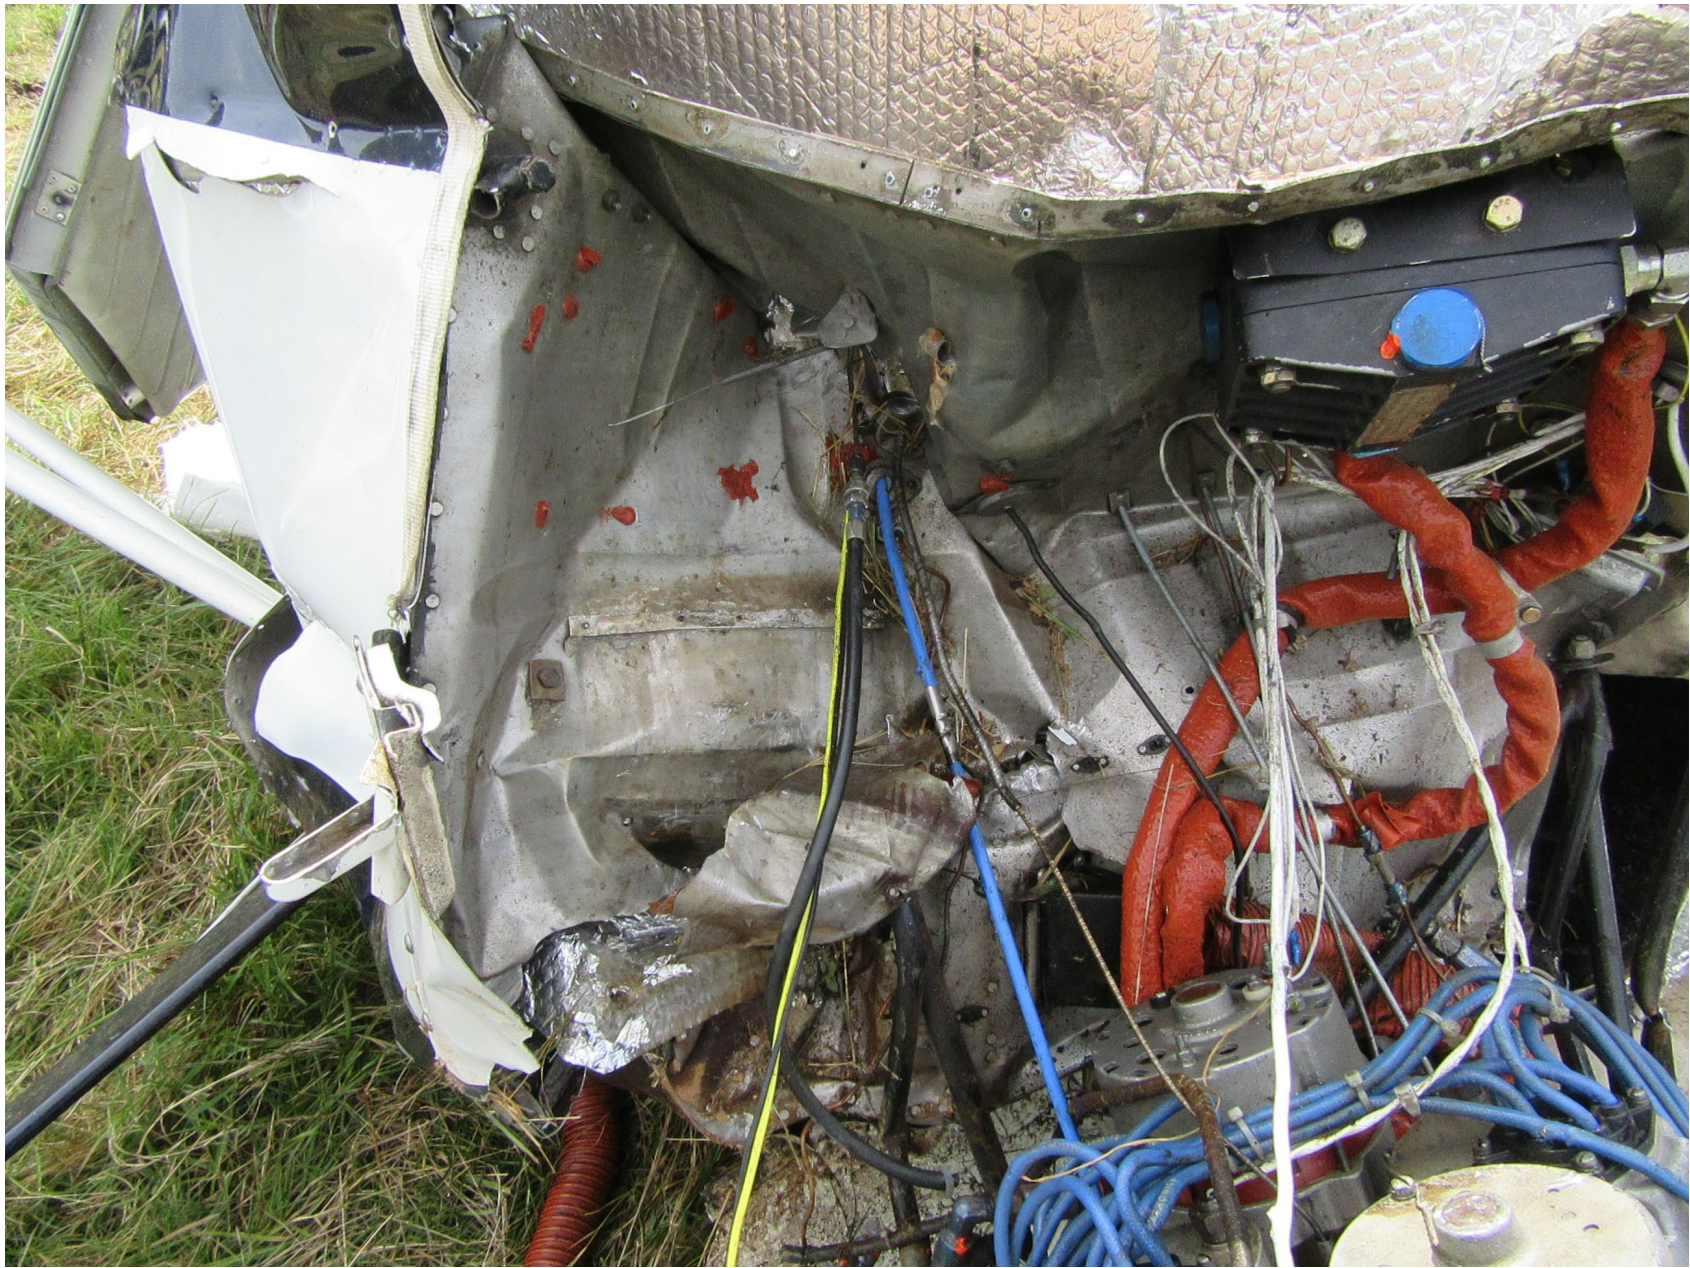
**Photo 7 – Firewall – Courtesy of FAA**

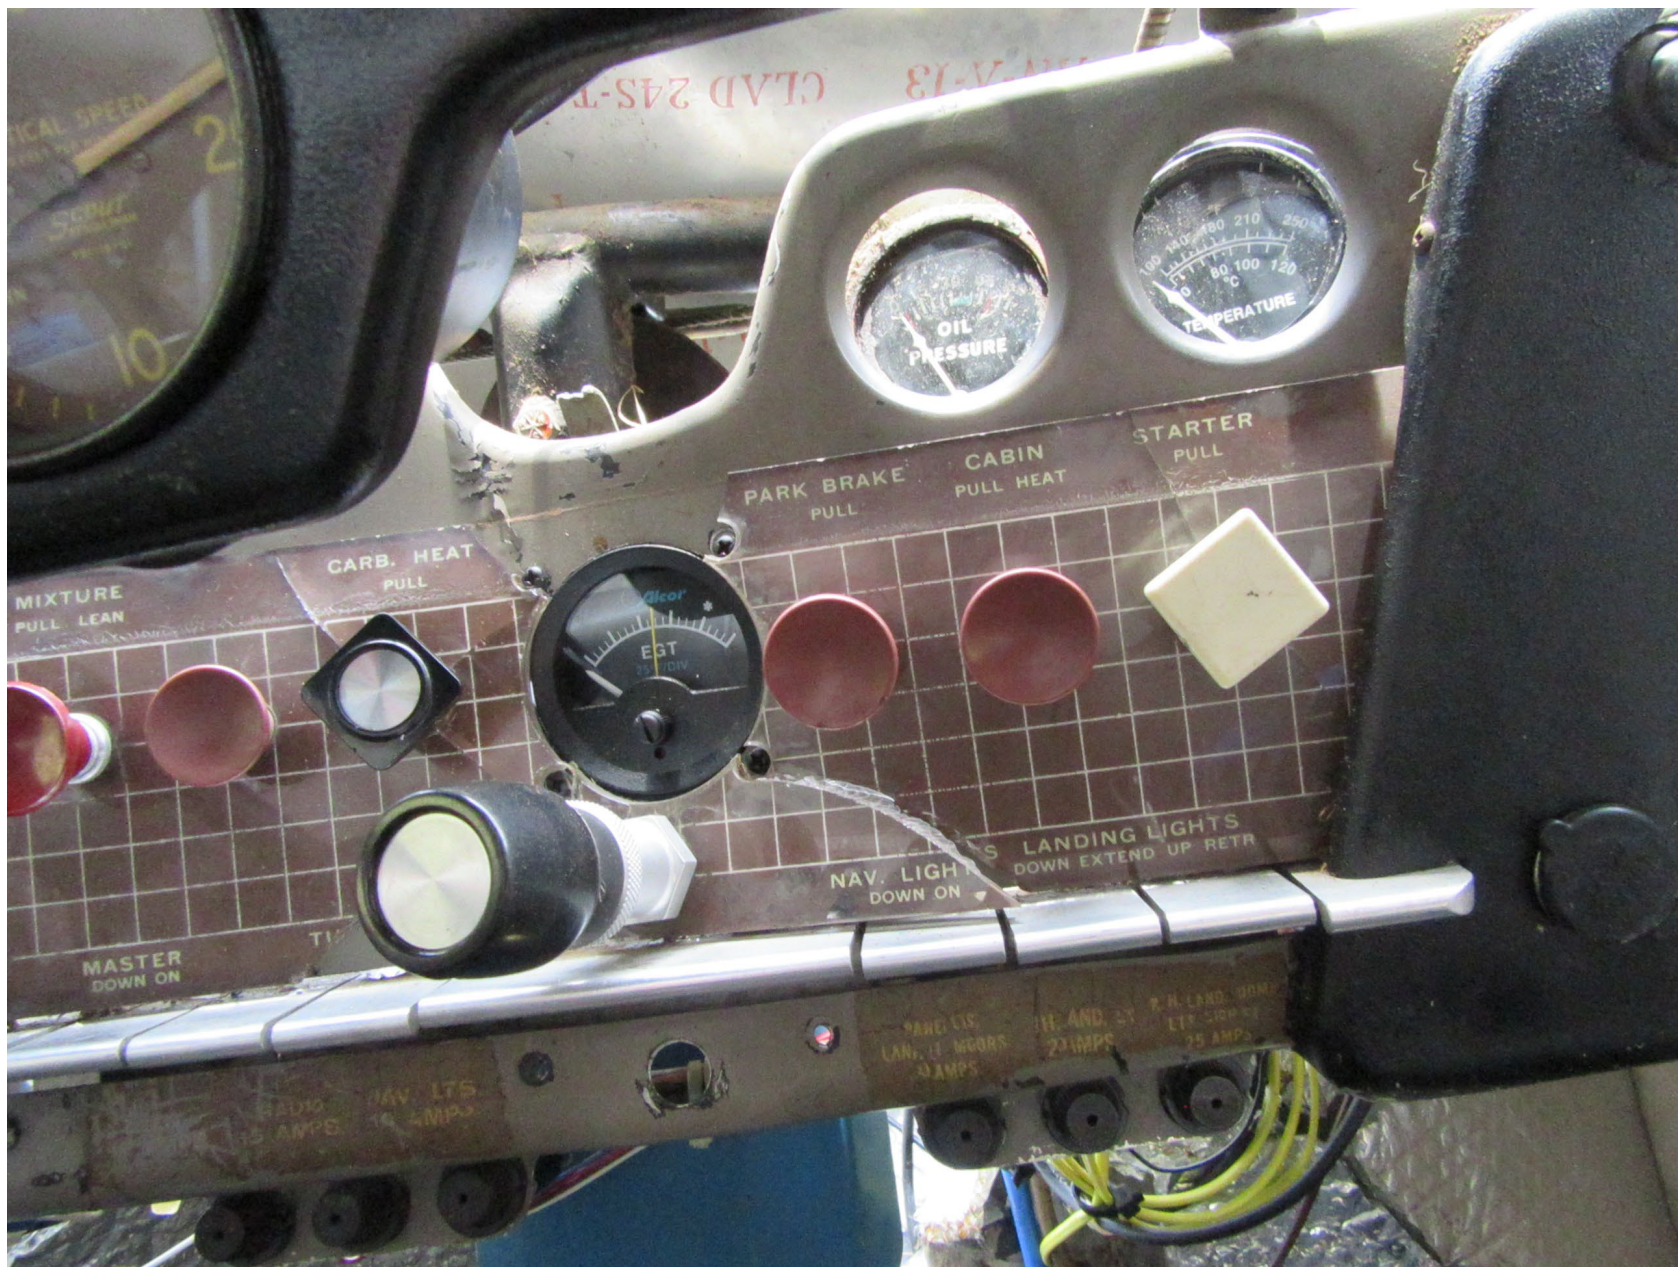
**Photo 8 – Mixture Control, Carburetor Heat Control, and Throttle Control – Courtesy of FAA**

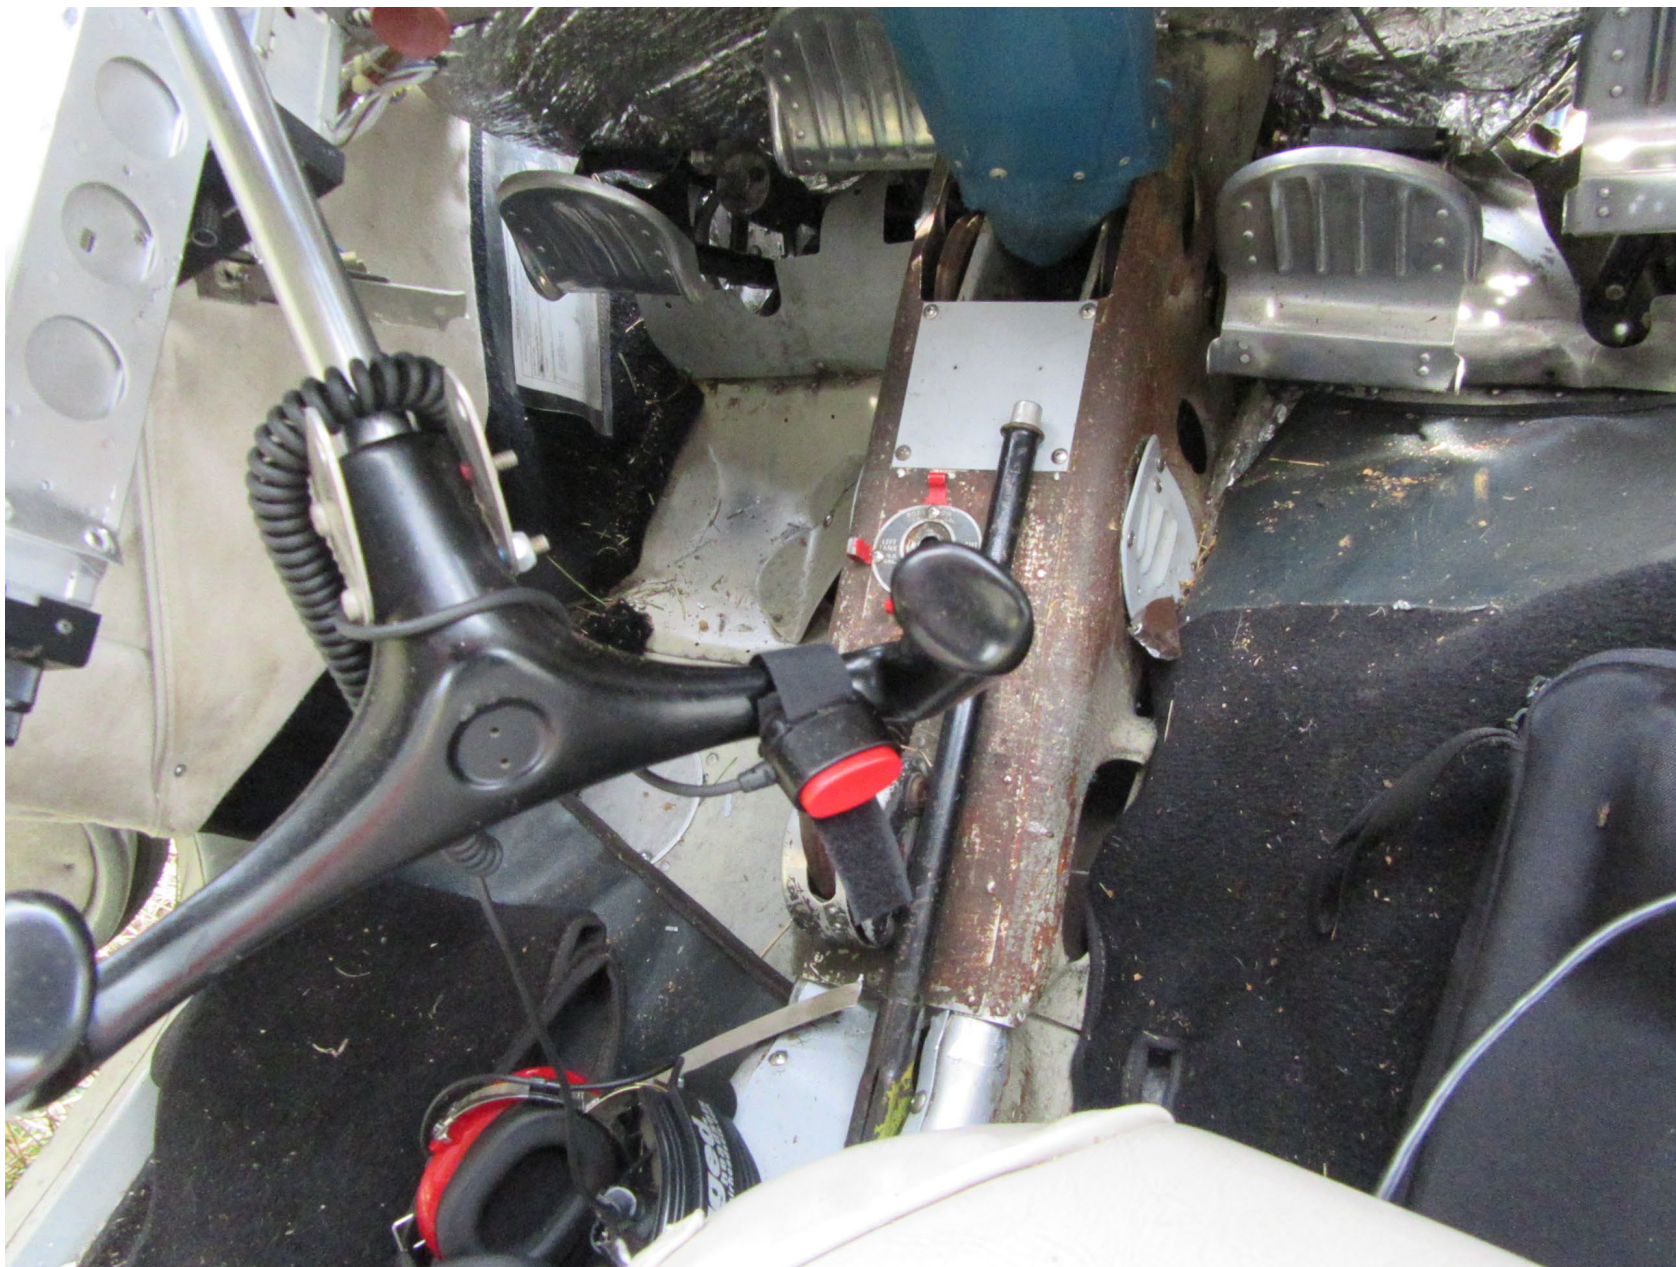
**Photo 9 – Flap Handle – Courtesy of FAA**

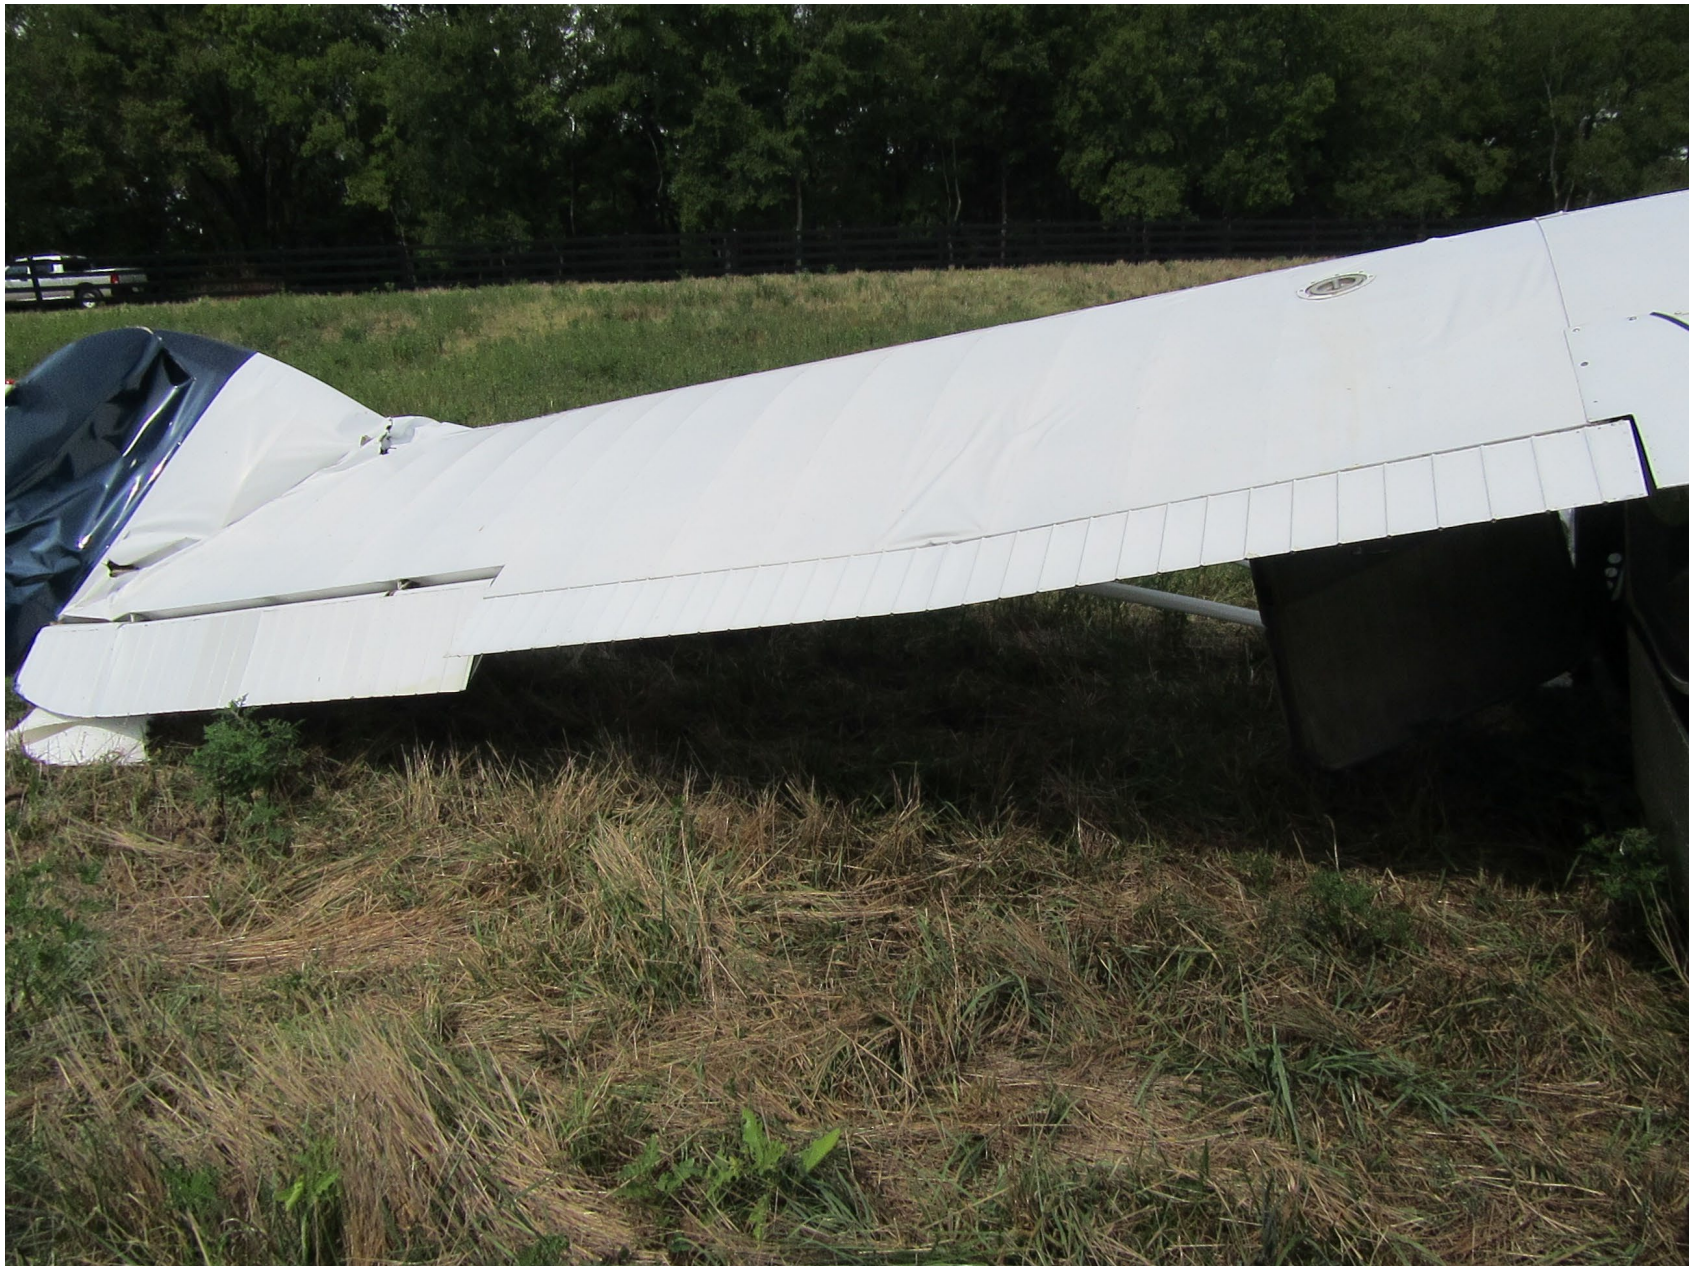
**Photo 10 – Wing Flap – Courtesy of FAA**

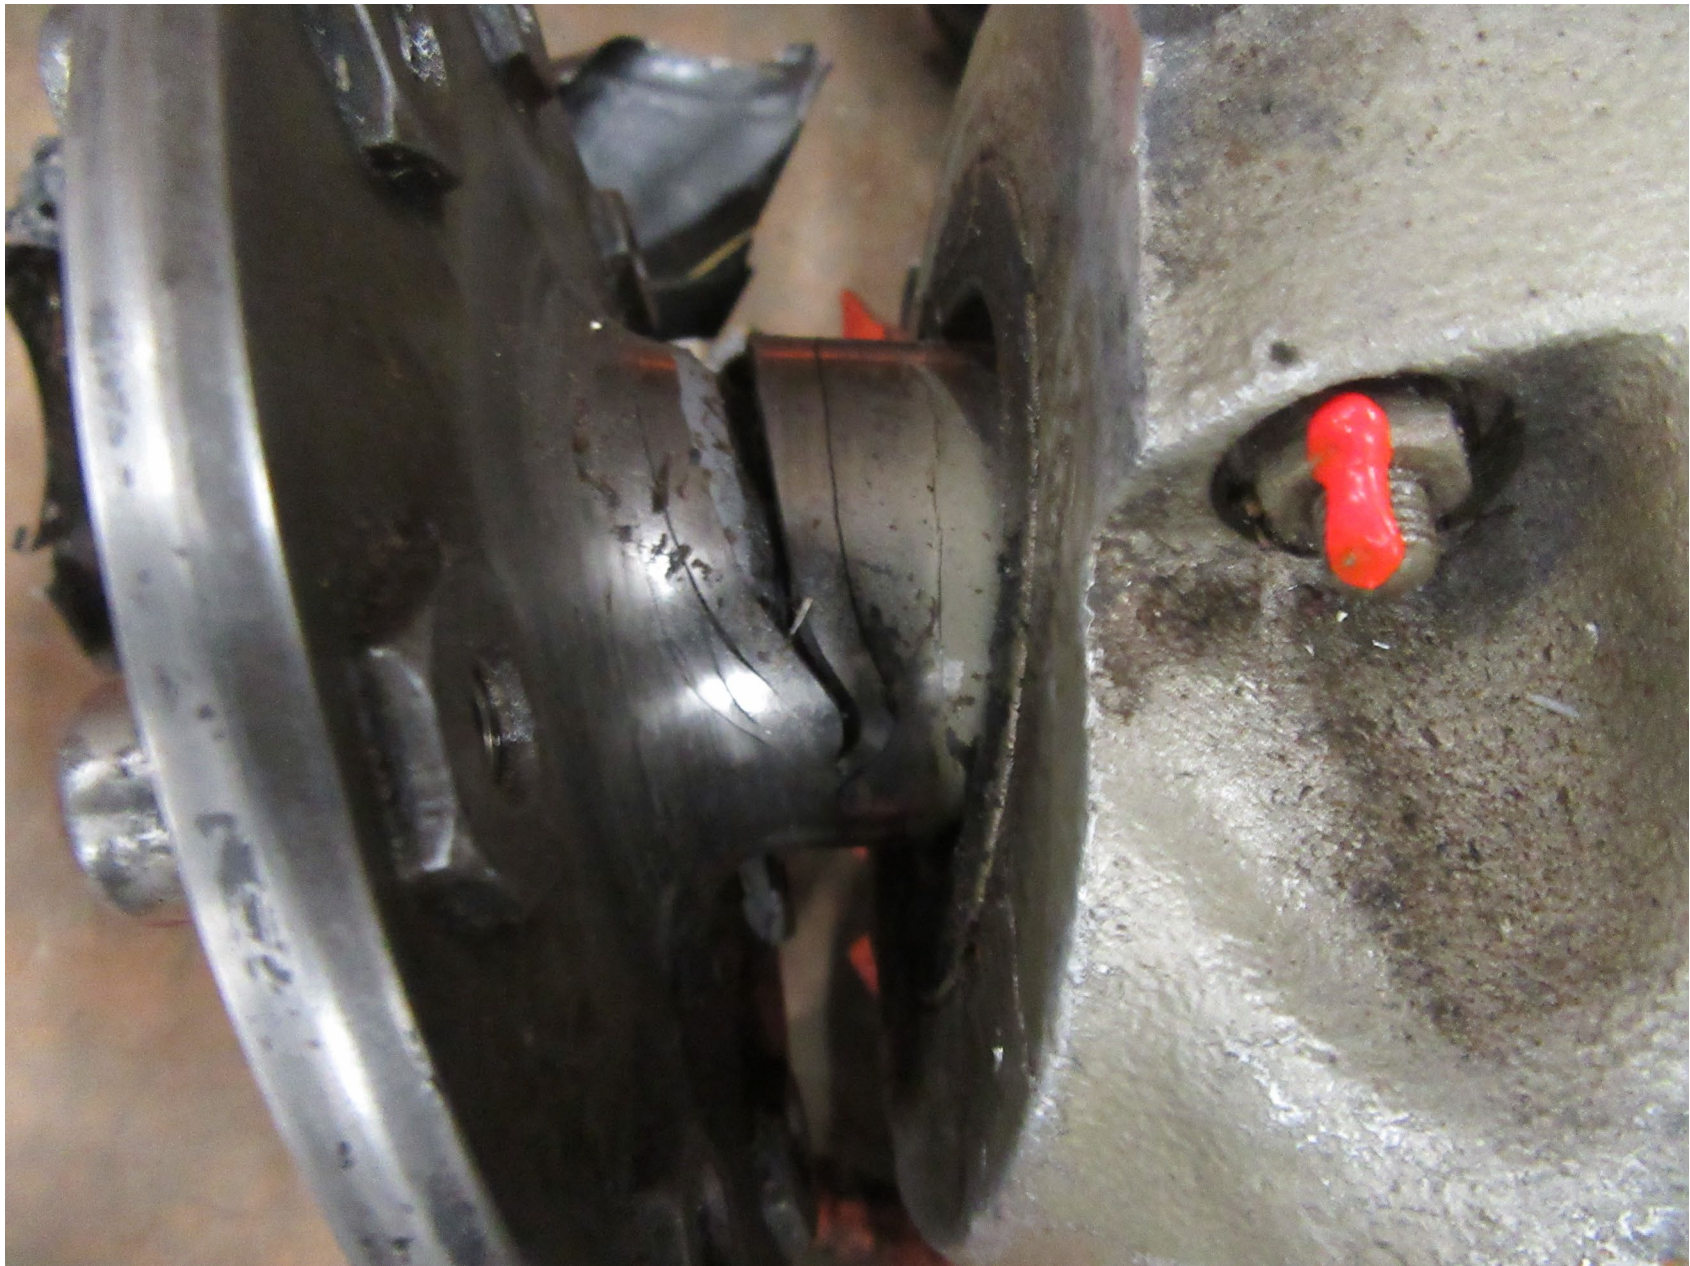
**Photo 11 -Side View of Crankshaft Fracture – Courtesy of FAA**
