**Photo 1 – Main Wreckage – Courtesy of FAA**

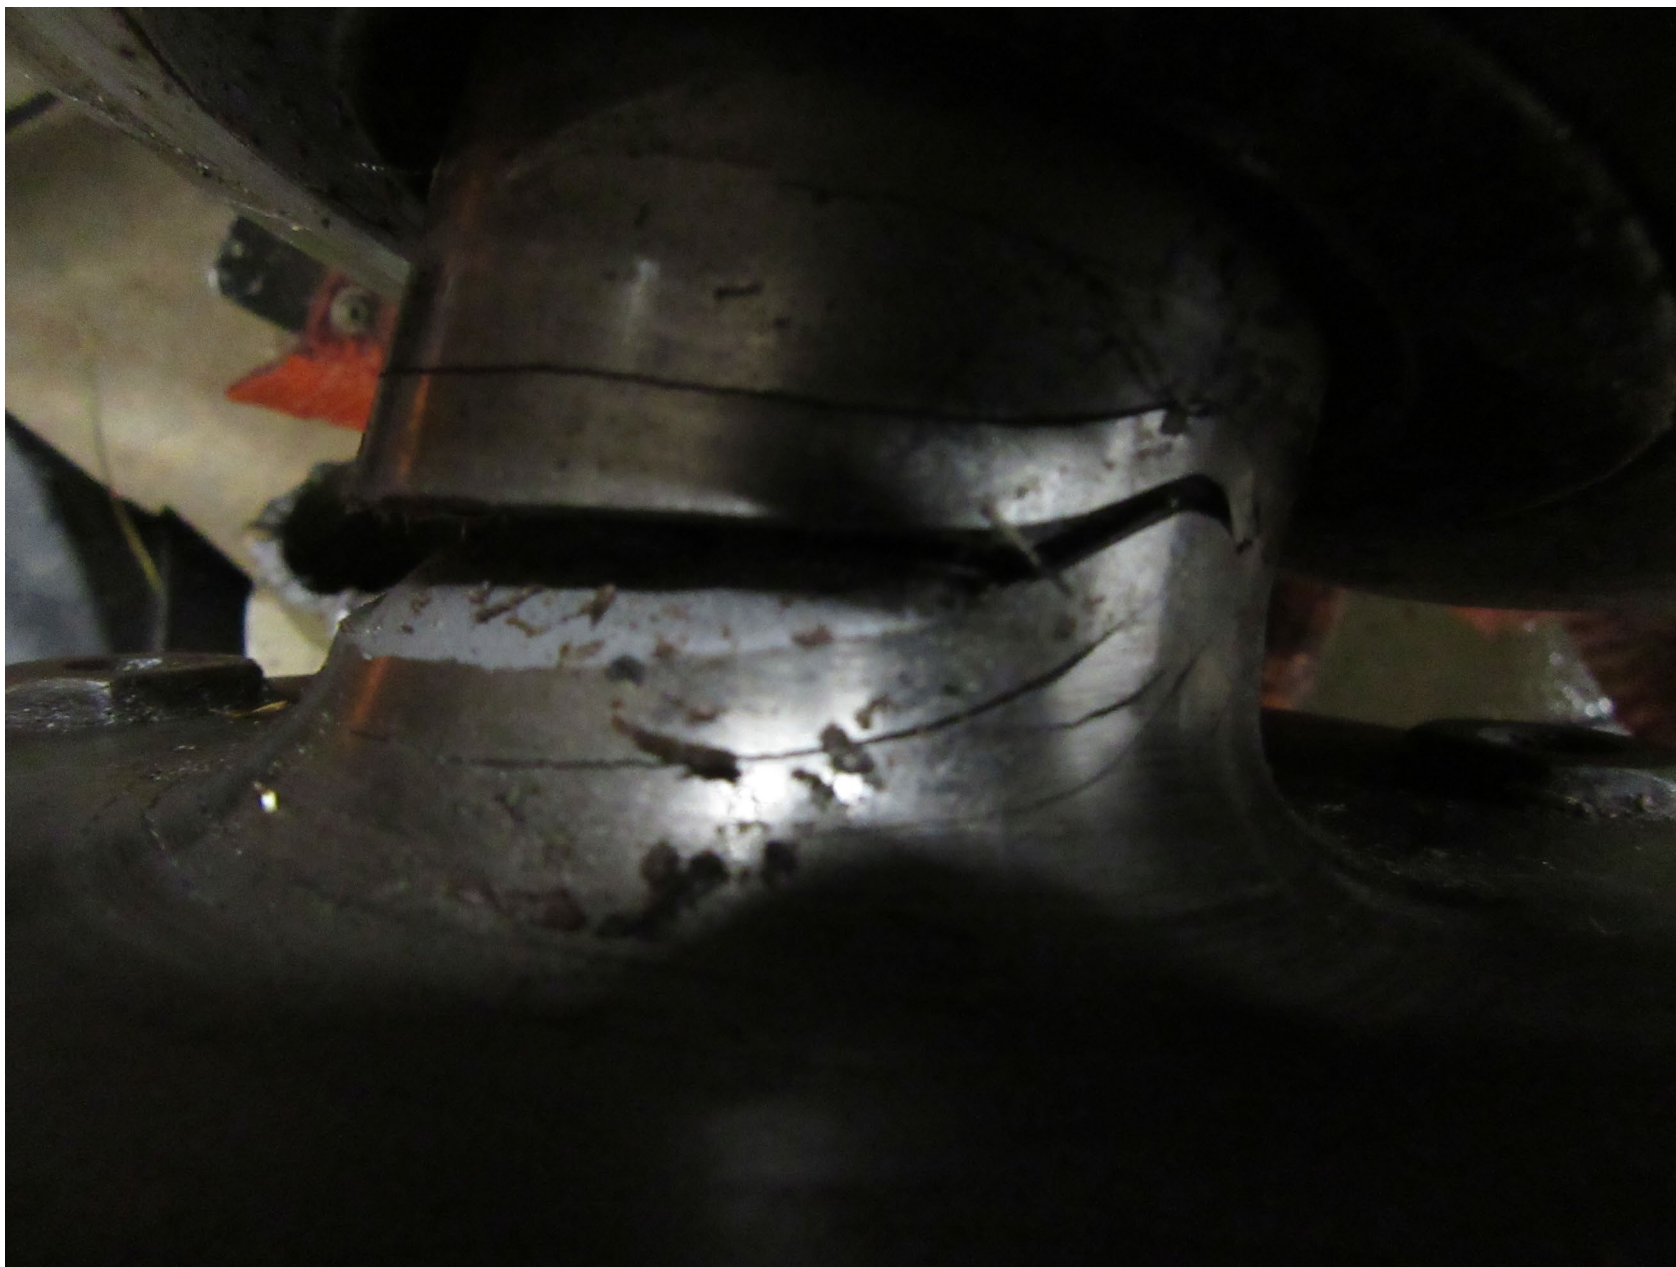
**Photo 12 -Top View of Crankshaft Fracture – Courtesy of FAA**

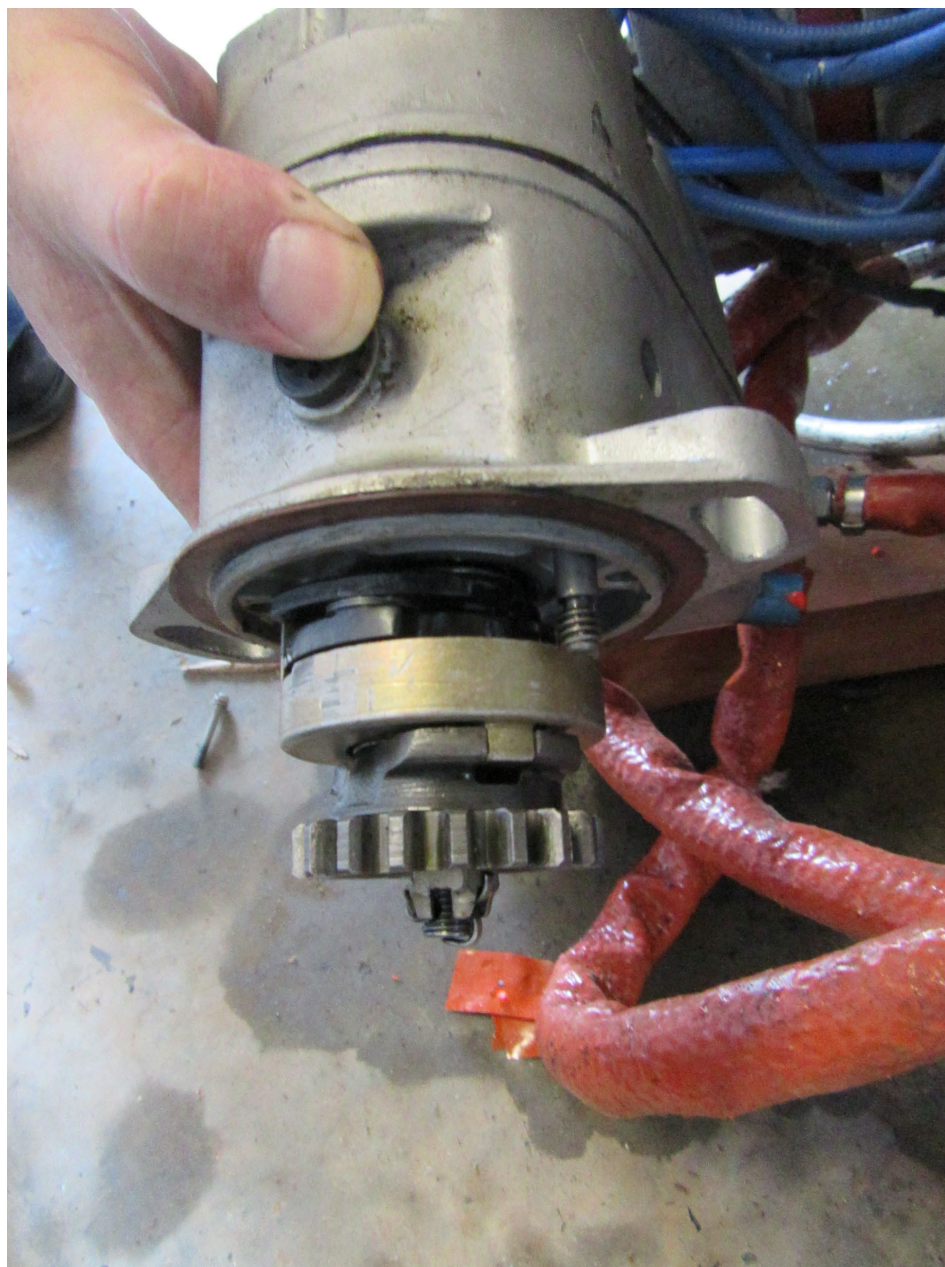
**Photo 13 – Right Magneto – Courtesy of FAA**

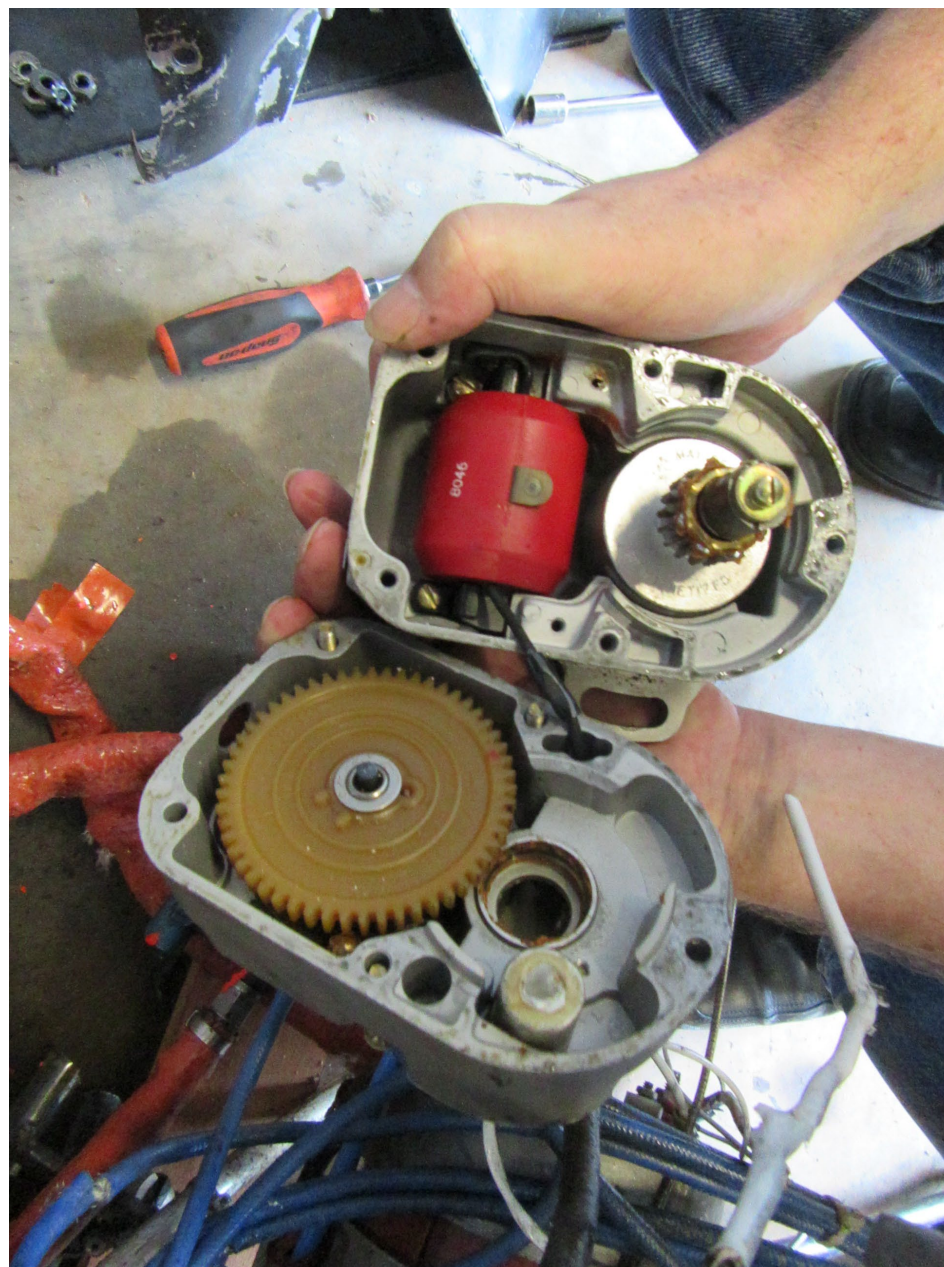
**Photo 14 – Inside of Right Magneto – Courtesy of FAA**

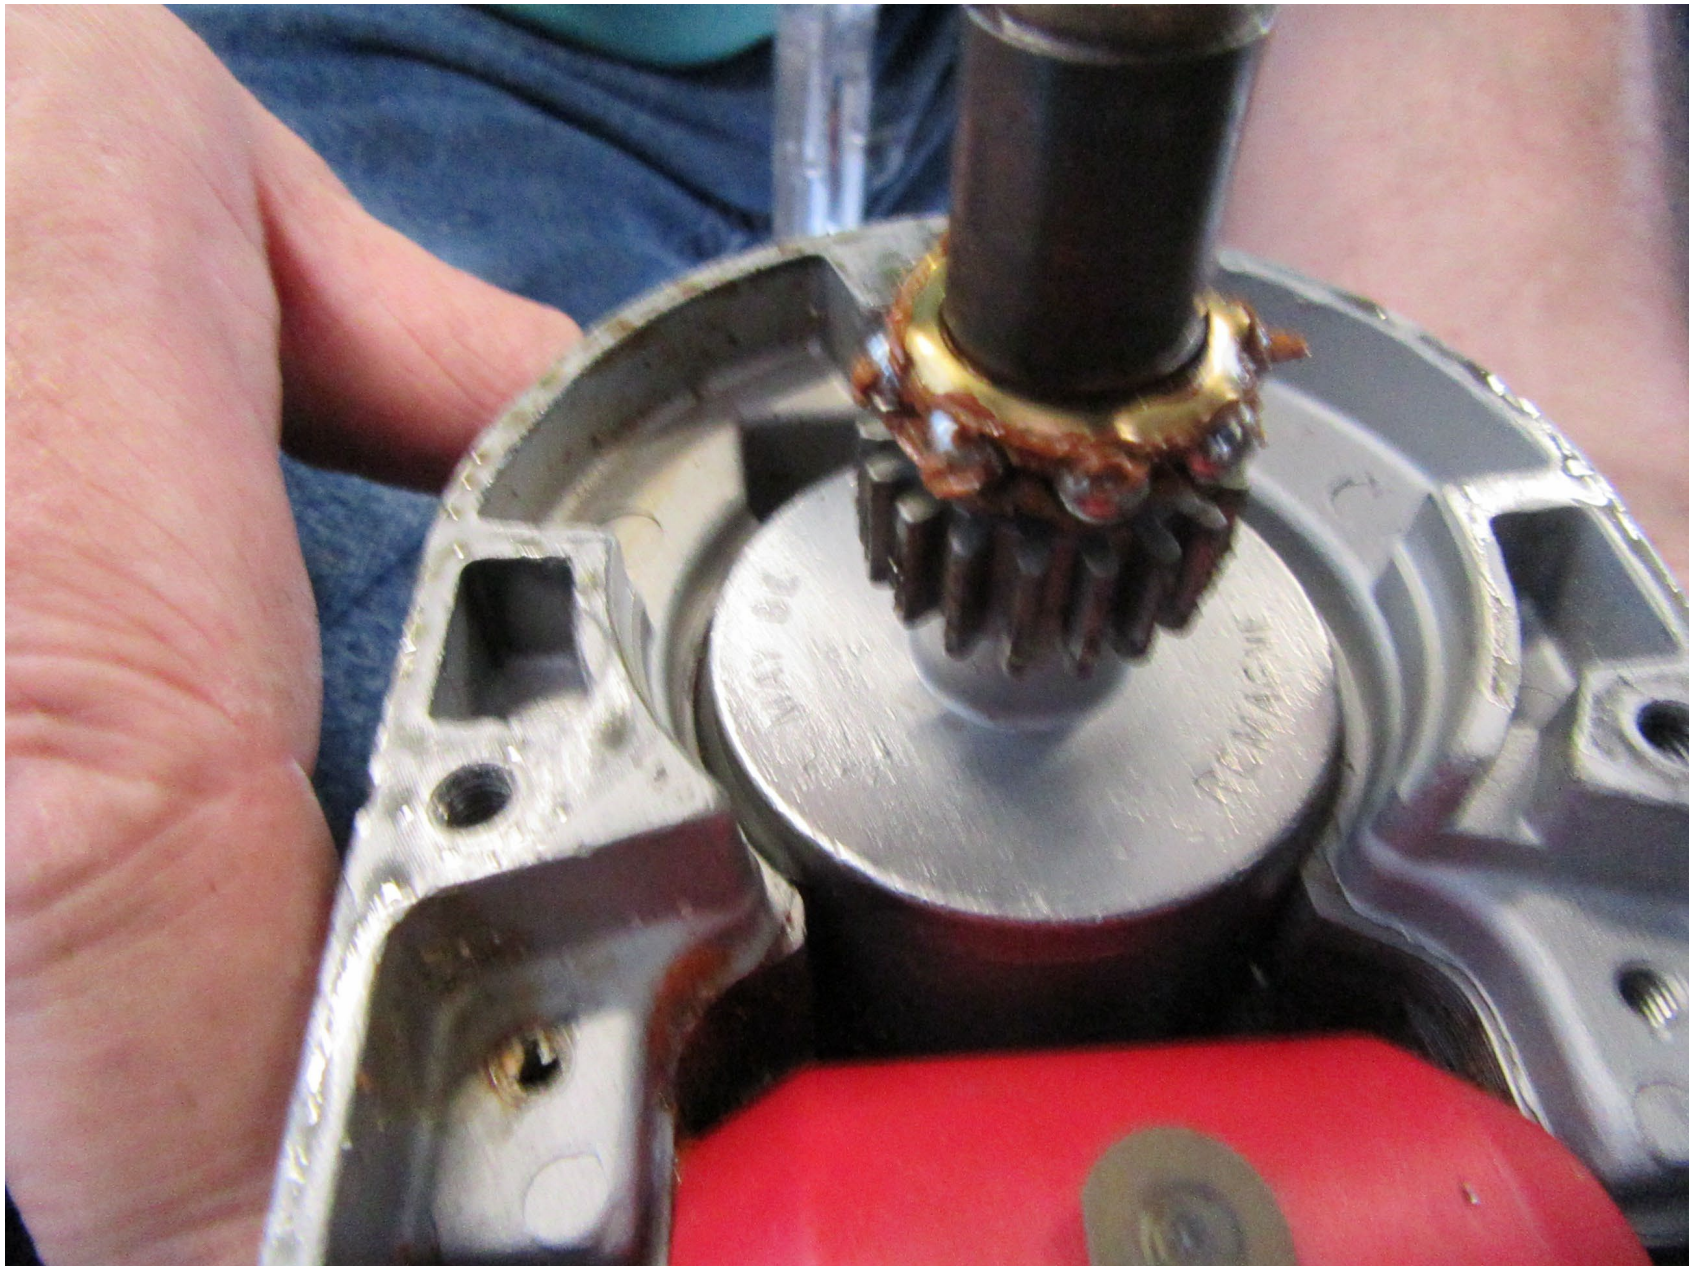
**Photo 15 – Impact Damaged Bearing – Courtesy of FAA**
