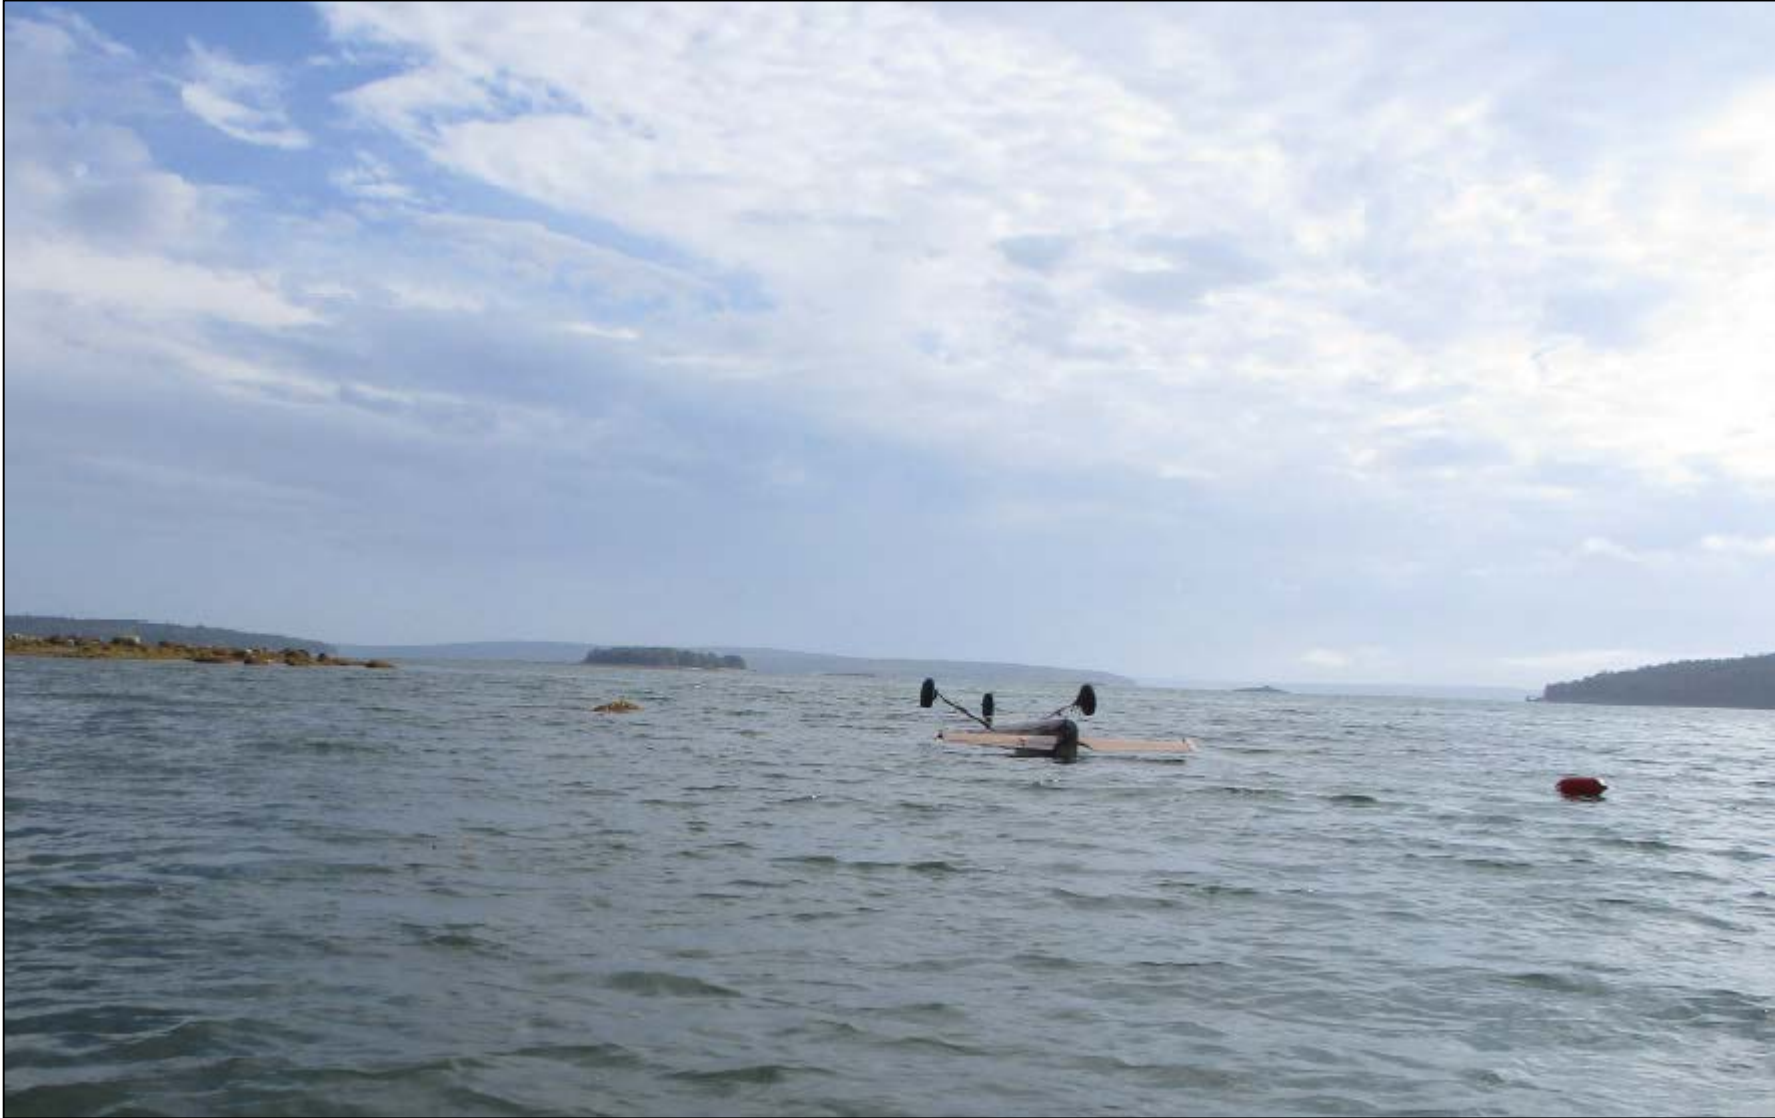
Photo 1 – View of the airplane inverted in the saltwater bay (Credit FAA)

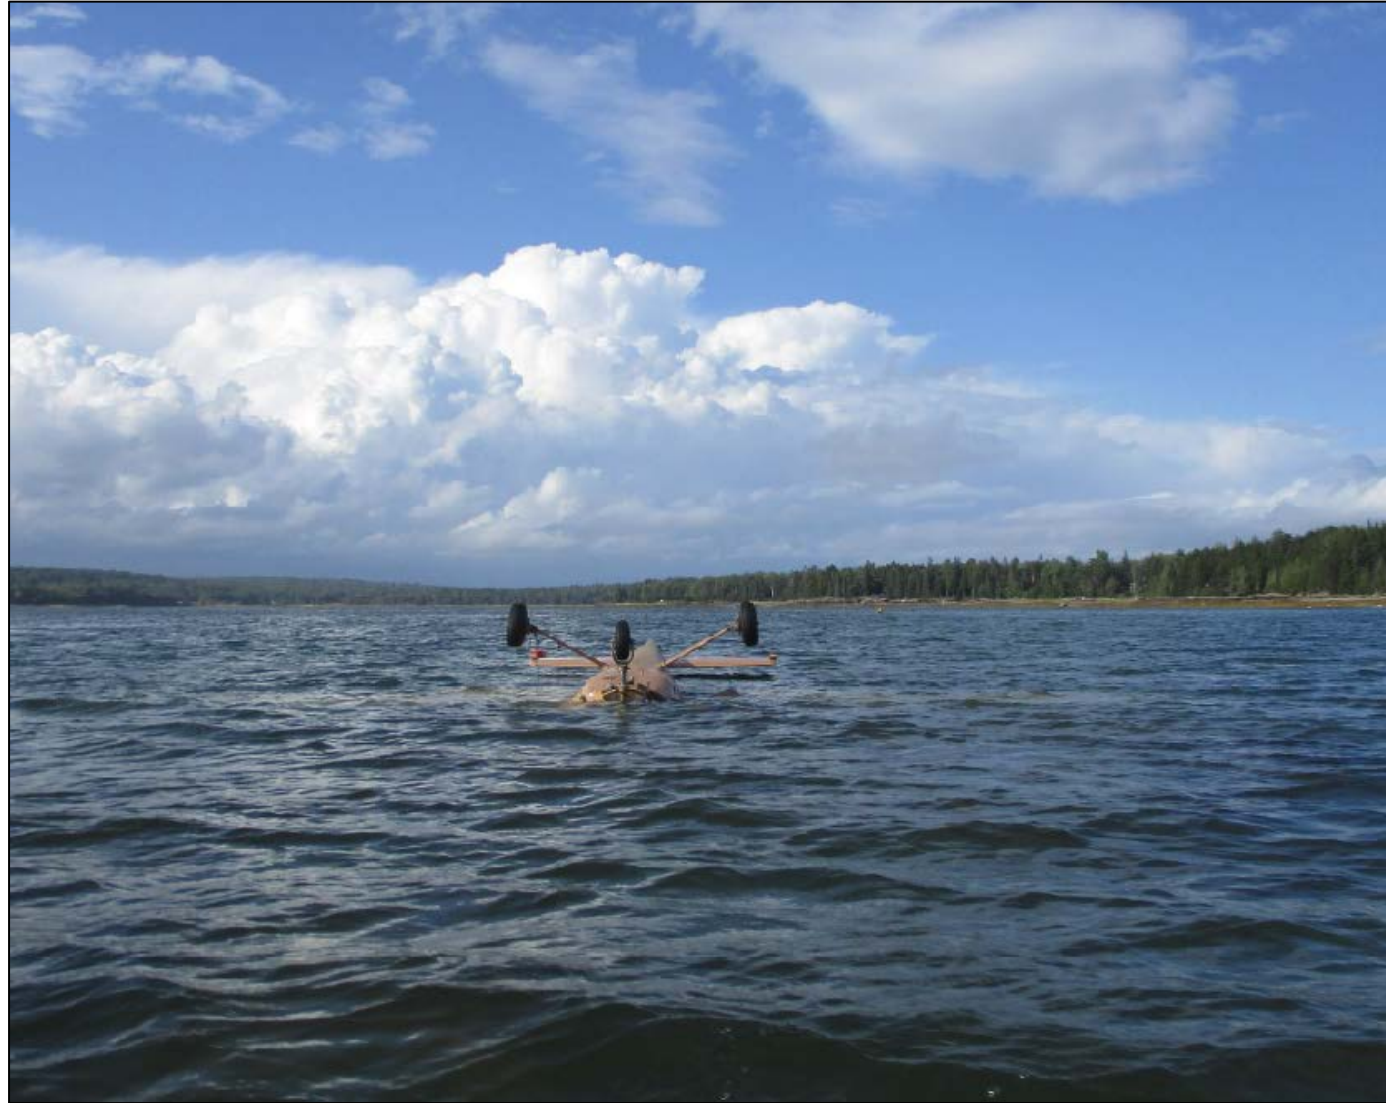
Photo 2 – View of the airplane inverted in the saltwater bay (Credit FAA)

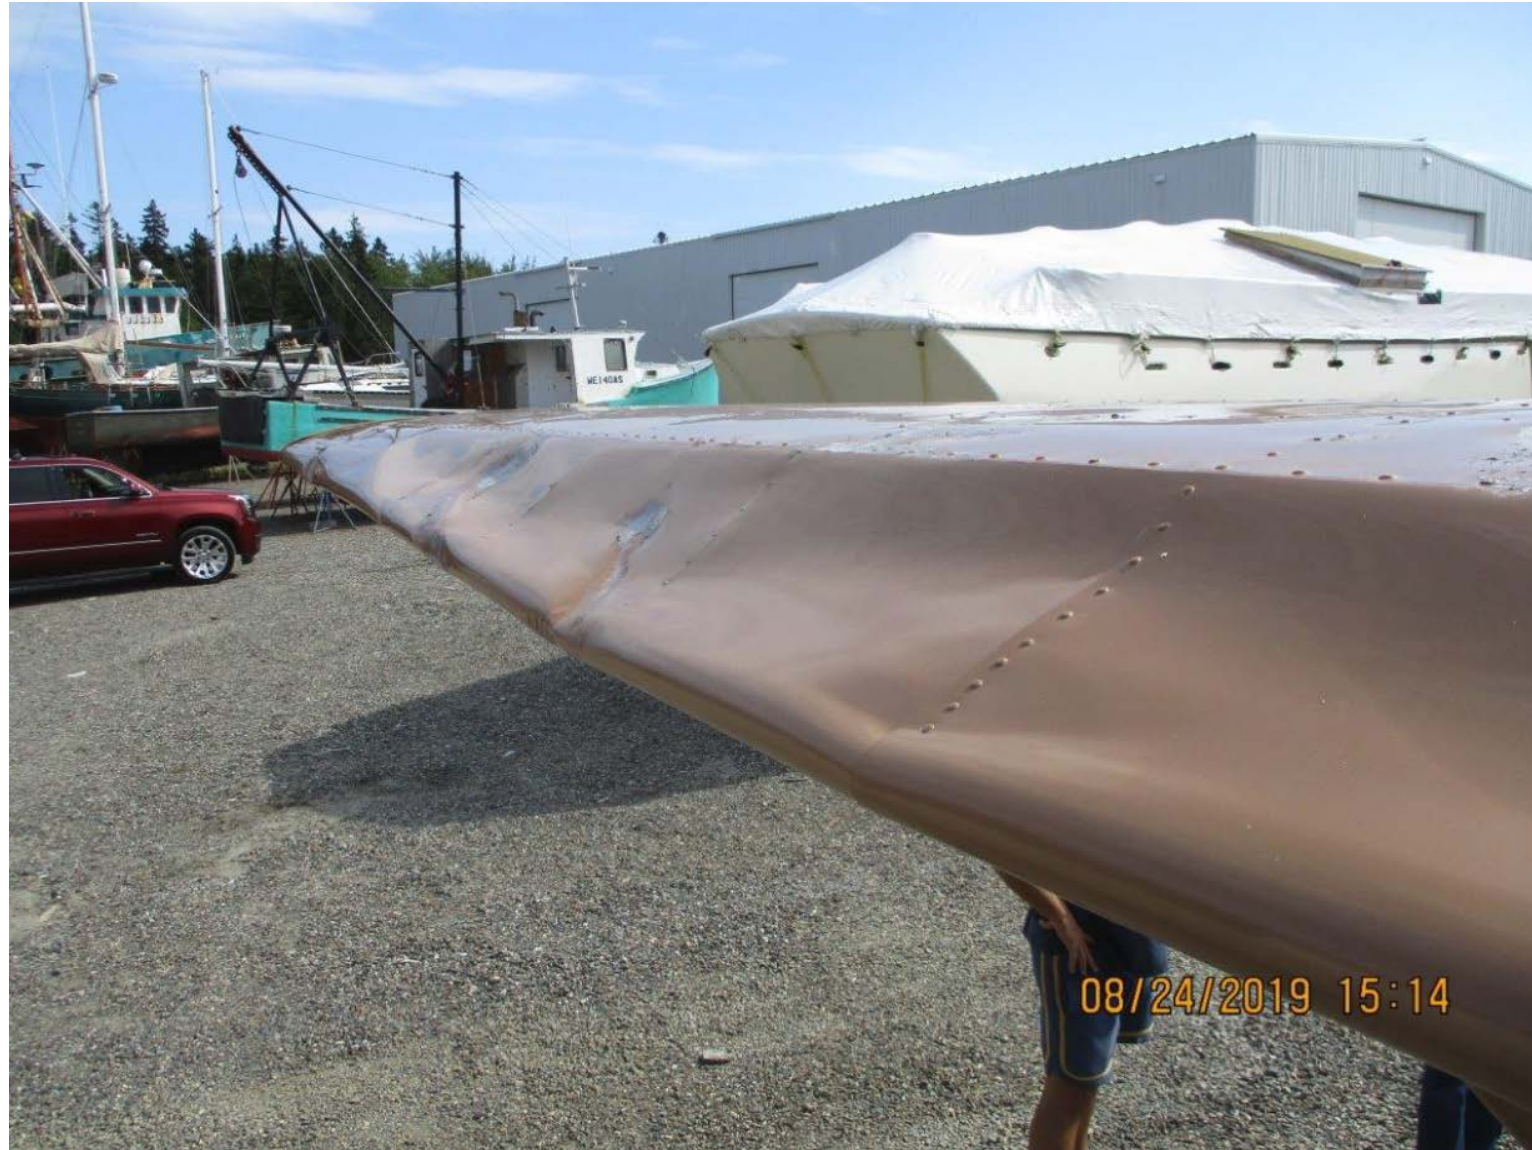
Photo 3 – View of right-wing substantial damage (Credit FAA)

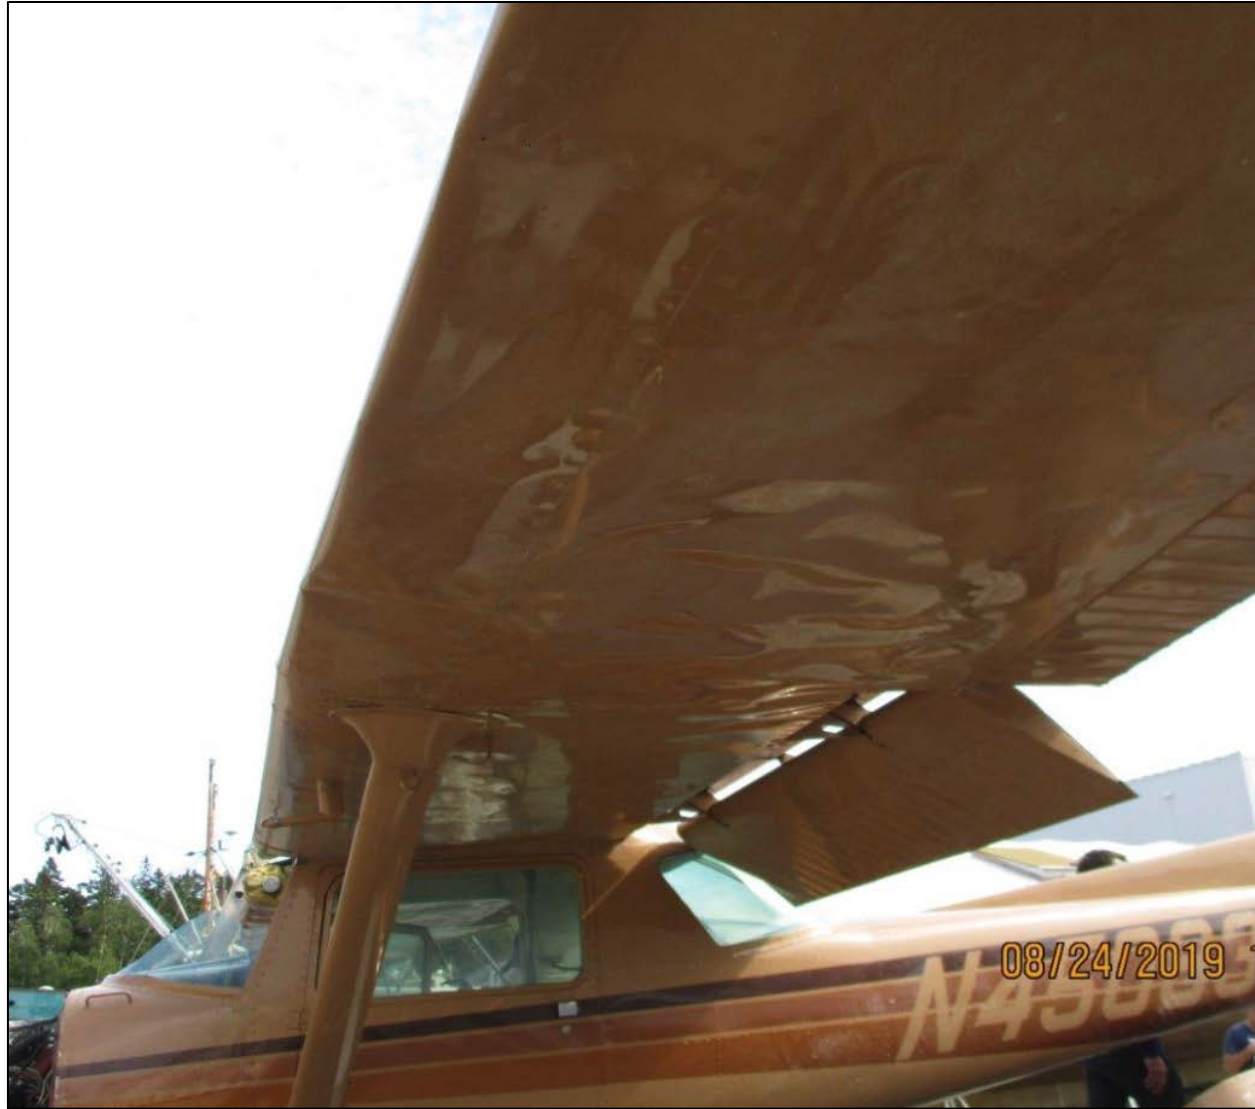
Photo 5 – View of the left-wing substantial damage (Credit FAA)
