**PROPELLER EXAM FACTUAL FINDINGS****Position:** LEFT**Propeller Model:** HC-C3YR-2UF with FC8468-6R blades**Propeller Assembly Serial Number:** CK4034A

Aircraft Accident/Incident report No.: 200828

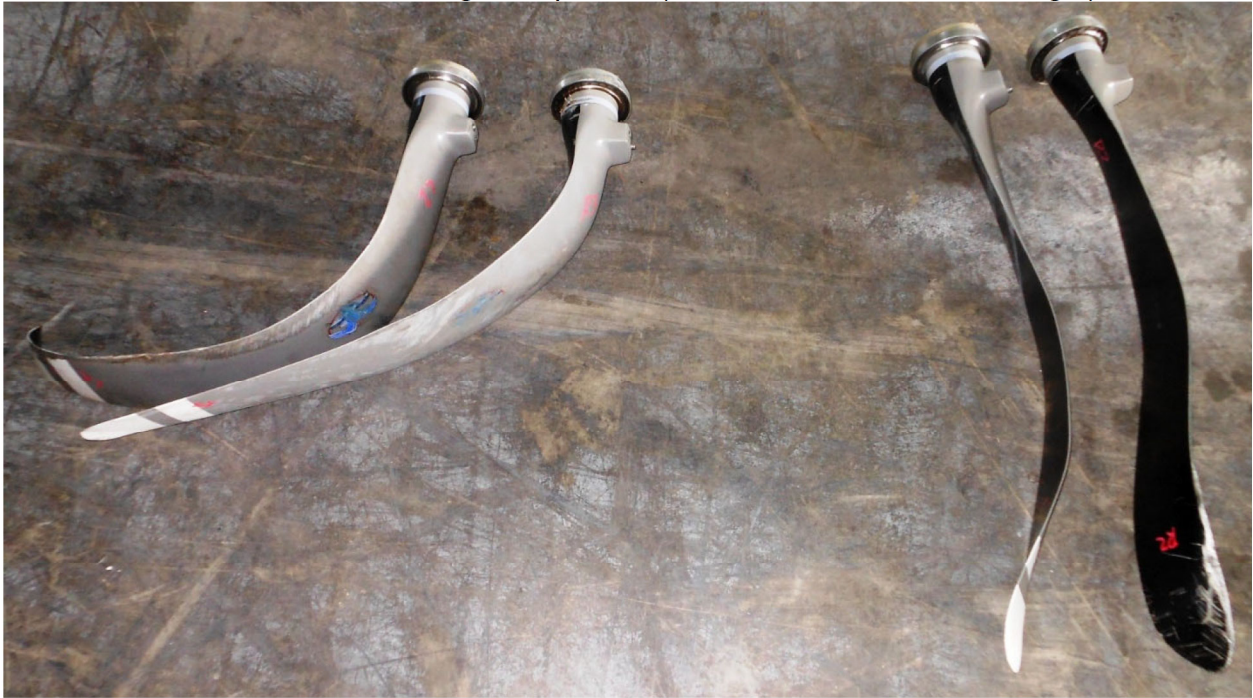
Photo #1 - Blade damage comparison (L2-R3 on left and L1-R2 on right)

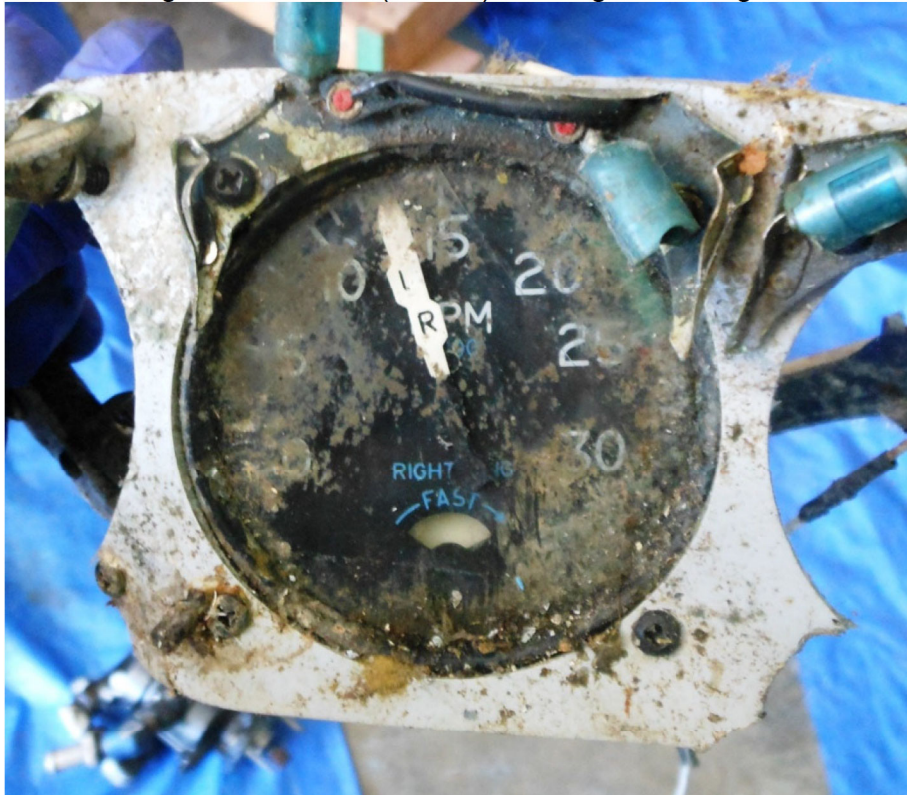
Photo #2 - Engine tachometer (electric) showing left and right ~1300 RPM

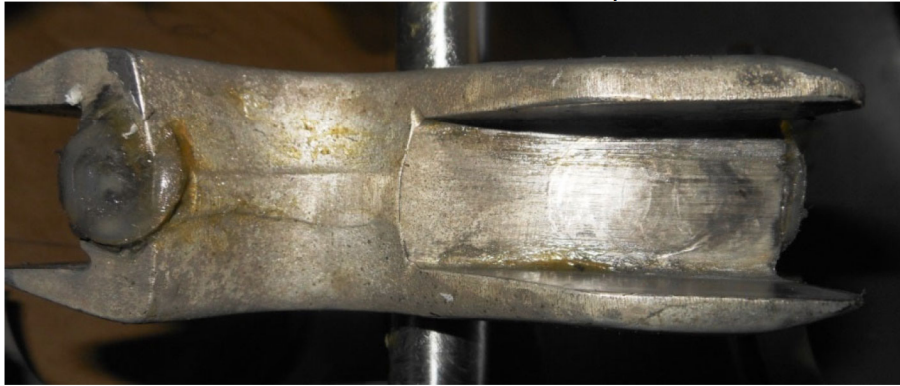
**Fork:** The fork was intact and remained on the pitch change rod (Photo #7). The plastic bumpers were smashed and there were knob block contact marks in each of the slots (Photo #10).

Photo #10 - Left fork knob block impact marks

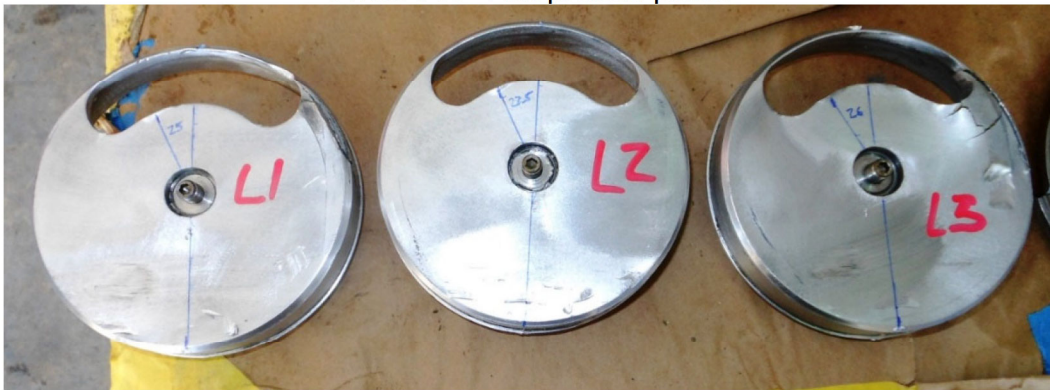
**Preload Plates:** All three preload plates had crushed and/or sheared lips (Photo #11).

Photo #11 - Left preload plates

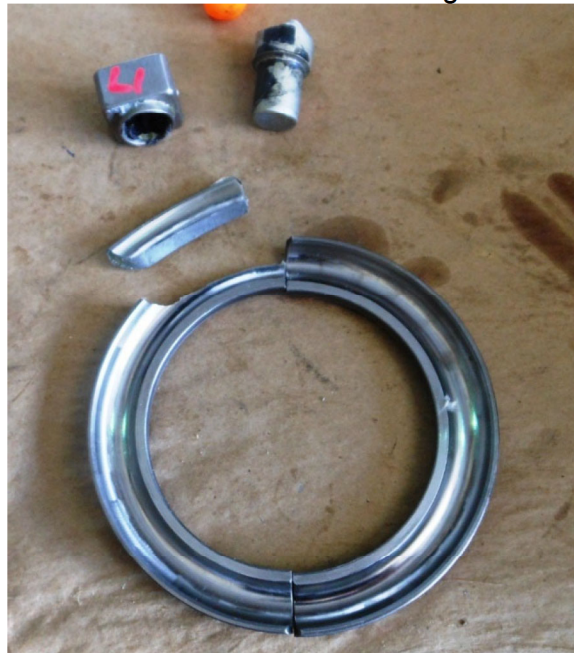
| Knob condition | Fractured, overload shear/bending (Photo #12) |
| Blade bearings | Hub-side race in leading edge quadrant fractured with ball imprints (Photo #12) |

Photo #12 - L1 hub-side blade bearing race fracture

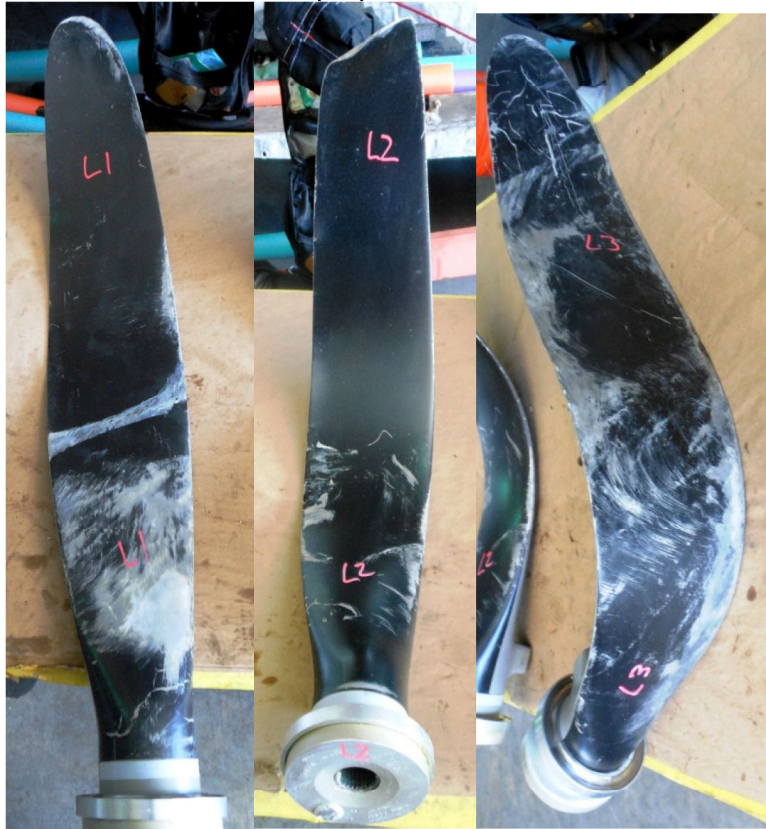
Photo #13 - Left propeller face side of blades

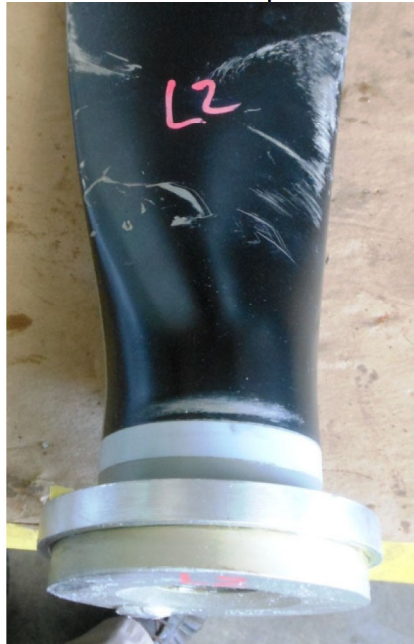
| Butt/shank impact marks | Impact crescent in the trailing edge quadrant. Hub aperture contact mark on the face side (Photo #14). |

Photo #14 - L2 blade shank impact mark on face side

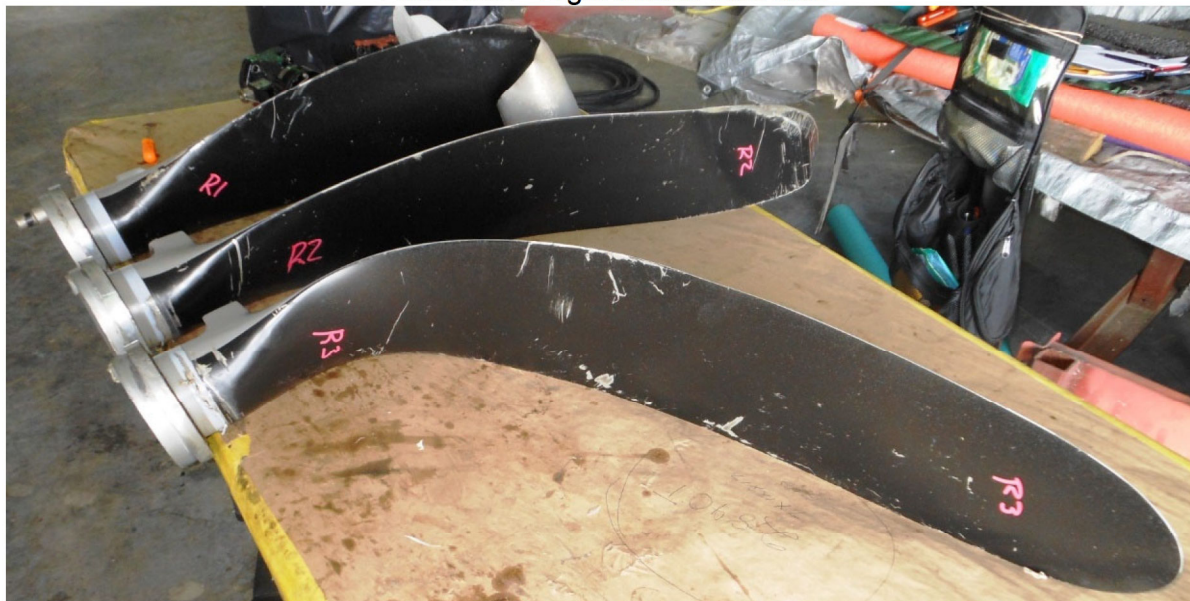
Photo #32 - Right blades face side

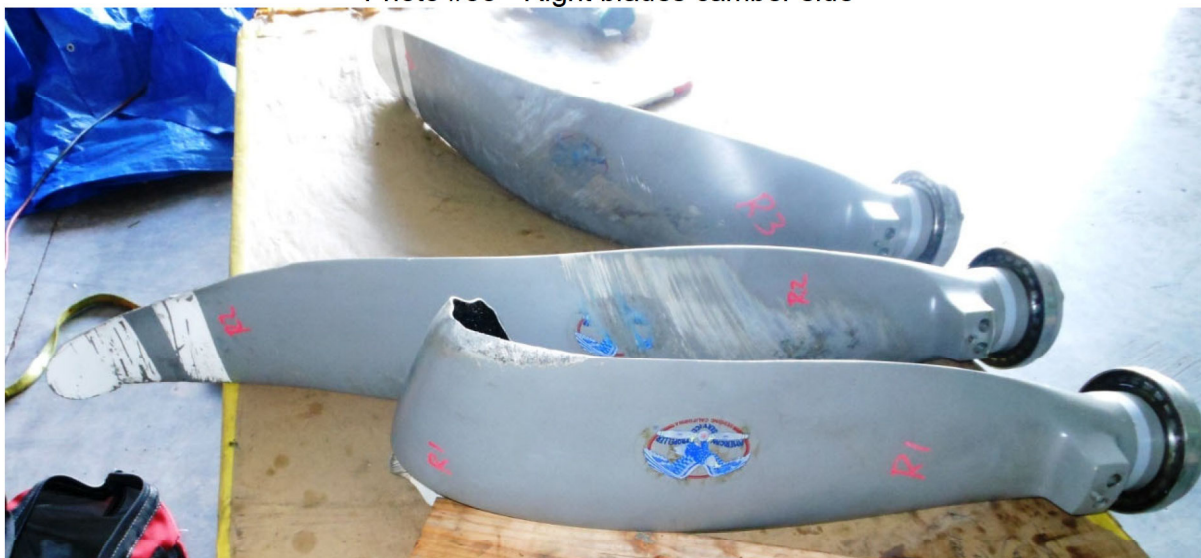
Photo #33 - Right blades camber side
