## RECORD OF CONVERSATION

**Timothy W. Monville**  
**Sr. Air Safety Investigator**  
**Eastern Region**

**Date: September 1, 2020**  
**Person Contacted: Barry S. Webber**  
**NTSB Accident Number: ERA20LA297**

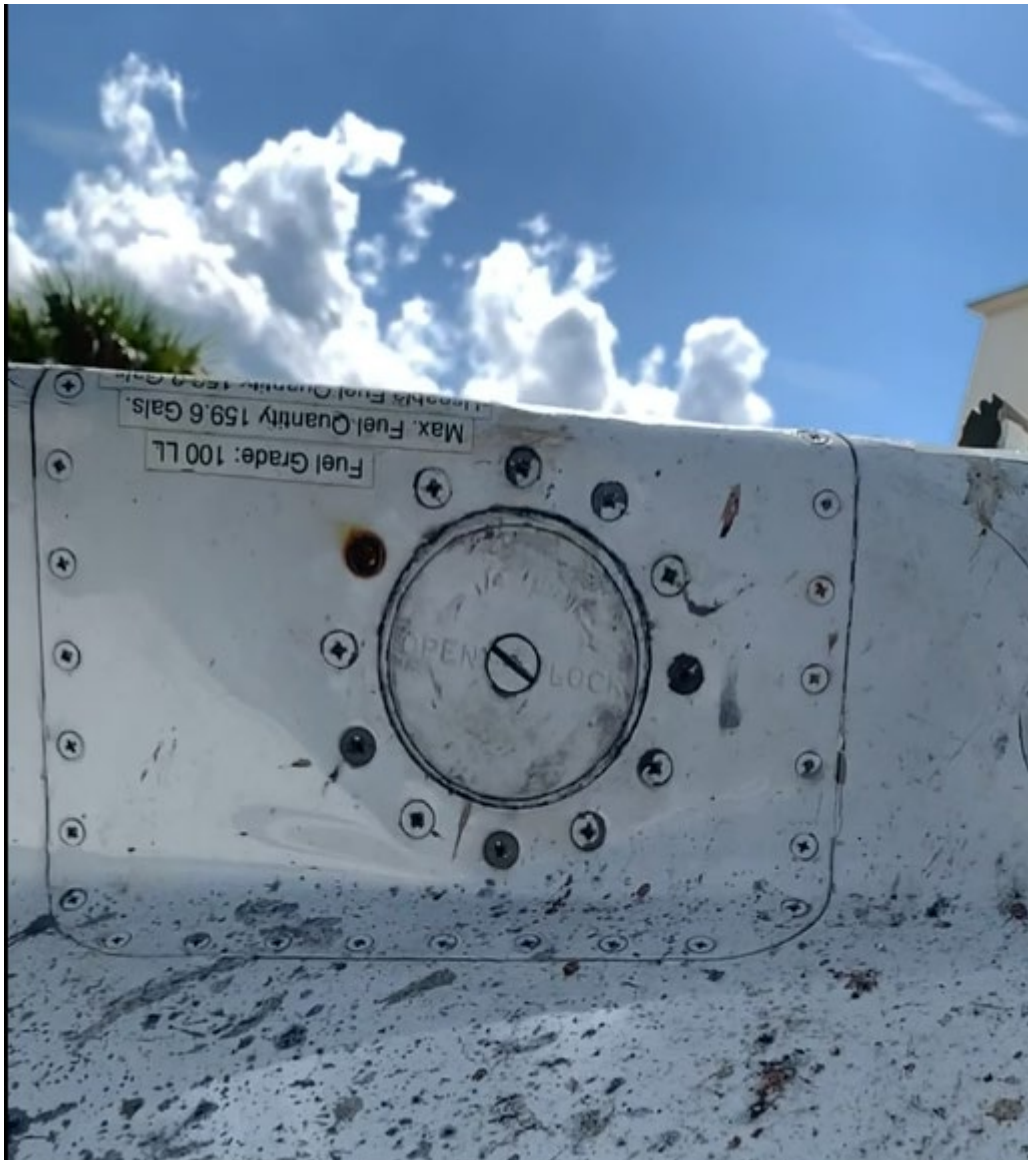
He inspected the single point filler cap and noted no fuel staining aft of the cap, which was in-place (Figure 1).

Figure 1: Screenshot From FAA Video Depicting Single Fuel Filler Port with Attached Fuel Cap.
