**Accident Investigation Results  
Aero Commander 500S  
National Transportation Safety Board**

Simmonds Precision Products, Inc.  
Tank Unit Assembly  
P/N EA515B-1404M

This document provides the results of the investigation for Tank Unit Part Number EA515B-1404M, being returned to Collins Aerospace as part of an accident investigation. This Tank Unit was equipped on the Aero Commander 500S which had a flight accident on August 28, 2020.

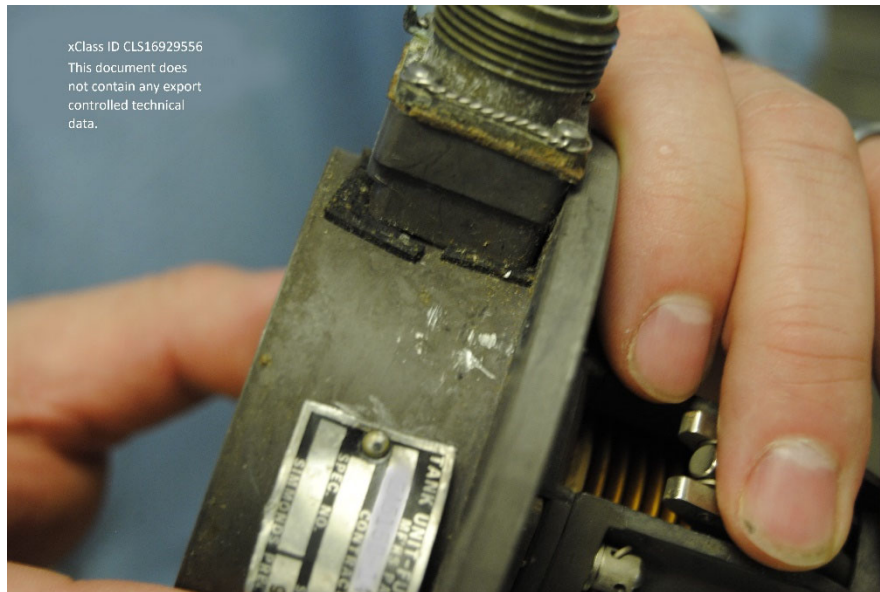
Figure 1: Housing with Nameplate and Seal Gap

Small opening in the seal between the main housing and the connector body, refer to Figure 1.

Several small scratches on the housing, refer to Figure 1.

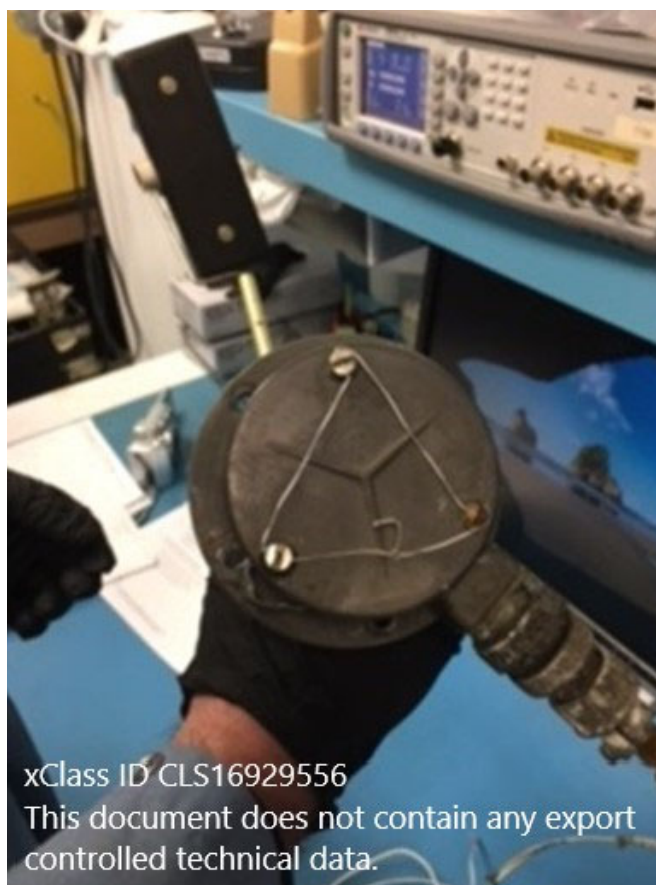
Figure 2: Housing Lockwire

Lock wire on top of the housing had been replaced and was not installed per Collins Aerospace requirements and appeared not to be original. Safety wiring shall be made so that any movement tending to loosen the part safety wired shall exert a pull causing a greater tension in the wire holding it. Safety wiring must always be to a part or location which cannot move other than to cause increased tension in the safety wire. Refer to Figure 2 lockwire installation for improper method and figure 3 for proper Lockwire representation.

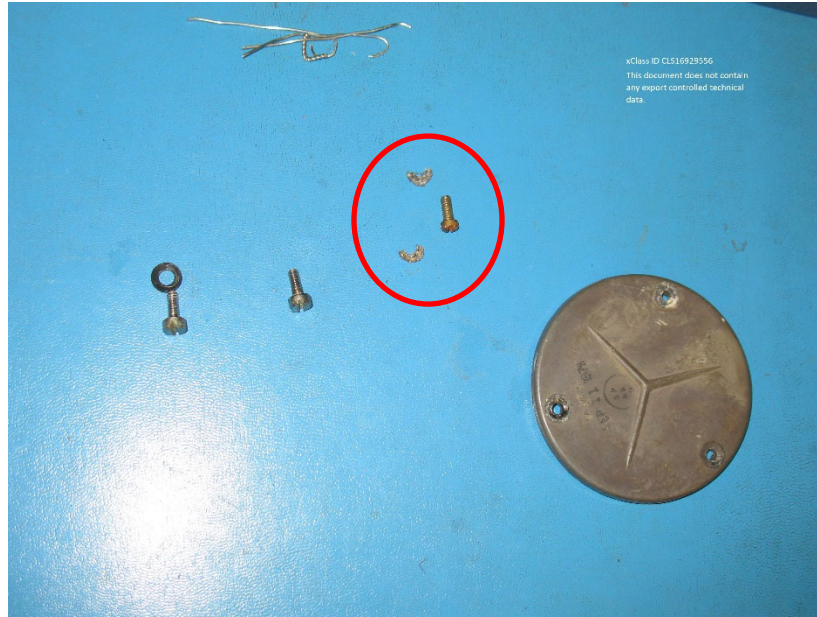
Figure 4: Cover Components

To gain access within the Tank Unit housing, the cover was removed. One of the three lock wire screws used to secure the cover was not original per the drawing. Figure 4 shows the incorrect screw annotated with a red circle. The two original screws appeared to have been fully seated and did not turn freely. The incorrect screw had been modified to accept lockwire. It was also noted that it is made from a different material than the original screws. This screw also required only a small amount of counterclockwise force to turn the screw for removal. The washer under the incorrect screw was also of a different material as compared to the parts list and broke easily into two pieces upon removal. One of the original screws did not have a washer, as per the assembly drawing.

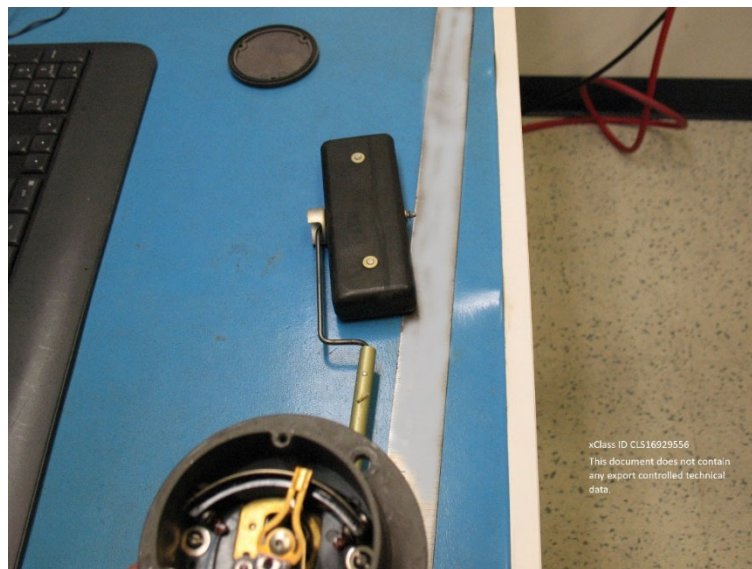
Figure 5: Bent in Float Arm

A Slight bend was identified in the float arm assembly (Figure 5) which per design should be parallel to the actuation arm. The part number printed on the float was verified to match the one called out on the drawing.

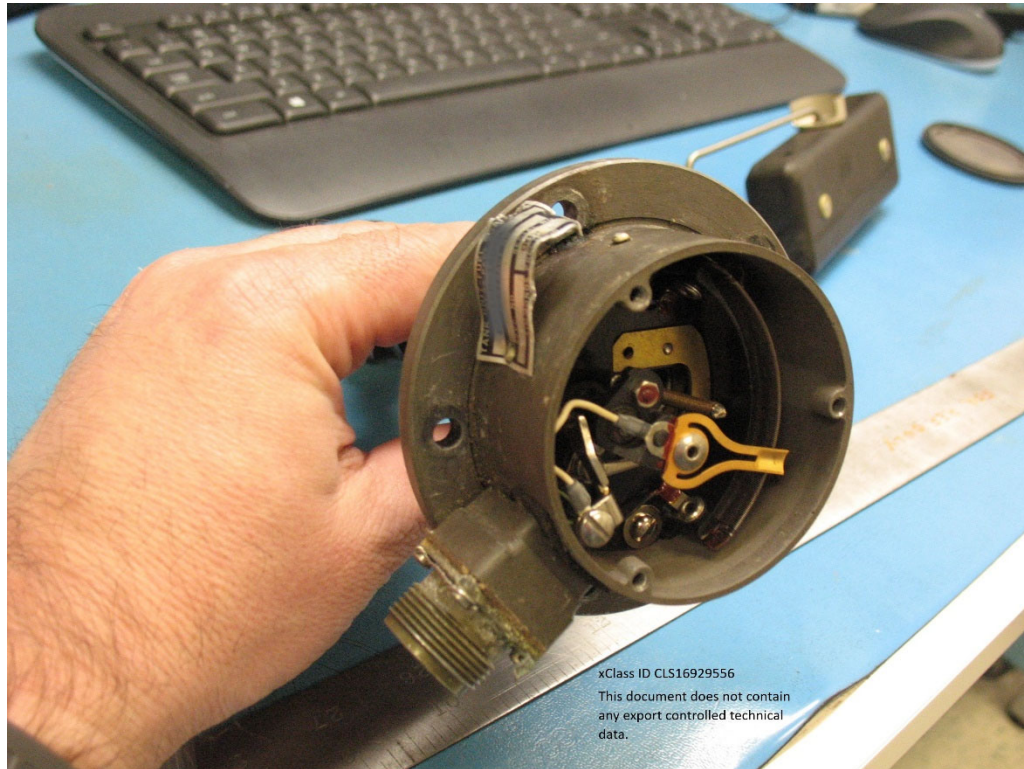
Figure 6: Interior of Tank Unit Housing

The nameplate was deformed and only attached by one of the two rivets, refer to Figure 6

The interior of the Tank Unit housing was clean with no evidence of loss of either the fuel seal on the bottom of the housing or the environmental seal. Refer to Figure 6.

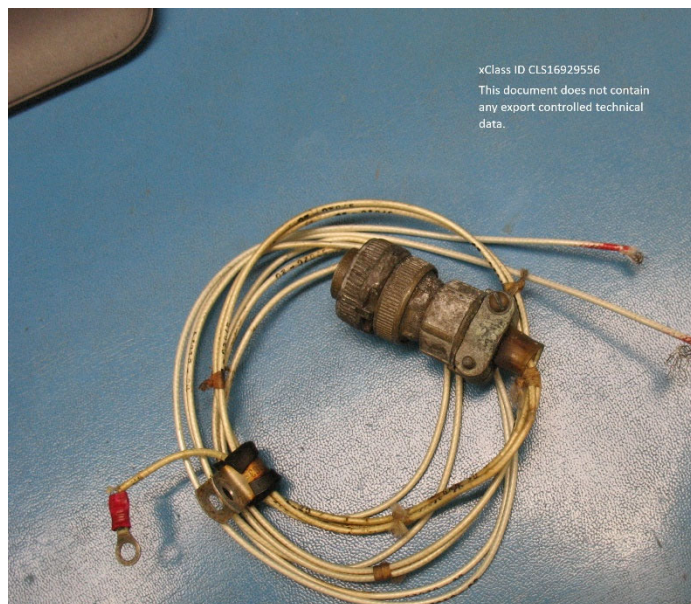
Figure 7: Aircraft Harness

The only oxidation present appeared to be on the mating connector and its back shell (Figure 7) which is to be expected of an aluminum connector after prolonged exposure in an uncontrolled environment. The harness assembly is not provided by Collins Aerospace.

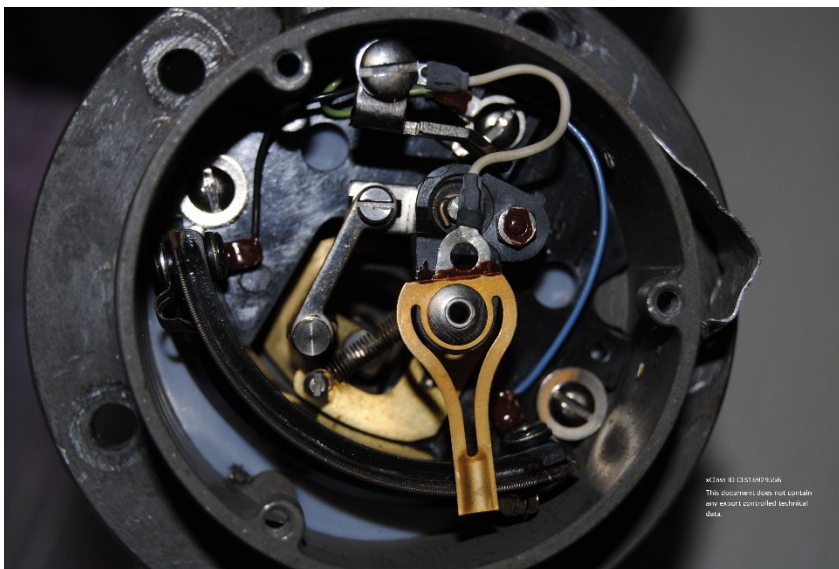
Figure 8: Interior of Housing

- **Remove lock wire and screws from housing cover:** 2 of the 3 screws securing the cover were tight. The one screw that was not original was not tight.
- **Inspect housing cover seal:** Seal around the inside of the cover was intact with no signs of damage.
- **Structural damage to electrical component:** No visual signs of structural damage to the wires or resistor element inside the housing (Figure 8)
- **Structural damage to mechanical components:** No visual signs of damage to the wiper or any other mechanical components inside the housing (Figure 8).

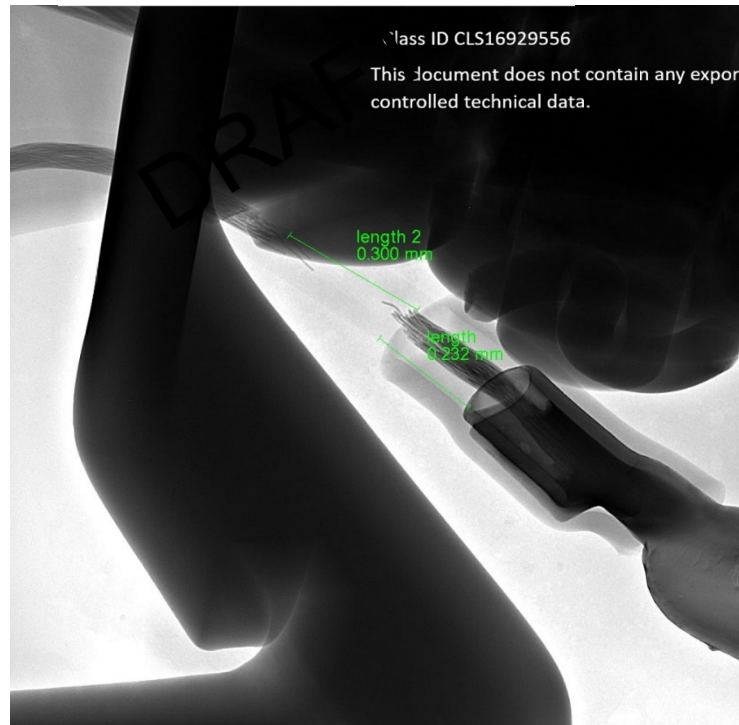
Figure 9: X-ray of Gap in White Wiper Wire

At the direction of the NTSB Investigator and concurrence from Collins Aerospace Engineering, the wire was x-rayed for further investigation of the open condition. Although, the insulation of the white wire to the wiper arm was found to be intact. X-ray imaging of the wire revealed that there was a gap in the conductor strands of the wire. This gap is located approximately 0.23mm from the terminal lug connected to the wiper. The gap in the conductor is about 0.30mm wide, refer to Figure 9.

The result of the investigation revealed an open connection between the back side of the tank unit wiper arm and pin C of the tank unit connector. All measurements were taken with a calibrated digital multimeter in a climate controlled lab setting.

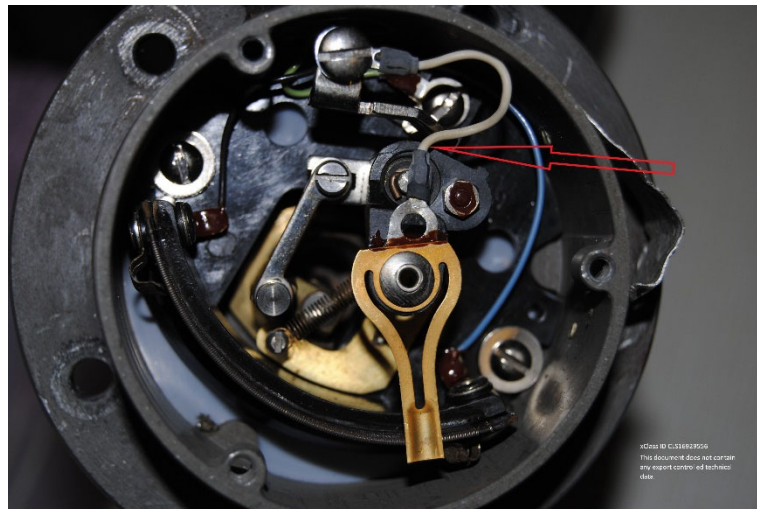
Figure 10: Location of Gap in White Wire

Approximate Location of break in the assembly view is identified in Figure 10. No other anomalies were discovered during the x-ray of the wire or surrounding area. The identified wire is part number EA7959. The properties are stranded silver plated copper conductor with white silicone rubber insulating 26 AWG.
