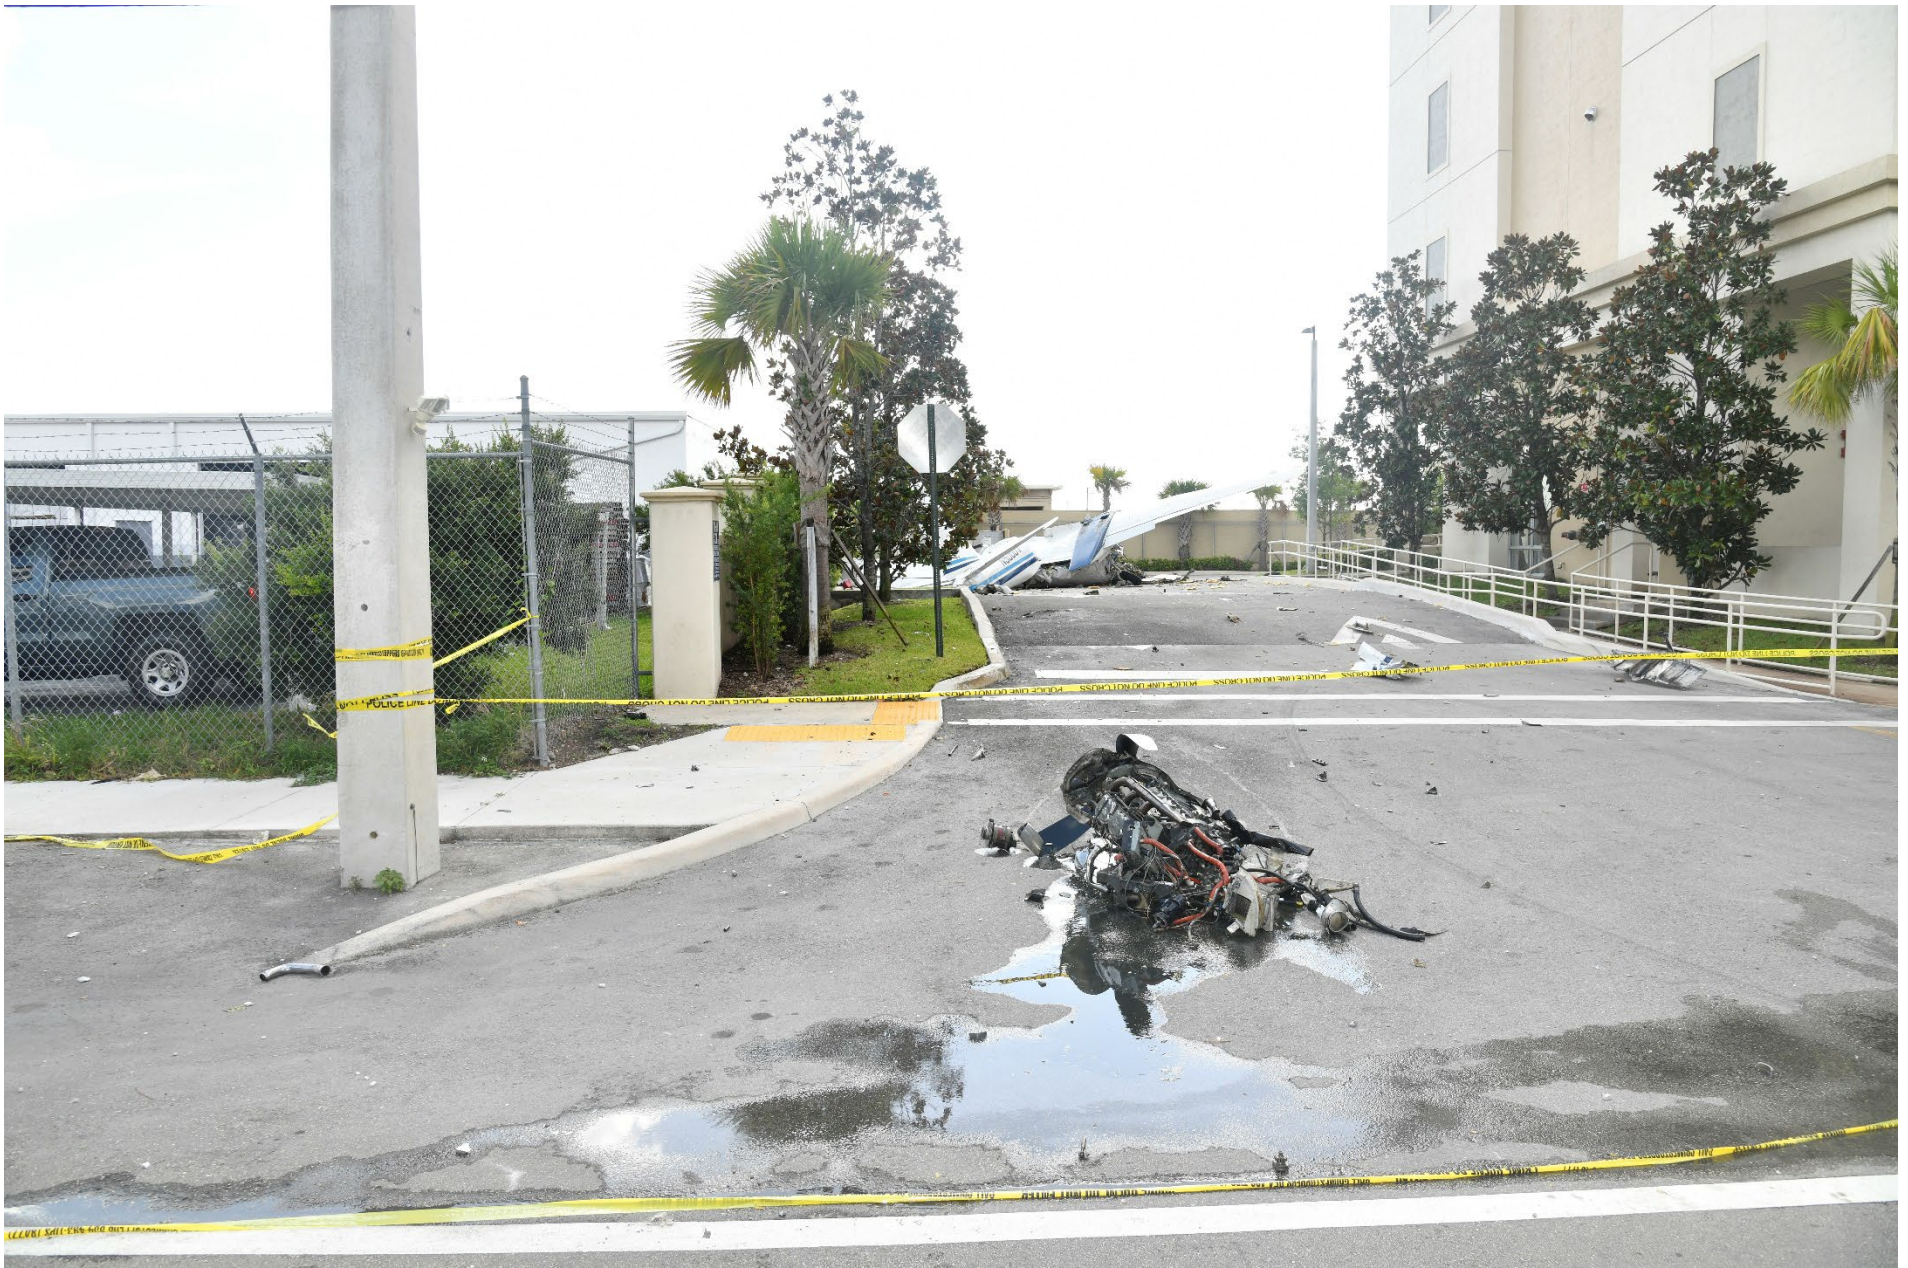
**Photo 1 – Broward Sheriff’s Office Digital Photograph. View Depicting the Separated Right Engine with Attached Propeller in the Foreground and Right Rear Quartering View of the Main Wreckage in the Background.**

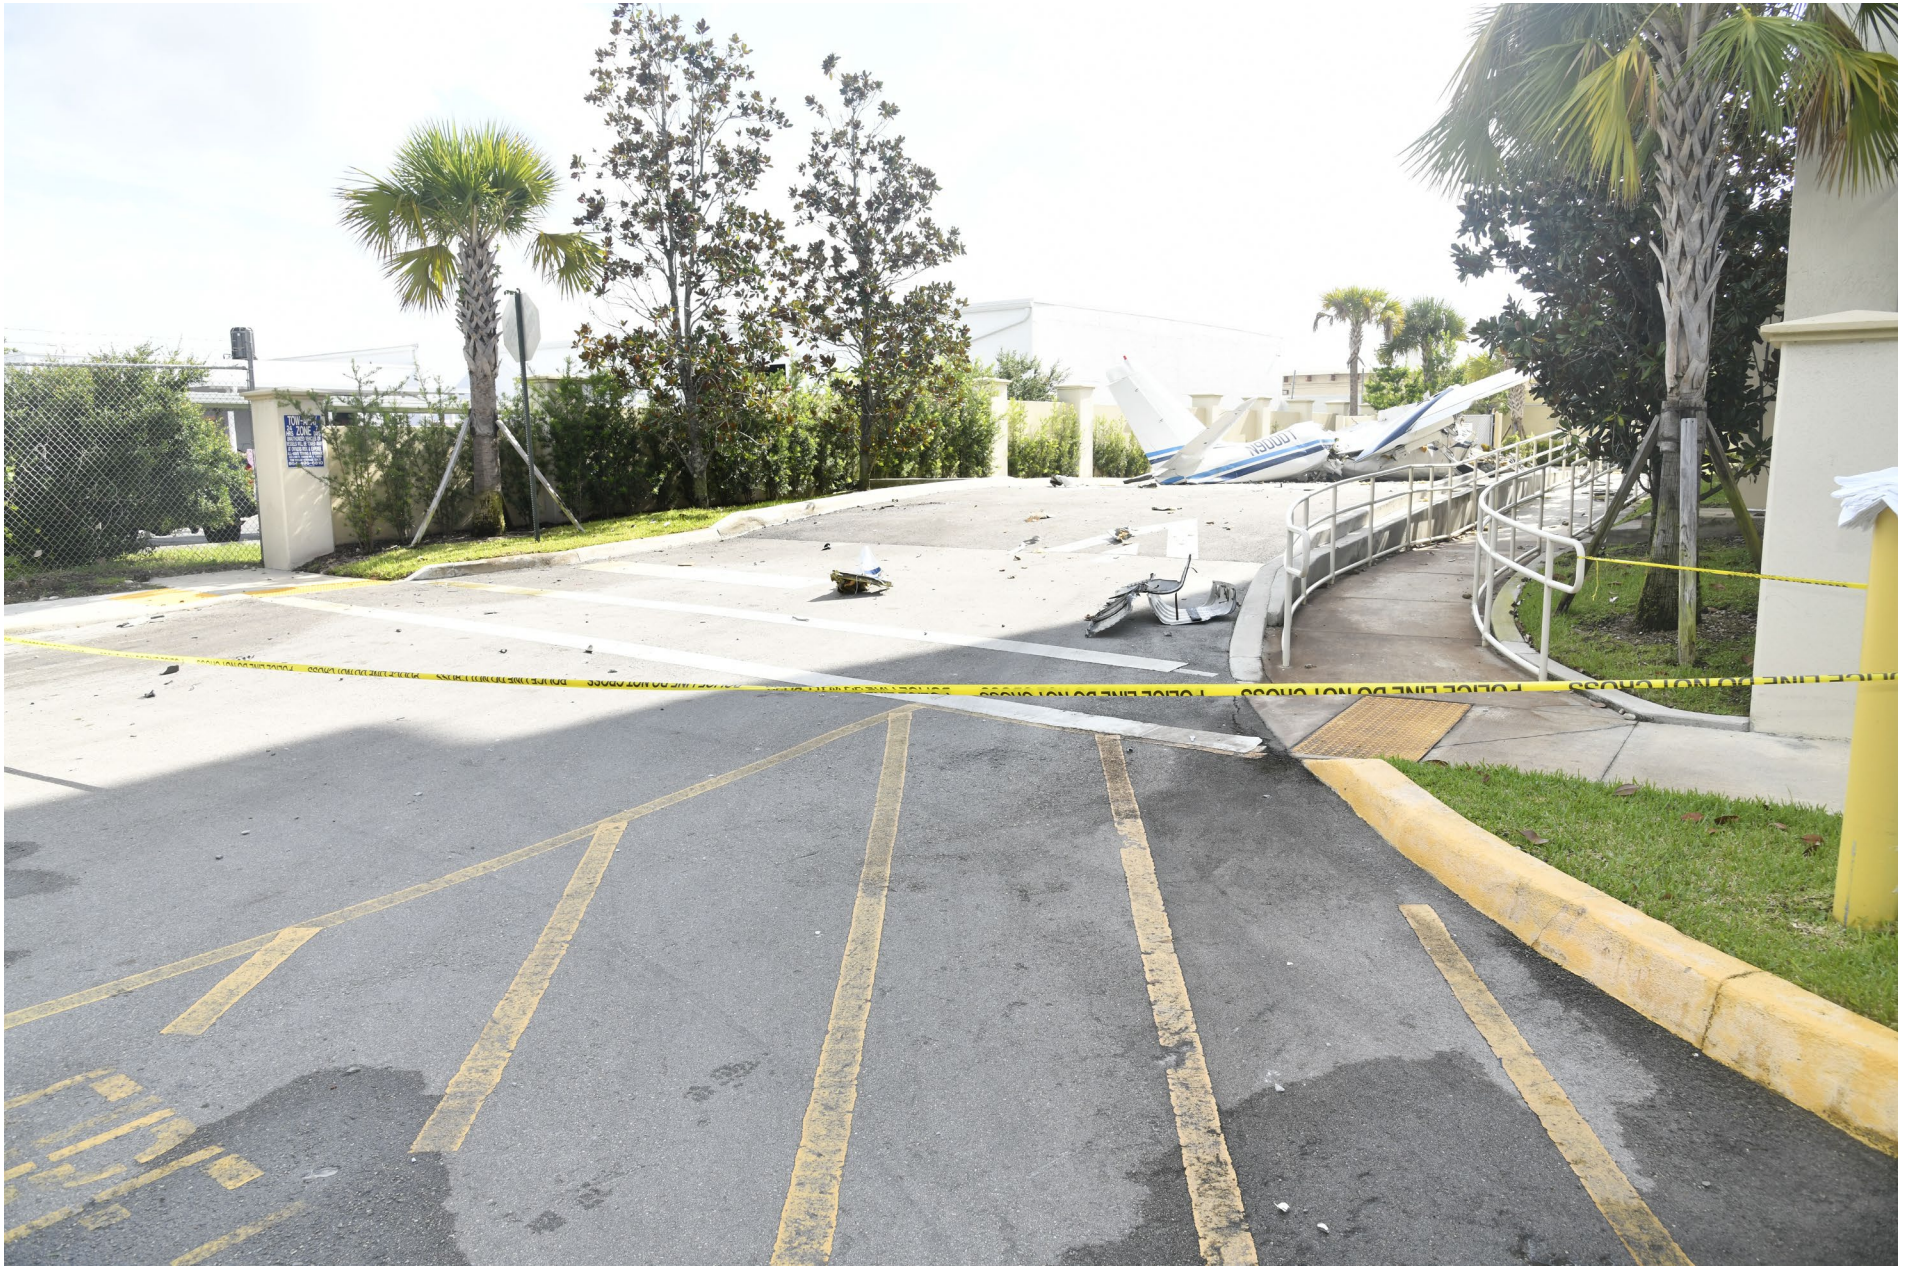
**Photo 2 - Broward Sheriff's Office Digital Photograph. Right Rear Quartering View of the Wreckage at the Accident Site.**

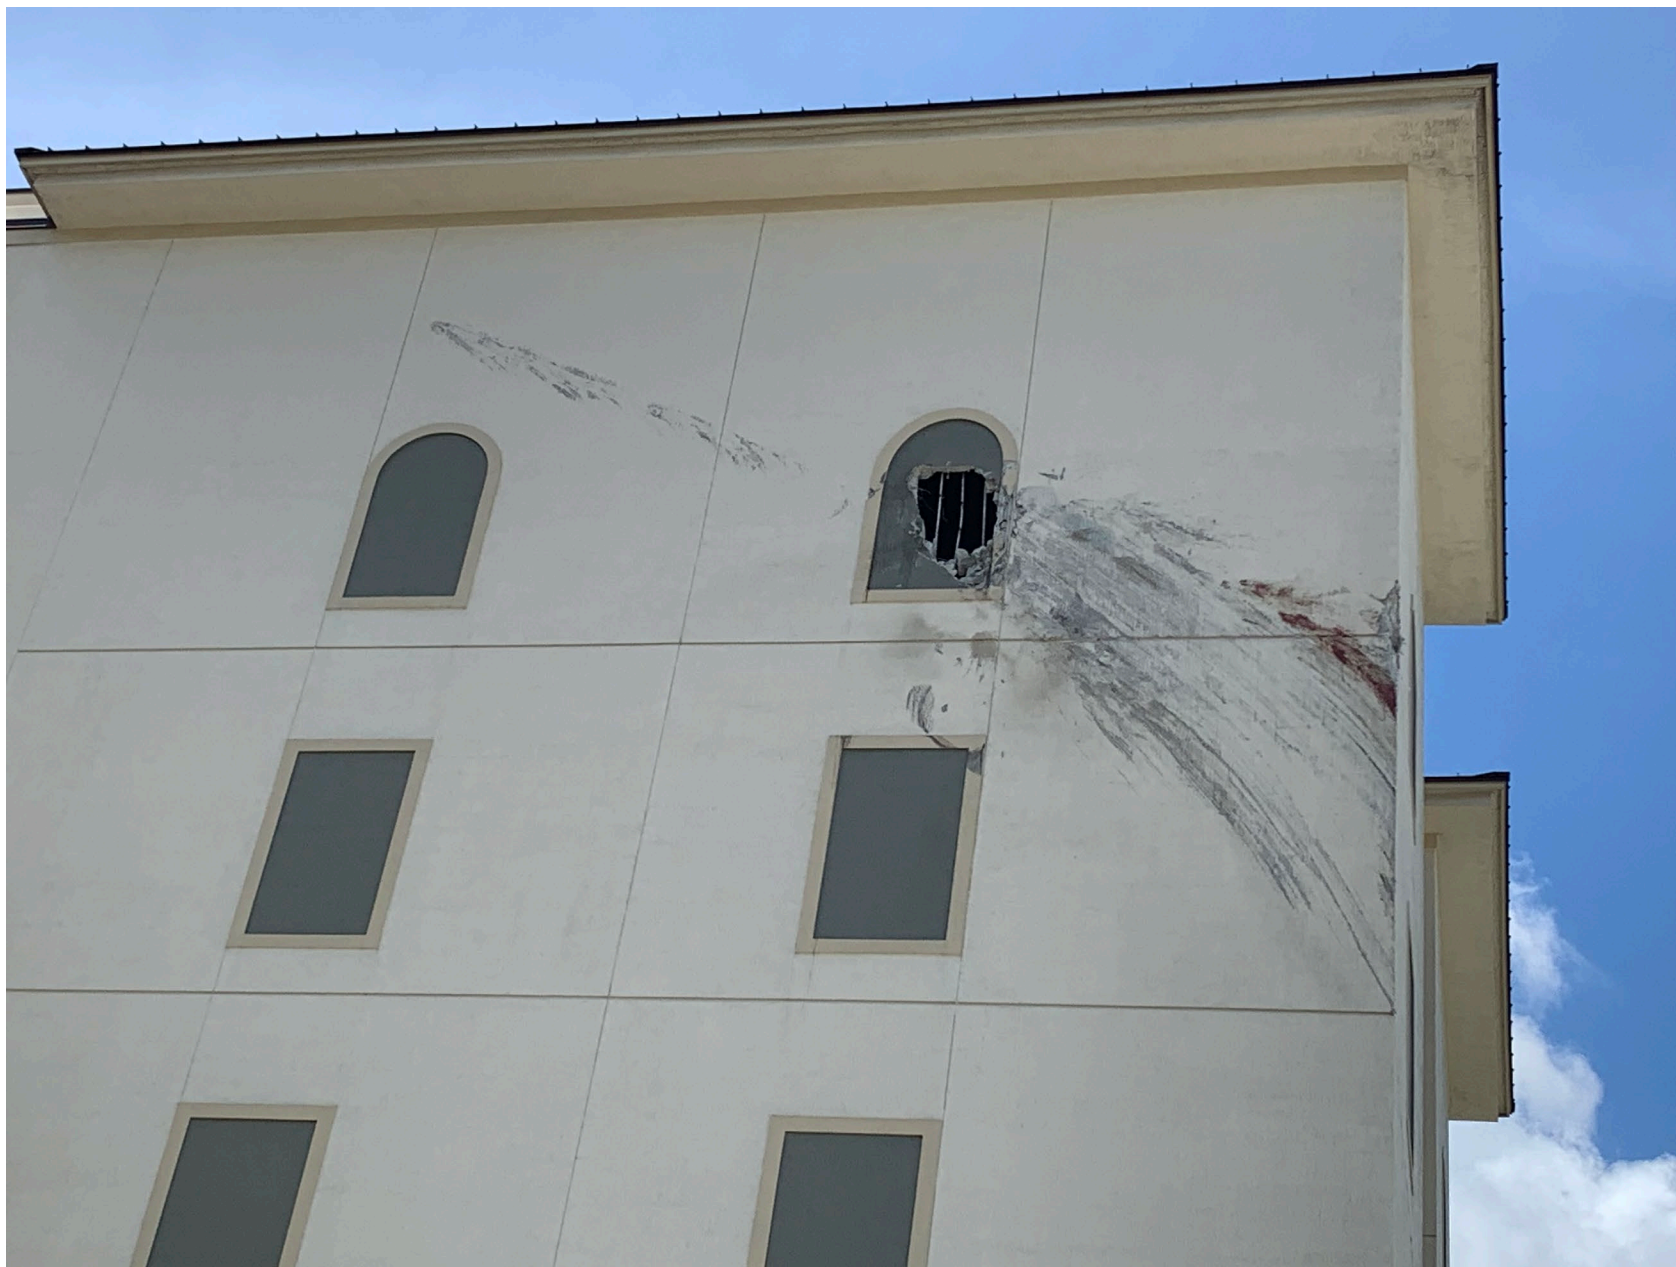
**Photo 3 – FAA Digital Photograph. View Depicting the Building Impact Point.**

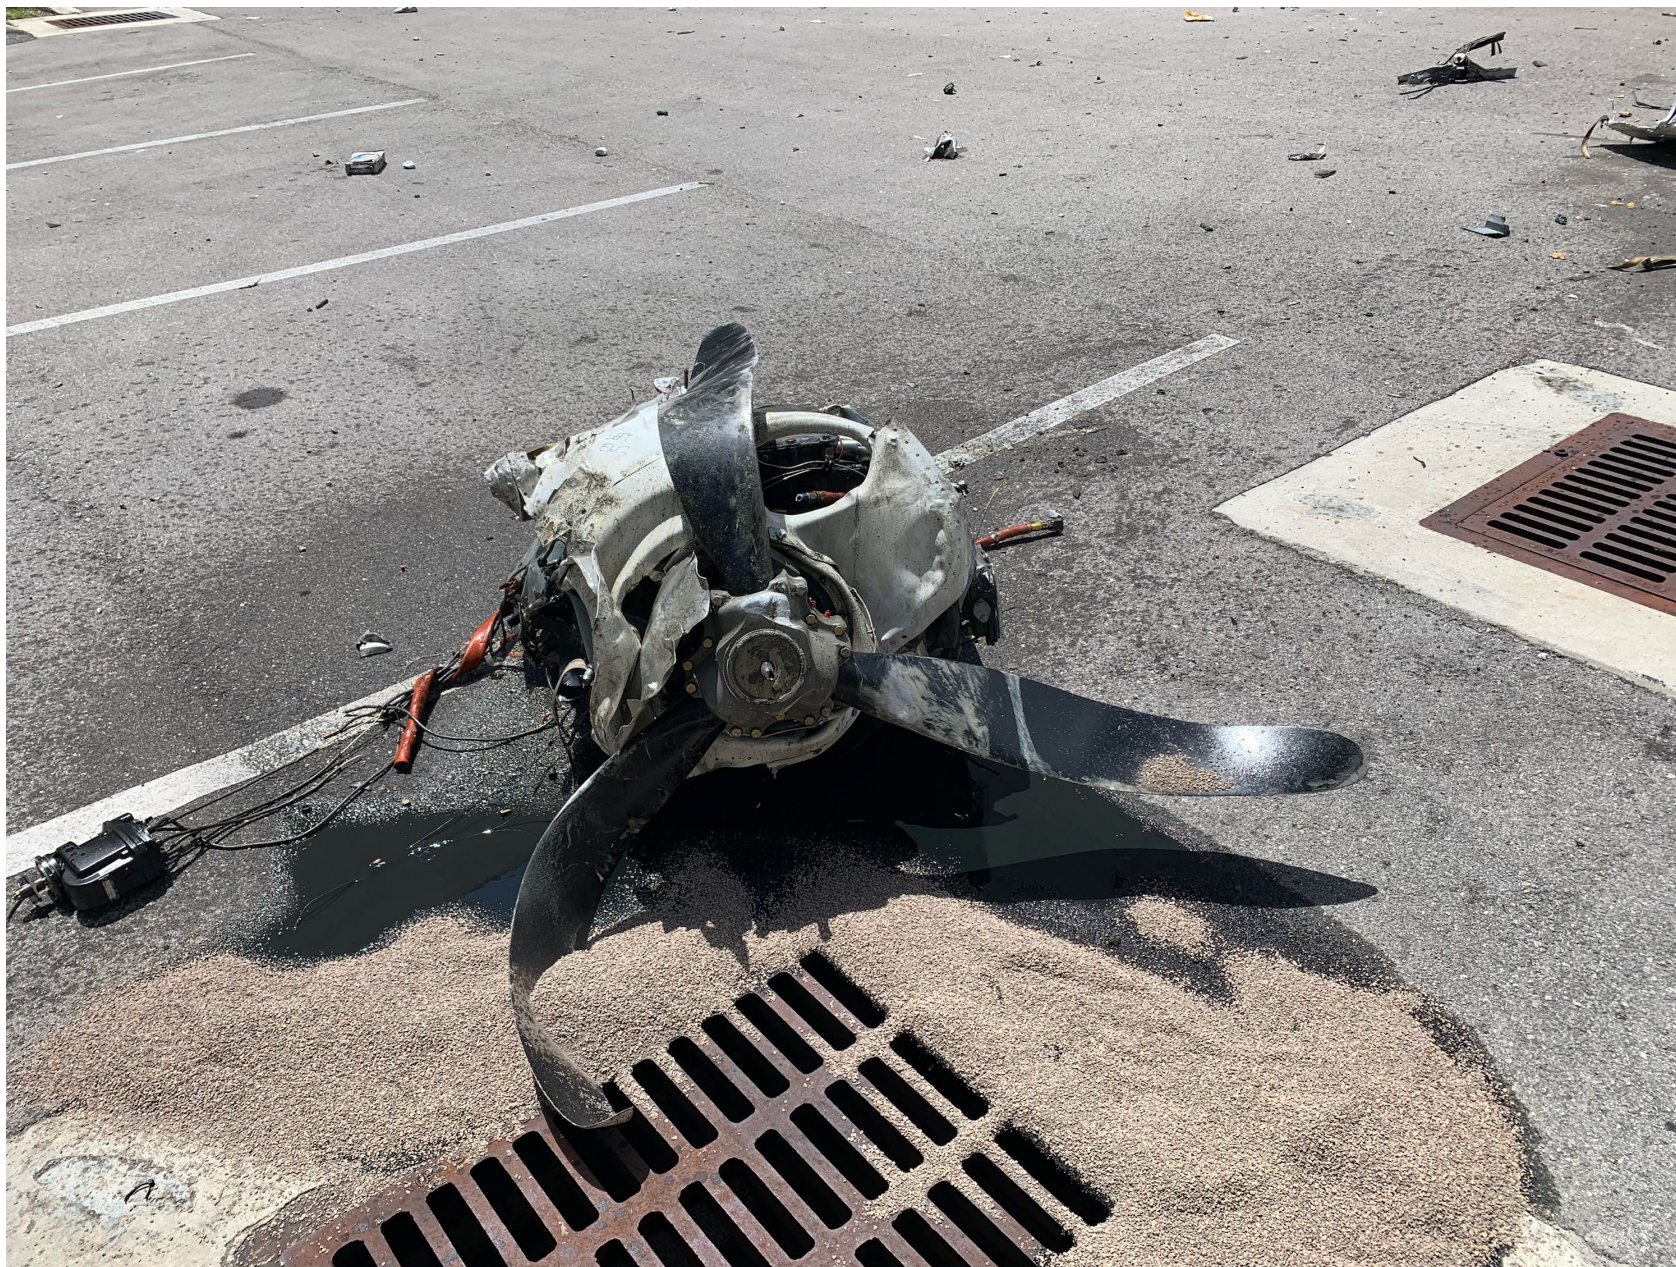
**Photo 4 - FAA Digital Photograph. View Depicting the Left Propeller Assembly Attached to the Separated Engine Assembly. Note the Separated Cylinder, Piston, and Spinner.**

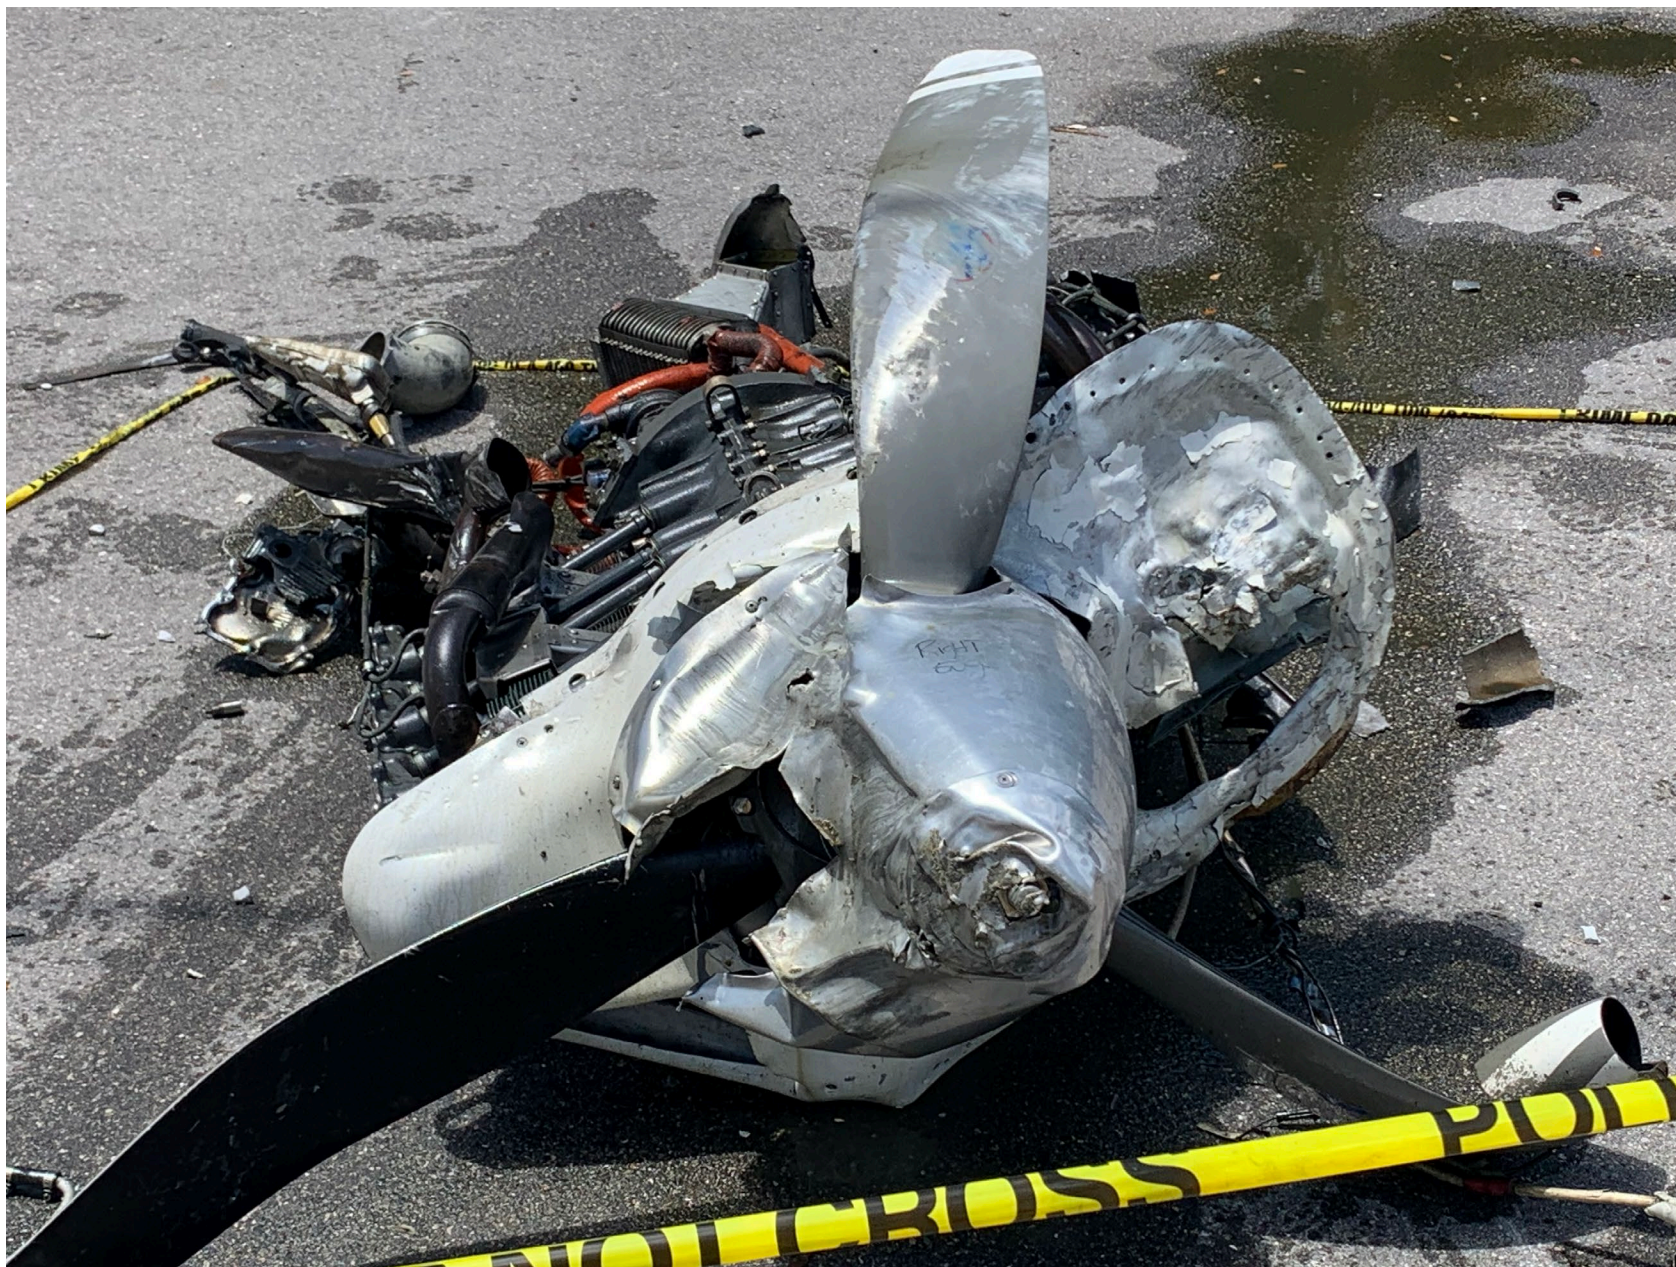
**Photo 5 - FAA Digital Photograph. View Depicting the Right Propeller Assembly Attached to the Separated Engine Assembly.**

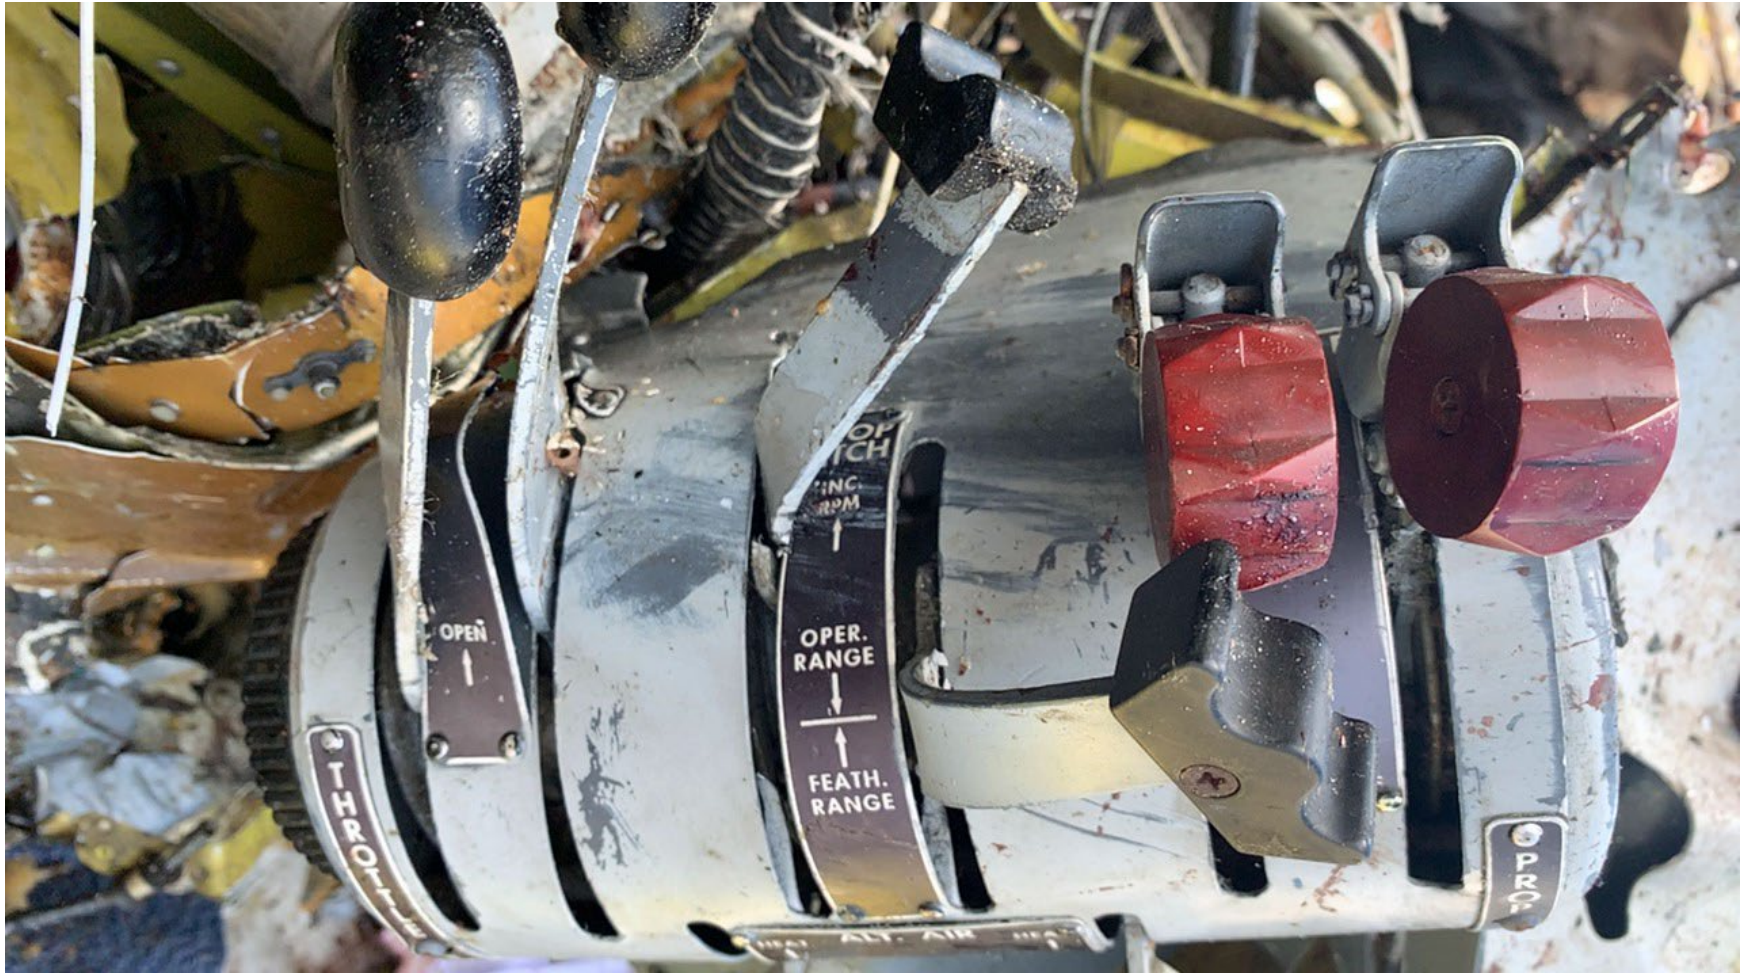
**Photo 6 - FAA Digital Photograph. Close-Up View of The Throttle Quadrant. Note that the right Propeller Control is at the Midpoint Open/Feather Range.**

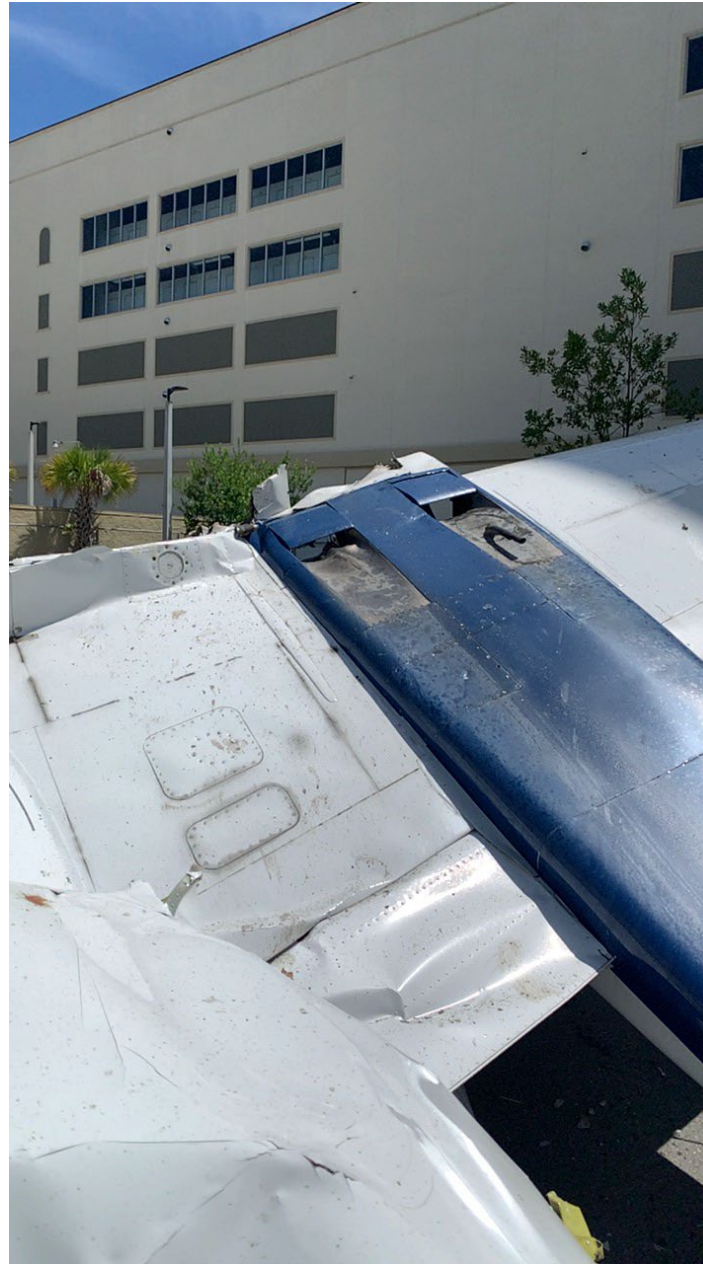
**Photo 7 - FAA Digital Photograph. View of The Upper Portion of the Right Wing Showing the Fuel Filler Port. Note no Blue stains Aft of the Cap.**

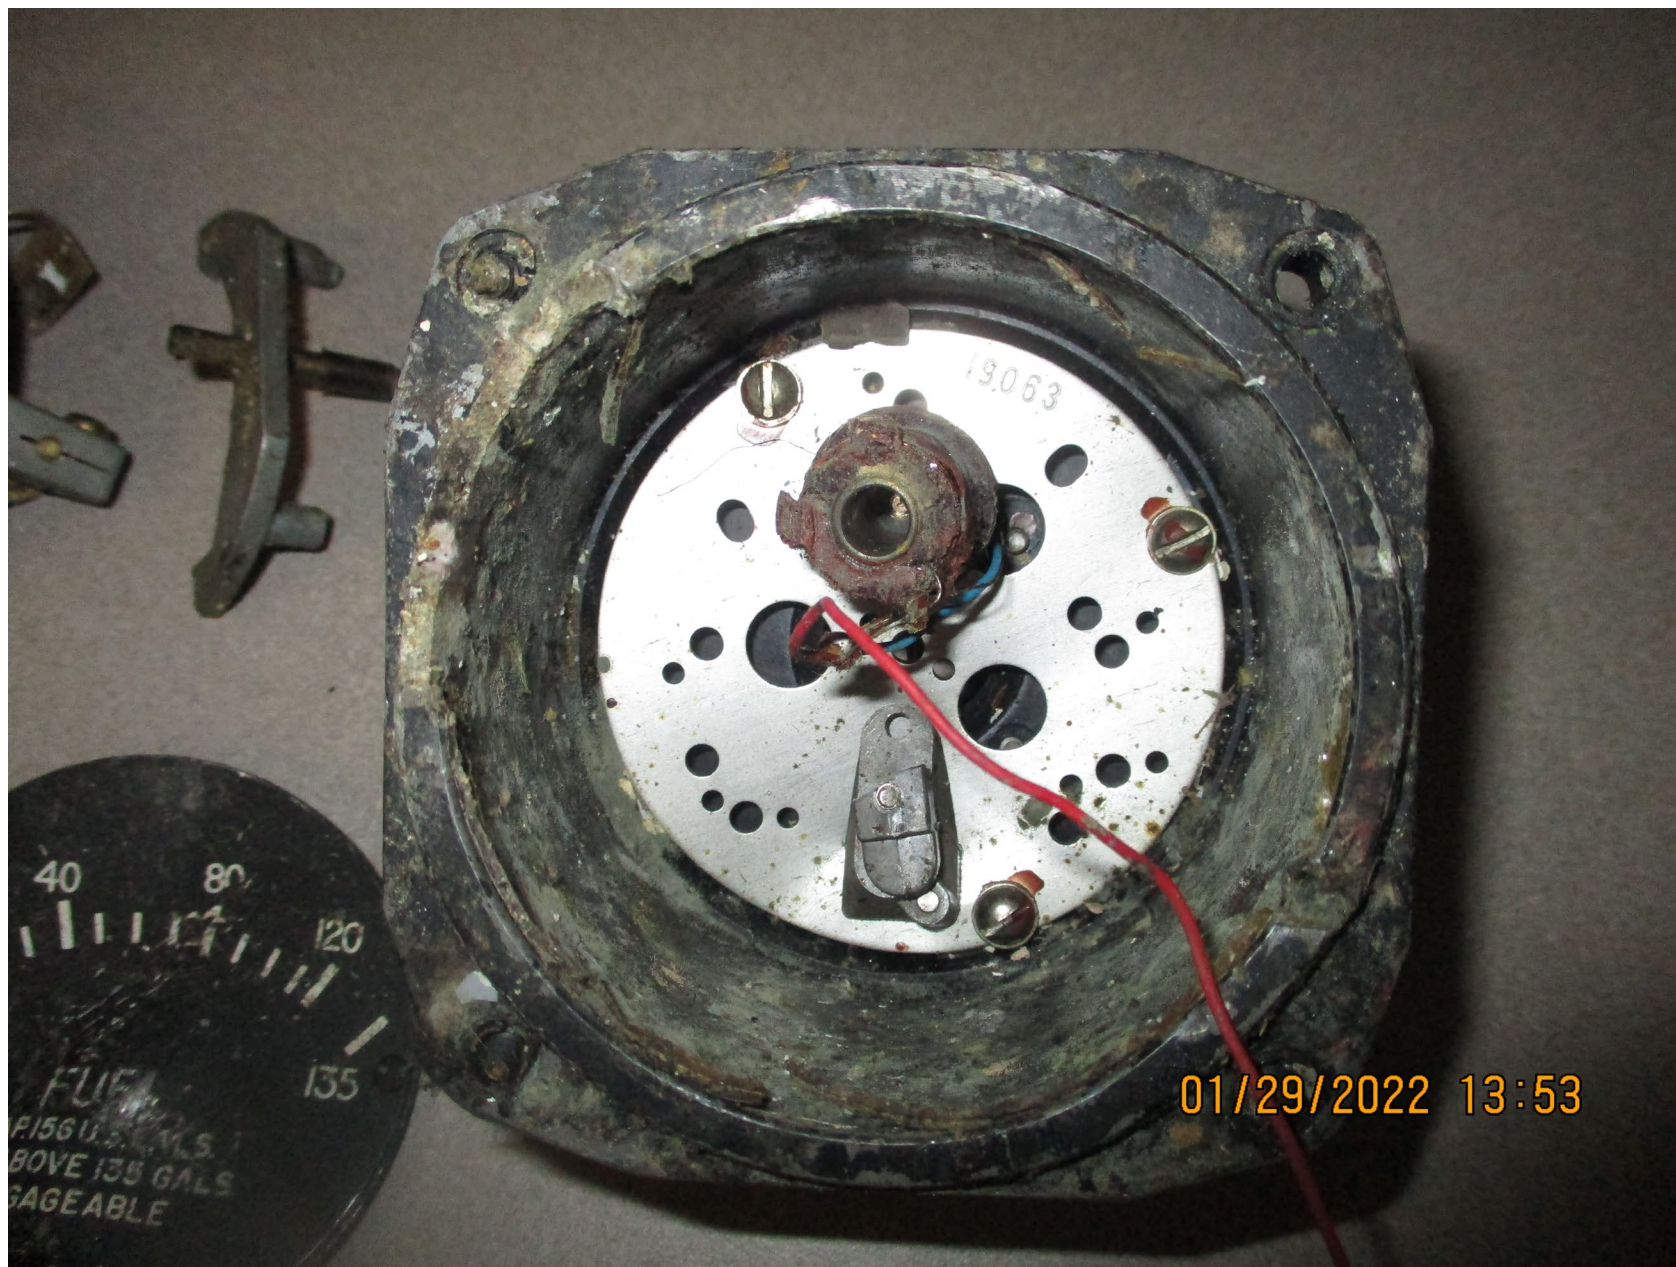
**Photo 8 - FAA Digital Photograph. View of The Impact Damaged Fuel Quantity Gauge and Separated Faceplate. Note the Separated Needle.**

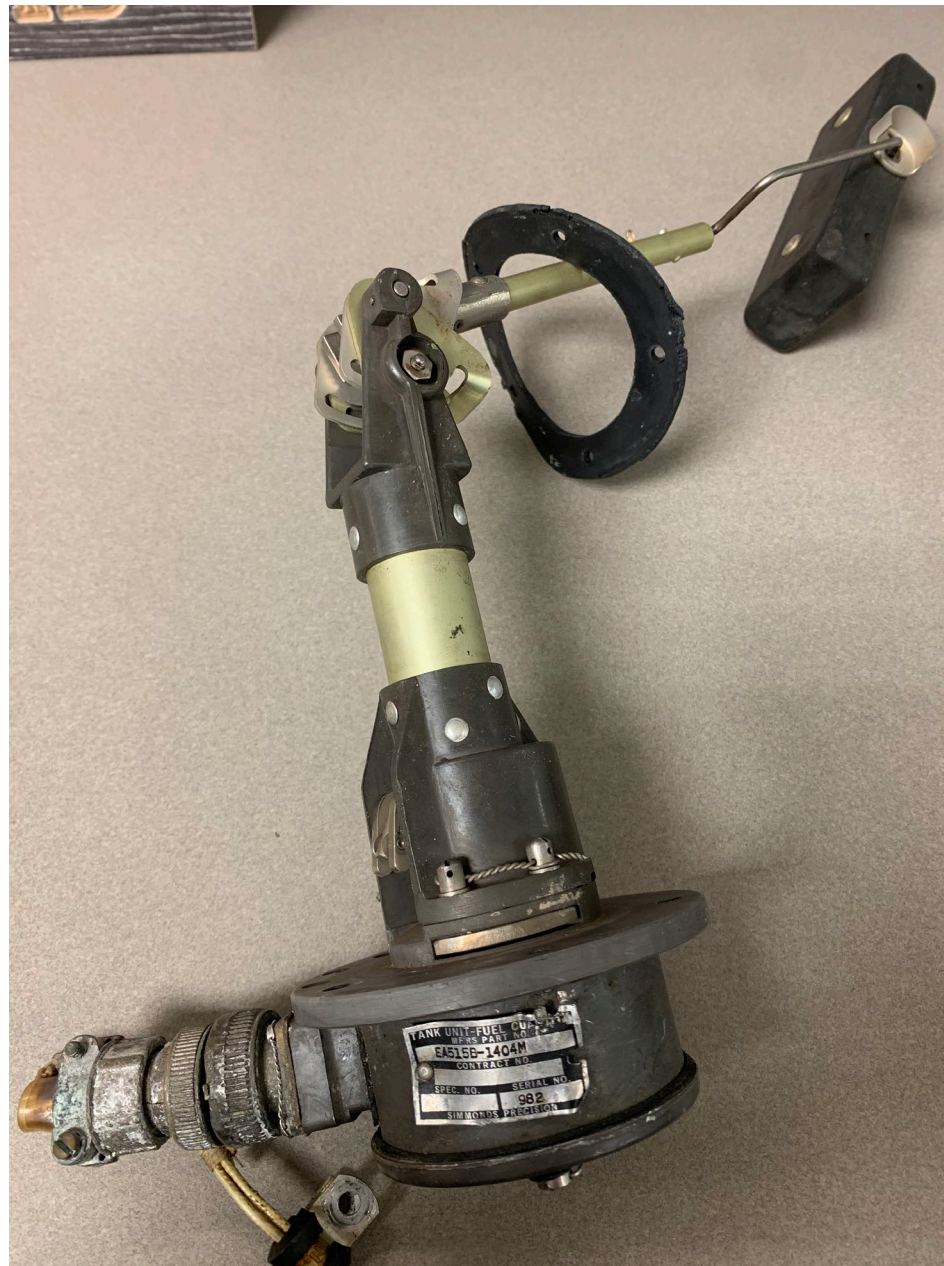
**Photo 9 - FAA Digital Photograph. View of The Tank Unit, Part Number EA515B-1404M.**
