# NATIONAL TRANSPORTATION SAFETY BOARD

## MATERIALS LABORATORY FACTUAL REPORT

Report No. 22-042

Place : Pembroke Park, Florida  
Date : August 28, 2020  
Vehicle : Aero Commander Aircraft 500-S, N900DT  
NTSB No. : ERA20LA297  
Investigator : Timothy Monville, AS-ERA

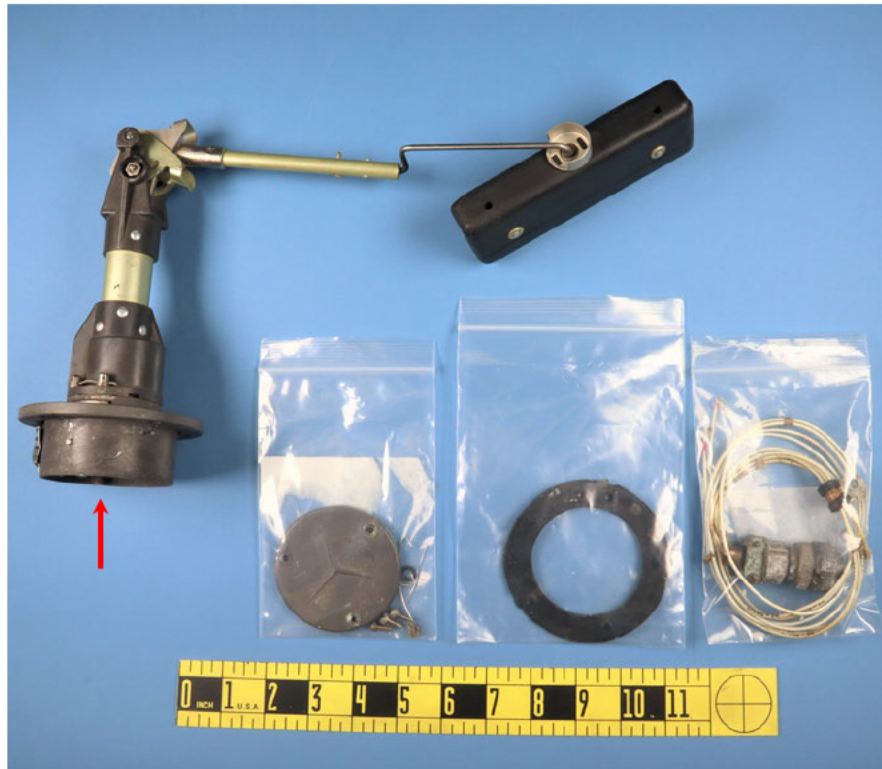
Figure 1.) As-received parts with red arrow pointing to the fuel transmitter assembly with float.

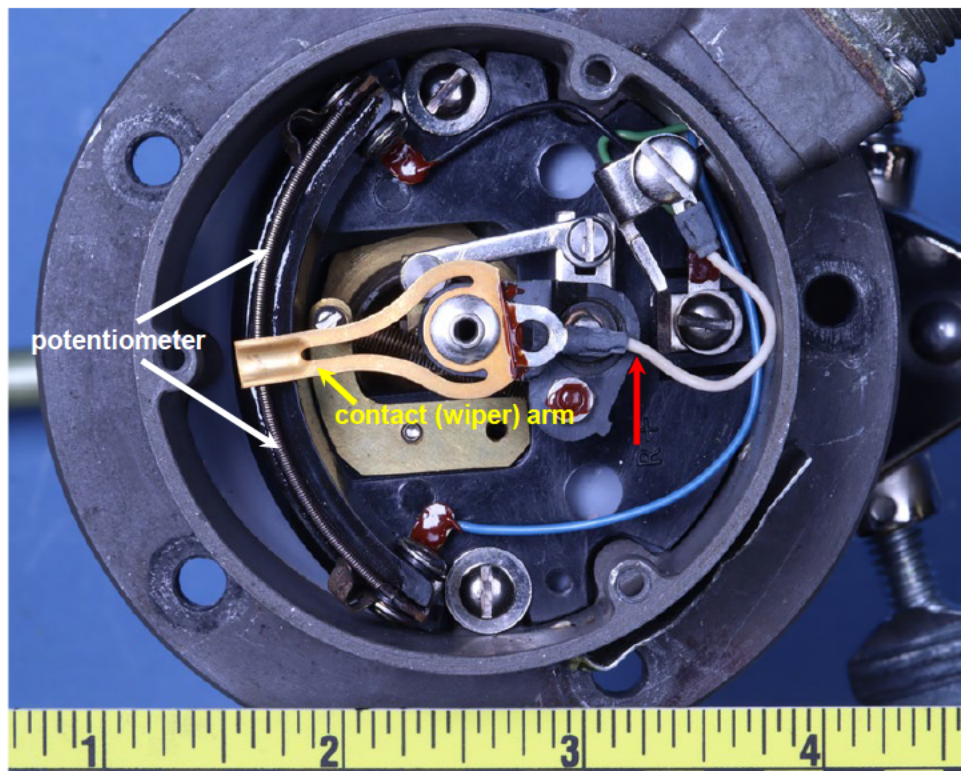
The as-received parts are shown in figure 1. The red arrow points to the part of interest; the fuel transmitter assembly. Figure 2 is the manufacturer's part number tag affixed to the side of the assembly along with its serial number. Figure 3 is a top view inside the assembly with the red arrow pointing to the area where the white connecting wire broke. Figure 4 is an x-ray image revealing the broken wires within the intact insulation coating. The distance between the two fractured ends was measured to be approximately 0.012 inches. The wire was then removed from the fuel transmitter assembly for further examination as shown in figure 5. The estimated total length of the wire (before fracture) was 1.57 inches. According to an engineering drawing for the wire, the specified length is [REDACTED] inches. The wire insulation coating was then cut as shown in figure 6 with the insulation coating stripped off to expose the fracture surfaces of the individual wires. After cleaning the tips of the wires ultrasonically in acetone, the exposed wire fracture surfaces were examined in a scanning electron microscope (SEM).

Figure 3.) Top-down view of fuel transmitter assembly with red arrow pointing to the broken wire with insulation intact.

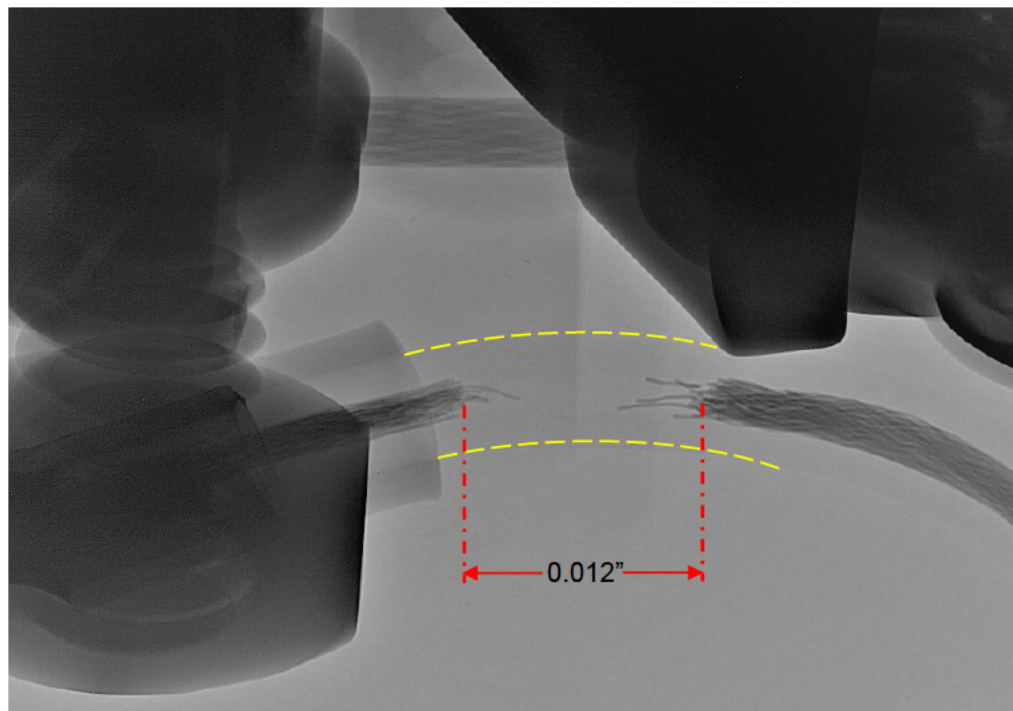
Figure 4.) X-Ray image of broken wire as assembled. The yellow dash lines correspond to the outside diameter of the wire insulation coating.

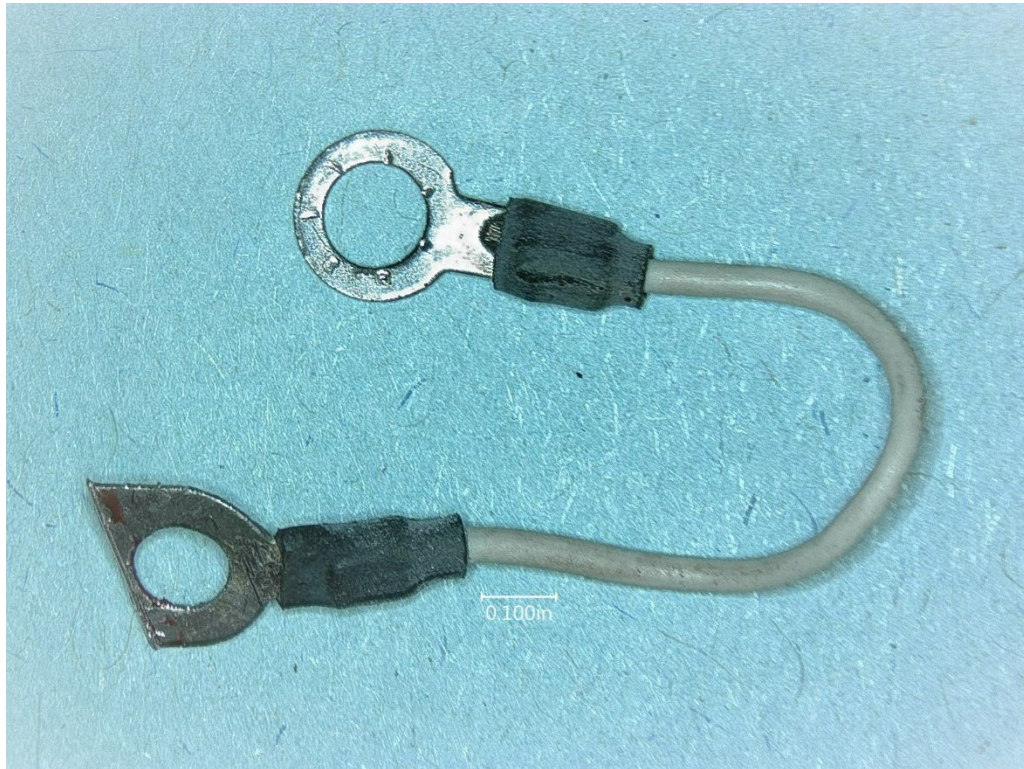
Figure 5.) White connecting wire prior to cutting. The manufacturer specifications indicate that the wire is 26 AWG and the conductor is silver plated copper with 66/44 stranding.

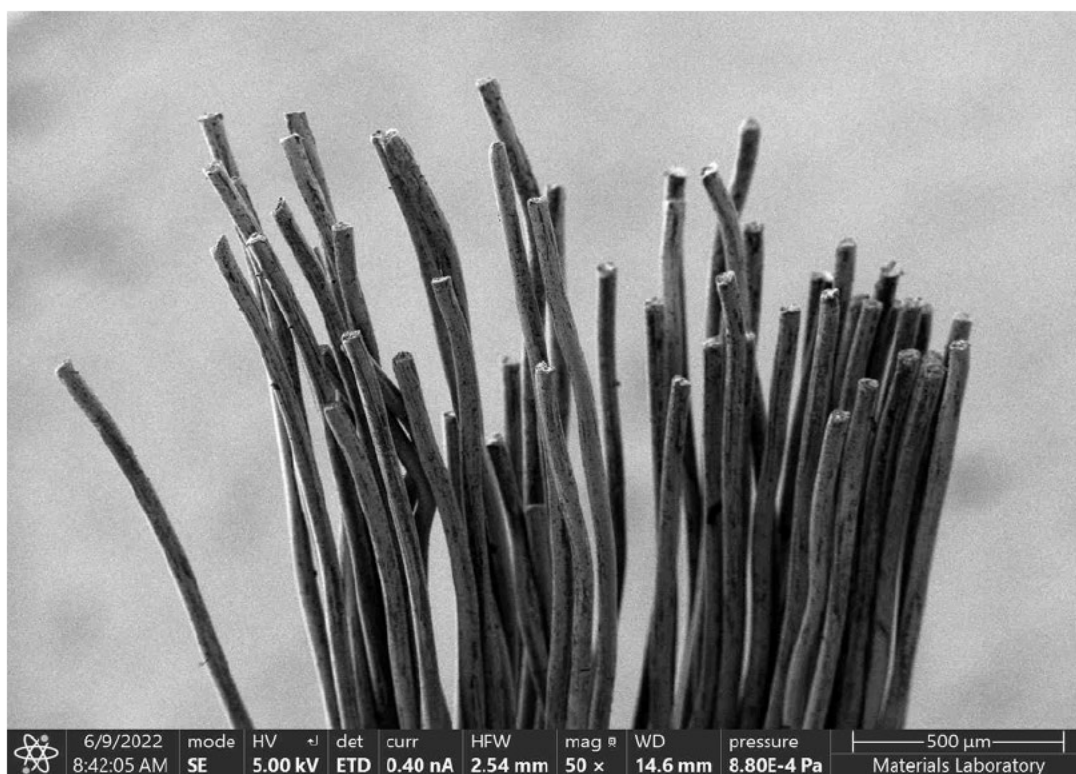
Figure 7 is a side view of a group of the wires showing no appreciable necking of the wires adjacent to the fracture faces. Solder (tin-lead) was found to be deposited near the fractures of a few wires, consistent with wetting by solder applied at the lug. Figure 8 is a SEM image with arrows pointing to the solder deposits around the outside of the wires. The color inset is an energy dispersive spectrometric (EDS) overlaid image of the tips of two joined wires. The color code is as follows; copper is red, silver is cyan, tin is blue, and lead is yellow. Due to a shadowing effect, not all of the overlaid SEM inset image is populated with color-coded x-ray pixels.

Figure 7.) Side view SEM image of the wires as a group.

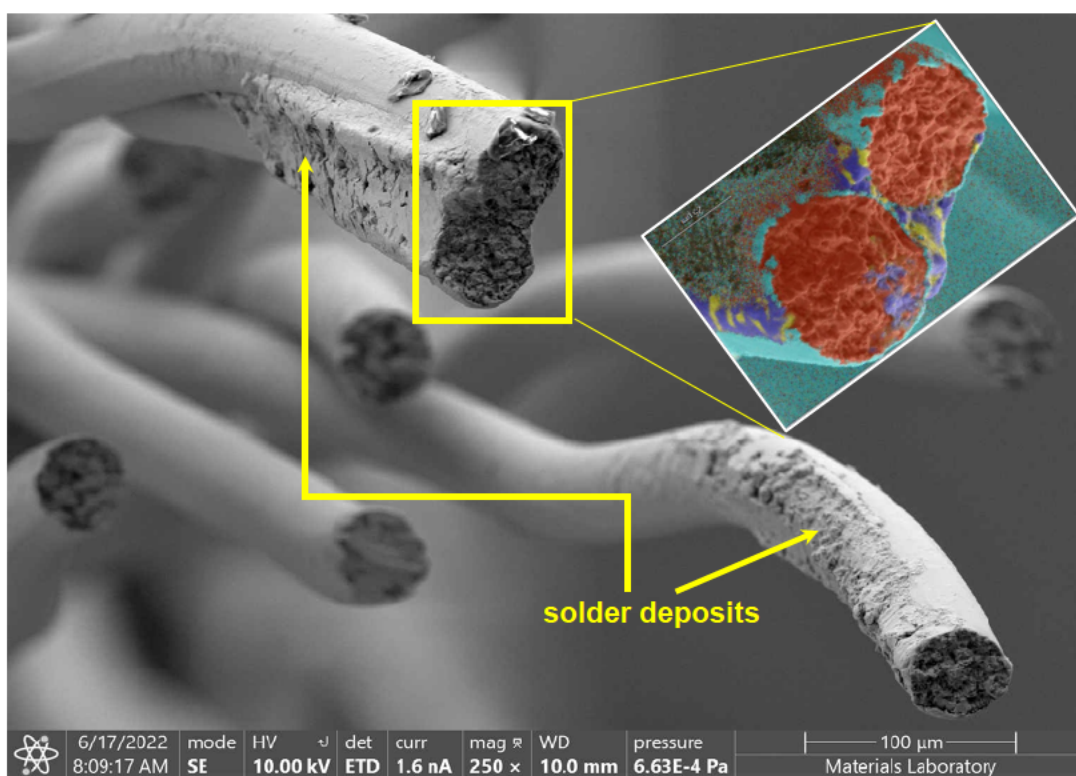
Figure 8.) Solder deposits on the outer diameter of wires including solder-jointed wires (yellow box) with EDS map inset.

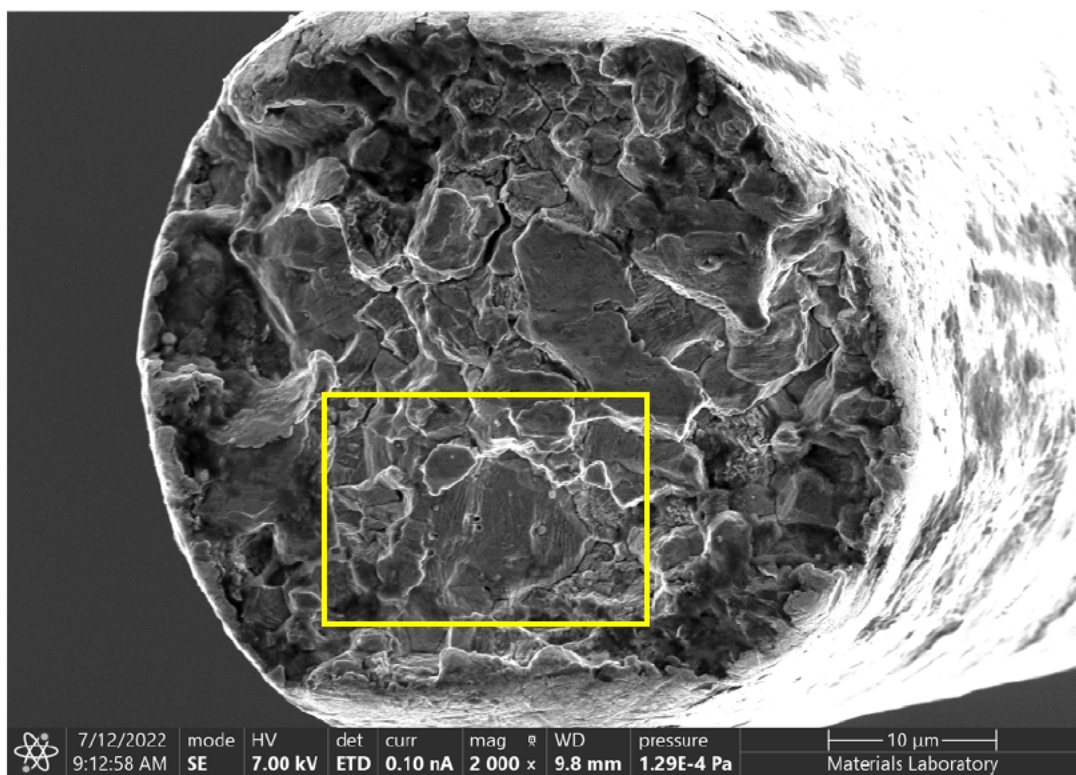
After cleaning many of the individual wires revealed intergranular fracture surface features with fatigue striations in various directions on some individual grains. No ductile fracture features, such as microvoids, were observed on any of the wire fracture surfaces. Several wires had mechanically damaged fracture faces with few features to examine.

Figures 9 – 11 show fatigue striations found on many of the fractured wire surfaces. Figure 10 is a closeup of the yellow boxed area in figure 9 with yellow arrows indicating fatigue striations. In all three images, note the intergranular grain structure of the fracture surface.

Figure 9.) Typical fracture surface on one of the silver-coated wires.

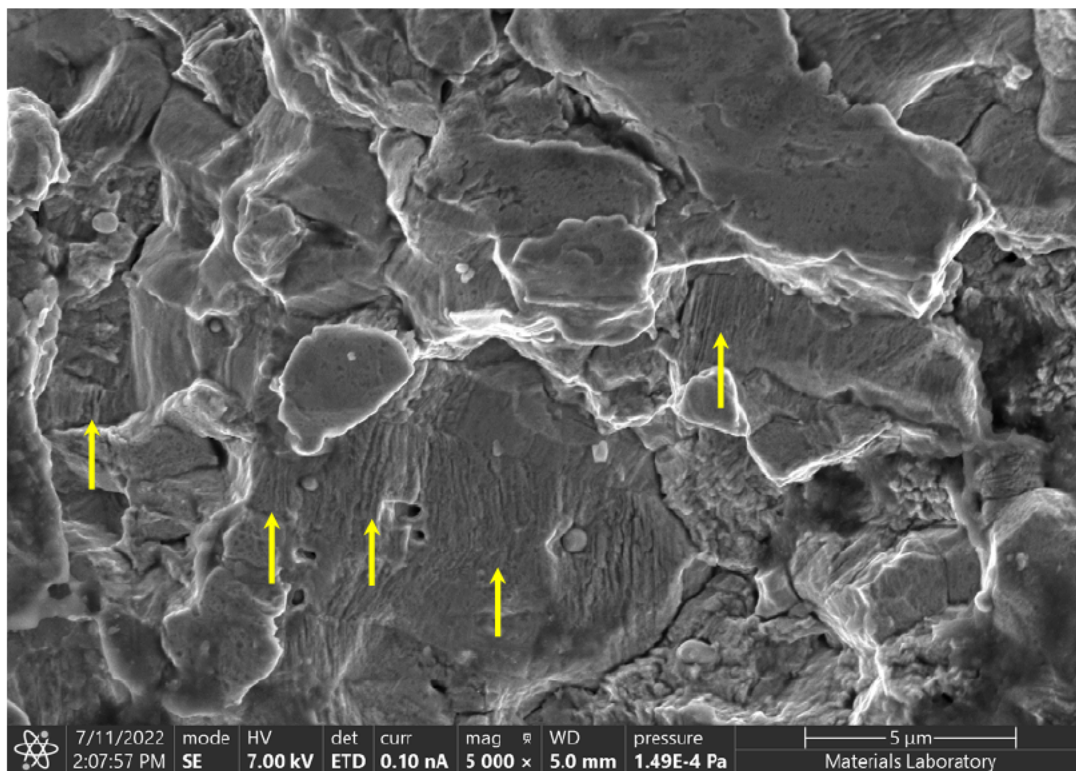
Figure 10.) Image of the yellow boxed area in figure 9 with arrows showing fatigue striations.

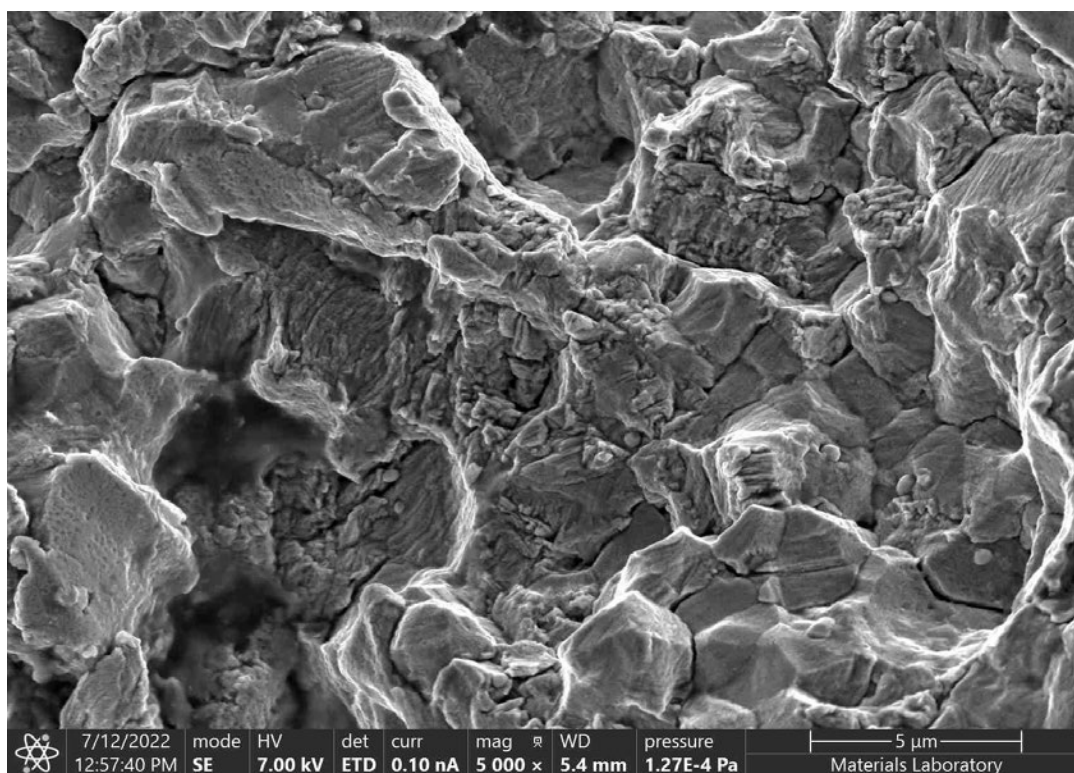
Figure 11.) Intergranular fracture surface with more striations.

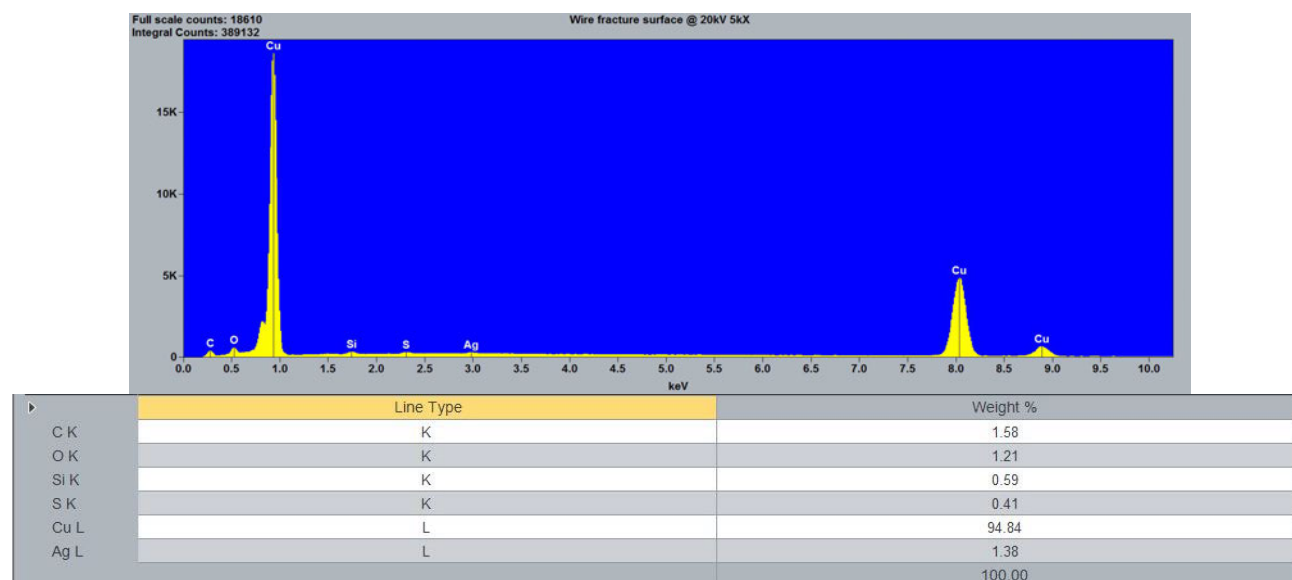
EDS confirmed the wire was silver coated, and standardless semi-quantitative results of the copper wire fracture surface EDS analysis are shown in figure 12.

Figure 12.) EDS spectrum of wire fracture surface and semi-quantitative composition.
