## MEMORANDUM FOR RECORD

**Subject:** N65645, Cessna 172, 8/27/20, Weston, Florida ERA20LA299  
Record of Conversation – Juan Garcia (FAA Inspector, Miramar, Florida Flight Standards District Office)

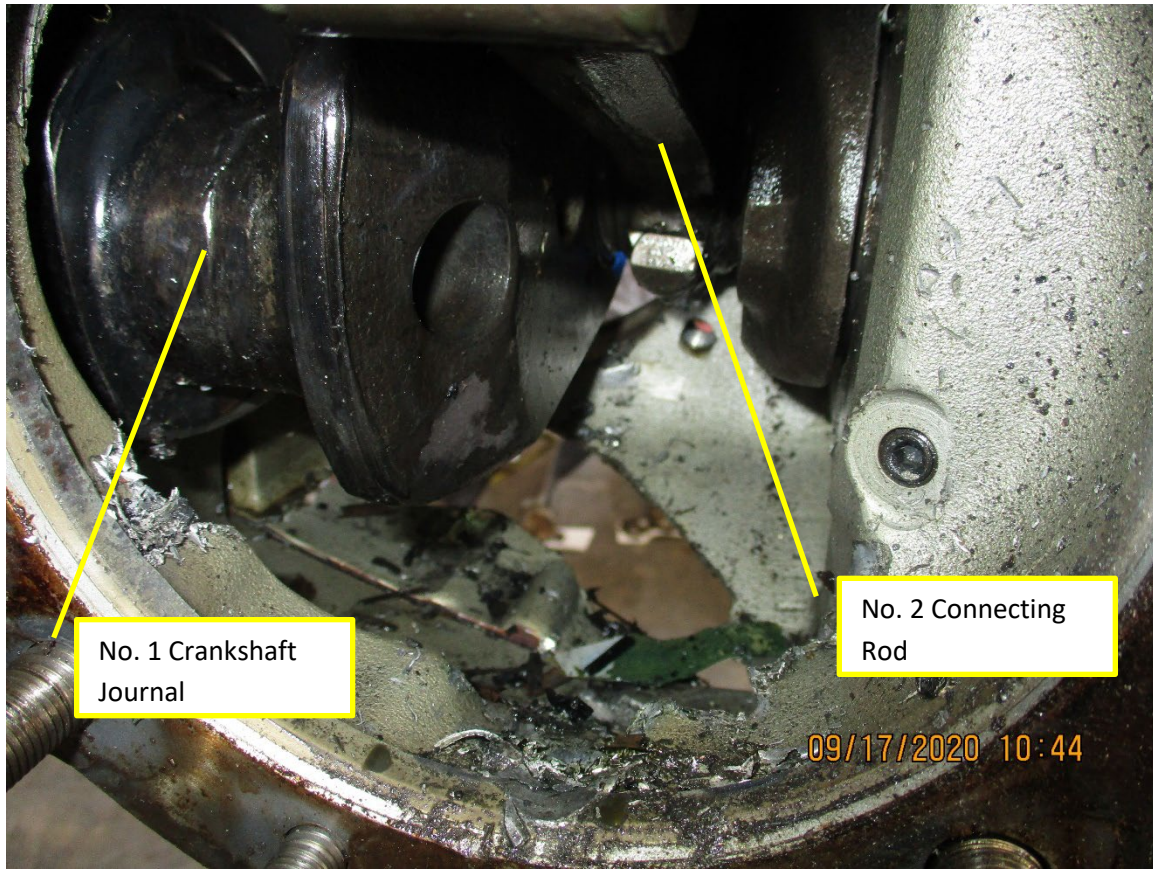
*Figure 1 View Through Cylinder No. 2*

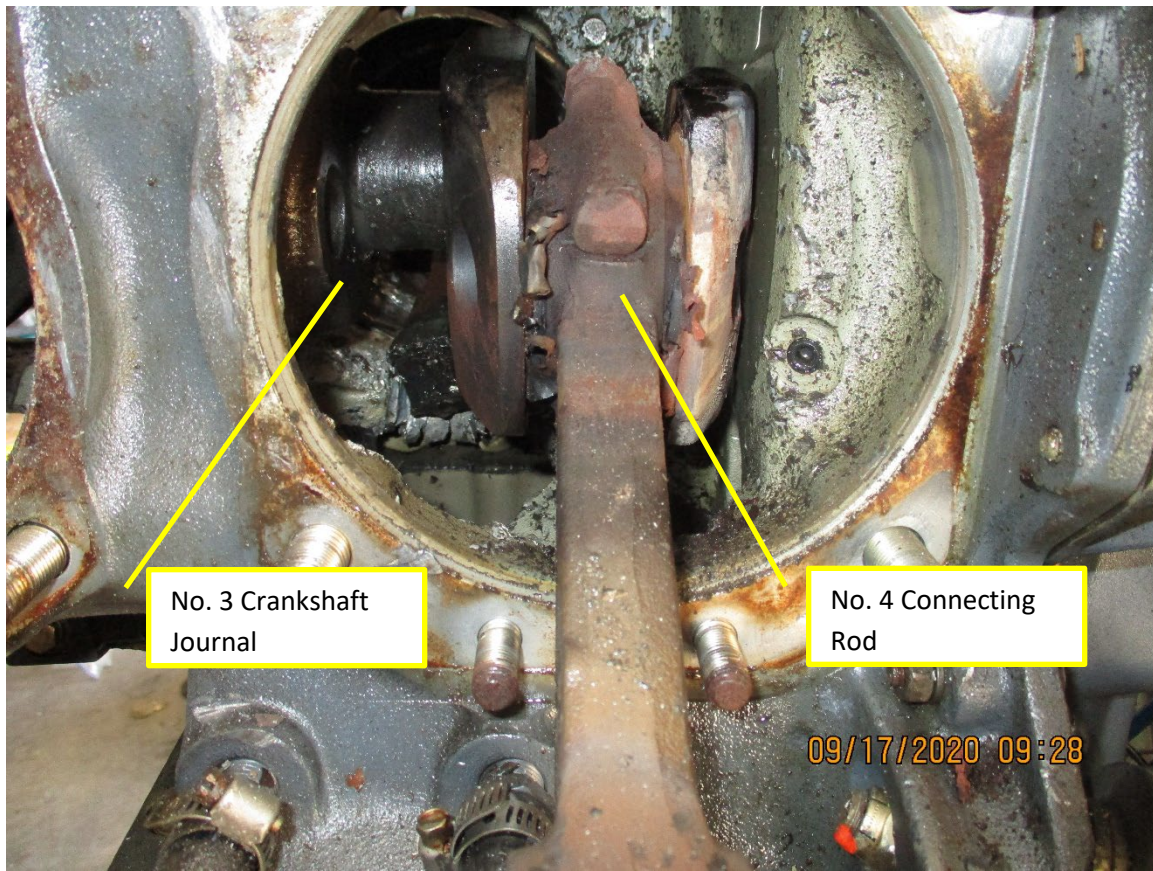
The Lycoming engine had been previously overhauled by Continental Motors, about 1,600 flight hours prior to the accident. Examination of the engine revealed a hole in the engine case near the base of cylinder No. 4. Metallic debris was found in the oil suction screen. The No.1 and No. 3 cylinder connecting rods were damaged and fracture separated near their crankshaft ends. Damaged remnants of connecting rod material were found in several locations inside the engine. The remnants and fracture surfaces of the rods, as well as the journals on the crankshaft were discolored (blackened and bluish surfaces) consistent with thermal stress/damage. The No.4 connecting rod remained attached to the crankshaft but would not rotate. The crankshaft end of the rod was discolored (black and rust colored), consistent with thermal stress. Bearing material appeared to be extruded between the rod and the crankshaft lobe. The No.2 connecting rod remained attached to the crankshaft and would rotate easily around the crankshaft. The rod appeared undamaged and its color was “normal.”

Figure 2 - View Through Cylinder No. 4

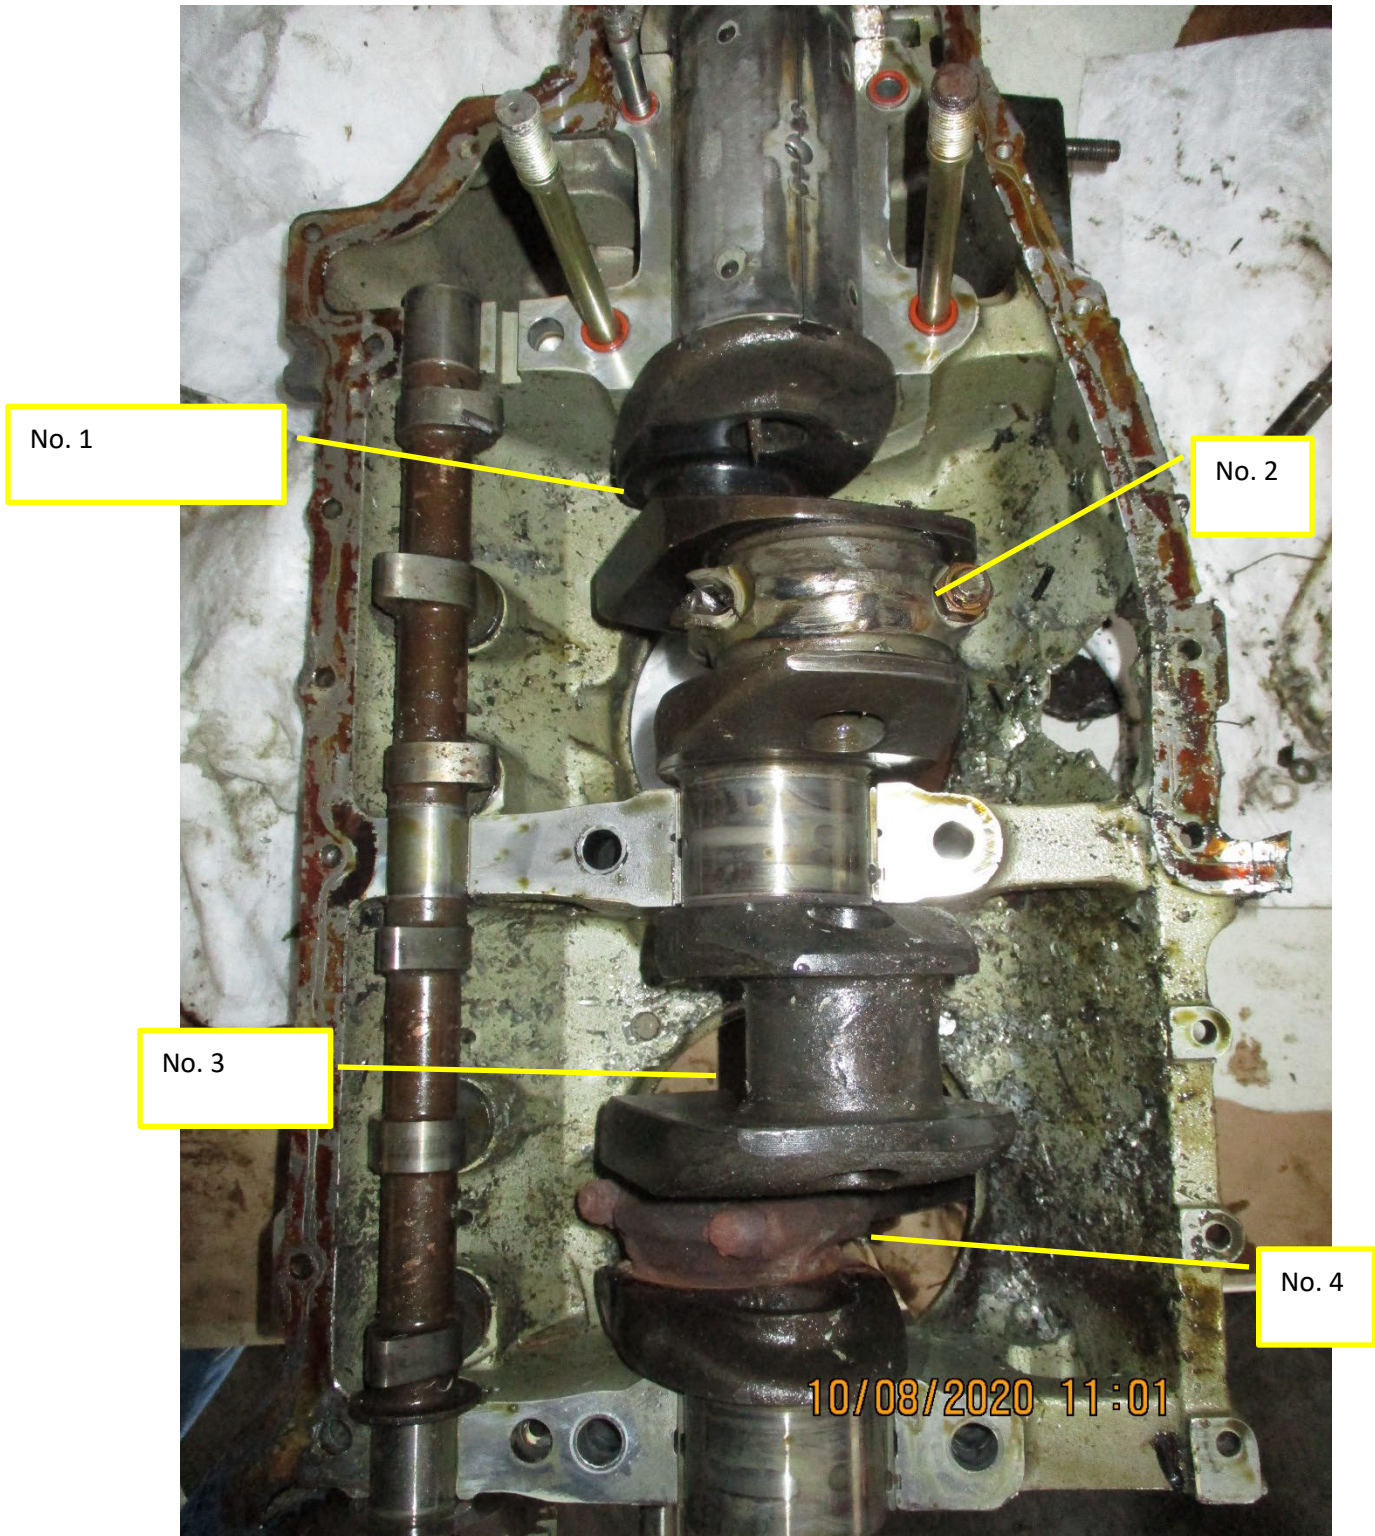
Figure 3 View of Crankshaft

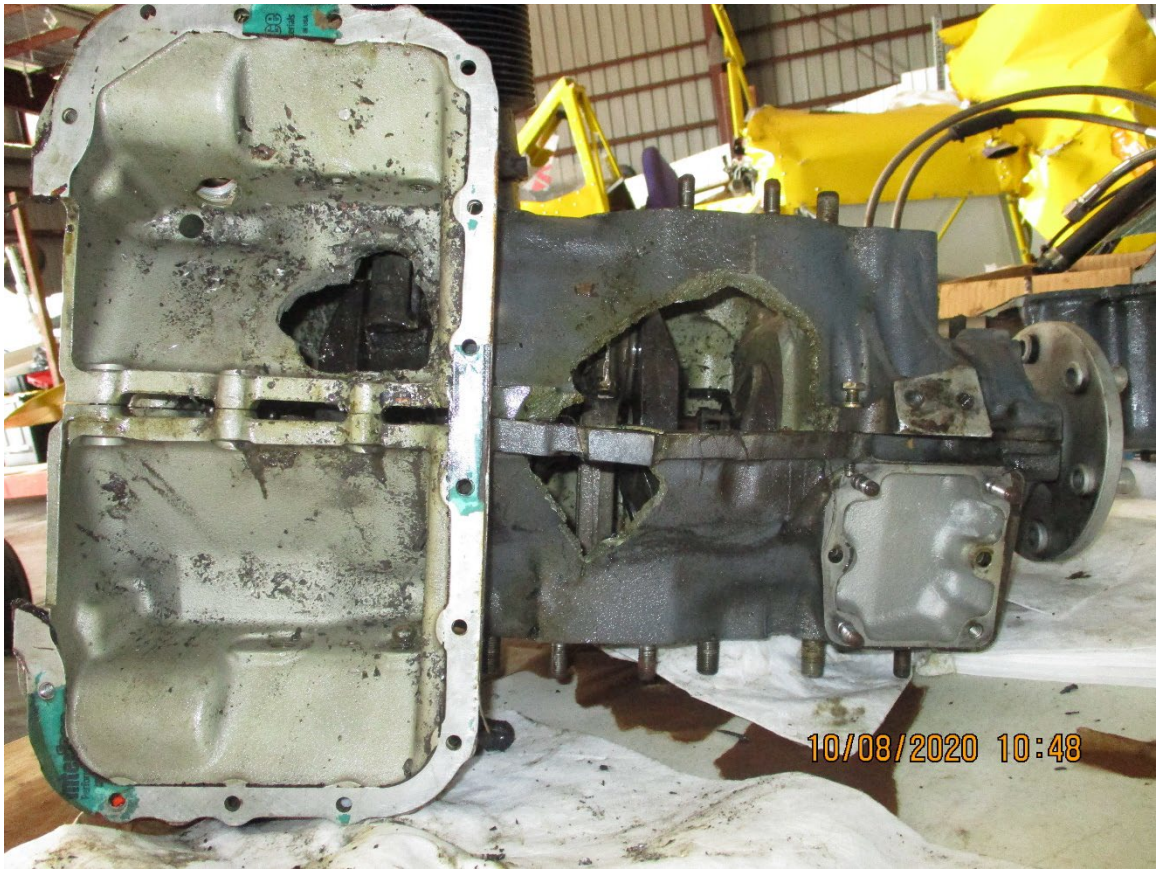
On October 8, 2020, Inspector Garcia performed a follow-up examination of the engine. The engine was removed from the airplane and further disassembled. The oil pump was intact with safety wire installed. The pump rotated smoothly with no binding. A small amount of oil was found inside the pump cavity, with no debris. The oil pump components were undamaged. The three crankshaft main bearings and journals exhibited some minor wear, and did not exhibit any bluing or other indications of excessive heat. There were no obstructions found in the visible oil passages in the crankshaft main journals. The crankshaft No. 1 and No.3 connecting rod journals were partially smeared (heat damaged) and the No.2 and No.4 connecting rods could not be separated from the crankshaft. The bottom of the crankcase had two large irregularly shaped holes, one on each case half, forward of the oil sump.

*Figure 4 View of Crankcase Bottom Side*
