# NTSB Investigation: ERA20LA305

Photo Array

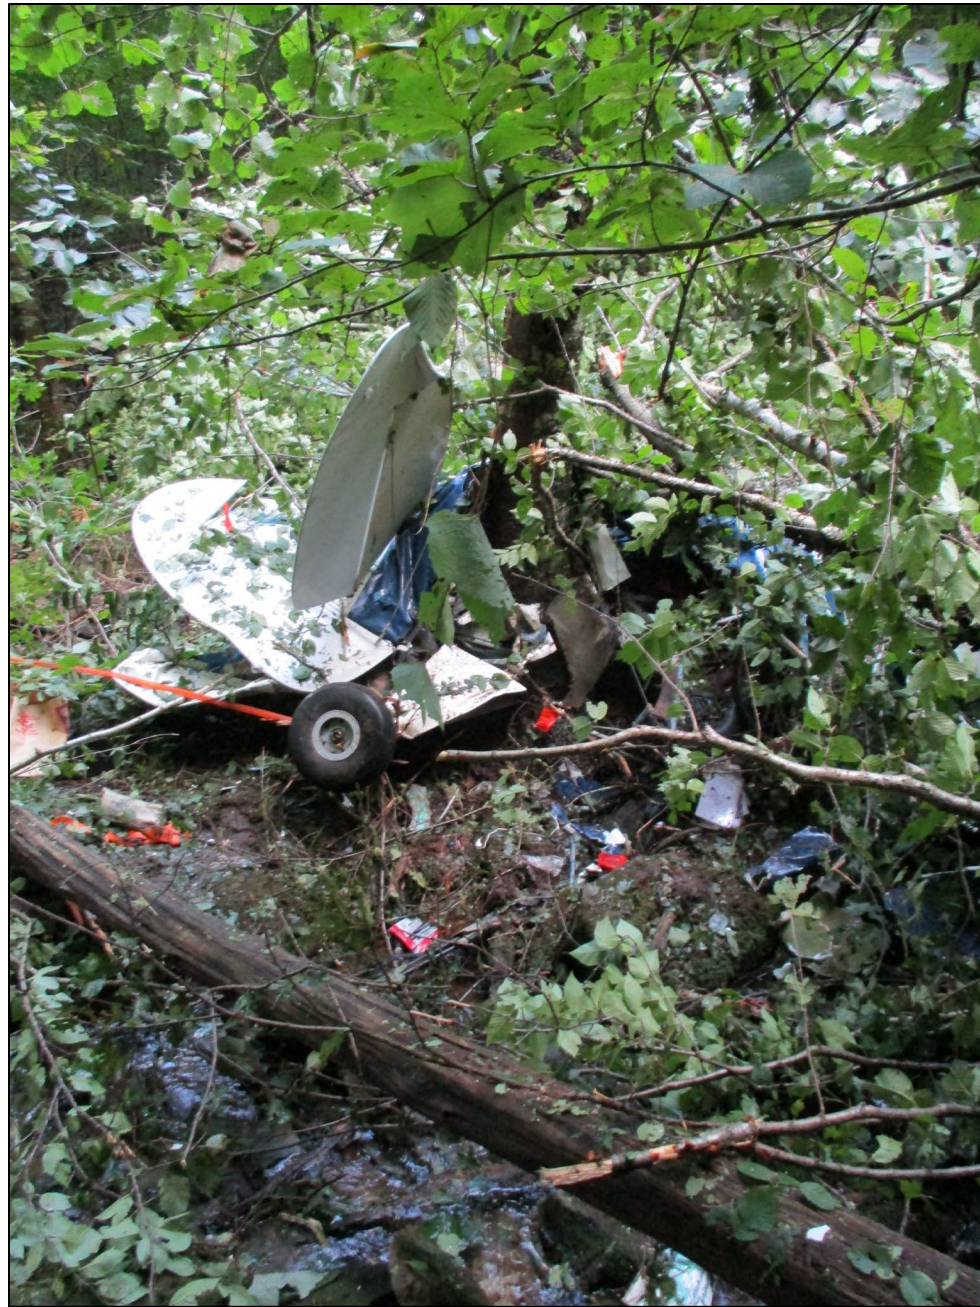
Photo 1 – View of the empennage at the accident site (Photo Courtesy of FAA)

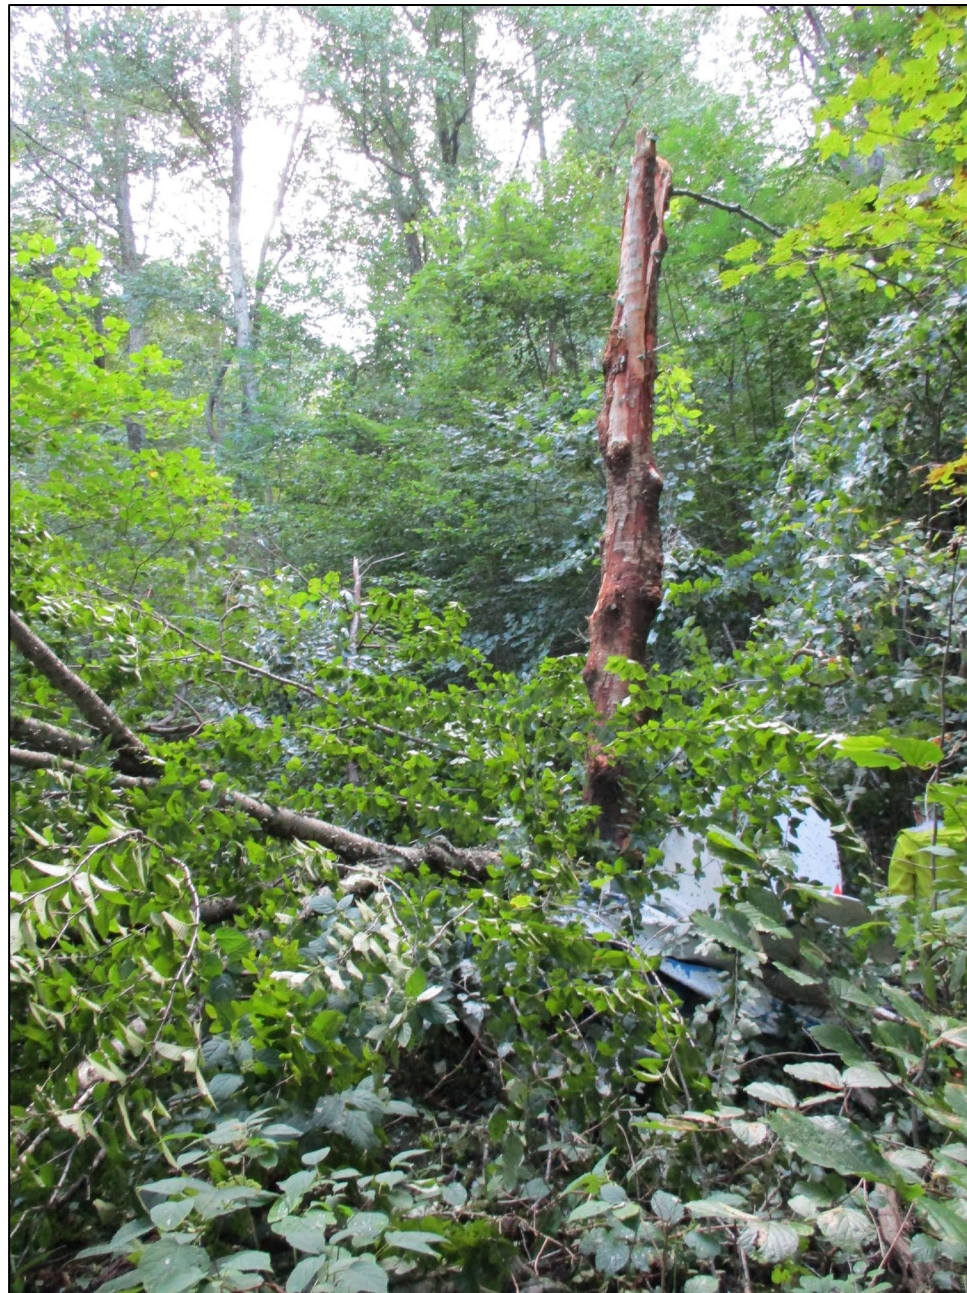
Photo 2 – View of the accident area showing the rudder within the heavily wooded terrain (Photo Courtesy FAA)

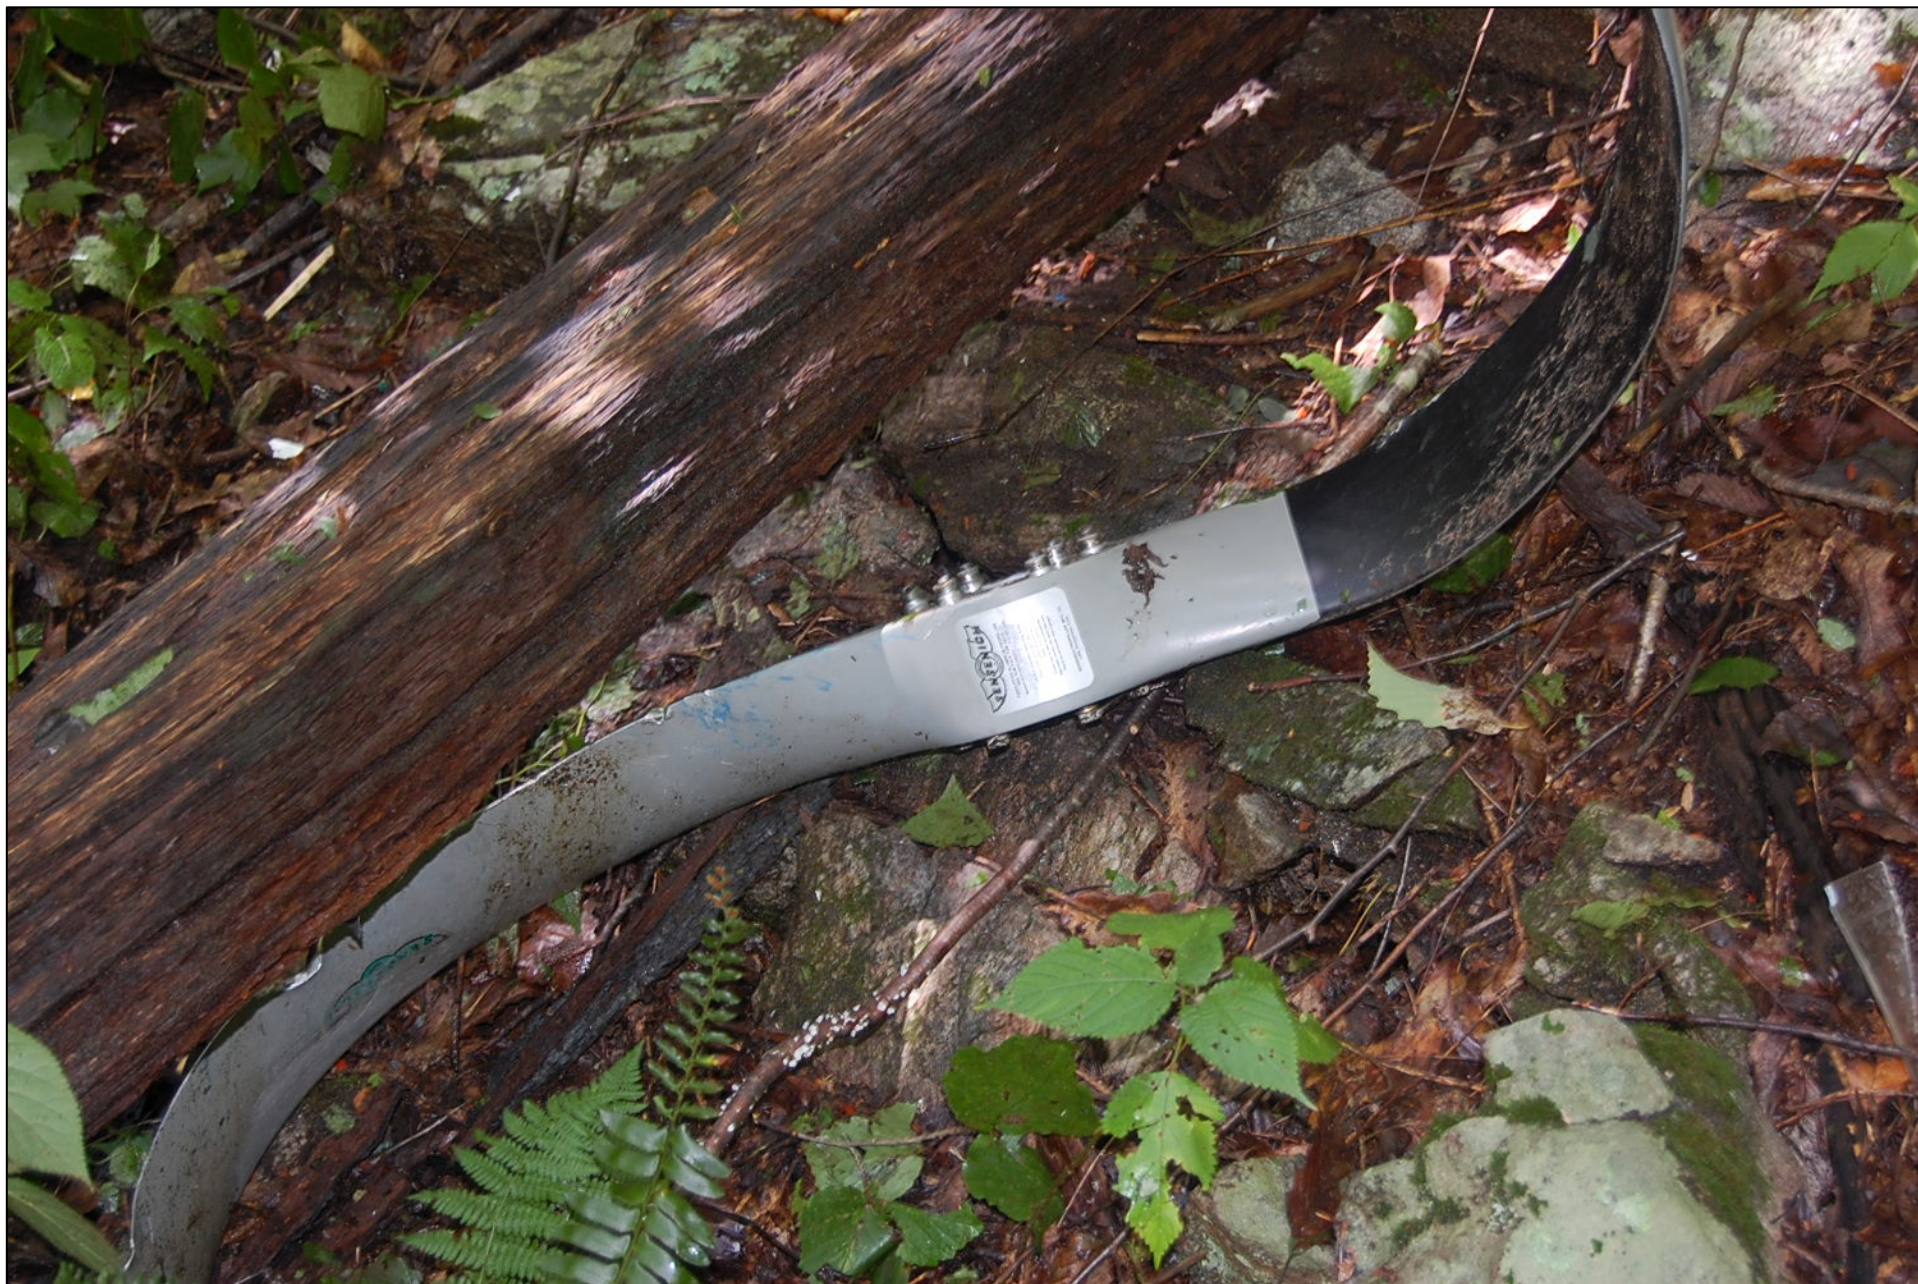
Photo 3 – View of the propeller at the accident site, separated from the engine (Photo Courtesy FAA)

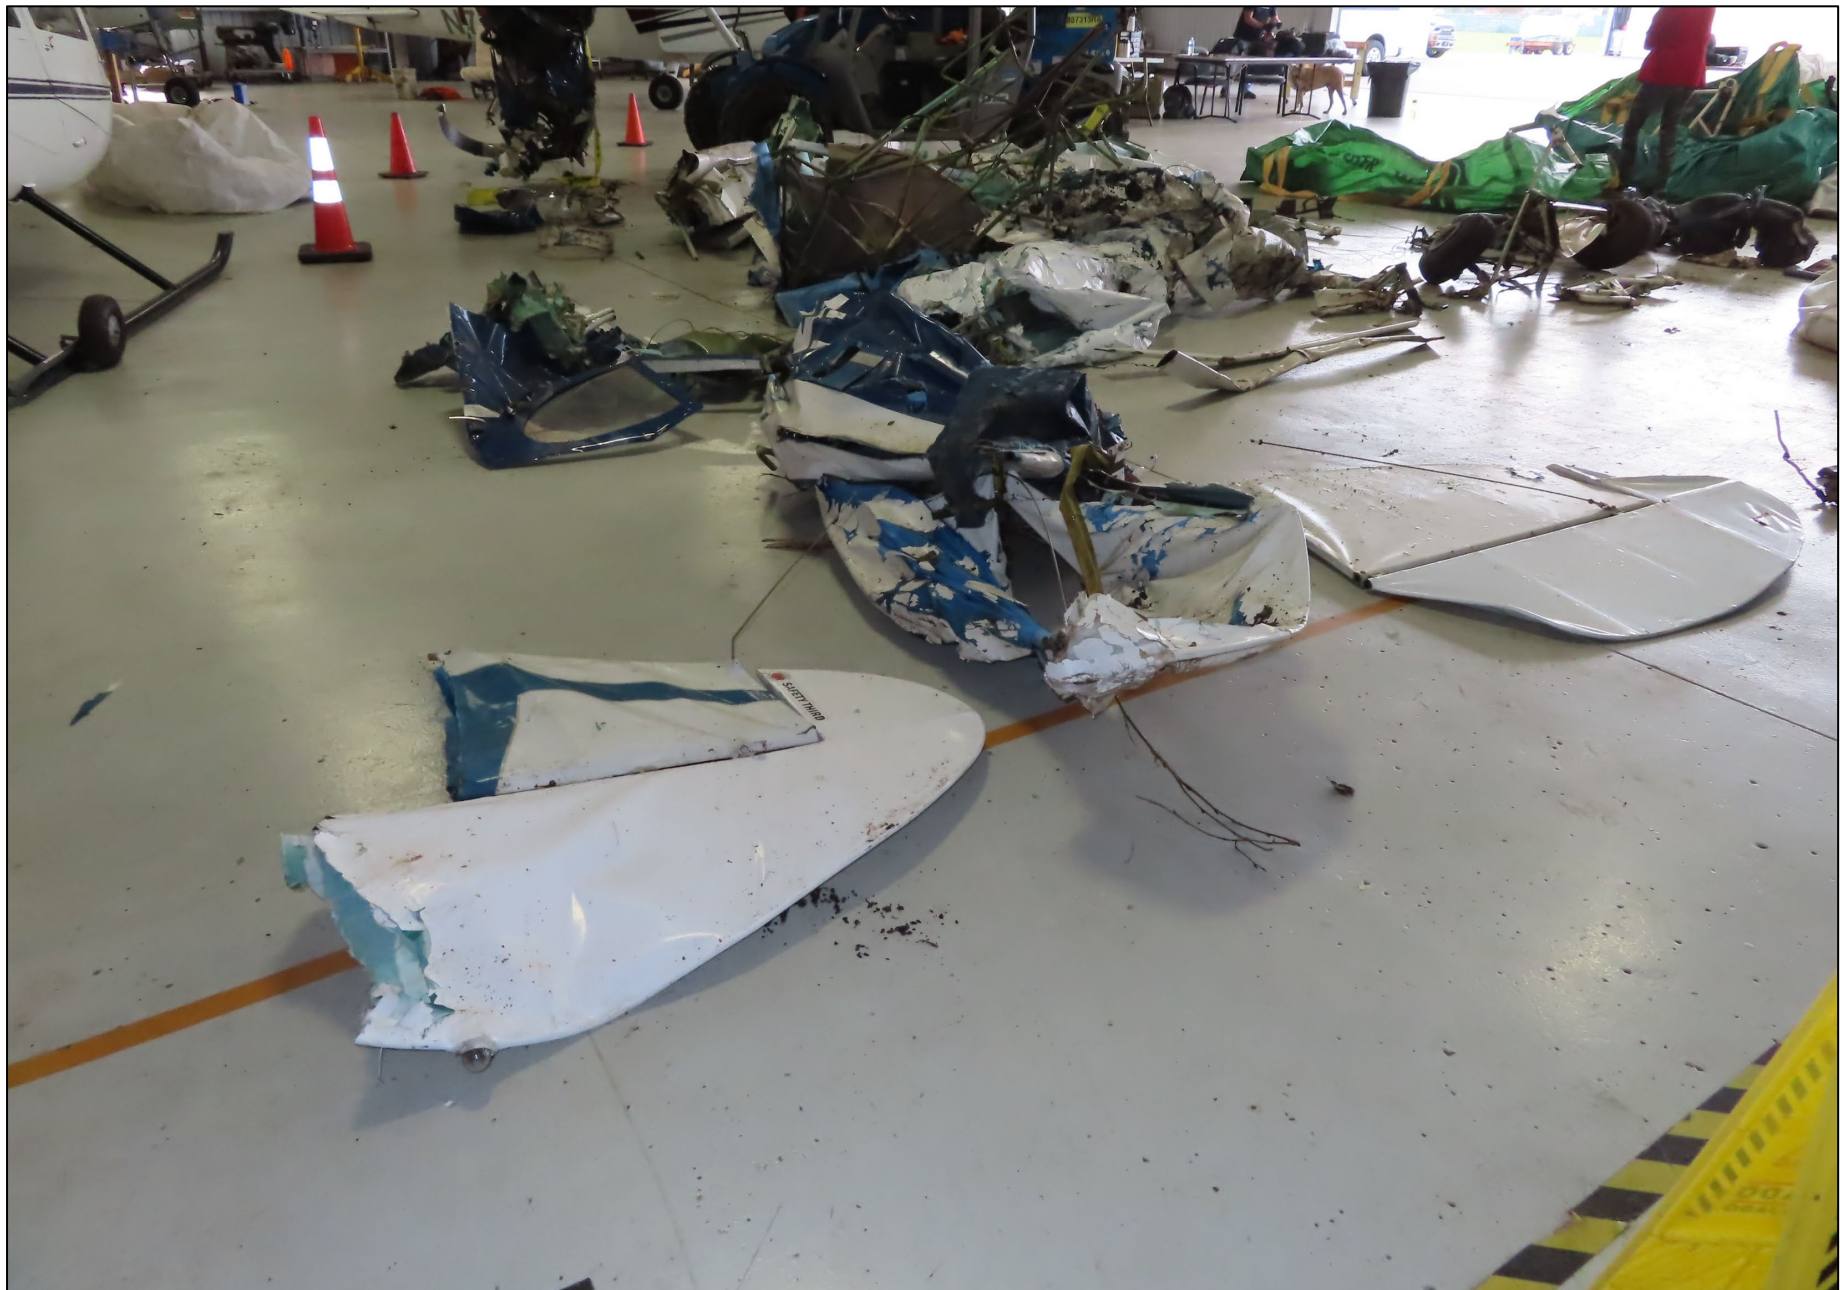
Photo 4 – View of the wreckage layout at the recovery facility

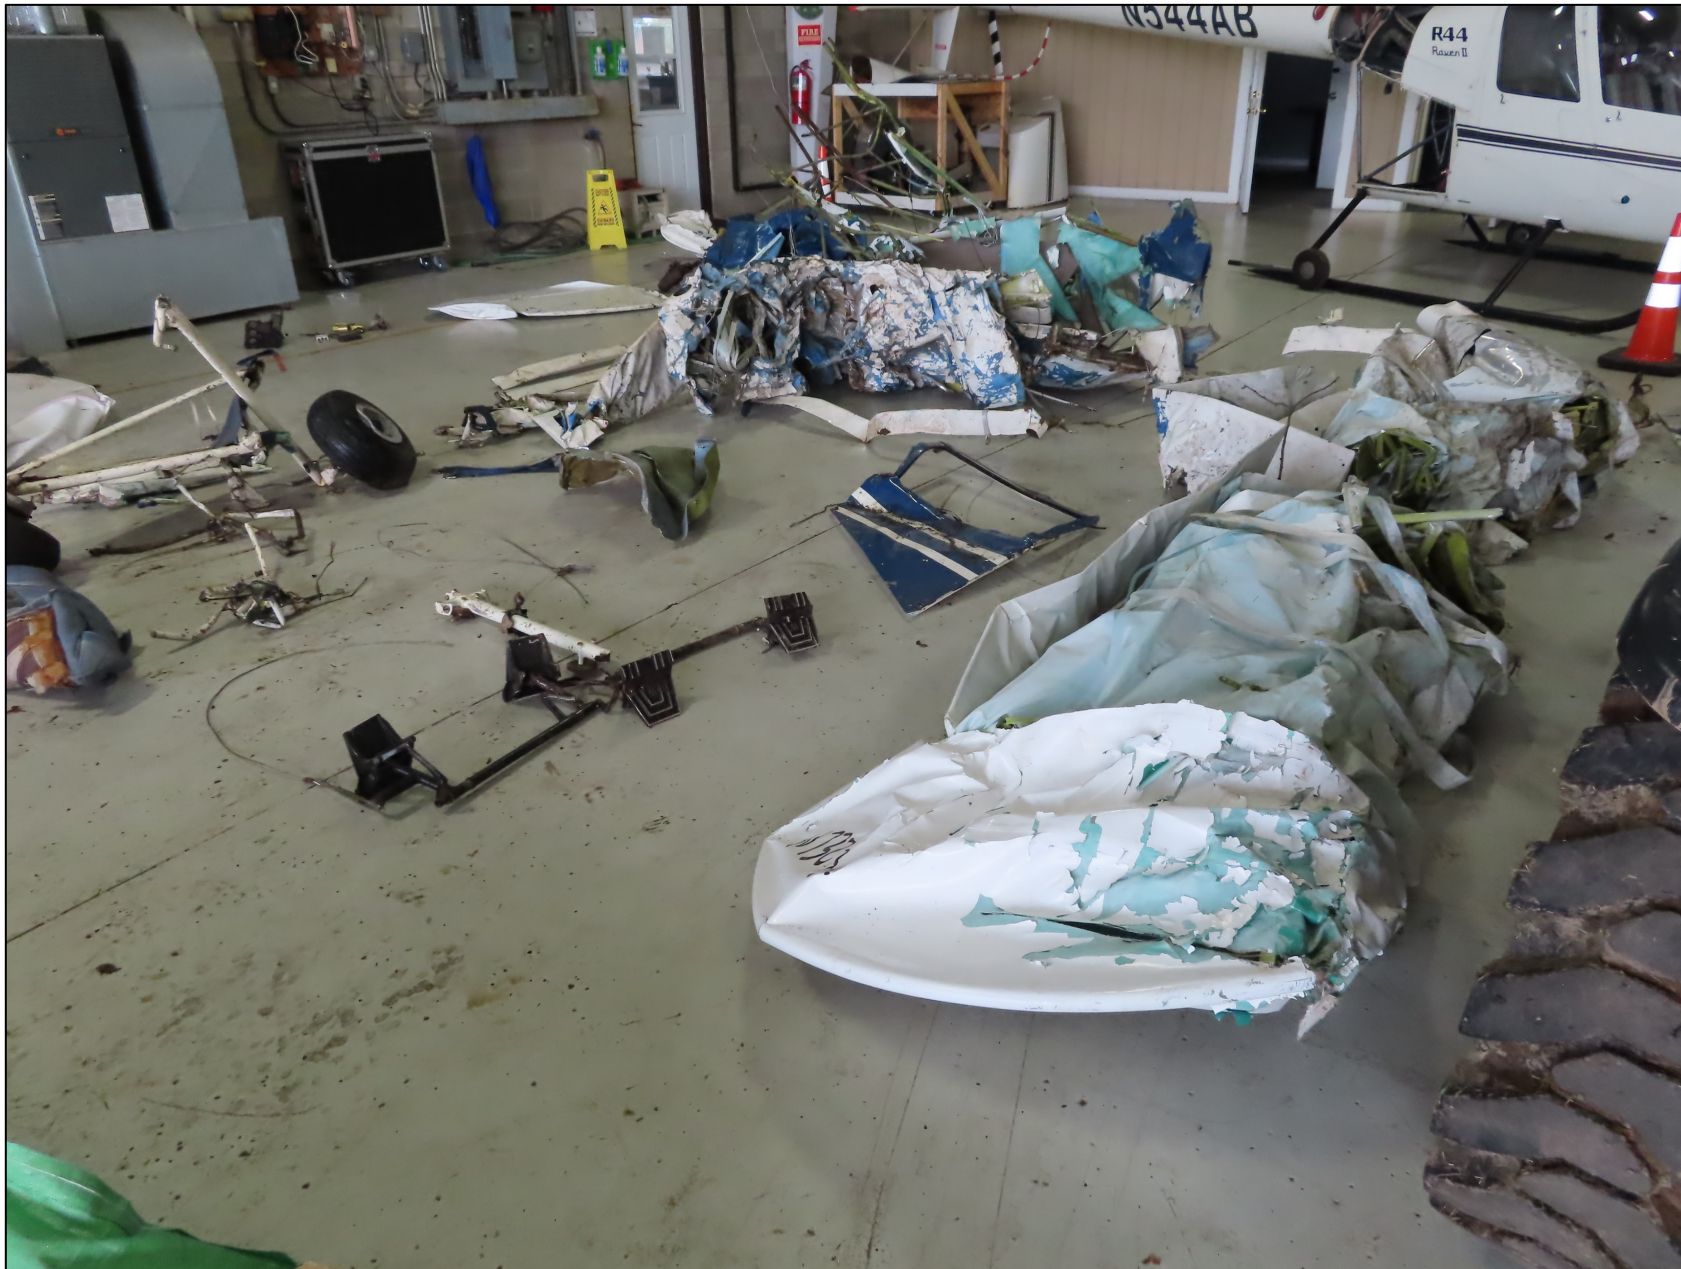
Photo 5 – View of the wreckage layout at the recovery facility

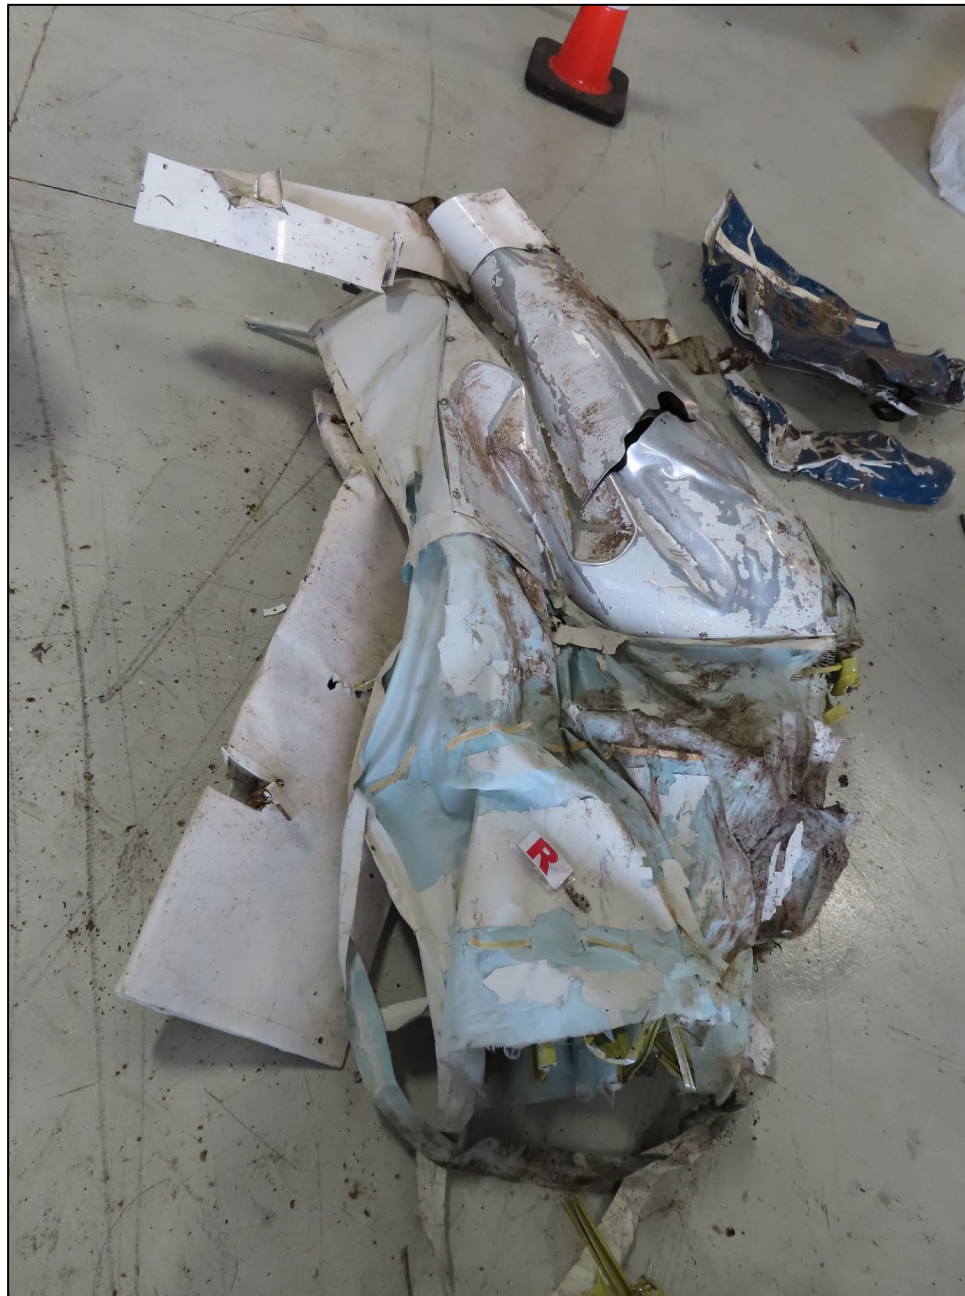
Photo 6 – View of the fragmented and impact damaged right wing

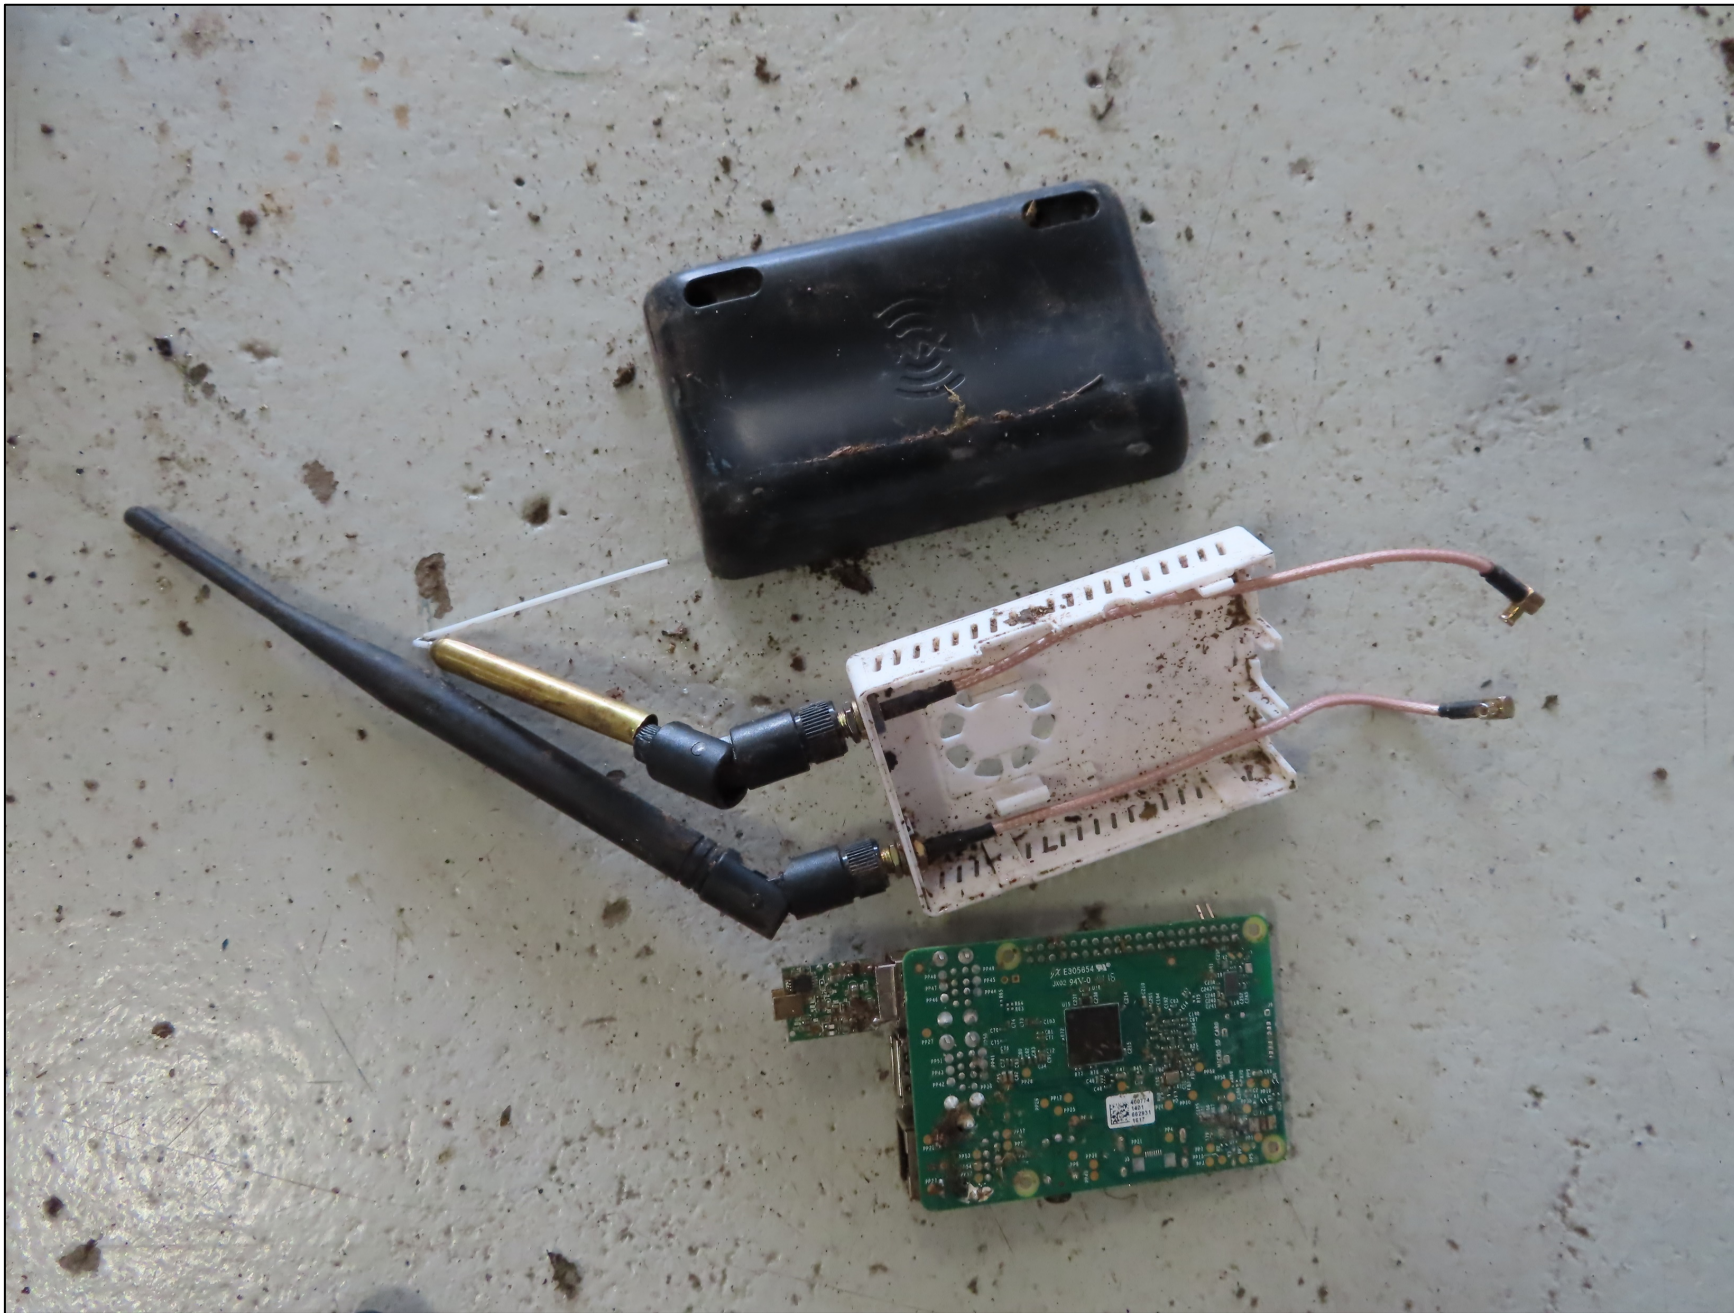
Photo 7 – View of the ADS-B Equipment located within the wreckage

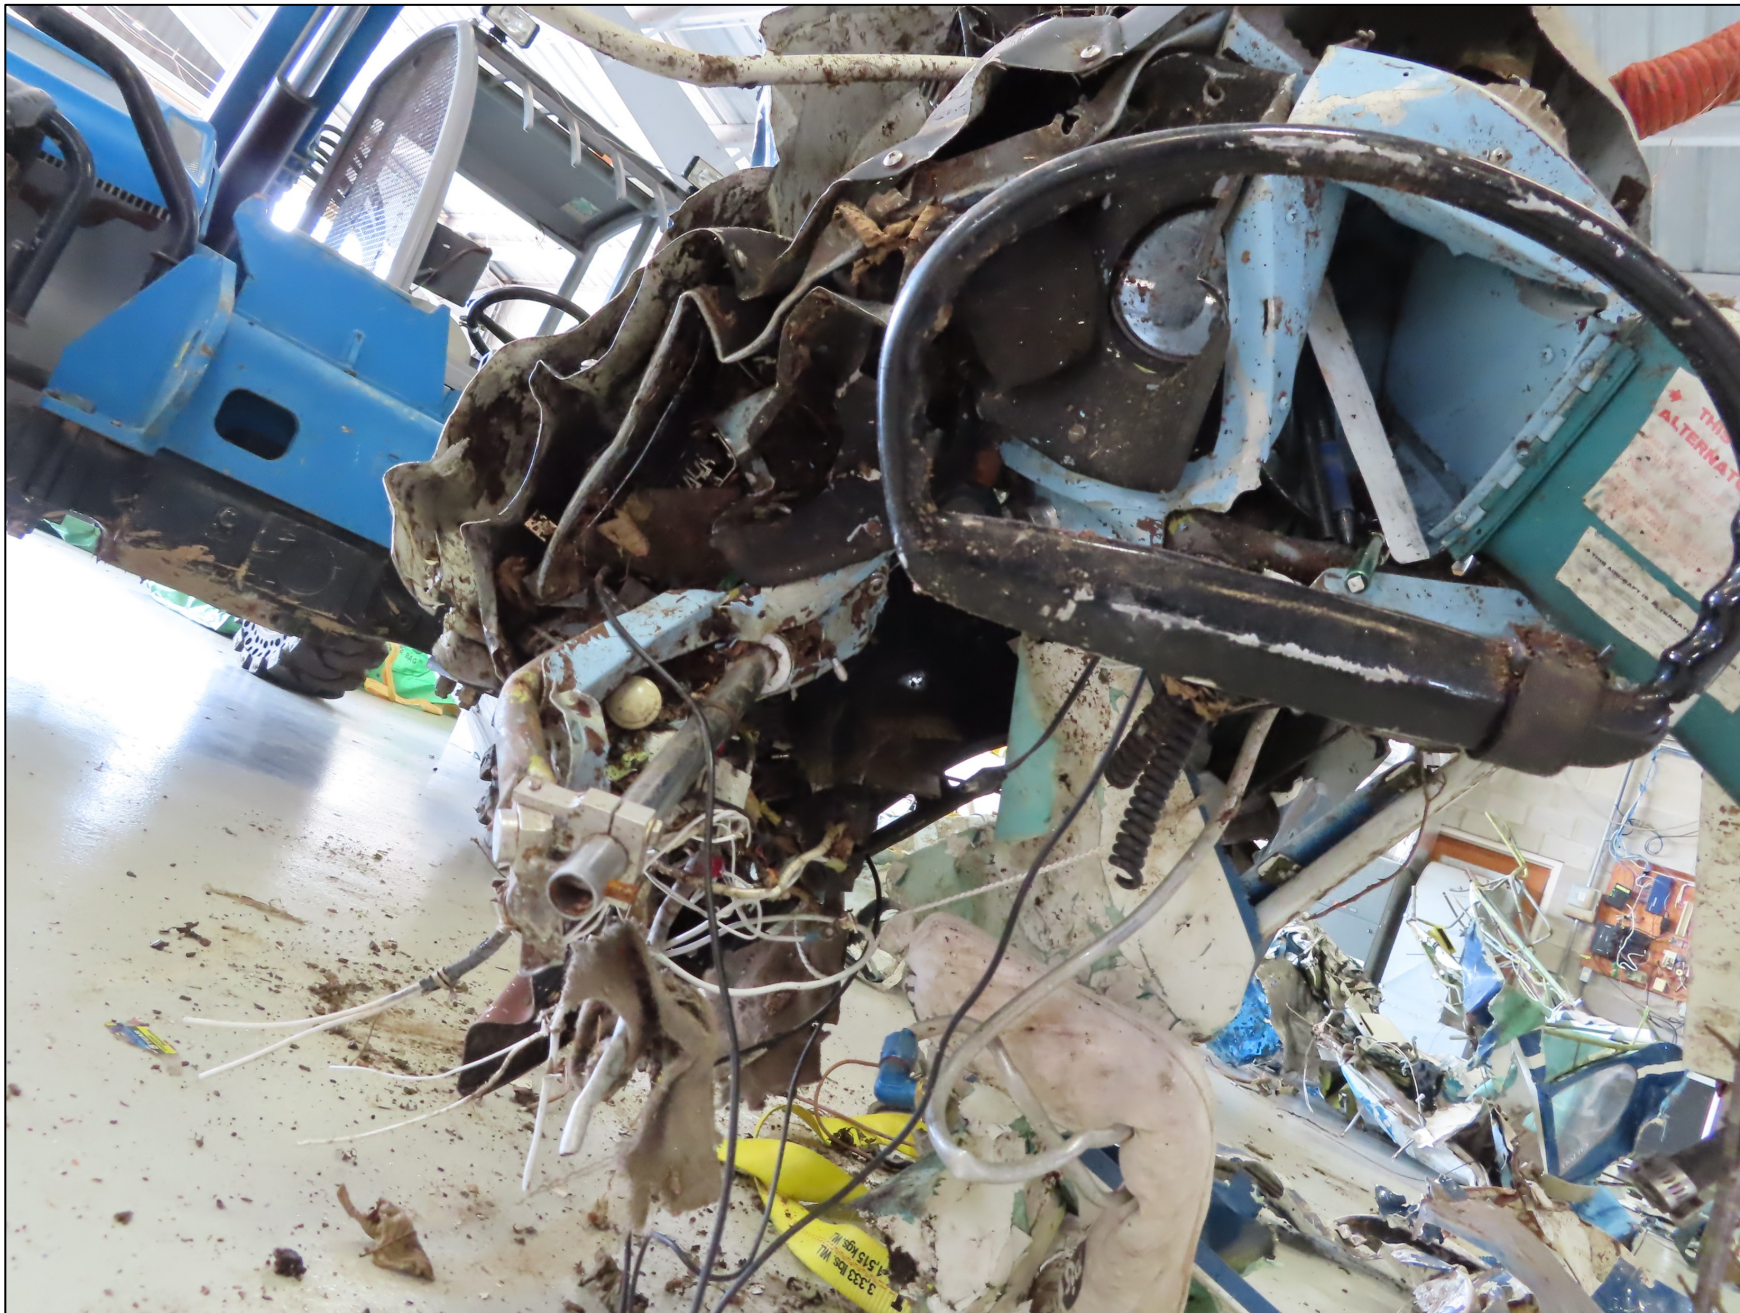
Photo 8 – View of the impact damaged flight controls and cockpit panel

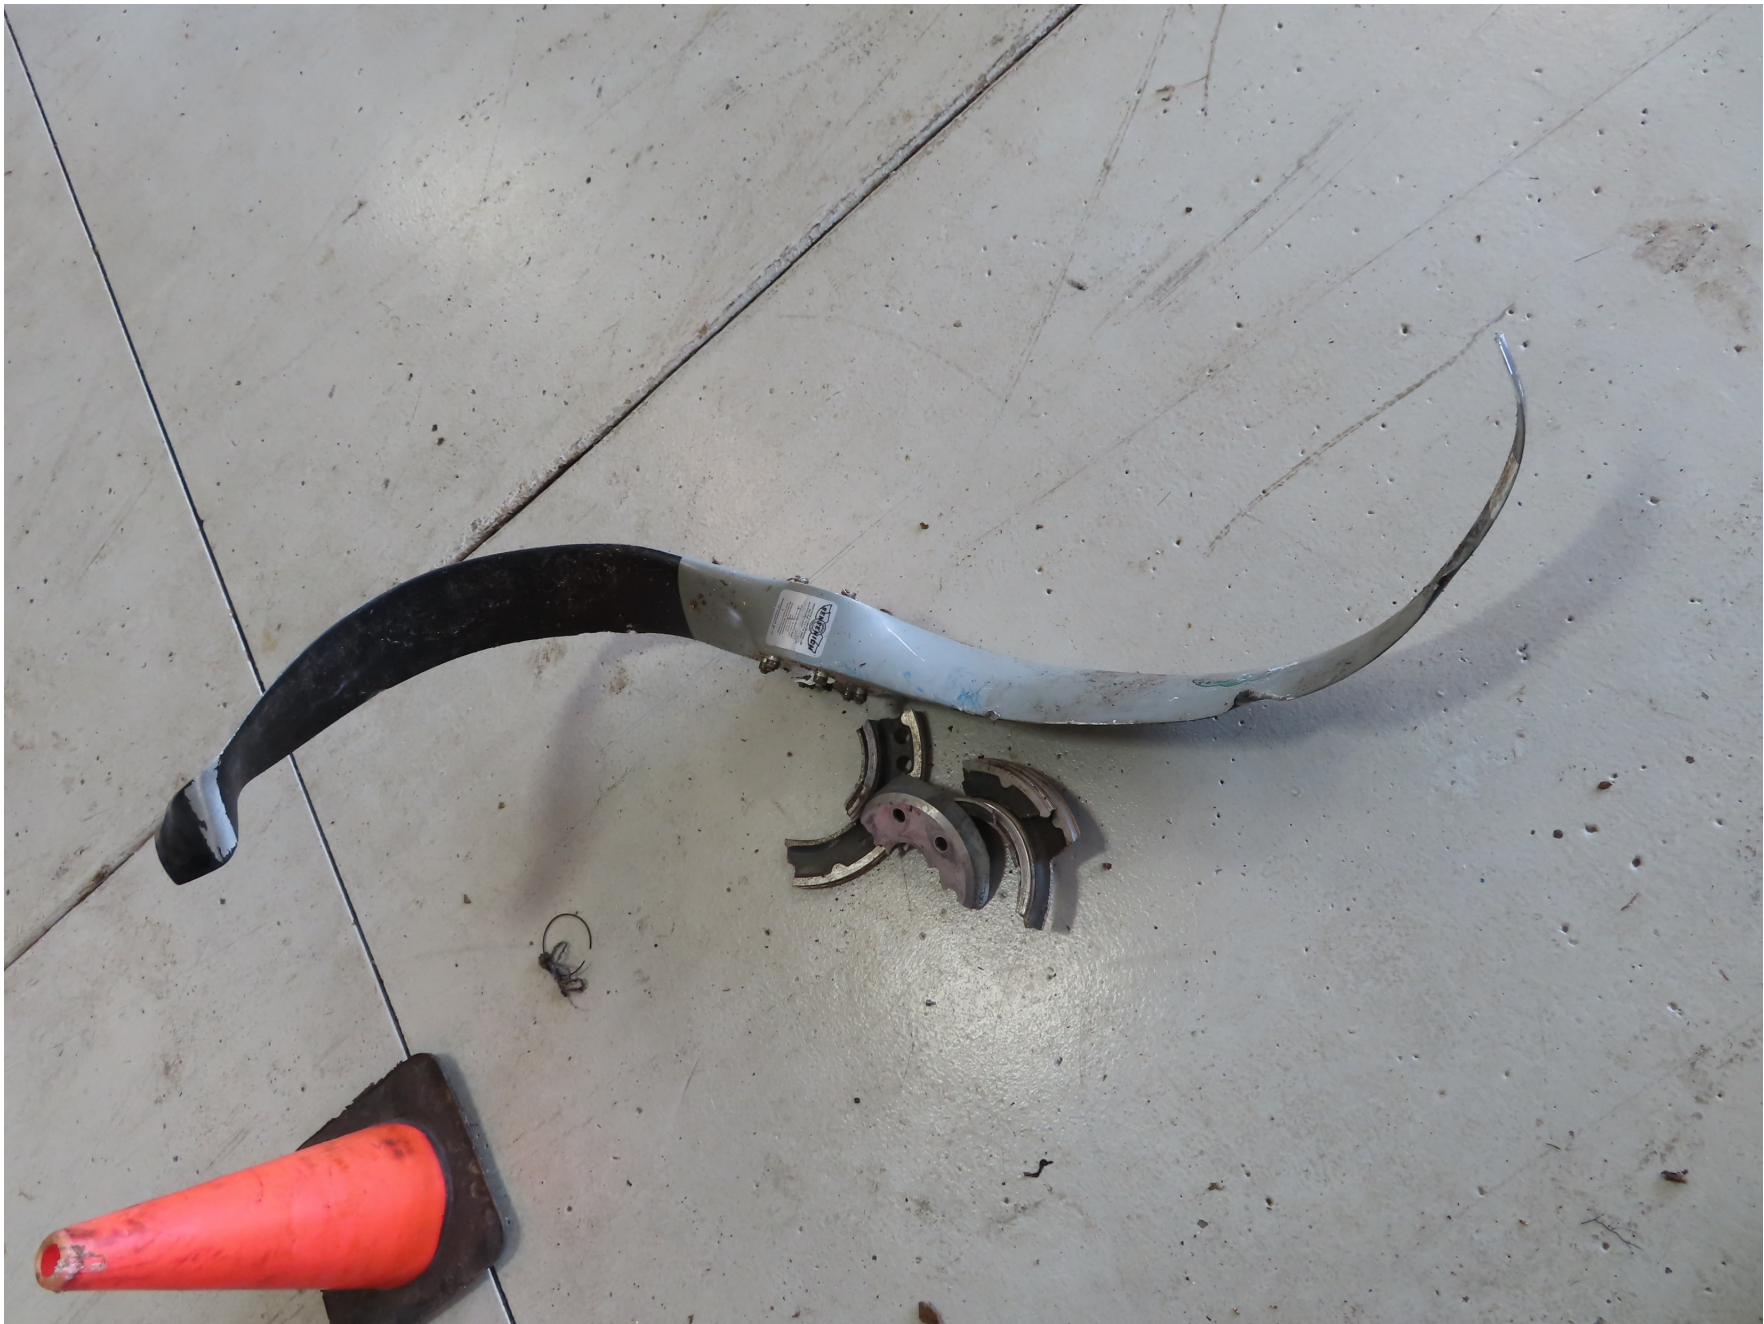
Photo 9 – View of the propeller

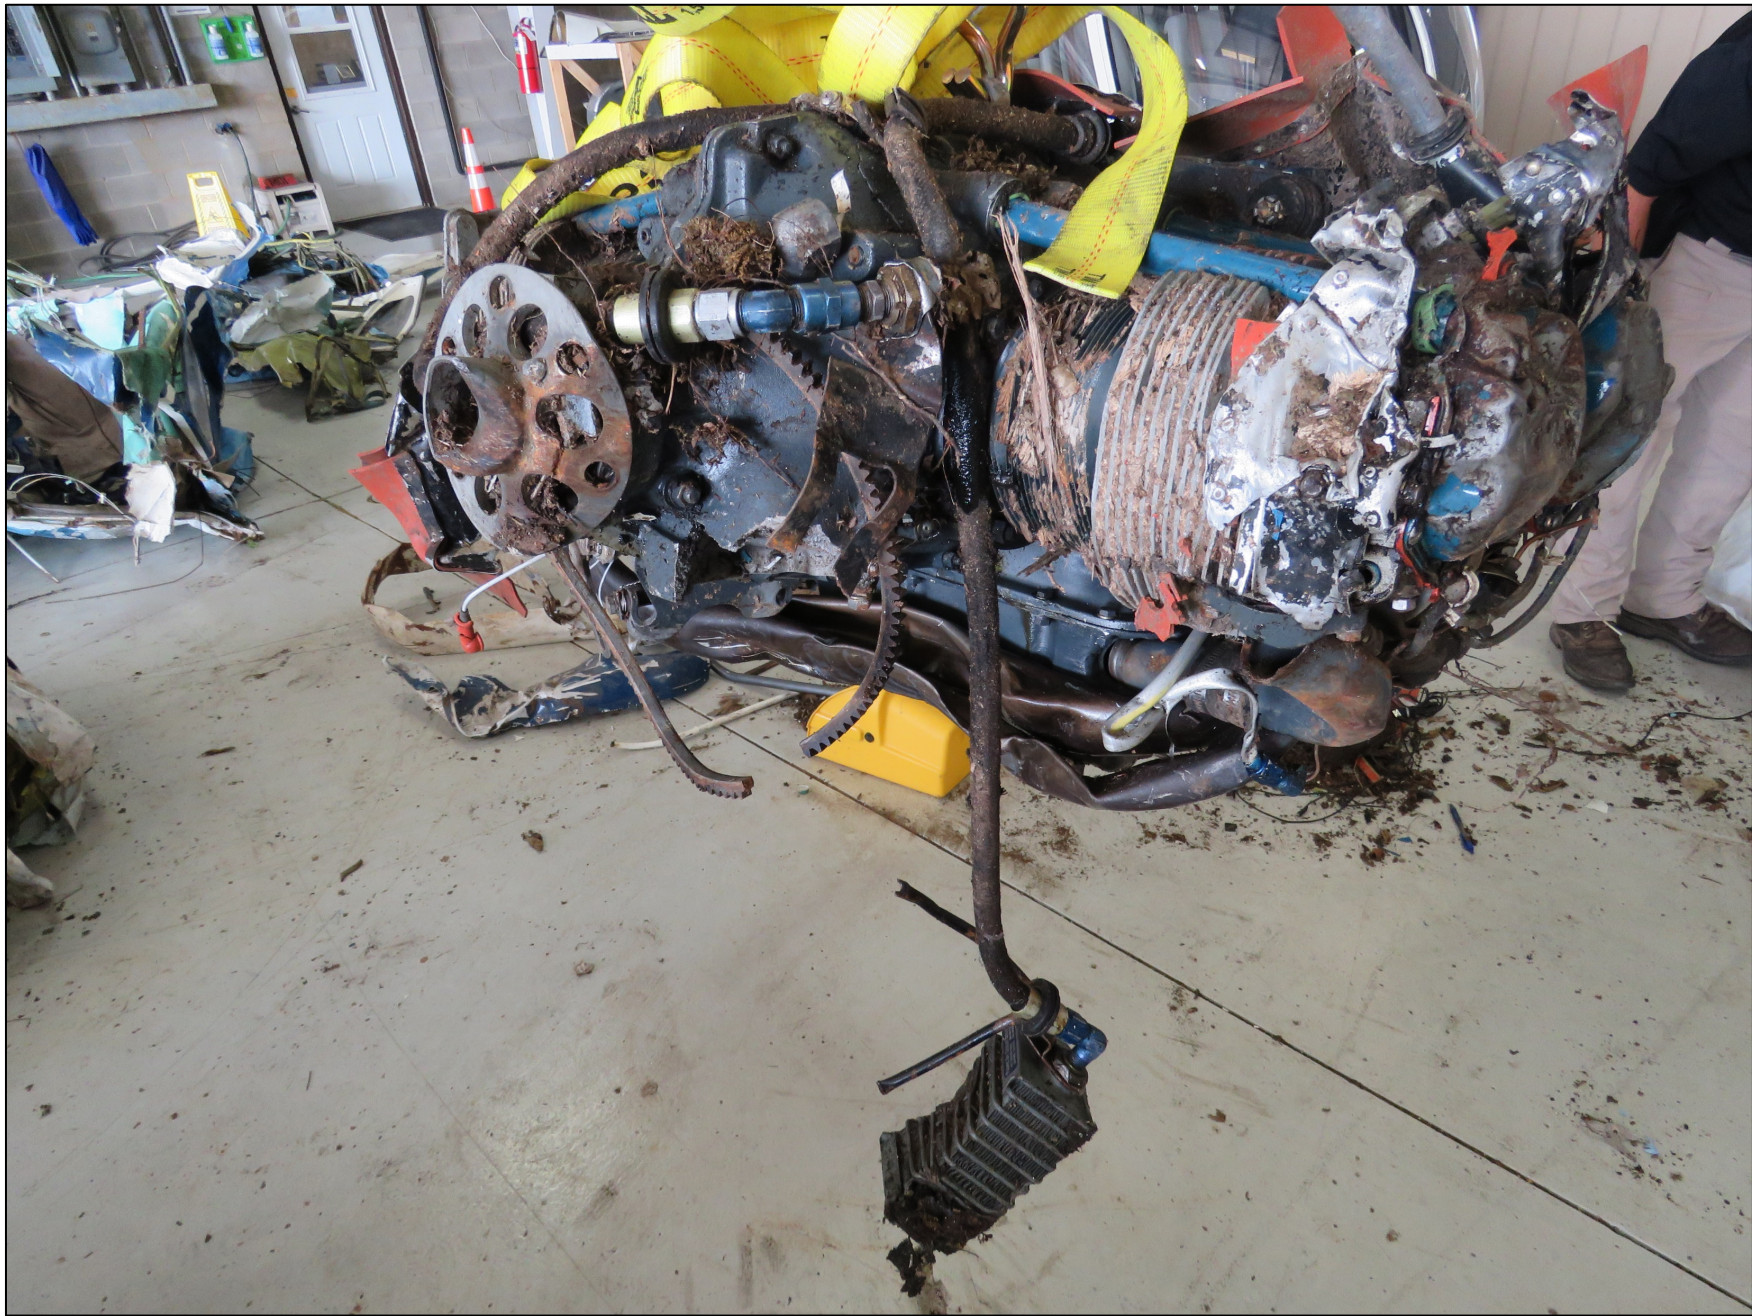
Photo 10 – View of the forward section of the engine

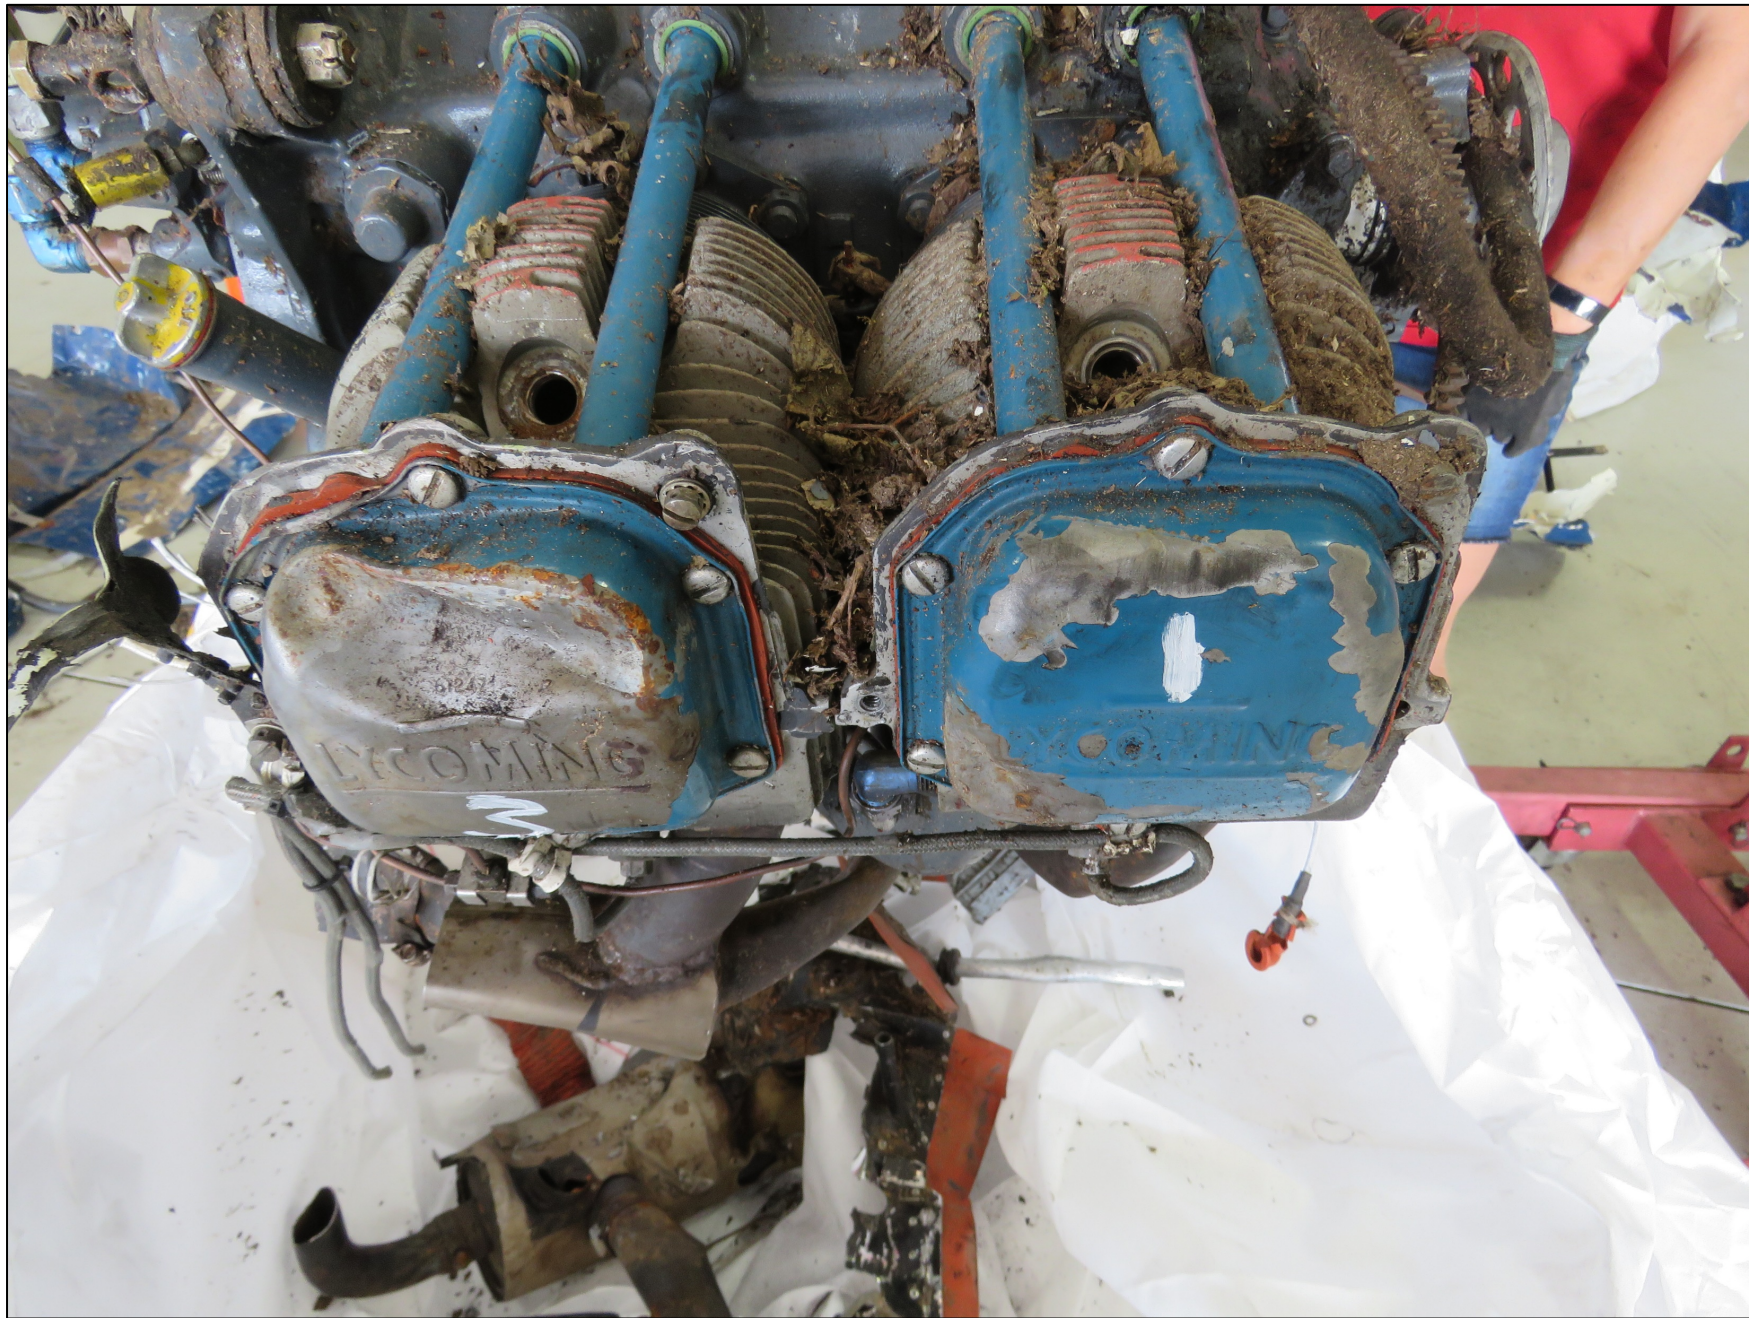
Photo 11 – View of the No. 1 and 3 engine cylinders
