# NTSB Investigation: ERA20LA305

Photo Array

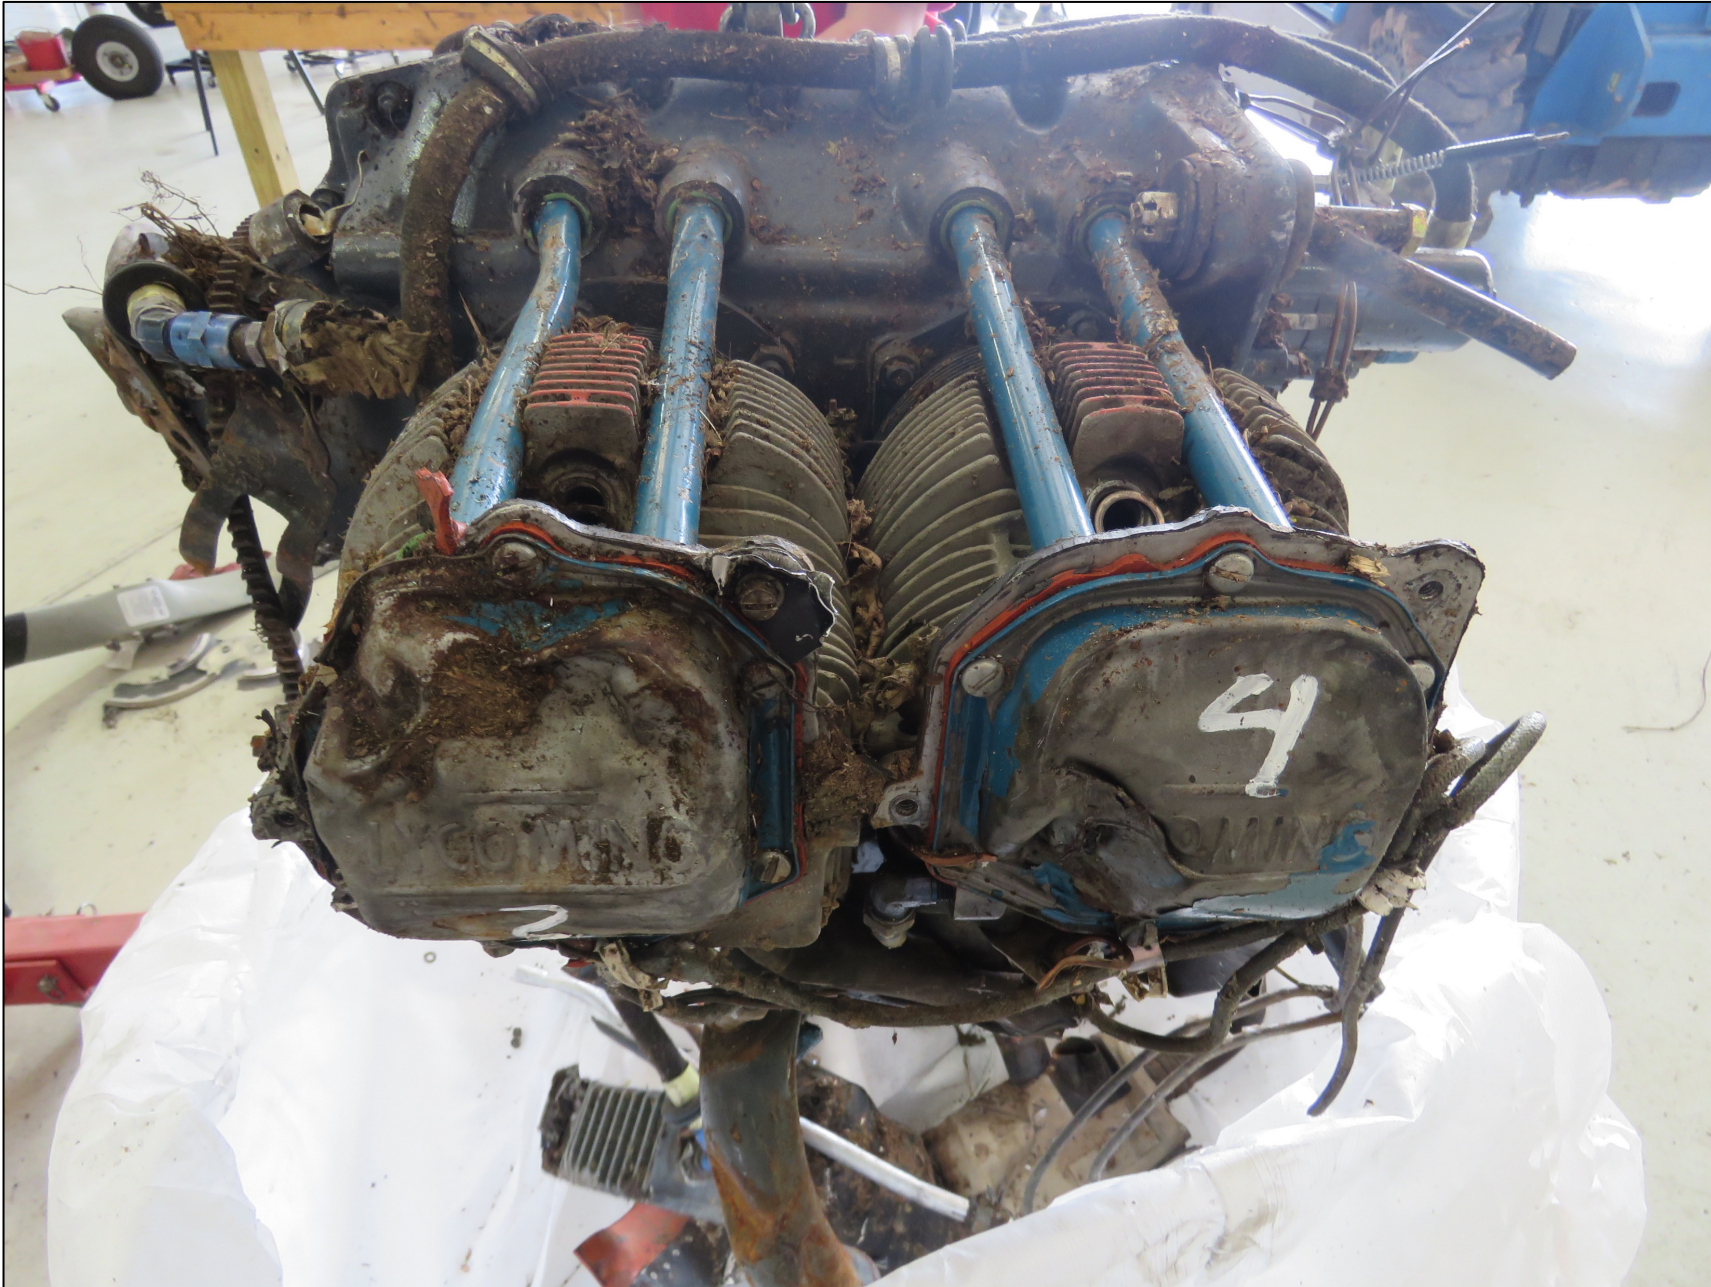
Photo 12 – View of the No. 2 and 4 engine cylinders

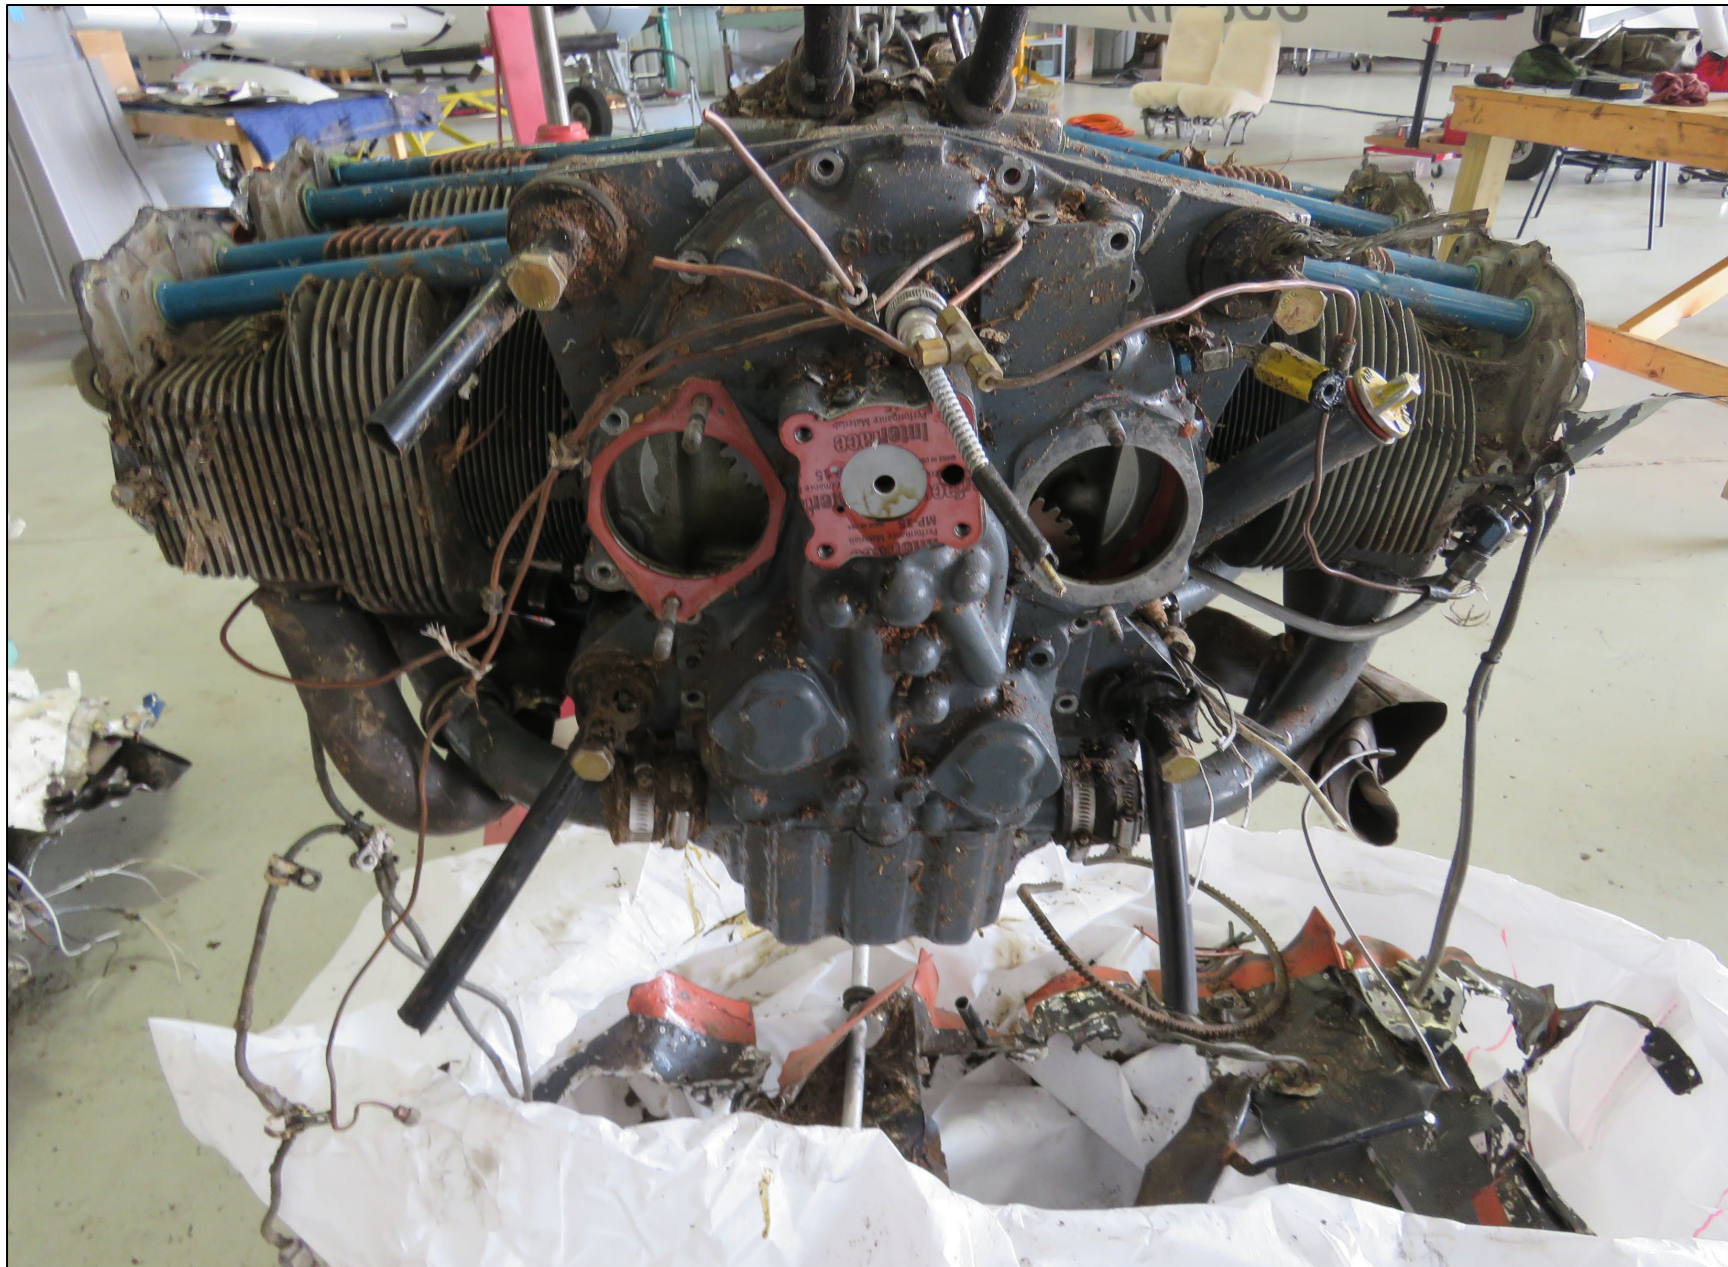
Photo 13 – View of the accessory section of the engine

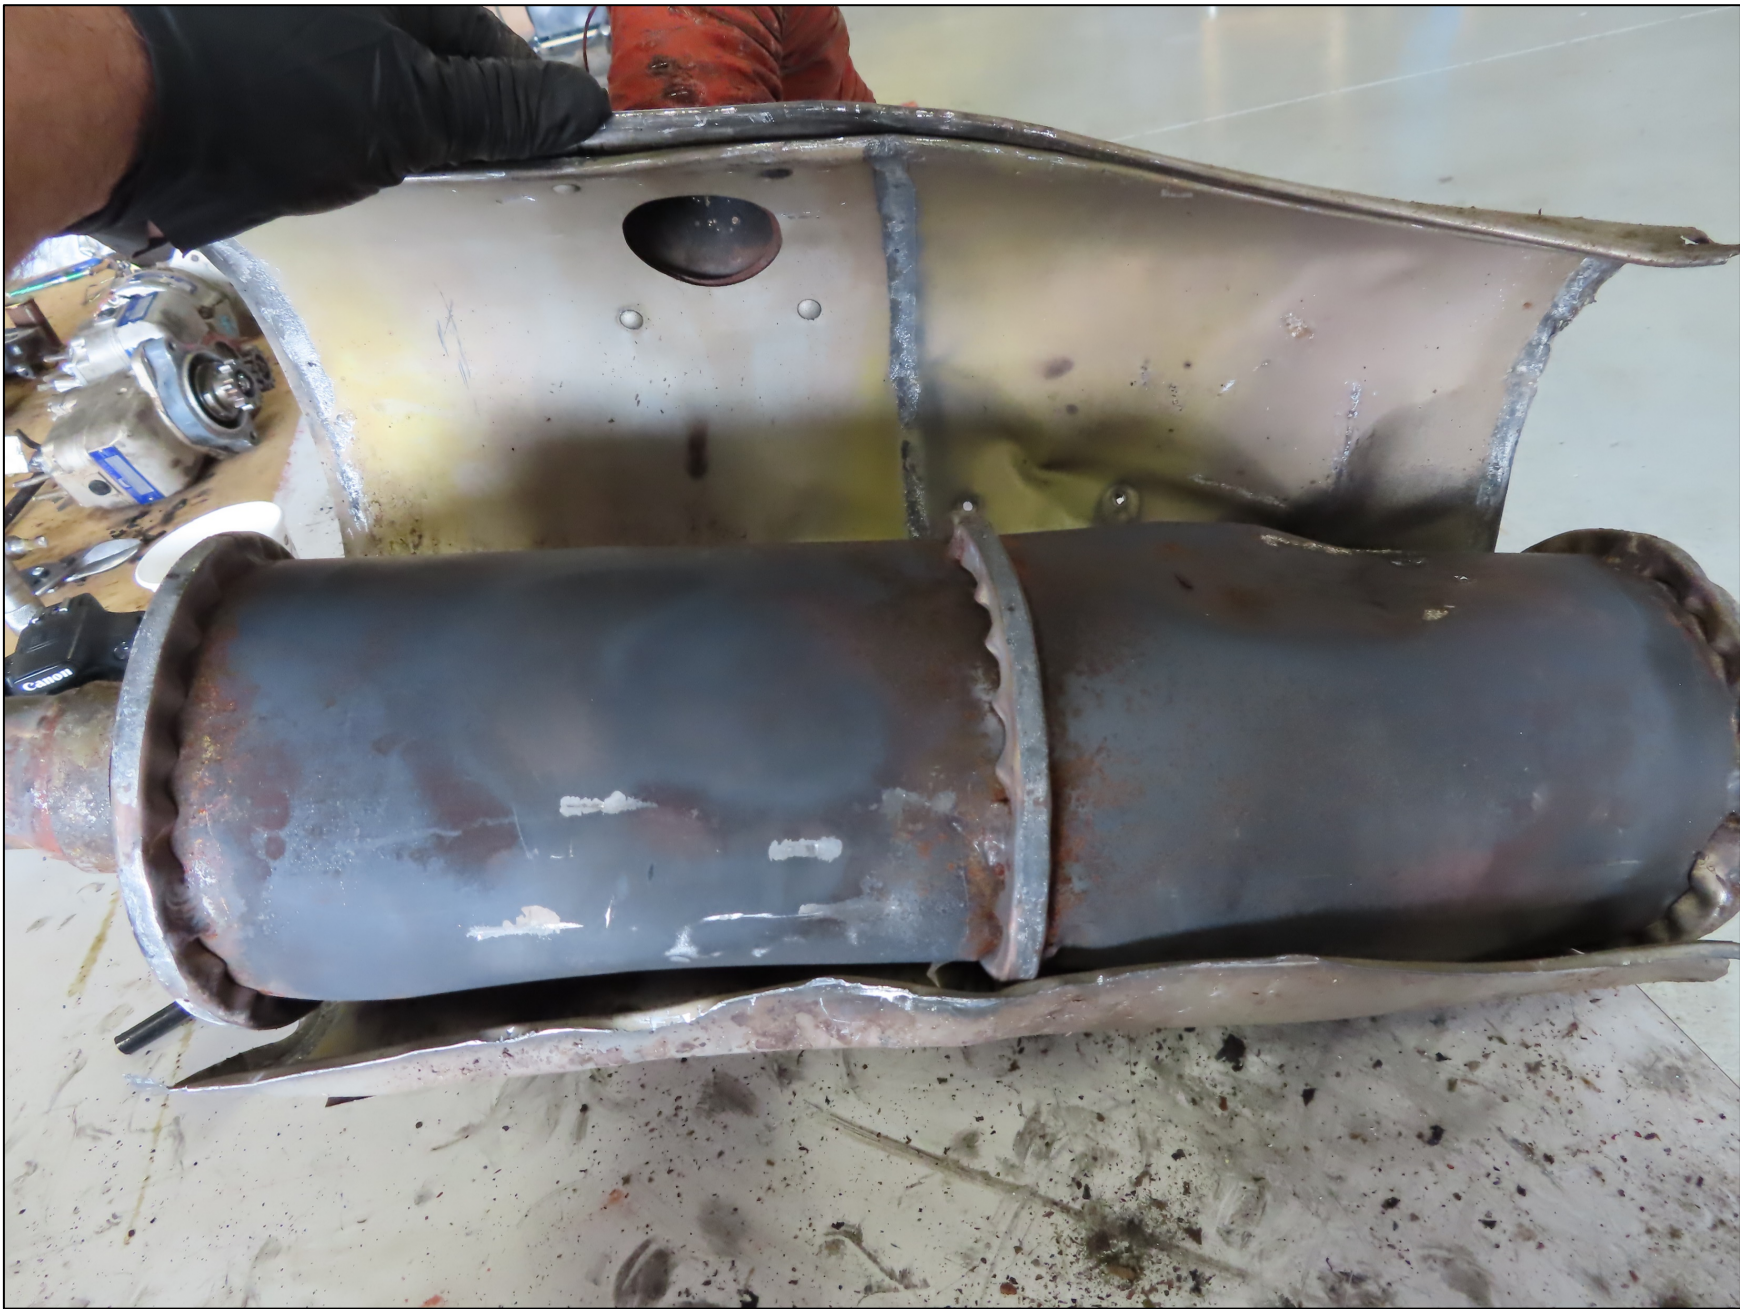
Photo 14 – View of the exhaust partially disassembled postaccident

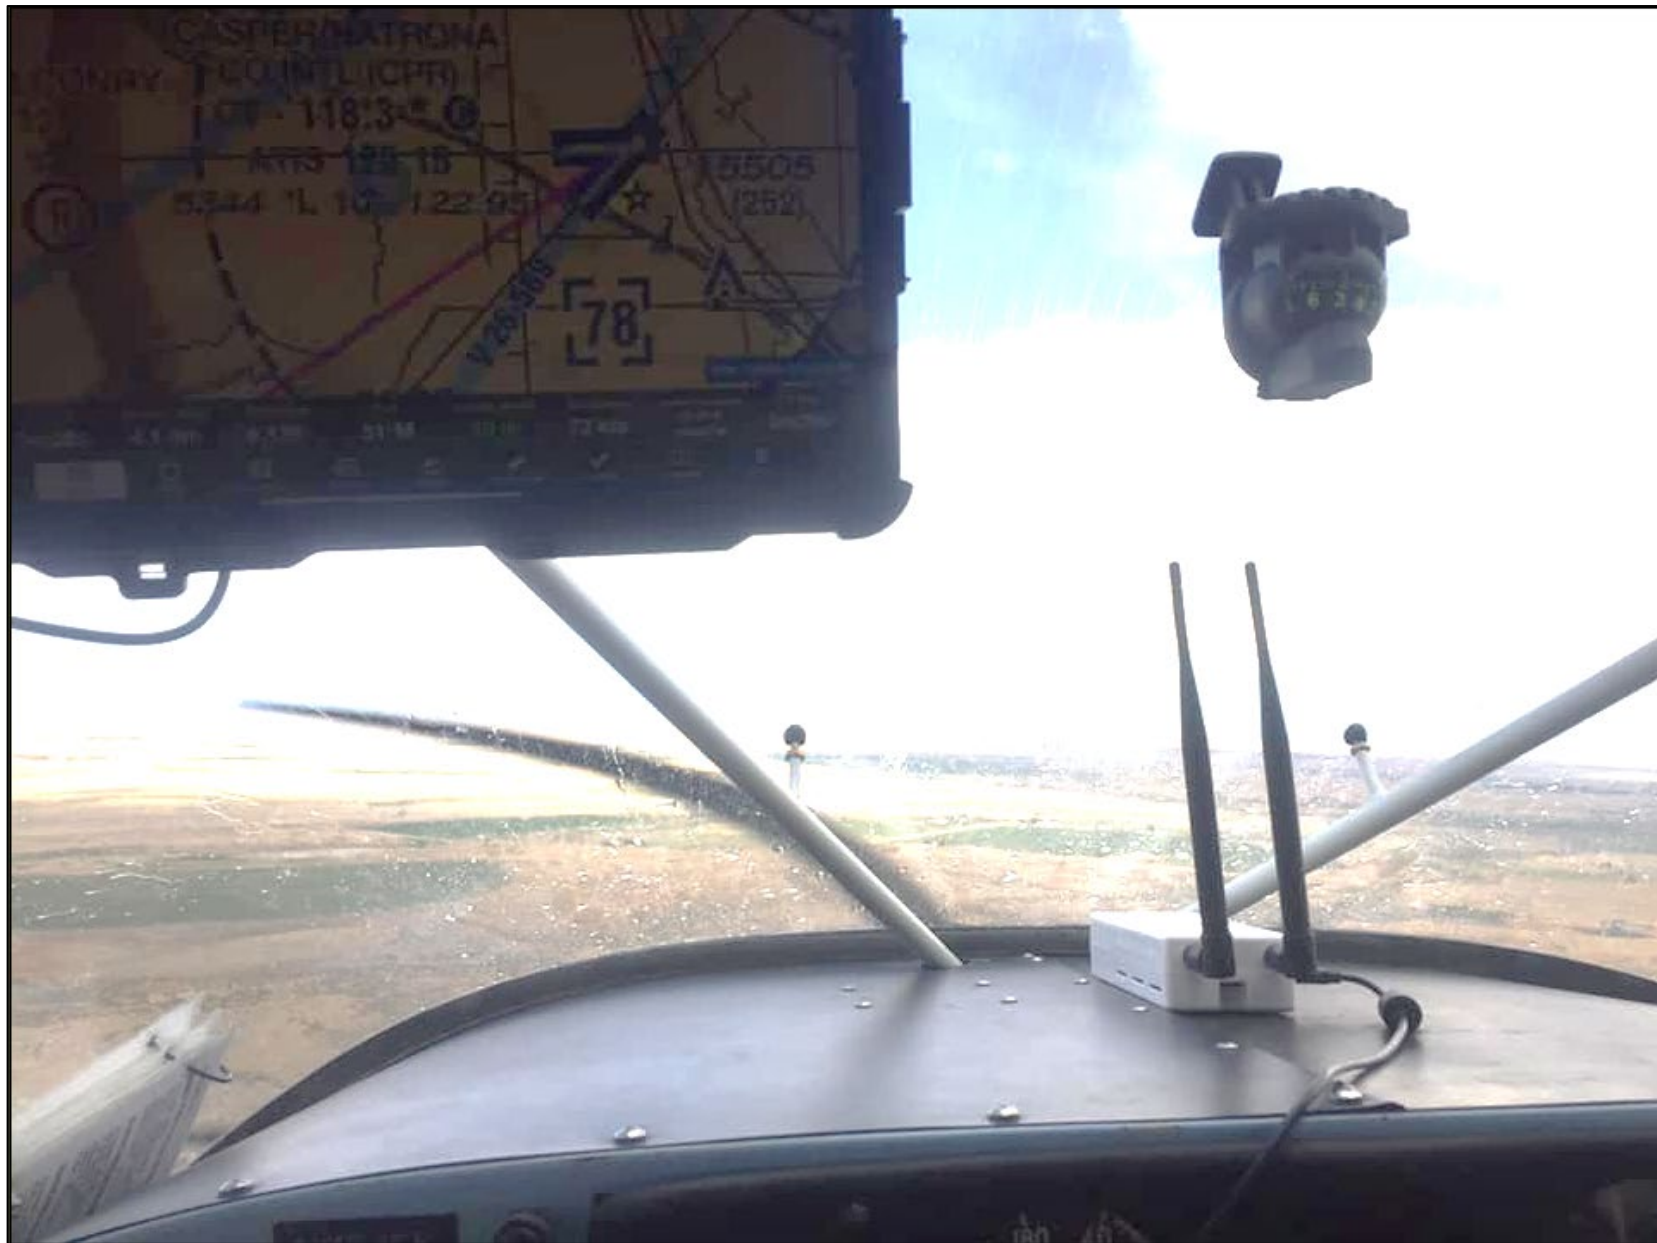
Photo 15 – Social media posted picture taken by the pilot preaccident showing the pilot's iPad and ADS-B equipment (facebook.com) *NOTE: this picture was not taken during the accident flight.*

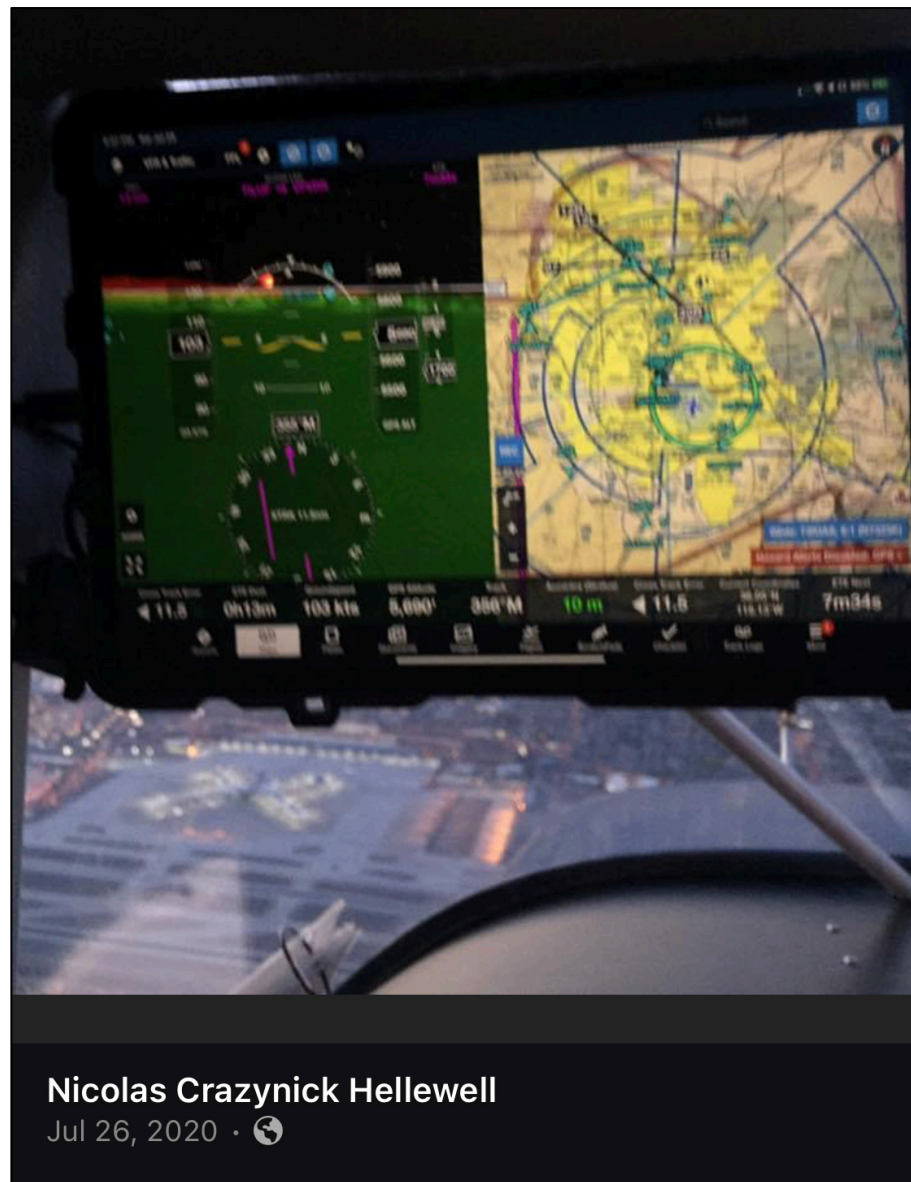
Photo 16 – Social media picture posted by the pilot preaccident showing the pilot's use of the iPad, ForeFlight, and the attitude indicator/ synthetic vision feature (facebook.com). *NOTE: this picture was not taken during the accident flight.*

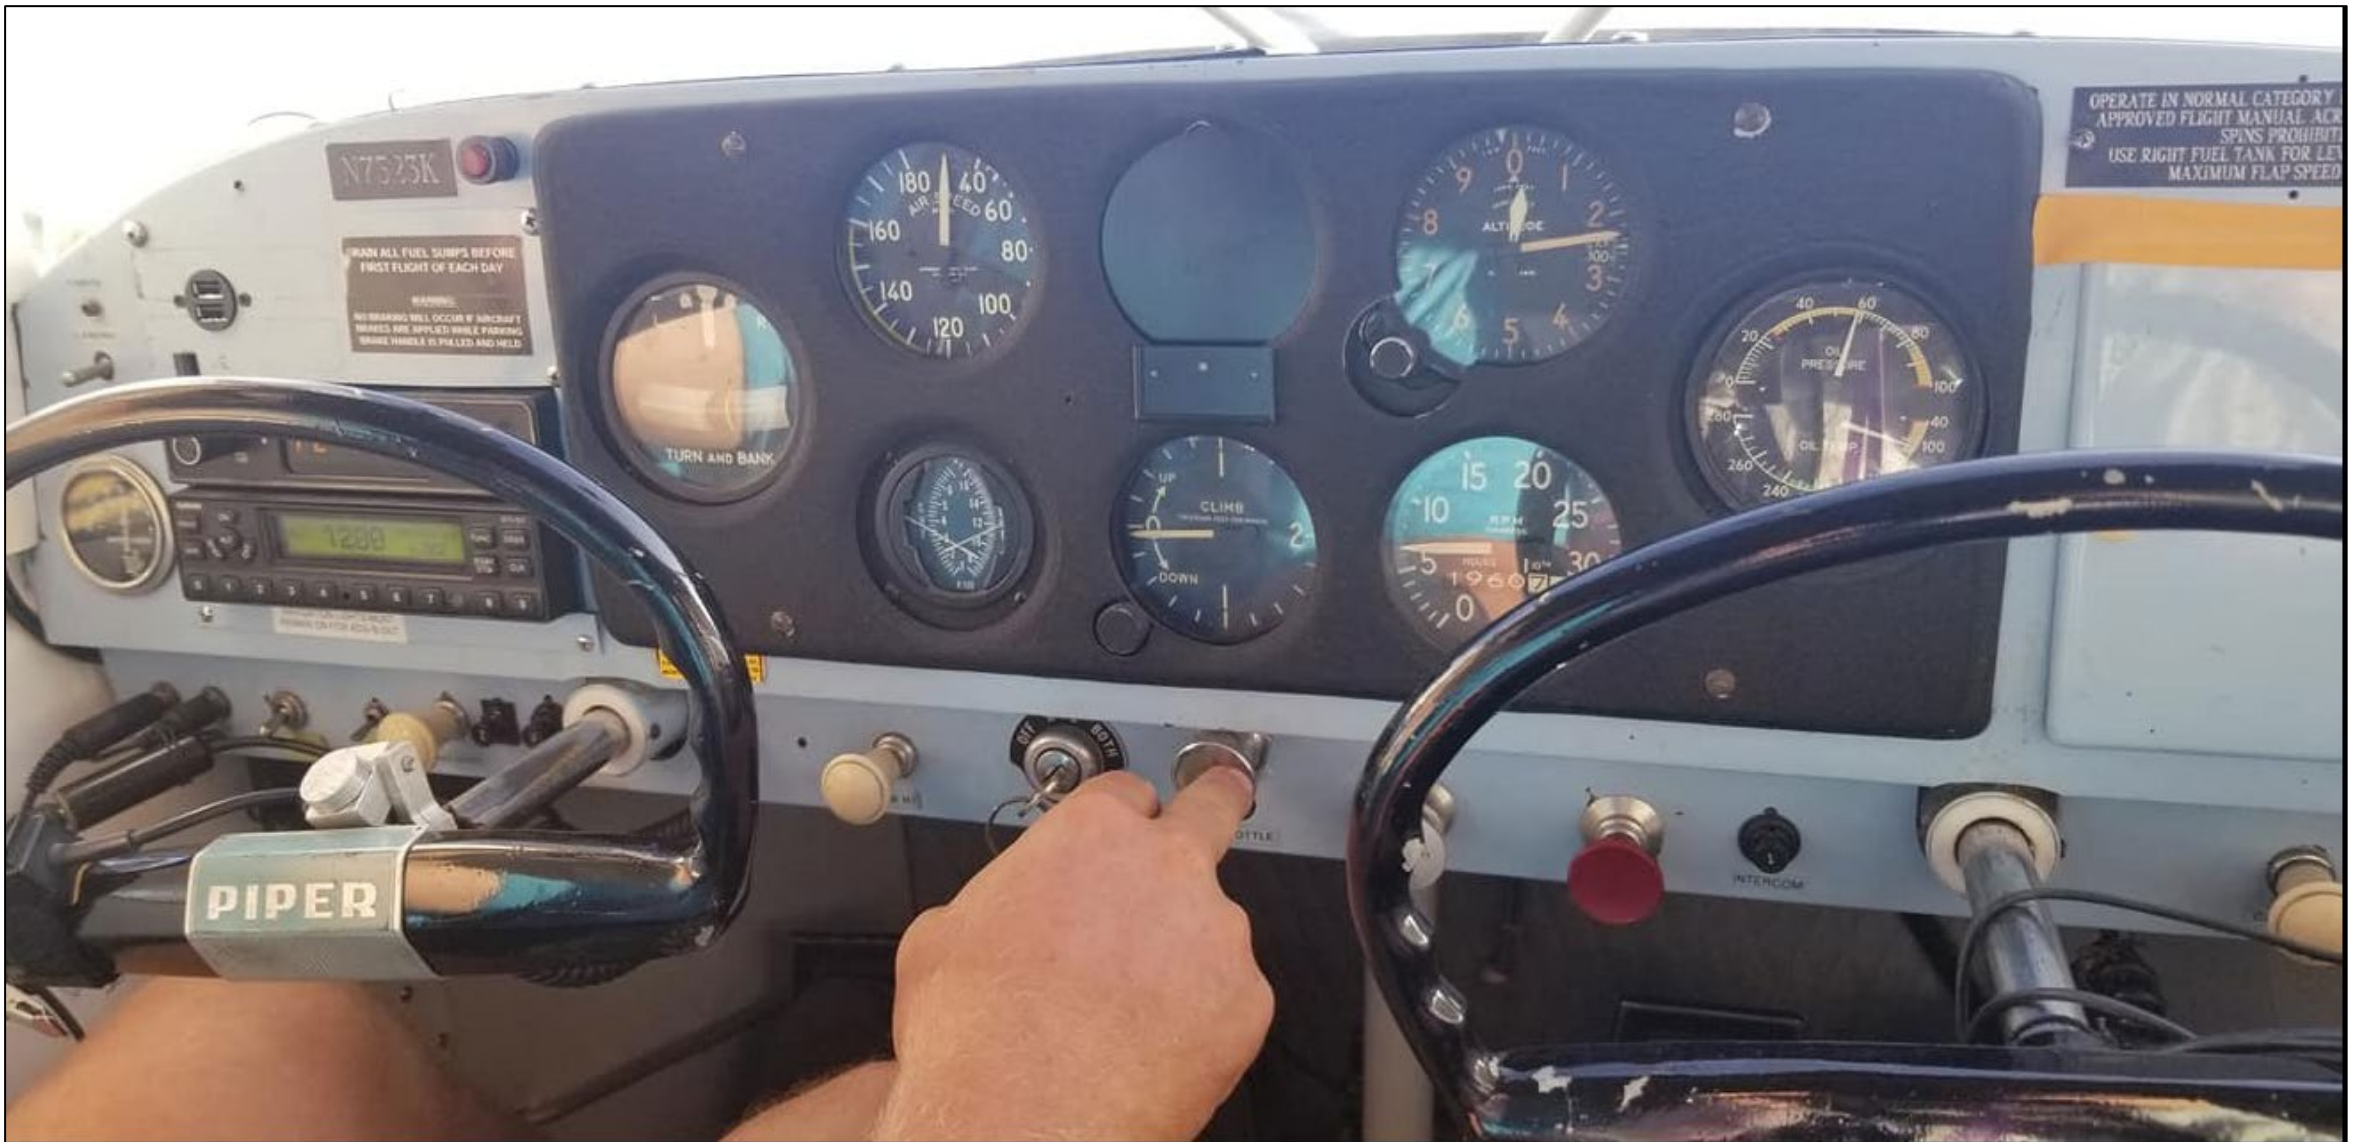
Photo 17 – Social media picture posted by the pilot preaccident showing the accident airplane's instrument panel (facebook.com). *NOTE: this picture was not taken during the accident flight.*

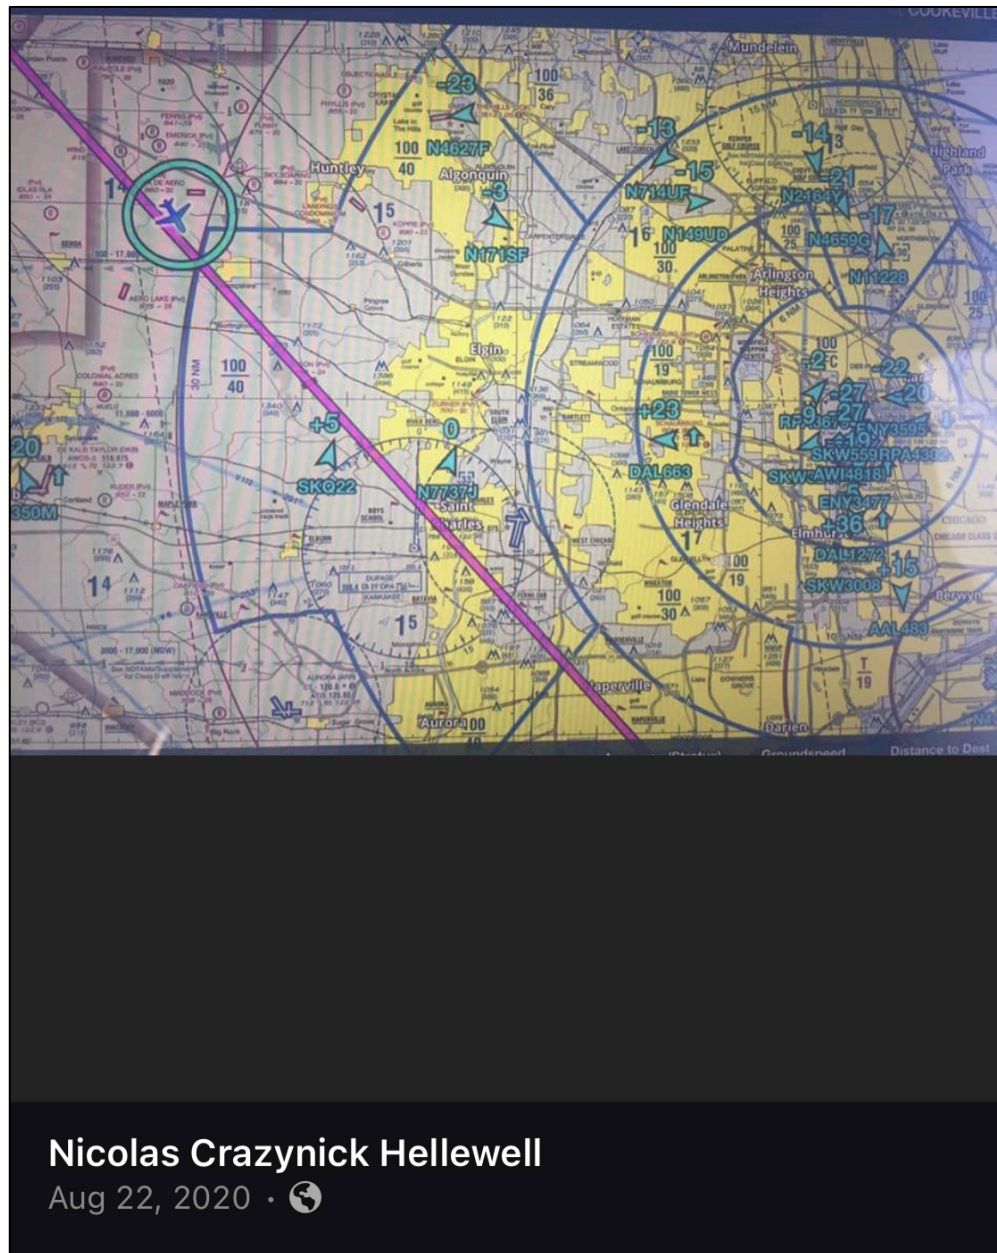
Photo 18 – Social media picture posted by the pilot preaccident showing the pilot's use of the iPad for navigation (facebook.com). *NOTE: this picture was not taken during the accident flight.*
