# NATIONAL TRANSPORTATION SAFETY BOARD

## MATERIALS LABORATORY FACTUAL REPORT

Report No. 21-006

Place : McMinnville, TN  
Date : September 8, 2020  
Vehicle : Piper PA28-181, N4166Z  
NTSB No. : ERA20LA309  
Investigator : Robert Gretz (AS-ERA)

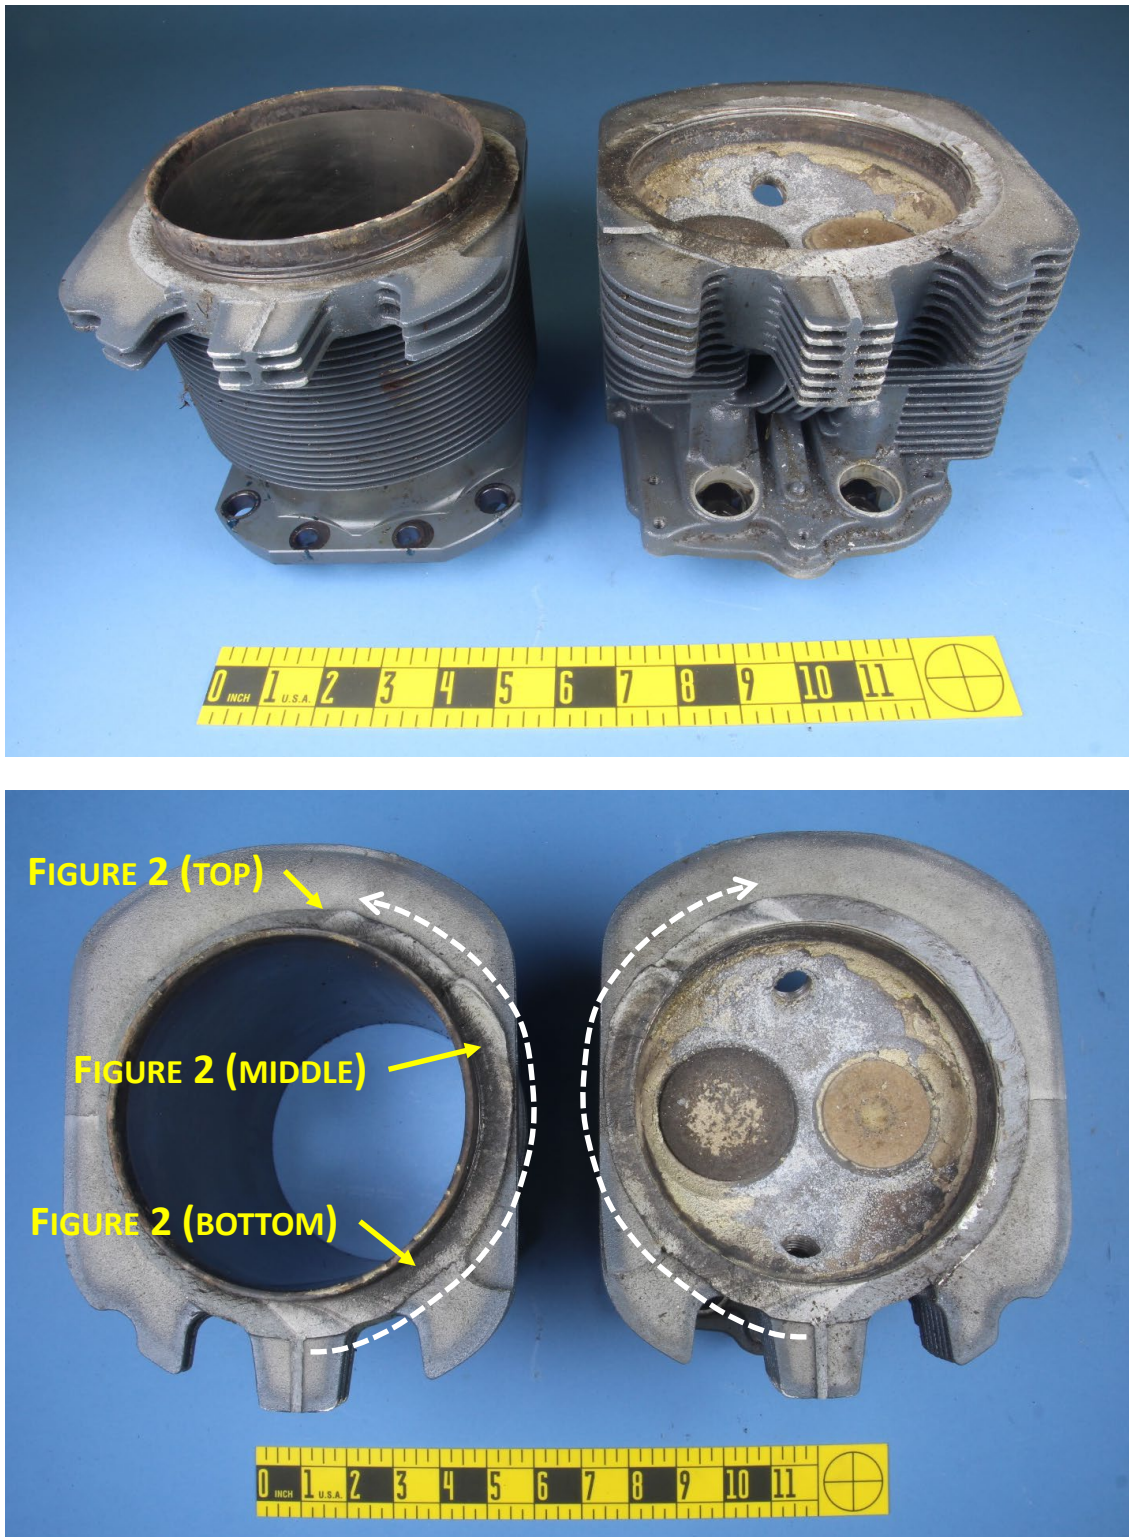
The no. 4 cylinder was submitted separated into 2 pieces, as shown in Figure 1. The separation occurred between the 3<sup>rd</sup> and 4<sup>th</sup> cooling fins. The following part markings were observed on the external surfaces of the cylinder:

A flat fracture with thumbnail-shaped arrest marks consistent with fatigue cracking, visible in Figure 2, was observed around approximately 180 degrees of the cylinder circumference (white dashed line, Figure 1). The fatigue cracking emanated from the vertical stiffener on the front of the cylinder between the 3<sup>rd</sup> and 4<sup>th</sup> fins (Figures 3 and 4). The fatigue cracking appeared to initiate at the start of the fillet between the vertical stiffener and the circumferential outer wall of the cylinder (yellow arrow, Figure 5). The remainder of the fracture surface was consistent with overstress.

Figure 1: Overall photos of the separated no. 4 cylinder. The white dashed lines indicate the fatigue cracking on the fracture surface. The indicated areas on the bottom half fracture surface are shown in more detail in Figure 2.

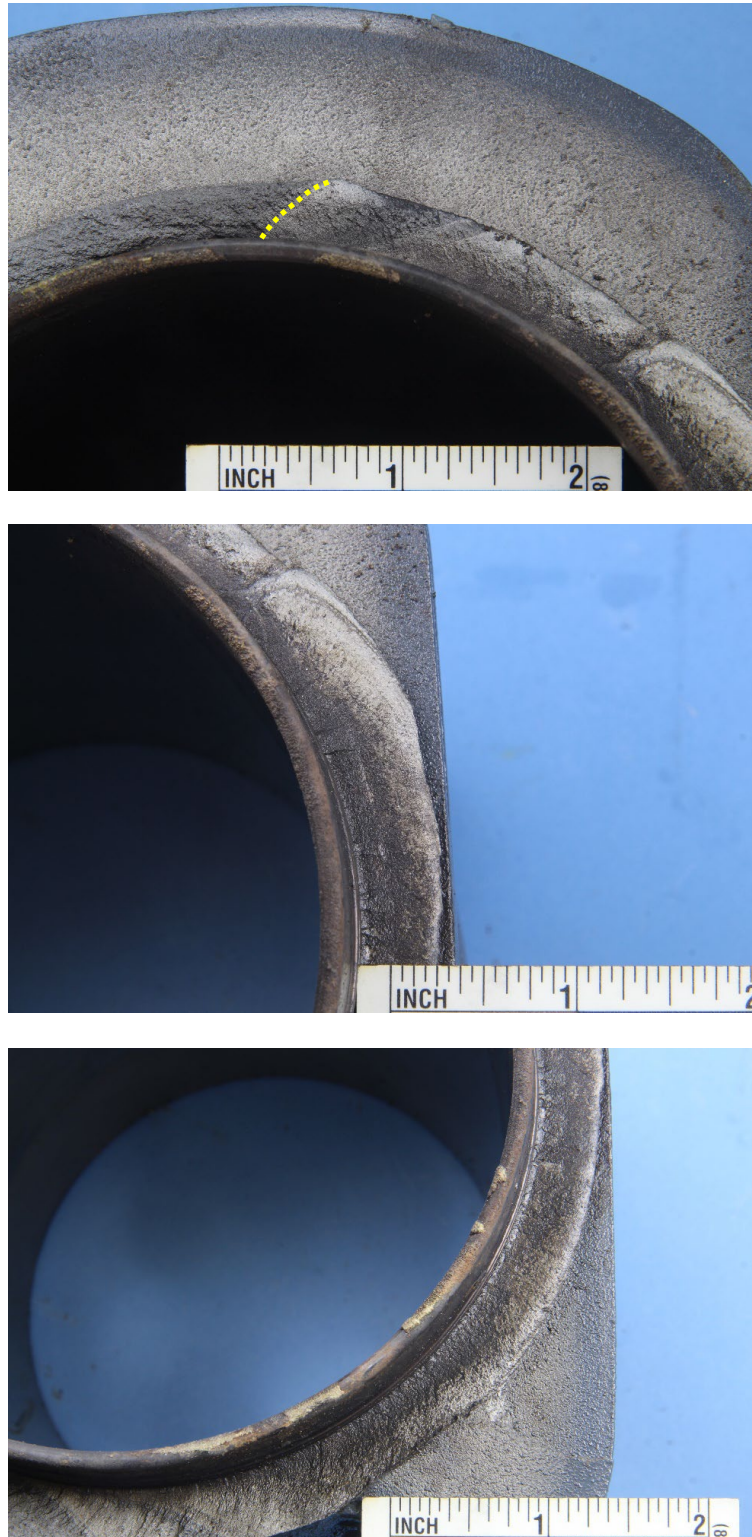
Figure 2: Close-up photos of the fatigue cracking on the fracture surface on the bottom half of the cylinder. The yellow dotted line in the top image indicates the interface where fatigue cracking ended, and overstress began.

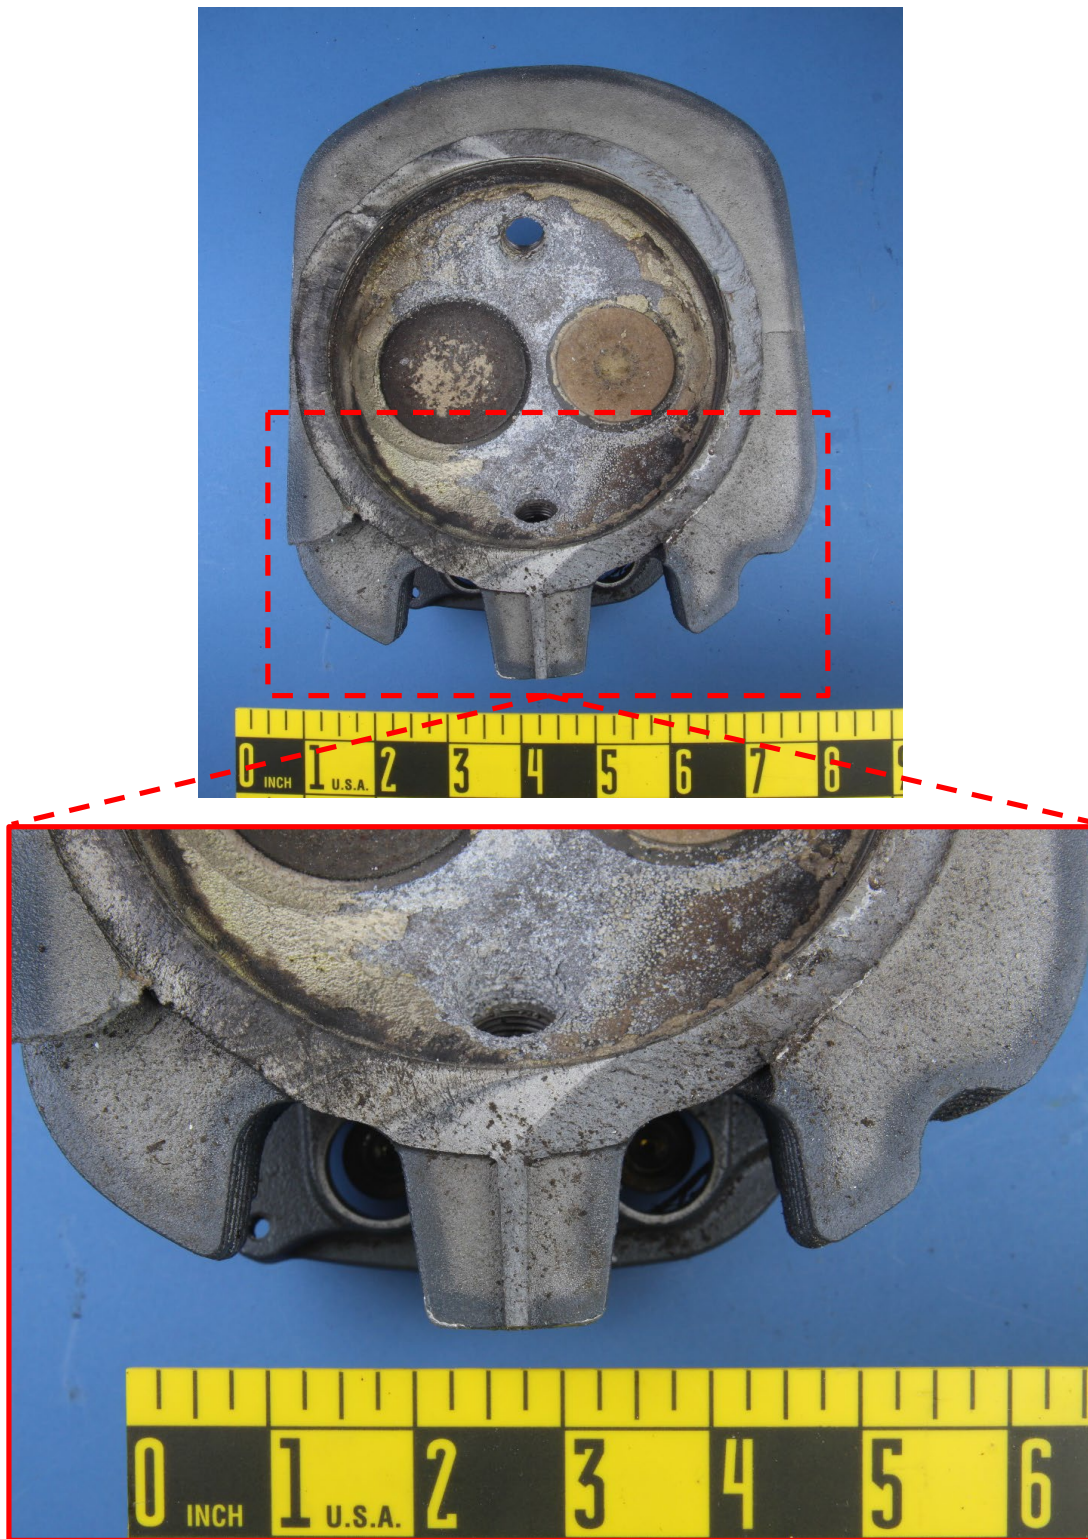
Figure 3: Overall and close-up photos of the fracture surface on the top half of the separated cylinder.

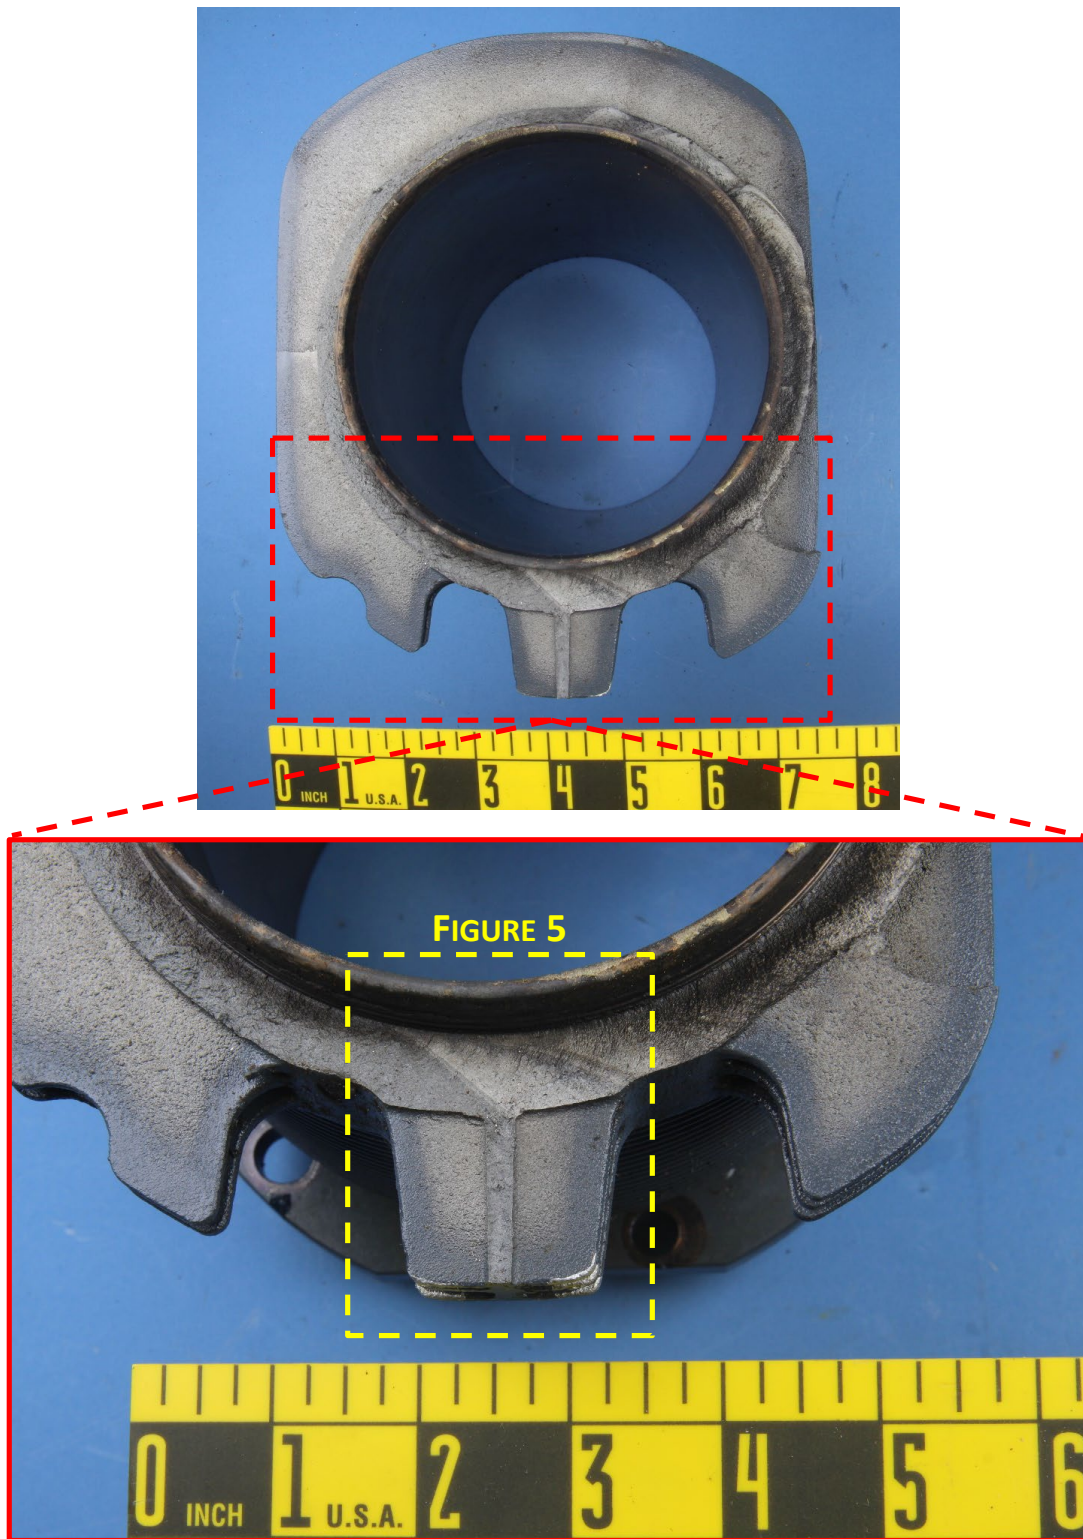
Figure 4: Overall and close-up photos of the fracture surface on the bottom half of the separated cylinder. The indicated area is shown in more detail in Figure 5.

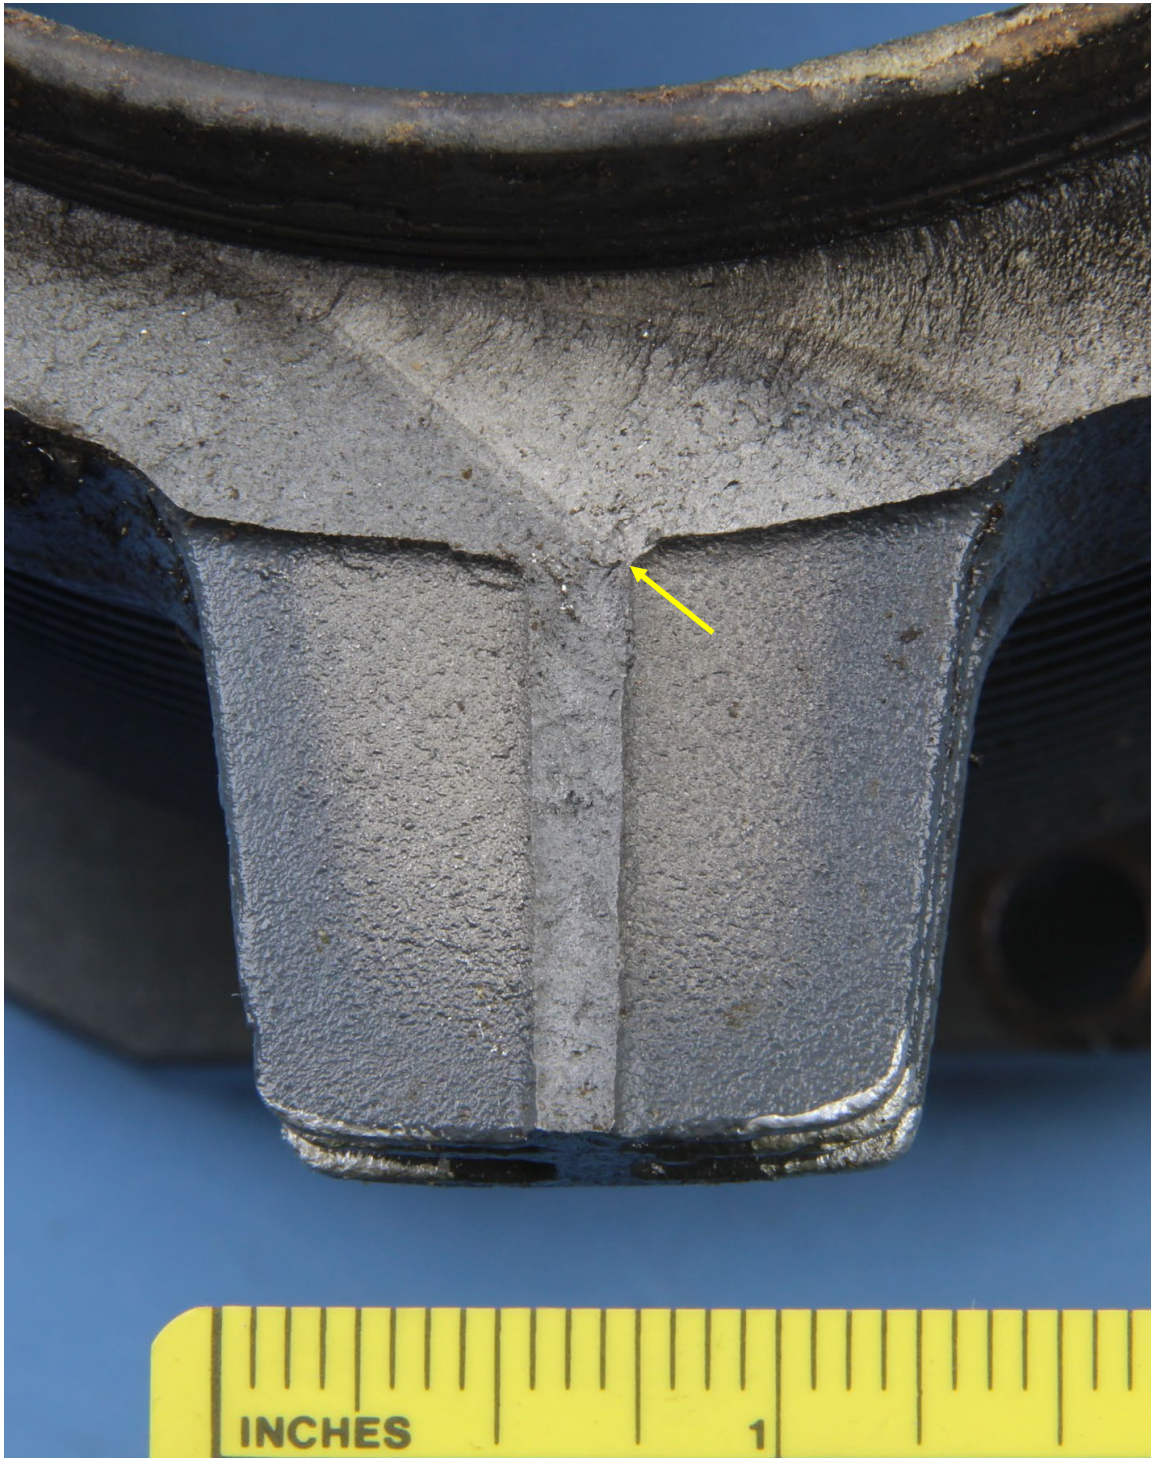
Figure 5: Close-up photo of the fracture surface on the bottom half of the separated cylinder. The yellow arrow points to the location of fatigue cracking initiation at the start of the fillet between the vertical stiffener and the circumferential outer wall of the cylinder.

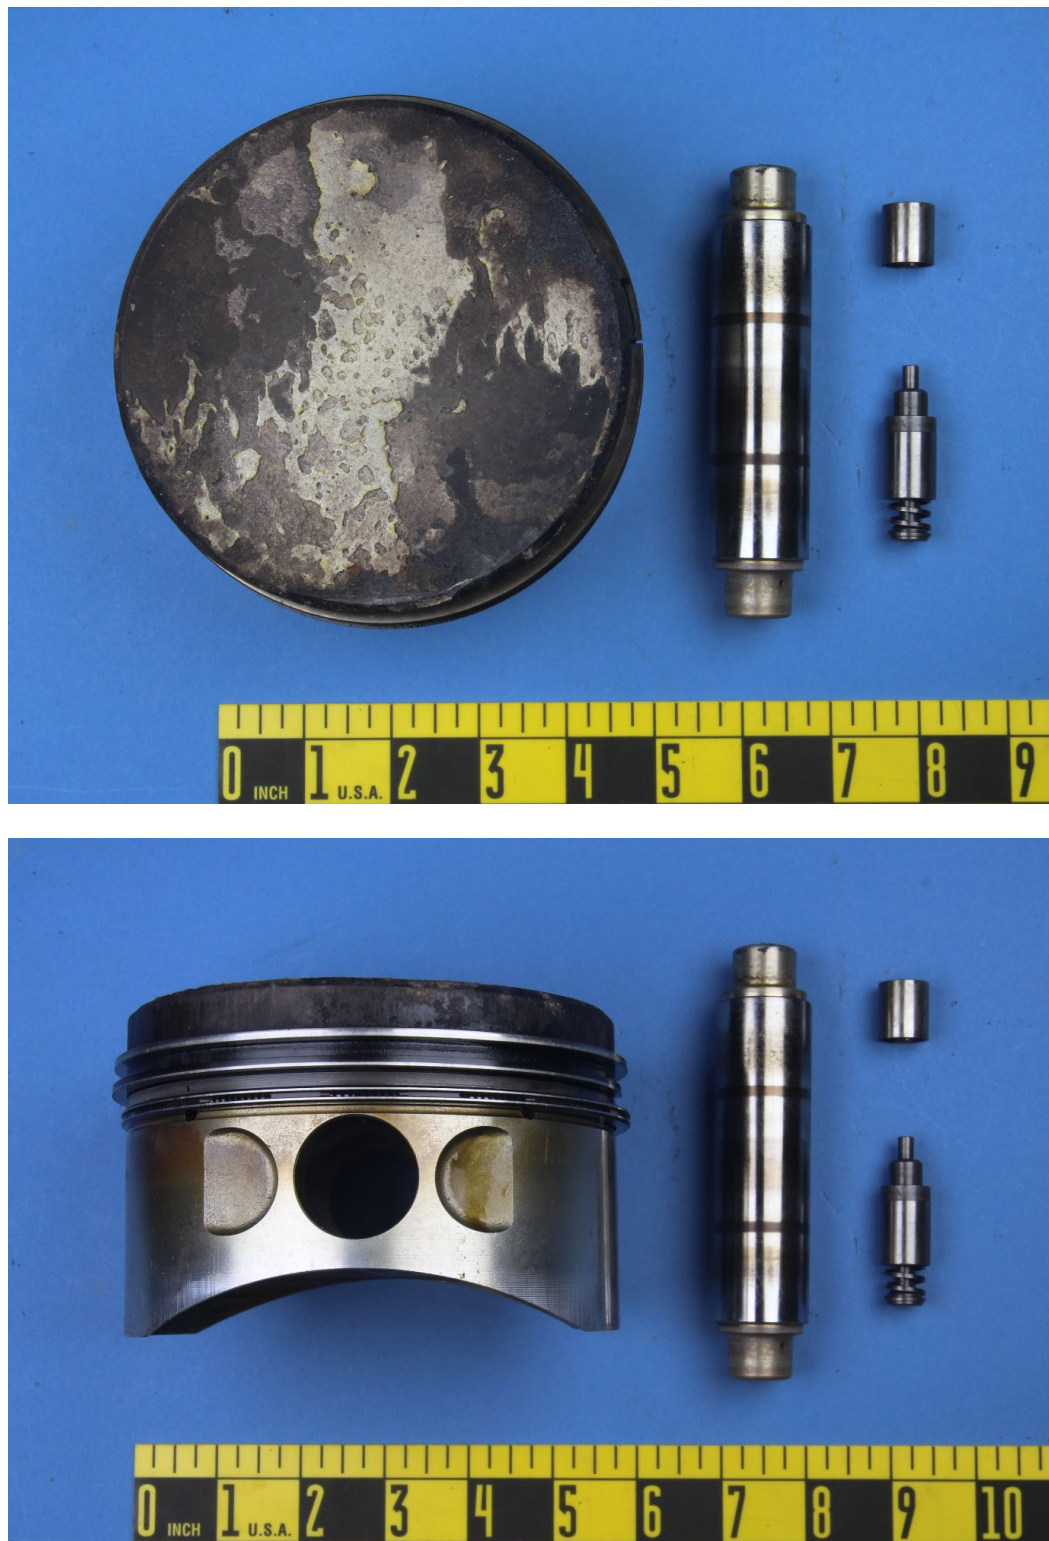
The piston head and piston pin were also submitted, as shown in Figure 6. Dark colored carbon deposits consistent with combustion byproduct were observed on the flat top of the piston head. A light tan color was observed on the piston skirt consistent with staining from oxidized engine oil. Light wear marks were observed around the circumference of the piston pin from where it mated to the piston head.

Figure 6: Overall photos of the piston head and piston pin.
