## **MEMORANDUM FOR RECORD**

Investigative Photographs  
ERA20LA313

**Peter Wentz**  
**Air Safety Investigator**  
**Eastern Region Aviation**

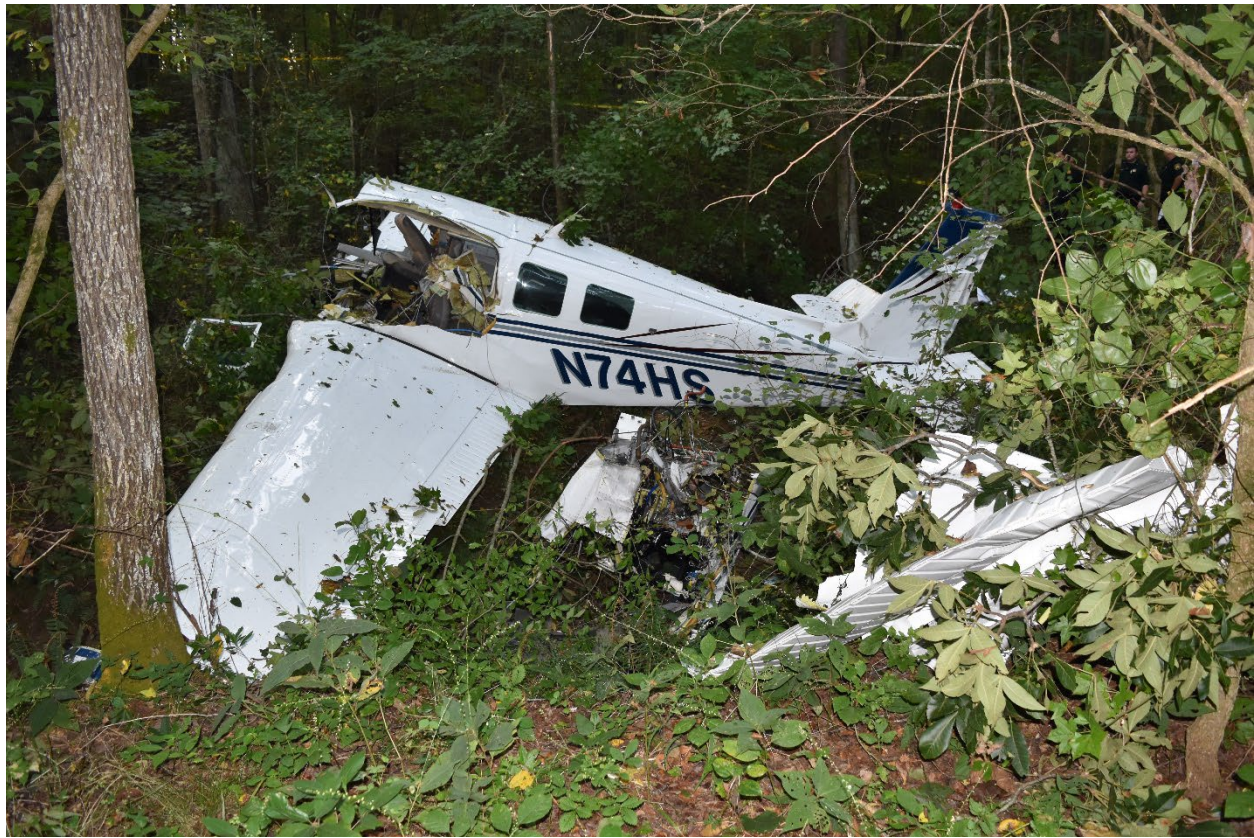
**Photograph 1 – Accident Site – Left side of airplane.**

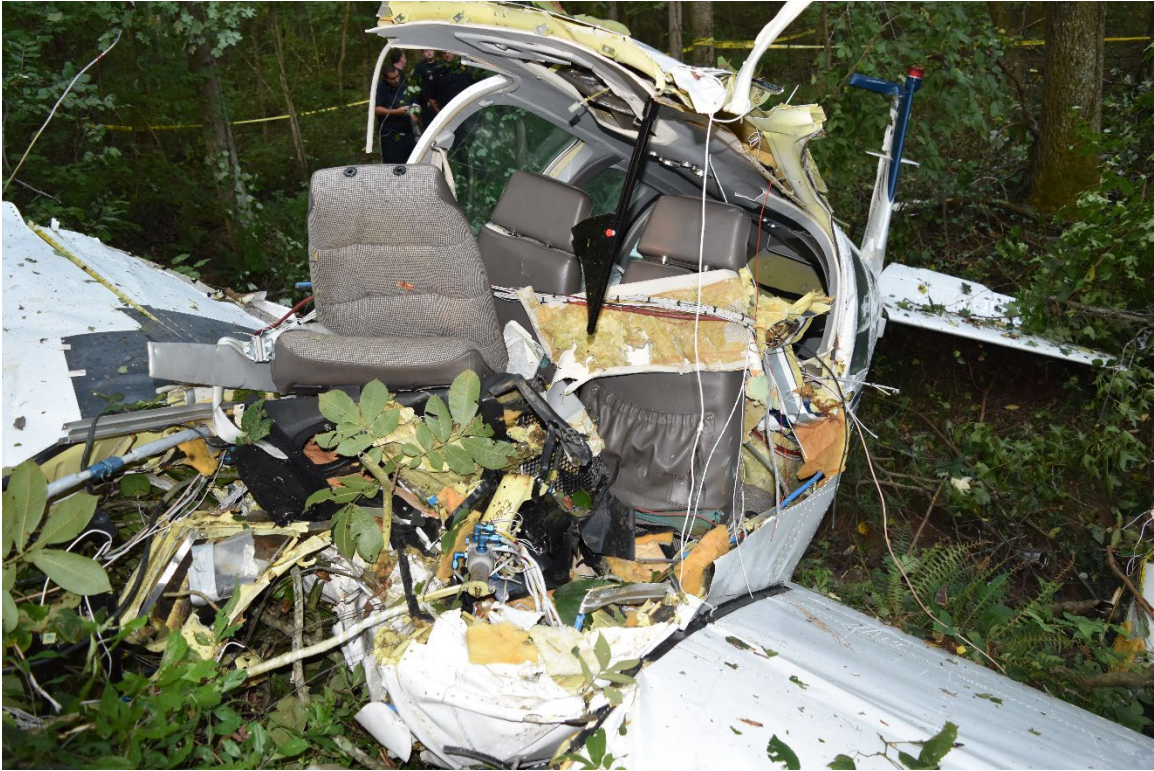
**Photograph 2 – Accident Site – Separated aft portion of fuselage.**

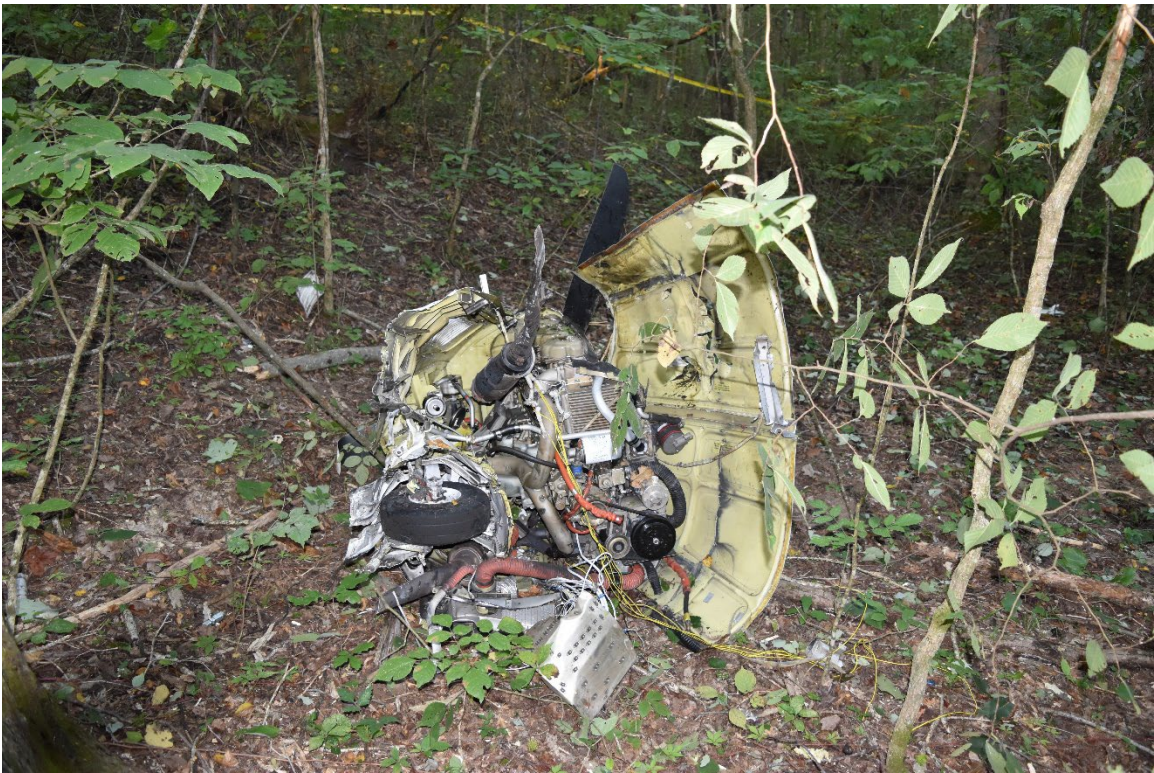
**Photograph 3 – Accident Site – Separated engine and landing gear.**

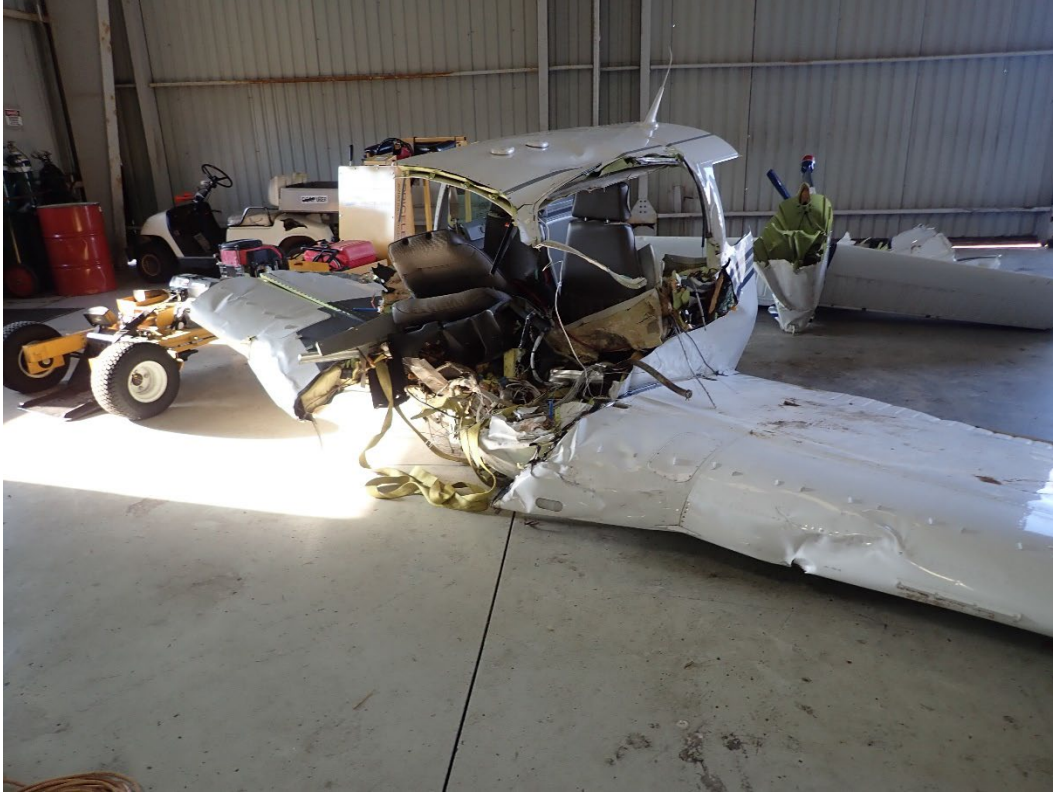
**Photograph 4 – Accident airplane – Post-examination of aft fuselage and left wing.**

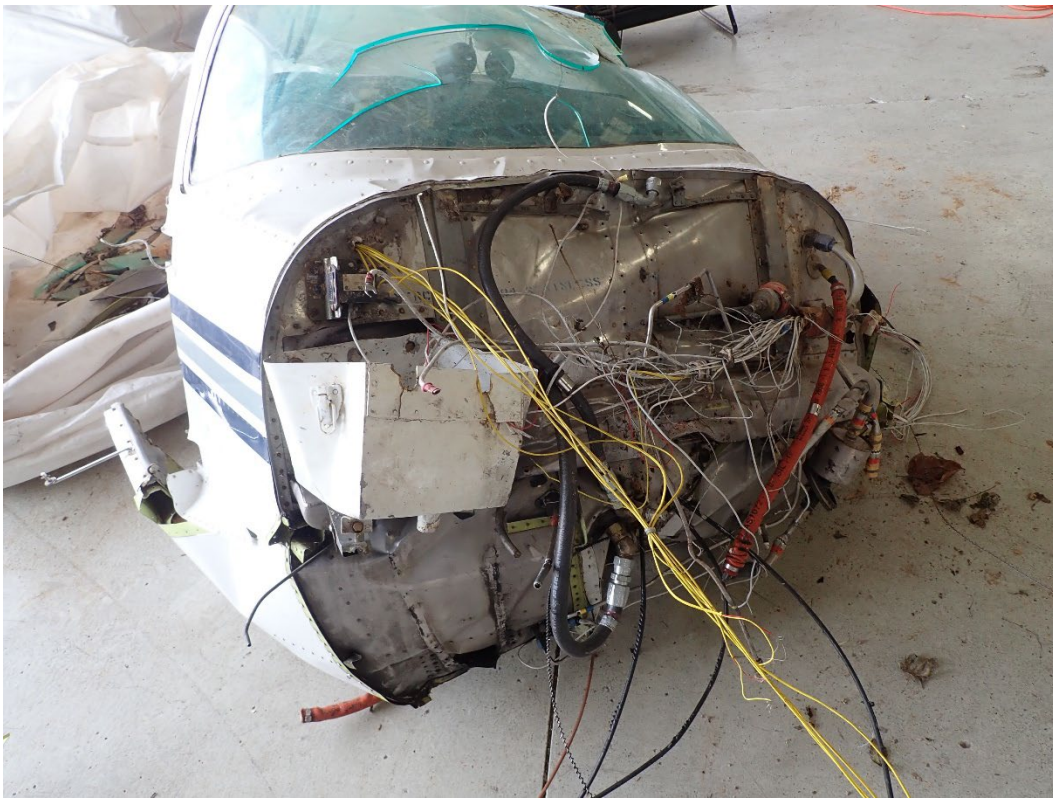
**Photograph 5 – Accident airplane – Post-examination of fuselage and firewall.**

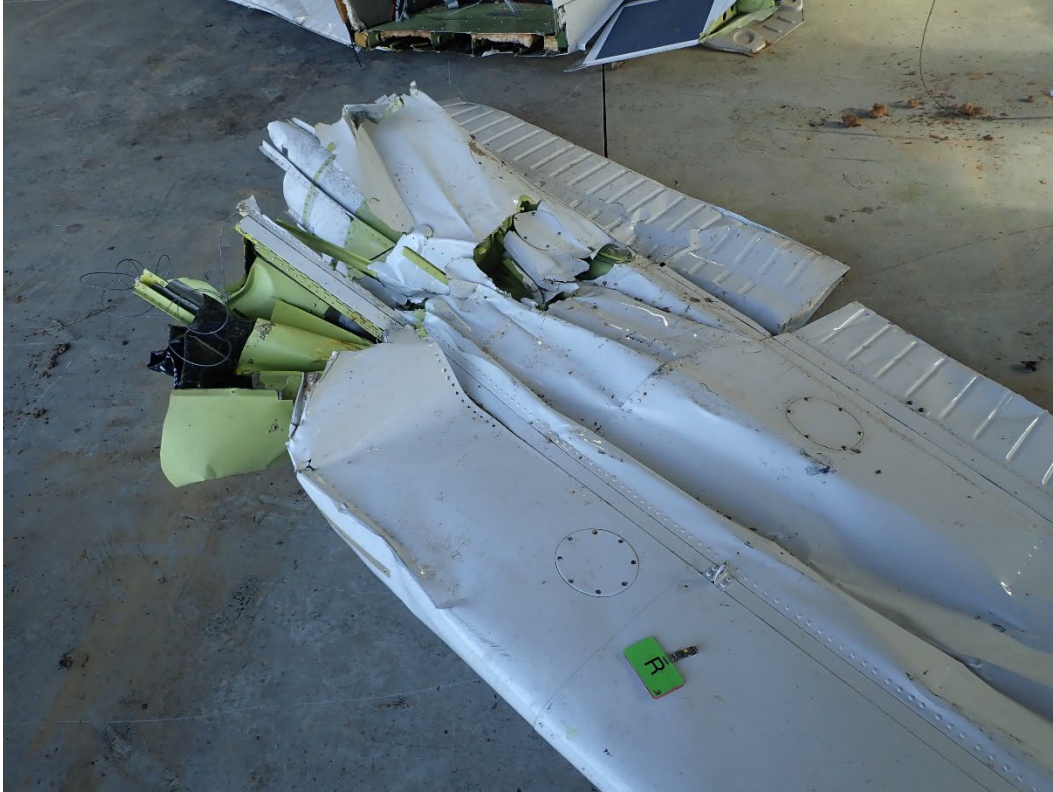
**Photograph 6 – Accident airplane – Post-examination of right wing.**

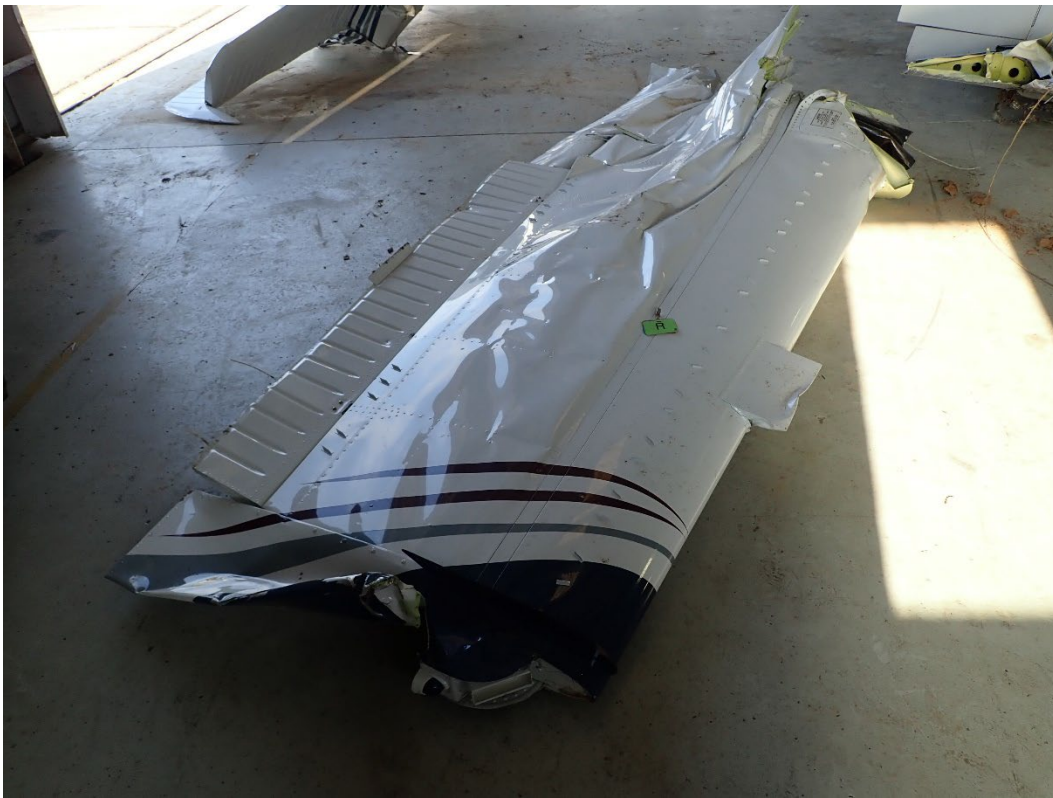
**Photograph 7 – Accident airplane – Post-examination of right wing.**

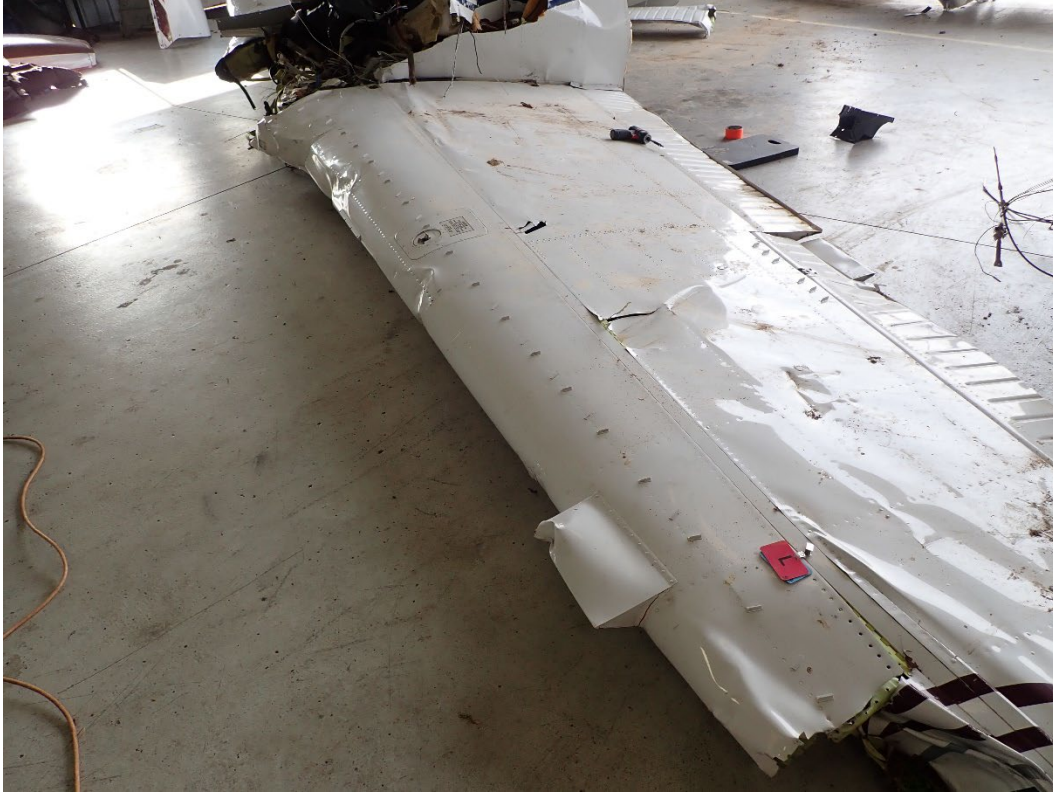
**Photograph 8 – Accident airplane – Post-examination of left wing.**

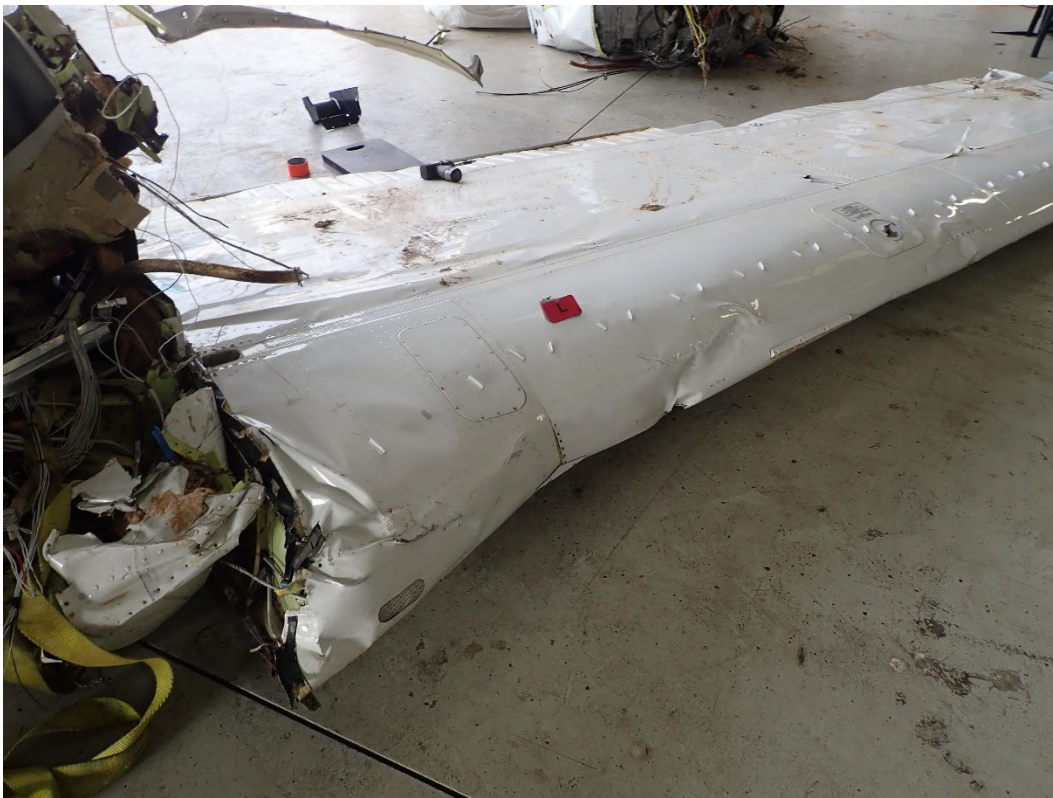
**Photograph 9 – Accident airplane – Post-examination of left wing.**

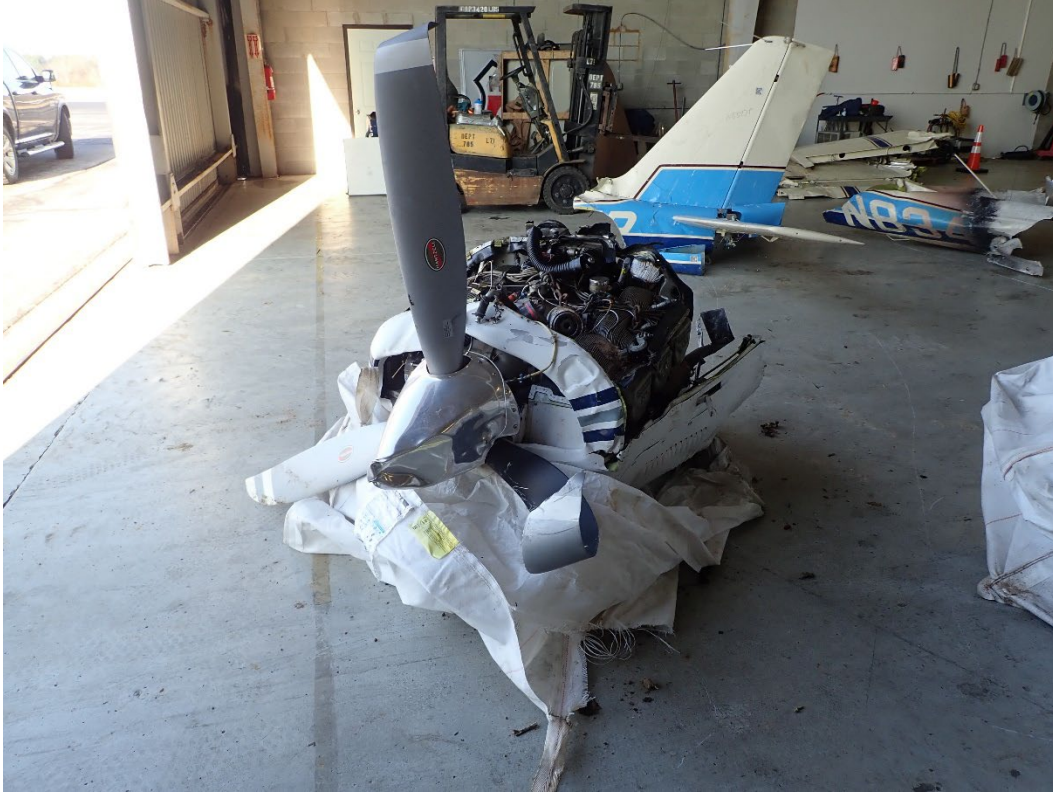
**Photograph 10 – Accident airplane – Post-examination of engine and propeller.**

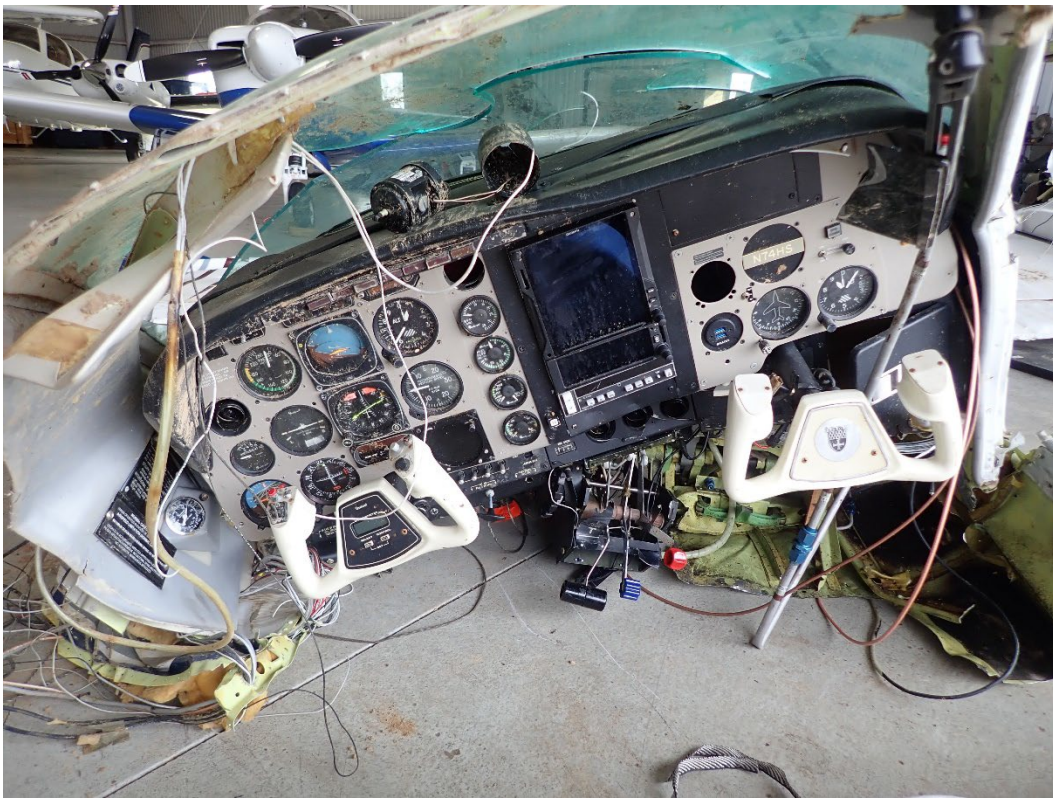
**Photograph 11 – Accident airplane – Post-examination of cockpit instrument panel.**

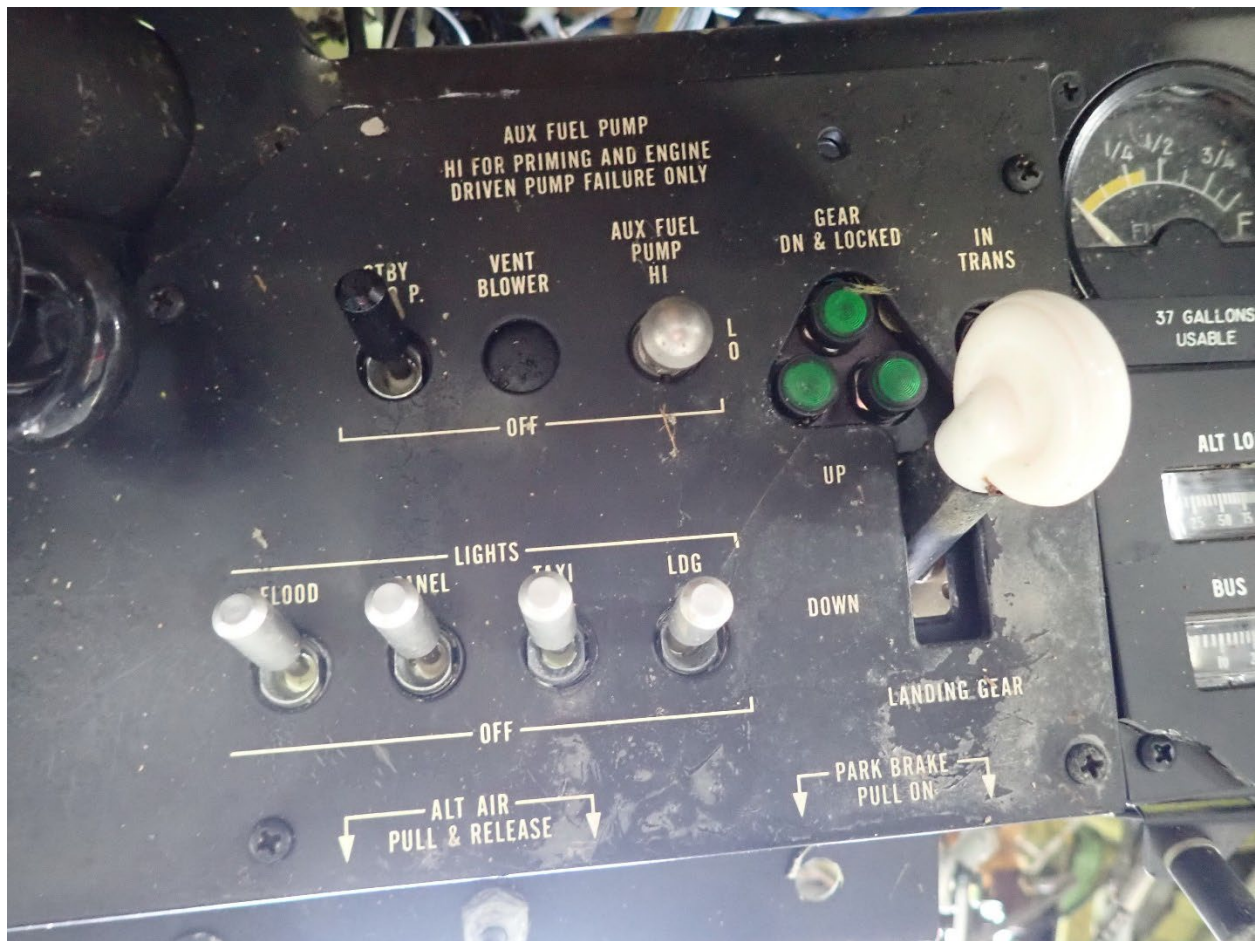
Photograph 12 – Accident airplane – Post-examination of cockpit instrument panel.
