**Photo 1 – Main Wreckage – Courtesy of FAA**

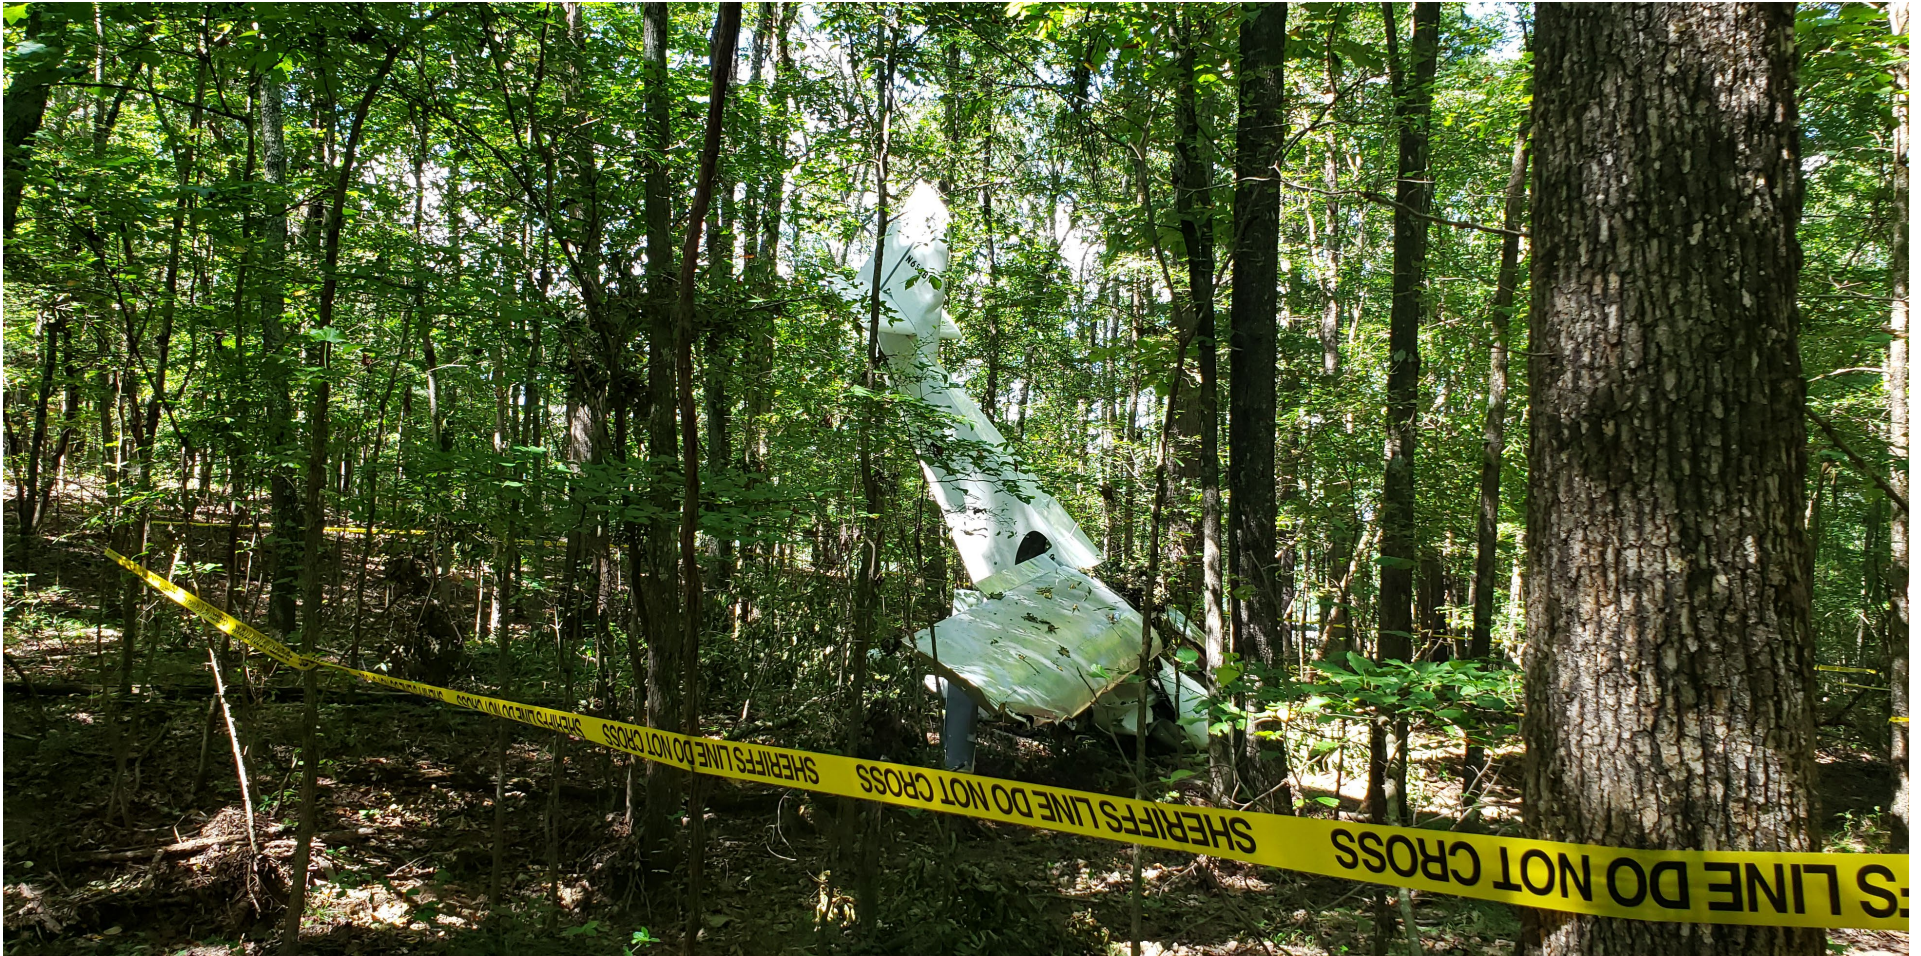
**Photo 2 – Right Side View of Main Wreckage – Courtesy of FAA**

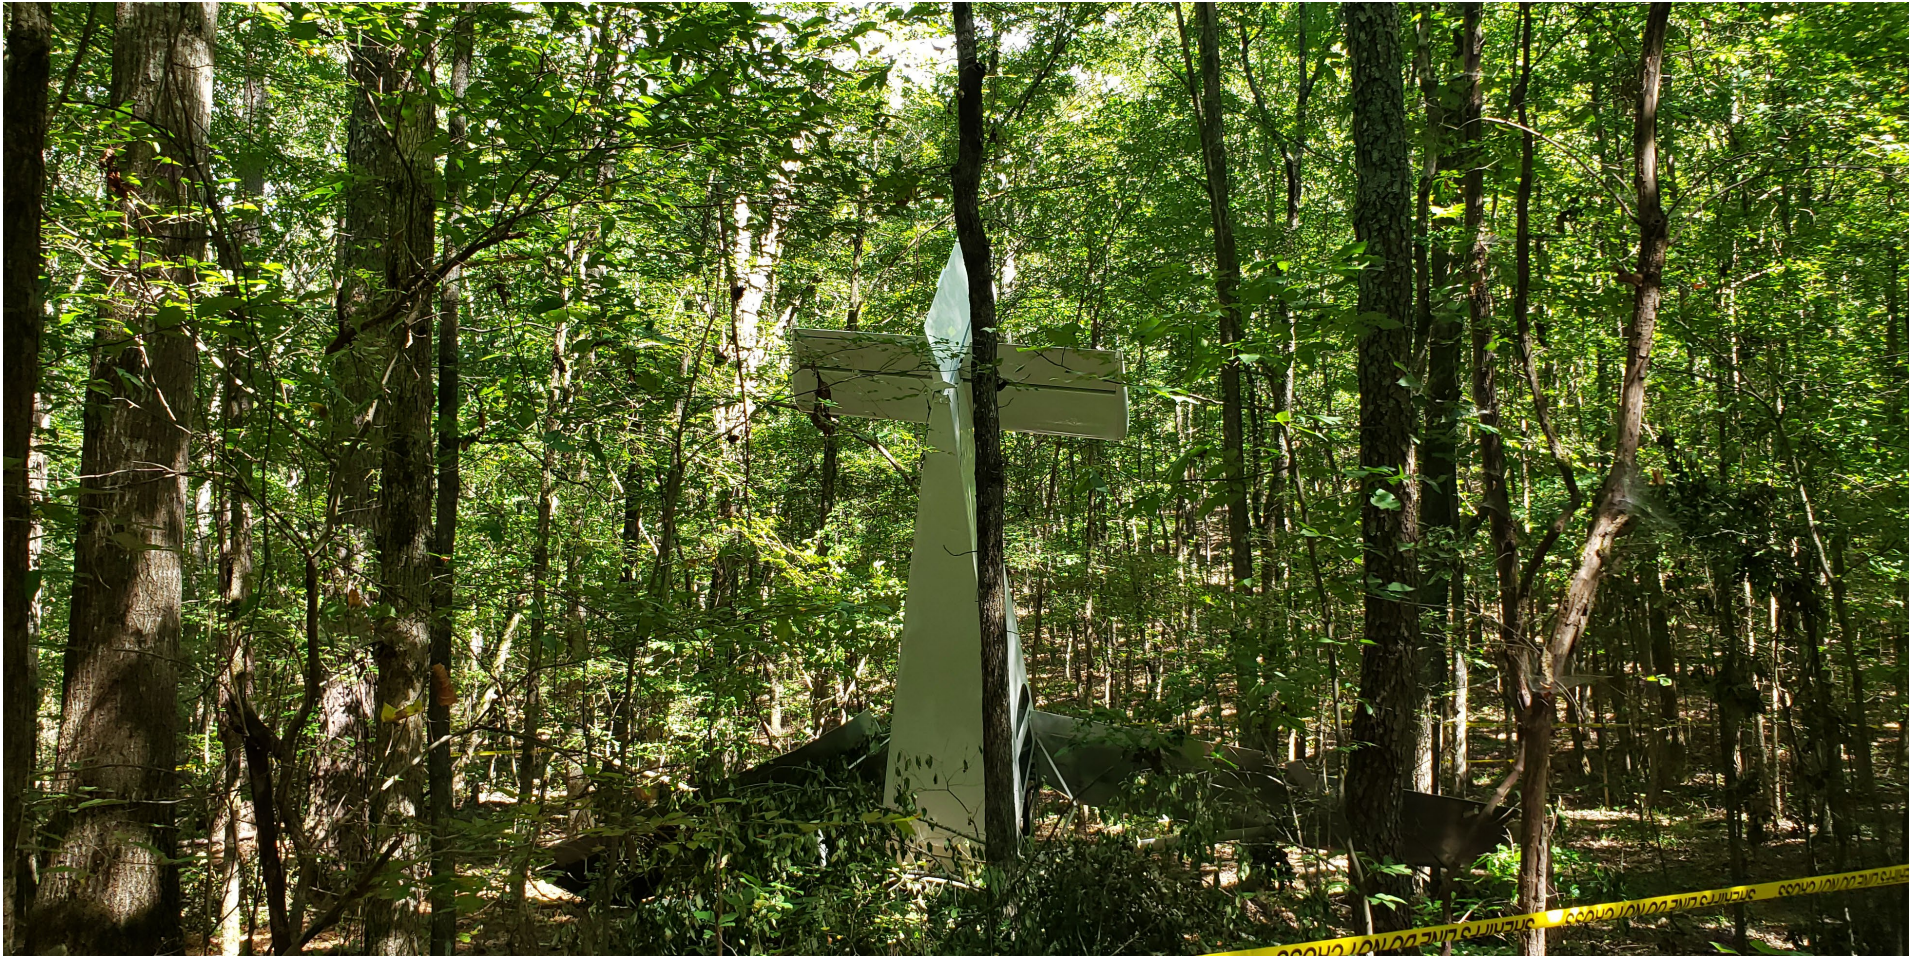
**Photo 3 – Rear Underside View of Main Wreckage – Courtesy of FAA**

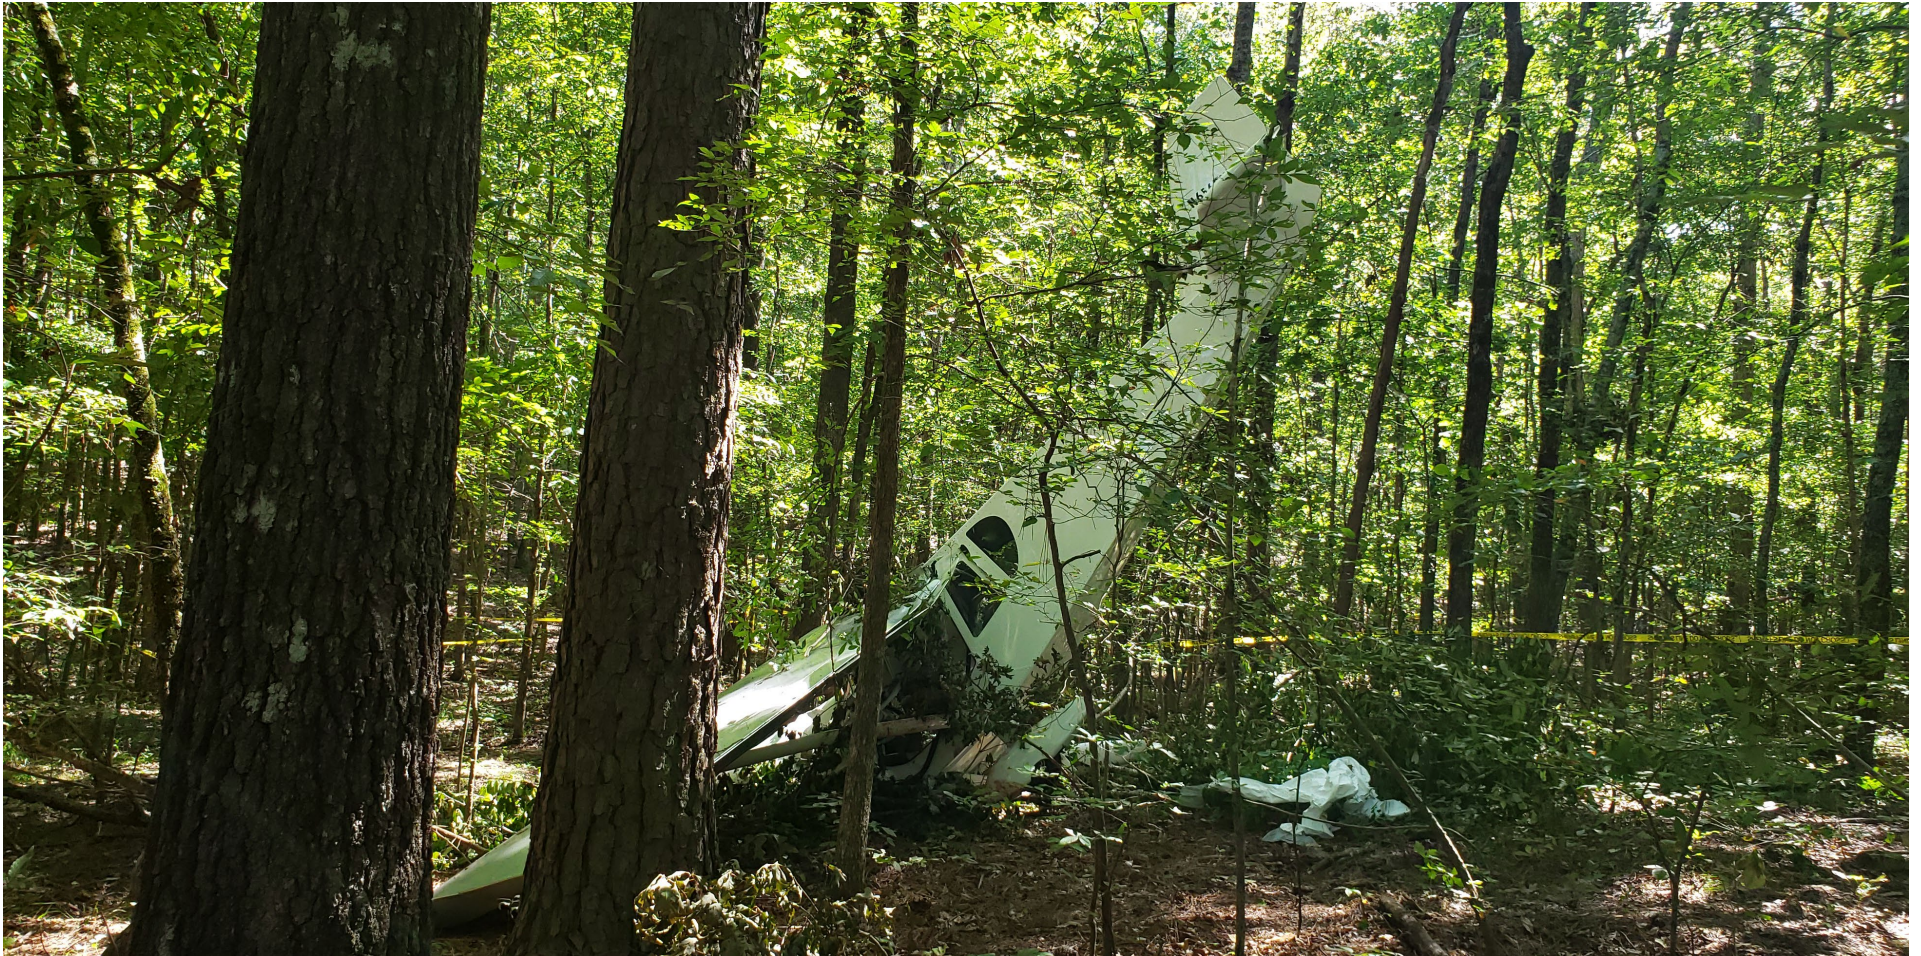
**Photo 4 – Left Side View of Main Wreckage – Courtesy of FAA**

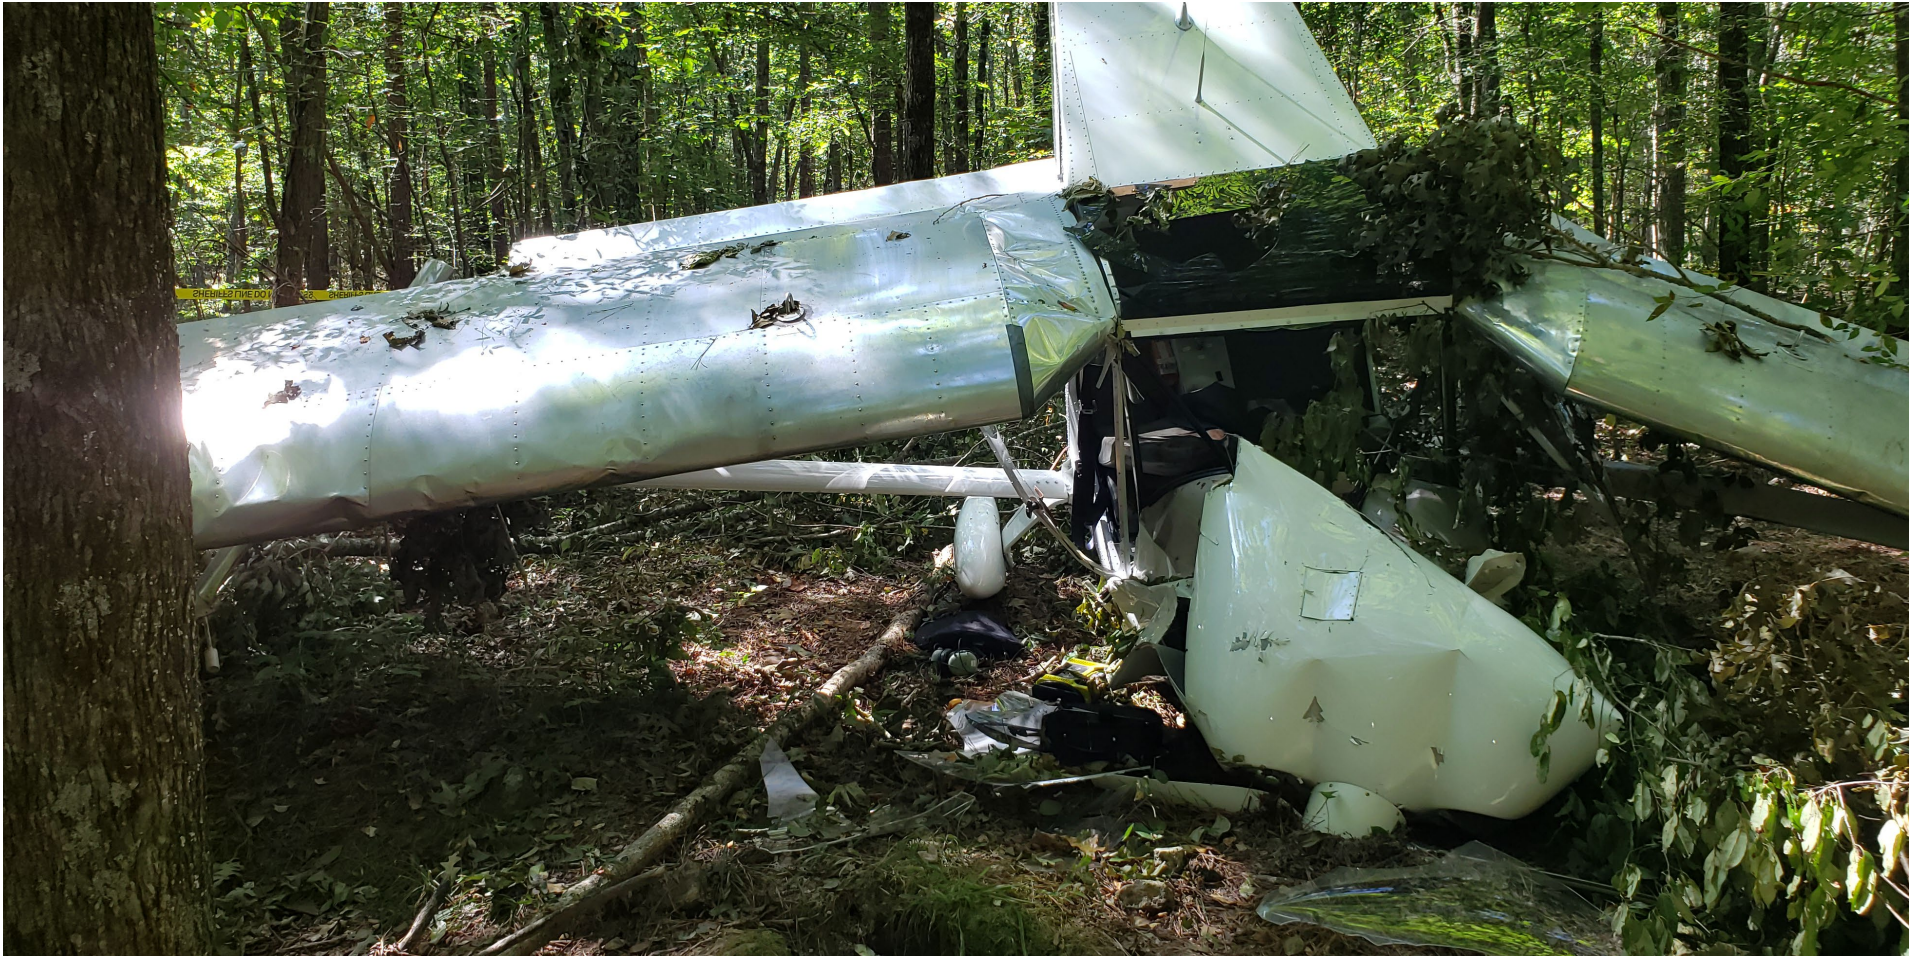
**Photo 5 – Close Up Photo of Front of Wreckage – Courtesy of FAA**

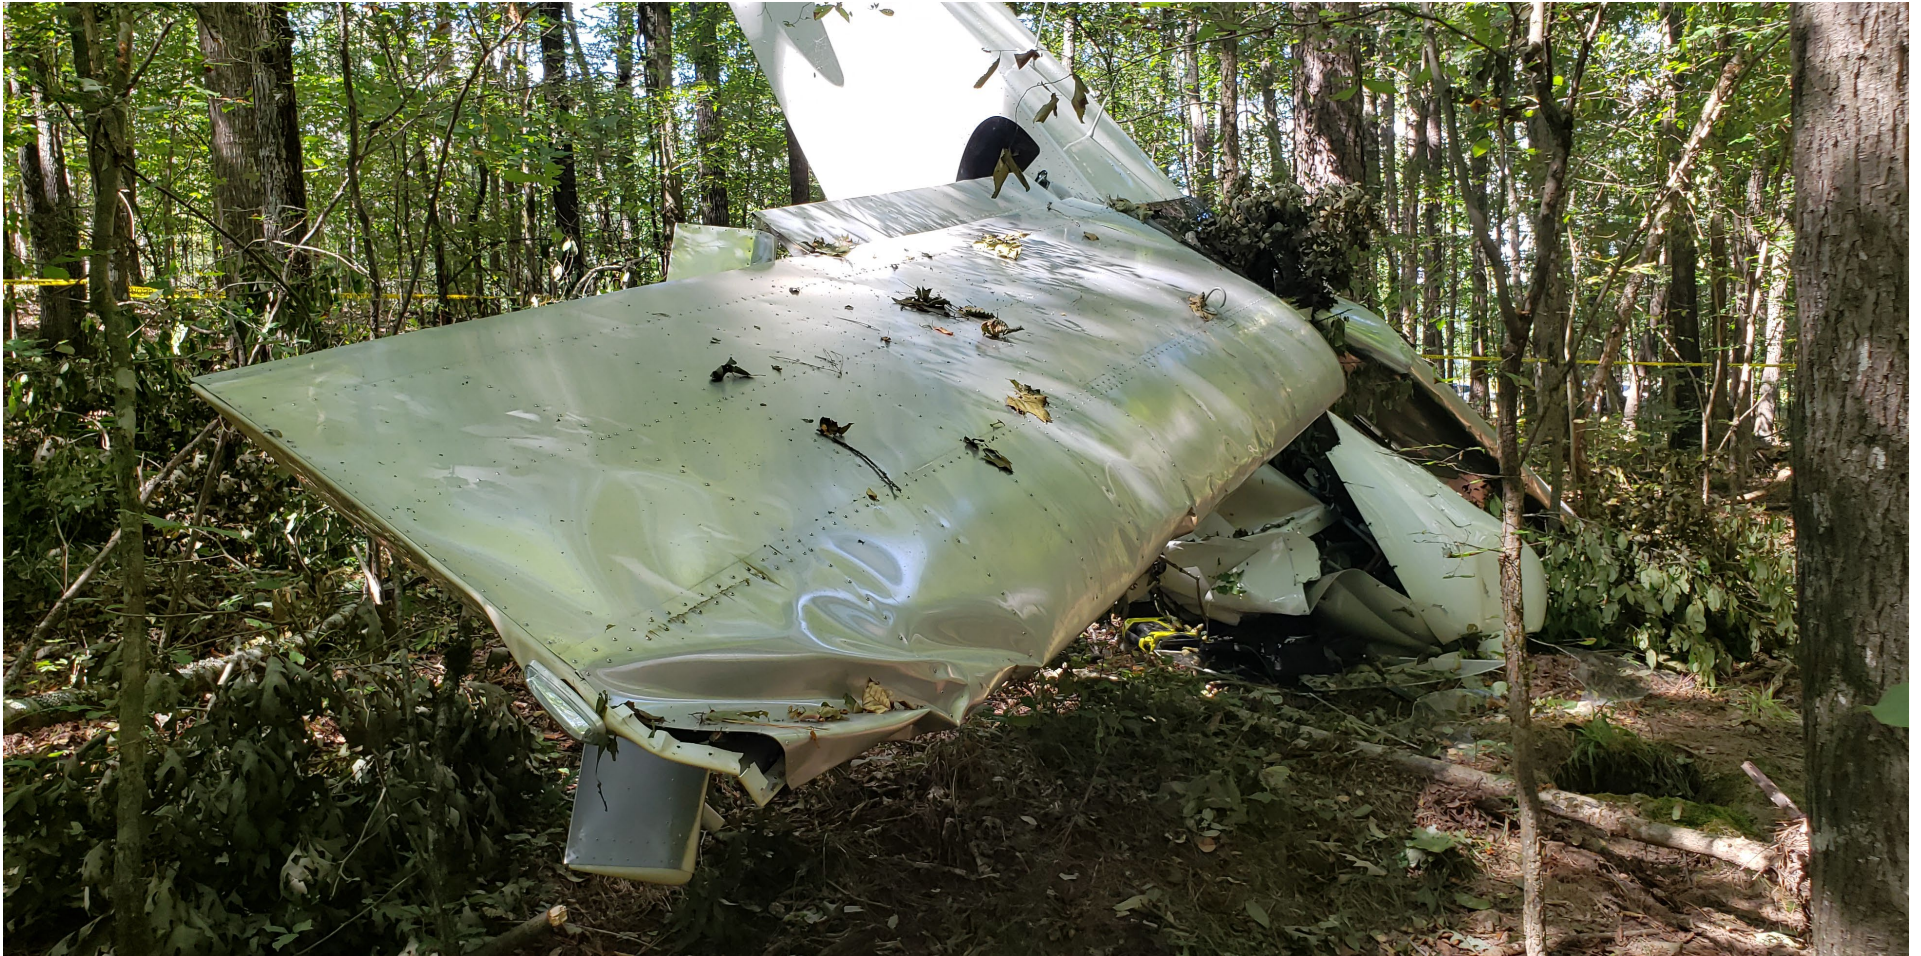
**Photo 6 – Right Wingtip – Courtesy of FAA**

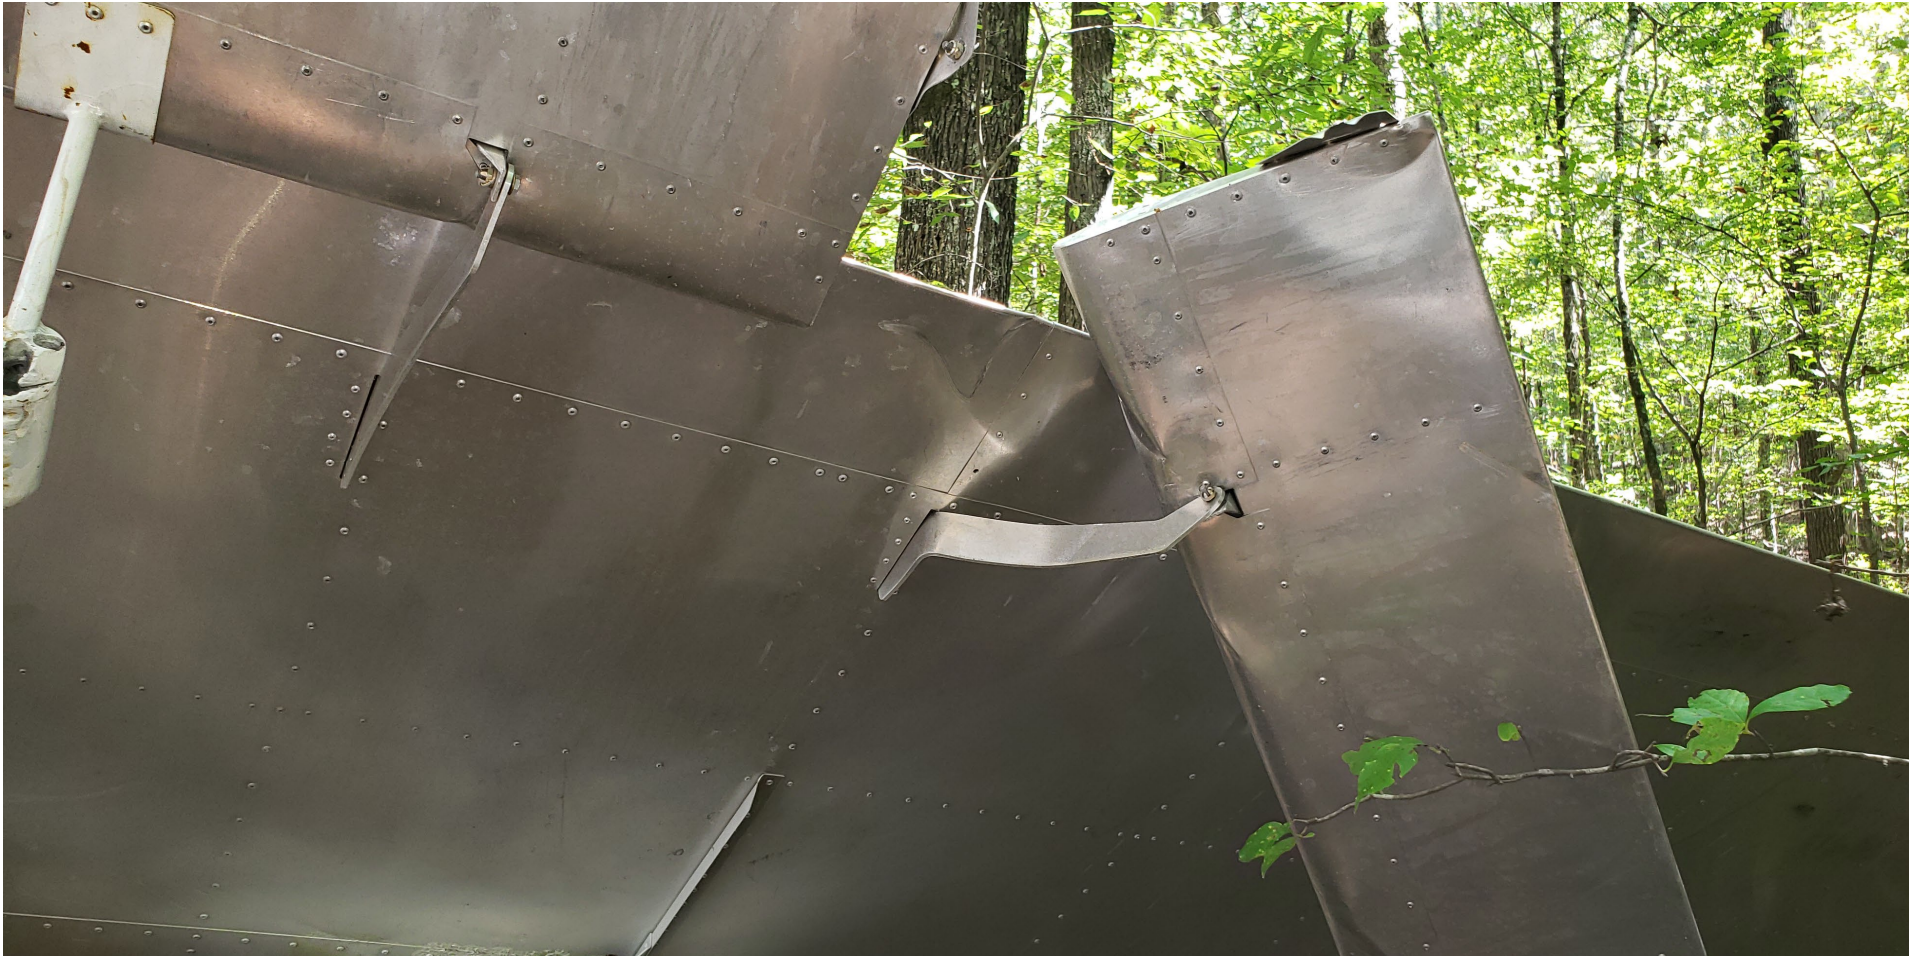
**Photo 7 – Right Aileron – Courtesy of FAA**

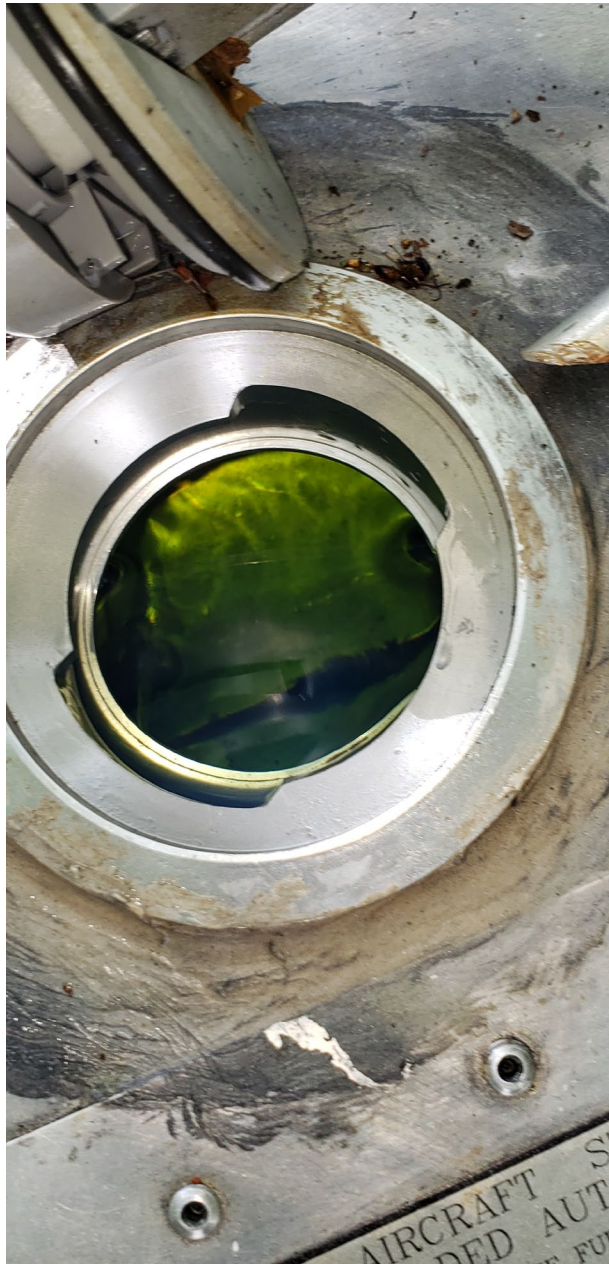
**Photo 8 – Right Fuel Tank – Courtesy of FAA**

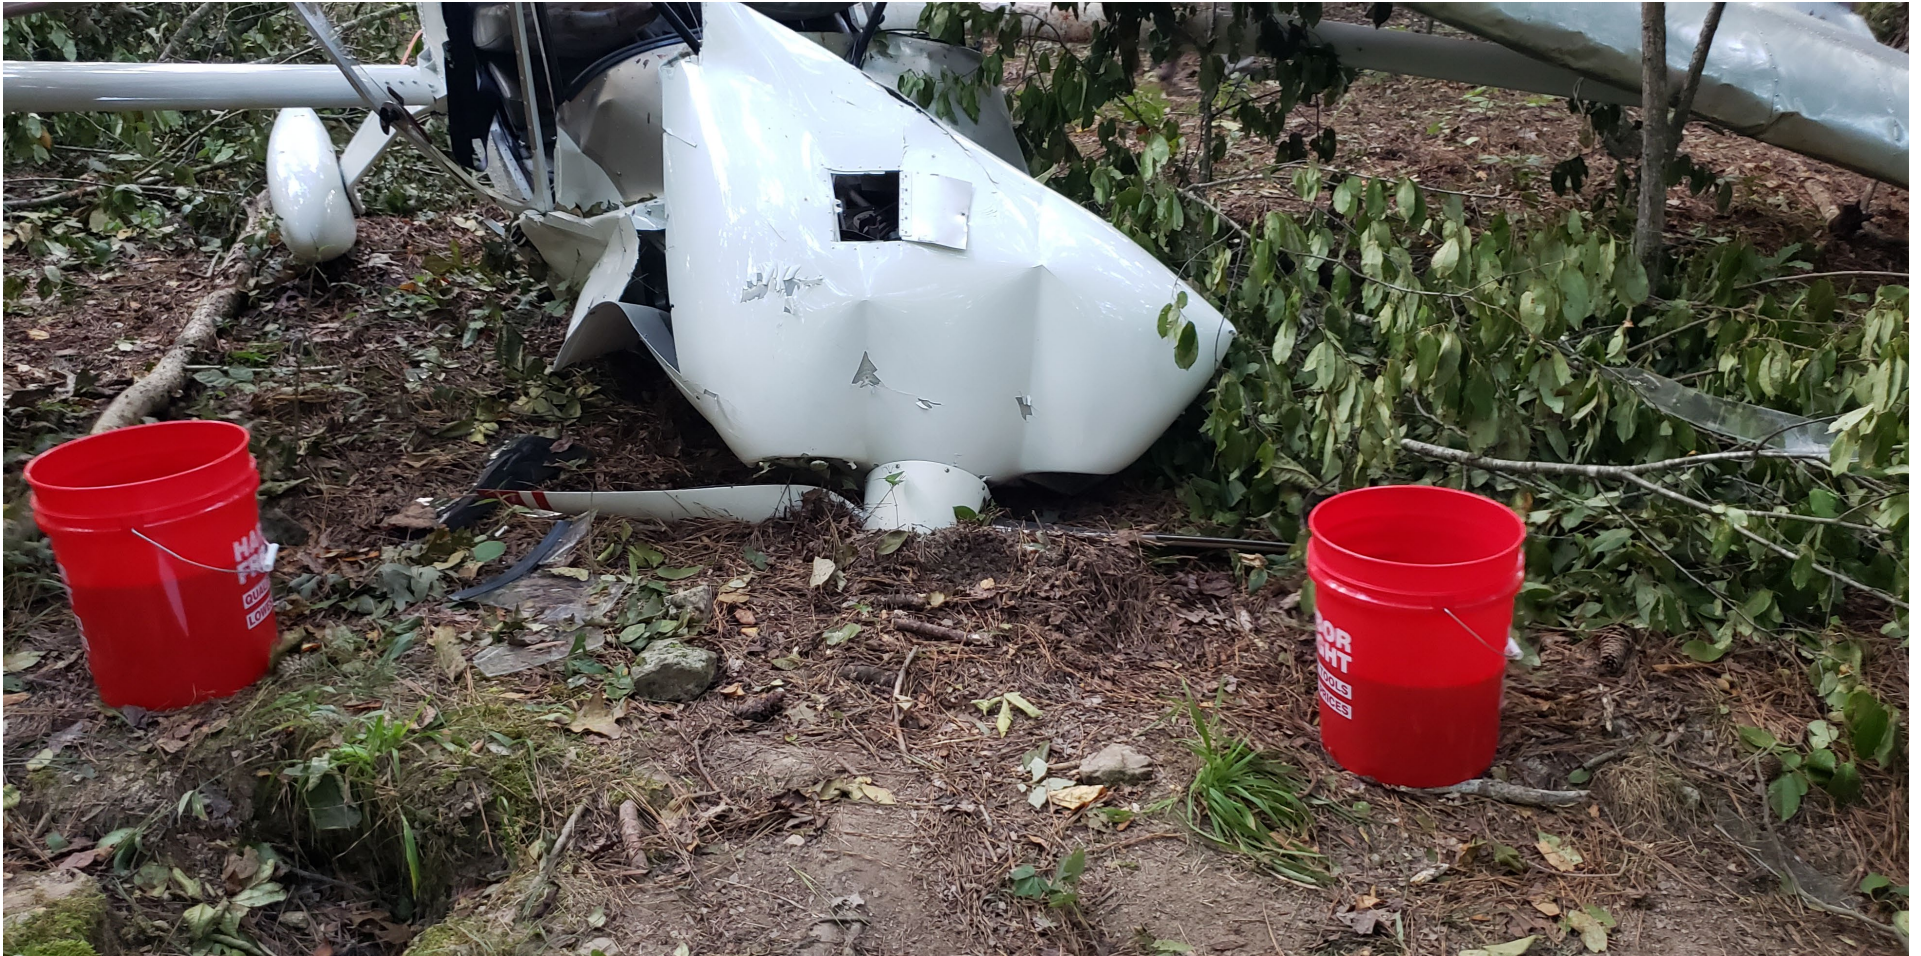
**Photo 9 – Fuel Recovered from Wreckage – Courtesy of FAA**

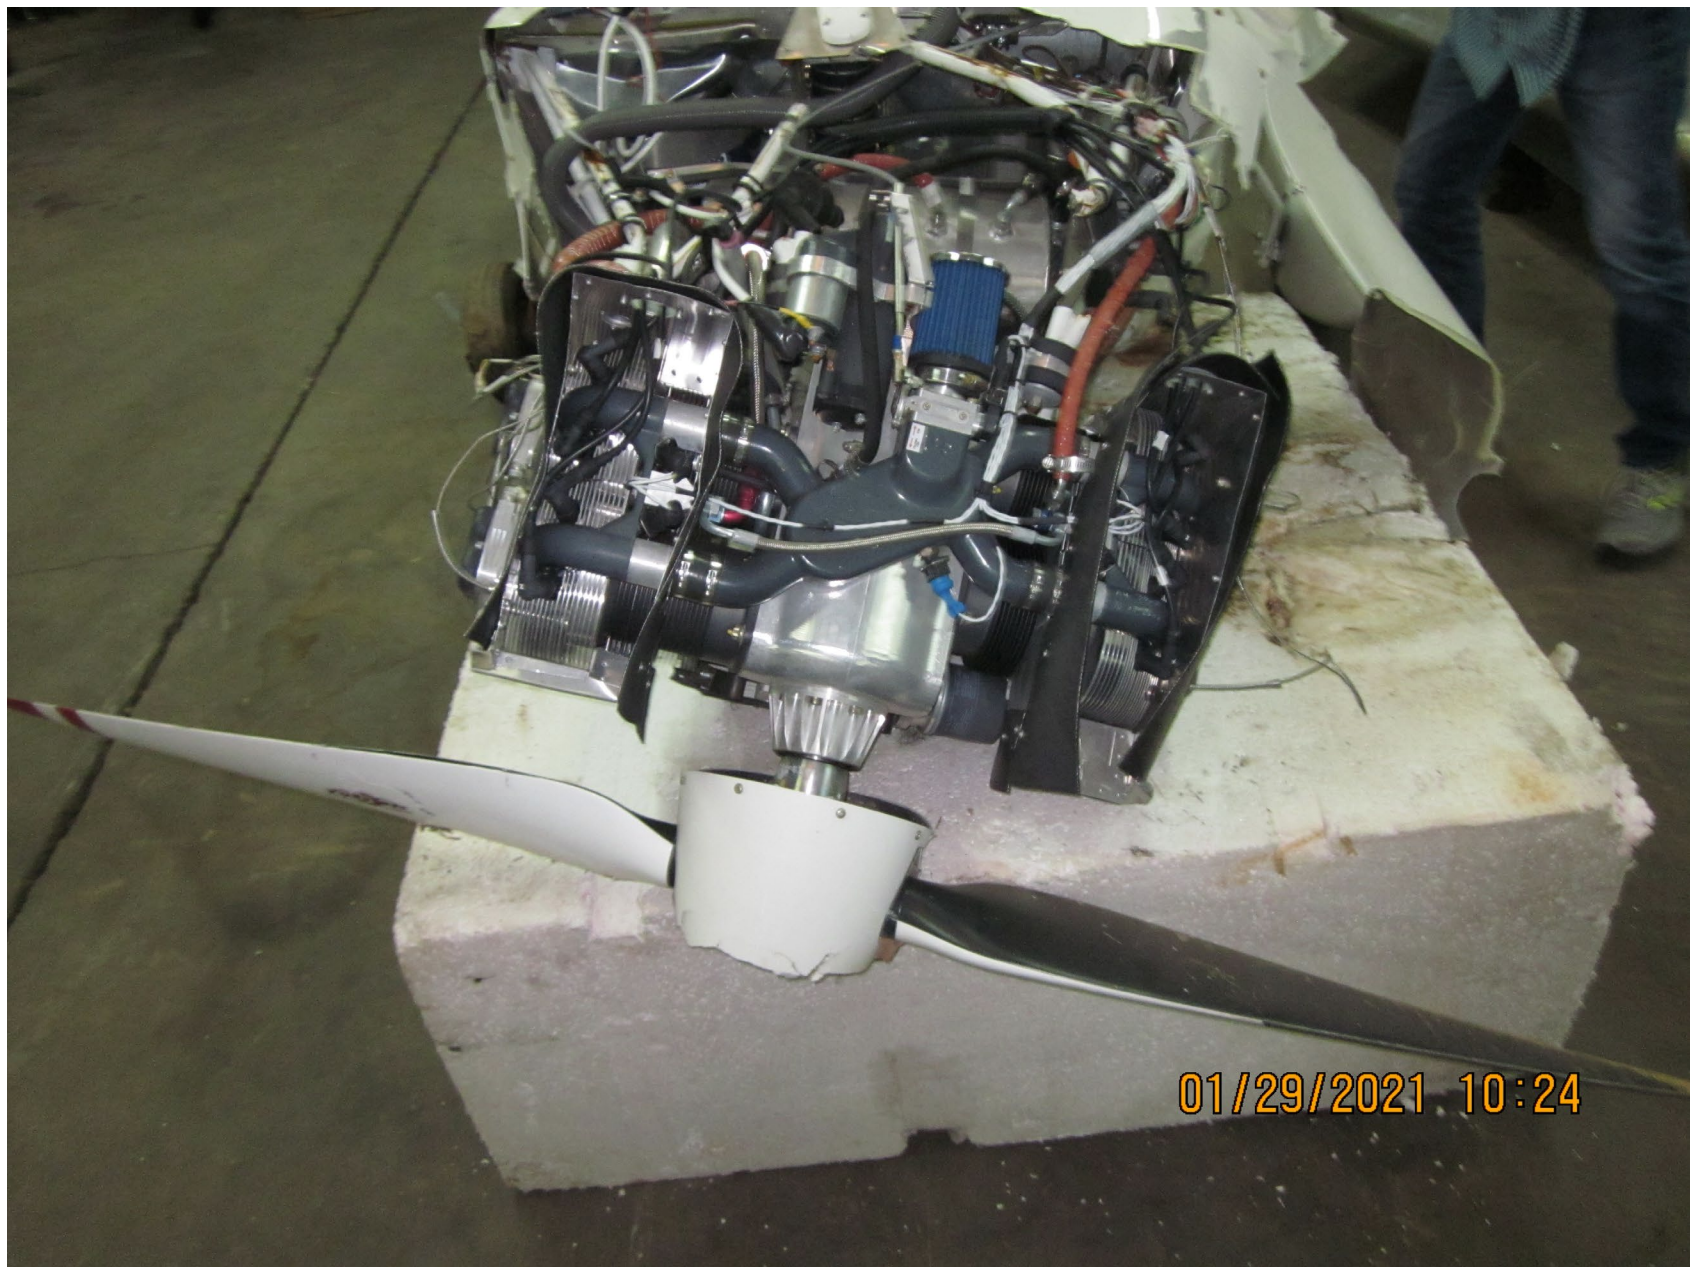
**Photo 10 – Top View of Engine – Courtesy of UL Power**

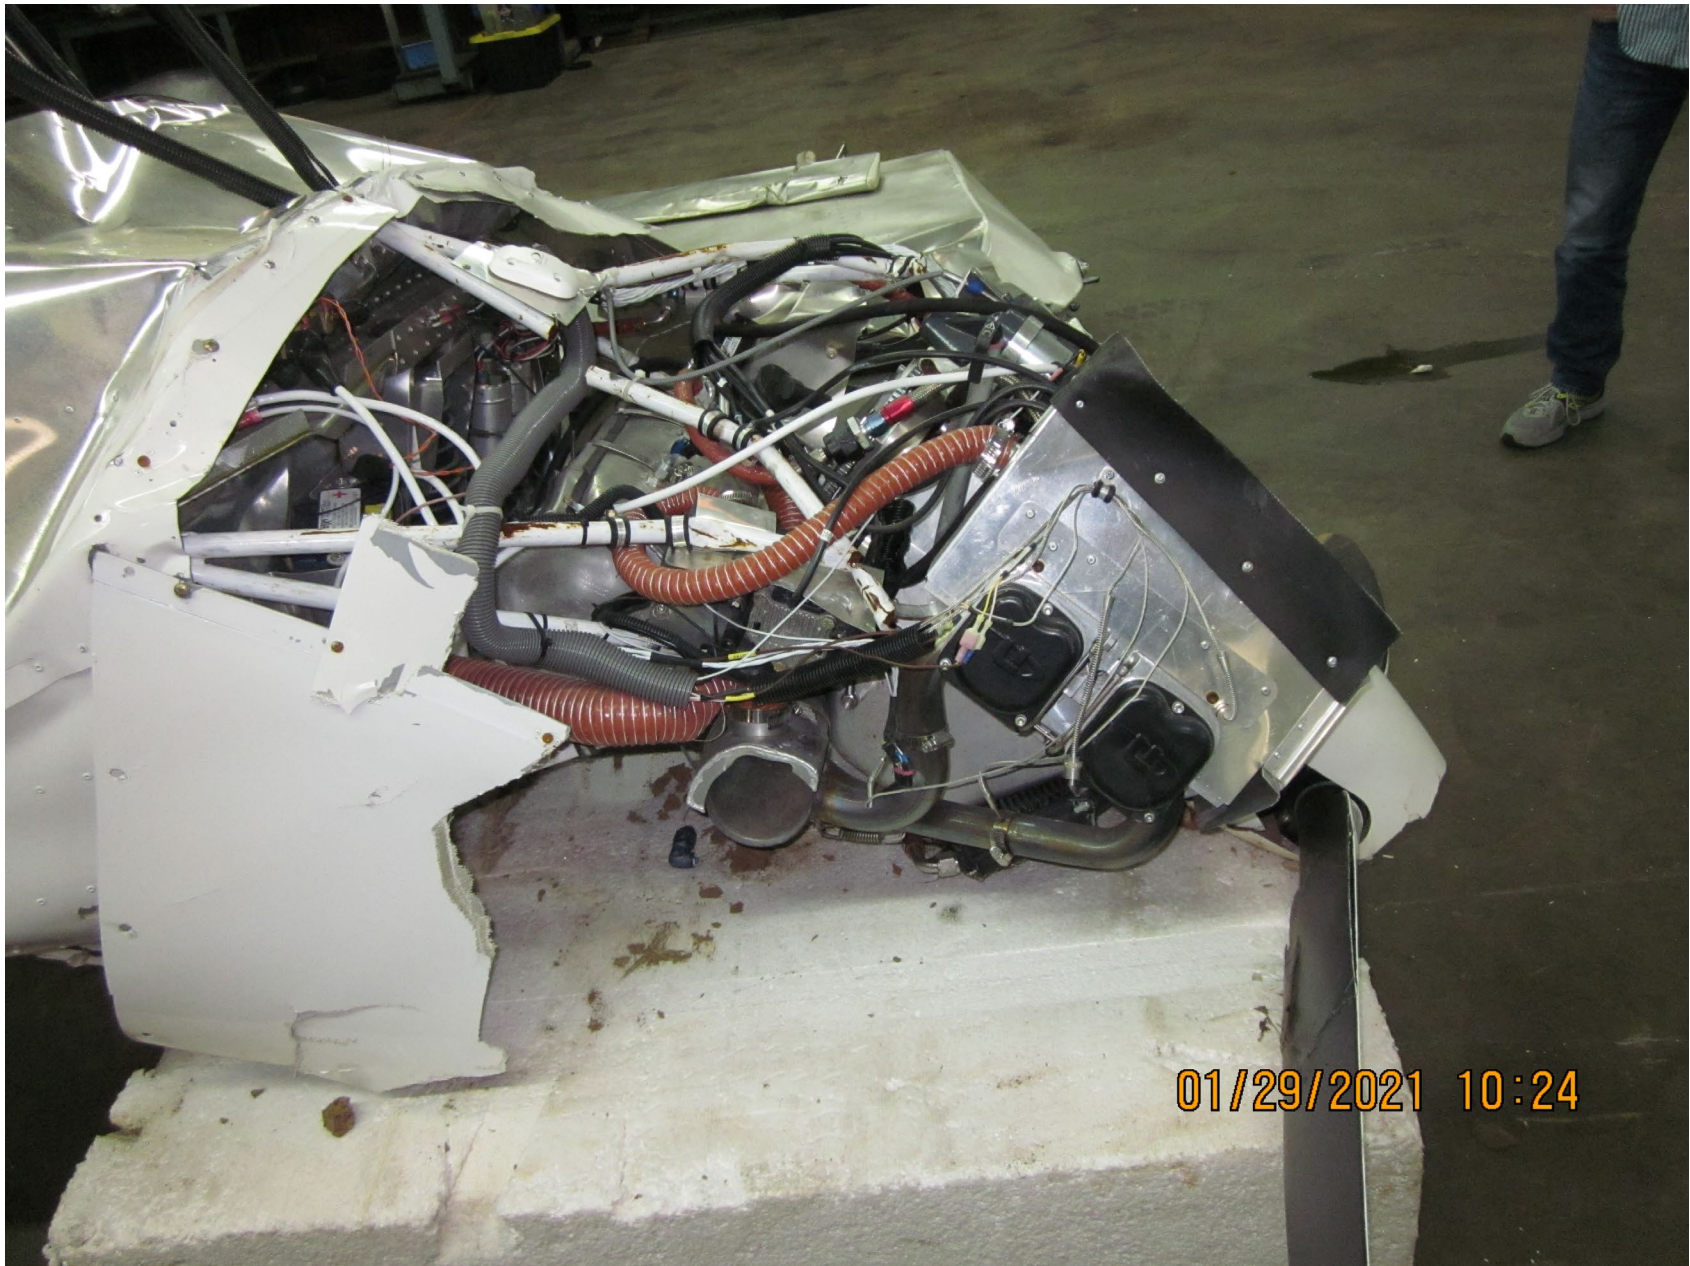
**Photo 11 – Right Side View of Engine – Courtesy of UL Power**

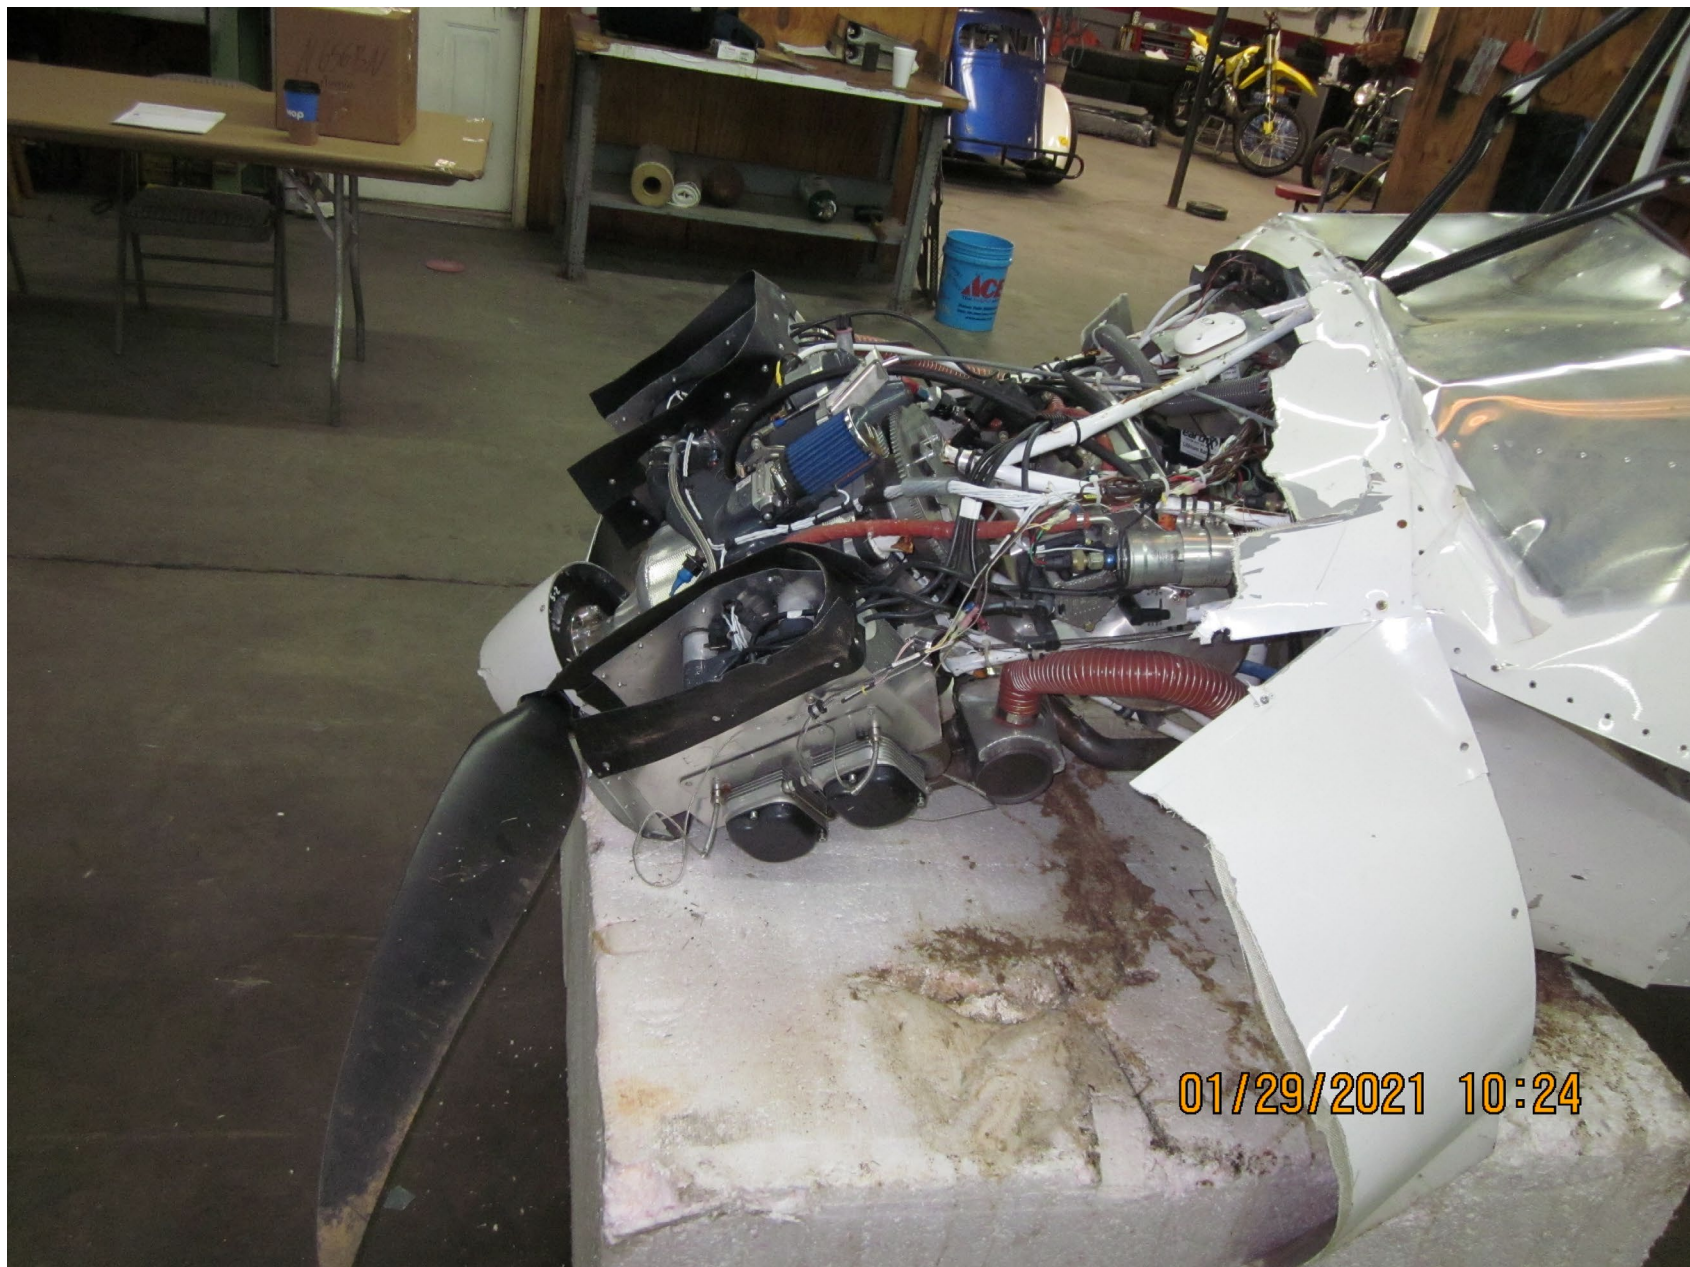
**Photo 12 – Left Side View of Engine – Courtesy of UL Power**

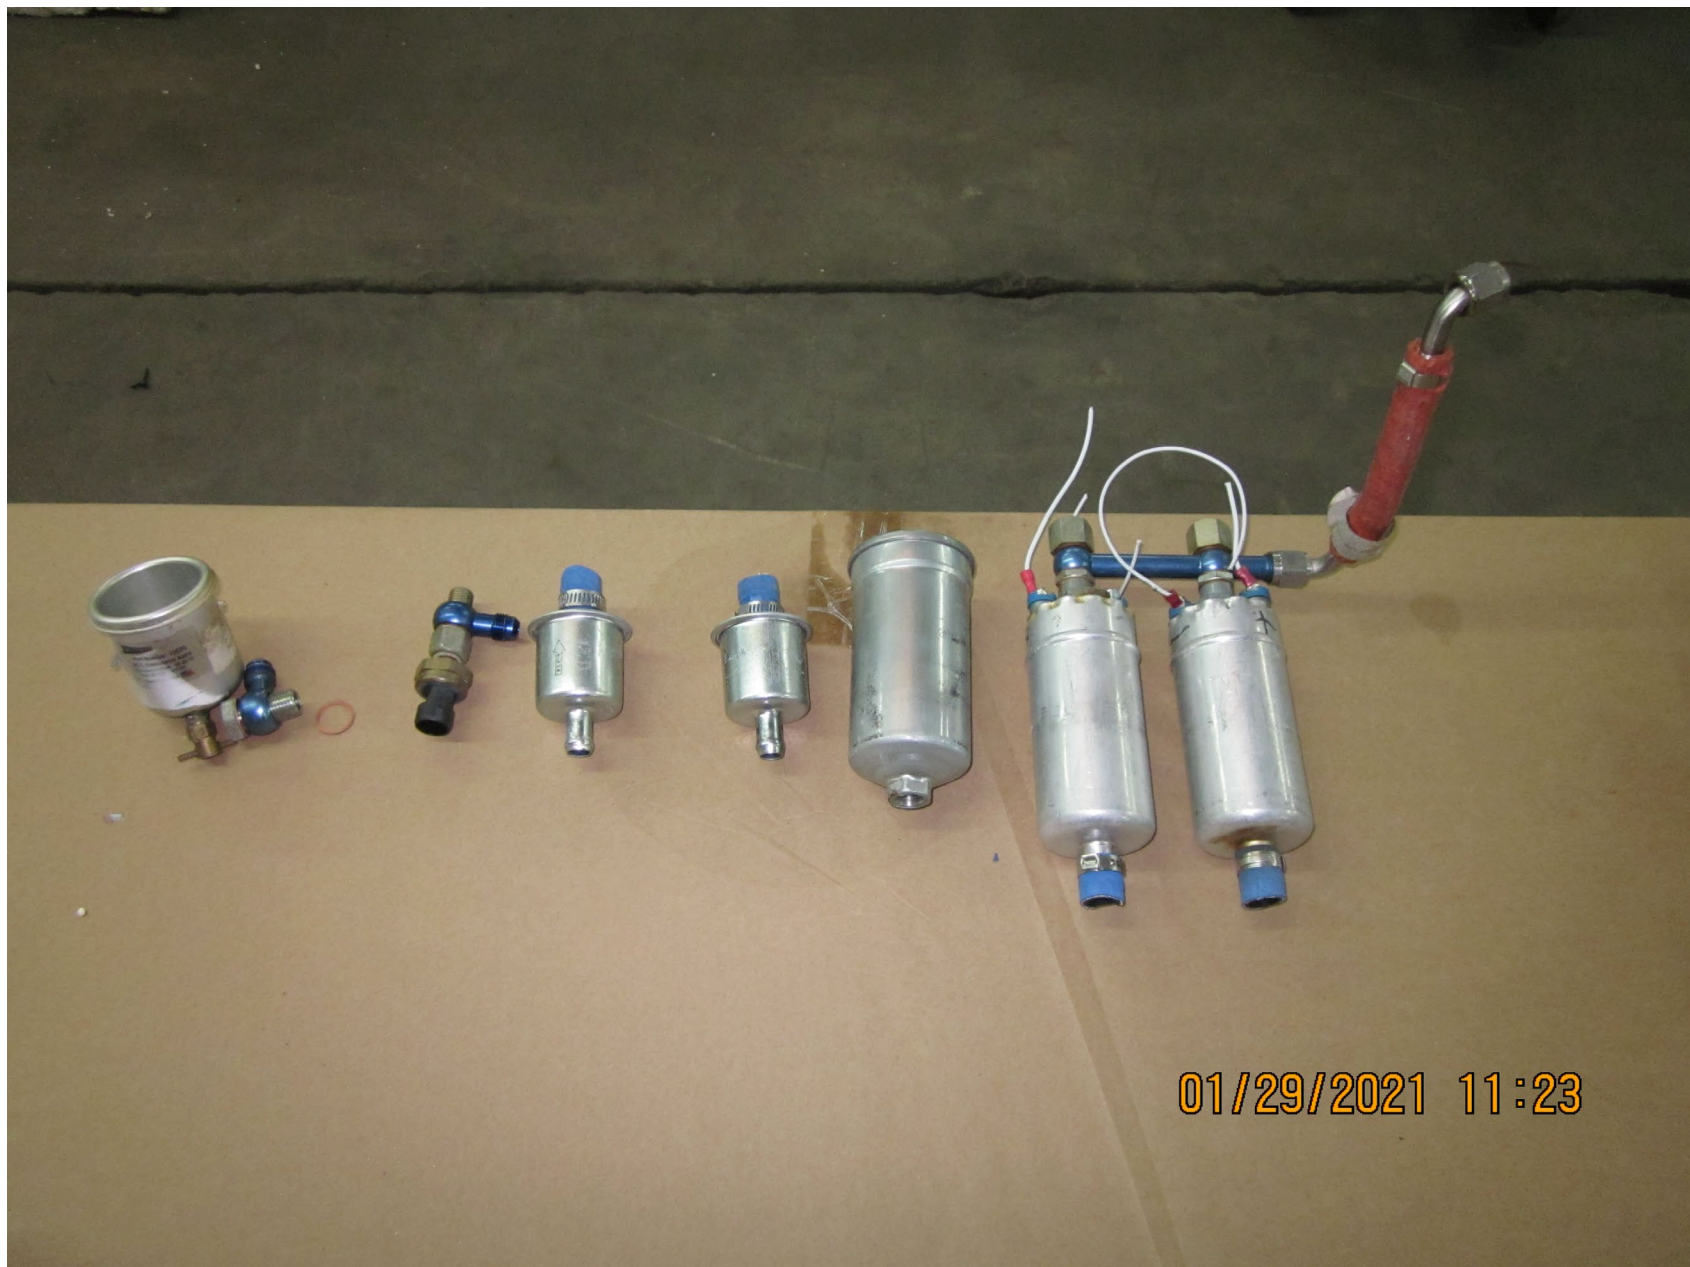
**Photo 13 – Fuel Strainers, Filters, and Pumps – Courtesy of UL Power**
