**Photo 1 – Main Wreckage – Courtesy of FAA**

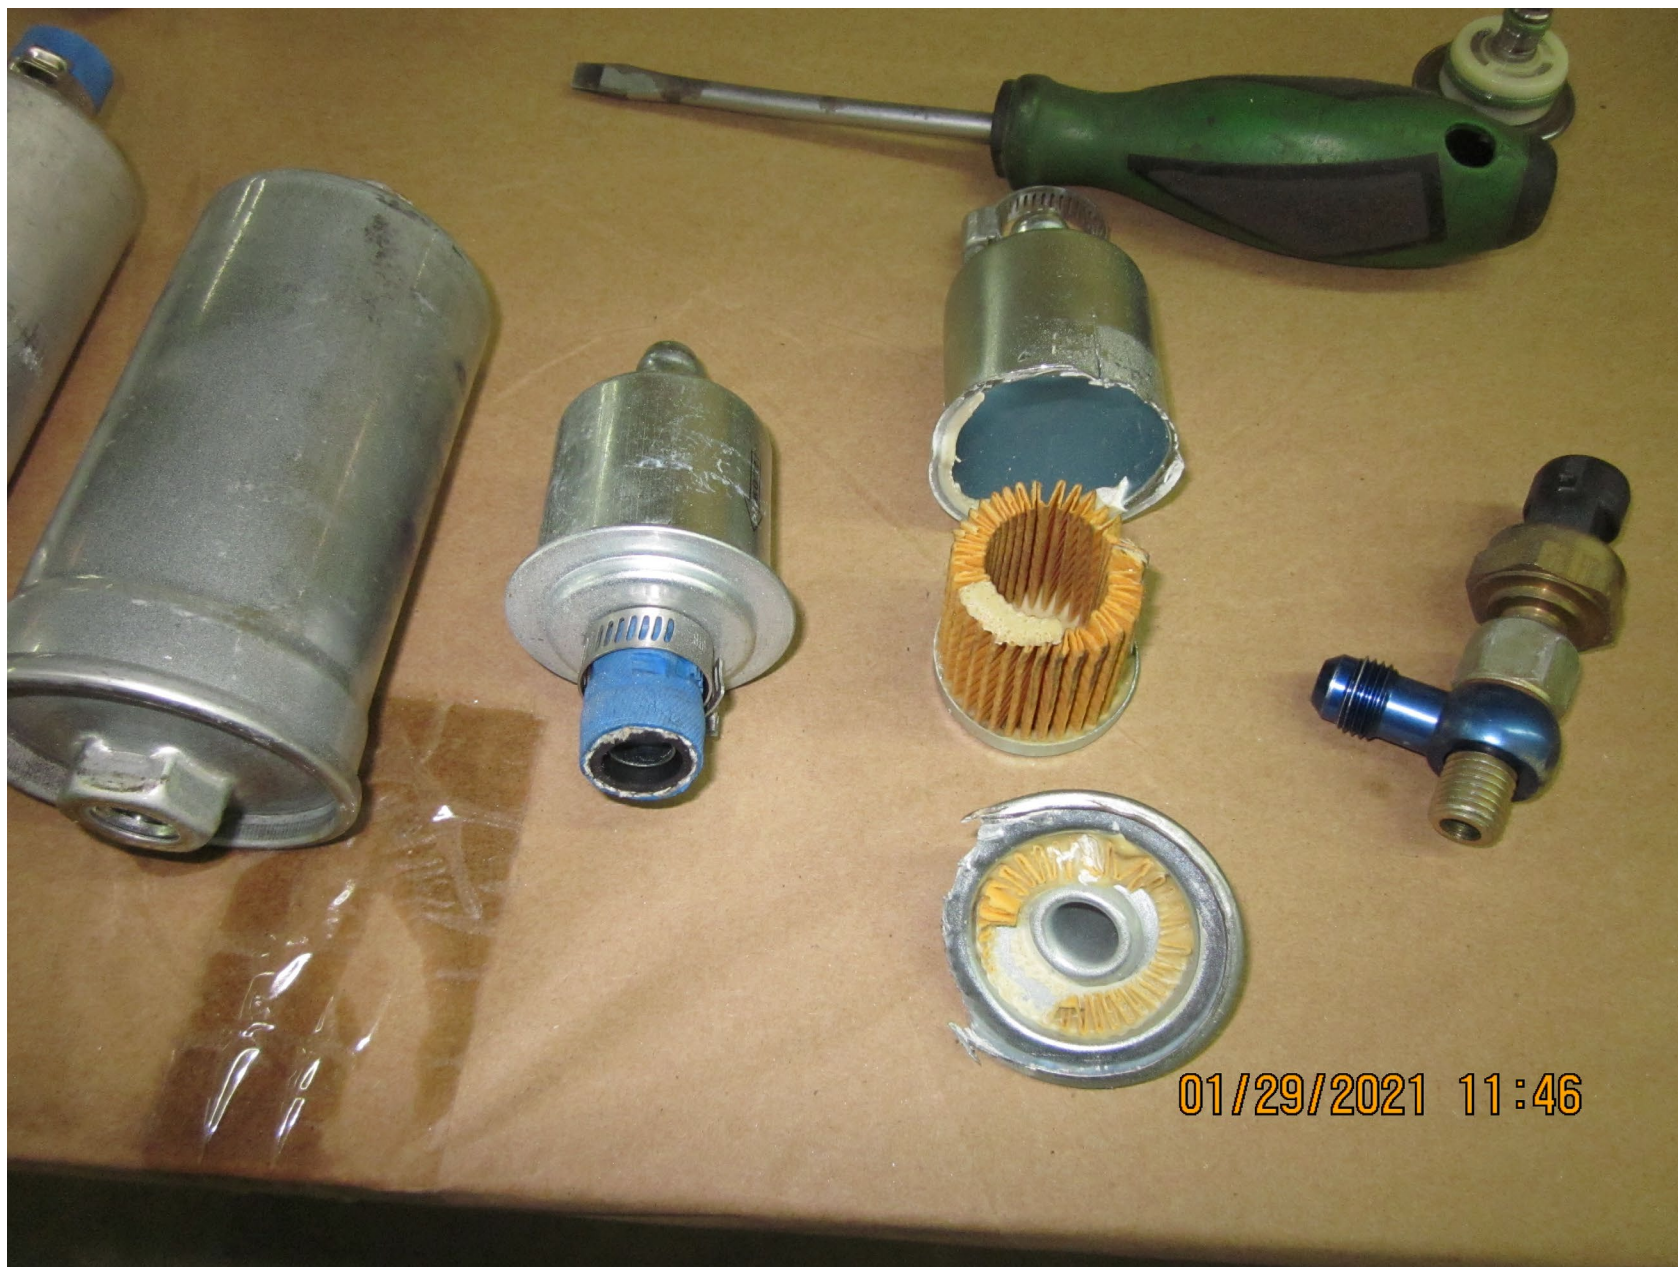
**Photo 14 – Inside of Fuel Filter – Courtesy of UL Power**

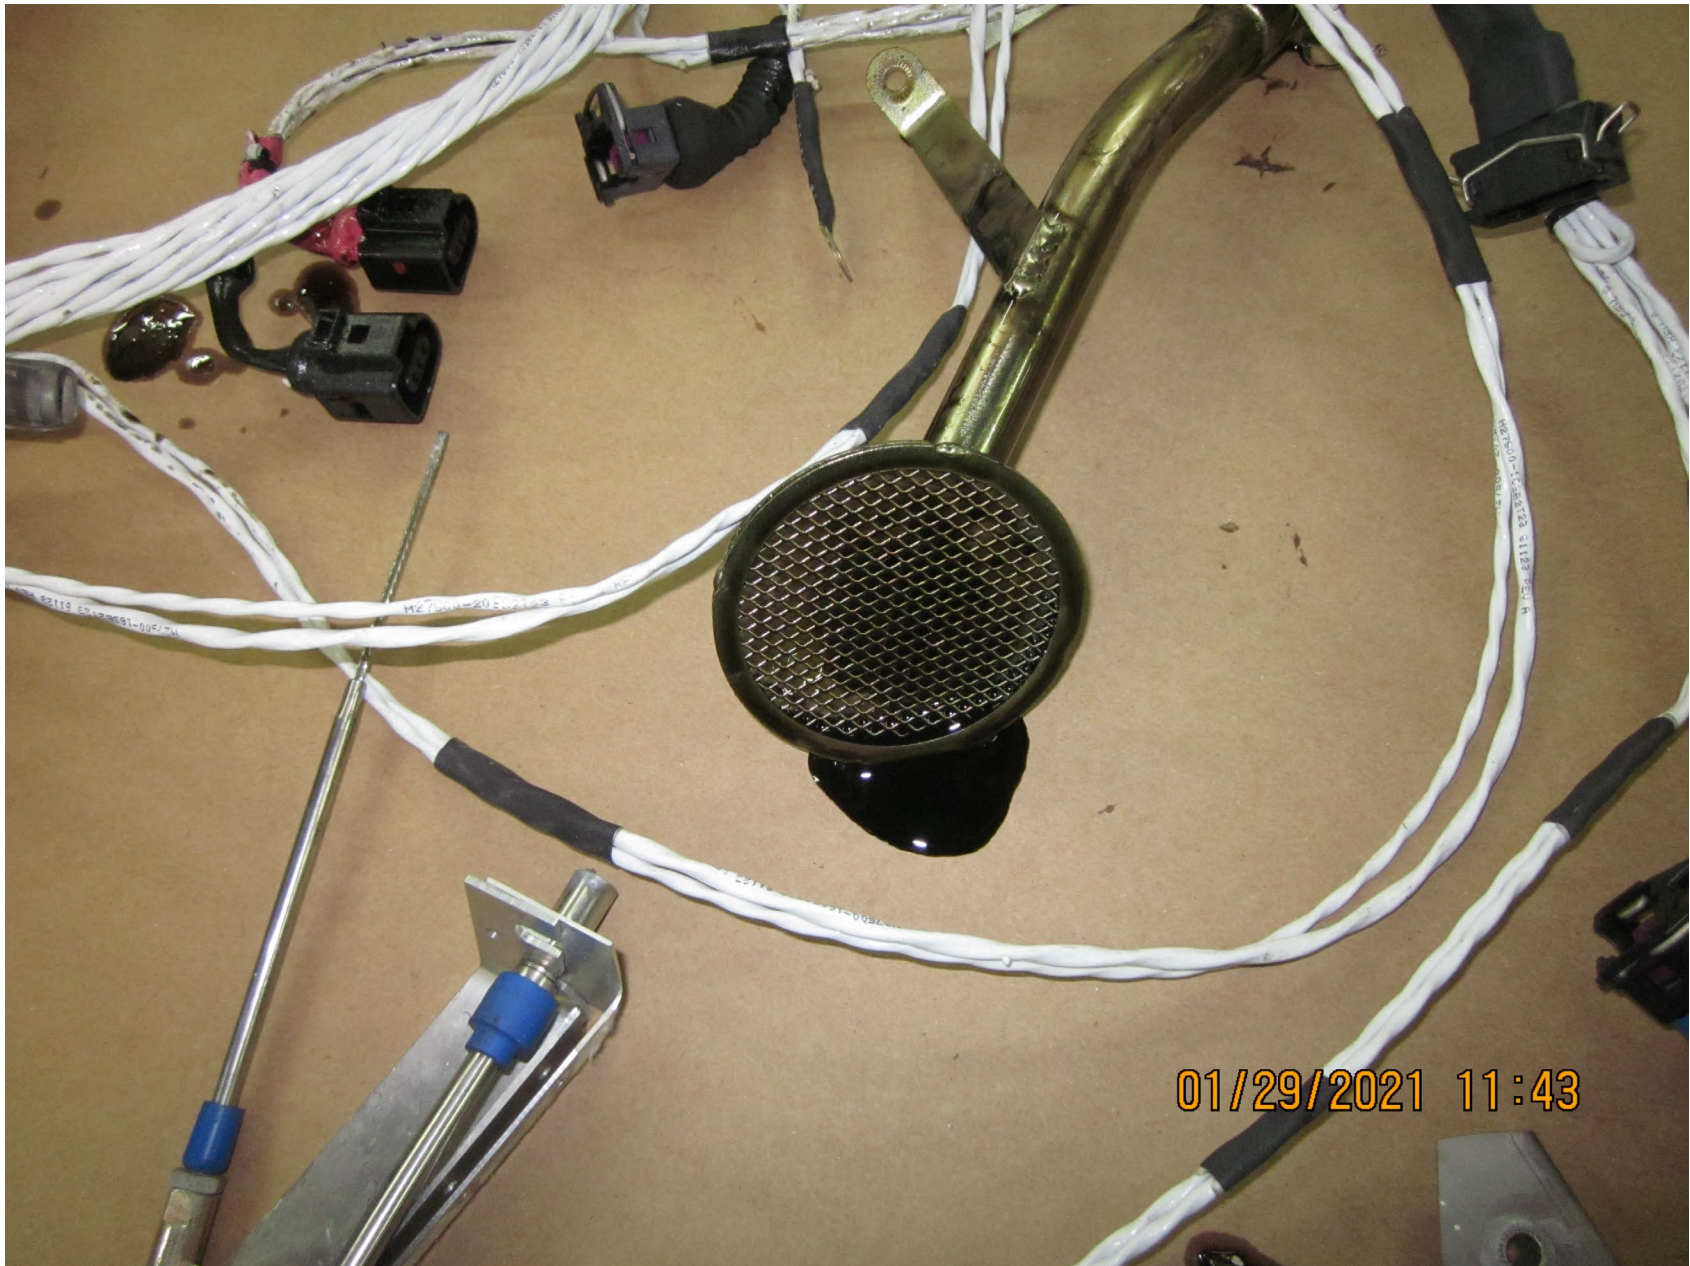
**Photo 15 – Oil Pickup Screen – Courtesy of UL Power**

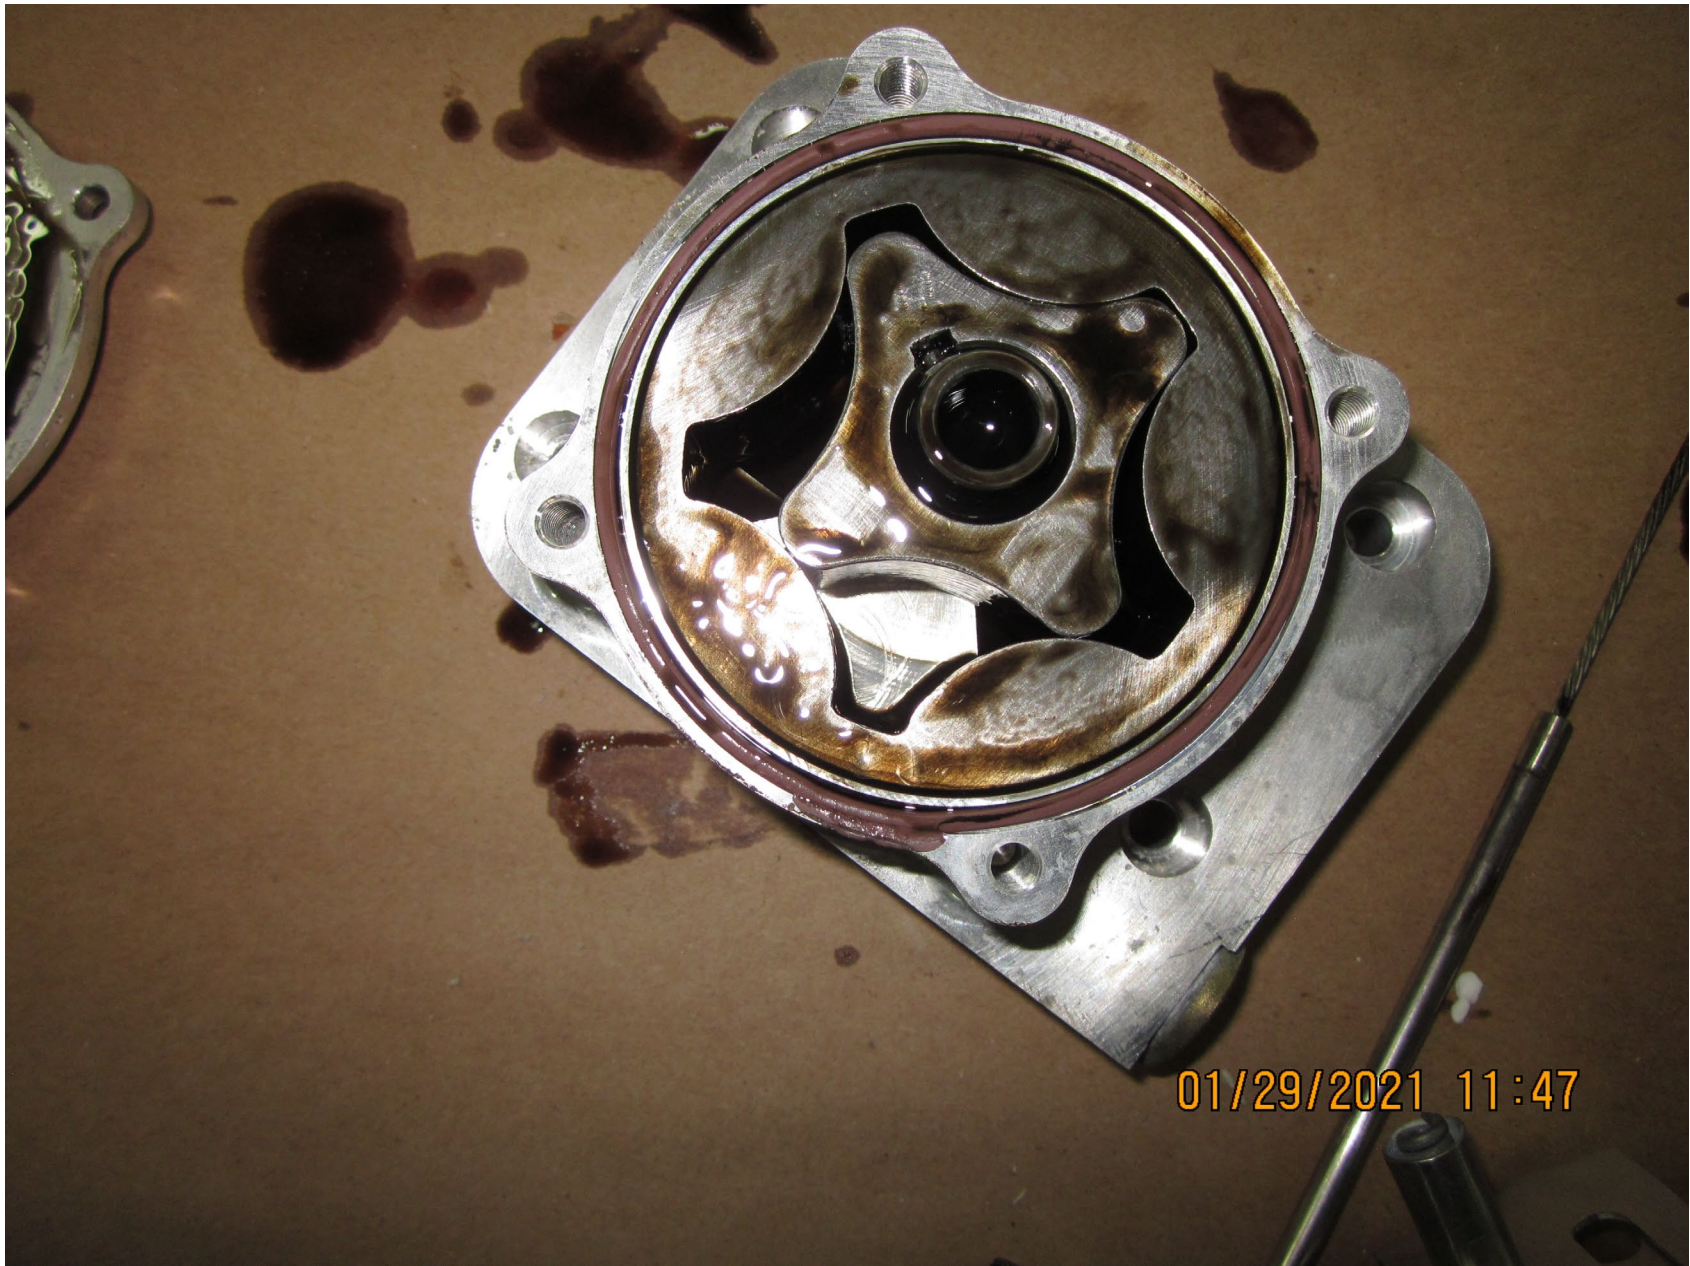
**Photo 16 – Oil Pump – Courtesy of UL Power**

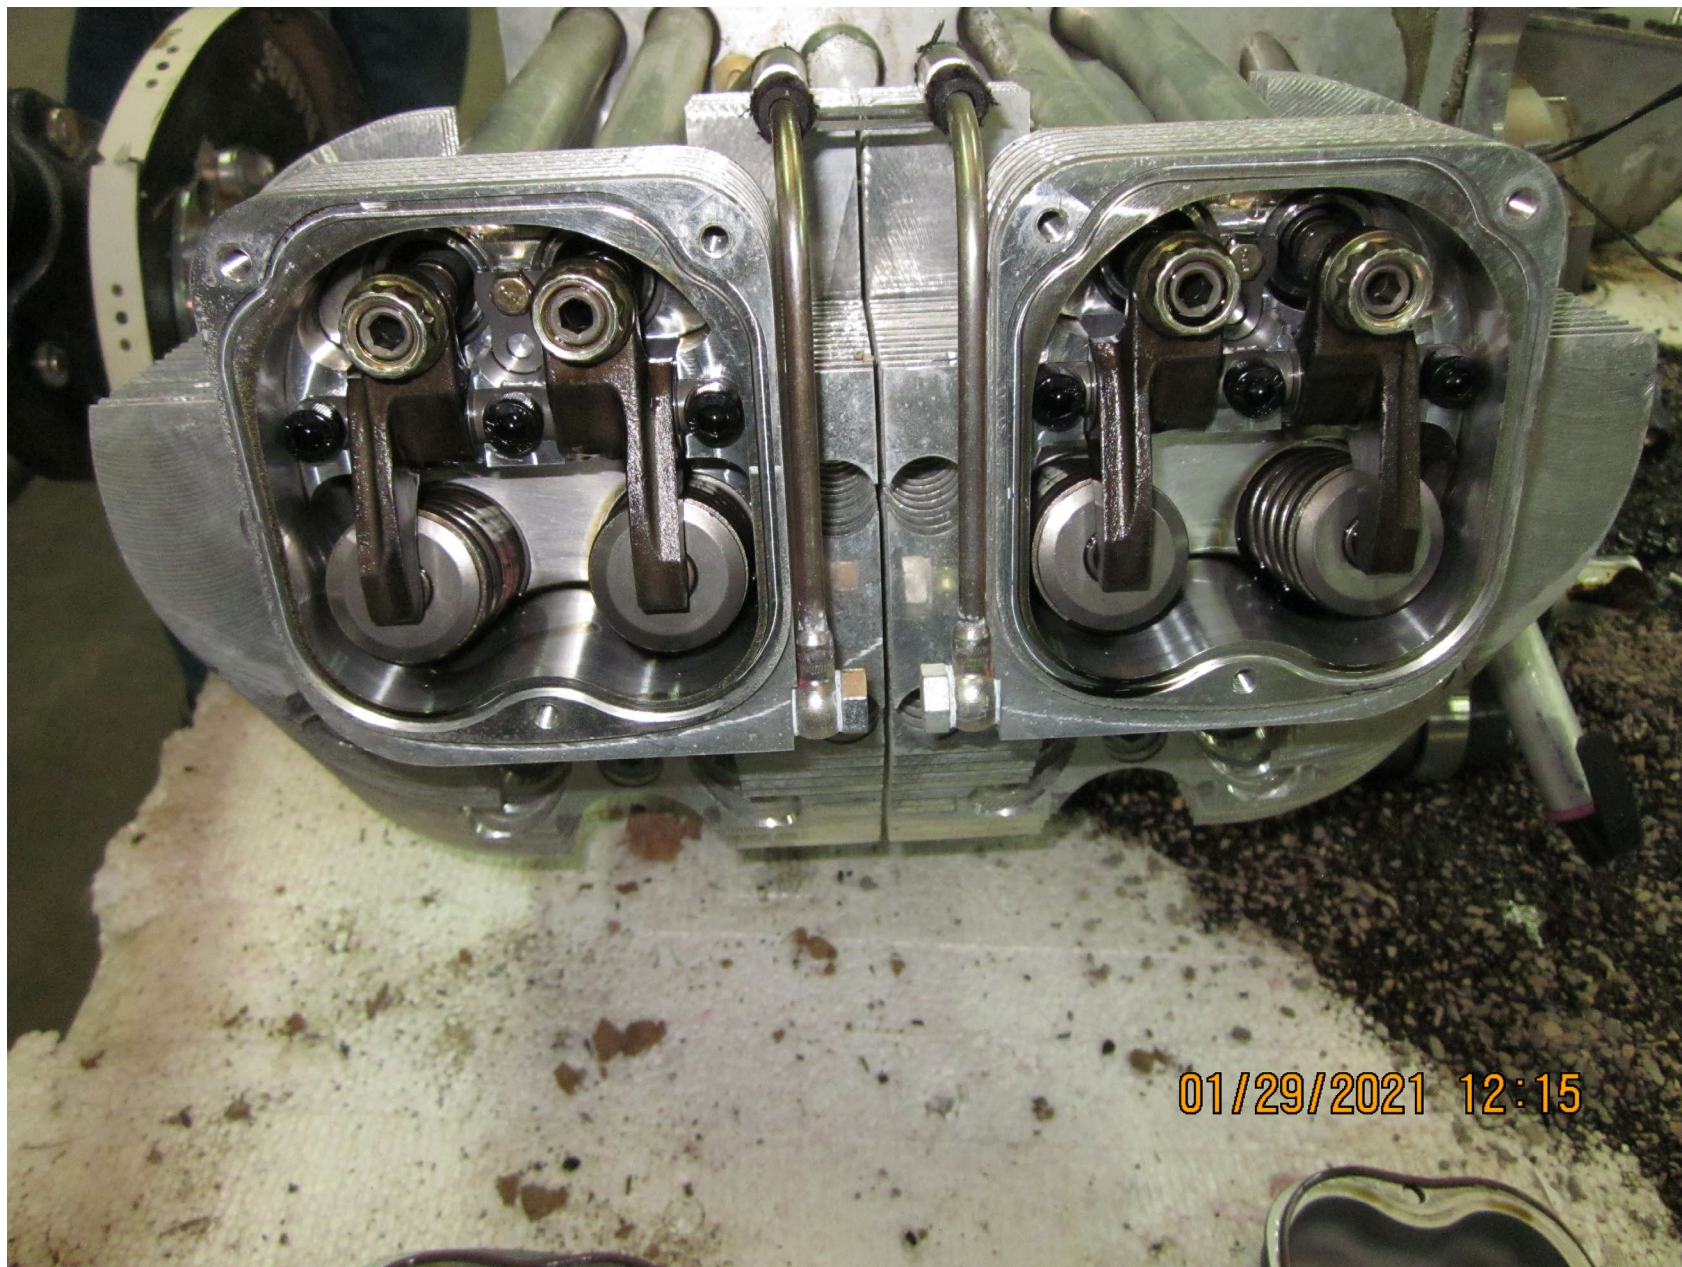
**Photo 17 – Interior of Left Side Rocker Boxes – Courtesy of UL Power**

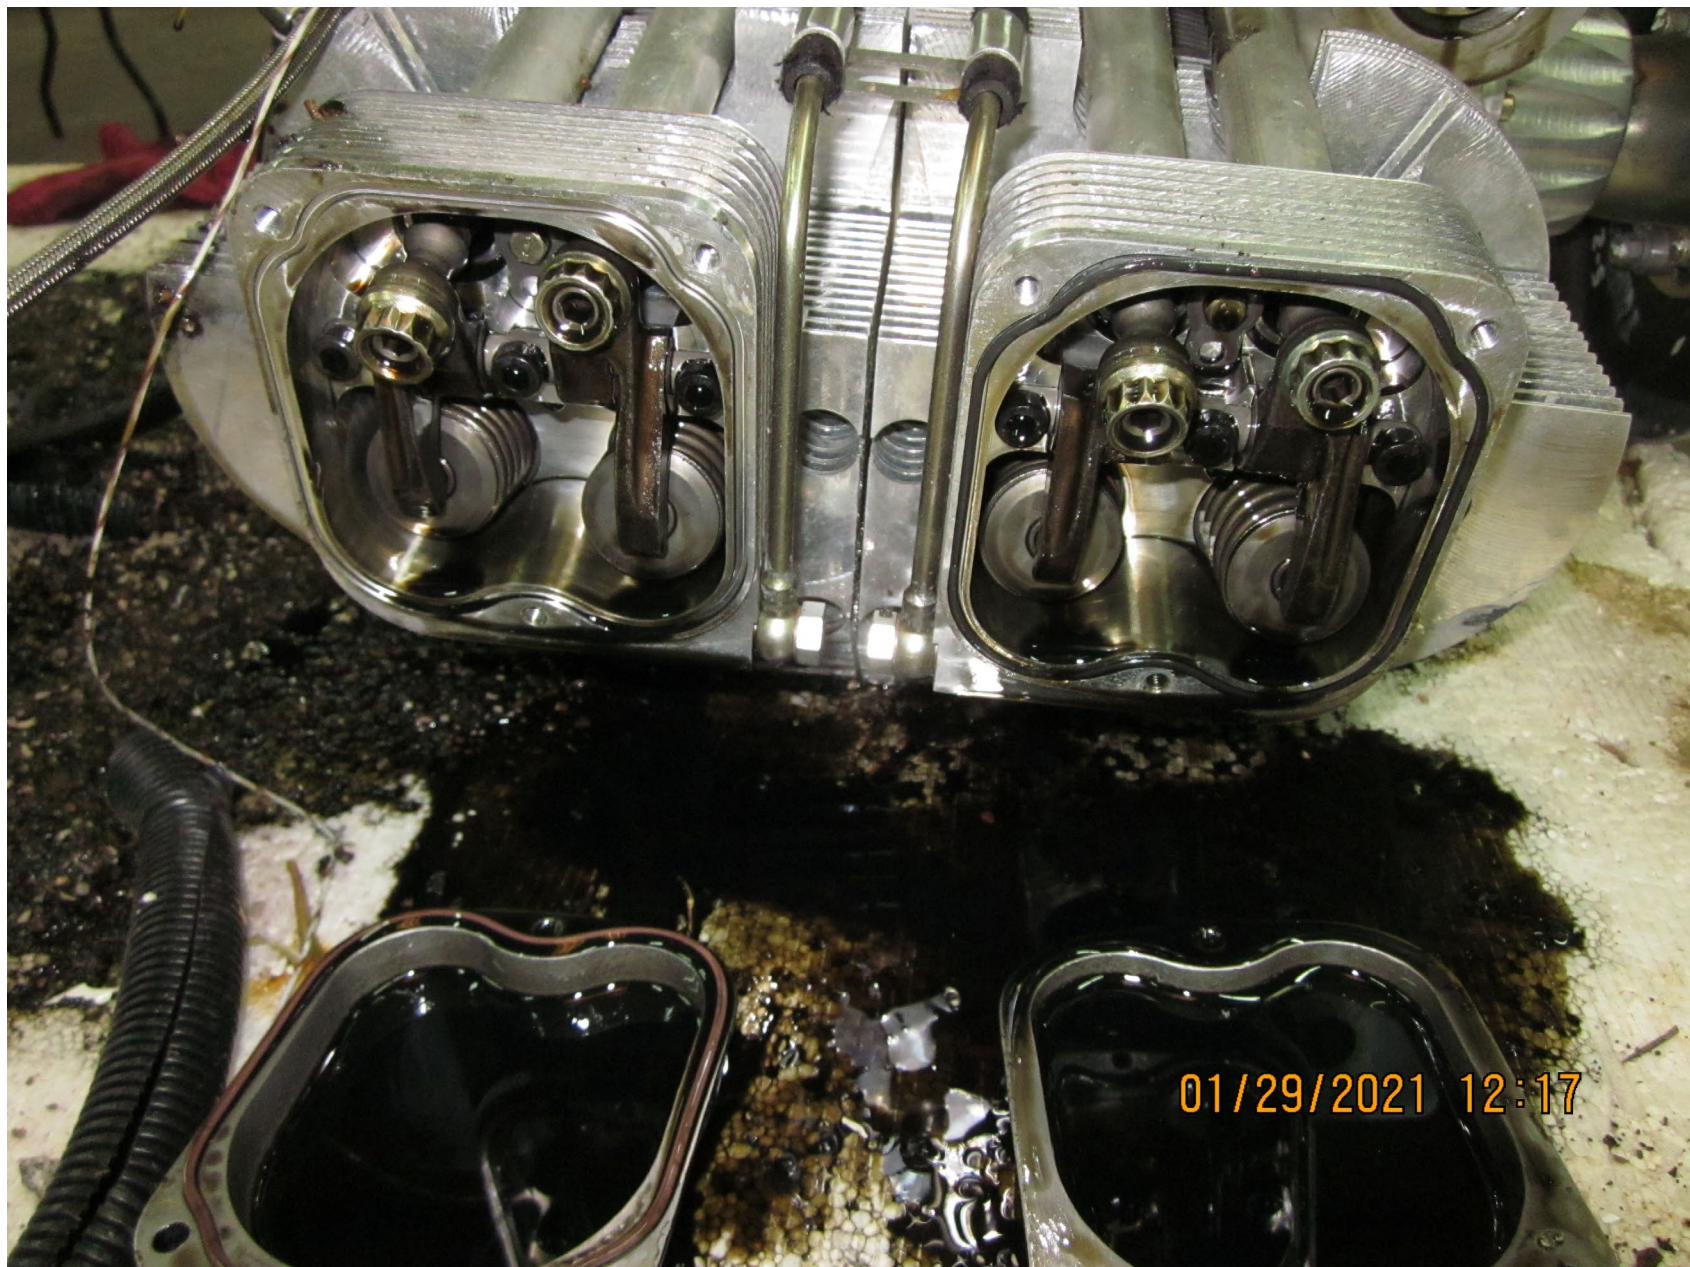
**Photo 18 – Interior of Right Side Rocker Boxes – Courtesy of UL Power**

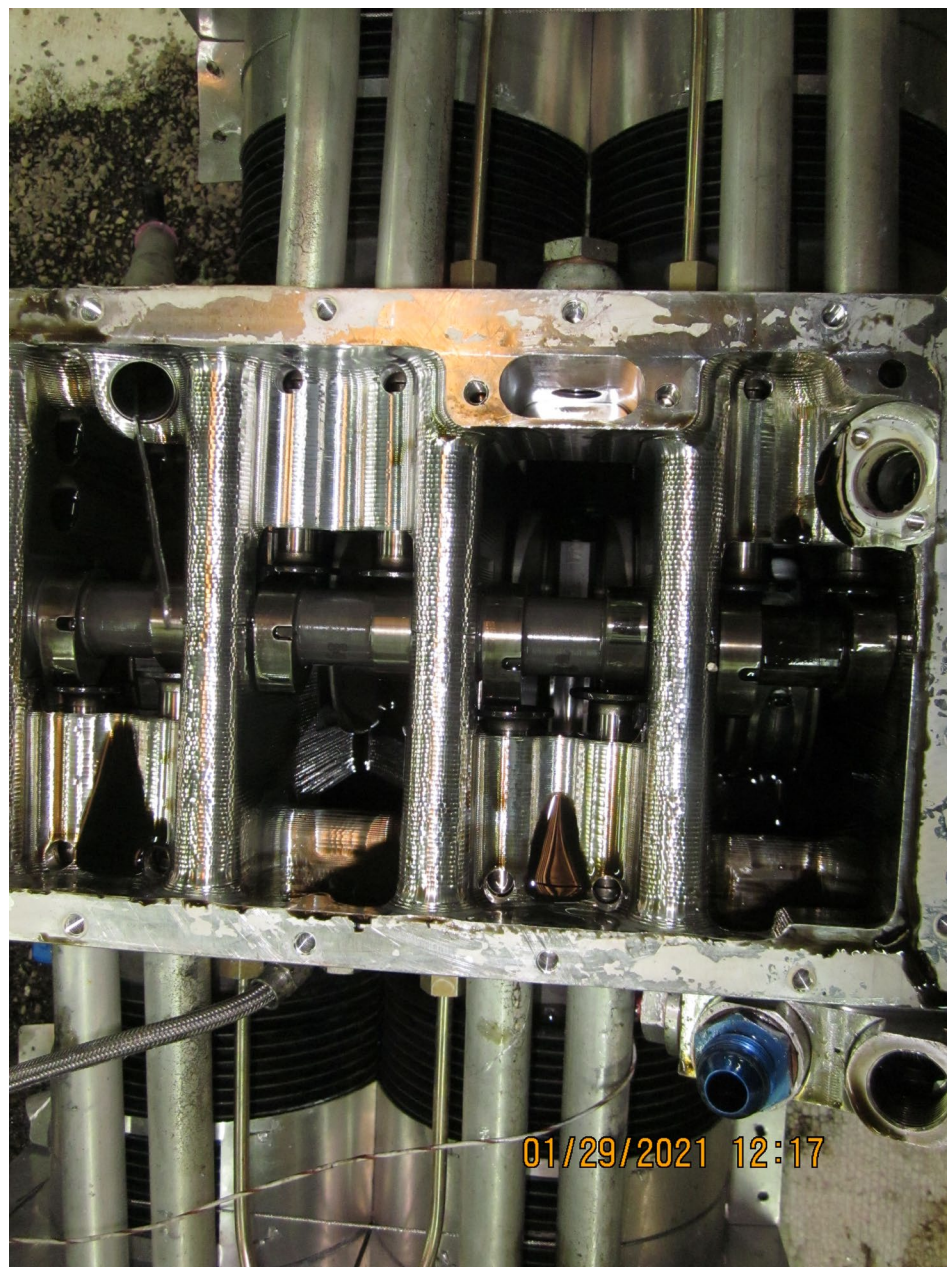
**Photo 19 – Camshaft and Lifters – Courtesy of UL Power**

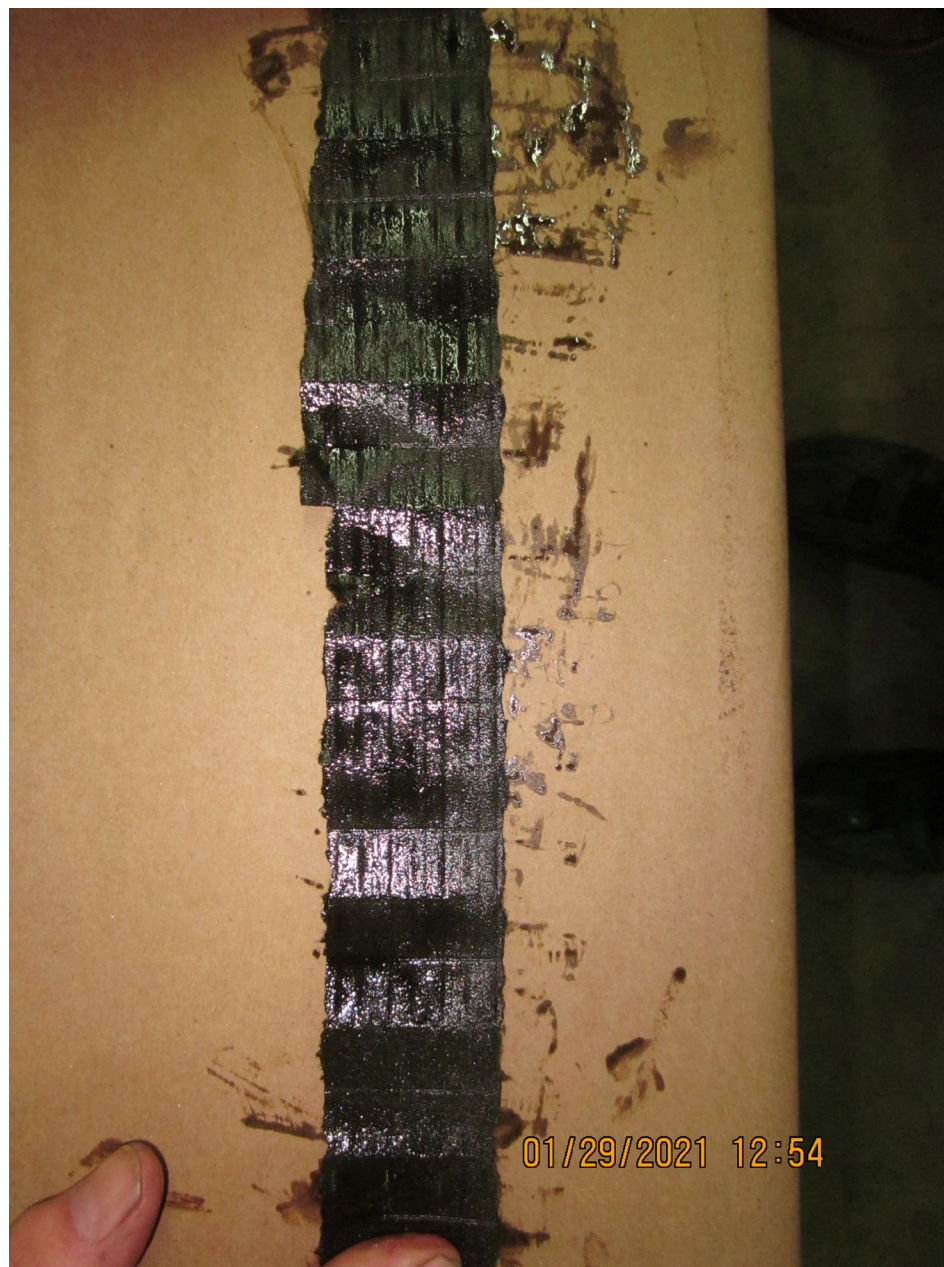
**Photo 20 – Inside of oil Filter – Courtesy of UL Power**
