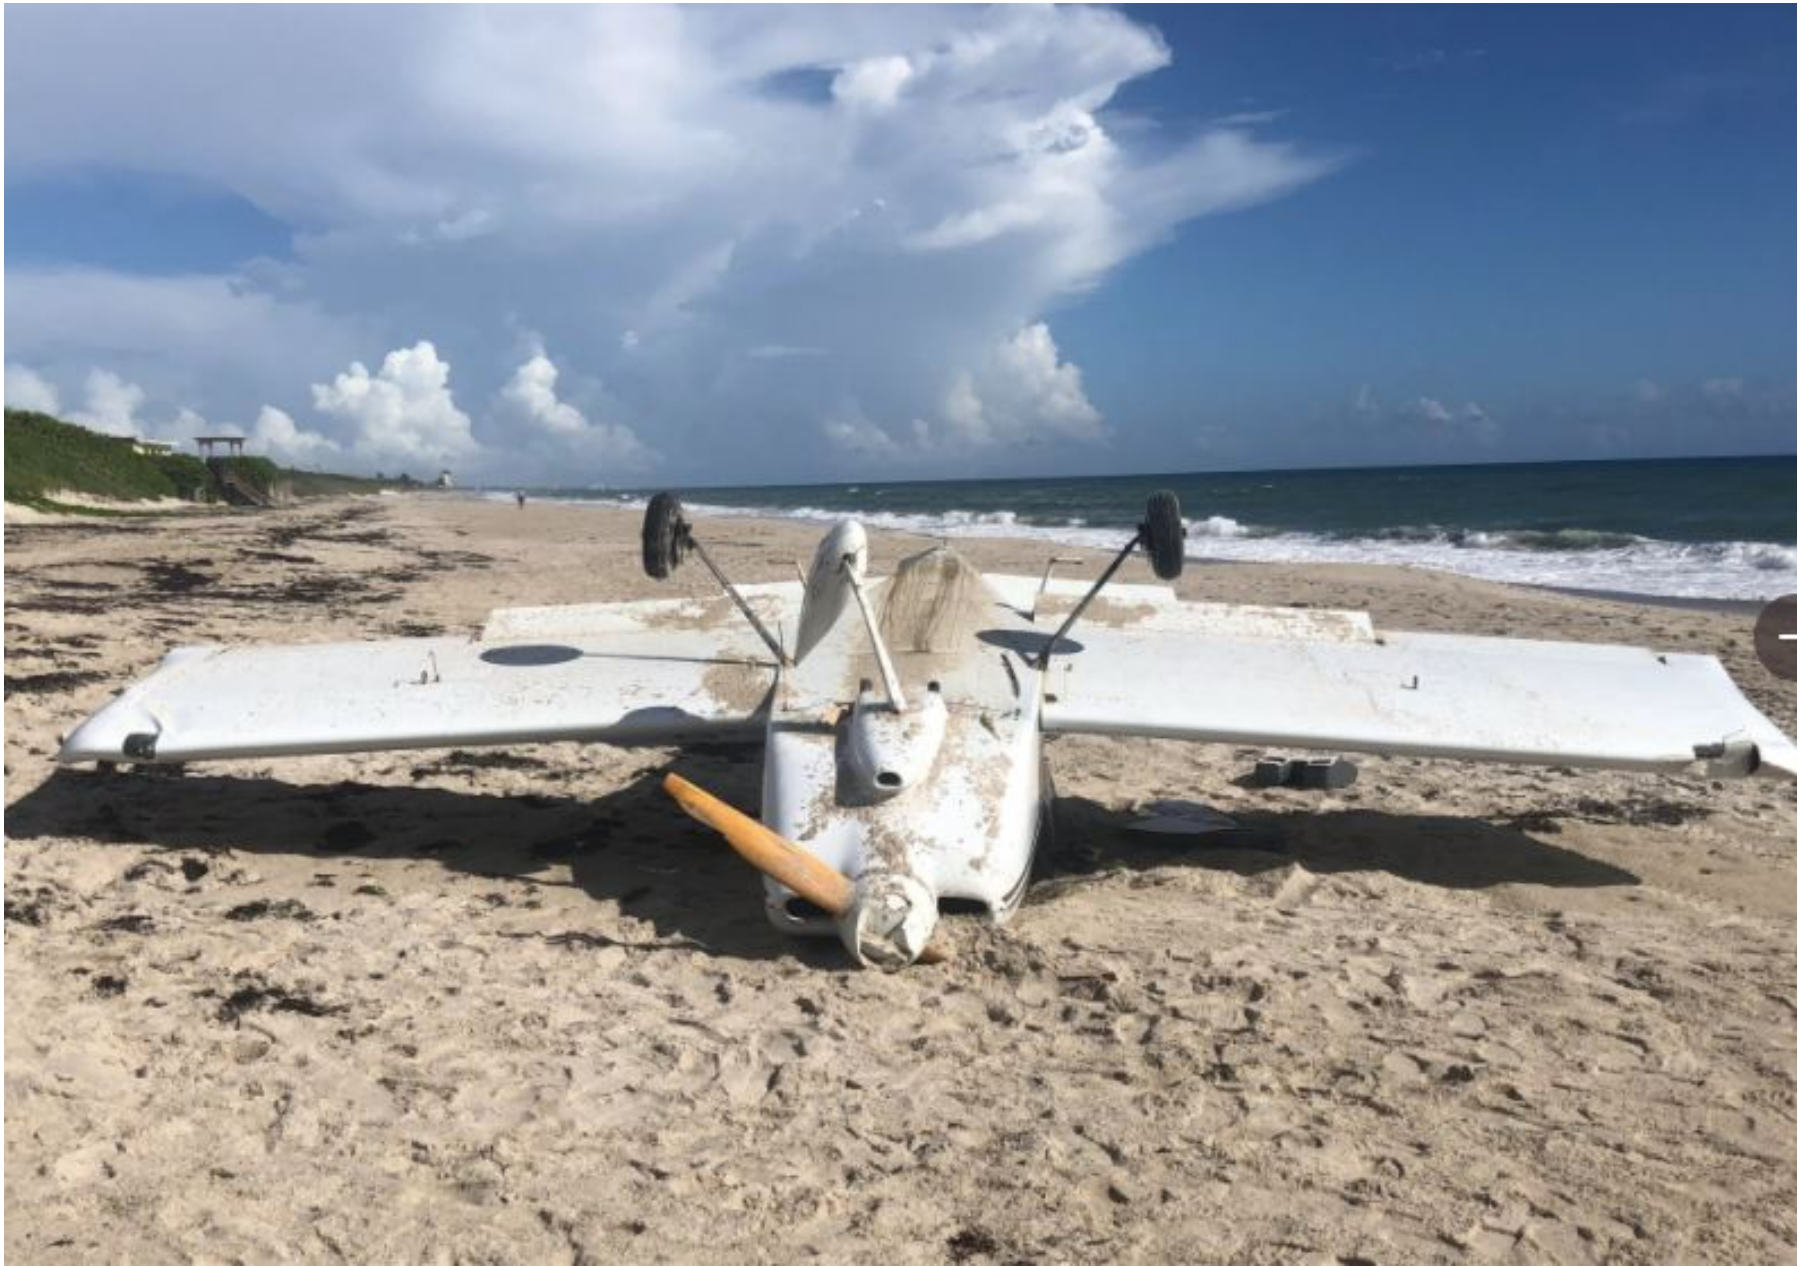
**Photo 1 – View of airplane inverted on beach after forced landing (also showing oil streaks on underside)**

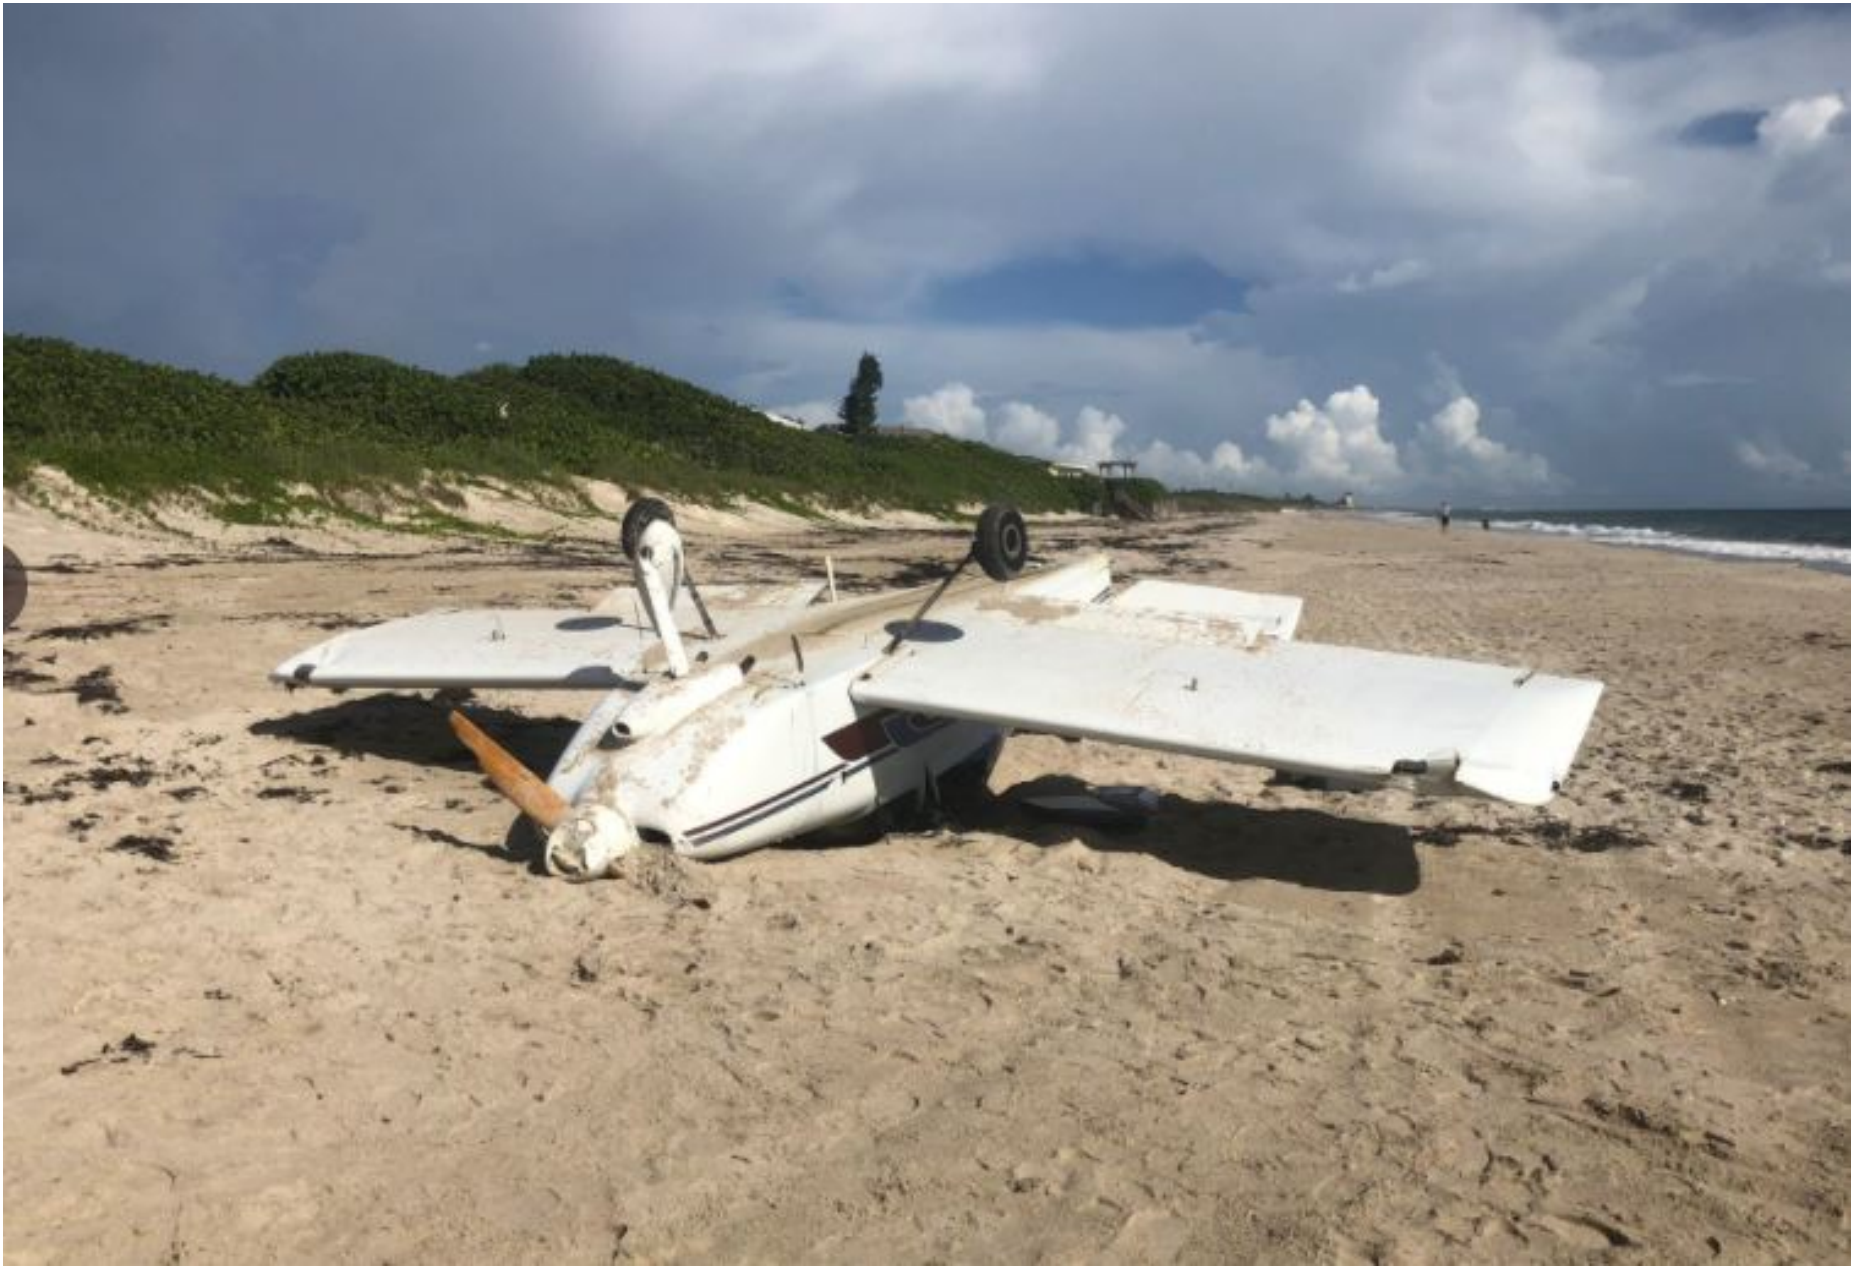
**Photo 2 – View of airplane wreckage inverted showing oil streaking**

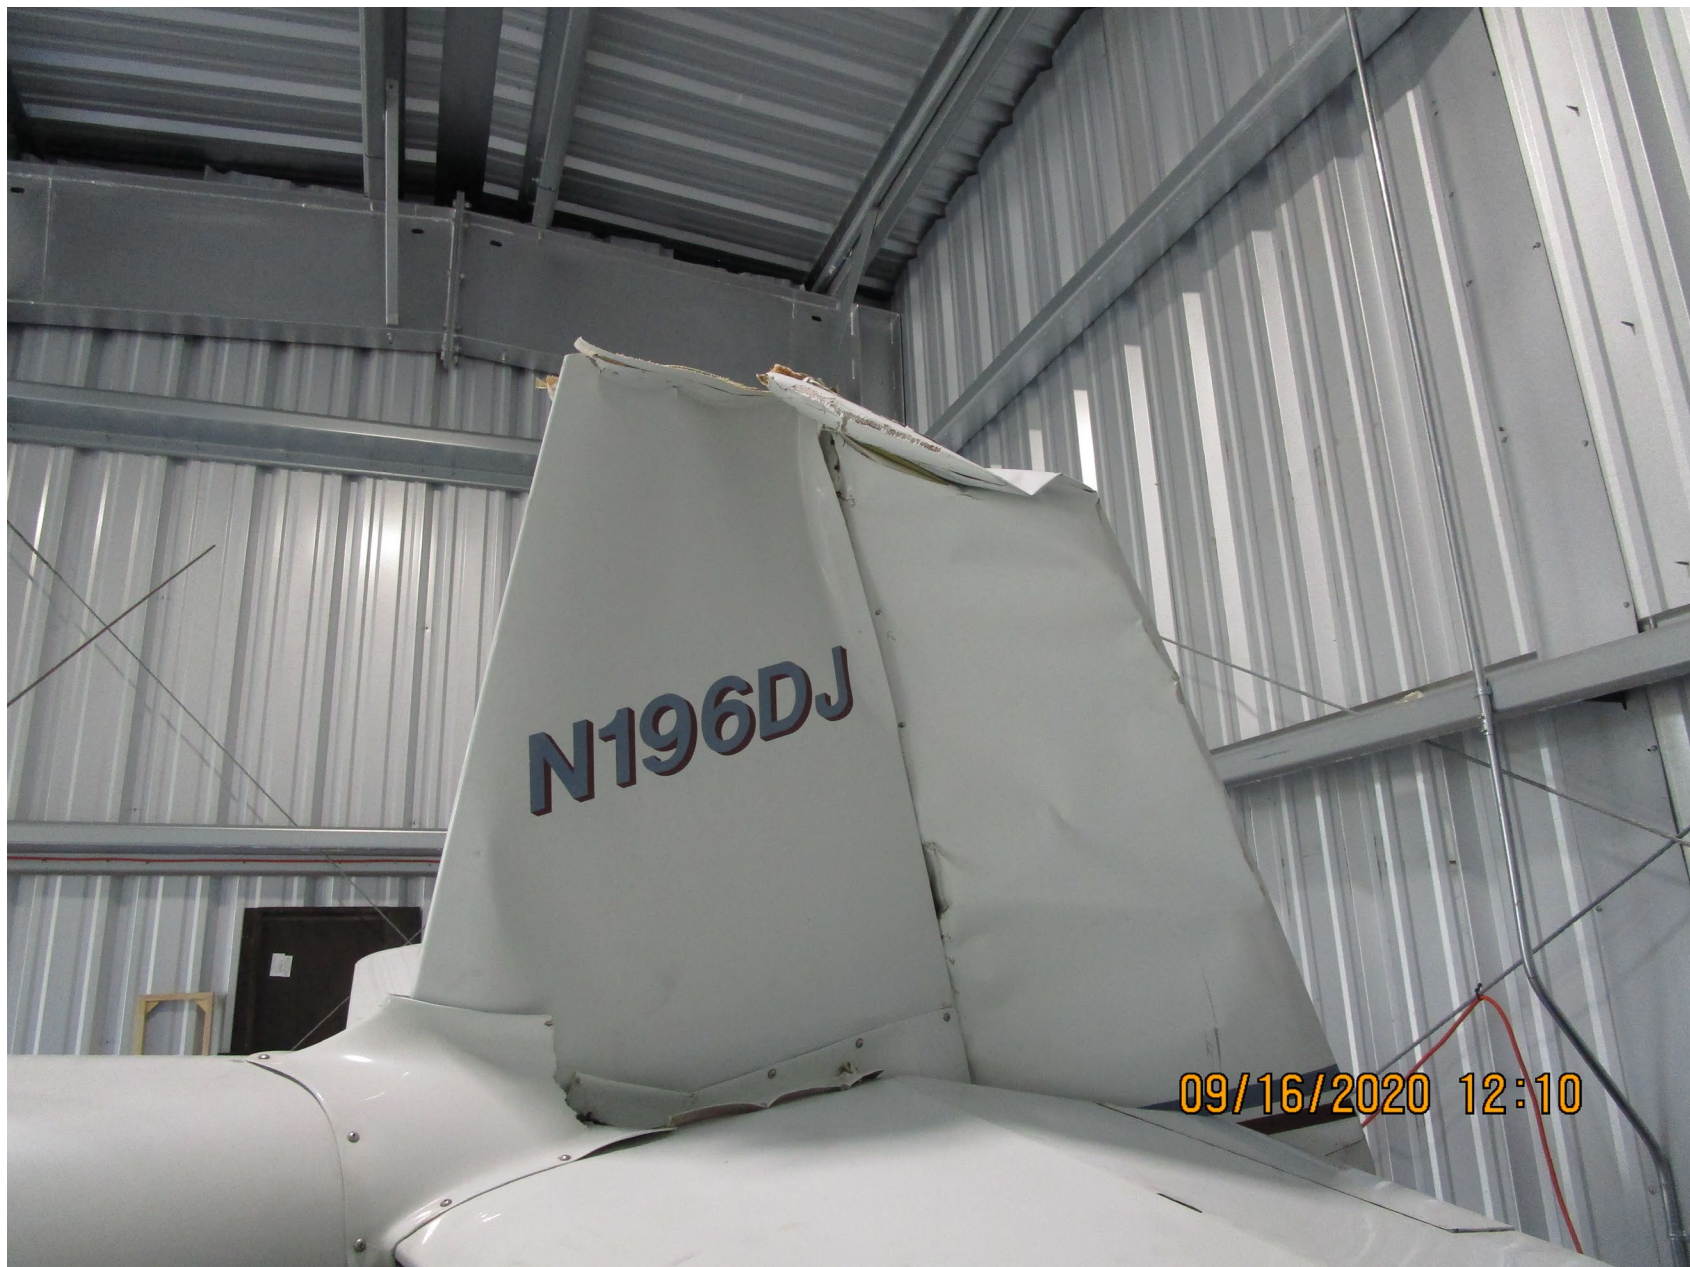
**Photo 3 – View of damaged vertical stabilizer and rudder**

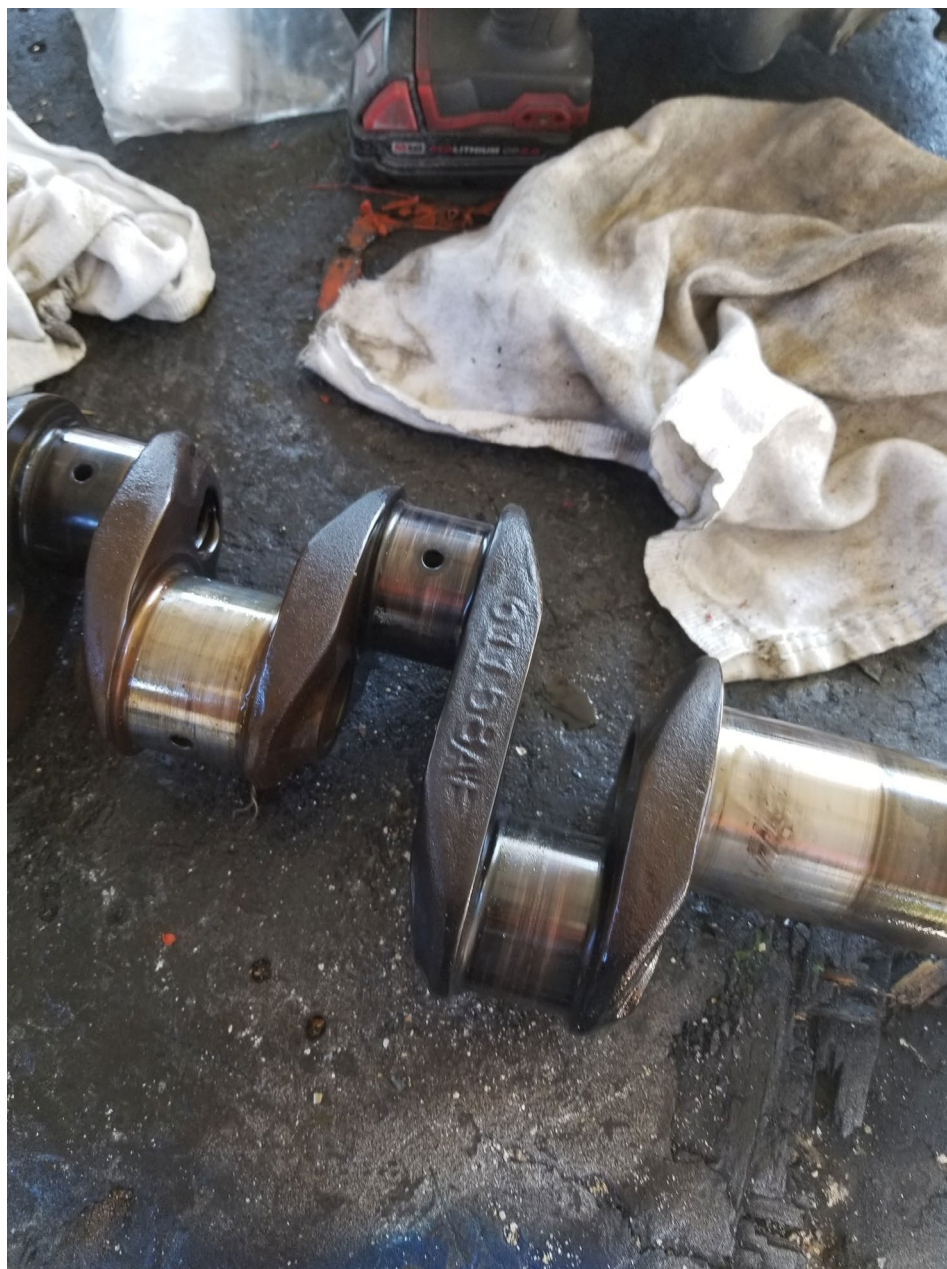
**Photo 4 – View of crankshaft showing overheating on journals.**
