**NATIONAL TRANSPORTATION SAFETY BOARD**

**FIELD ENGINE EXAMINATION**

**ERA20LA320**

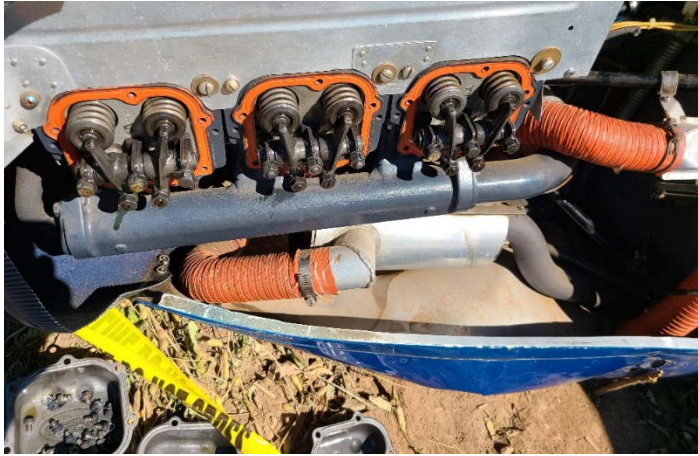
When holding down the tail of the airplane, it was possible to turn the propeller about  $\frac{3}{4}$  of a revolution. It turned freely but was limited by contact of the straight blade with the ground. Spark plugs were removed and appeared serviceable and undamaged. Thumb compression was obtained on two cylinders. Five of the six rocker valve covers were removed and upon turning the propeller, the valve rocker arms moved. The magneto impulse coupling could also be heard.

Photo 1: Cylinders 1, 3, 5 with covers removed (Photo courtesy of Federal Aviation Administration)

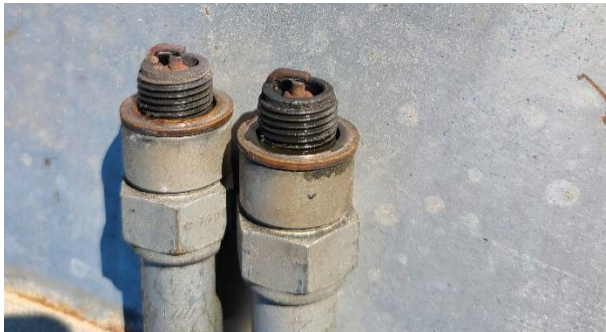
Photo 2: Spark Plugs (Photo courtesy of Federal Aviation Administration)

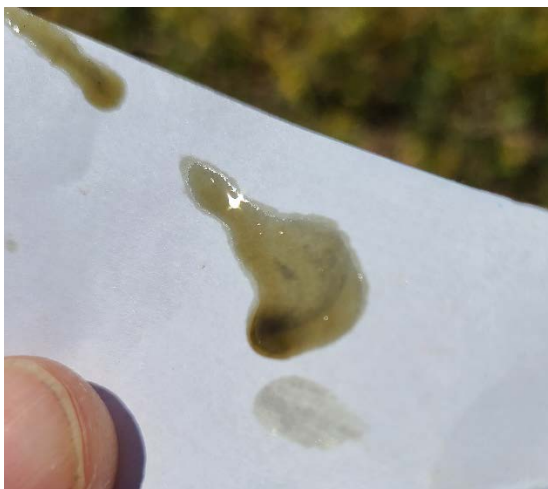
The fuel had already been removed from both wing tanks prior to the exam. Fuel was drained from the gascolator and the carburetor bowl drain. The fuel was blue and free of contaminants. Air was blown through the fuel cap vent tubes to the carburetor fuel supply hose and the vents and fuel lines were found to be free of obstruction. The carburetor screen was free from obstruction. Fine metal sparkles were visible in the oil, consistent with an airplane that sat for an extended period.

Photo 3: Bits of shiny particles in oil (Photo courtesy of Federal Aviation Administration)
