**NATIONAL TRANSPORTATION SAFETY BOARD**

**ENGINE EXAMINATION 2**

**ERA20LA320**

Follow-up examination of N336C, a Stinson 108-2, 1947, was conducted on October 7, 2020 at Blairstown Airport, Blairstown, NJ. Examination of the airframe revealed a disconnected mixture control arm in the cut-off position.

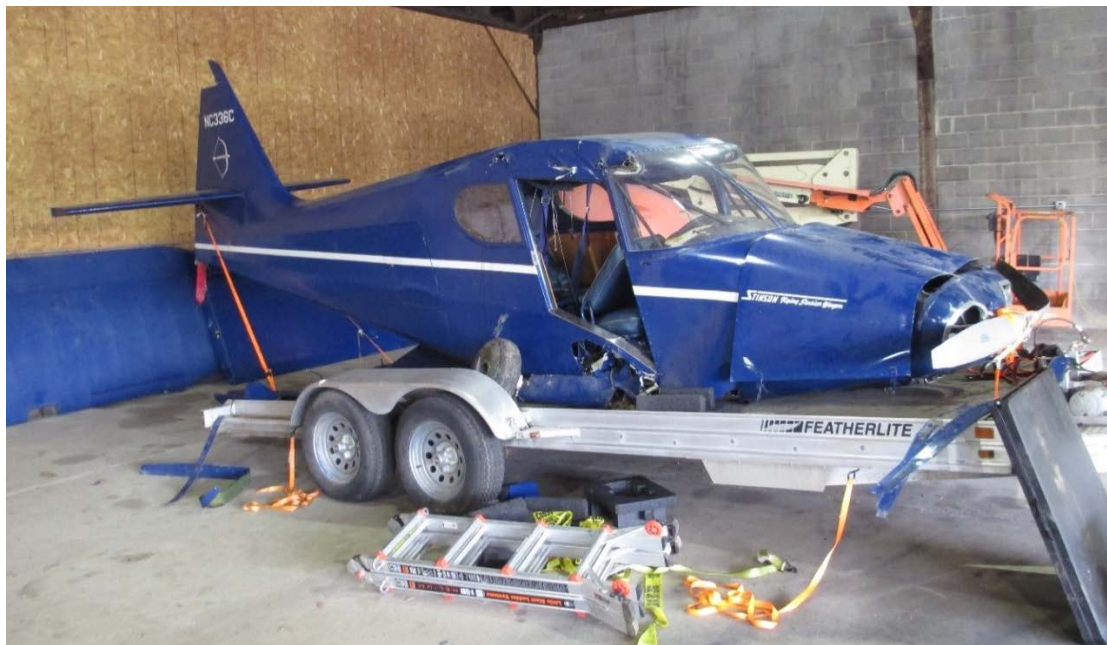
*Photo 1: Airplane with wings removed (Photo Courtesy of Federal Aviation Administration)*

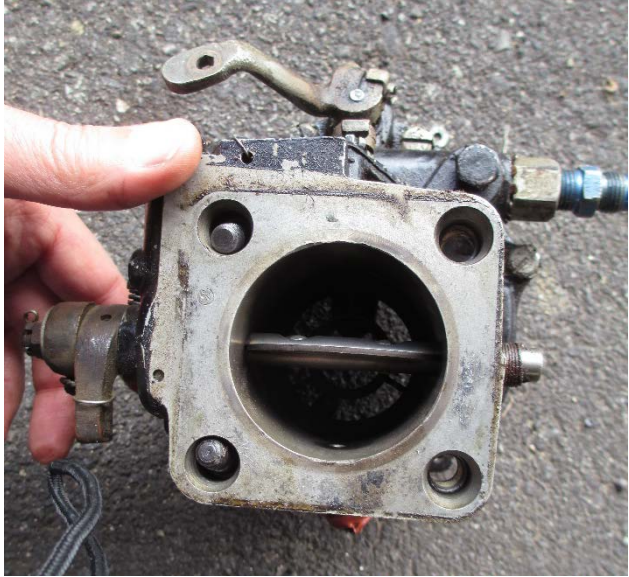
No obstructions were found in carburetor or induction system. Induction air filter present and unremarkable.

*Photo 2: Carburetor throat and throttle valve (Photo courtesy of Federal Aviation Administration)*

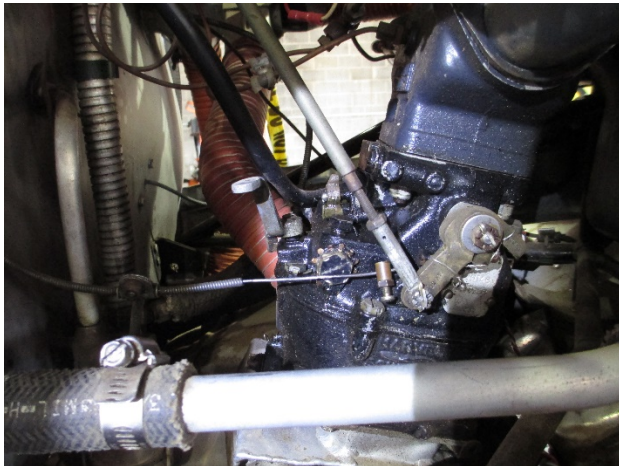
Carburetor mixture control found disconnected at carburetor. Throttle control and carburetor heat control found connected and secure. Carburetor mixture lever on carburetor found in idle cutoff position, throttle lever on carburetor found in full power position, carburetor heat found in off position. Continuity for all engine controls were established; however, travels could not be verified (throttle due to impact related structural deformation of aircraft/engine mount, mixture due to disconnection, carburetor heat due to impact related damage to carburetor heat box).

*Photo 3: Disconnected mixture control cable (Photo courtesy of Federal Aviation Administration)*

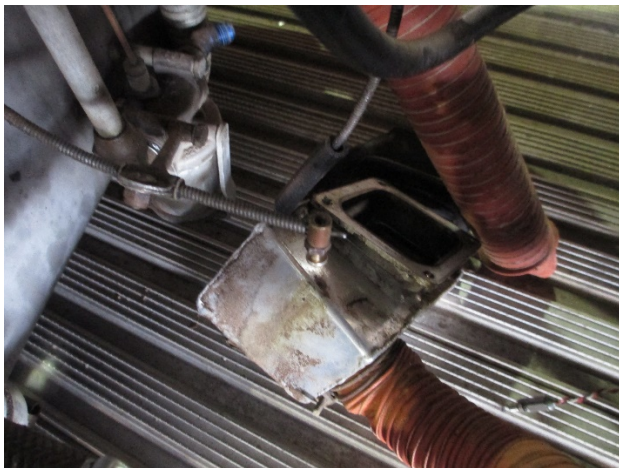
*Photo 4: Mixture control cable connector fitting (Photo Courtesy of Federal Aviation Administration)*
