# NATIONAL TRANSPORTATION SAFETY BOARD

## MATERIALS LABORATORY FACTUAL REPORT

Report No. 21-032

Place : Moosic, Pennsylvania  
Date : 09/20/2020  
Vehicle : Piper PA-28R-180, N3790T  
NTSB No. : ERA20LA322  
Investigator : Timothy W. Monville

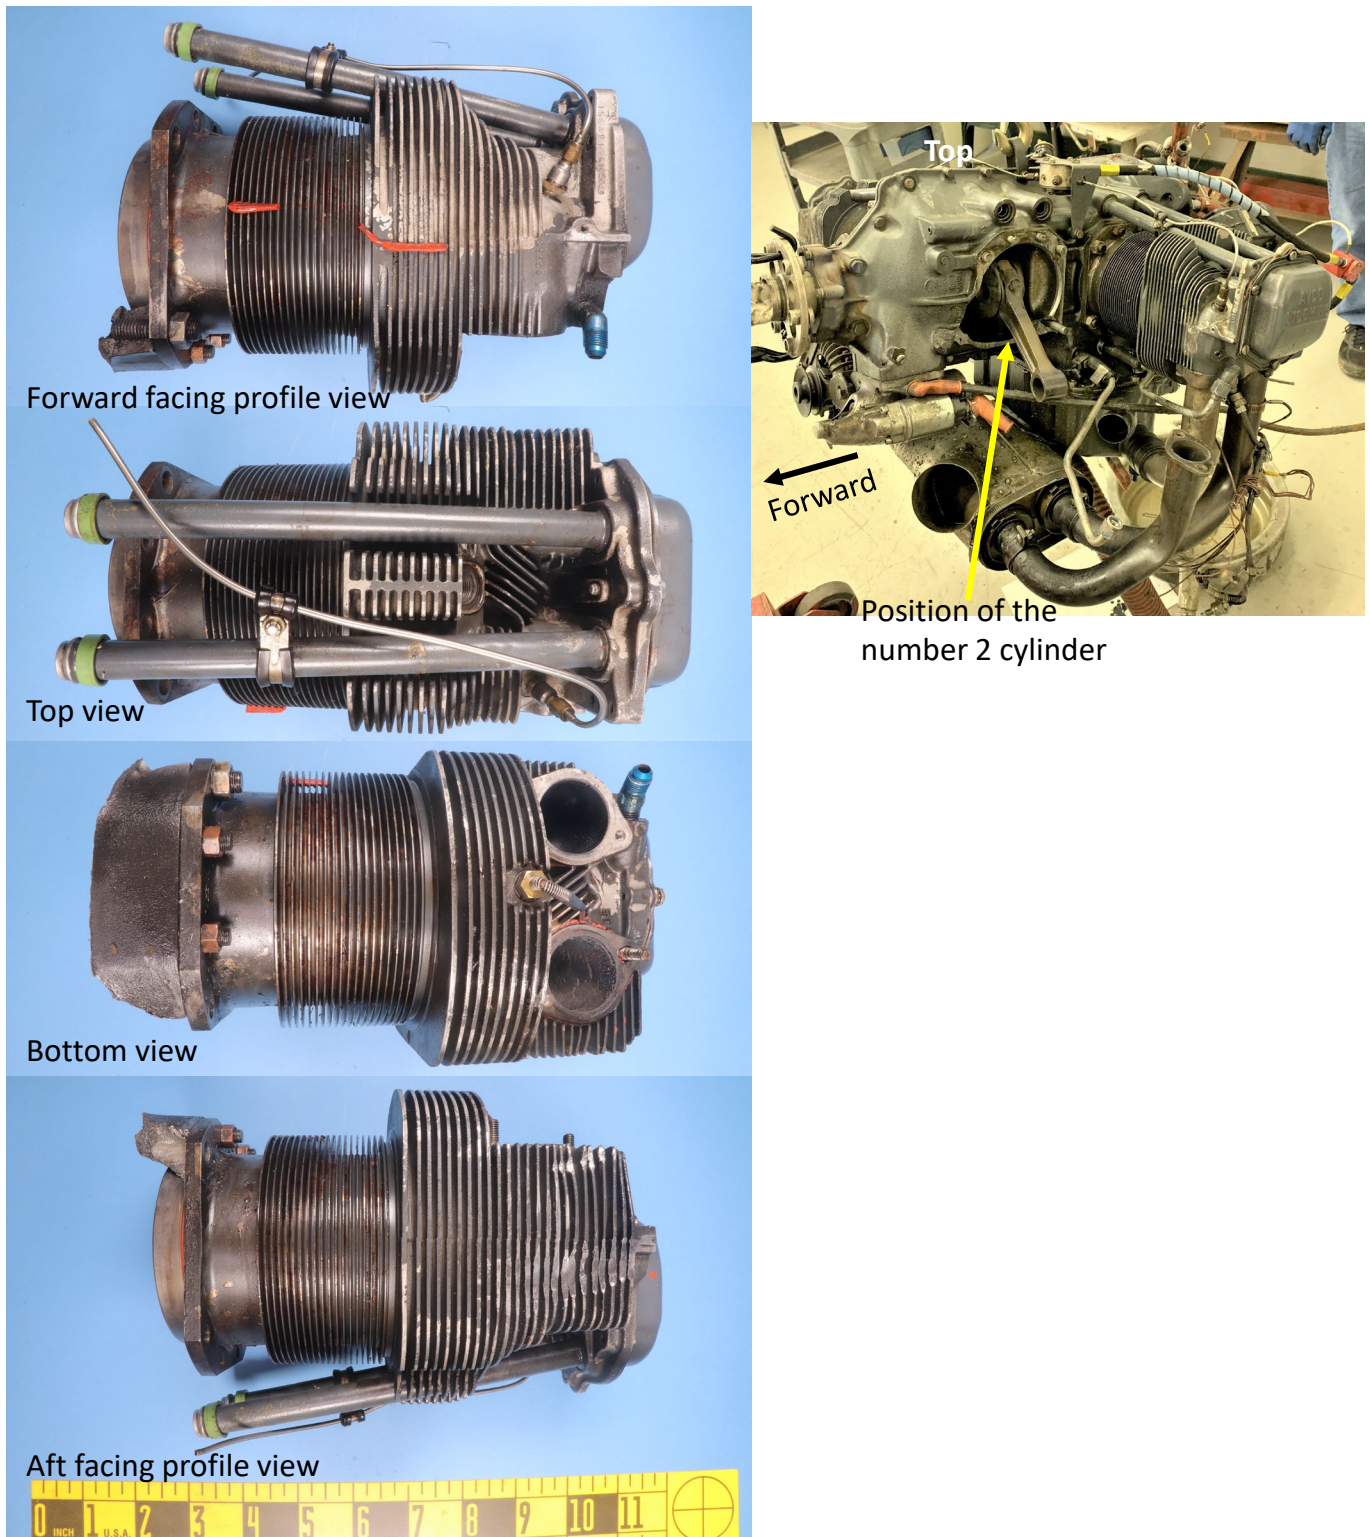
Figure 1 Top, bottom and profile views of the as-received number 2 cylinder.

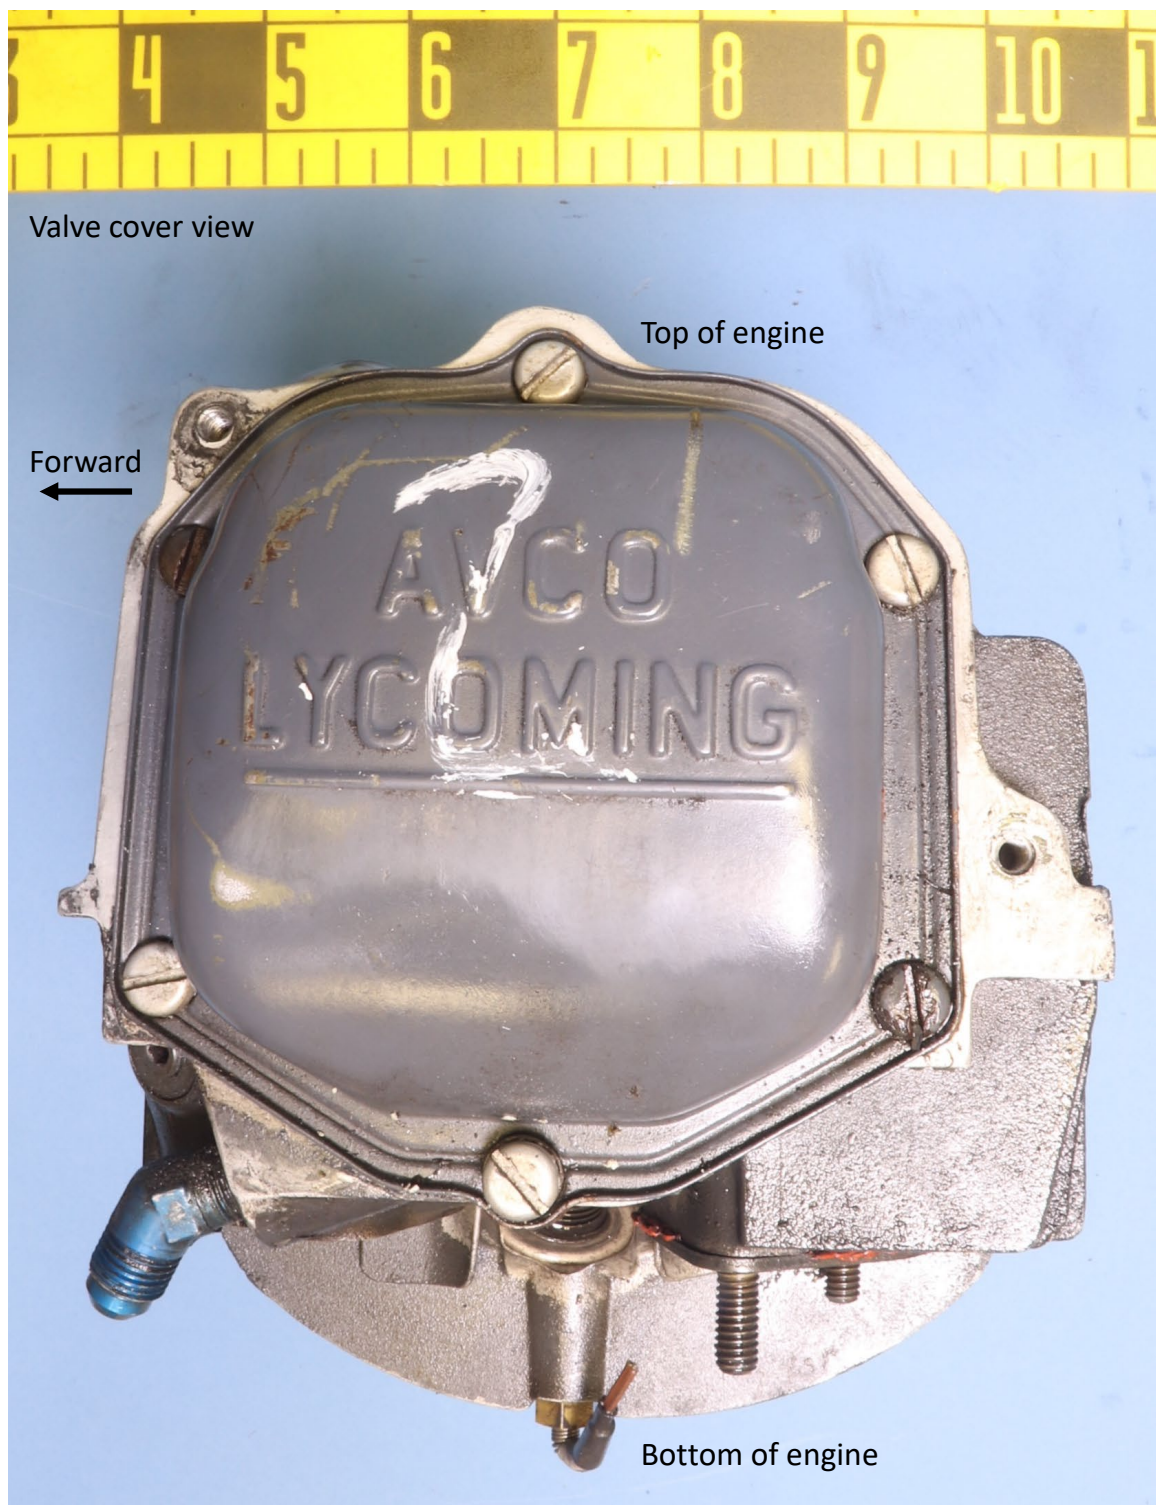
Figure 2 Valve cover view of the as-received number 2 cylinder.

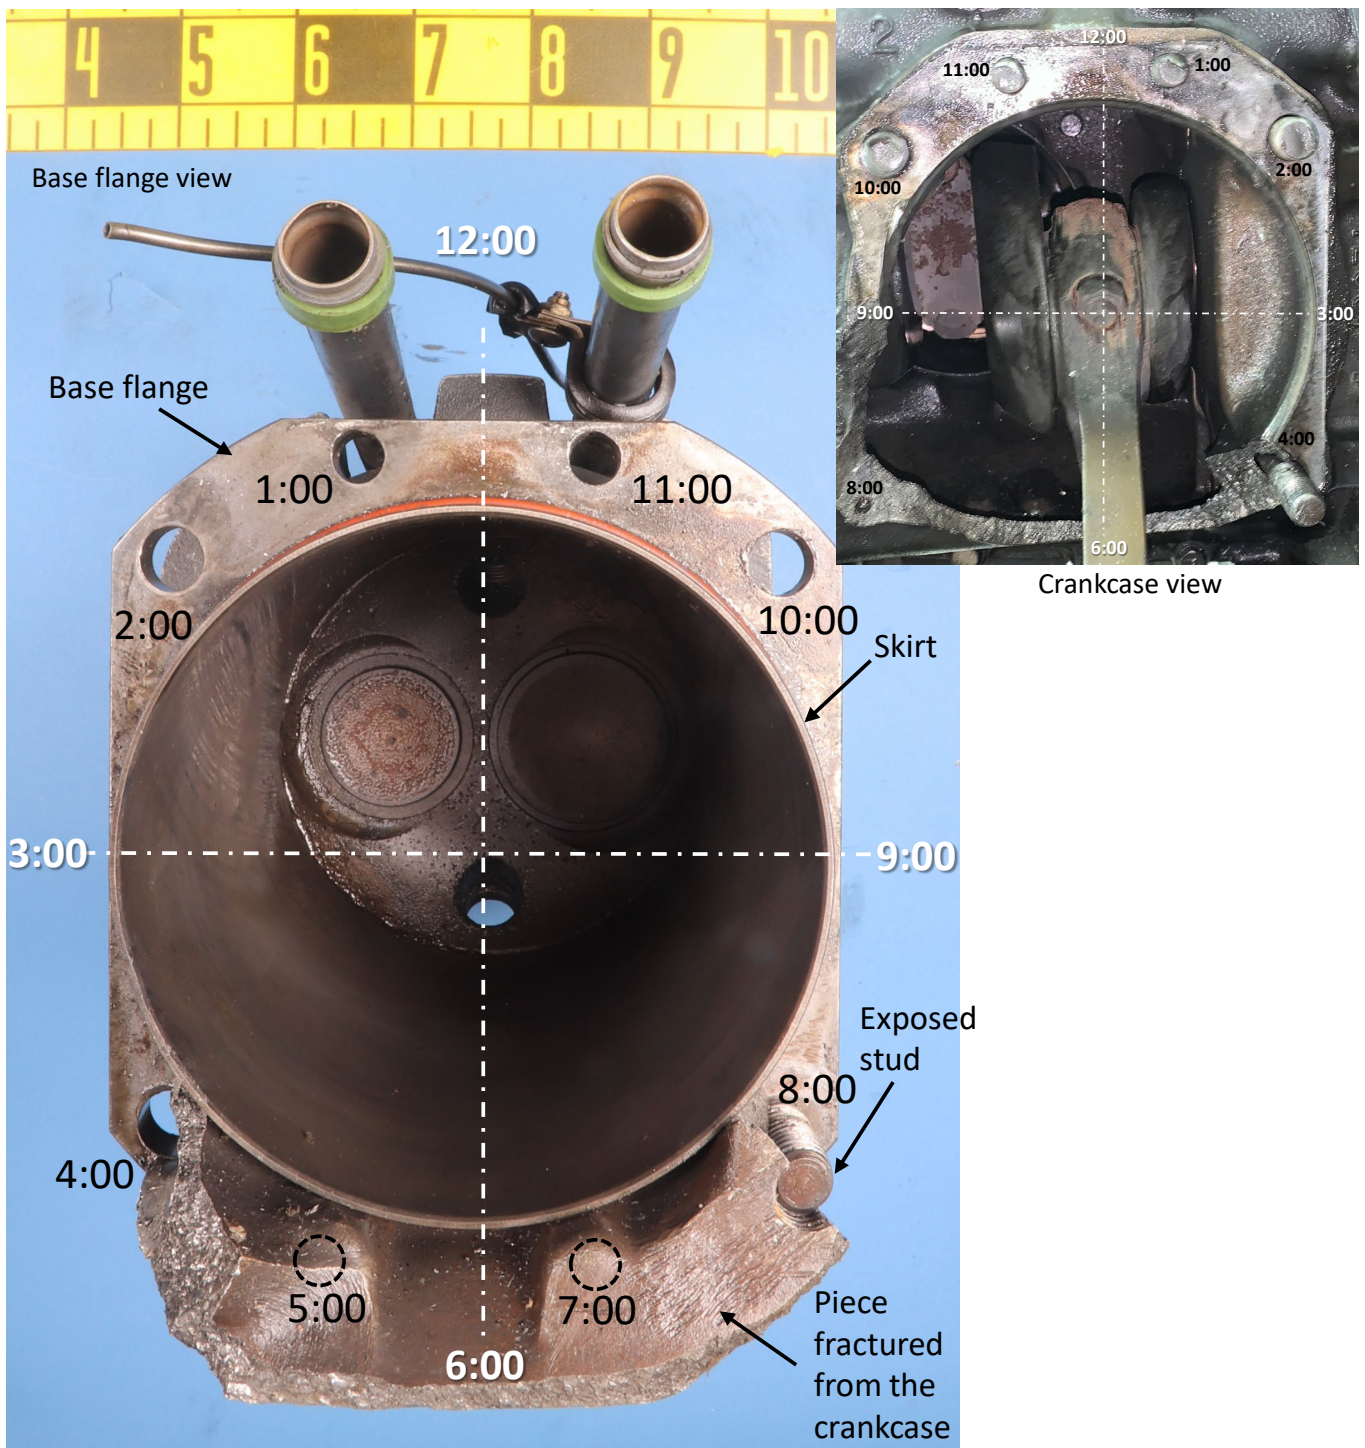
Figure 3 Base flange view the of the as-received number 2 cylinder. The stud positions are annotated in the image based on clock positions.

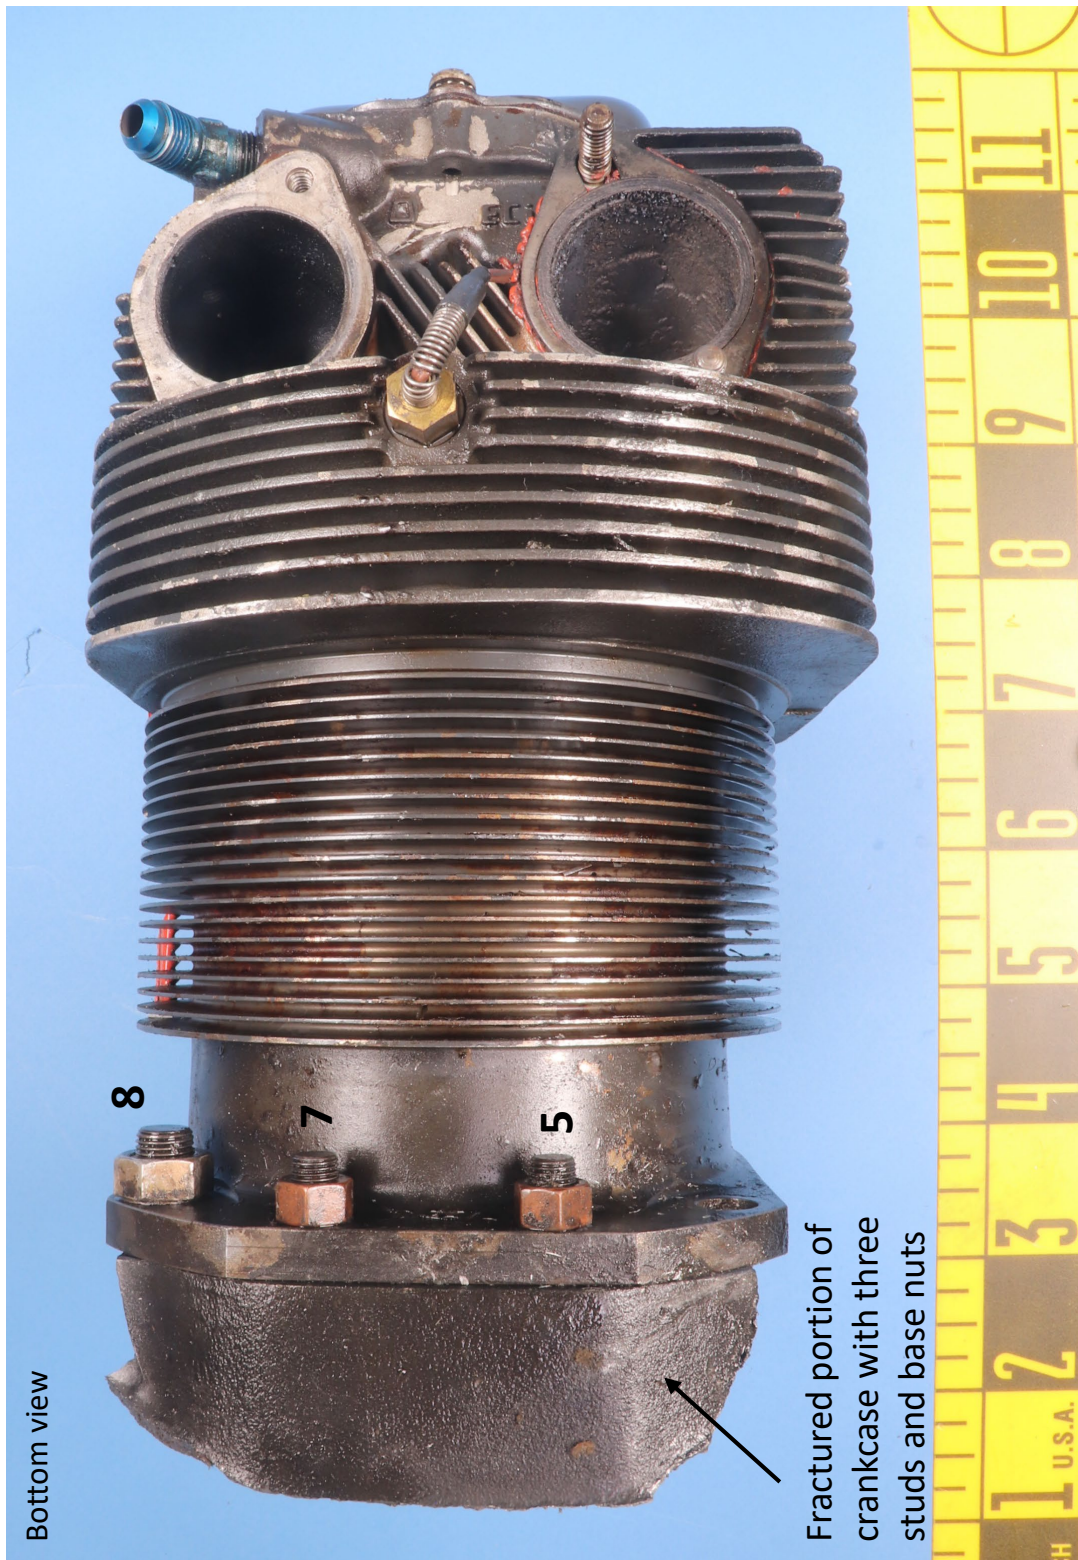
A bottom view of the cylinder in Figure 4 shows a fractured portion of the crankcase that remained attached to the number 2 cylinder through clamping force provided by the 5:00, 7:00 and 8:00 studs.

Figure 4 Bottom view of the cylinder shows a fractured portion of the crankcase that remained attached to the cylinder through clamping force provided by the 5:00, 7:00 and 8:00 studs.

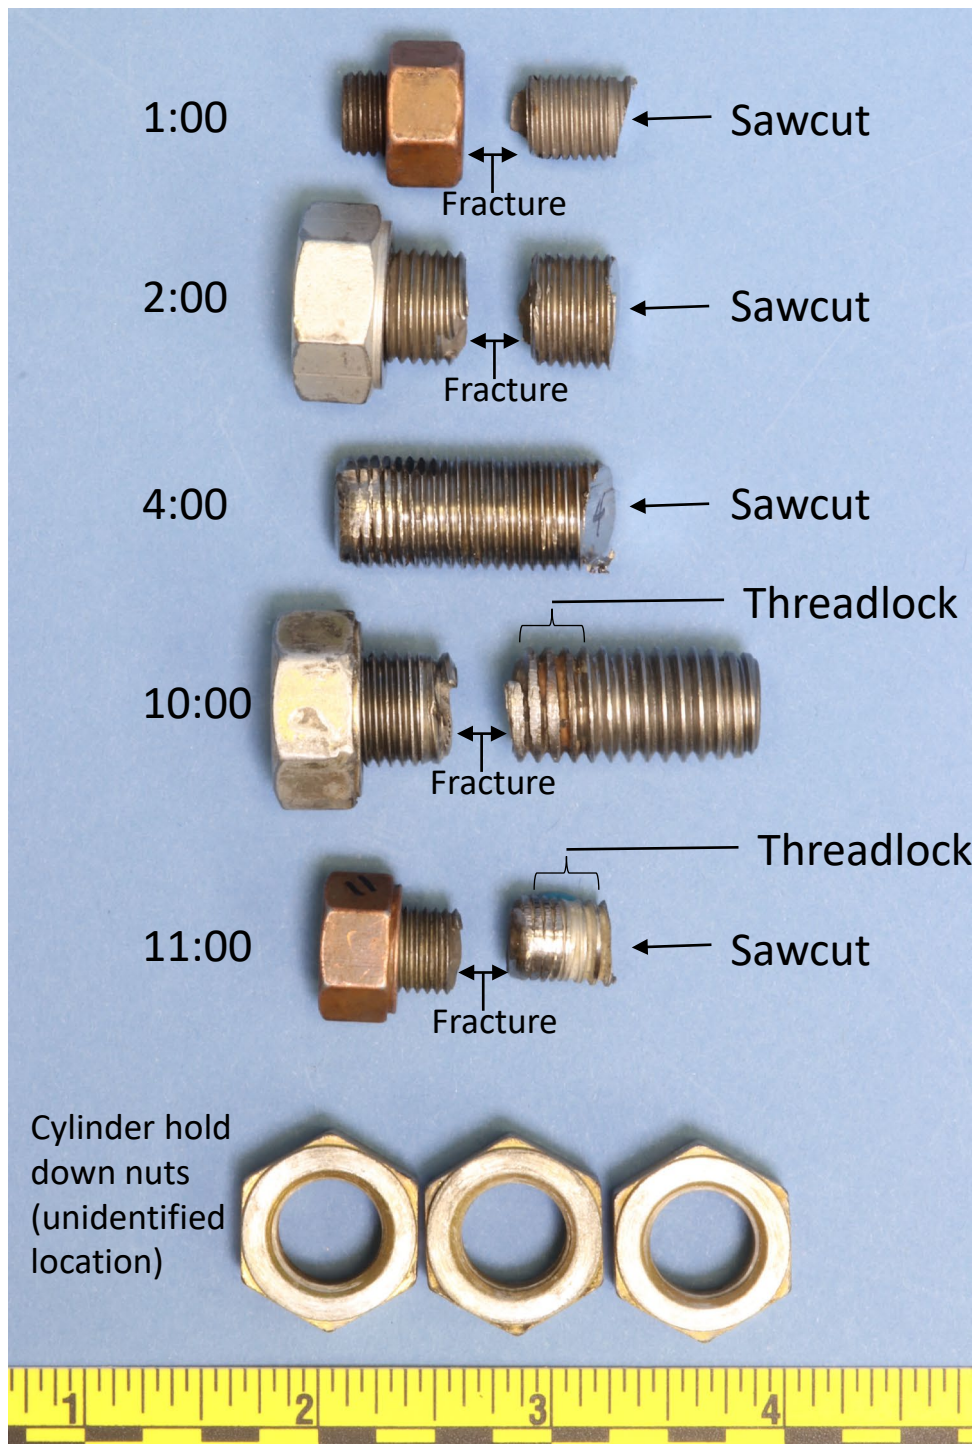
The as-received base studs (anchored and free-thru) and hold down nuts retained during the engine teardown are shown in Figure 5. The stud pieces are numbered according to their installation clock position (see Figure 3 for reference).

Using a 5X to 50X stereo zoom microscope and a UV light source, the stud remnants were examined for the presence of an acrylic thread locking adhesive. Studs in the 8:00, 10:00, and 11:00 positions exhibited a thread locking compound on some of the threads engaged in the crankcase (see Figures 5 and 6).

Figure 5 The as-received stud pieces with base nuts. In some instances, the lower portion of the stud was saw-cut from the crankcase. Three hold down nuts were submitted but the locations were not identified.

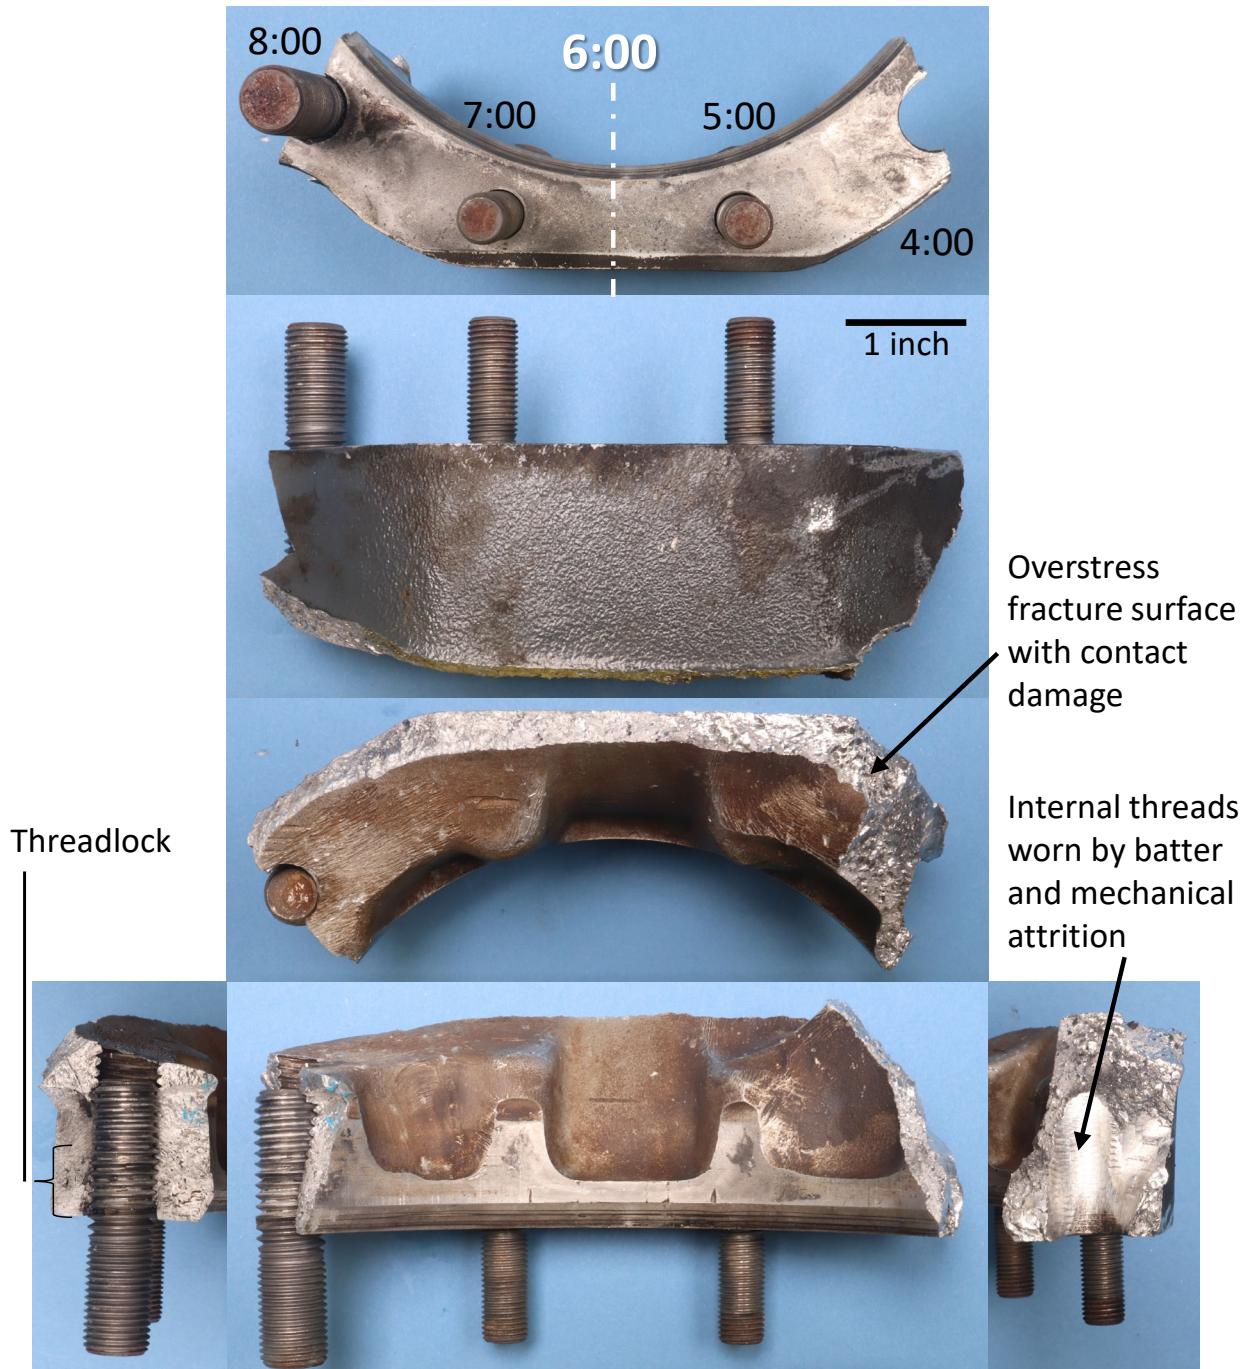
The portion of crankcase that remained attached to the number 2 cylinder (see Figure 4) was removed as shown in Figure 6. The nut torque for the 5:00 and 7:00 studs was measured using an RS Technologies Model 962 Load and Torque Recorder with a 5 to 50 lb-ft transducer. The nut on the 8:00 stud was removed using a wrench and the nut torque was not measured. The approximate torque values are summarized in the table below.

The fracture surface on the crankcase remnant was examined using a 5X to 50X stereo zoom microscope. The fracture features were consistent with overstress fracture in an aluminum casting. No injurious casting defects were noted on the fracture surface. As indicated in Figure 6, the threaded hole for the 4:00 free-thru stud position exhibited batter and mechanical attrition such that the threads were almost entirely worn away and the hole was enlarged.

Figure 6 Images of the fractured portion of crankcase with three studs that was attached to the number 2 cylinder base flange.

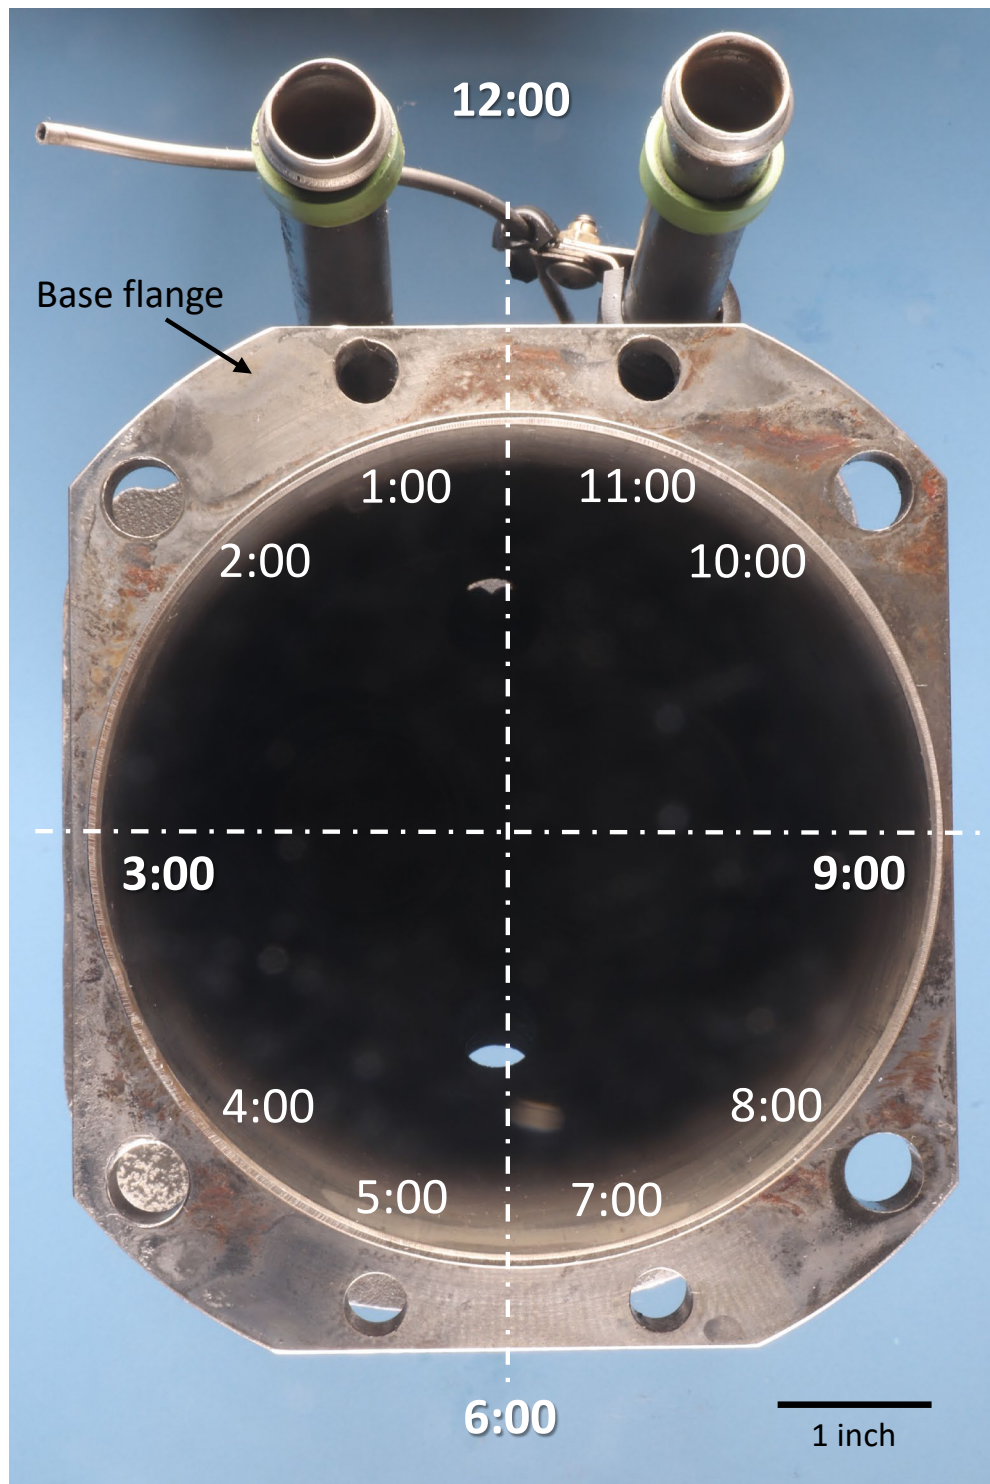
Figure 7 shows the face of the base flange that mates with the crankcase. The clock positions of the mounting studs are noted in the figure as well as the clock position datums. Areas of darker discoloration on the face of the base flange are areas of material loss and oxidation typical of fretting wear scars.

Figure 7 Image of the number 2 cylinder base flange face that mates with the crankcase. The dark regions are areas of material loss and oxidation indicative of fretting wear.

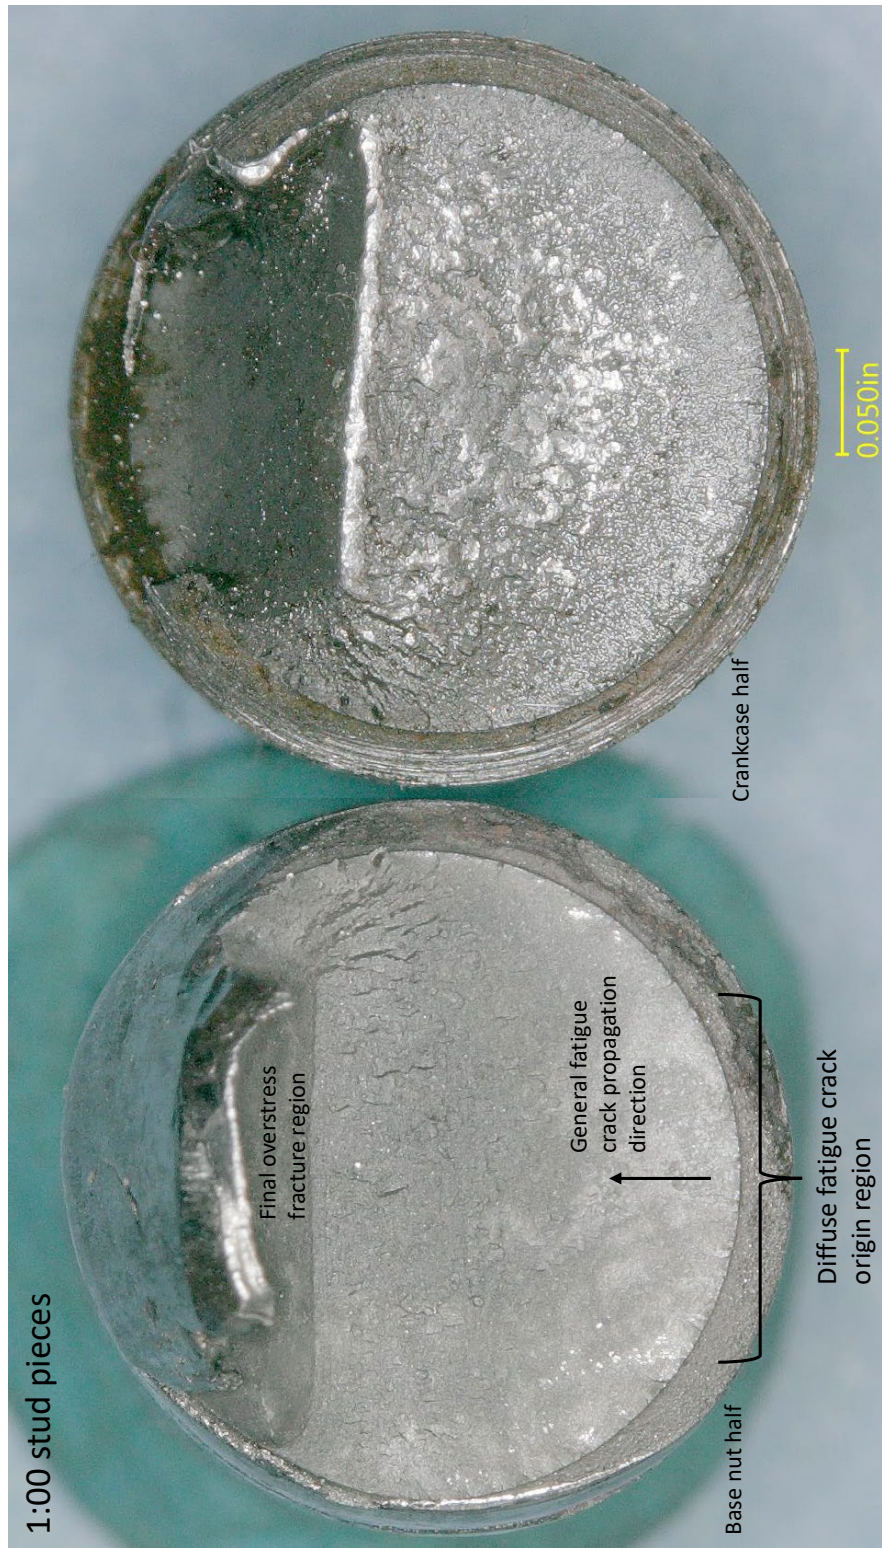
The fracture surfaces on the stud remnants were examined using a 5X to 50X stereo zoom microscope (see Figure 5, pieces from stud locations 1:00, 2:00, 10:00, and 11:00). Figures 8-11 show digital microscope fractographs of the mating stud fracture surfaces. In all instances, diffuse-origin fatigue cracks initiated at the roots of the threads and propagated through about 70 to 80% of the diameter of the stud before succumbing to final overstress fracture.

Figure 8 Fracture surfaces on the mating halves of the stud in the 1:00 position. Annotations indicate the general region of fatigue crack initiation and direction of propagation.

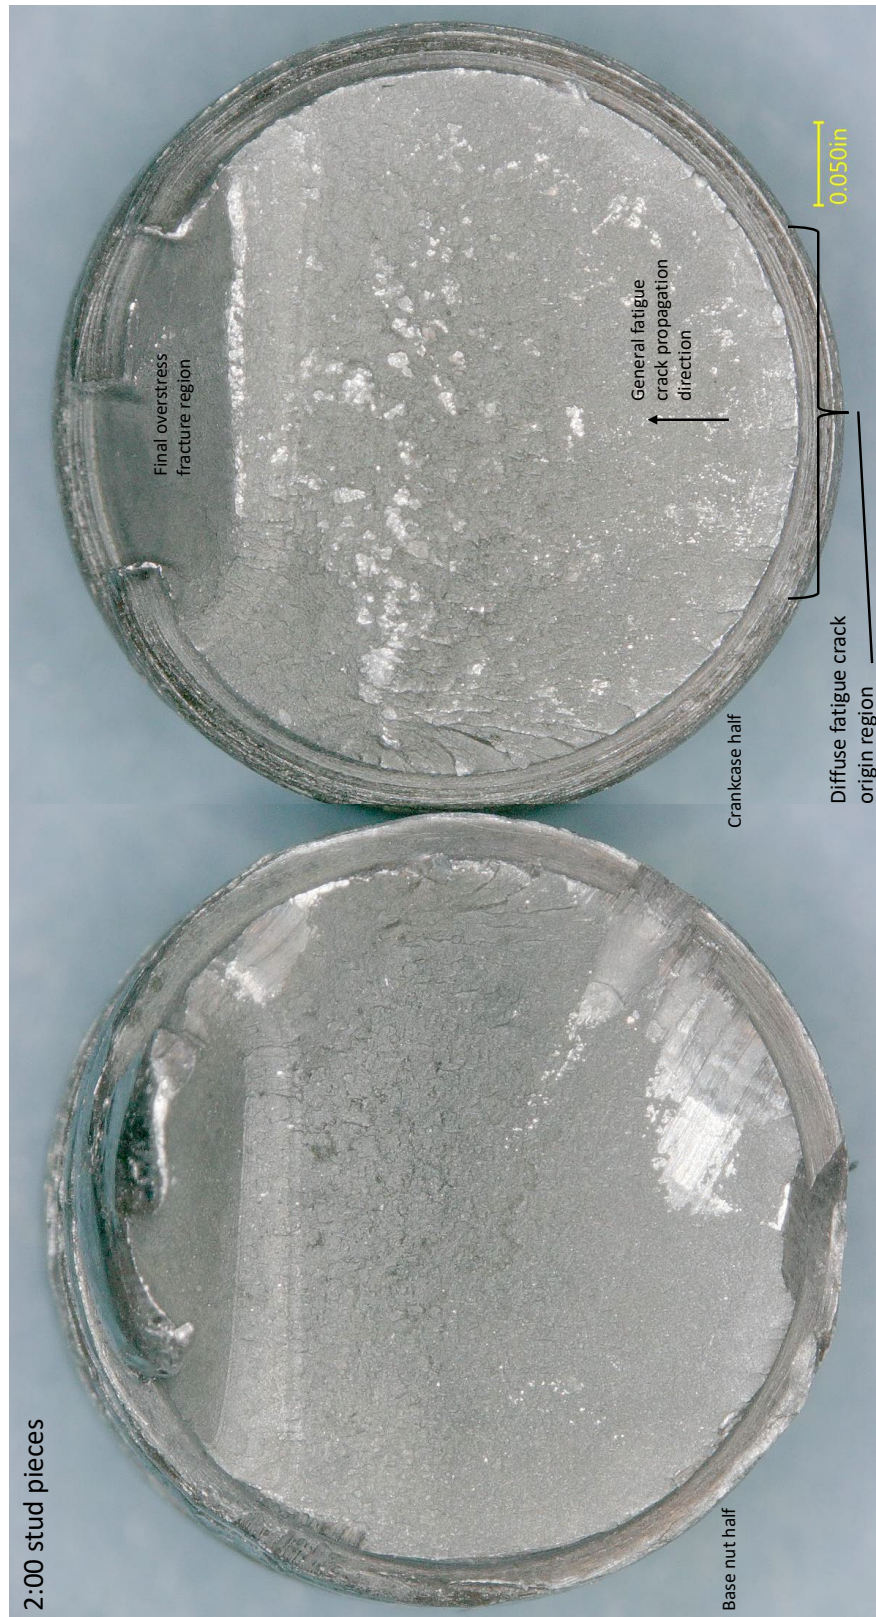
Figure 9 Fracture surfaces on the mating halves of the free-thru stud in the 2:00 position. Annotations indicate the general region of fatigue crack initiation and direction of propagation.

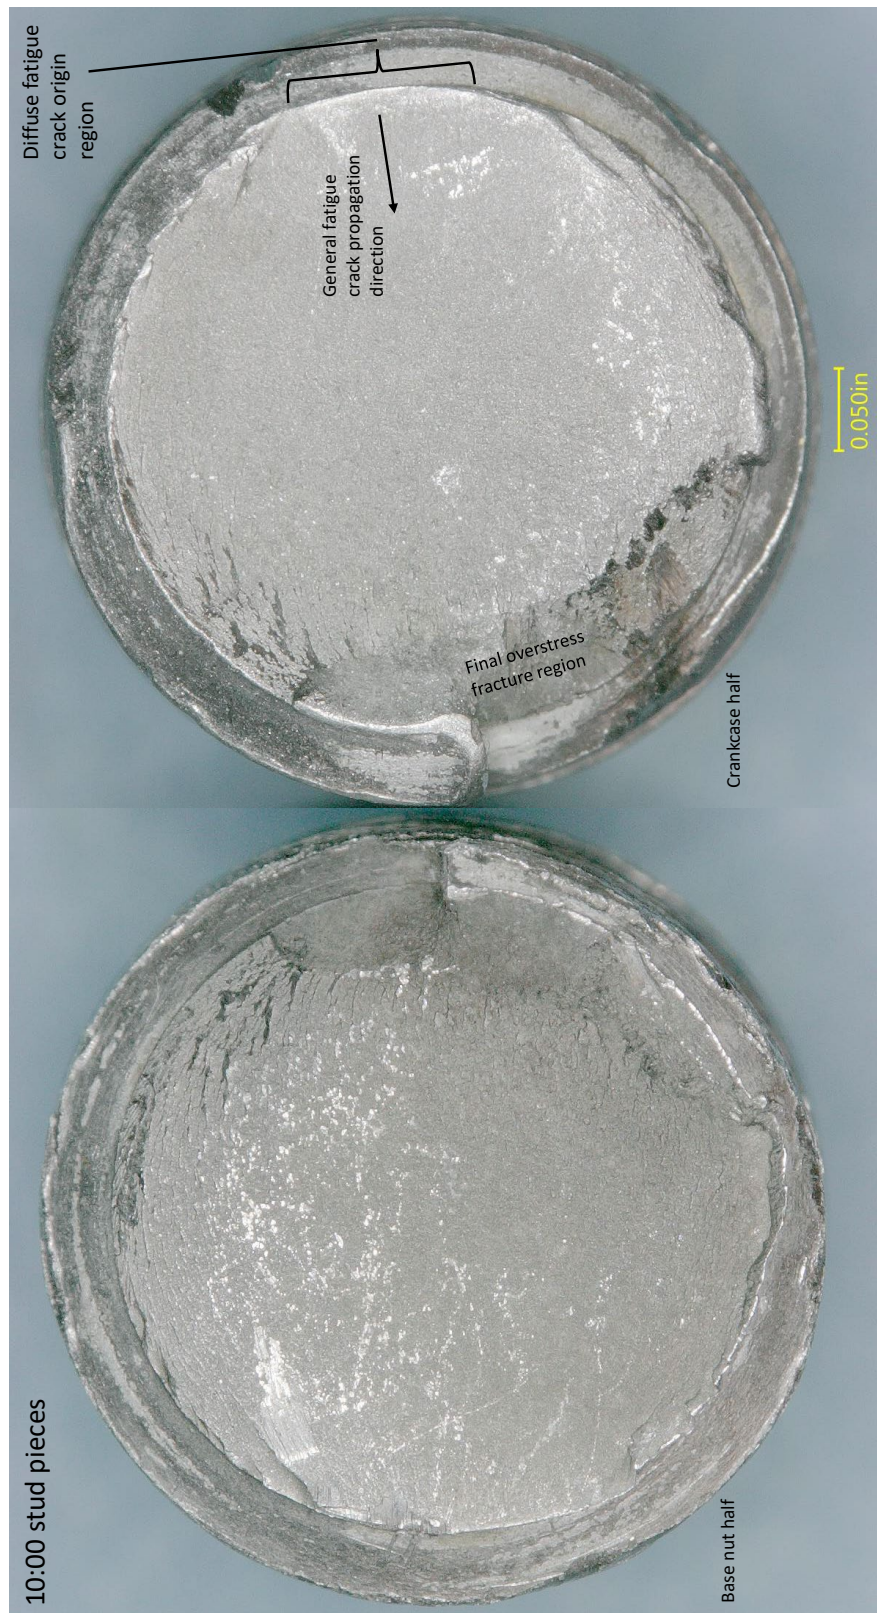
Figure 10 Fracture surfaces on the mating halves of the stud in the 10:00 position. Annotations indicate the general region of fatigue crack initiation and direction of propagation.

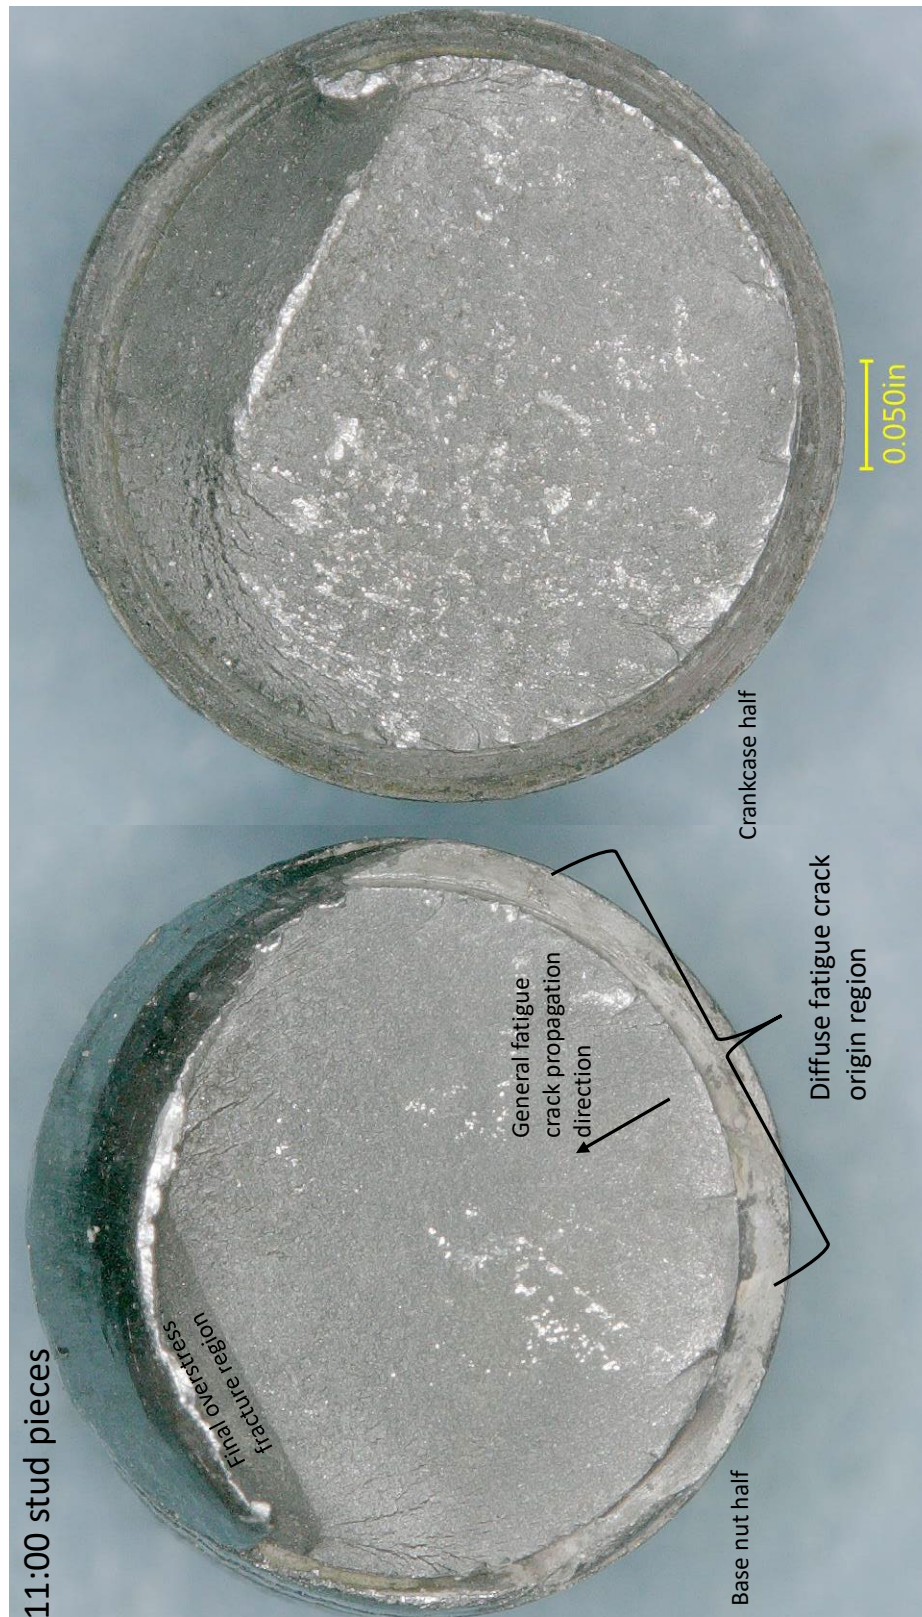
Figure 11 Fracture surfaces on the mating halves of the stud in the 11:00 position. Annotations indicate the general region of fatigue crack initiation and direction of propagation.
