## ENGINE ANALYTICAL INSPECTION REPORT

ENGINE MODEL: IO360B1DA2

ENGINE SERIAL: 03207

REGISTRATION: N800PB

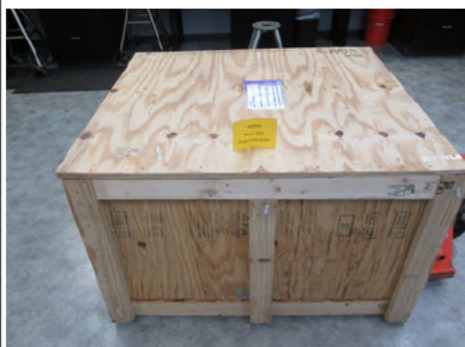
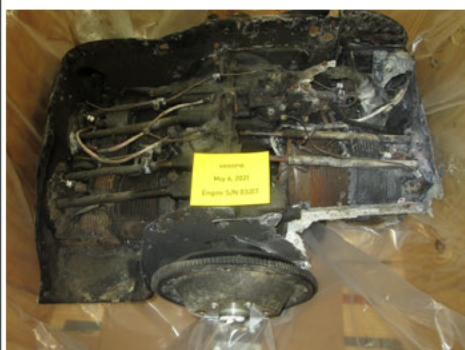
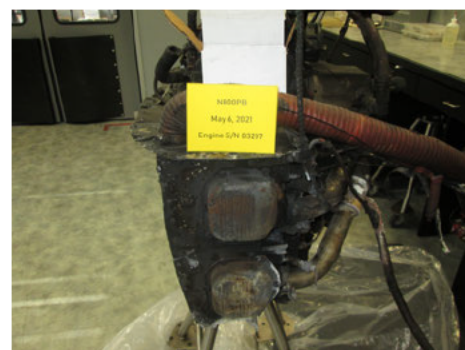
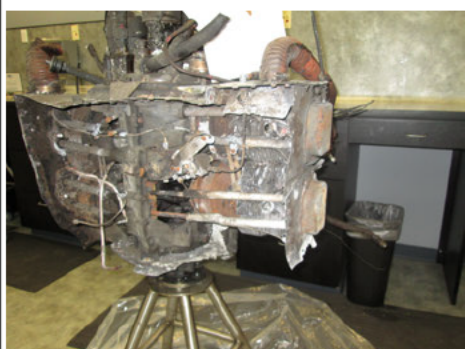
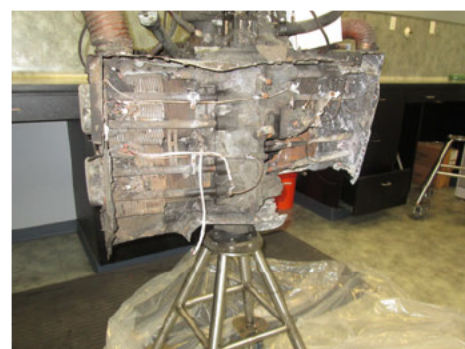
**EXTERNAL INSPECTION OF ENGINE:** The engine was received in a wooden crate and was not NTSB or FAA tagged. The box was undamaged. The engine was wrapped in plastic and secured to the engine crate.

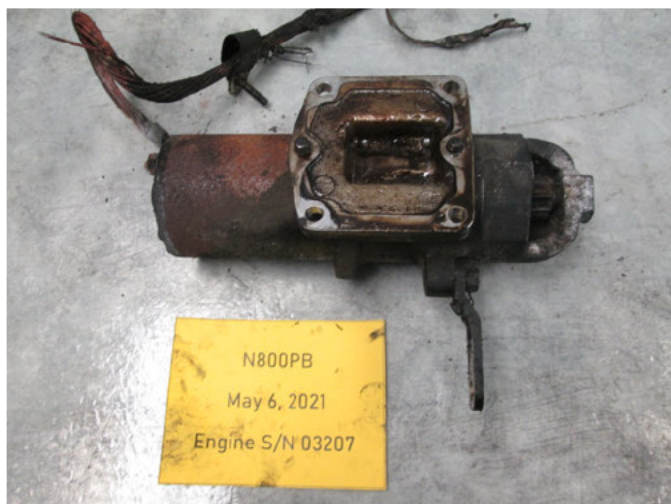
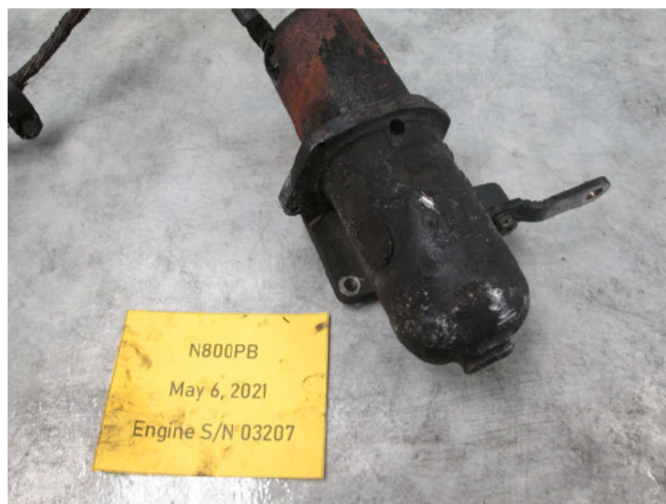
Starter

Condition: The starter was intact and exhibited damage from thermal exposure. The electrical cable remained attached to the starter motor.

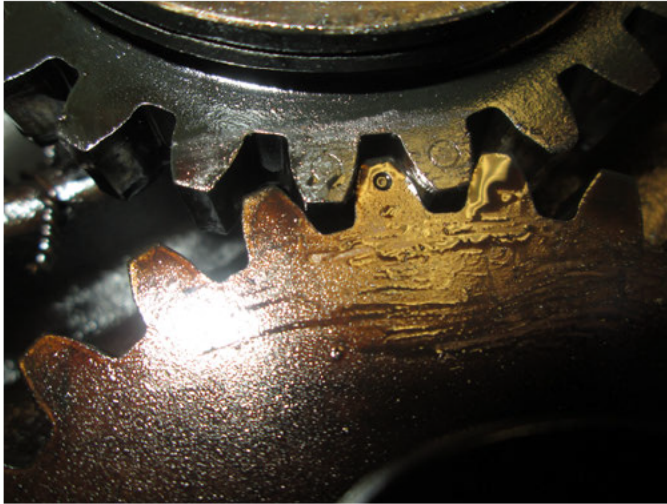
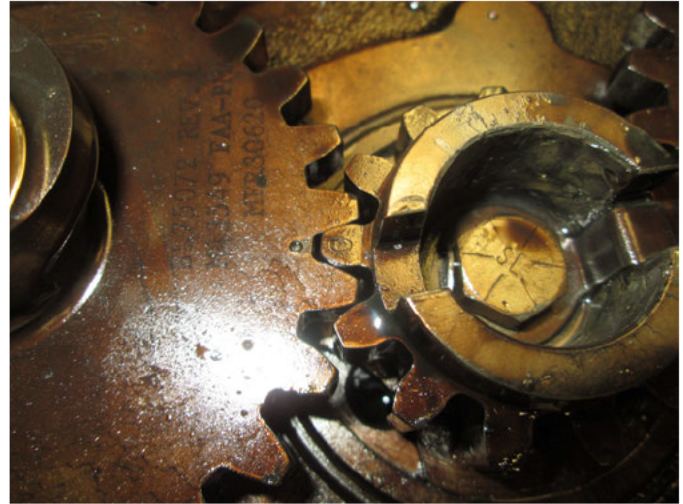
#### Crankshaft to Camshaft Timing

The crankshaft to camshaft timing was verified correct by alignment of the gears and timing marks.

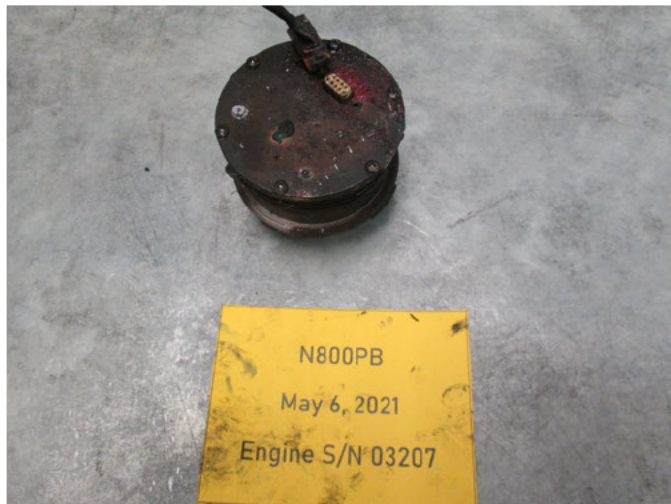
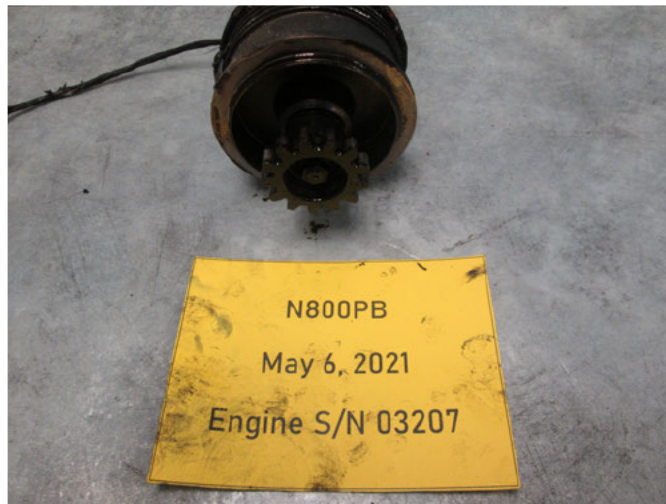
#### L/H EI Controller

Condition: The control unit was securely mounted to the mount flange and exhibited impact and thermal damage. The drive coupling was intact and exhibited normal operational signatures.

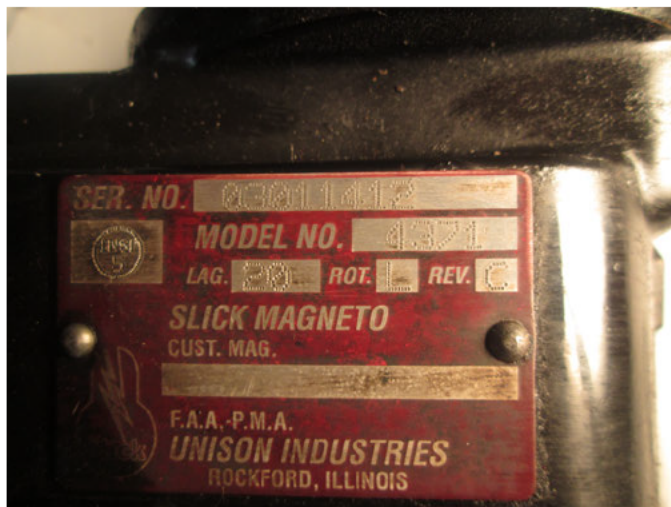
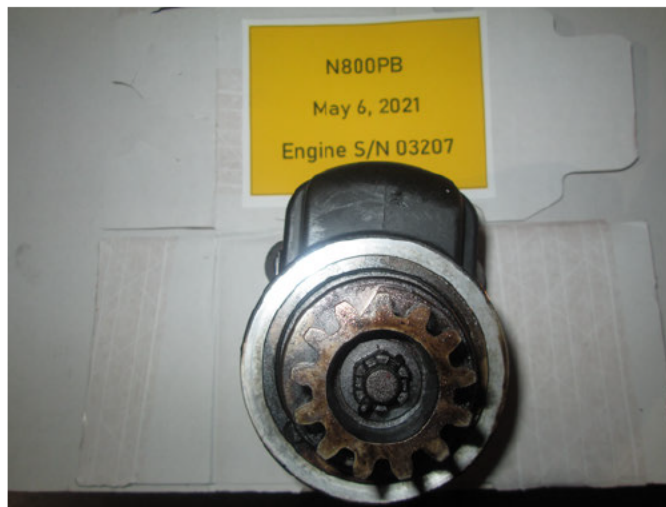
#### R/H Magneto

Condition: The right hand magneto exhibited thermal damage. The right hand magneto rotated freely when turned by hand and the drive gear was undamaged and exhibited normal operational signatures. There was no spark noted when rotated by hand.

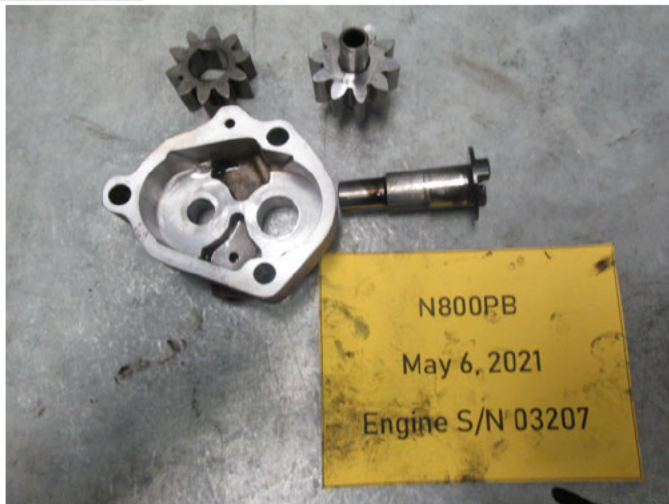
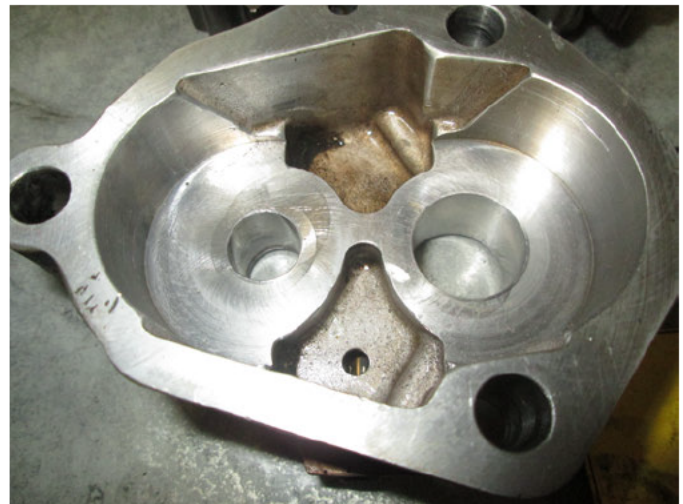
Oil Pump    Condition: The oil pump was intact and exhibited normal operational signatures. The oil pump body had no scratches or abnormal wear signatures. There was no sign of hard particle passage or damage to the pump gears. The oil pump drive was intact and exhibited no damage.

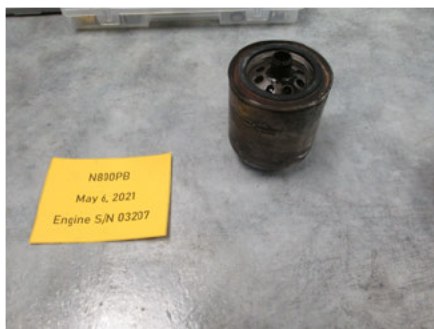
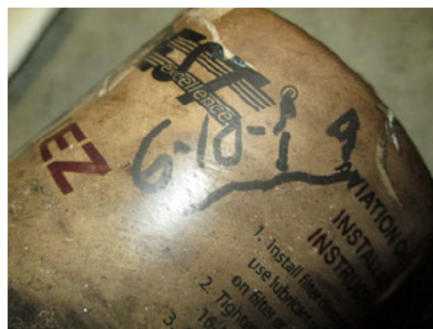
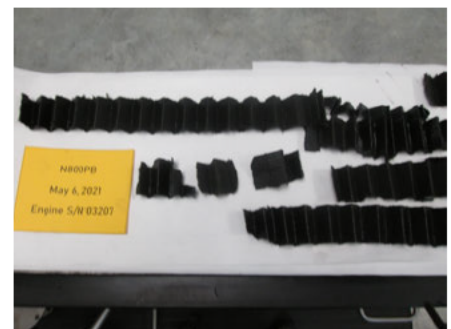
Oil Filter    Manufacturer: Tempest    Part number: AA48110-2

Condition: The oil filter was intact and safety wired to the oil filter adapter pad. The oil filter was removed and cut open for examination. The oil filter exhibited no metal or foreign material in the pleats. The outside of the oil filter was marked 06-10-1?. It is difficult to determine the last digit noting the year. The number of hours at installation was not indicated on the oil filter.

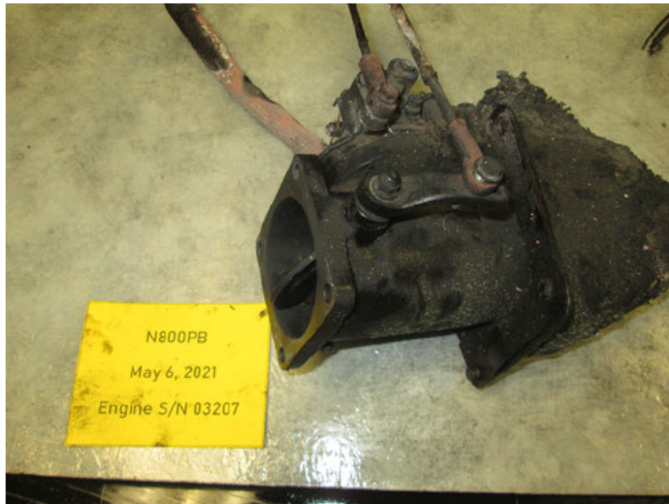
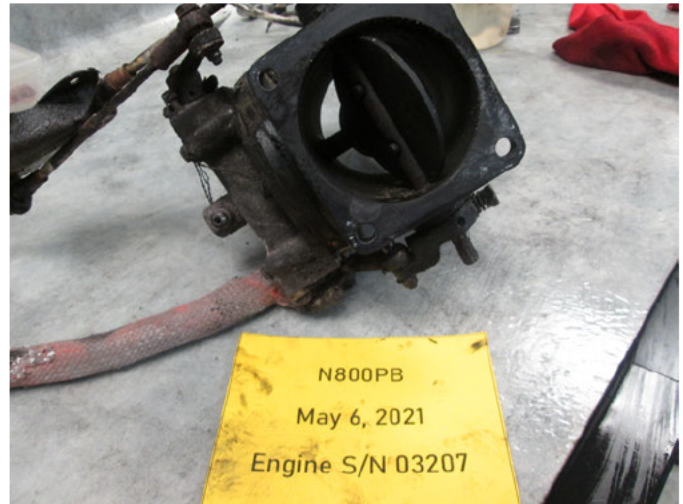
# Fuel Servo

Condition: The fuel injection servo exhibited damage and discoloration from thermal exposure. The link rod and throttle moved freely through its full range of travel.

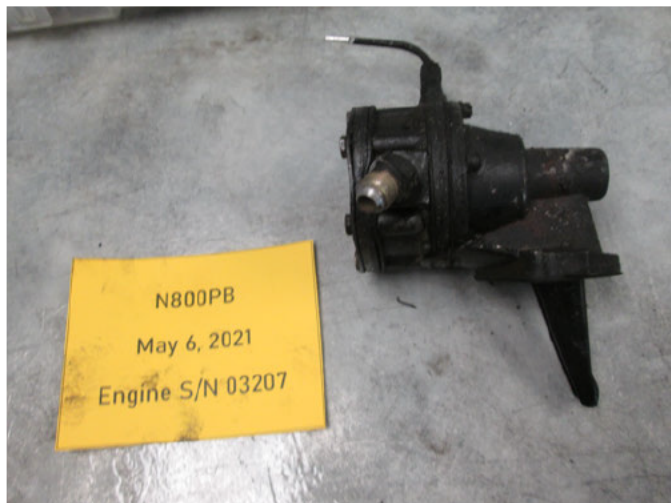
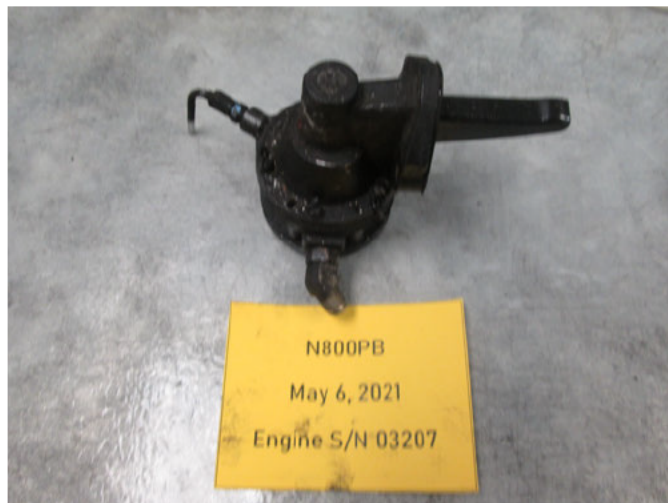
#### Fuel Pump

Condition: The fuel pump was intact and the actuator arm moved freely by hand. The fuel pump exhibited damage and discoloration from thermal exposure.

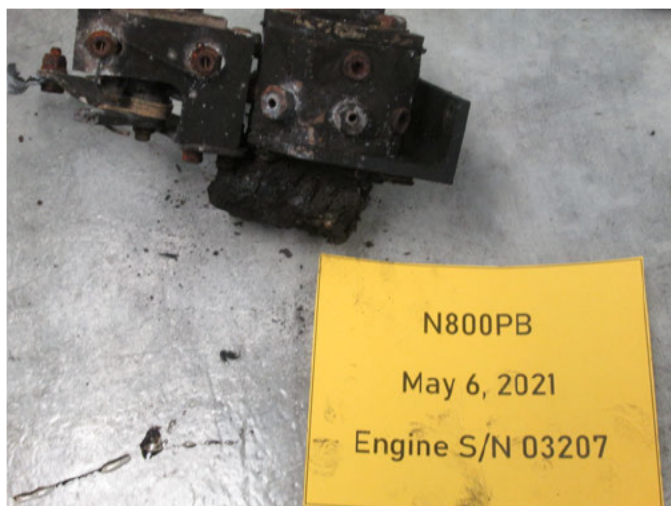
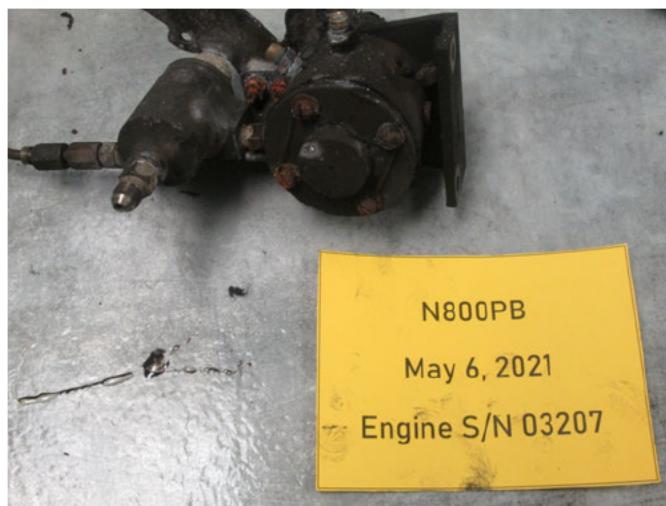
Fuel Manifold Valve    Manufacturer: Illegible    Part Number: Illegible    Serial #: Illegible

Condition: The manifold valve exhibited damage and discoloration from thermal exposure.

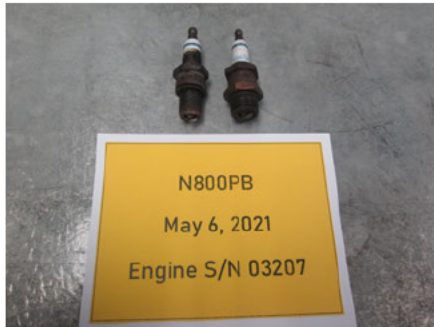
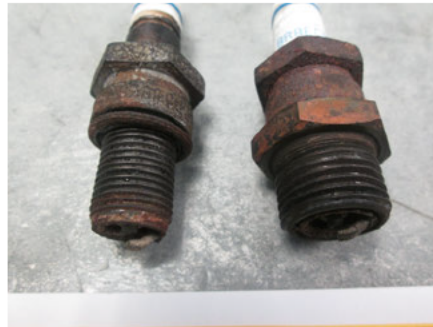
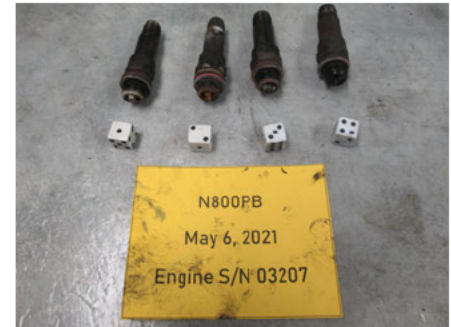
### Spark Plugs

Condition: The top spark plugs were automotive type and the bottom plugs were aviation type. The spark plugs exhibited worn normal signatures as compared to the Champion Aviation Check A Plug comparison chart.

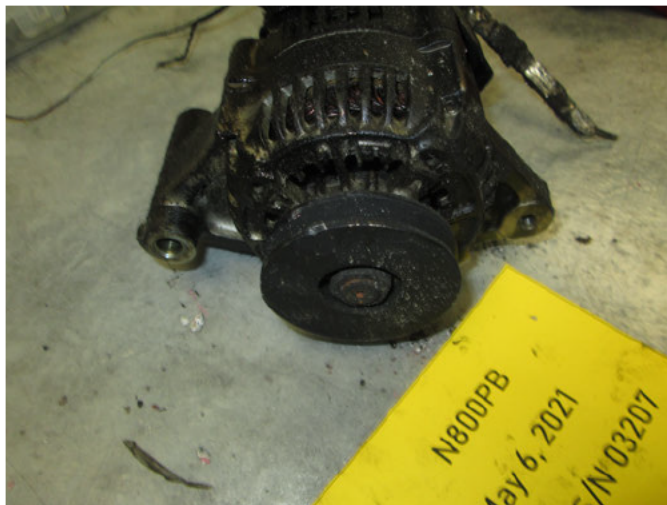
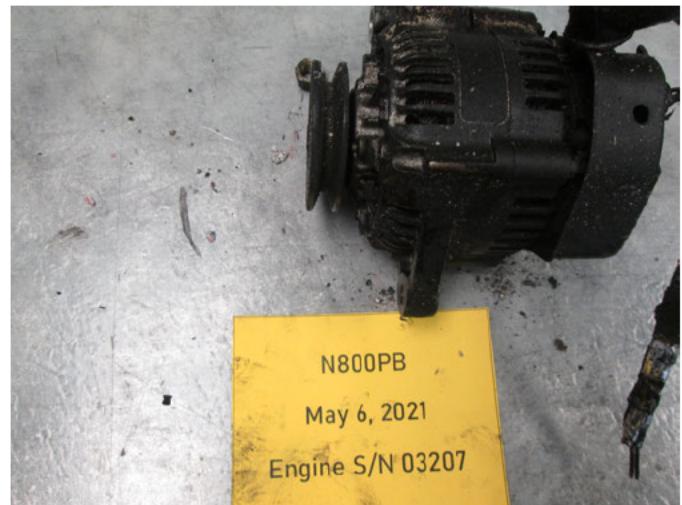
### Alternator/Generator

Condition: The alternator exhibited thermal discoloration and damage. The alternator rotated freely by hand.

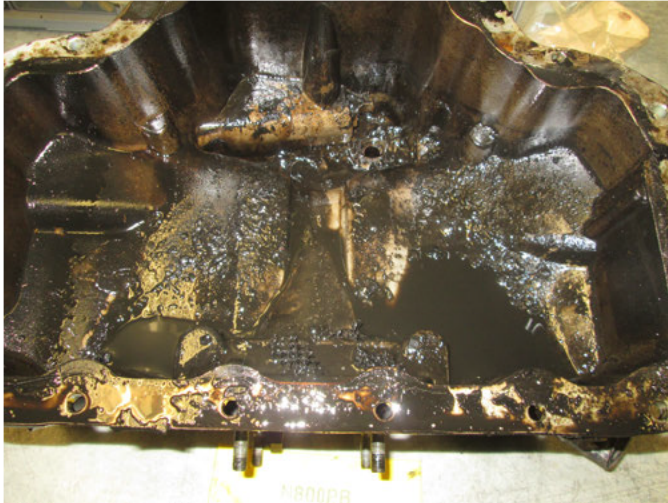
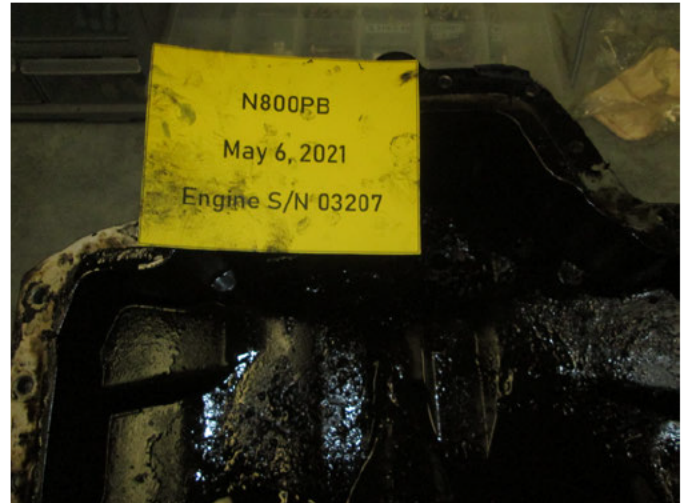
#### Oil Sump

Condition: The oil sump contained only a residual amount of oil. The oil drain plug was intact and safety wired. The oil sump contained various metallic particles. The sump also contained an unidentified honeycomb type of material.

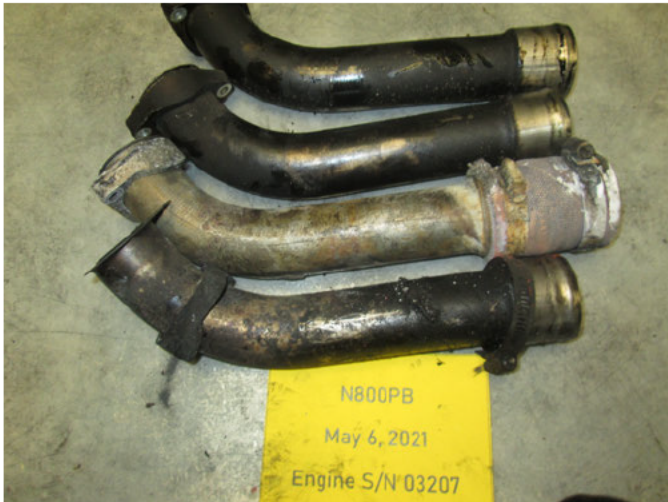
#### Induction System

Condition: The induction system was intact and exhibited thermal discoloration.

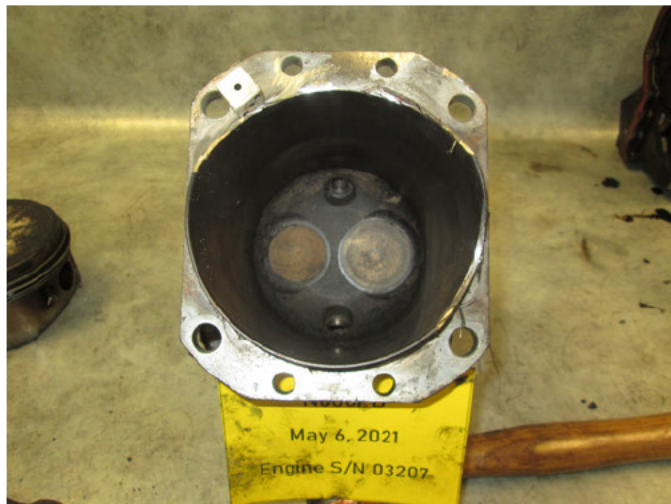
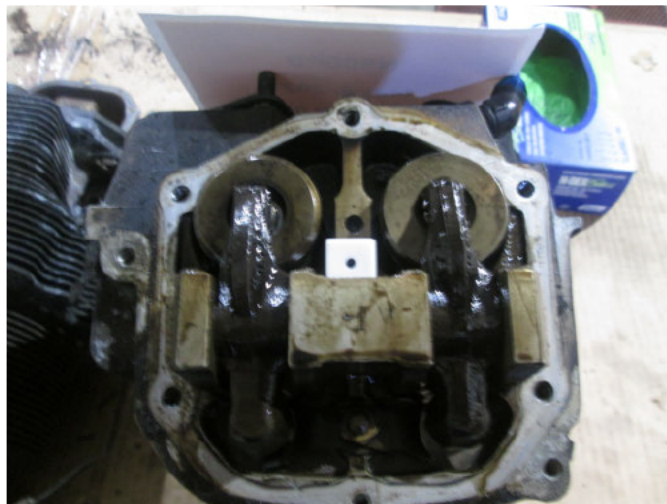
Cylinder #1 Part Number: SL36006W-A20P

Condition: The cylinder exhibited mechanical damage to the skirt. The skirt required cutting to facilitate removal of the piston from the cylinder. The cylinder bore exhibited rust but otherwise normal wear and operational signatures. The intake and exhaust valves exhibited normal operational signatures.

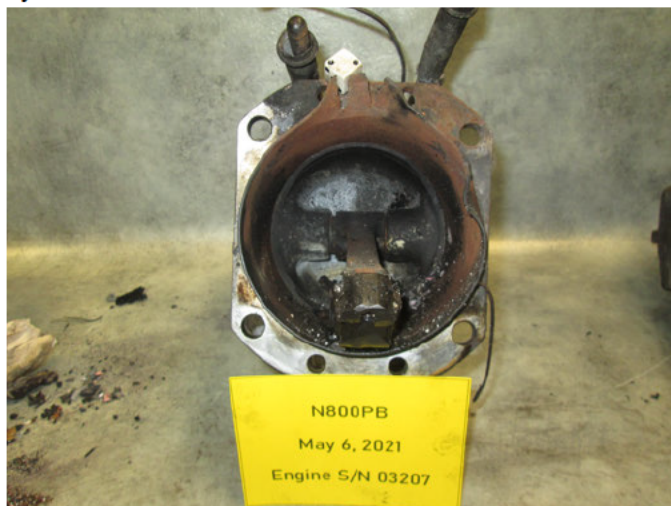
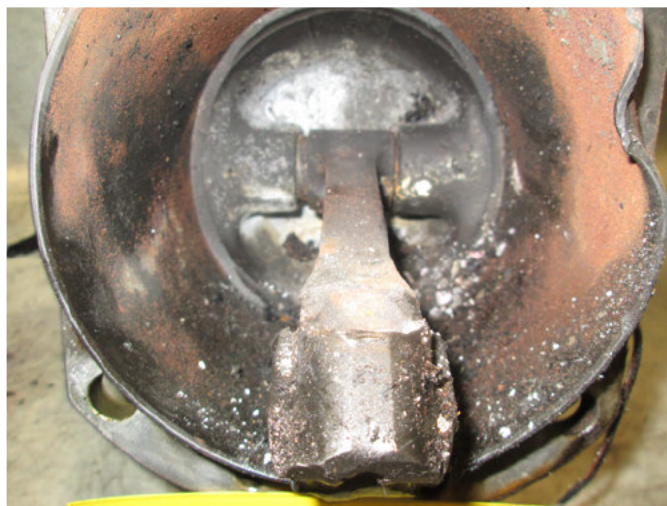
Cylinder #2 Part Number: SL36006W-A20P

Condition: The number 2 cylinder and connecting rod exhibited extensive mechanical damage. The cylinder skirt was mechanically removed using a cutting wheel in order to facilitate removal of the piston and connecting rod. The piston and connecting rod remnants could not be removed from the cylinder. The visible portion of the cylinder bore exhibited rust. The intake and exhaust valves could not be accessed due to the inability to remove the piston from the cylinder.

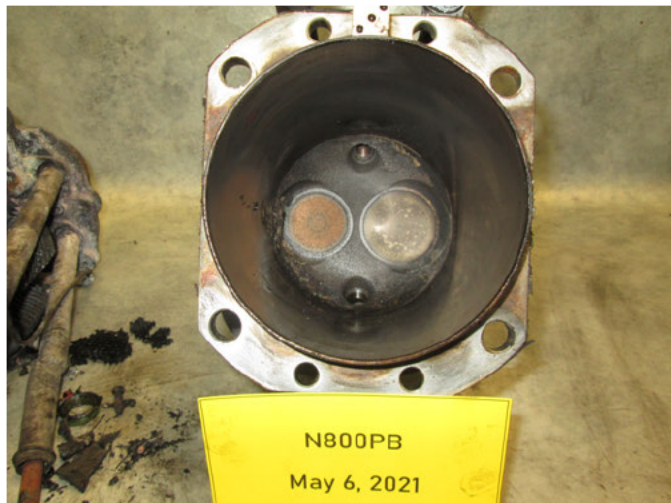
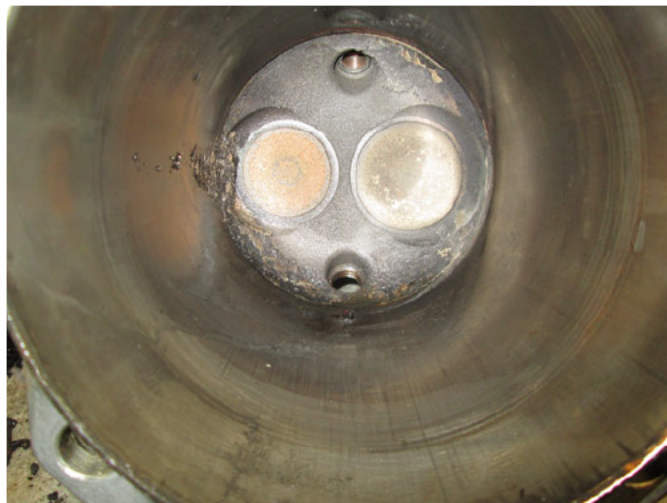
Cylinder #3 Part Number: SL36006W-A20P

Condition: The cylinder bore exhibited rust but otherwise normal wear and operational signatures. The intake and exhaust valves exhibited normal operational signatures.

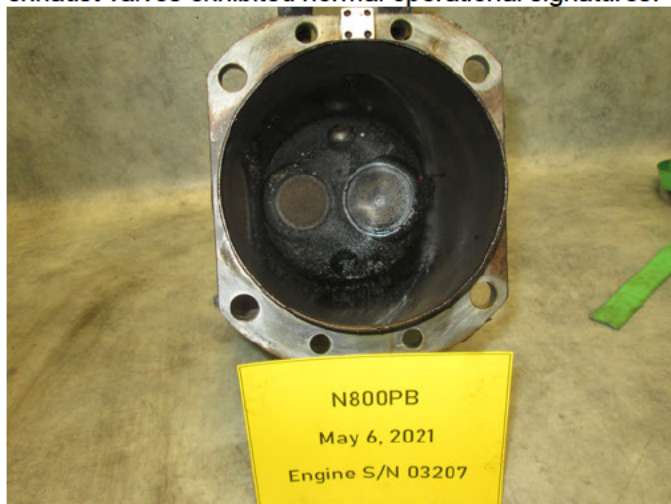
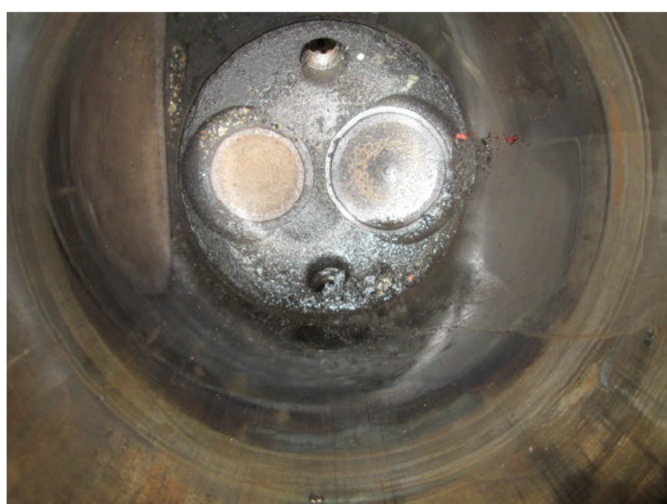
Cylinder #4 Part Number: SL36006W-A20P

Condition: The cylinder bore exhibited rust but otherwise normal wear and operational signatures. The intake and exhaust valves exhibited normal operational signatures.

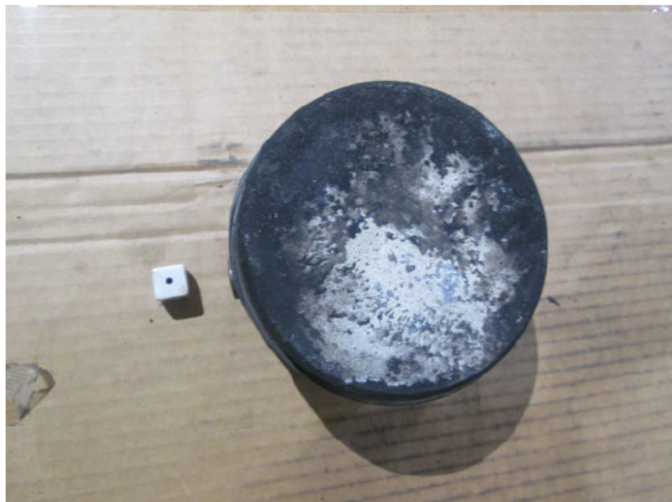
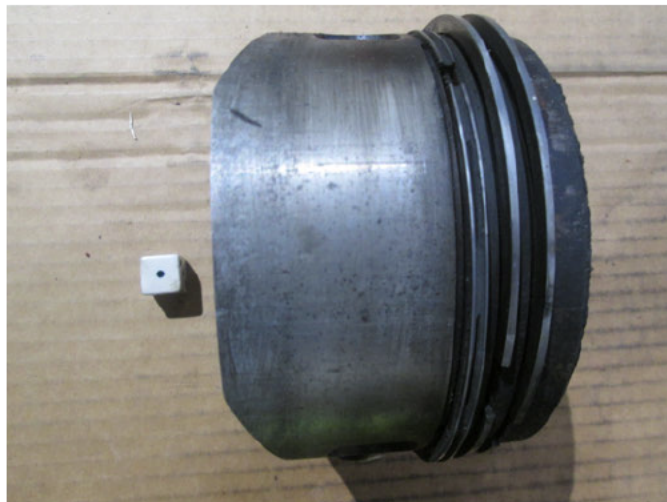
#1 Piston, Rings and Pin      Piston Part Number:      Illegible

Condition: The number 1 piston exhibited light combustion deposits on the face. The rings moved freely in the ring lands and there were no scoring or scuffing signatures present.

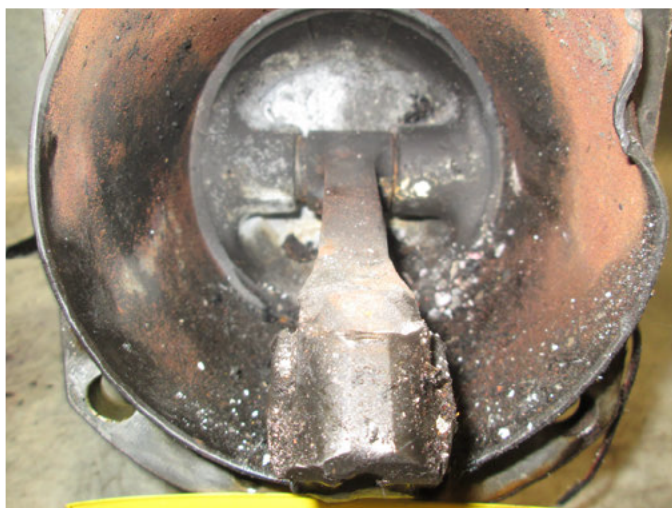
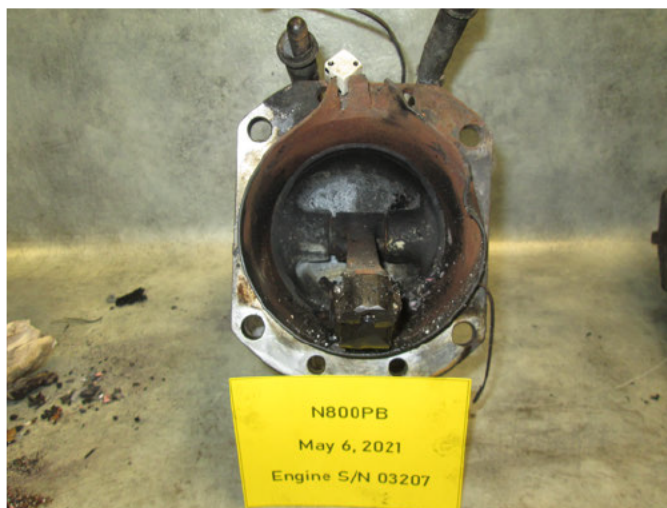
#2 Piston, Rings and Pin      Piston Part Number:      Illegible

Condition: The number 2 cylinder skirt was mechanically removed in order to attempt removal of the number 2 piston. The piston could not be removed from the cylinder.

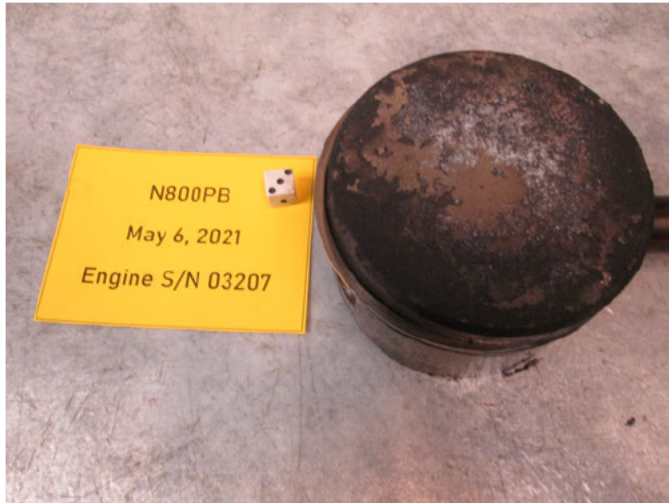
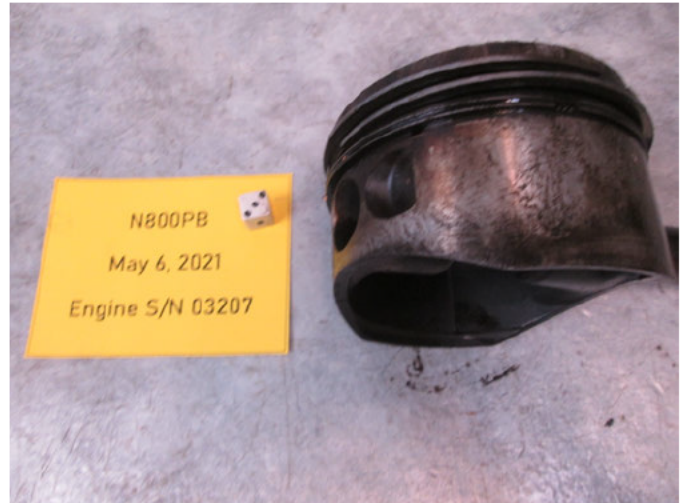
#3 Piston, Rings and Pin      Piston Part Number:    Illegible

Condition: The number 3 piston exhibited light combustion deposits on the face. The rings moved freely in the ring lands and there were no scoring or scuffing signatures present.

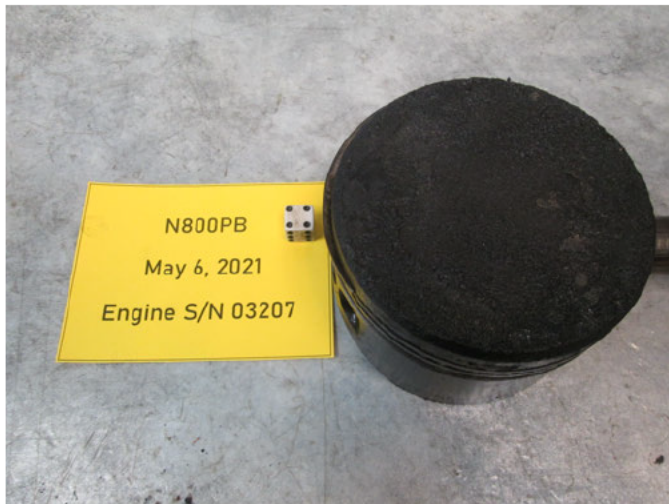
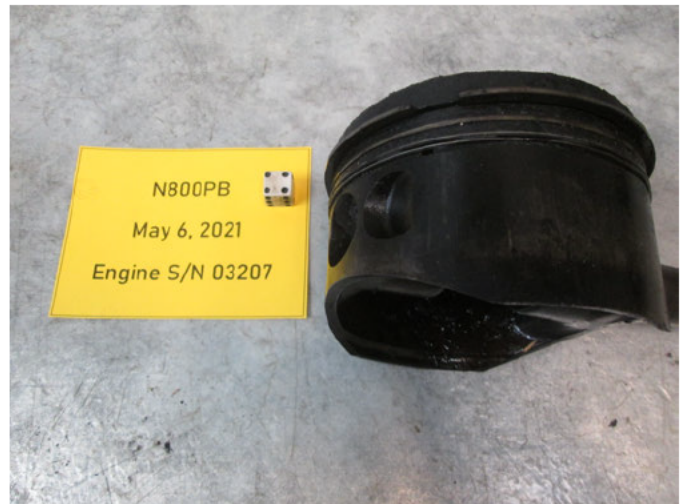
#4 Piston, Rings and Pin      Piston Part Number:    Illegible

Condition: The number 4 piston exhibited light combustion deposits on the face. The rings moved freely in the ring lands and there were no scoring or scuffing signatures present. The piston exhibited a dark appearance.

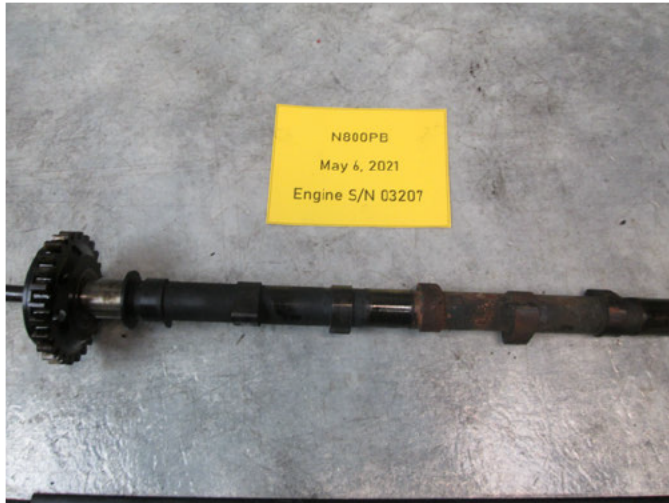
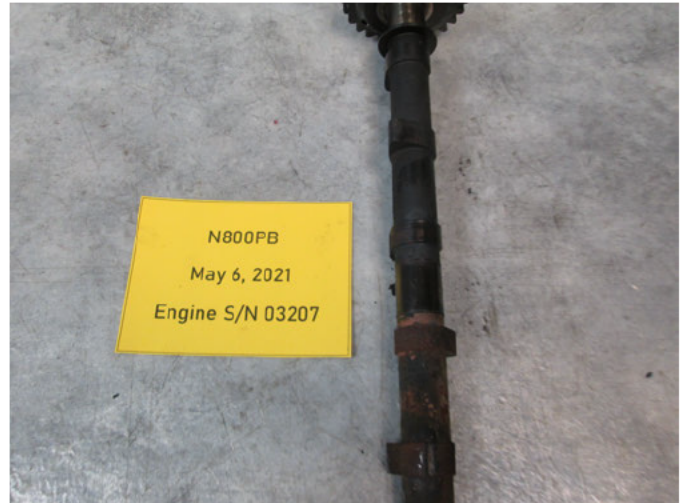
Camshaft P/N SL18840

Condition: The camshaft exhibited rust on the shaft and lobes. The camshaft exhibited normal wear signatures. The camshaft gear was intact, undamaged and exhibited normal operational signatures.

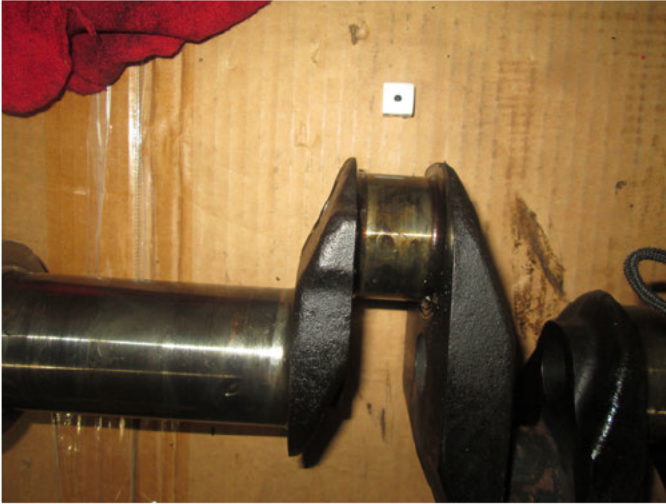
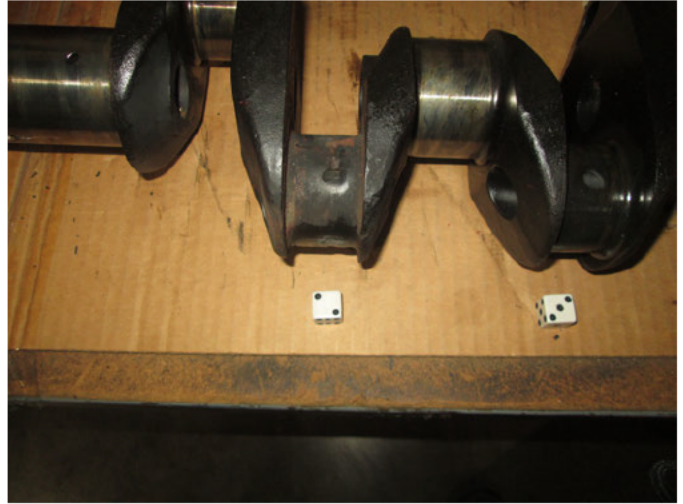
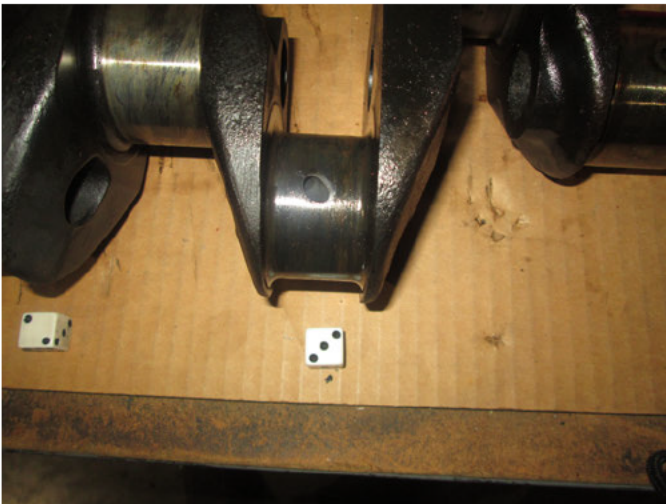
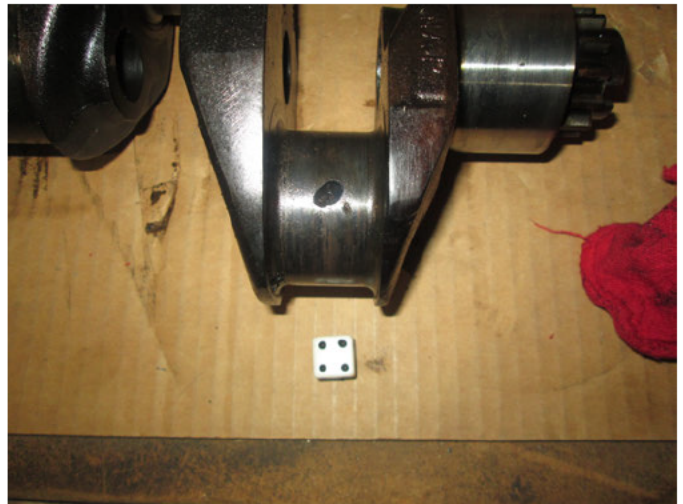
Crankshaft P/N SL36500-A31

Condition: The crankshaft exhibited severe lubrication distress signatures on all connecting rod bearing journals consistent with a systemic loss of oil pressure. The number 2 connecting rod journal exhibited extreme lubrication distress signatures resulting in obliteration of the connecting rod bearing and cap. All main bearing journals exhibited some lubrication distress signatures. The crankshaft propeller flange was intact and exhibited normal operational signatures. The crankshaft gear was intact, secure and exhibited normal operational signatures.

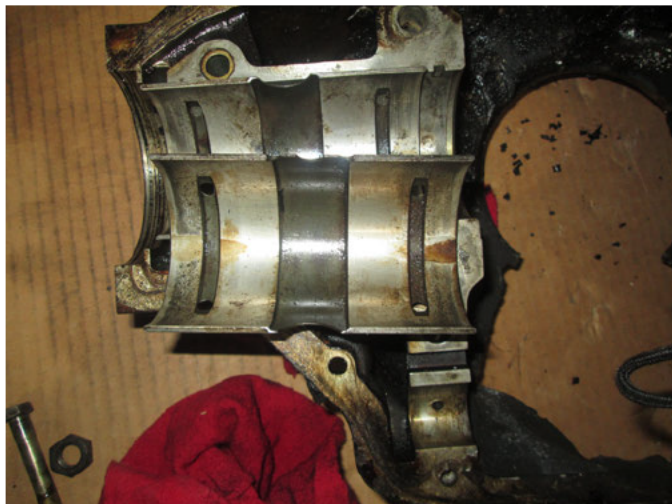
#### #1 Main Bearings

Condition The number 1 main bearing exhibited slight lubrication distress.

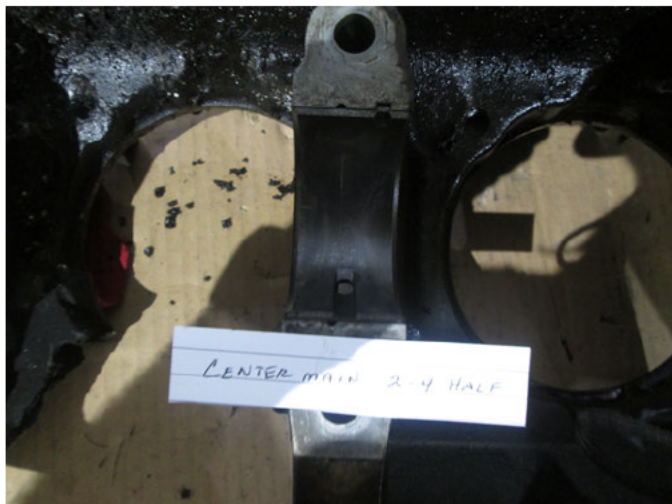
#### #2 Main Bearings

Condition The number 2 main bearing exhibited lubrication distress.

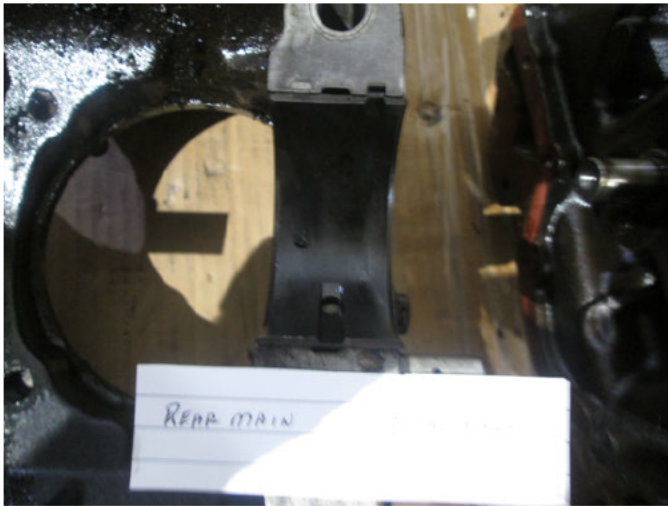
### #3 Main Bearings

Condition The number 3 main bearing exhibited lubrication distress.

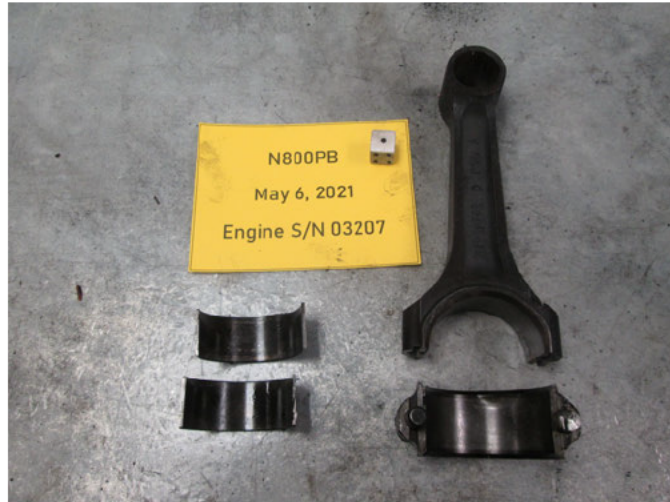
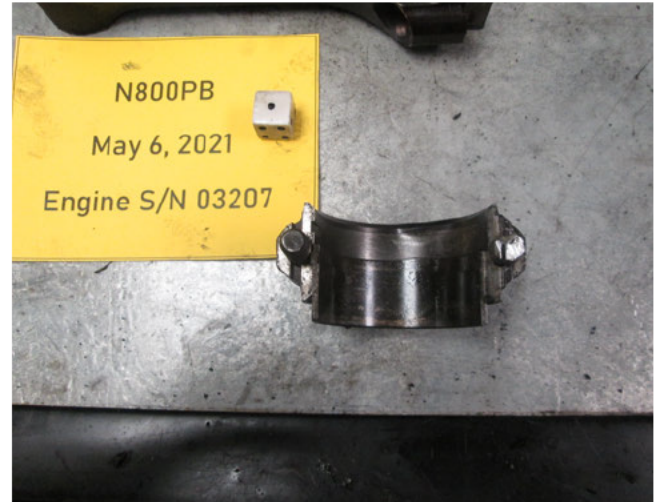
Condition: The number 1 connecting rod was intact and exhibited thermal discoloration from lubrication distress. The connecting rod top nut required cutting for removal due to mechanical damage an inability to securely fasten a wrench to the nut flats. This was required in order to facilitate the removal of the 1-3 side of the crankcase. .

Condition: The number 1 connecting rod bearing exhibited lubrication distress and smearing of the Babbitt exposing the copper layer.

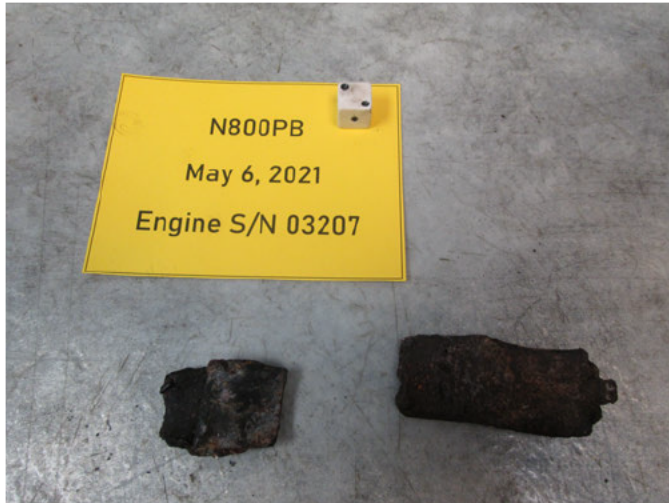
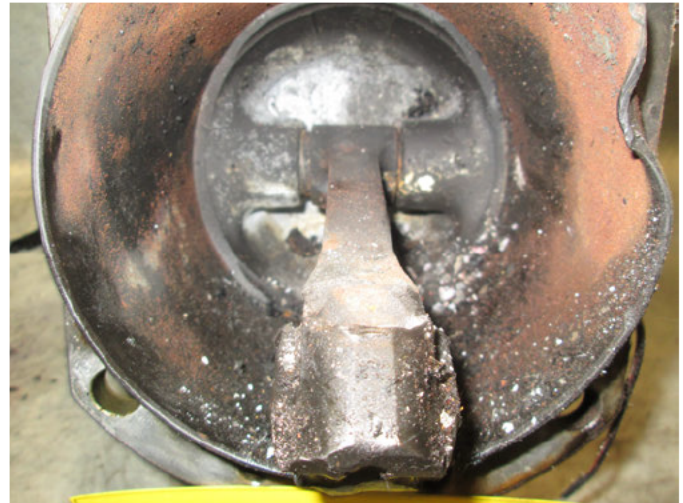
Condition: The number 2 connecting rod exhibited extreme mechanical damage. The connecting rod cap was returned in a box separate from the engine and exhibited extreme mechanical damage. The number 2 connecting rod could not be removed from the crankcase.

Condition: Only fragments of the number 2 connecting rod bearing could be found in the oil sump.

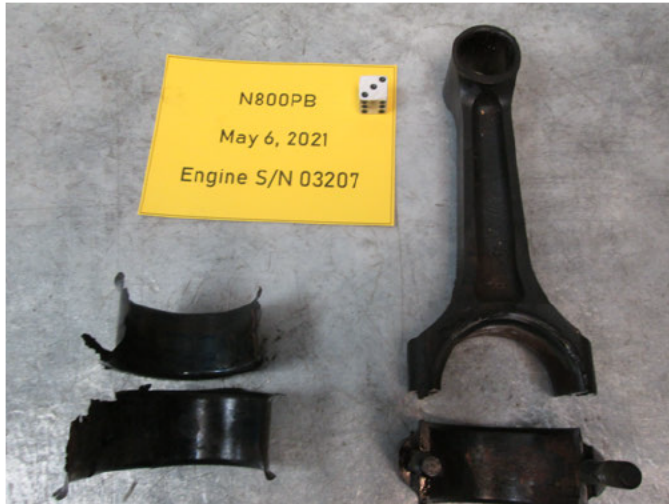
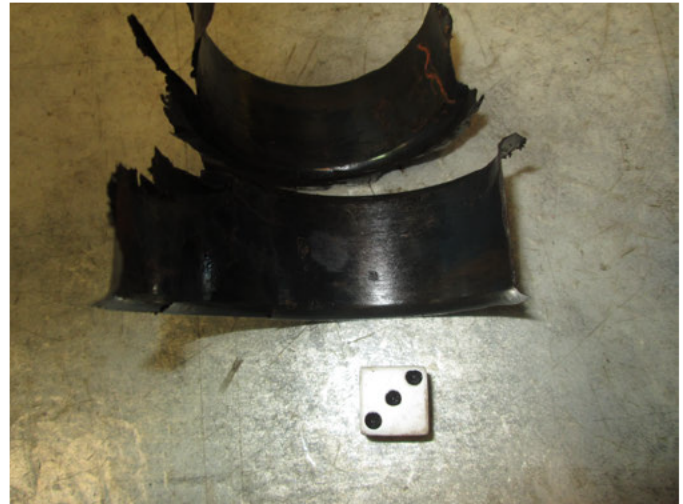
Condition: The connecting was intact and exhibited thermal discoloration from lubrication distress.

Condition: The number 3 connecting rod bearing exhibited extreme lubrication distress and smearing of the Babbitt exposing the copper layer. The number 3 bearing was extruded.

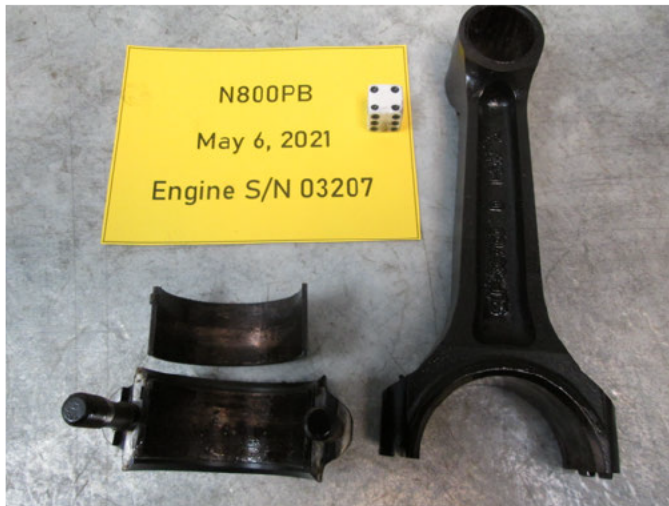
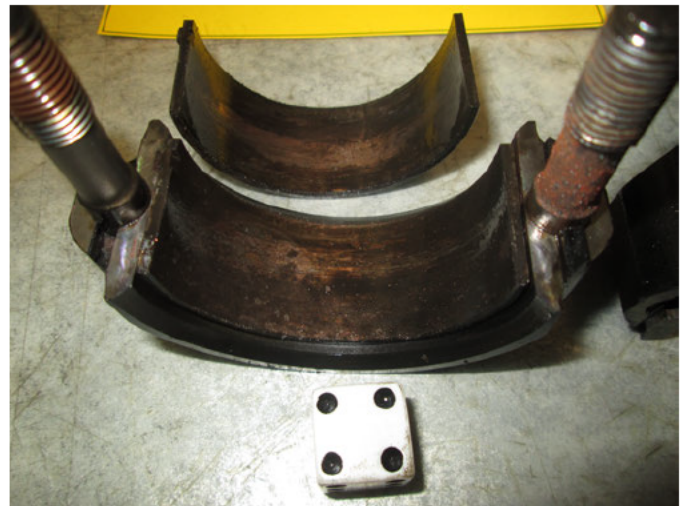
Condition: The number 4 connecting rod was intact and exhibited thermal discoloration from lubrication distress.

Condition: The number 4 connecting rod bearing exhibited severe lubrication distress and smearing of the Babbitt exposing the copper layer.
