## ENGINE ANALYTICAL INSPECTION REPORT

ENGINE MODEL: IO360B1DA2

ENGINE SERIAL: 03207

REGISTRATION: N800PB

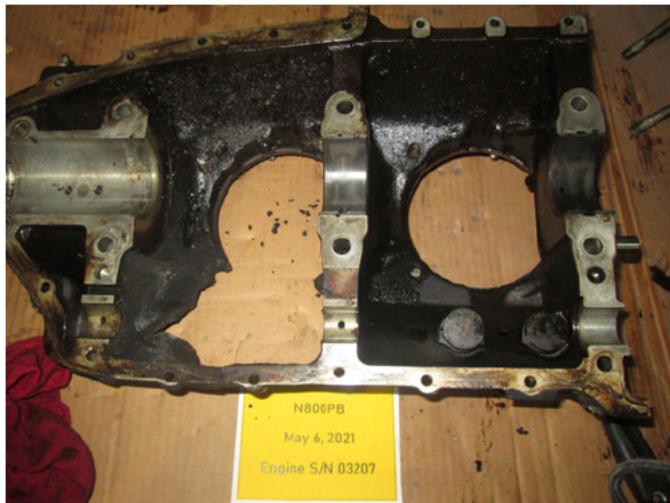
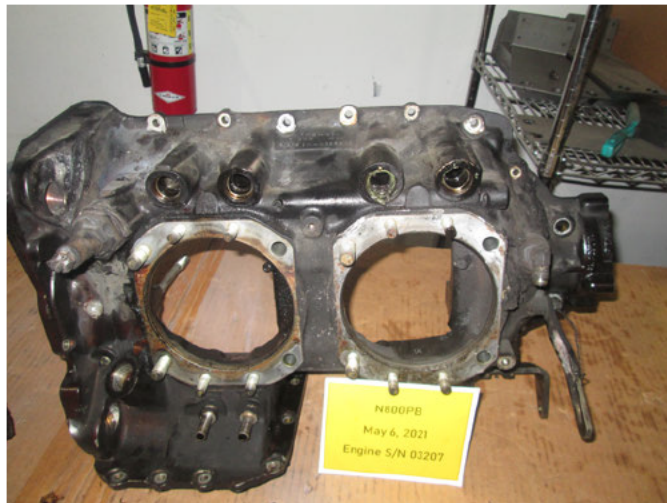
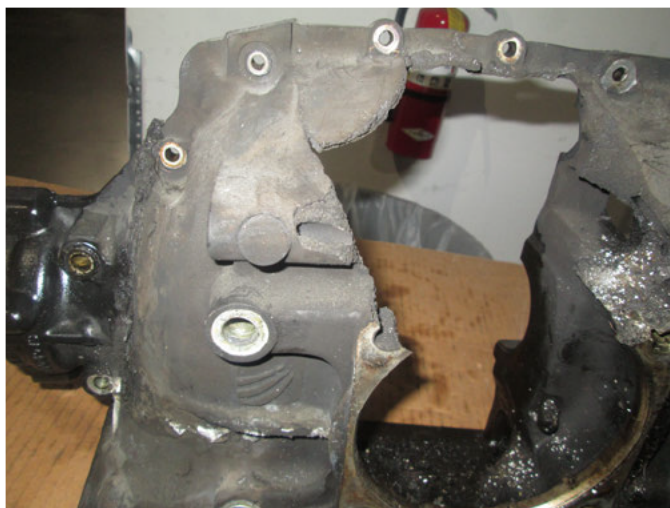
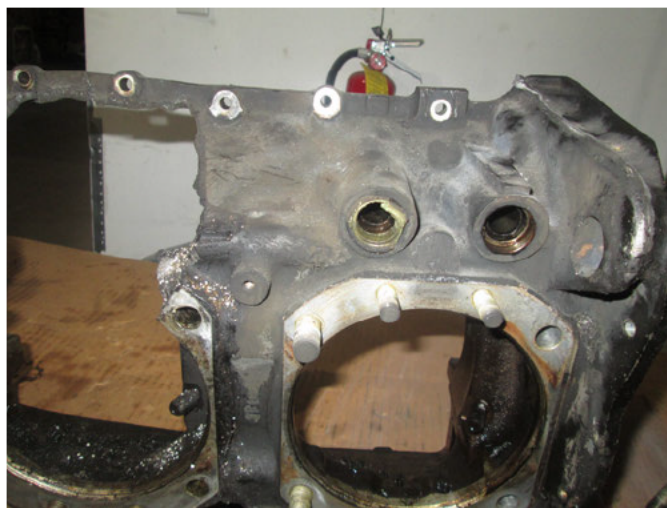
Crankcase P/N SL36800-W11 Serial Number: S0207

Condition: The crankcase was fractured above the number 2 cylinder mounting deck. There was approximately a 5 inch by 6 inch section missing. The crankcase exhibited discoloration from thermal exposure. The main bearing saddles were intact and all oil galleries were clear of obstructions.
