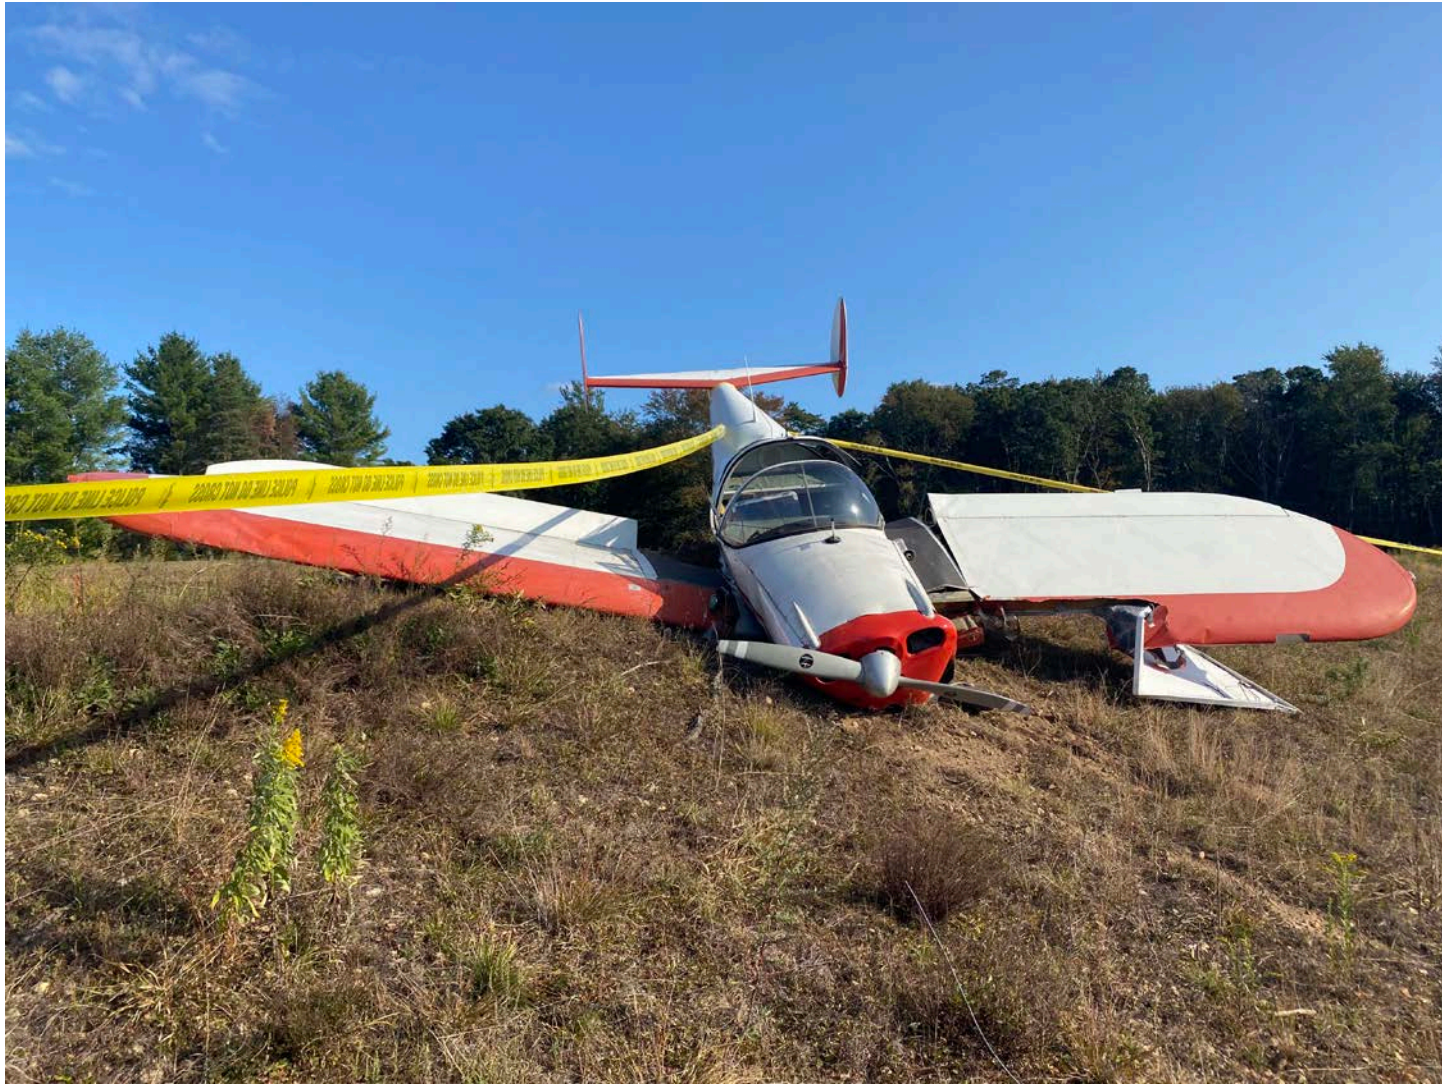
**Photo 1 – View of airplane resting on embankment. Both wings substantially damaged. Note panel embedded in leading edge of left wing. (Courtesy of FAA)**

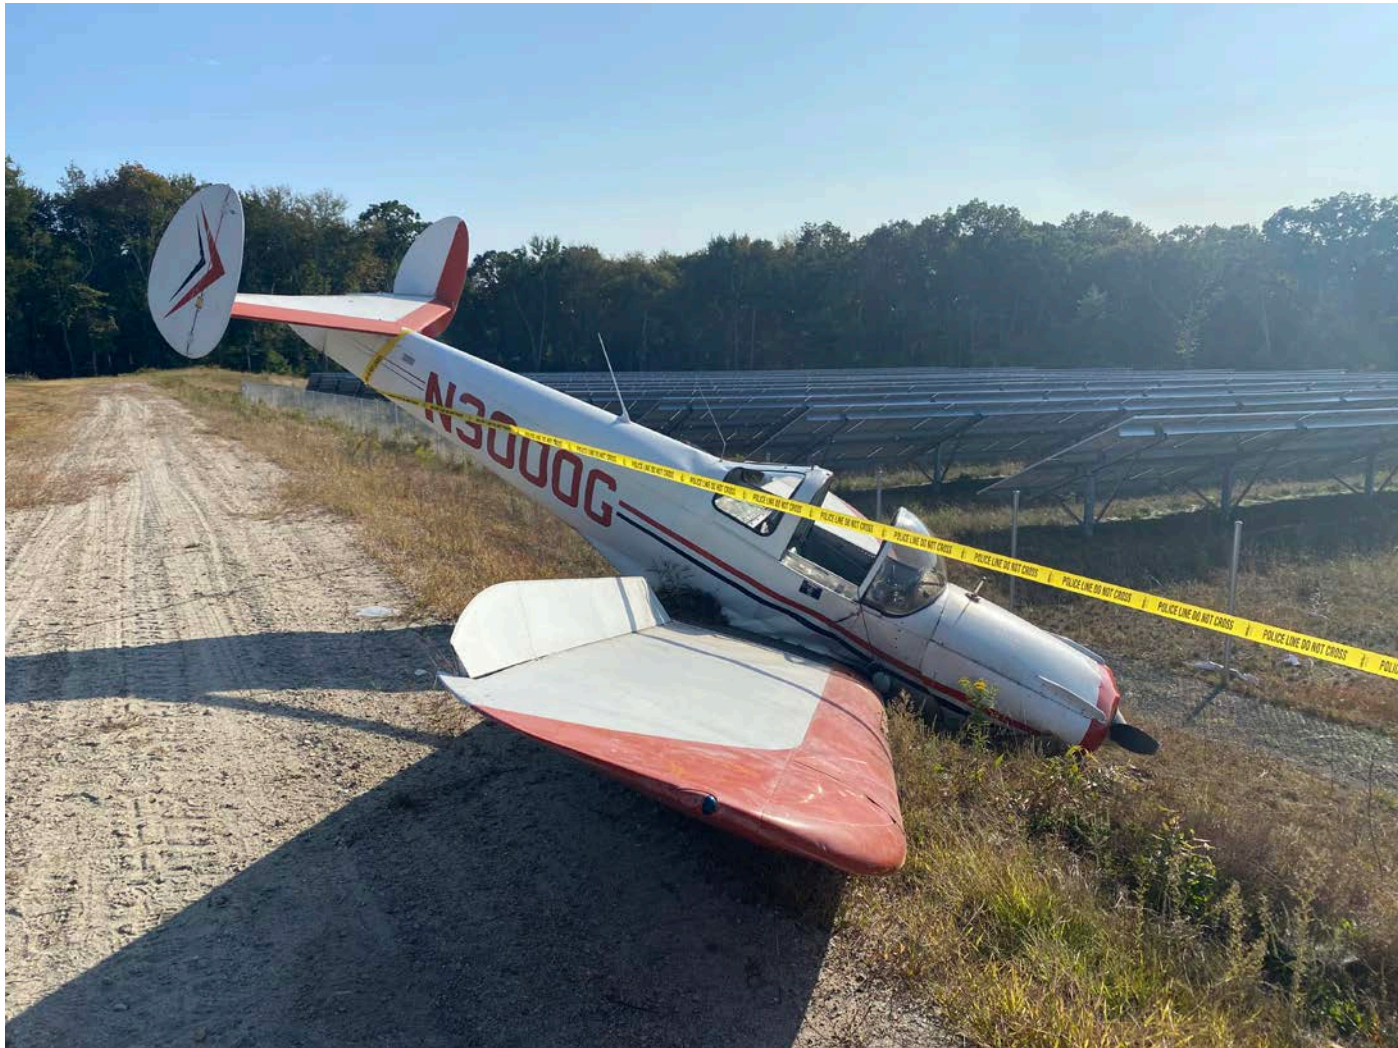
**Photo 2 – Right profile view of airplane damage. Note solar panels in background. (Courtesy of FAA)**

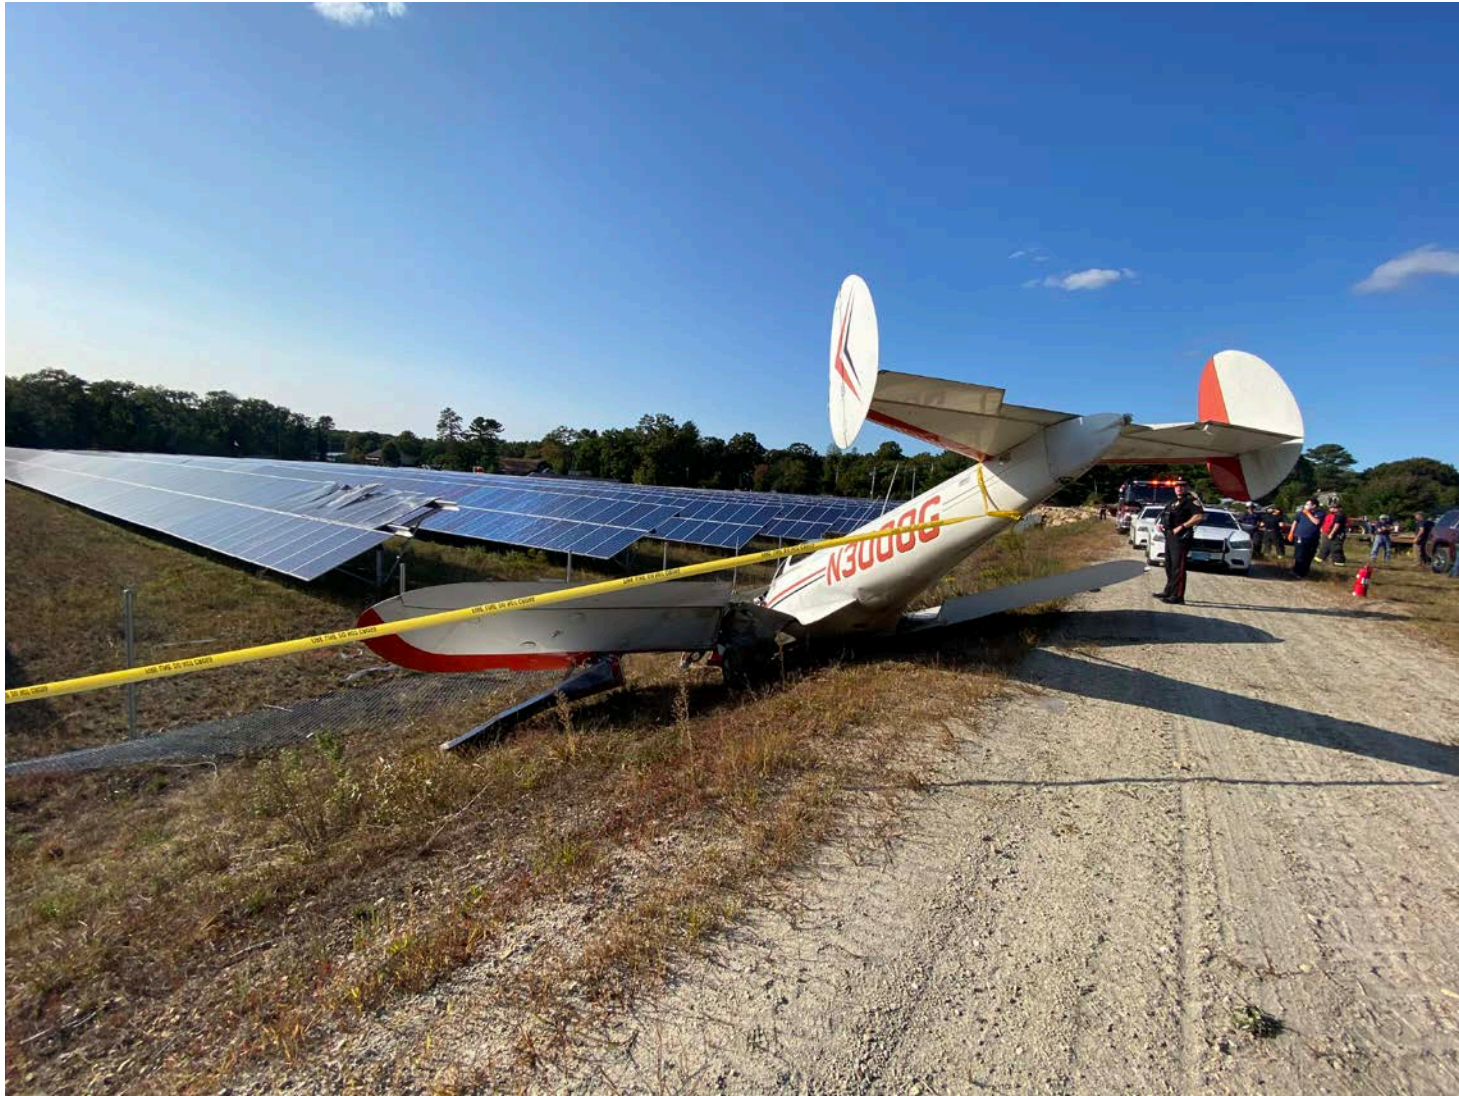
**Photo 3 – View of left aft quarter of airplane and damage, with damaged solar panels in background. (Courtesy of FAA)**

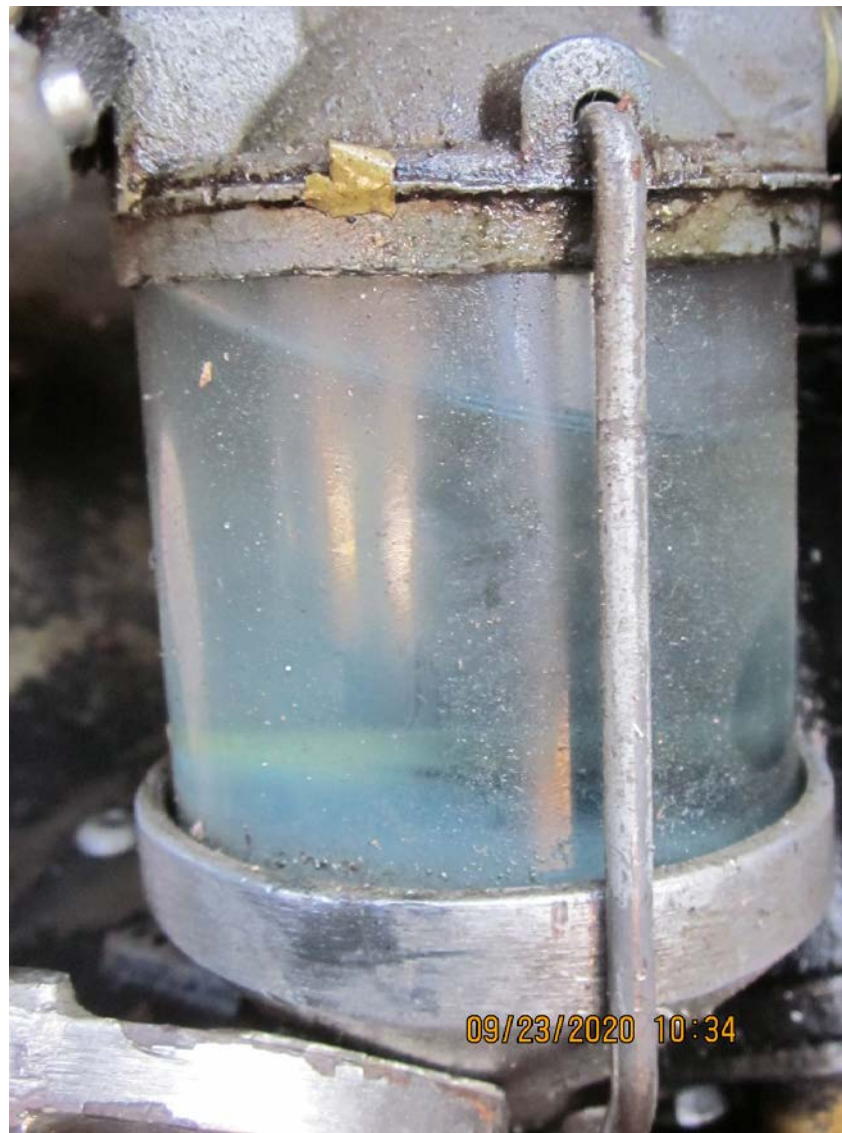
**Photo 4 – Photograph of fuel inside gascolator. (Courtesy of FAA)**

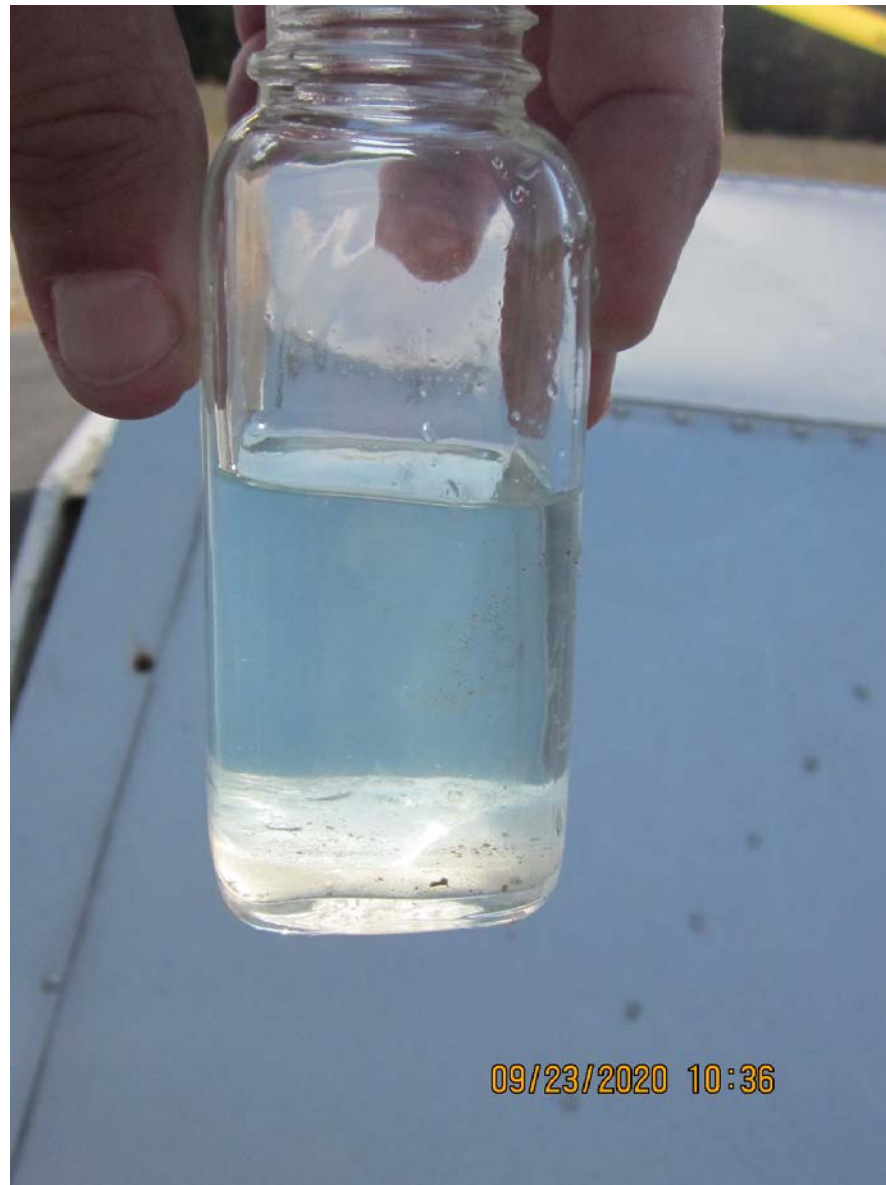
**Photo 5 – Photograph of drained fuel and water. (Courtesy of FAA)**

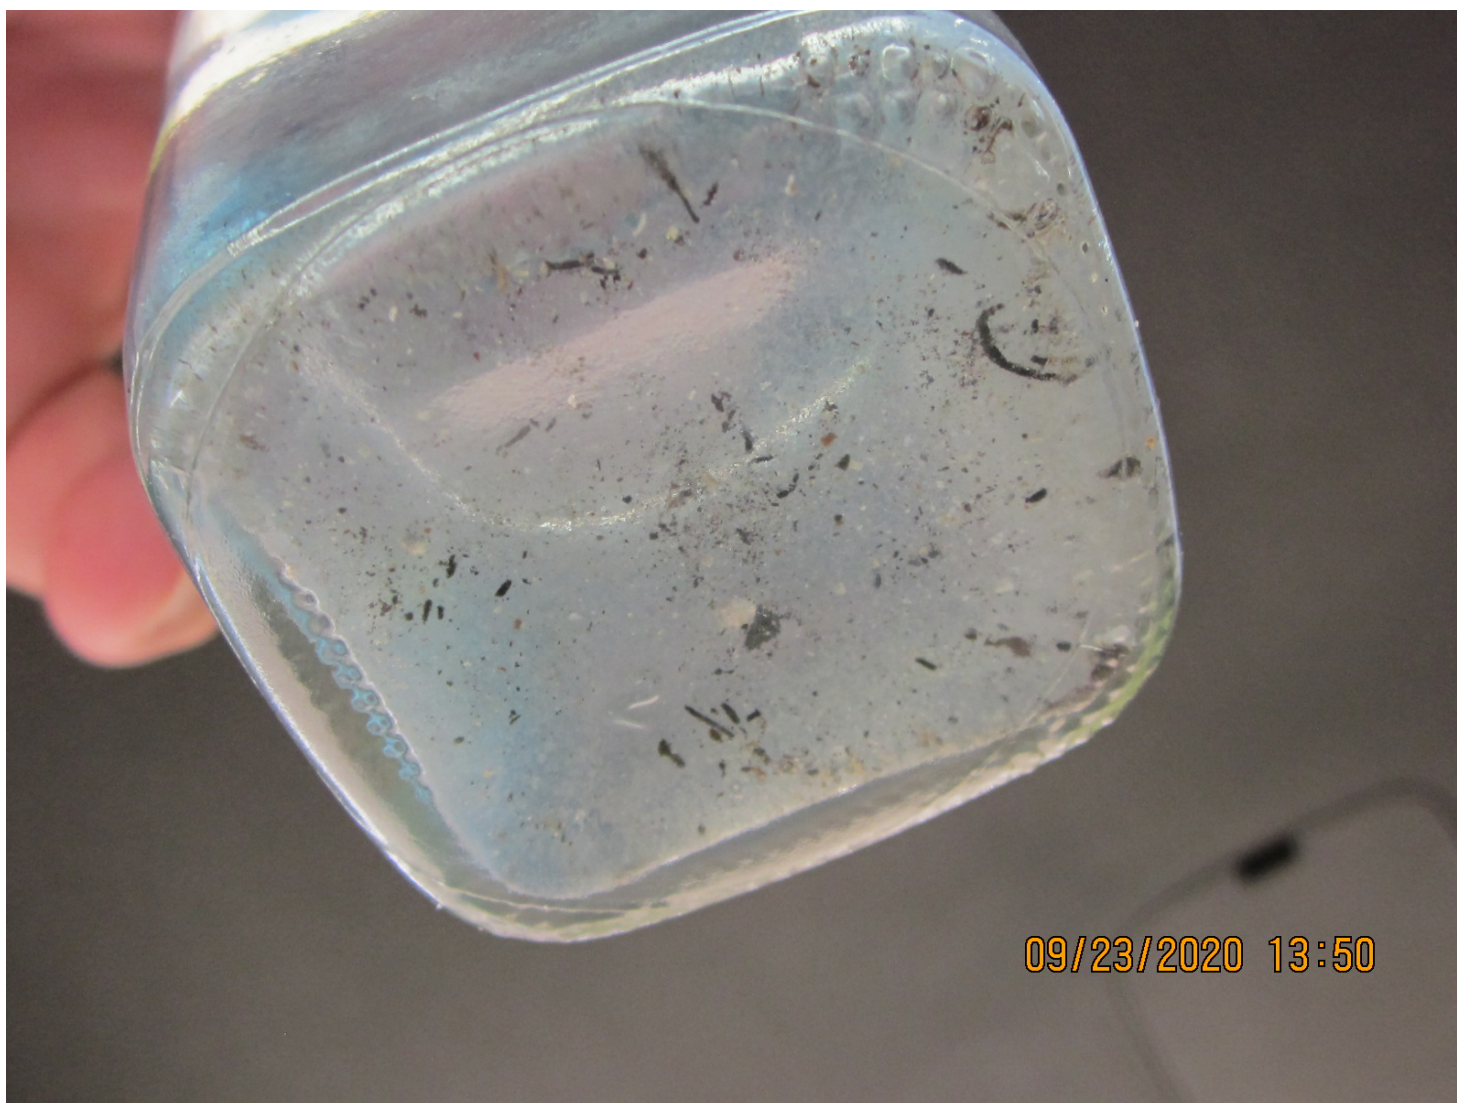
**Photo 6 – Photograph of fuel, water and debris on bottom of container. (Courtesy of FAA)**
